Natural England Commissioned Report NECR141

# New Forest SSSI Ecohydrological Survey Overview

**Annex G: Vales Moor and Foulford Bottom**

First published 06 March 2014

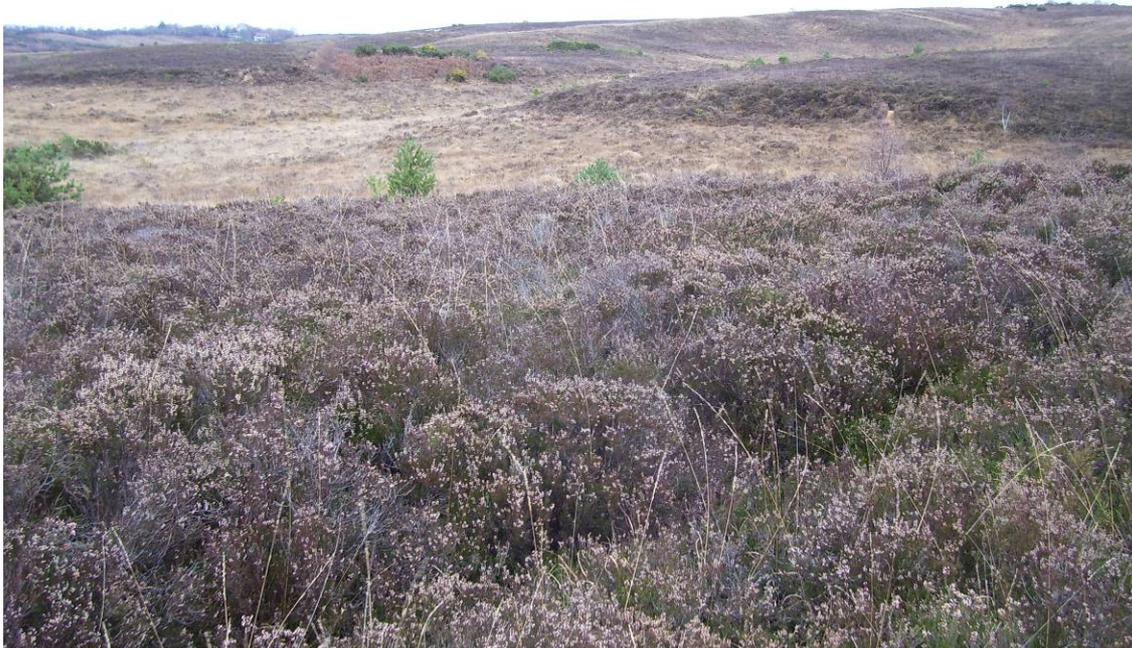
**Figure 1-2: General view of one of the valley mires (Unit 125) showing the break in slope associated with the base of the Becton Sand Formation (NGR 418792 104890)**

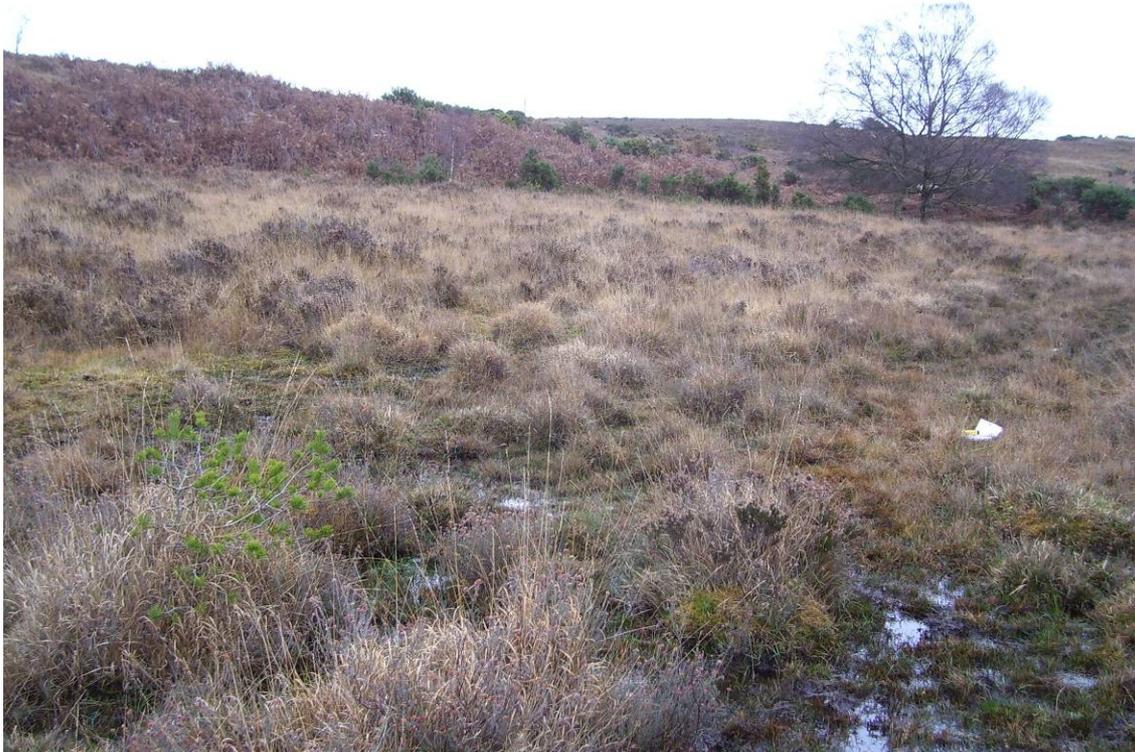
**Figure 1-3: Seepage (interpreted as being from the base of the Becton Sand Formation) at the head of the valley mire in Unit 132 (NGR 418655 104307)**

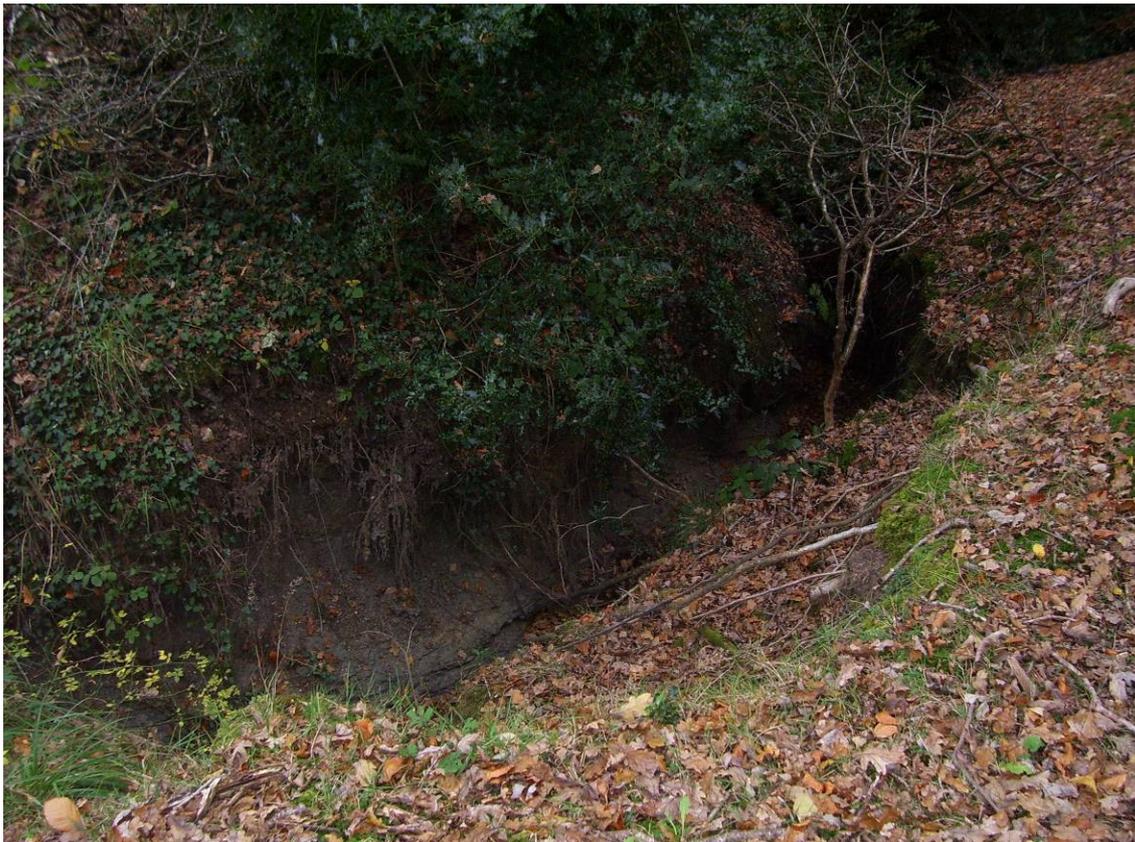
**Figure 1-4: Over-deepened channel (c.2 m deep) at outflow from Unit 133 (NGR 418413 104714)**

There are no areas of significant hydrological damage within the mire areas themselves. However, it would be prudent to monitor the outflow channels from Unit 133 for headward erosion (see Figure 1-7).

No ecohydrological restoration proposals are made for this site, but it is recommended that the outflow channels from Unit 133 be monitored to detect any further significant headward erosion. If a problem is identified then it may be necessary to take preventative measures by installing some kind of slope control. This could involve the use of staked heather bales (where flows are not too energetic), the installation of wooden weirs and/or the infilling or re-profiling of the channel. The engineering design of suitable measures would need to be based on a detailed study beyond the scope of this report.

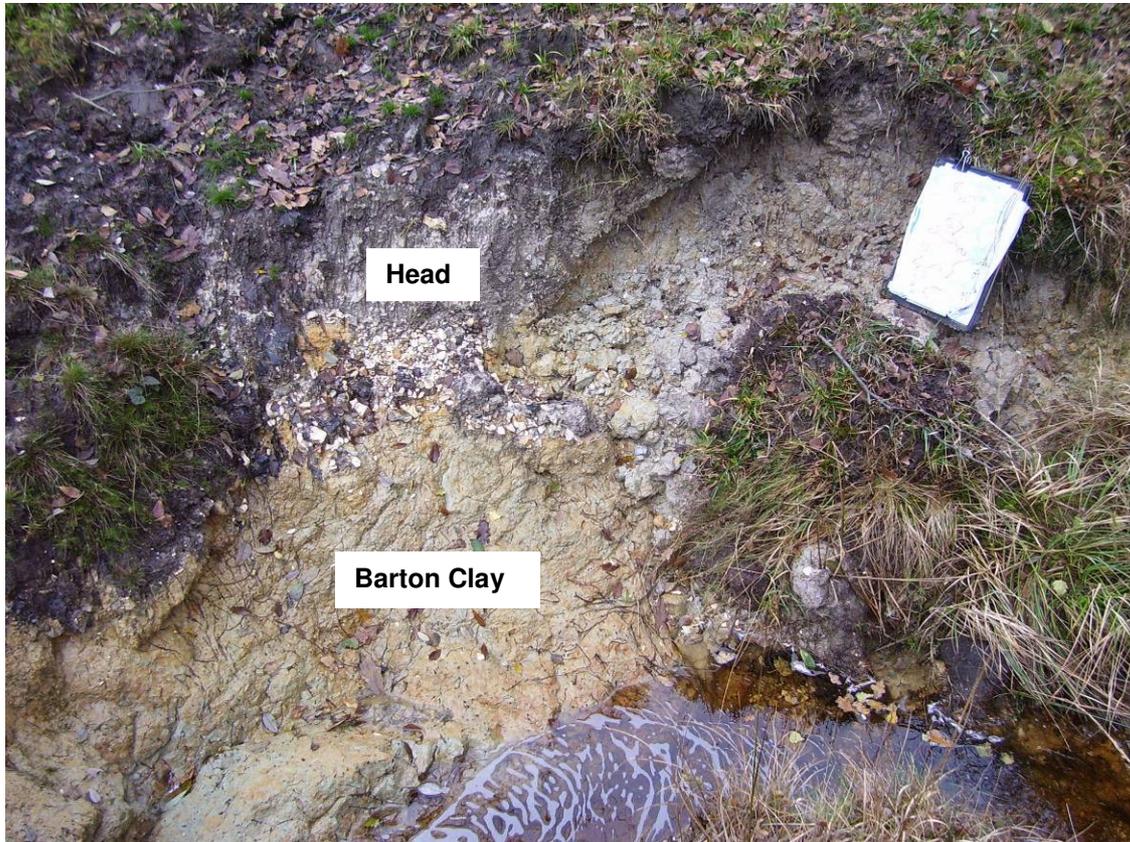
Figure 1-5: Evidence of bank failure in outflow channel from Unit 133 (NGR 418533 104664; the clipboard is 0.3 m long)

Table 1-2 shows the geology at Vales Moor and Foulford Bottom. Note that thin superficial head deposits (clay, silt, sand and gravel) cover most of the Tertiary Formations in the New Forest area and that only the thicker deposits are indicated on published 1:50,000 geology maps. No head is mapped within the Vales Moor and Foulford Bottom area, but thin head deposits are exposed within stream cuttings (Figure 1-5).

Hand augering undertaken during the site walkover survey found the Barton Sand Formation to consist of grey to grey/brown, very fine- to fine-grained, locally clayey sand with scattered flint pebbles. The Chama Sand Formation was found to consist of grey/brown sandy clay. The Barton Clay Formation, exposed in stream cuttings, was seen to consist of grey/buff/orange clay (Figure 1-5).

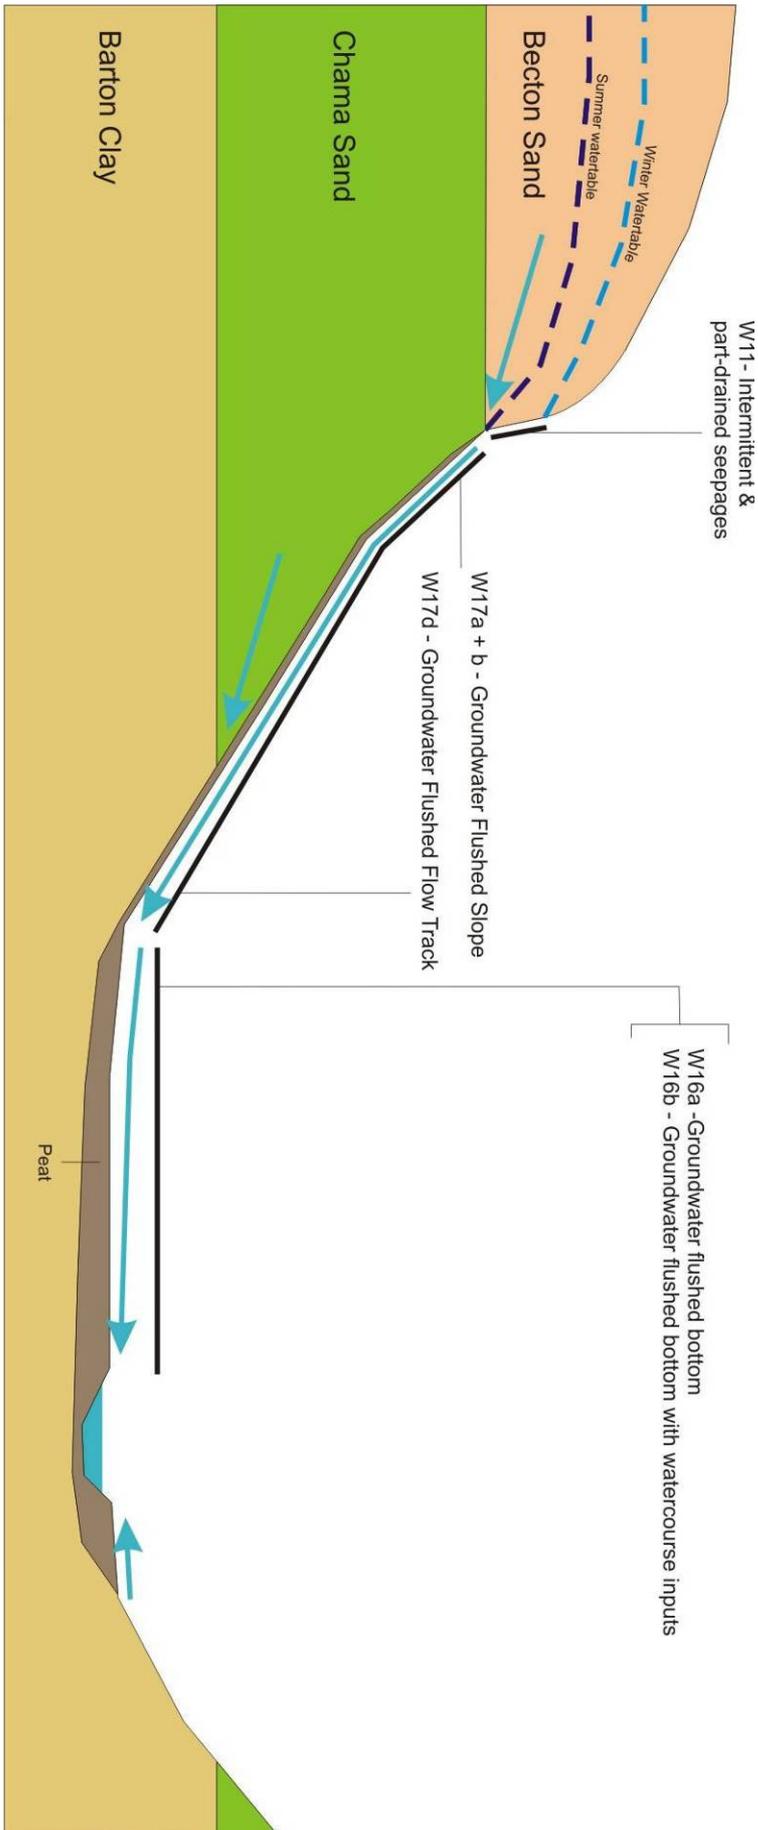
Figure 1-6: Conceptual Model Diagram (applicable to the whole EcoHAA)

The wetlands on site are flush dominated (see Figure 1-6). They receive water from a seepage face (i) at the junction between the Becton Sand Formation (aquifer) and the underlying Chama Sand Formation (aquifer/aquitard) and possibly also (ii), at the junction between the Chama Sand Formation (aquifer/aquitard) and the underlying Barton Clay Formation (aquitard)\*. The water runs over the surfaces of the lower permeability Chama Sand and Barton Clay Formations, forming flushed slopes before reaching the valley bottoms.

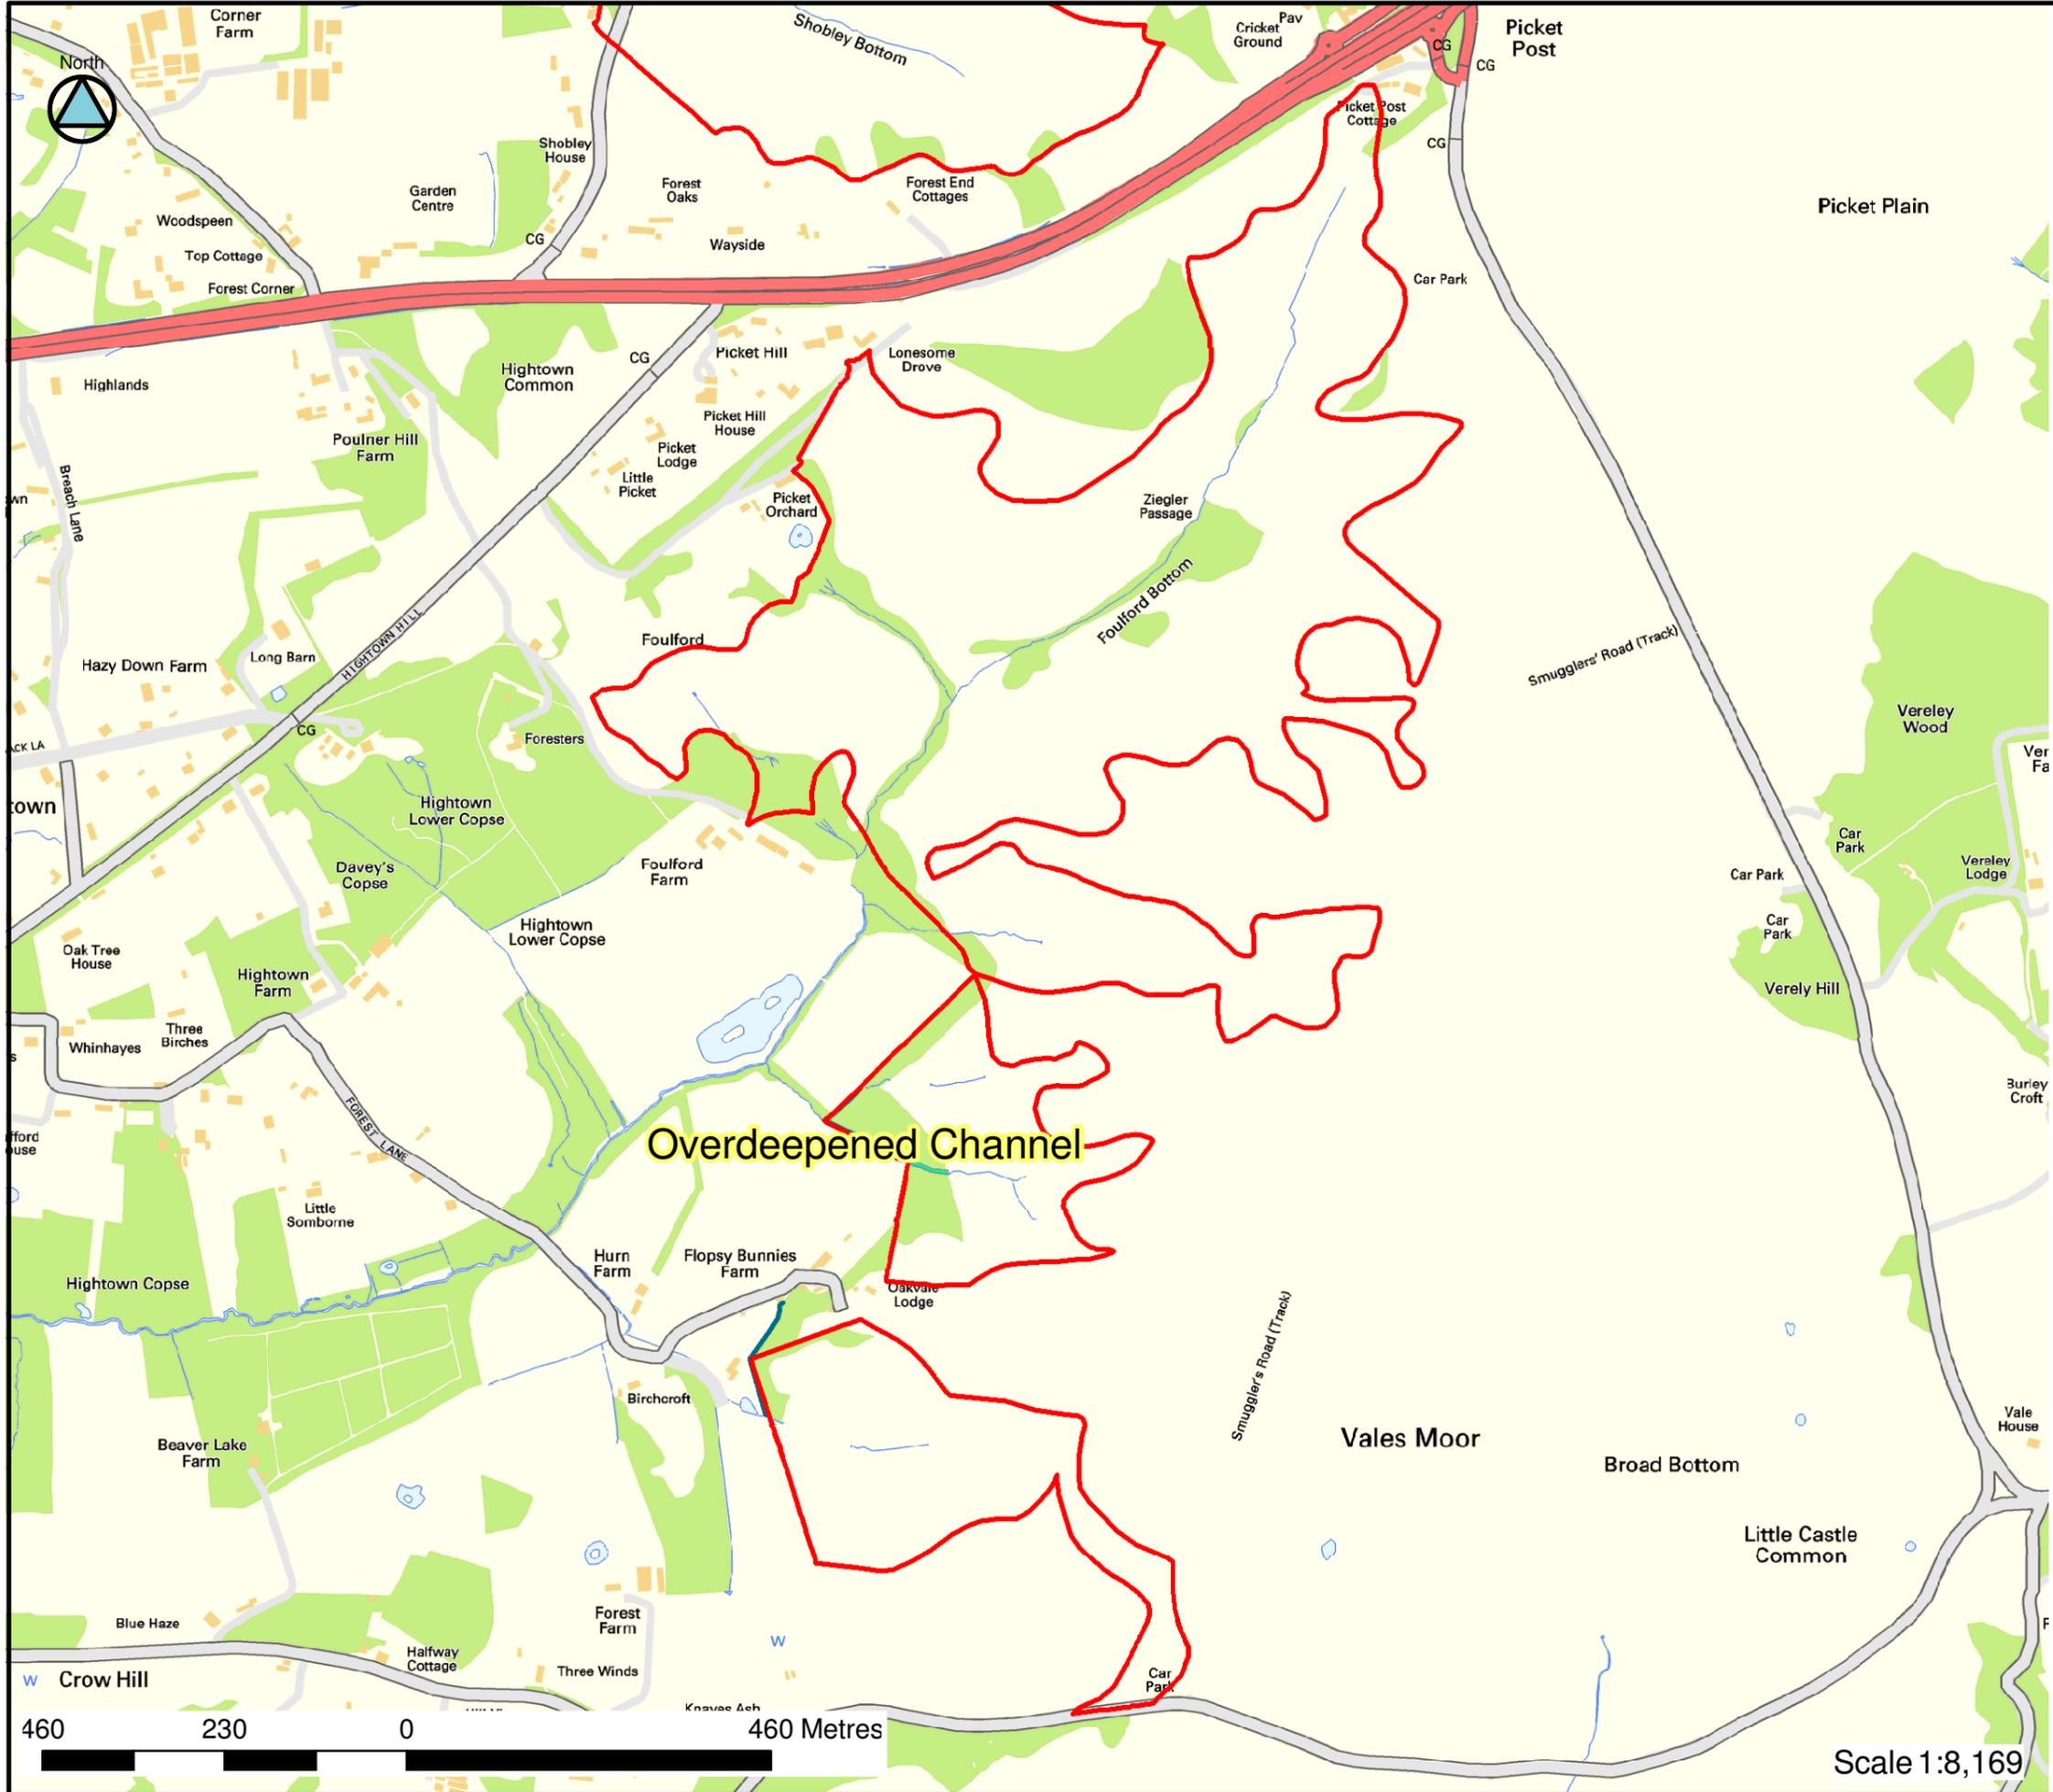
**MAP 8**  
Restoration Plan

Parts of the area are suffering from encroachment by Scot's Pine (in particular Vales Moor, Unit 132 and the southern part of Foulford Bottom, Unit 125) and Rhododendron (most notably Vales Moor, Unit 132, but also some parts of Vales Moor, Unit 133 and the northern part of Foulford Bottom, Unit 125).

Restoration proposals are made in relation to the scrub encroachment issues (see Table 1-3).
