Coastal Catch-Up: How a soft rock cliff evolves when coastal defences fail

Godwin Battery, Kilnsea

Mark Lee. 2018. *Coastal Catch-Up: How a soft rock cliff evolves when coastal defences fail. Godwin Battery*. Natural England Commissioned Reports, Number 256.

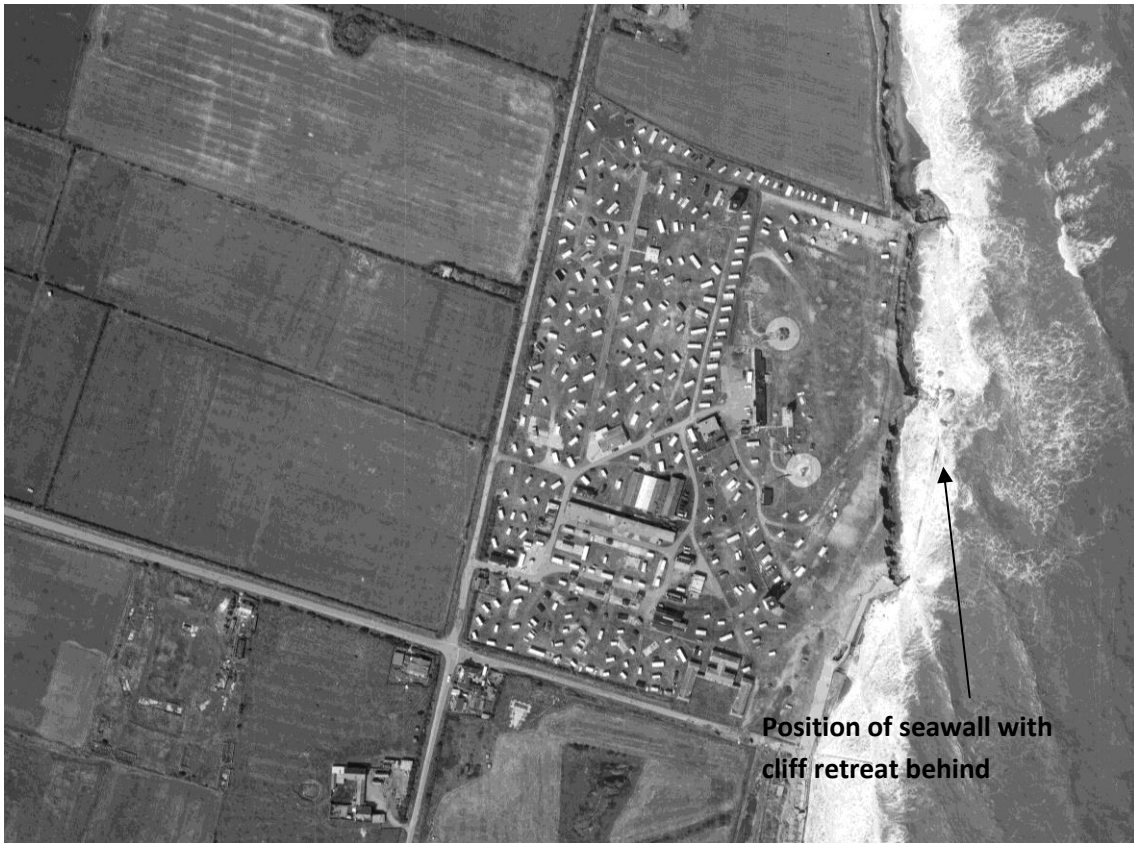
The cliff retreat and loss of the monuments between 1953 and 2008 can be observed on the sequence of vertical aerial photographs presented as Photos 7 to 13. The 1969 photograph clearly shows on-going cliff recession behind the seawall and provides evidence of seawall failure at some time prior to that date.

Photo 8 Aerial photograph (24.8.1969); original scale 1:7,500 (source: Air Images Ltd.)

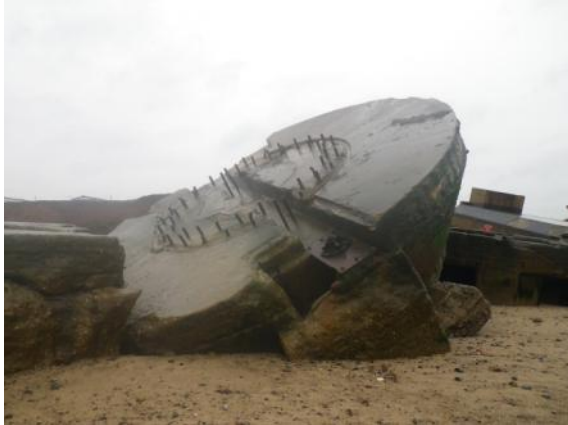
Photo 14 The mounting for the southern 9.2 inch gun; it is surrounded by pieces of the concrete apron

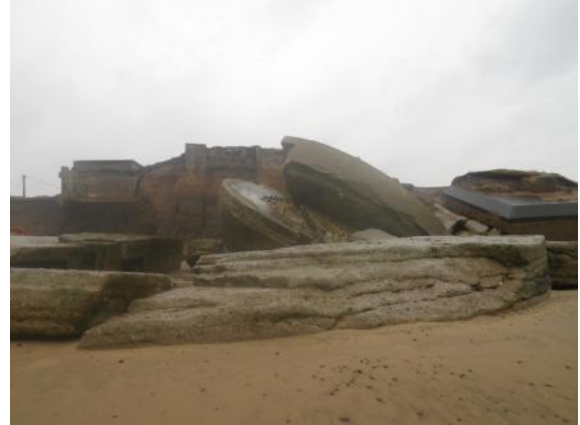
Photo 17 The apron and mounting for the northern 9.2 inch gun (the magazine is on the right)

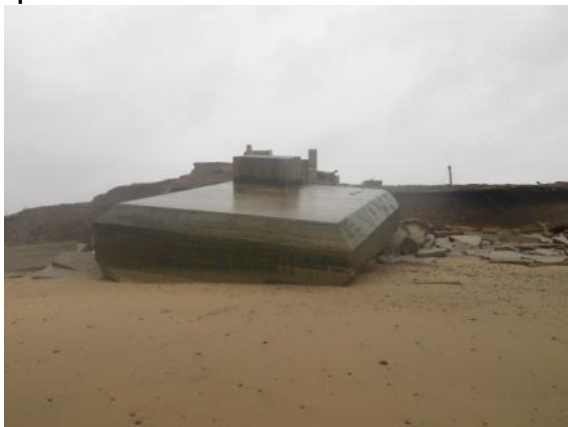
Photo 15 The magazine for the southern 9.2 inch gun

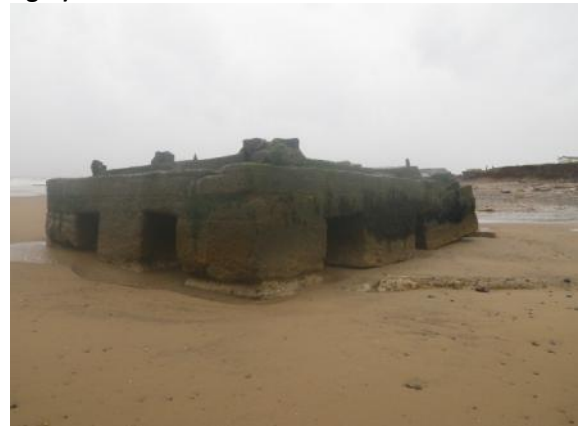
Photo 18 Remains of a concrete building (possibly the southern BOP blockhouse)

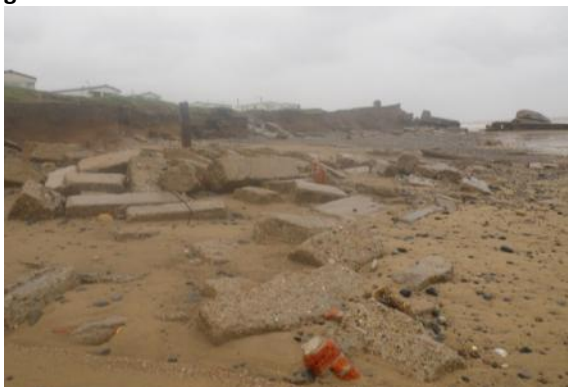
Photo 16 Sections of the old seawall and brickwork rubble, south of the southern 9.2 inch gun apron

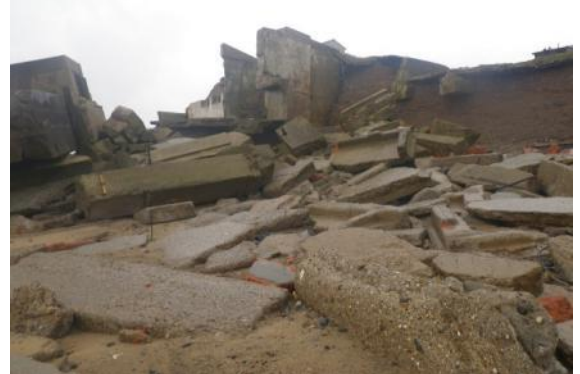
Photo 19 Concrete and brickwork rubble on the foreshore, between the two 9.2 inch gun aprons

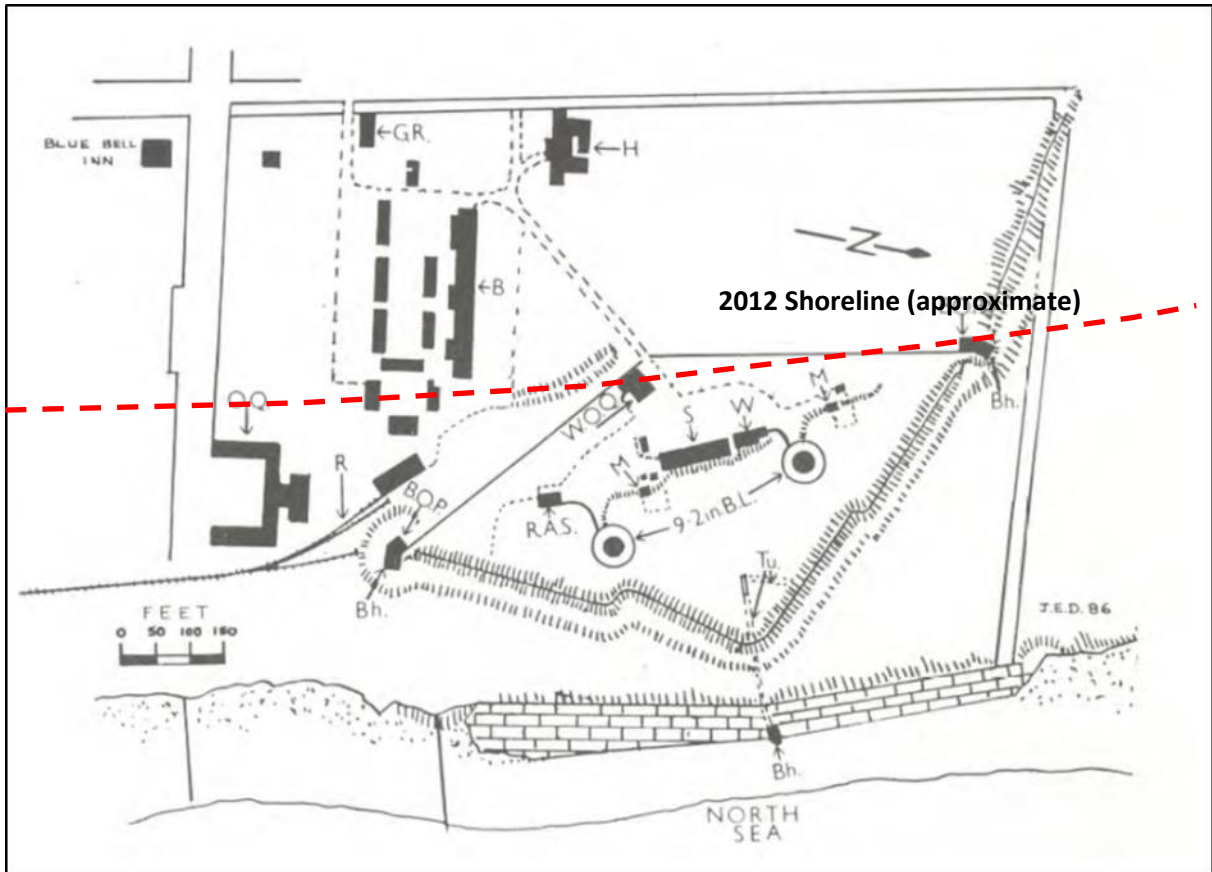
As of April 2012 the foreshore is littered with large blocks of mass concrete from the Battery, including the two 9.2 inch gun mountings and aprons, the magazines, the battery observation posts (BOPs) and blockhouses, along with parts of buildings "S" and "W" on Figure 1 (see Photos 14 to 19). Much of the ruins are concentrated on a 120m long section between the two gun aprons. There are no more major concrete structures from the Battery to be lost (Figure 4).

Figure 4 Approximate position of the shoreline in 2012 (red line), highlighting the loss of all of the major concrete structures. Some of the buildings shown landward of the red line have been demolished during the conversion of the site into a caravan park (base plan from Dorman 1990).

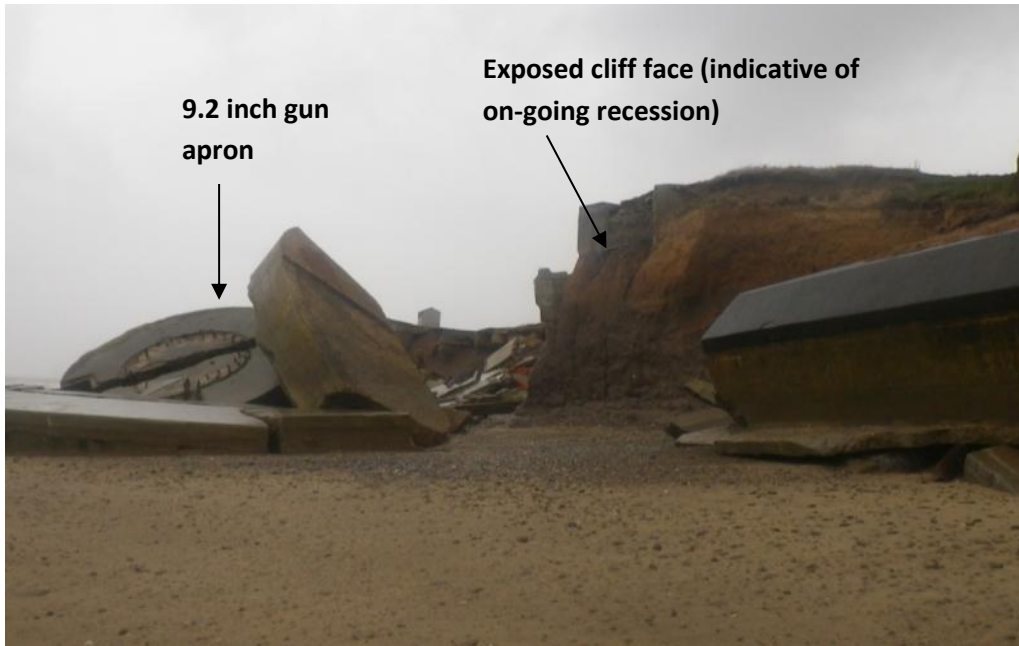
From the field visit in April 2012, it was clear that the mass concrete blocks on the foreshore do not prevent wave attack at the cliff foot, and that cliff recession is on-going (Photo 20).

Photo 20 Exposed cliff face behind the northern 9.2 inch gun apron

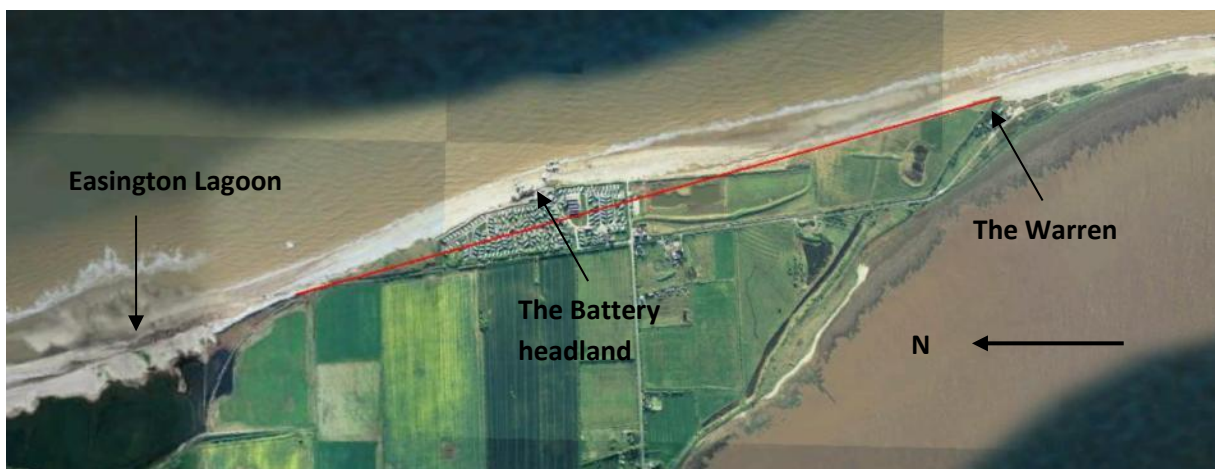
Since 1915, the cliffline in front of the Battery (Point B on Figure 2) has retreated around 110 - 130m. The cliffline would have been expected to have retreated further if the defences had not been constructed, matching the recession of the adjacent unprotected cliffs. The result has been the formation of a small headland. If it is assumed that, if unprotected, the 2km long cliffline between the southern end of the Easington Lagoons to the Warren would have developed as a straight line (as it almost was in 1892; Figure 5), then the Battery headland currently projects in front of this cliffline by

around 60-70m at its maximum point (Photo 21).

Photo 21 The Battery headland, projecting seaward from a hypothetical 2km long straight cliffline (the red line) between the Easington Lagoons and the Warren (note that the shoreline has been rotated through 90°; image source: Google Earth, image date 2008)
