Physical and biological monitoring of STREAM restoration projects

Annual Report – Year 2

Natural England

November 2007

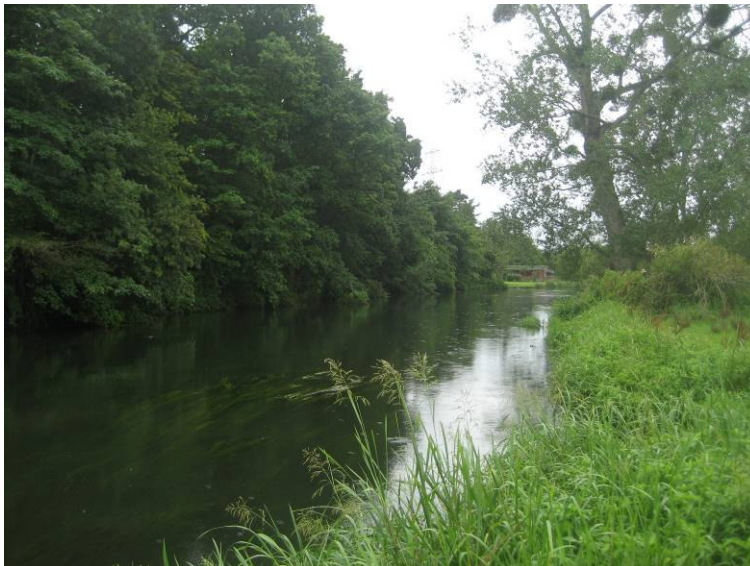
Photo HAR01-e:
Looking downstream along the glide with broadleaved woodland along the left hand bank.

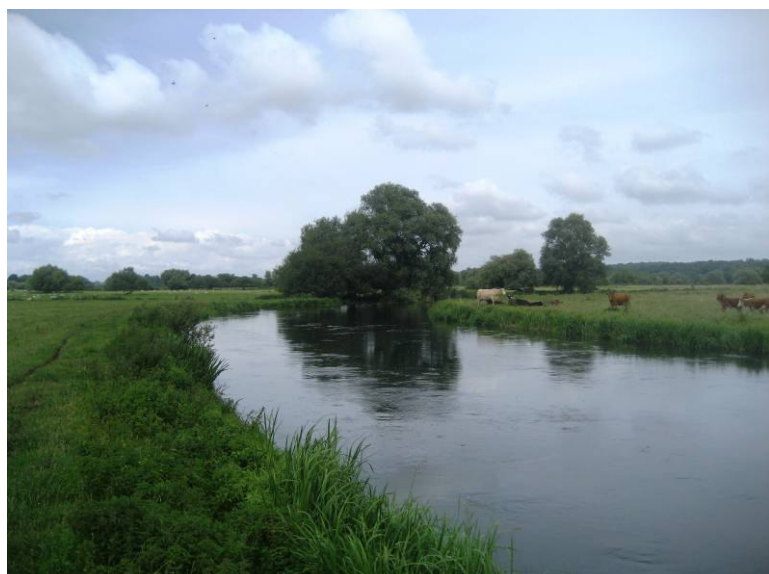
Photo HAR02-f:
Looking upstream along the glide from the downstream boundary.

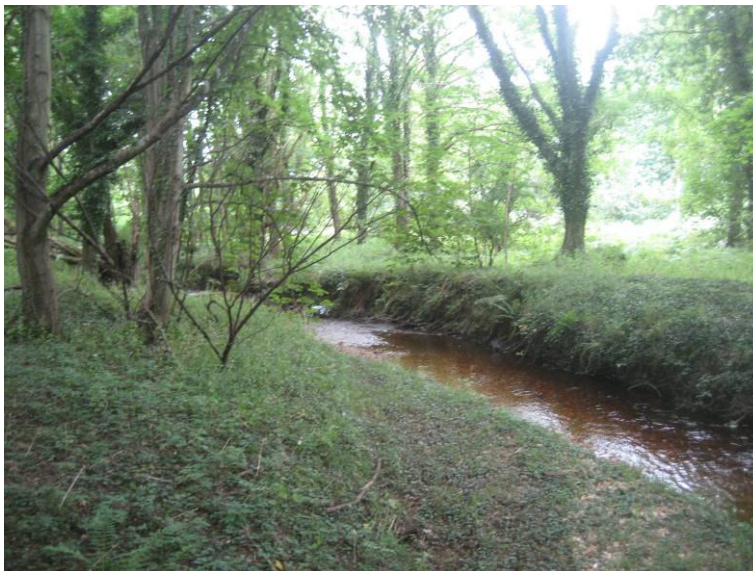
Photo DOR01-n:
Looking downstream with vegetated bar in the foreground.

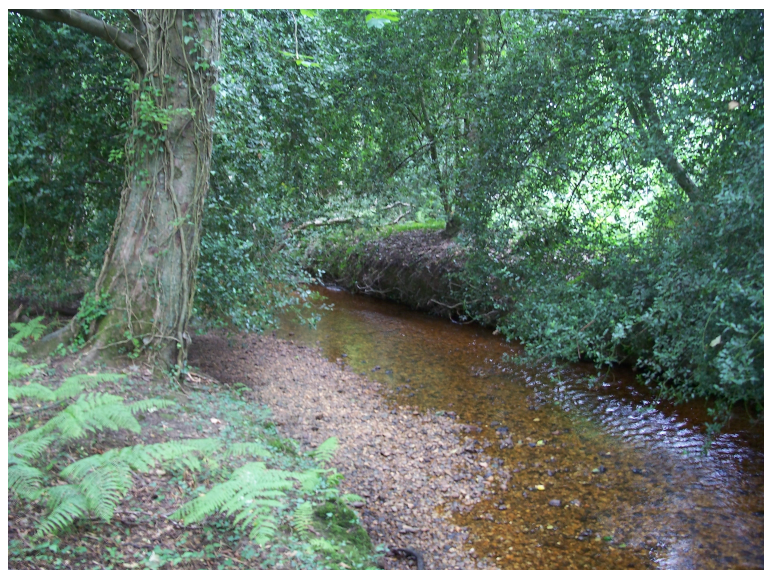
Photo DOR01-i:
Looking downstream with a point bar on the inside of the meander.
