POST WORKS ASSESSMENT OF THE STREAM RESTORATION PROJECT SITES AT UPPER WOODFORD ON THE RIVER AVON

Summary of post works assessment following final site visit
on 9th April 2009

the River Restoration Centre

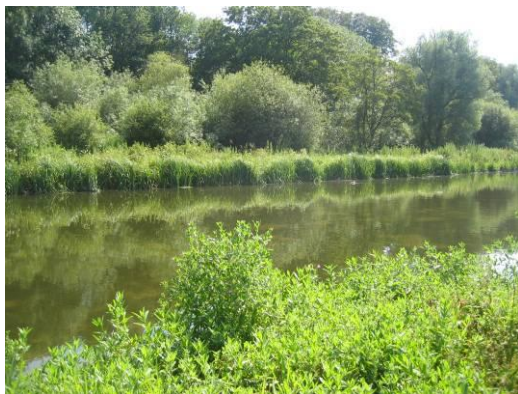
R. Avon, Upper Woodford – Pre Scheme

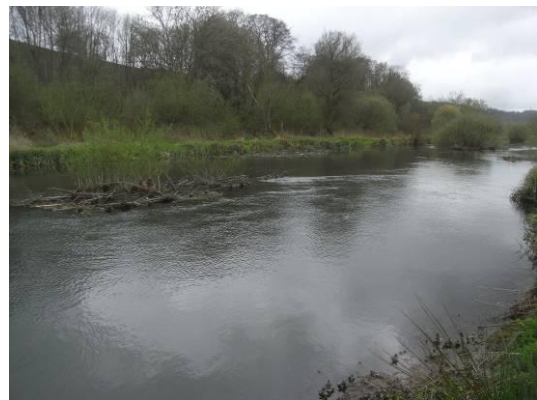
R. Avon, Woodford – Post Scheme

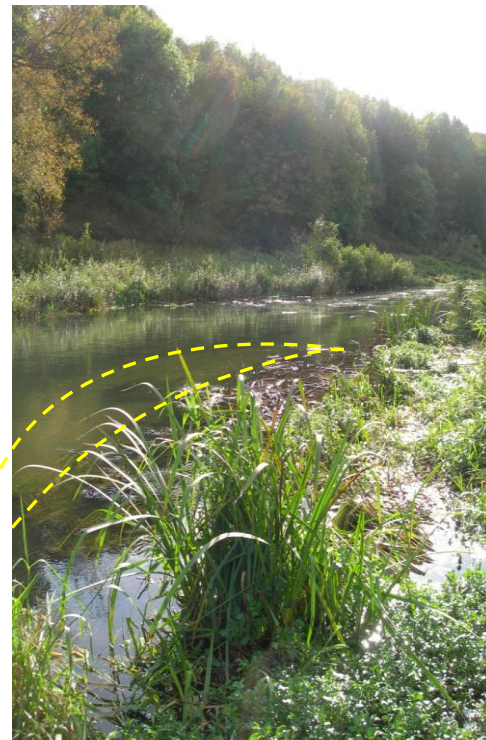
Figure 3.4 Changes to 'D' Deflectors

Plate VII Deflector Reduced in Size

The two 'D' deflectors in the upper part of the reach occupy a larger proportion of the channel than those lower down and therefore were likely to influence flow/level more than the other structures. Adjacent and upstream of these structures the banks are low and vulnerable to changes in water levels. Consequently in October 2008 these deflectors were reduced from approximately 5 metres to 3 metres wide. The original and new shape can be seen in Figure 2.6.

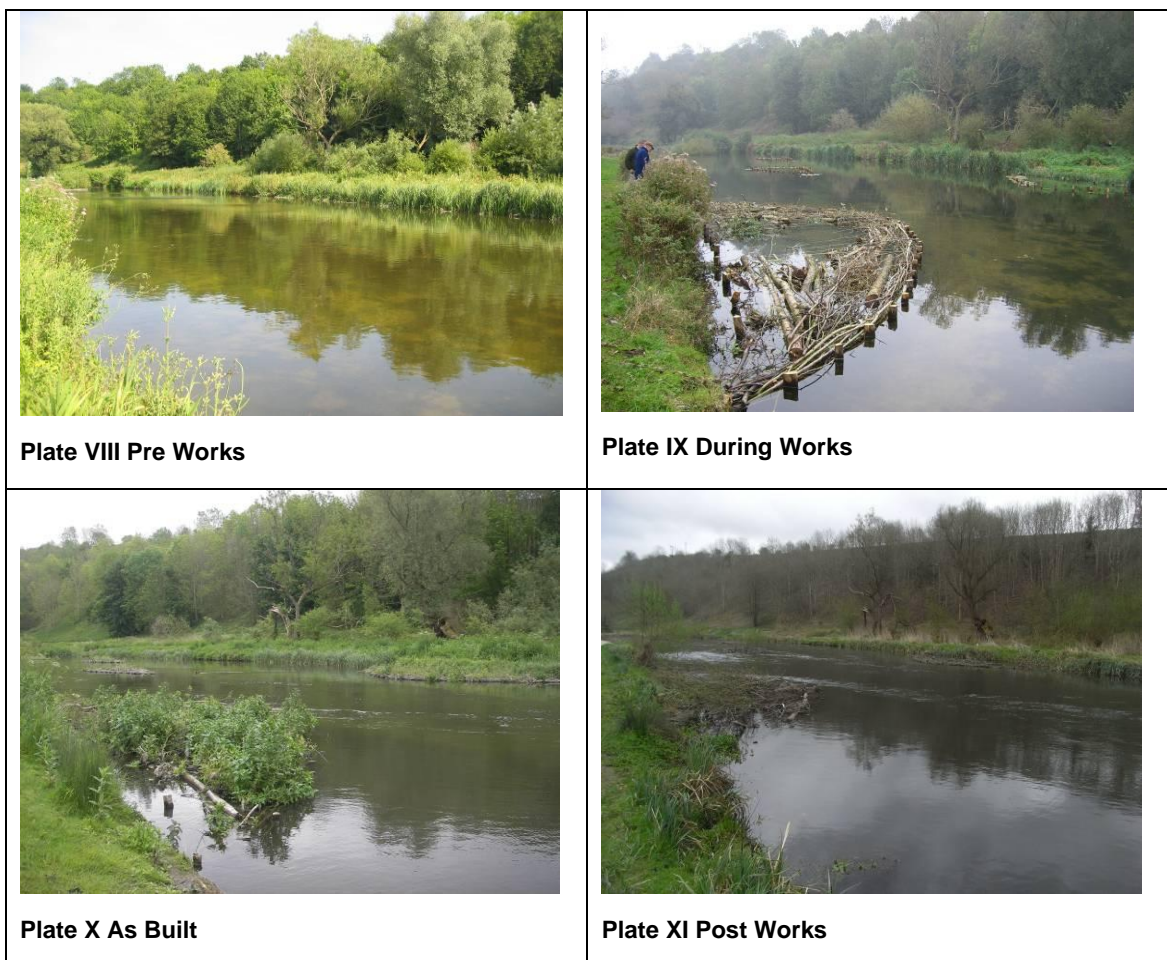
Figure 5.1 'D' deflector towards the lower end of Reach 2 (Photo Location 37)

Eight 'D' deflectors were installed in Reach 2 and one in reach 3. None of the deflectors in Reach 2 have been vegetated to any significant degree. They are however, providing areas of refuge for fish fry and there is evidence that silt is being trapped within the brushwood in-fills (see Figure 2.1). The lack of vegetation may be the result of persistent high flows over the winter of 2008/2009. The deflector have created areas of variable flow.

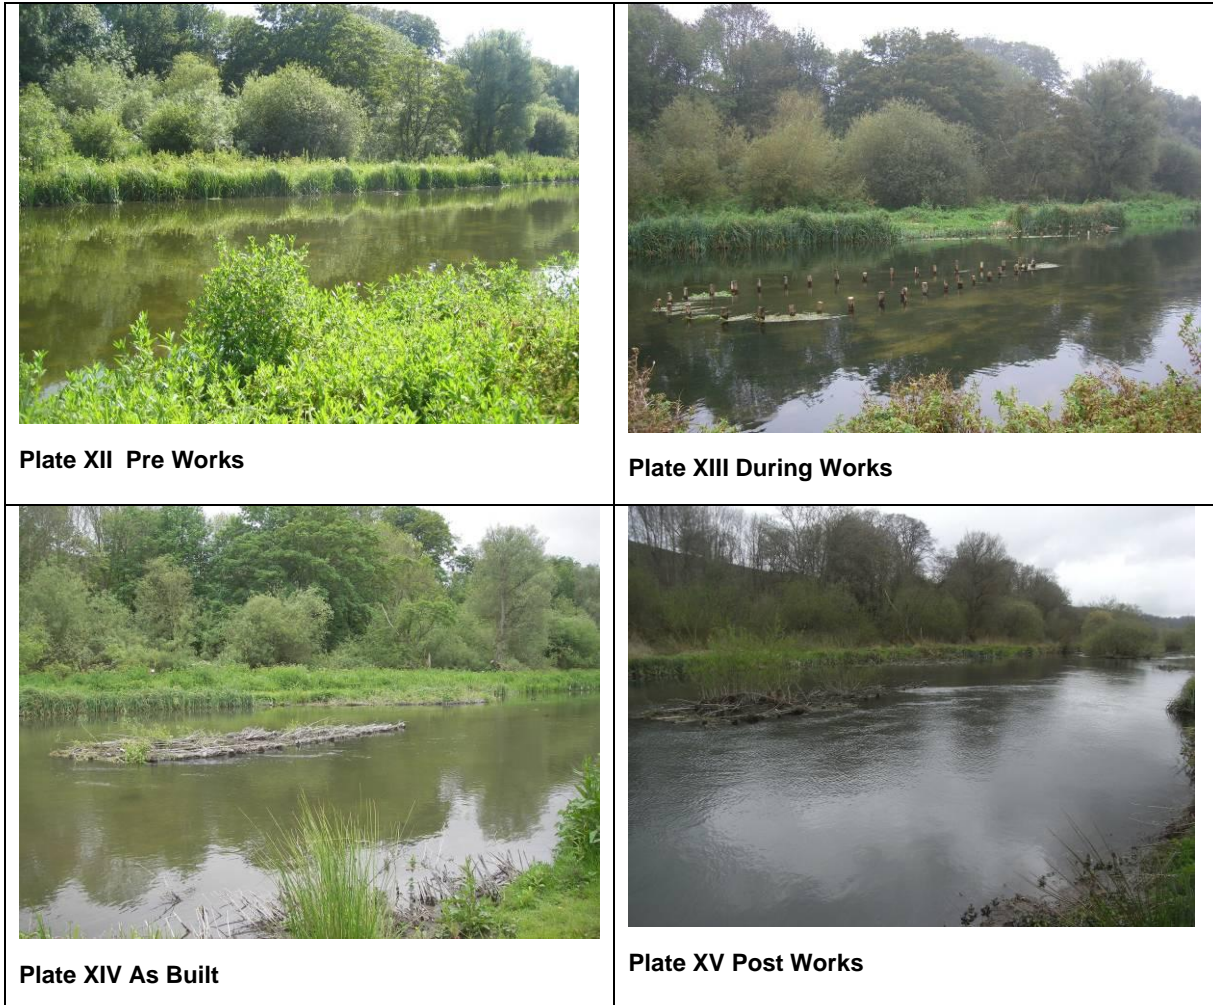
Figure 5.2 New Island at the top of Reach 3

The islands, like the deflectors were lacking in vegetation at the time of the site visit and this may be due to particularly high flows experienced over the winter of 2008/2009. The willow

branches used to create the island have started to sprout and there is some evidence of siltation. The islands, in combination with the deflectors have created variable flow condition and refuge areas for fish fry (see Figure 5.2).

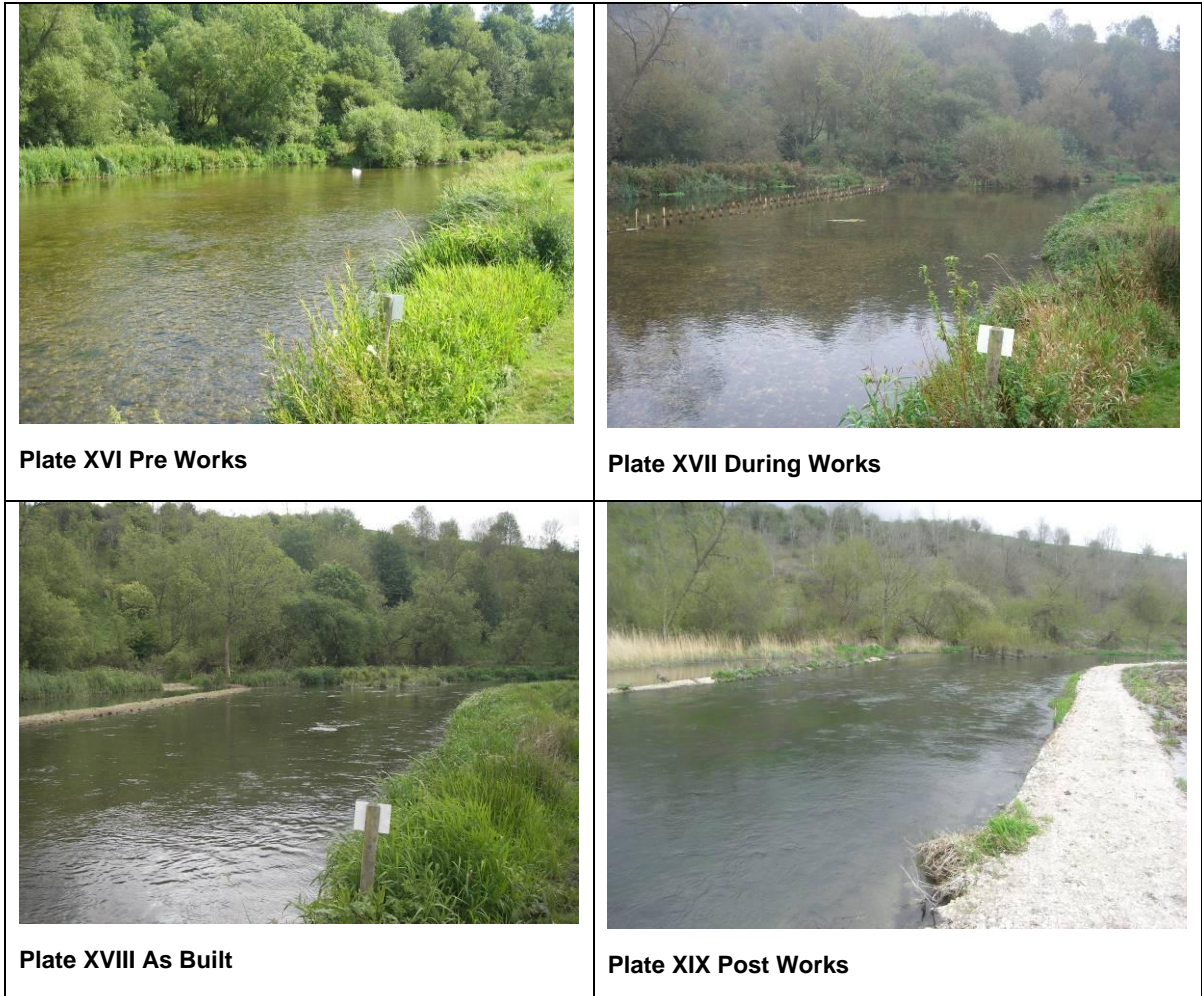
Figure 5.3 The Causeway at the Top of Reach 2

The causeway was partly vegetated over, but still looks very unnatural. The lack of vegetation was probably due to the high water levels. It was reported that in June/July 2008 it was completely vegetated over. The upstream and downstream limits of the structure have been breached, but an area of slack water is still in evidence behind the structure (see Figure 5.3).

The upstream causeway has narrowed the channel from its significantly over-wide state. The thin strip of made land now separates an area of slow flowing to still water (beneficial for fry and amocetes). The lower edge of the causeway is consistently over-topping due to the raise water levels of the past two years and some minor erosion of the chalk structure is occurring. This could continue to develop into a breach and may need repair to prevent the ponded section from flowing. As marginal and submerged vegetation grows within this area, the flow path through the ponded section will become more occluded.
