POST WORKS ASSESSMENT OF THE STREAM RESTORATION PROJECT SITES AT FOVANT

(R. NADDER)

Summary of post works assessment following final site visit
on 9th July 2009

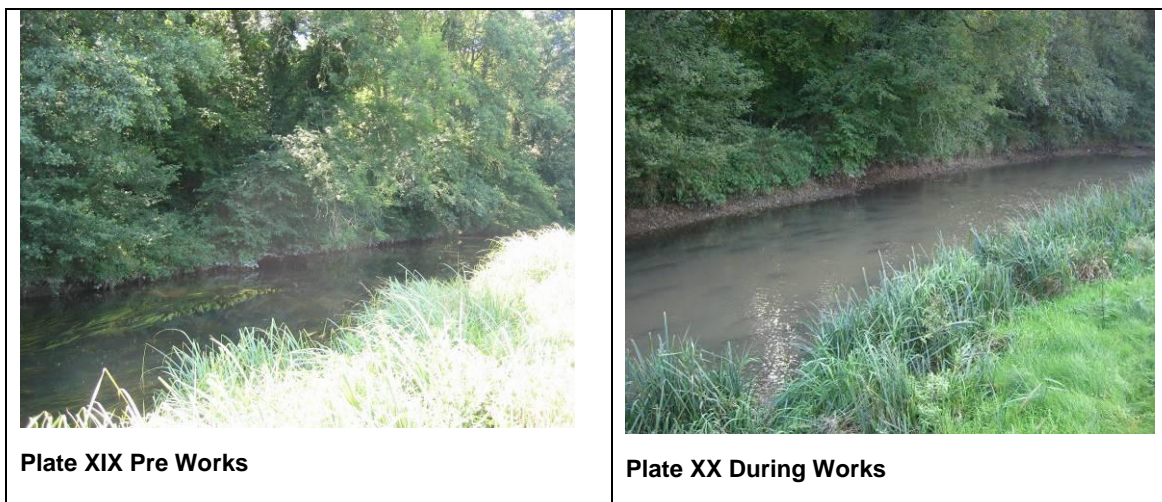
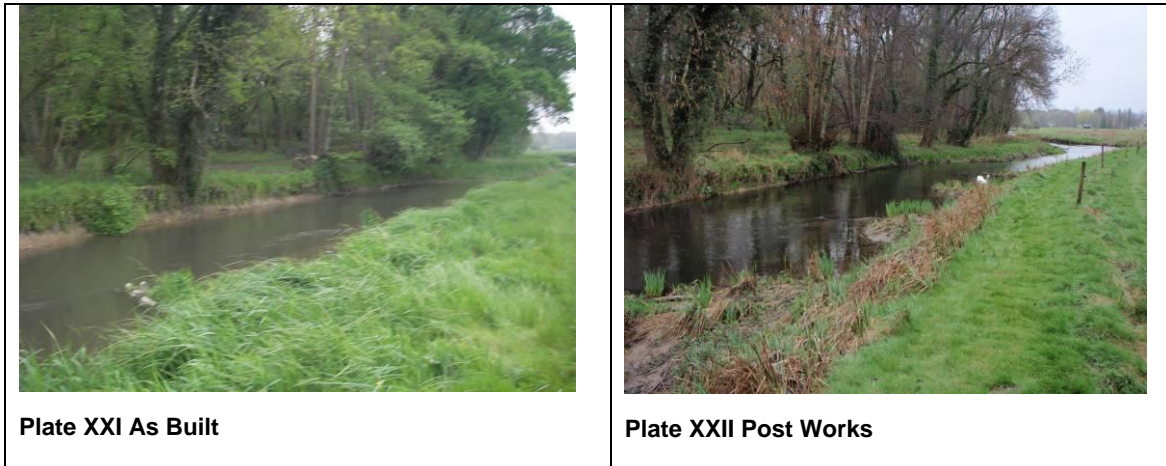
Figure 5.1 Photo Site 36 'V' Deflectors on Left Bank and Brush Clearance

The 'V' shaped deflectors installed in Reach 5 are shown in Figure 5.1 and **Error! Reference source not found.** In Figure 5.1 the amount of siltation which has occurred between the deflectors and resulting growth of emergent vegetation is clear. The river has been narrowed down by some 1 to 1.5 m. The deflector itself has become well vegetated (see also **Figure 5.2 Plate XXI**).

The raising of the hatches proved to have a major effect on the two reaches immediately upstream (See Figure 5.1, Plates XIX and Plate XX). In the latter plate the bare bank exposed as a result of the drop in water level is clear. Plate XXX in Figure 5.3 shows the hatches fully open; however it is clear that the sill of the hatches is still having an impounding effect because the cascade of water created as it flows over the sill and drops down on the other side can clearly be seen.

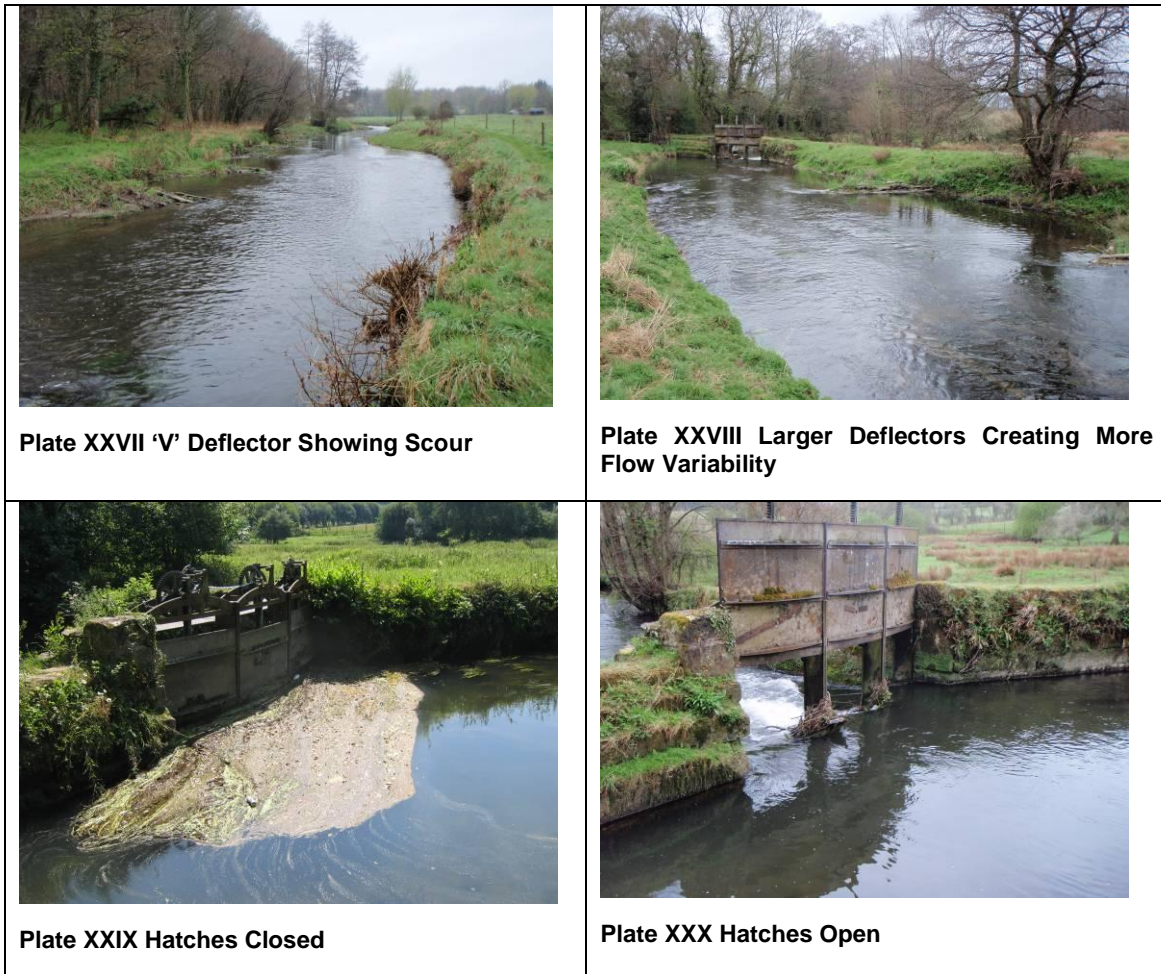
Figure 5.3 Reach 6 Deflectors and Hatch Operations

Plate XXVIII in Figure 5.3 demonstrates how the larger deflectors at the downstream part of Reach 6 create more flow variability, suggesting that the larger deflectors were more successful in achieving the objectives of the STREAM project for the Fovant site.
