POST WORKS ASSESSMENT OF THE STREAM RESTORATION PROJECT SITES AT HALE (R. AVON)

Summary of post works assessment following final site visit
on 1st May 2009

1.3 Aims and Objectives for the River Avon at Hale

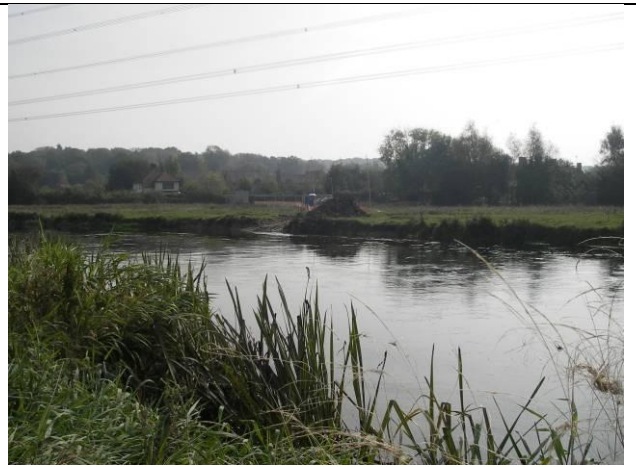
Plate I Tree Kicker

Plates IX to XII show the site where the tree kicker was installed. The effect of the kicker is localised but areas of refugia are in evidence on the downstream side (see Plate I).

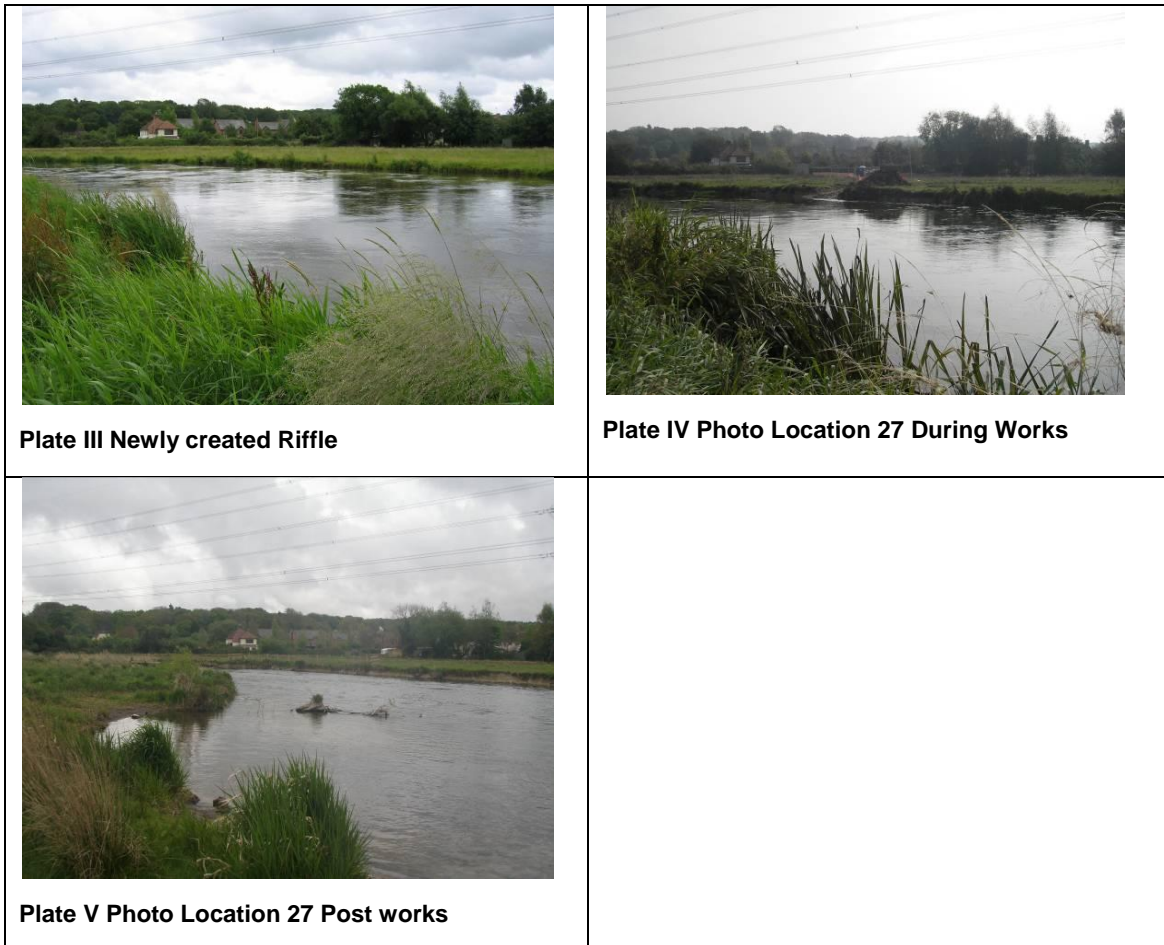
Figure 5.1 Riffle Site Photo location 27

Plates III to V (Figure 6.1) show the site of the riffle which was installed in Reach 2. The flow variability is evident and the riffle is working well since Barbel have been reported spawning on it. It is hoped that salmon will spawn on the riffle in future.

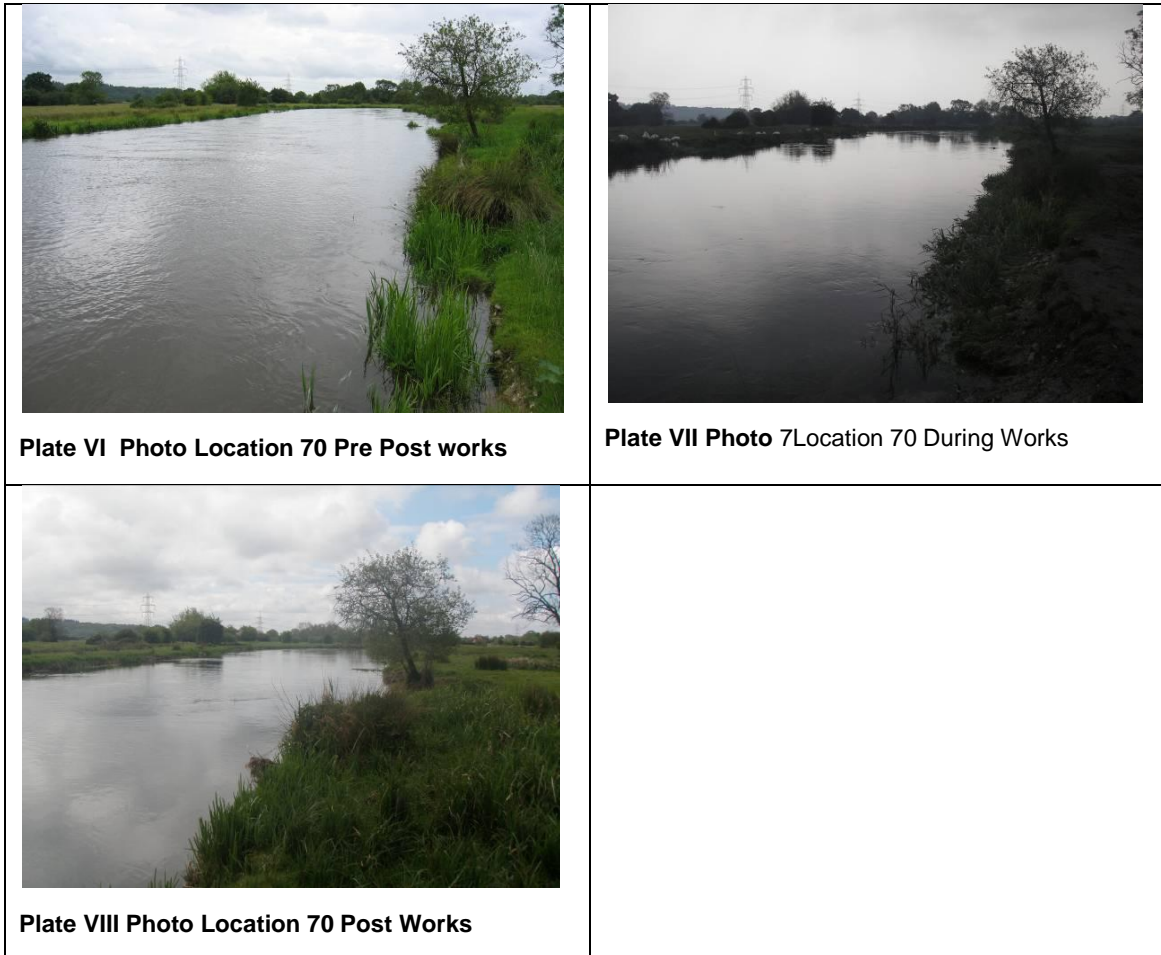
Figure 5.2 Gravel Reworking at Location 70

Figure 6.2 shows the site where the gravels have been re-worked. The central channel exhibited much faster flow and generally the flow diversity was greater. There are very few bankside trees along this reach, so very little shading is in evidence.
