POST WORKS ASSESSMENT OF THE STREAM RESTORATION PROJECT SITES AT SEVEN HATCHES

(R. WYLYE)

Summary of post works assessment following final site visit
on 30th April 2009

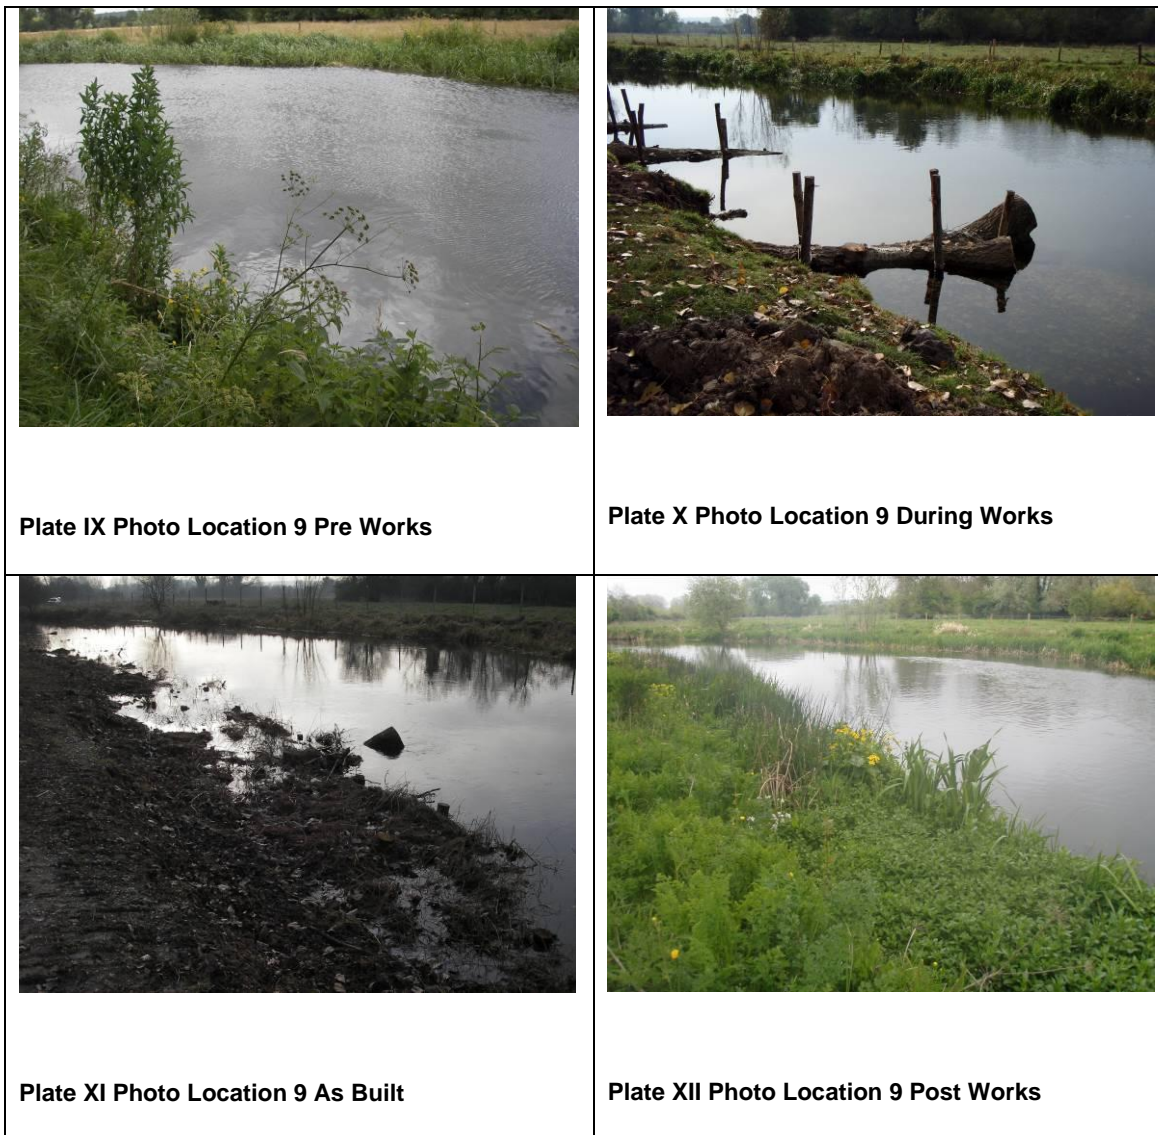
Figure 5.1 Berm in Reach 2 at Photo Location 9

Some of the pre planted coir mat vegetation such as the water parsnip failed to survive possibly because the water levels are now much higher than when the construction work was carried out in 2007 (See note in Section 3).

The berm are currently causing a health and safety concern for the anglers. The wires holding the brush in place are a possible trip hazard as they are hidden at the far extent of the 'new bank' below water level. As a result it is planned that coir rolls will be fitted to the front edge of the deflectors to visually mark the point where shallow water becomes deep river.

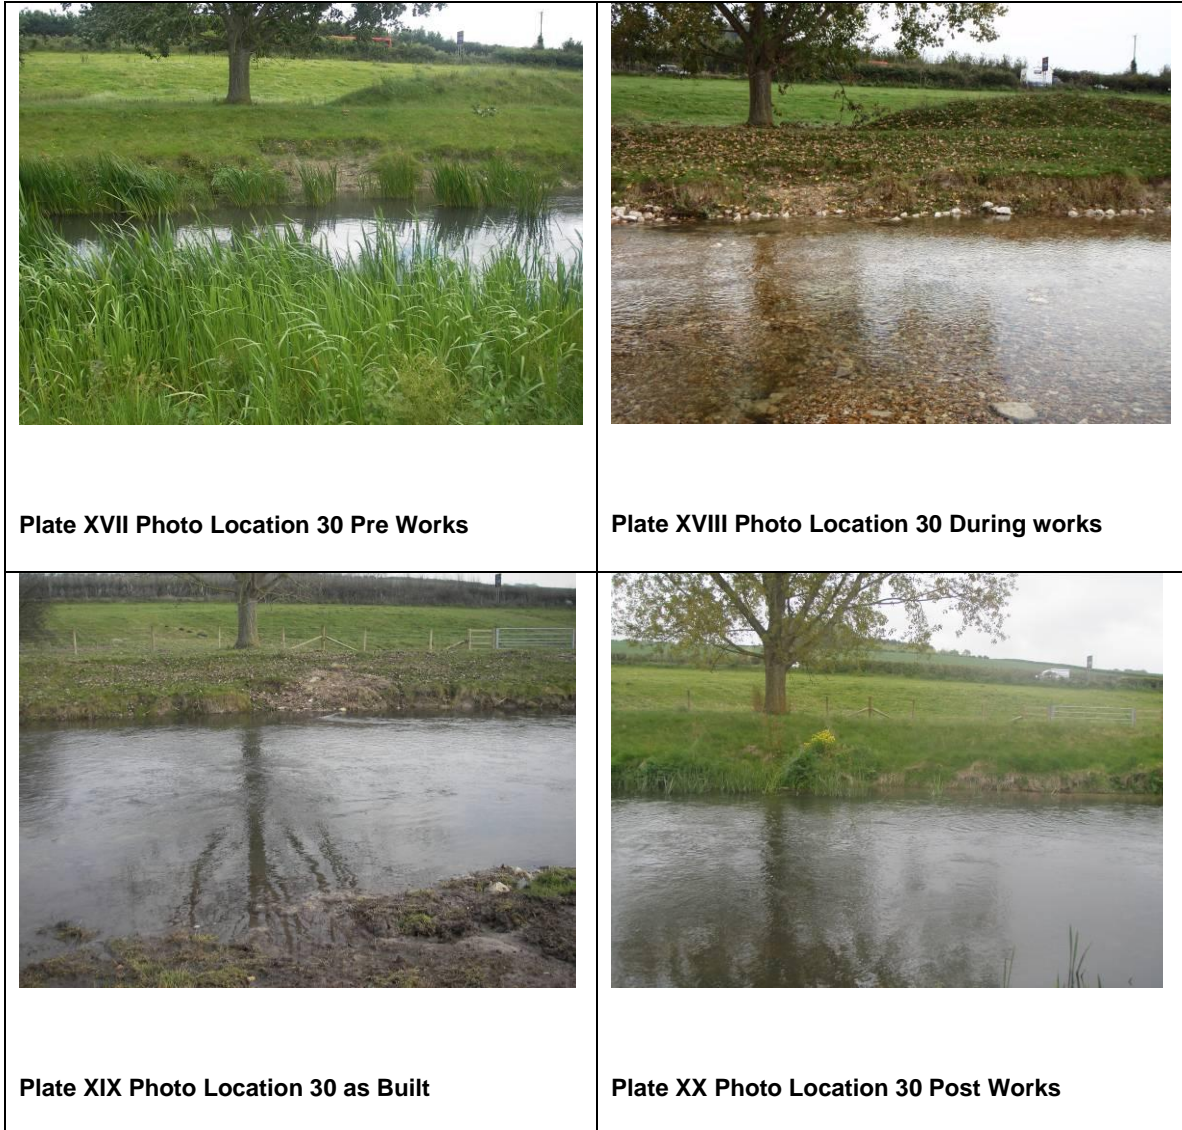
Figure 5.3 Riffle in Reach 4 at Photo location 30

Reach 4: Downstream of the riffles a significant amount of silt had been deposited. It was also noted that the material used to create the riffles was quite large (approximately 20cm in diameter) this was the base fill that was observed at the time of the site visit rather than the top layer of gravels which were 20-60mm in size.

For Reach 4, large quantities of gravel and stone were imported to create riffles. Originally the gravel was planned to be recovered from the riparian zone whereby a line of mature trees were to be felled and the gravel removed from beneath. However, it transpired that there was little gravel in the area, so the trees remained in place and the gravel was imported from outside the site. As well as the gravel being imported, log deflectors were pinned into the substrate (see Section 5.3). The riffle sections have significantly altered the flow dynamics with shallower and faster flowing water. The wood deflectors create localised flow variability (see Figure 5.3) providing additional habitat diversity across the gravels. Stone was used to build up the river bed and the gravel lain on top. In the lower riffle the blockstone underneath the gravels has now been exposed. Ideally this is not desirable; however it has resulted in an additional habitat type where scour has occurred on the downstream side creating hollows.

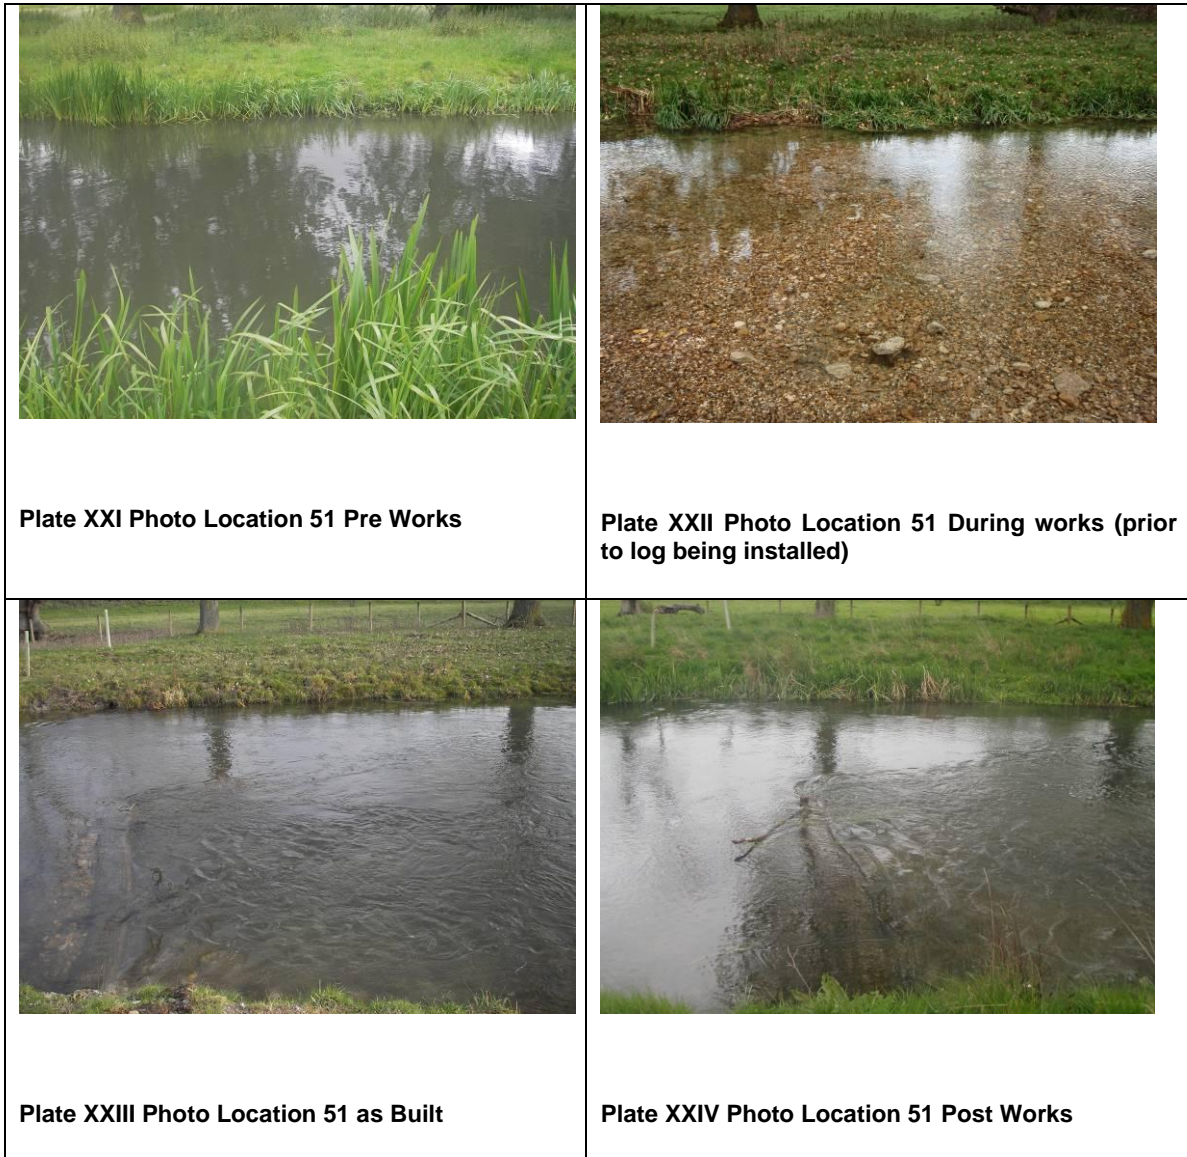
Figure 5.4 Log Deflectors in Reach 4 at Photo Location 51

Large logs were pinned into the imported gravel substrate. The gravels had been placed to create a riffle and the logs were installed to increase the flow variability. Figure 5.4 Log Deflectors in Reach 4 at Photo Location 51(Plates XXI to XXIV) shows one of the sites where the logs have been installed. Plate XXIV shows that even when the flows are relatively high the log deflectors are working well and the variation in flow can be seen clearly.
