# New Forest SSSI Ecohydrological Survey Overview

Annex V: Ma 5 Wet Part 3 (including Acres Down and Warwick Slade Bog)

First published 06 March 2014

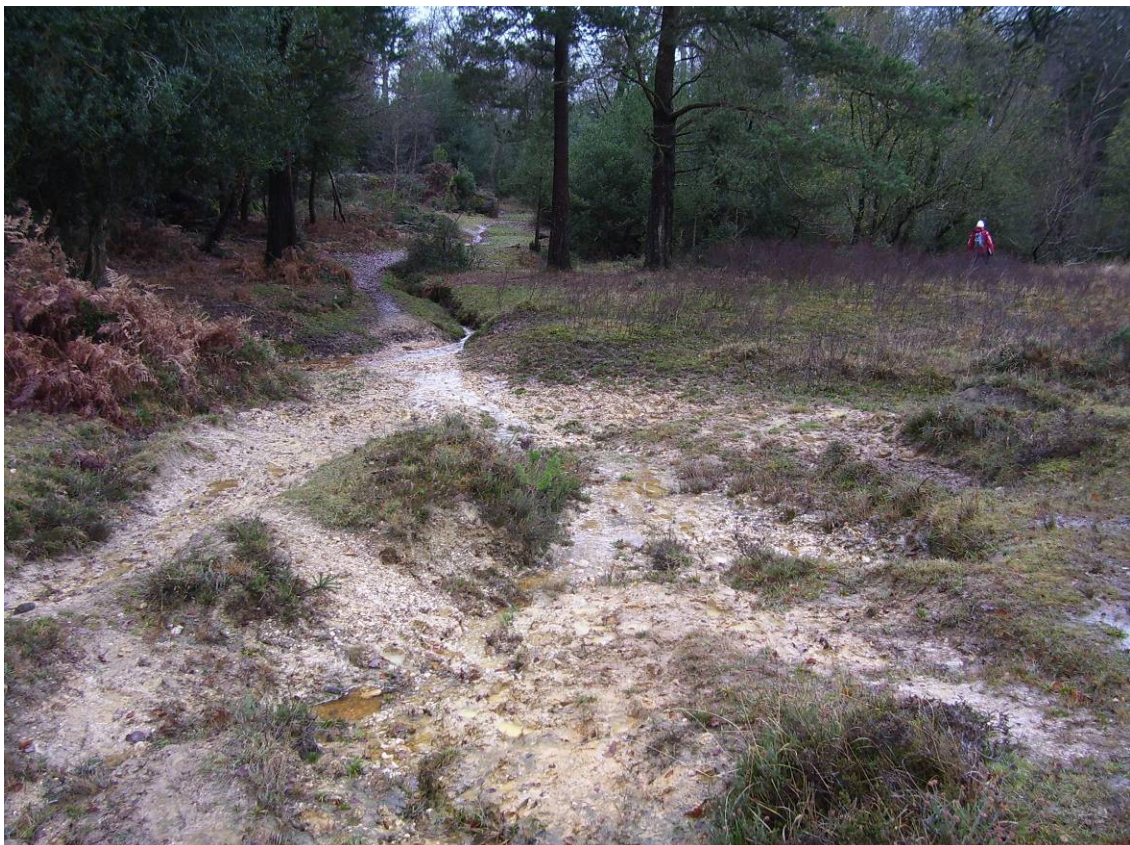
**Figure 1-5: Poaching and erosion of footpath near Corbet's Hat (Area C, NGR 426876 108598)**

The W-shaped area at Corbet's Hat (Area C) has particularly severe footpath erosion issues within the central area, which have provided a conduit for water flow downslope, further exacerbating the erosion issues (see Figure 1-5). This area contains three small separate valley mires which drain towards a Bog Pondweed dominated soakway habitat, which then forms a stream (not shown on OS maps); this then discharges from the unit to the south. This stream is very narrow, but quite incised, with some headwater erosion occurring, again exacerbated by the footpath erosion issues. The valley mire habitat contains Deergrass *Trichosporum germanicum*, Carnation Sedge, *Sphagnum* tussocks, White Beak-sedge *Rhynchospora alba*, Bog Asphodel *Narthecium ossifragum*, Bog Pondweed and some Cross-leaved Heath *Erica tetralix*, Heather *Calluna vulgaris* and Bog Myrtle. Poaching was also significant in places in this unit and some areas were heavily grazed.

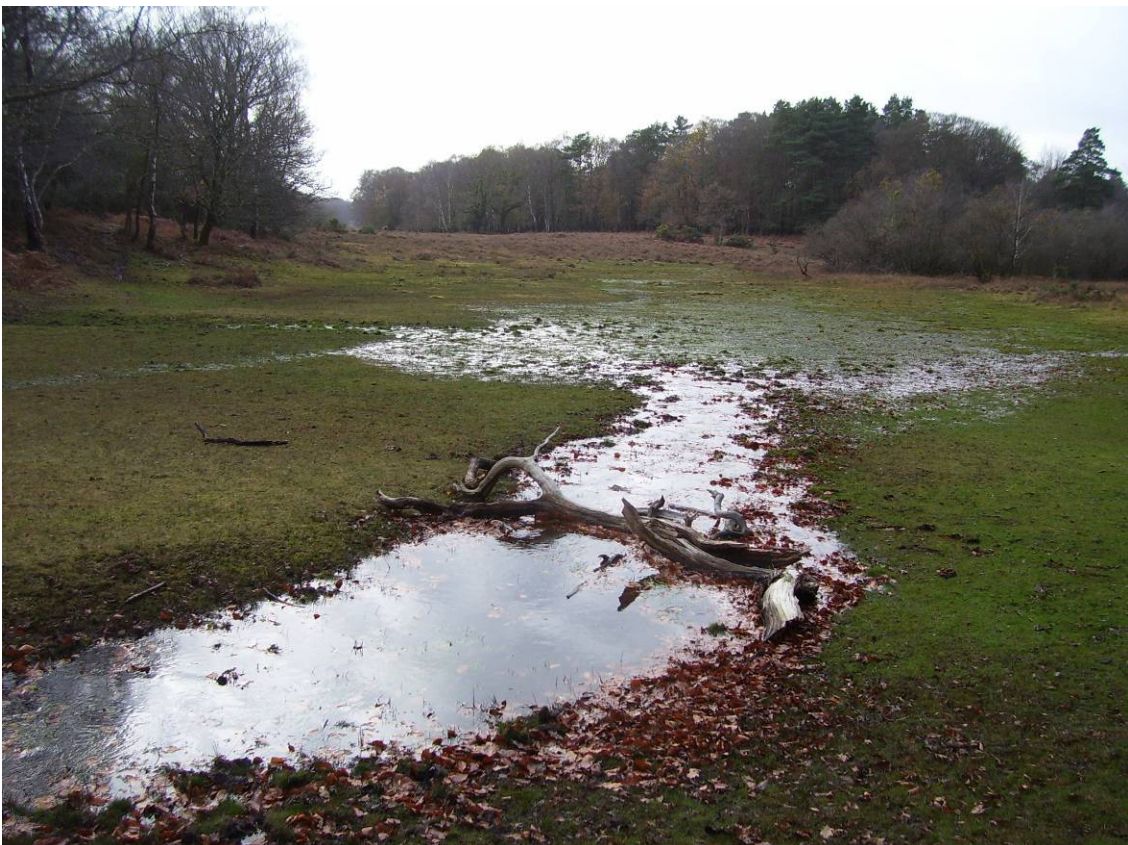
**Figure 1-7: Wooden debris dam (probably natural) and "spreads" in valley bottom wetland (Area F, NGR 427806 108303, looking southwest)**

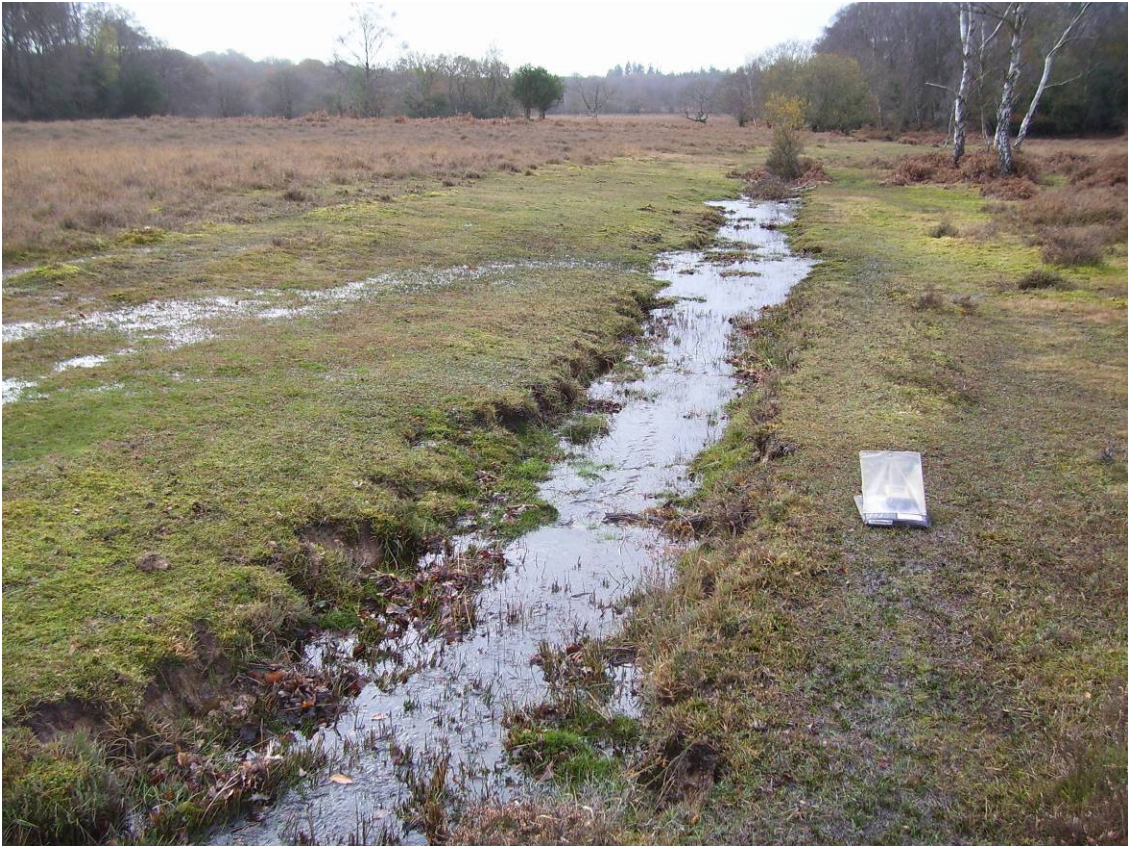
The northern valley-side mires, and Warwick Slade Bog, have little or no artificial drainage. In contrast, the central valley bottom wetlands are dissected by a network of drainage ditches. Here, drainage and grazing have converted former mire areas into "lawns". The W-shaped wetland south of Corbet's Hat (Area C) is drained by an unmapped watercourse, and a footpath crossing over this watercourse on the southern edge of the wetland shows significant

**Figure 1-8: "Lawn" development along drainage ditch in the south-eastern part of the area (Area F, NGR 427816 108109, looking southwest)**

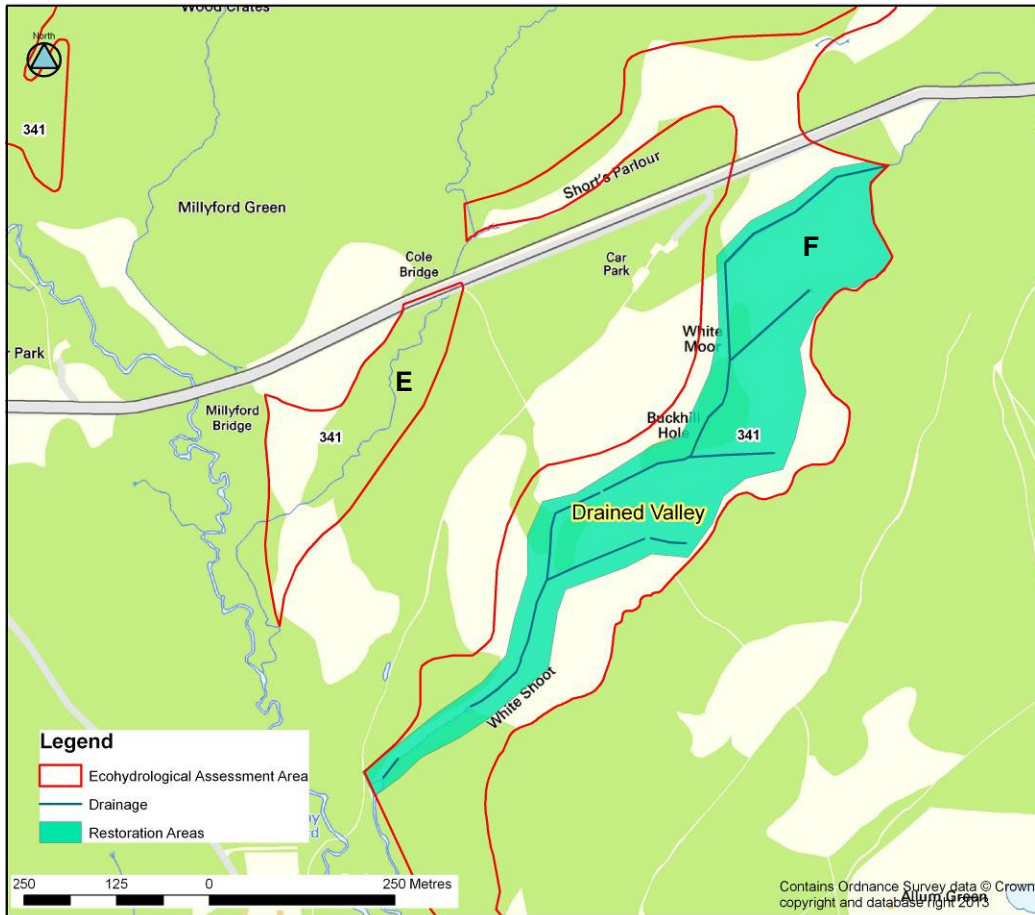
Figure 1-13: Restoration Areas Map 1: Central Part of Site (Areas E and F)

There is one area of significant damage (see Figure 1-13), where drainage and grazing have led to the destruction of valley mire and its replacement by "lawn". Footpath erosion and poaching by animals are an issue locally (Figure 1-14). Headward erosion of watercourses draining mire areas has occurred in areas B and C. It is recommended that these areas be monitored to detect any further significant headward erosion. If a problem is identified then it may be necessary to take preventative measures by installing some kind of slope control. This could involve the use of staked heather bales (where flows are not too energetic), the installation of wooden weirs and/or the infilling or re-profiling of the channel. The engineering design of suitable measures would need to be based on a detailed study beyond the scope of this report.

Restoration Area	Damage Type	Restoration Proposals	Improvement	Constraints and Issues
Drained valley (Area F)	Drainage and grazing turning mire into "lawn"	Blocking of ditches	Retention of more water in valley bottoms. Encourage the re-establishment of mire communities alongside streams.	Lawn areas may themselves be considered of ecological interest/ importance locally and would qualify as Interest Features under the SAC designation as habitat 6410; implementation of restoration will be dependent on selected objectives and target habitats for the unit.
W-shaped wetland (Area C)	Eroding channel, poaching and footpath erosion	Grazing management plan and possible bridge construction.  Monitor headward erosion and potentially take measures to prevent further erosion.	Safeguard the southern edge of the valley mire habitats from erosion, degradation of habitats and excess grazing pressure.	Grazing rights may limit any restrictions on grazing regime.  The engineering design of suitable erosion control measures would require a more detailed study beyond the scope of this report.  Heather bales may be washed away by high energy flows, and weirs may be bypassed.
