# New Forest SSSI Ecohydrological Survey Overview

## Annex F: Whiteshoot Bottom

First published 06 March 2014

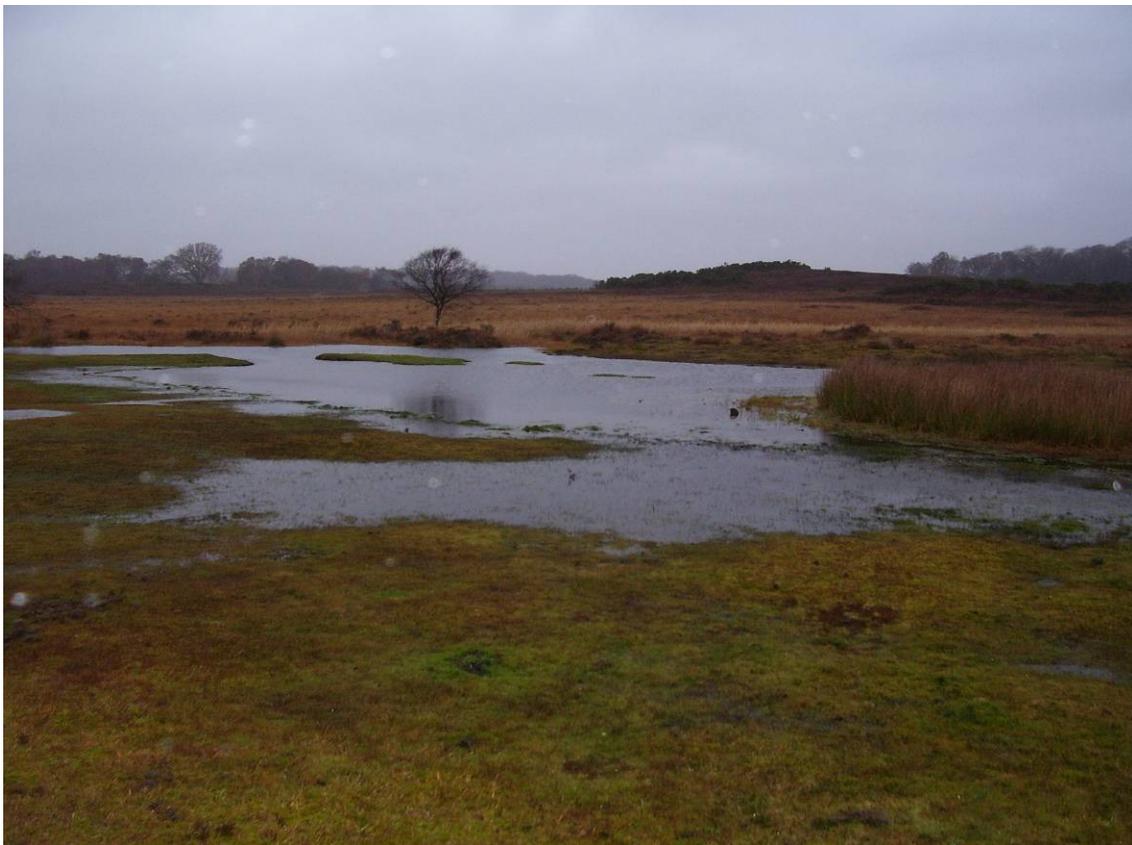
**Figure 1-2: View over marshy grassland and open water areas towards valley mire and swamp - the break in slope in the background is interpreted as the base of the Chama Sand and a line of groundwater seepage (NGR 421108 104728, looking northwest)**

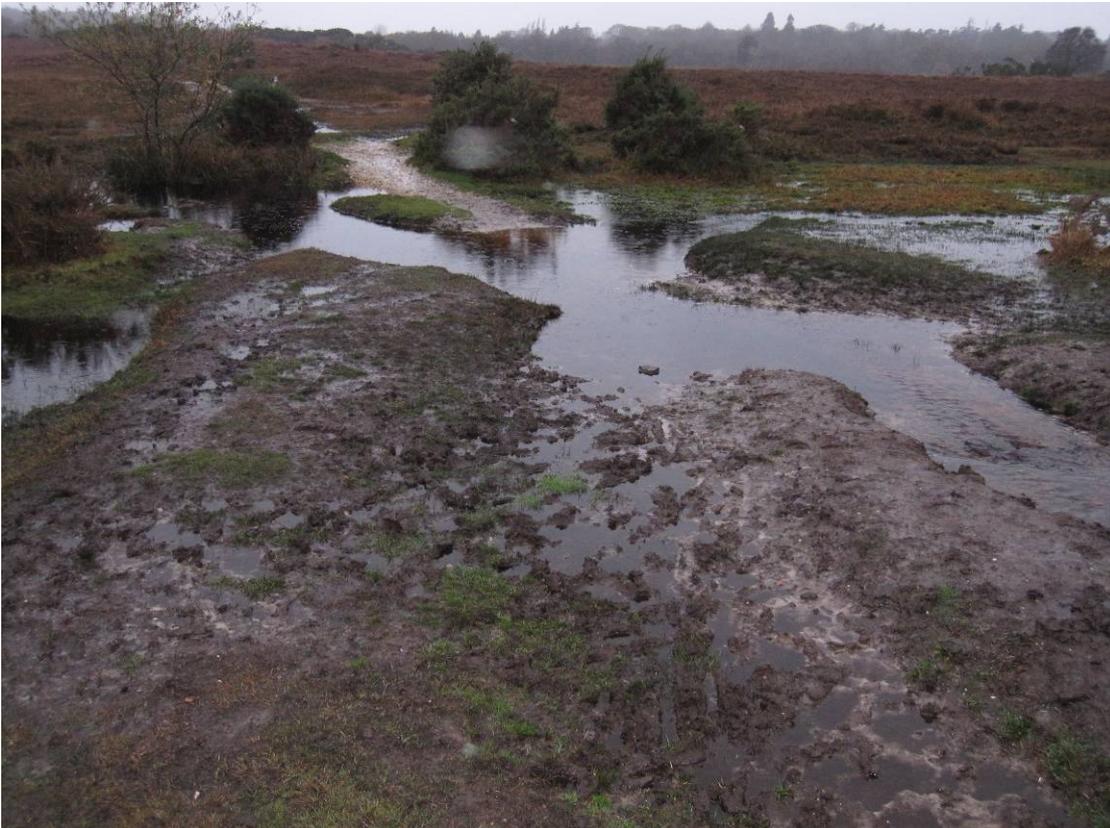
Recreational pressure was identified as an issue on this site, with several tracks and paths cutting through the wet heath and also a number of flooded vehicle tracks, particularly in the west of the site. Where the footpath crosses the stream in the centre of the site, grazing pressure, poaching and footpath erosion is particularly severe. Also at this location, due to the heavy rain, the stream was out of bank and completely bypassing the culvert over which the footpath crosses; given the extent of poaching and standing water, this is considered to be a regular occurrence, potentially exacerbated by the inadequate size of the culvert.

**Figure 1-3: Extensive footpath erosion and poaching around crossing point (NGR 421175 104605)**

Recreational pressures and grazing were identified as having a localised impact, particularly in the centre of the site. Improvements to the culvert (e.g. upsizing or replacement with a boardwalk) at this location should allow water to flow more readily and reduce the localised ponding around the crossing point. This should help to alleviate the poaching and footpath erosion issues.

Restoration Area	Damage Type	Restoration Proposals	Improvement	Constraints and Issues
Crossing point in centre of unit	Ponding of water around crossing point exacerbated by poaching and recreational pressures	Modification of footpath (e.g. boardwalks) and/or culvert (e.g. upsizing) to remove impediment to flow	Localised restoration of valley mire and wet heath habitats	Footpaths are an important amenity resource which could suffer from short-term disruption

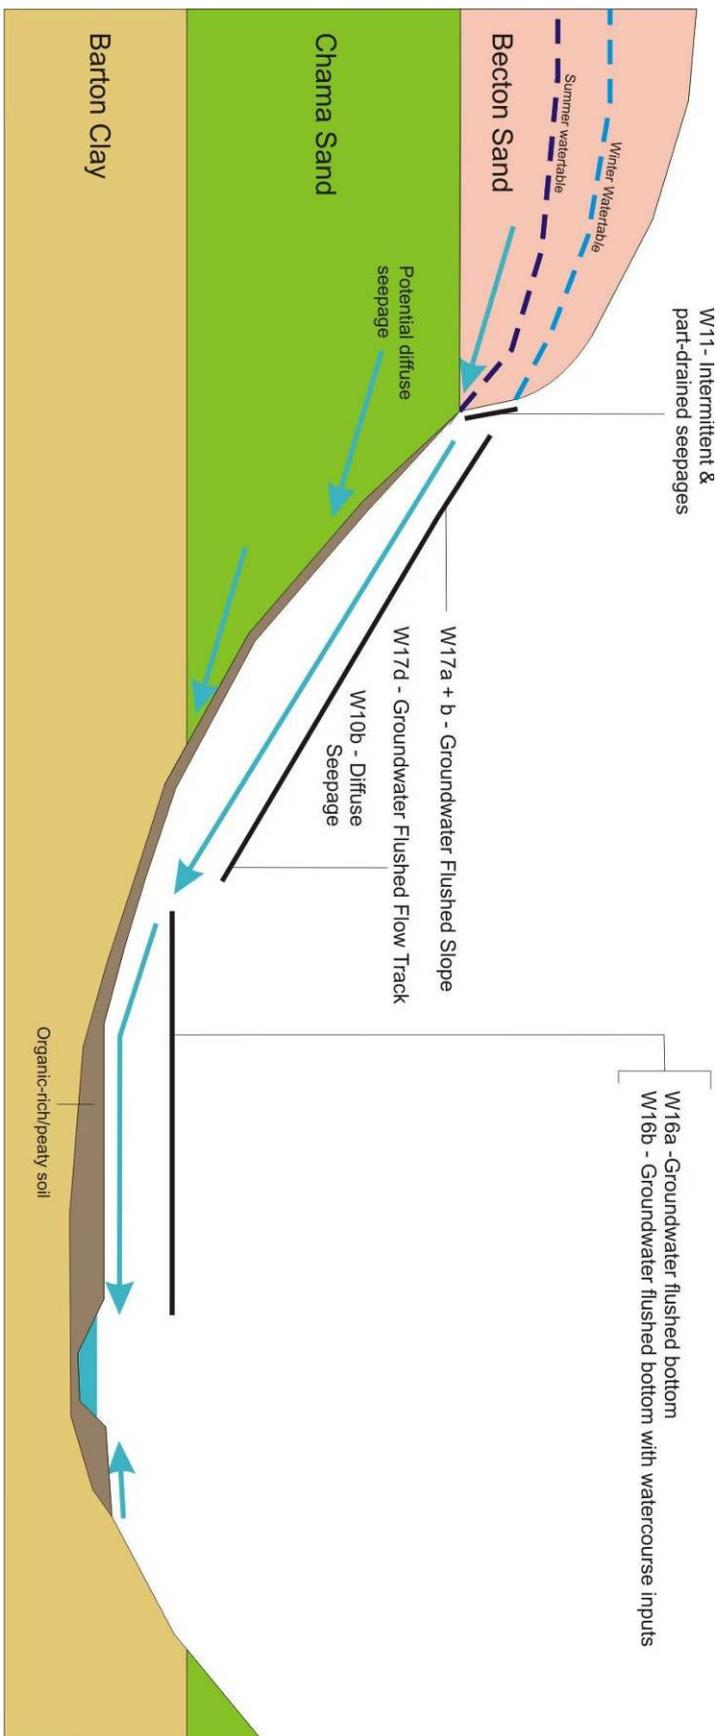
Figure 1-4: Conceptual Model Diagram

The wetlands on site are flush-dominated (see Figure 1-4). They receive water from groundwater seepage at two distinct stratigraphic horizons, each marked by a permeability contrast: (i) the base of the Becton Sand Formation (where it overlies the lower permeability Chama Sand) and (ii), the base of the Chama Sand Formation (where it overlies the lower

permeability Barton Clay). There may also be some diffuse seepage from the Chama Sand Formation. Water runs over the surface of the low permeability Barton Clay Formation, and gathers in depressions to form ponds and "collects", before flowing away in streams.

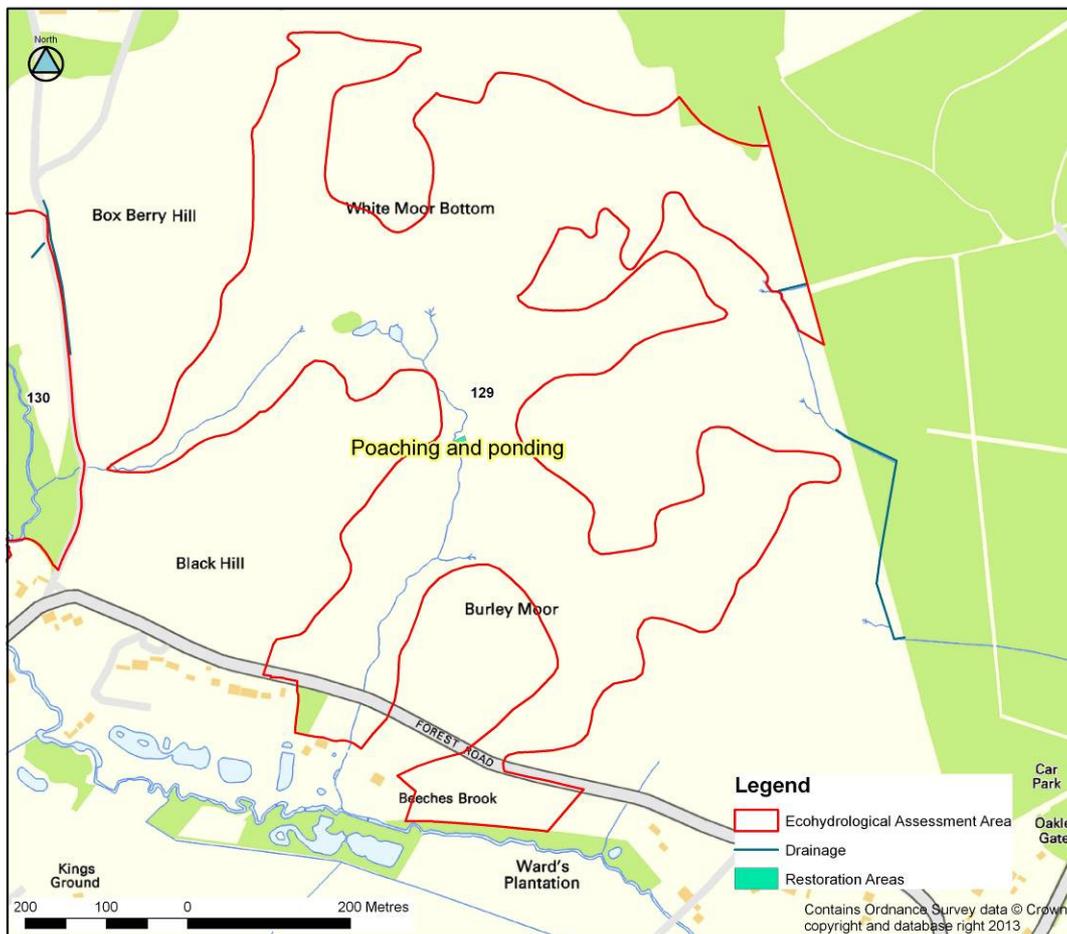
Figure 1-5: Restoration Areas Map

There are no areas of significant damage associated with drainage (see Figure 1-5). There has been some artificial straightening of the channel of the stream crossing Burley Moor, but this straightened section is not close to the areas of mire habitat.
