New Forest SSSI Geomorphological Survey Overview

Annex D: Linford Bottom Restoration Plan - SSSI Unit 88

First published 06 March 2014

1 Linford Bottom Restoration Plan - SSSI Unit 88

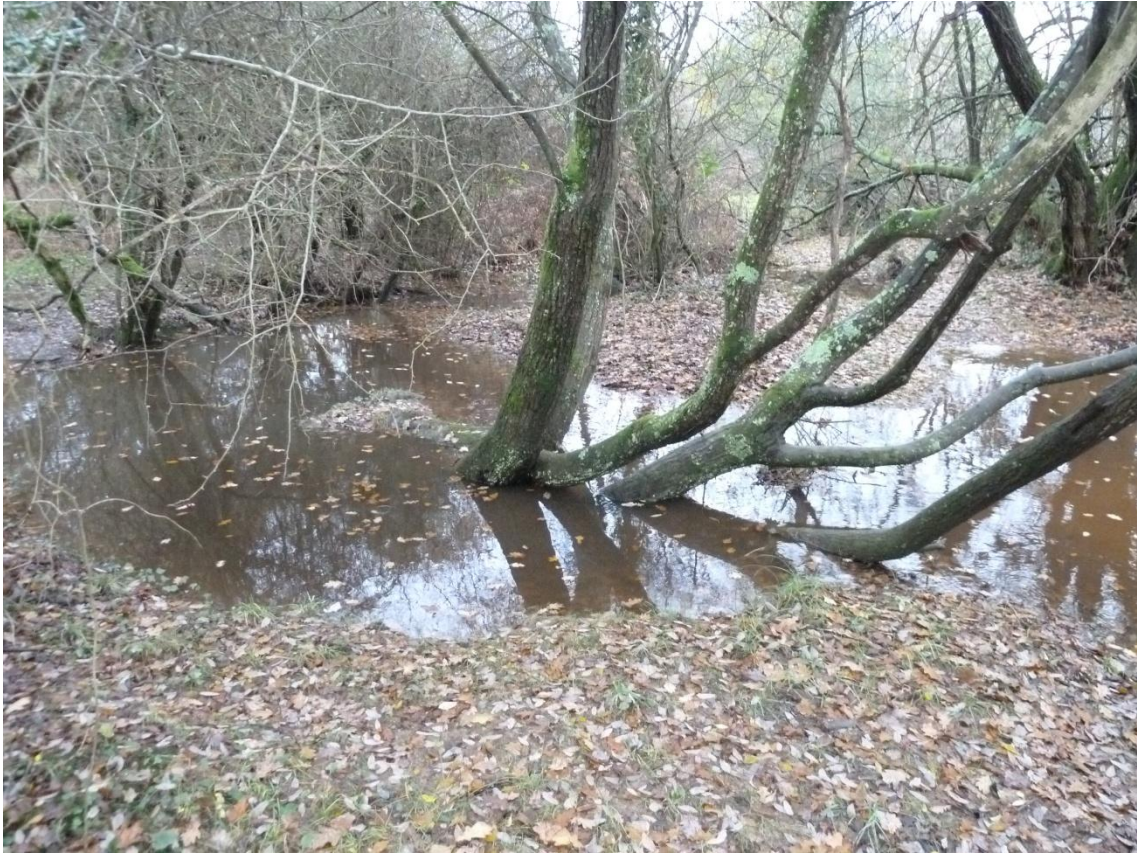
Linford Brook within SSSI Unit 88 is an active single thread channel with some short weakly anastomosed sections (Figure 1-2), that are moderately disconnected from the main channel. It has a strong upstream and local gravel supply, resulting in significant gravel shoal accumulations (Figure 1-3), particularly in the lower reaches linked to large scale local deposition and associated widening.

Figure 1-2: Anastomosed section characteristics

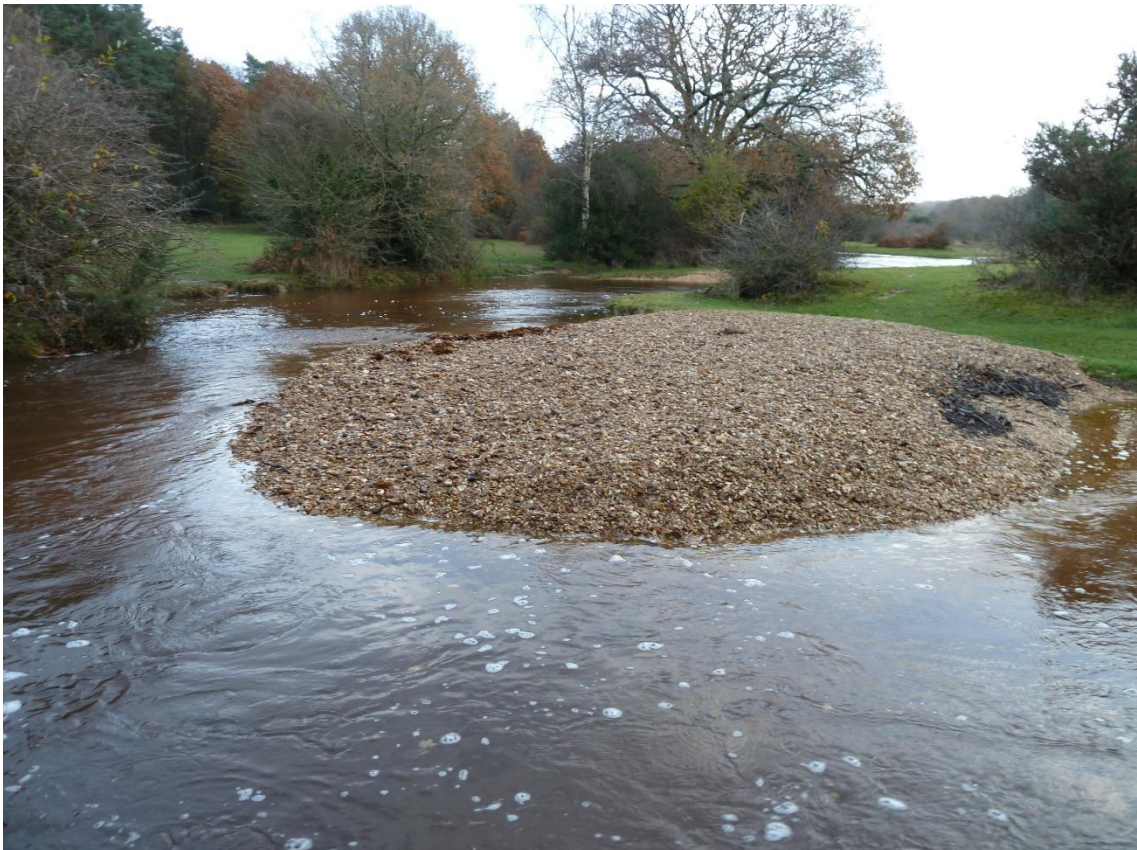
Figure 1-3: Gravel shoal development in some locations

Significant shoals in the downstream sections of the unit are influencing channel hydraulics immediately upstream, reducing the water slope and promoting more deposition. This 'cut and fill' activity is evident along the stream with fill zones characterised by plane bed, shallow gravel reaches and more local gravel shoals and bars causing local lateral erosion. This pattern is often repeated over time as gravels are re-eroded and re-deposited.

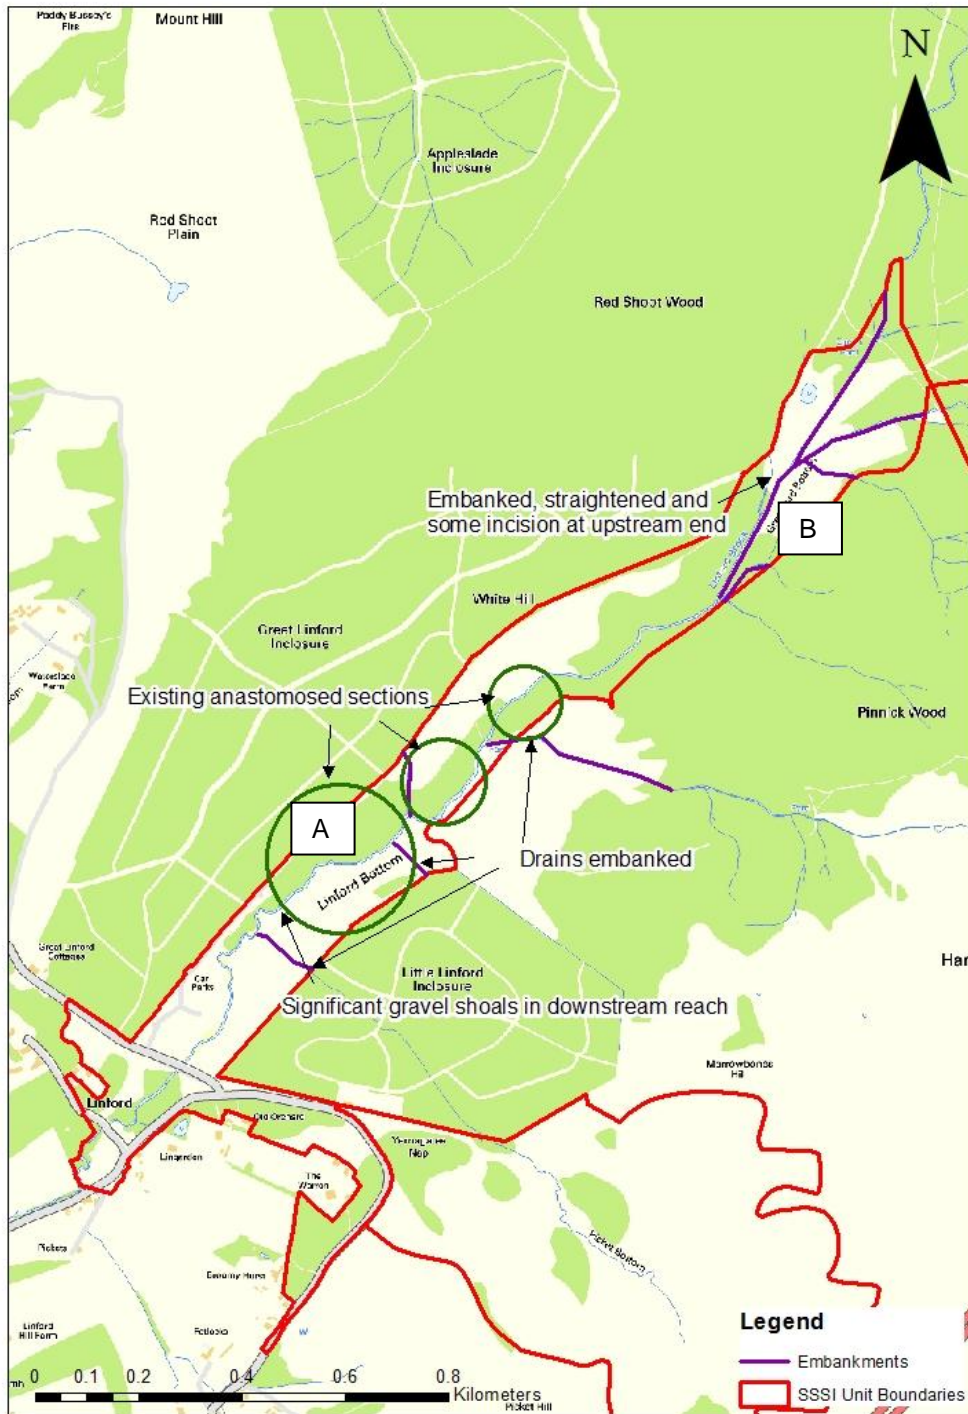
Figure 1-4: Current hydromorphic conditions and pressures

Linford Brook has a moderate gradient throughout, with minor reductions where there are short anastomosed sections (Figure 1-4 - A). Straightening of the watercourse has occurred in the past, particularly in the upper reaches (Figure 1-4 - B), and this has had an effect on the functioning of the river in this section. The length of the watercourse will have been shortened (palaeo channels are evident from the LIDAR, particularly in the upper reach), which leads to steepening of the system and the dredging that will have occurred has over-deepened the channel. This leads to increased flood shear stress levels that can result in heightened erosion (Figure 1-5)

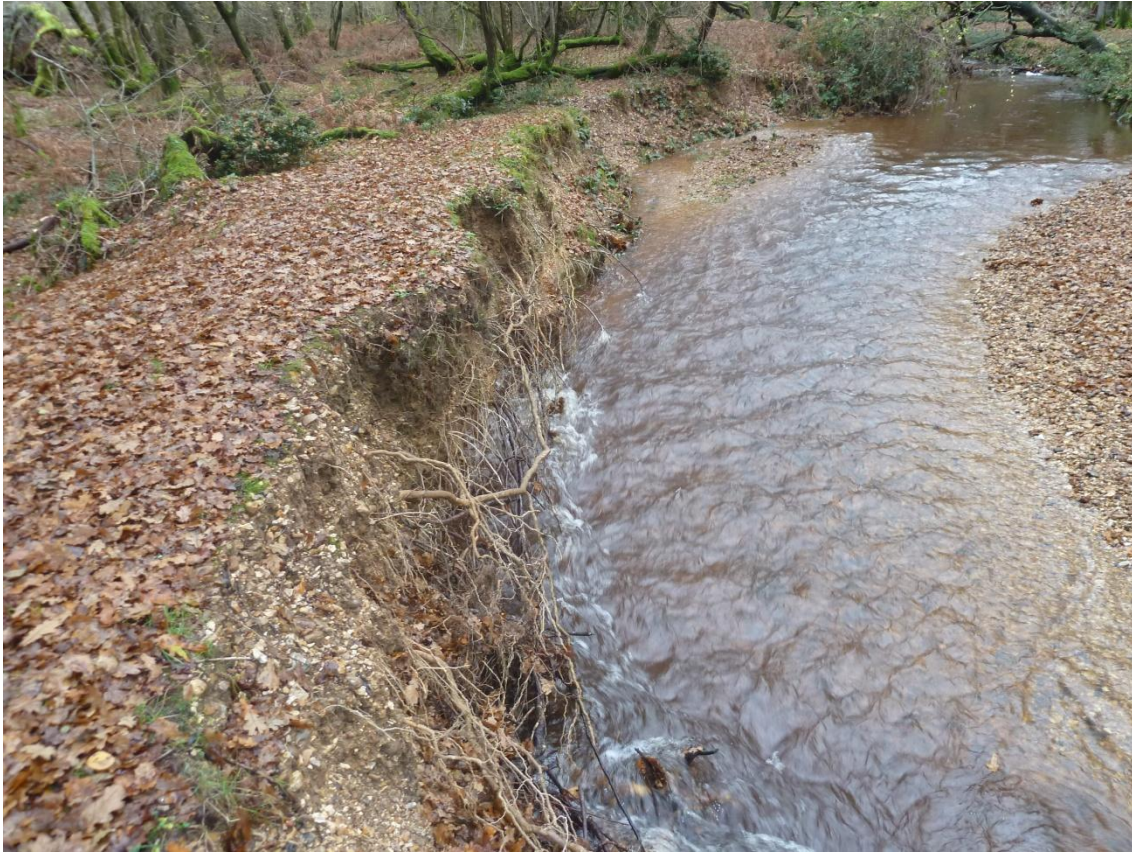
Figure 1-5: Bank erosion common in upper reaches

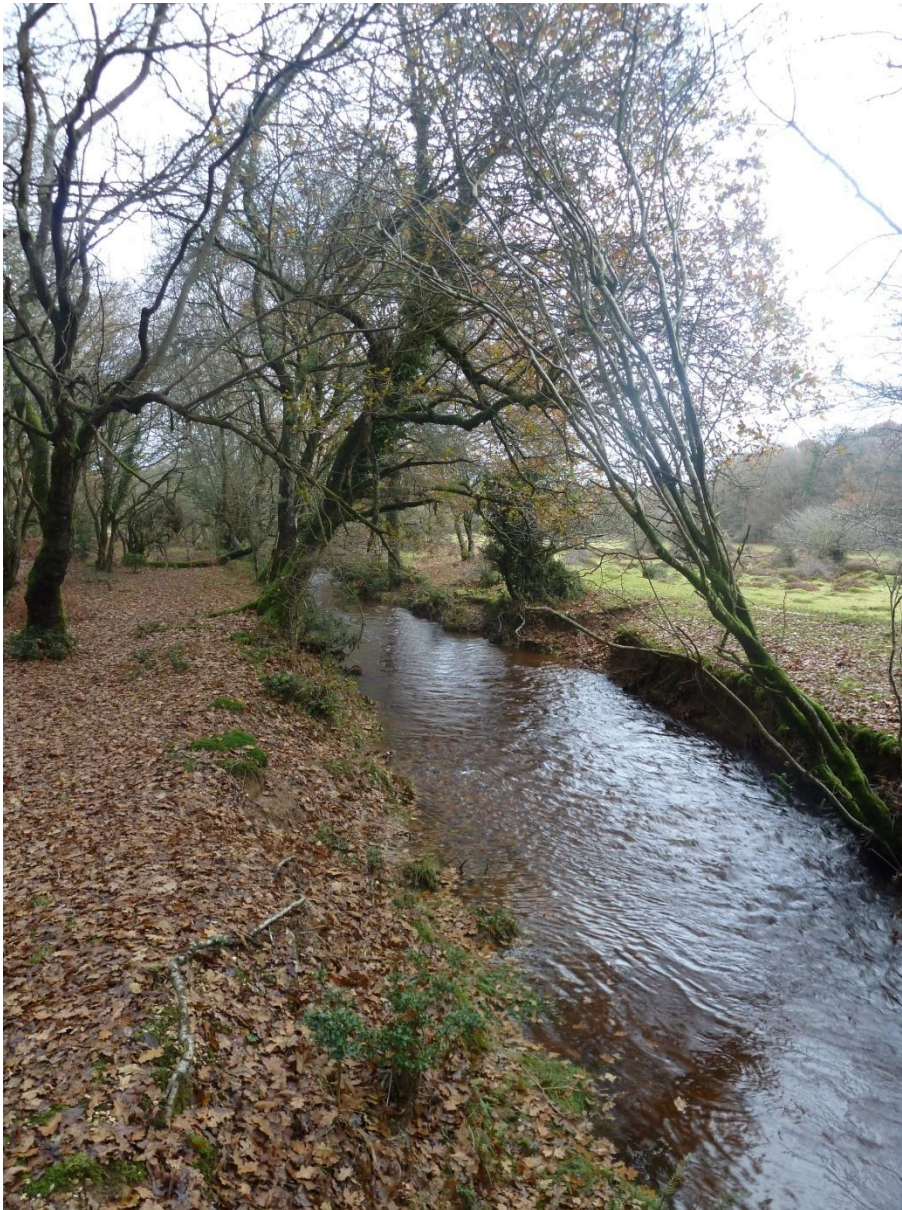
Figure 1-6: Incision evidence in upper reaches - tree leaning

The initial impact of straightening would have been some incision along the upper sections of this unit (Figure 1-6) and channel widening across areas with erodible banks, which may have partially occurred in the lower reaches.

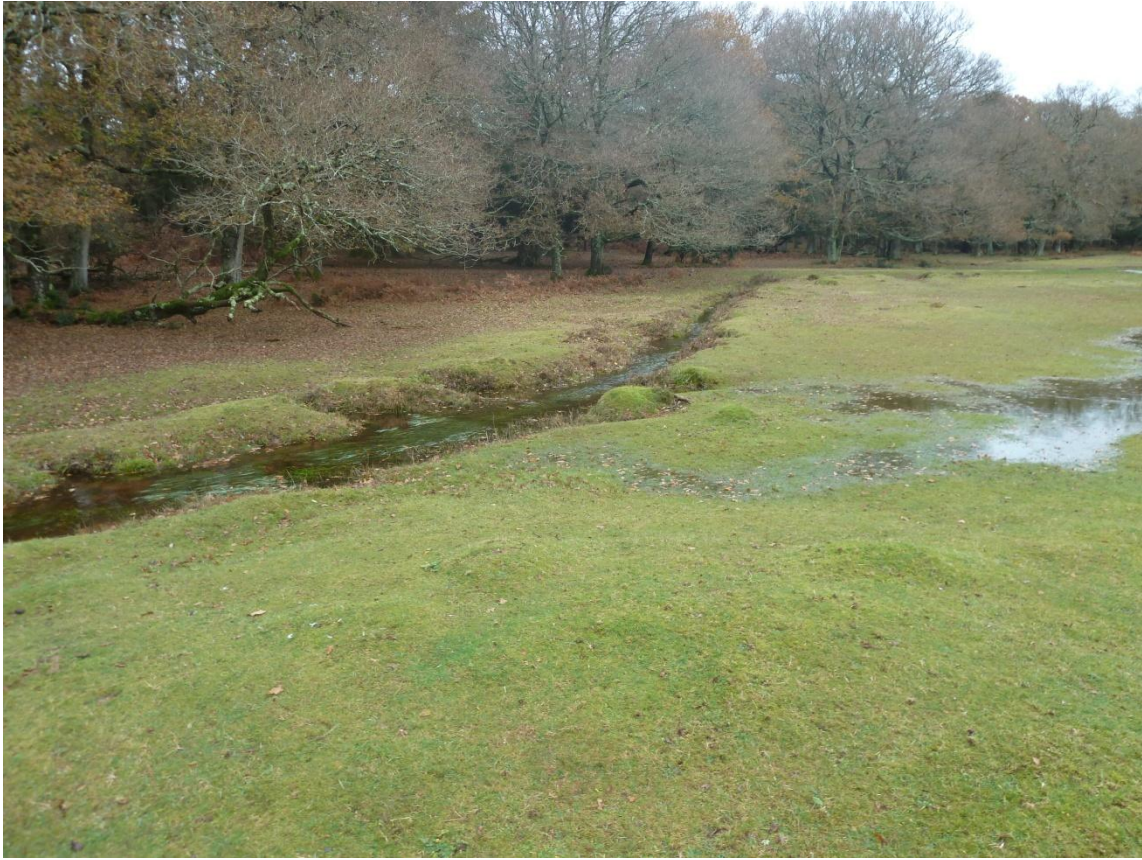
Groundwater levels are likely to have been altered in the upper sections of this unit where there has been mild incision and embanking. Sections of the immediate floodplain have become drier than natural, resulting in heavy grazing. This is also true for areas local to straightened and embanked drains (Figure 1-7).

Figure 1-7: Straightened and embanked drain

The straightened and embanked drains also require works to restore a more natural flood regime.

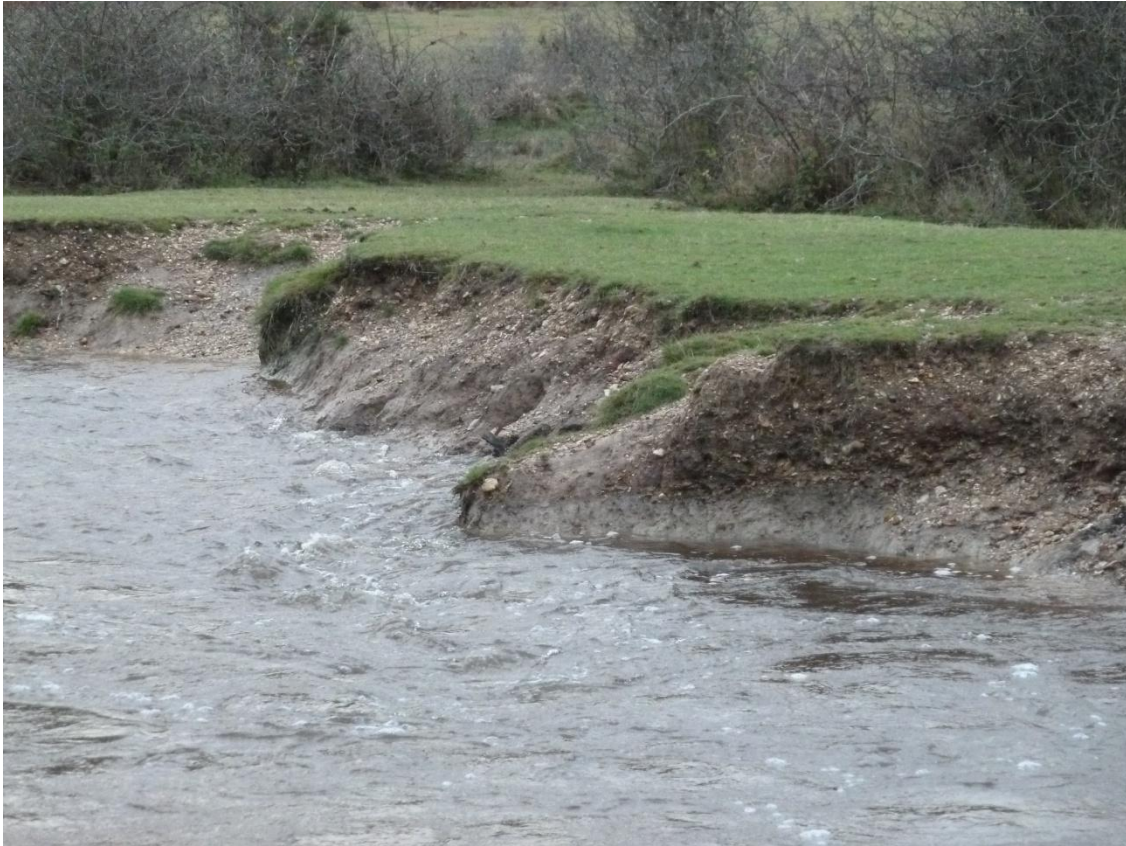
Gravel supply (there are significant gravel sources within the river banks locally, particularly in the mid to lower reaches, Figure 1-8) is strong and this, combined with flow regime alterations through surrounding drains, as well as historic tree clearance, results in responsive channel conditions.

Figure 1-8: Local gravel sources within banks

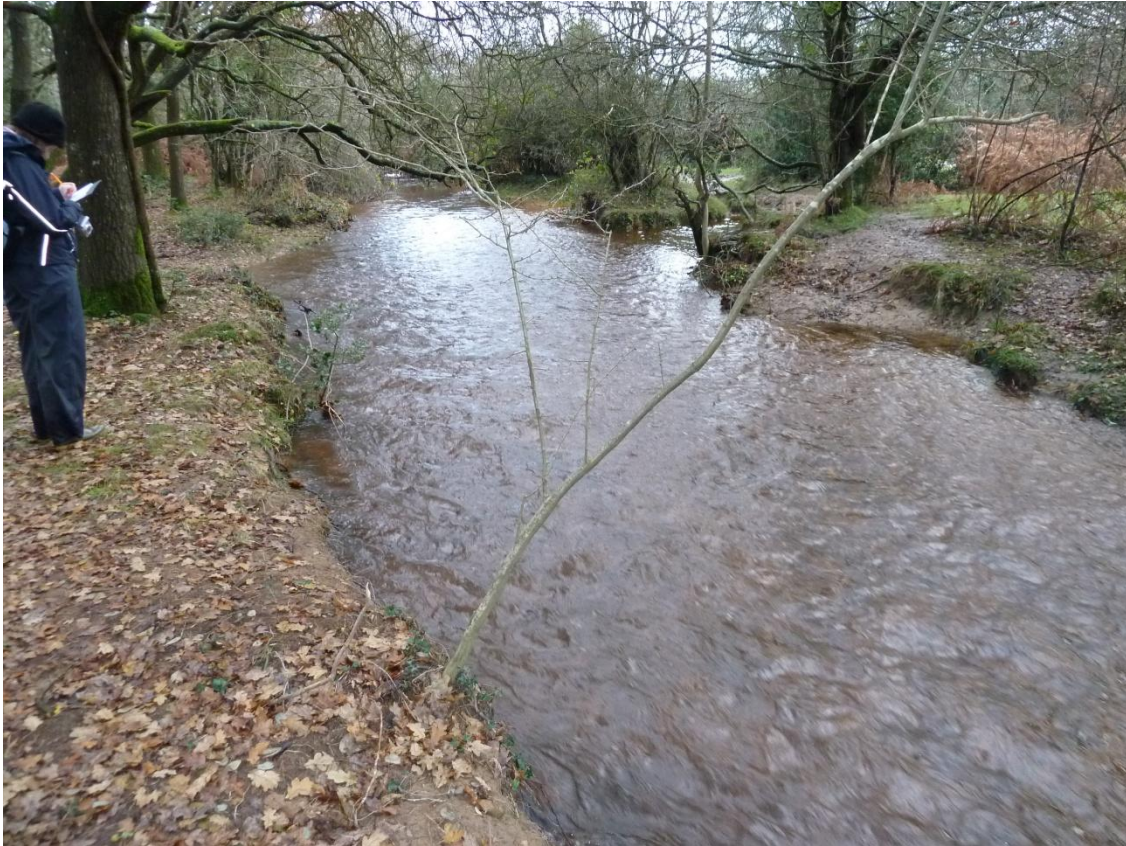
The strong supply of gravels has resulted in significant gravel feature growth within the channel in the form of mid channel bars, lateral bars, transverse bars and point bars (Figure 1-3 and Figure 1-5). There is also a good riffle - pool - run sequence development in the mid to lower reaches, as well as some shorter plane bed sections.

Figure 1-9: Riffle - pool sequencing in mid to lower reaches

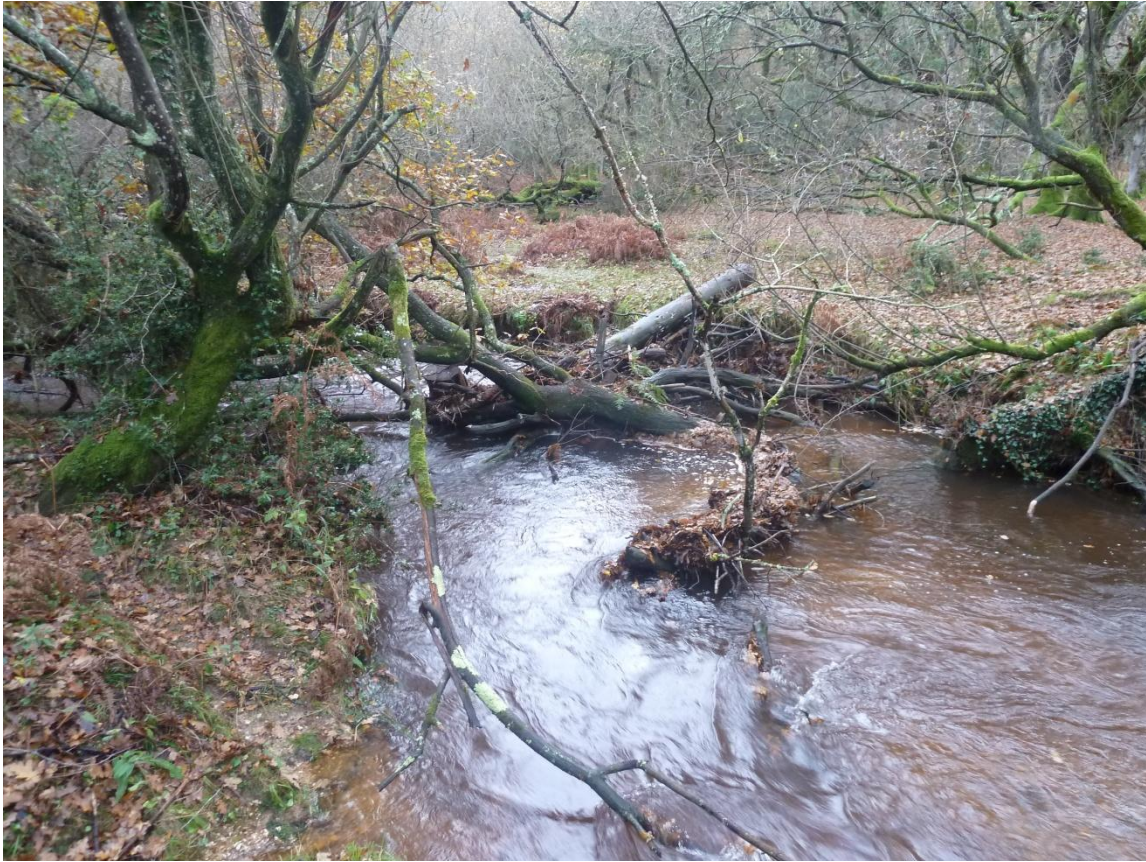
Natural woody debris features are also evident along the channel, within the wooded sections of the unit (Figure 1-10). These provide useful analogue features for incision management and water level raising to improve floodplain connectivity in the upper reaches of this unit.

Figure 1-10: Natural woody debris jams

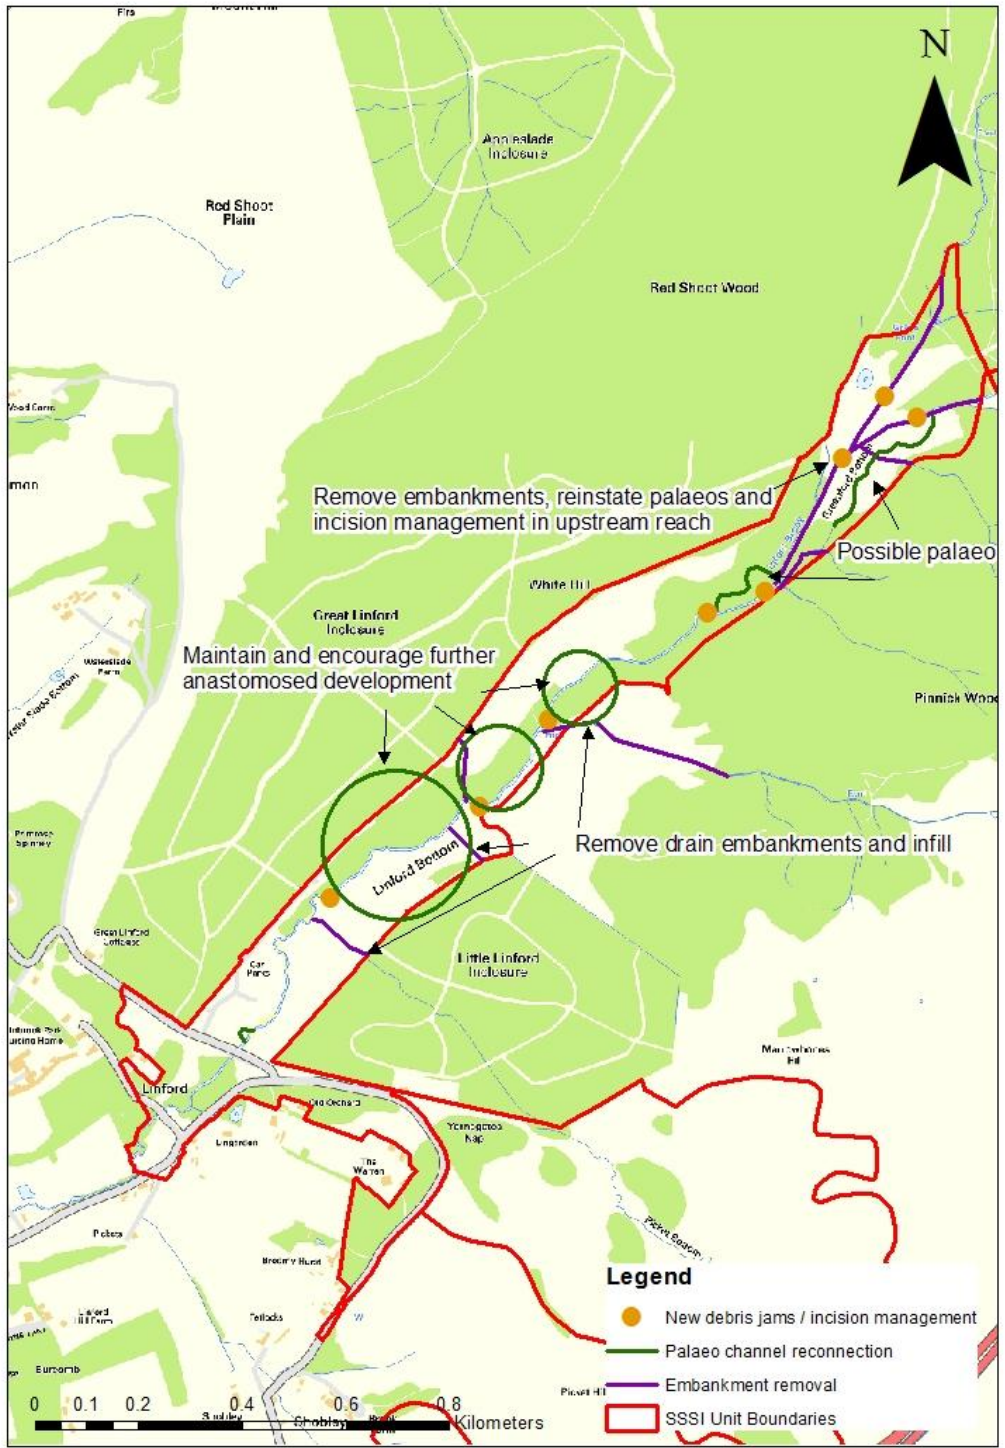
Figure 1-12: Proposed restoration measures for SSSI Unit 88

There are numerous palaeo channels within this unit that are shown in Figure 1-12 and show where reconnection could be possible through some of the proposed restoration measures in Table 1-2. These have been identified from the audit and supplied LIDAR and a significant channel has been identified in the upper reach towards the east that would improve the hydromorphic condition through this section if it could be reconnected.

A summary of the current pressures, unmitigated impacts and restoration proposals is given in Table 1-2 and shown in Figure 1-12.

The major straightened / modified drainage channels are identified in Figure 1-12. Other minor modifications could be considered for infilling and Appendix A should be used for reference.
