Natural England Commissioned Report NECR140

New Forest SSSI Geomorphological Survey Overview

Annex I: The Grove - SSSI Unit 286

First published 06 March 2014

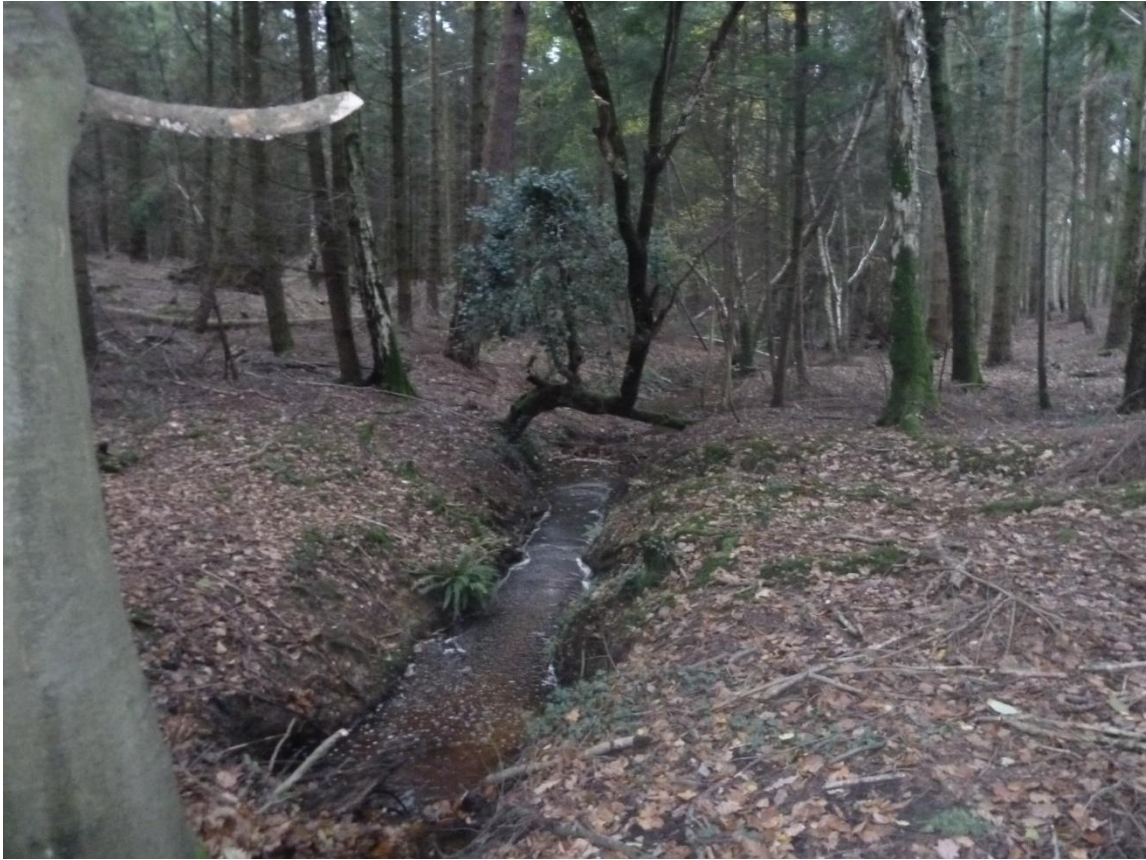
Figure 1-2: Active single thread characteristics

The Grove SSSI Unit and Fleet Water is characterised by an active single thread river type throughout (Figure 1-2 and Figure 1-3). The stream is within a relatively confined valley with relatively steep sides, restricting lateral activity to a narrow active band. This has resulted in a poorly developed marginal floodplain.

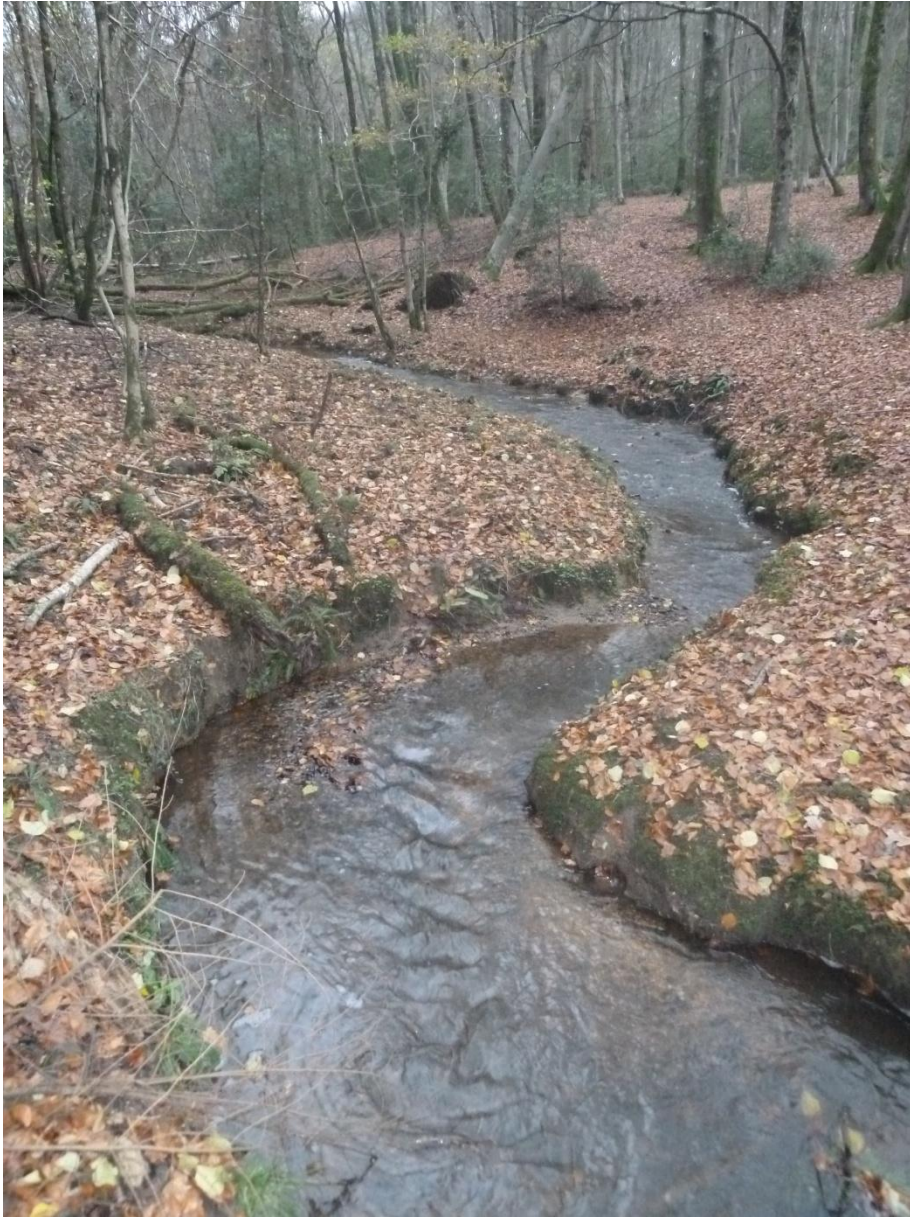
Figure 1-3: Active single thread channel type - bank erosion

The gravel supply to the unit, and from local bank sources, is moderate but gravels are not abundant enough to create and sustain large gravel features (Figure 1-3). Riffle - pool - run sequencing has developed (Figure 1-9) throughout the unit as a result of the moderate gravel supply and moderate / steep gradient. Gravel bars and berms are generally only small, embryonic features throughout.

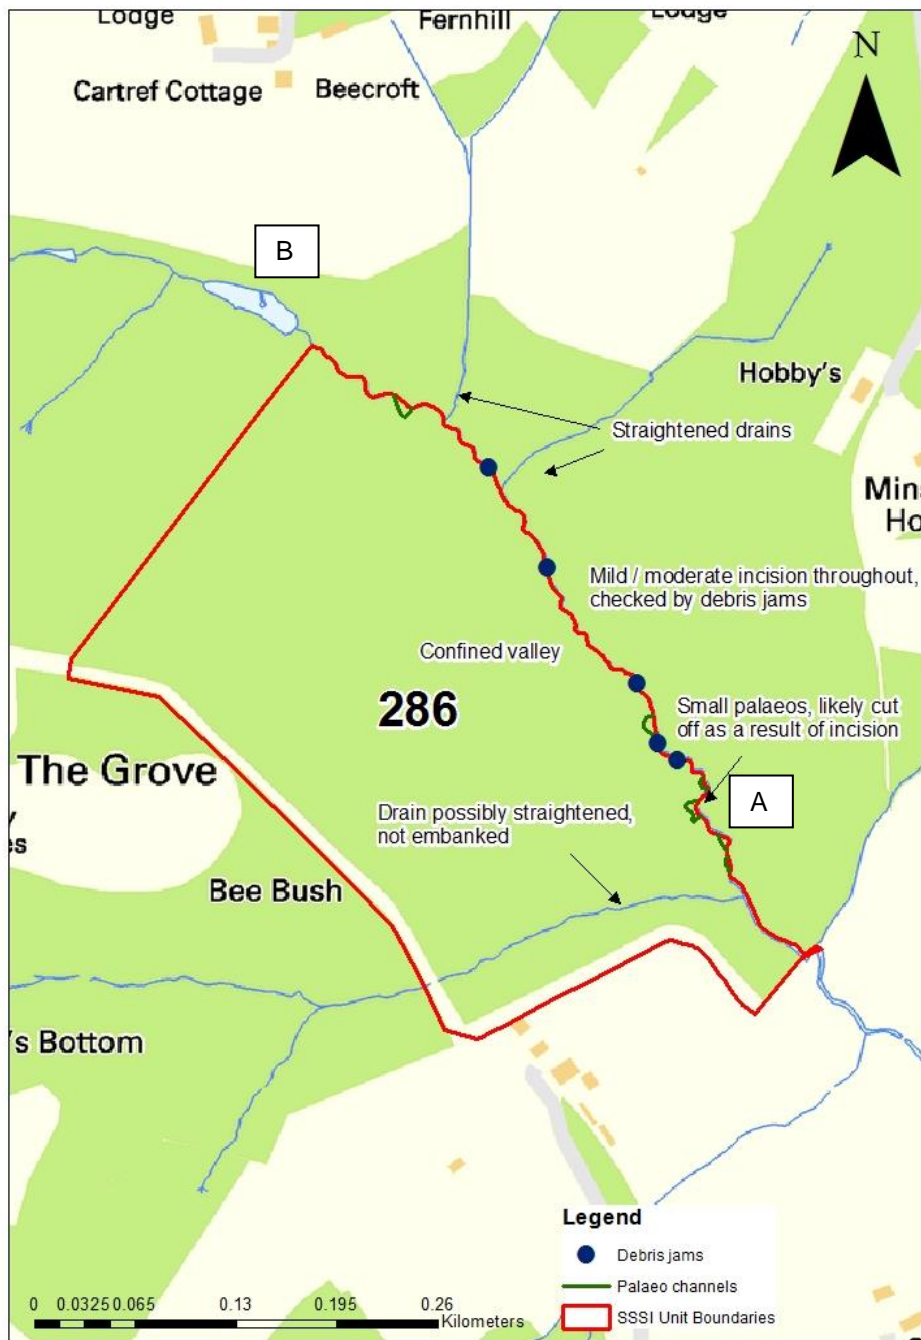
Figure 1-5: Current hydromorphic conditions and pressures

It was not apparent during the survey that significant straightening of the main channel has occurred in the past as only small meander palaeos were identified (Figure 1-5 - A), which are likely to be linked to incision rather than artificial straightening. Only small palaeo channel sections were identified from the LIDAR (Appendix A). The palaeos are likely to have been left where there was once channel bifurcation, with incision in the dominant channel leaving the bifurcation at a higher level. As a result, there are no obvious embankments (constructed from in-channel arisings) along the bank tops throughout the unit. Therefore, artificial straightening is unlikely to be a reason for the mild to moderate incision seen along the reach.

The major drains within this SSSI unit show evidence of past straightening and over-deepening, although they have no significant embankments along the bank tops. The smaller flow routes show some signs of artificial modification through straightening and realigning, as shown in the flow line maps in Appendix A. The modifications to the main drains marked in Figure 1-5 are likely to be concentrating flows at local points in the main channel, leading to elevated erosive conditions. This is likely to be a contributing factor to the mild to moderate incision within this unit (Figure 1-6). The pond upstream of the SSSI unit (Figure 1-5 - B) is likely to be acting as a sediment sink, starving the reach of some sediment, resulting in some bed incision.

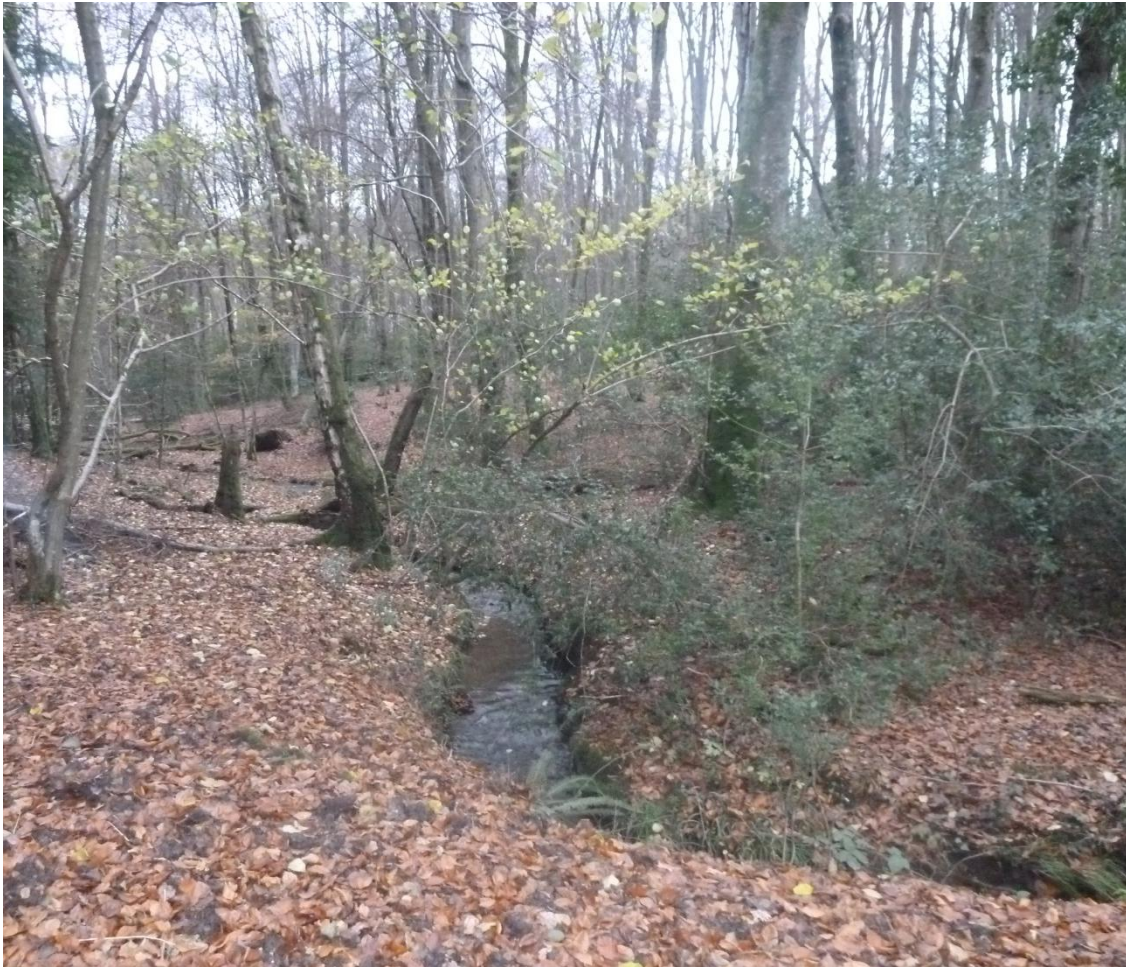
Figure 1-6: Mild / moderate incision

The modified drainage regime, concentrating flows in the main channel, leads to energetic flow conditions that increase erosive energy potential. The well wooded riparian corridor (Figure 1-7) has largely prevented excessive lateral erosion, hence erosive energy is focused on bed incision. This has resulted in variable disconnectivity from the floodplain, although the v-shaped valley means that connectivity levels would naturally be reduced. There are some small floodplain areas at a lower level where improved connectivity may result in multi thread channel development, possibly where bifurcation once occurred. The lowered bed level will have impacted groundwater levels locally however, resulting in drier areas within the floodplain. Widespread incision has also been prevented through the frequent occurrence of natural woody debris jams within the channel (Figure 1-8).

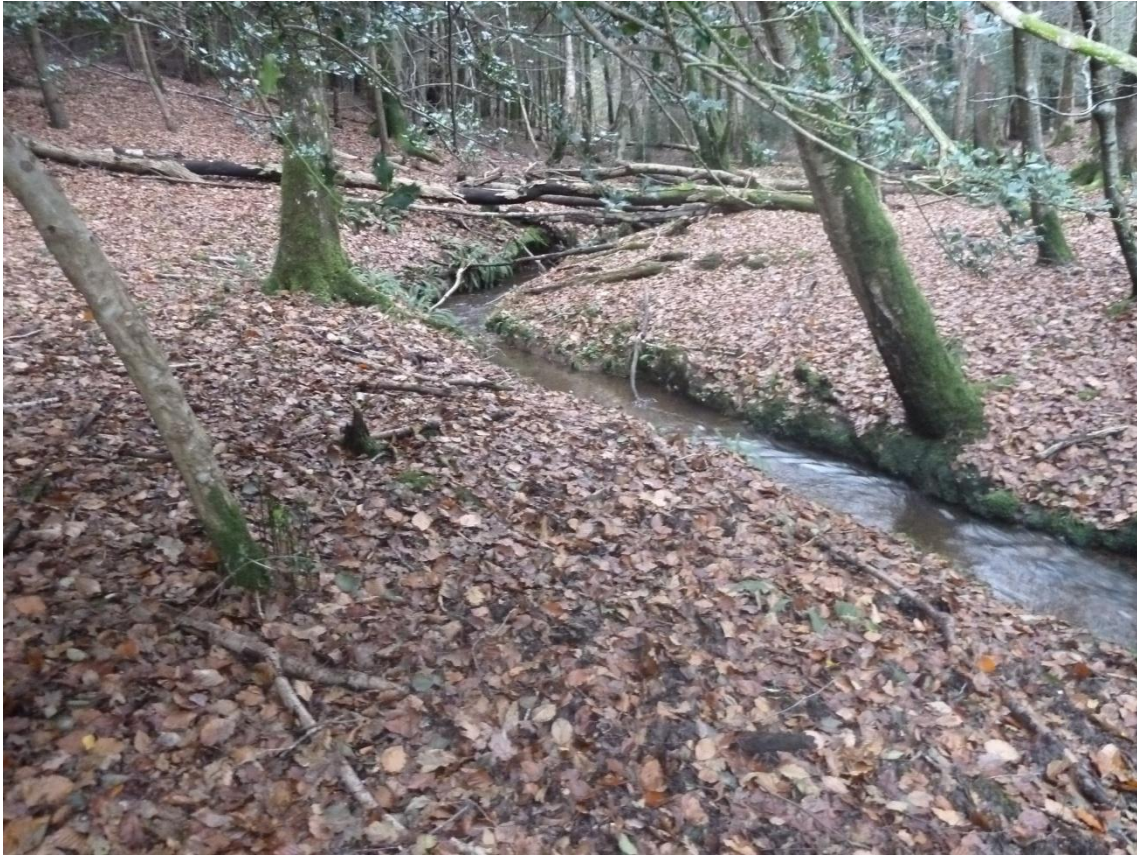
Figure 1-9: Riffle - pool - run development

An assessment should be made as to whether the pond just upstream of the SSSI unit is significantly impacting the sediment transfer to the reach, which may be inhibiting morphological feature development and starving the reach of gravel and in turn providing excessive erosive energy for bed incision. The development of gravel features is also controlled by the mild incision in the channel and the limited connectivity to the floodplain. However, this unit is considered to be a transporting reach, due to the gradient and surrounding topography, therefore significant gravel features are unlikely to naturally occur within the channel.
