**RISLEY III LANDFILL SITE ASSESSMENT**

**Resource Planning Team  
ADAS Statutory Group  
WOLVERHAMPTON**

**ADAS Job No: 09/96  
MAFF Ref: EL 06/10397  
LUPU Com: W01828**

## ASSESSMENT OF RISLEY III LANDFILL SITE

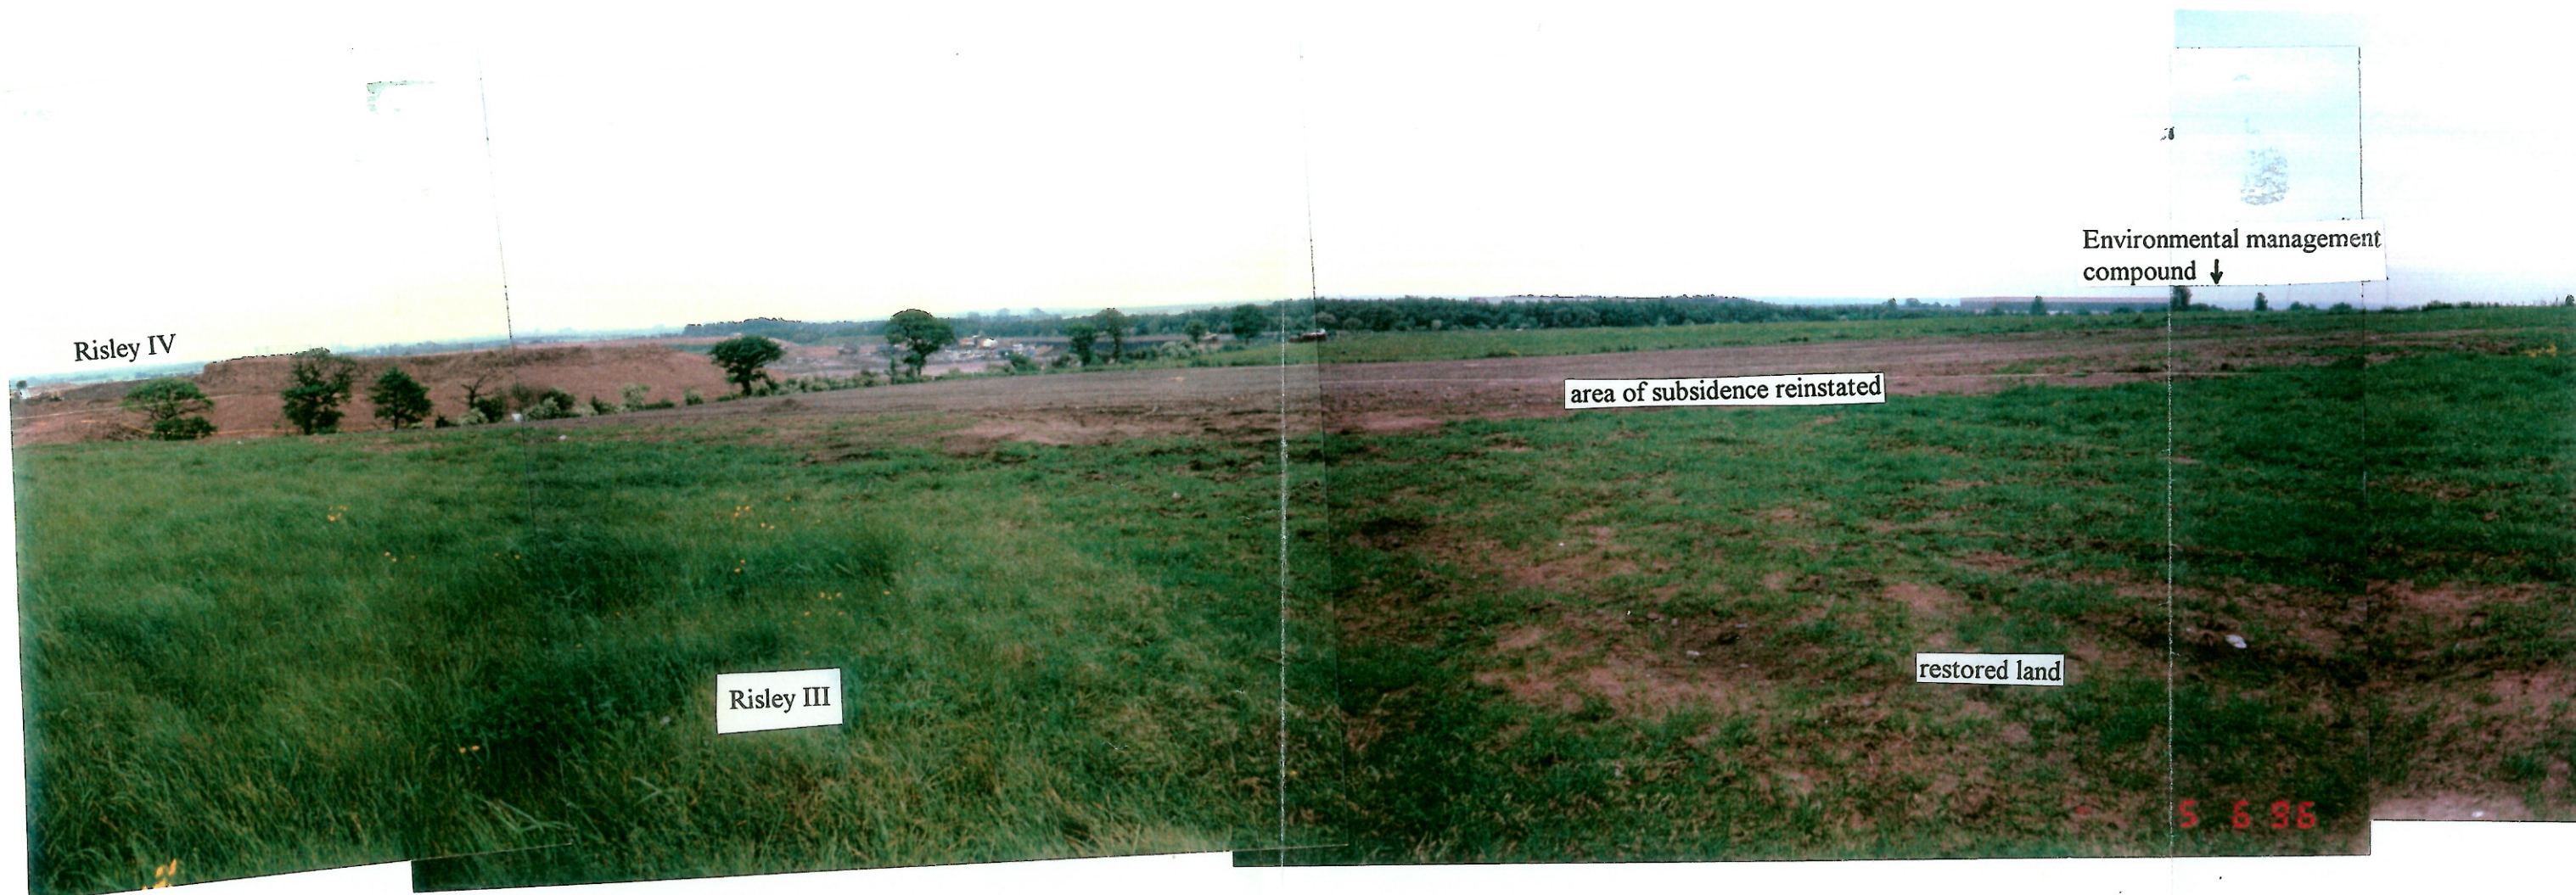
Photograph 1

Showing the restored Risley III phase in the foreground, including the recently re-engineered area of subsidence. To the left can be seen the progressive restoration of Risley IV.

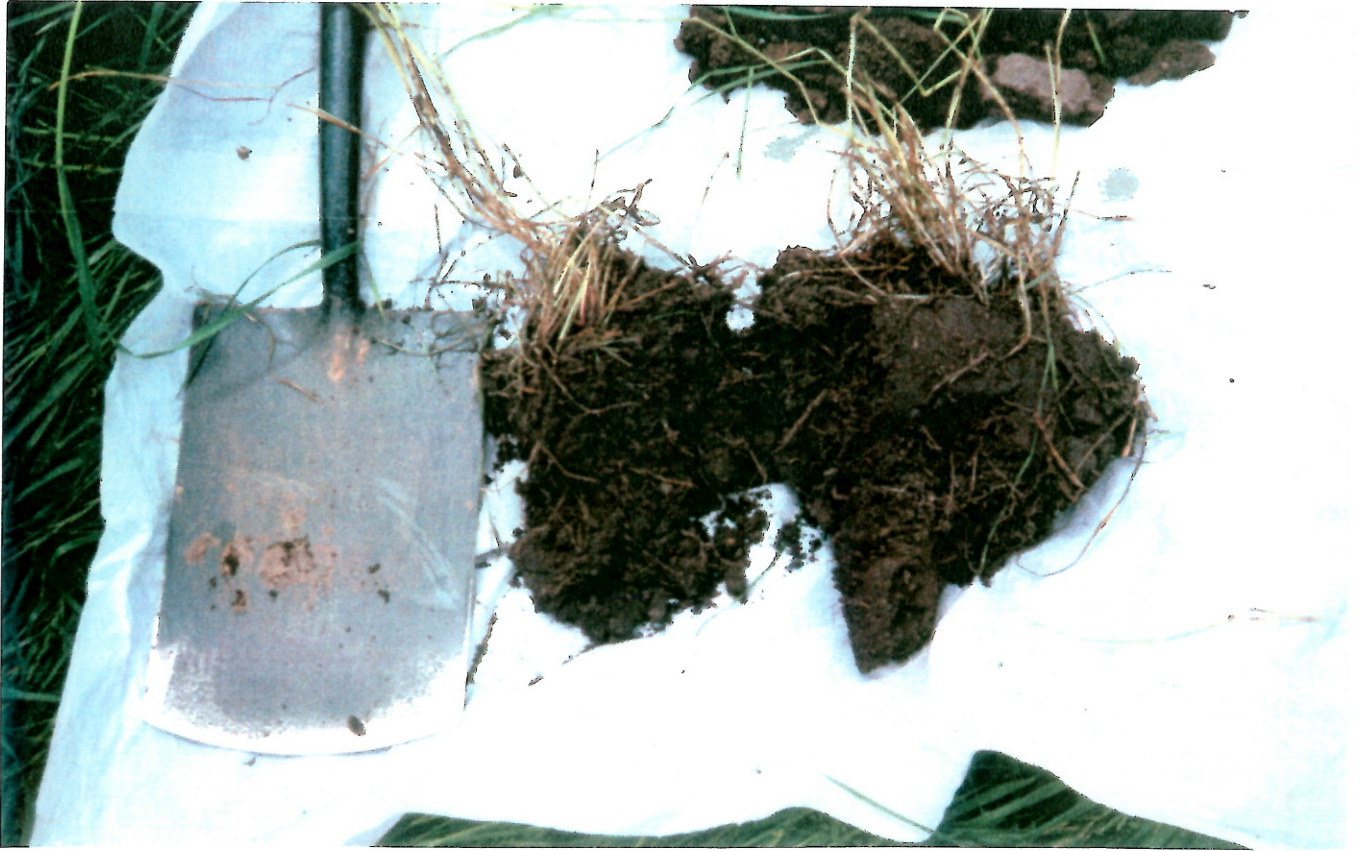
Photograph 2a

An example of darker topsoil material which displays good structural development.

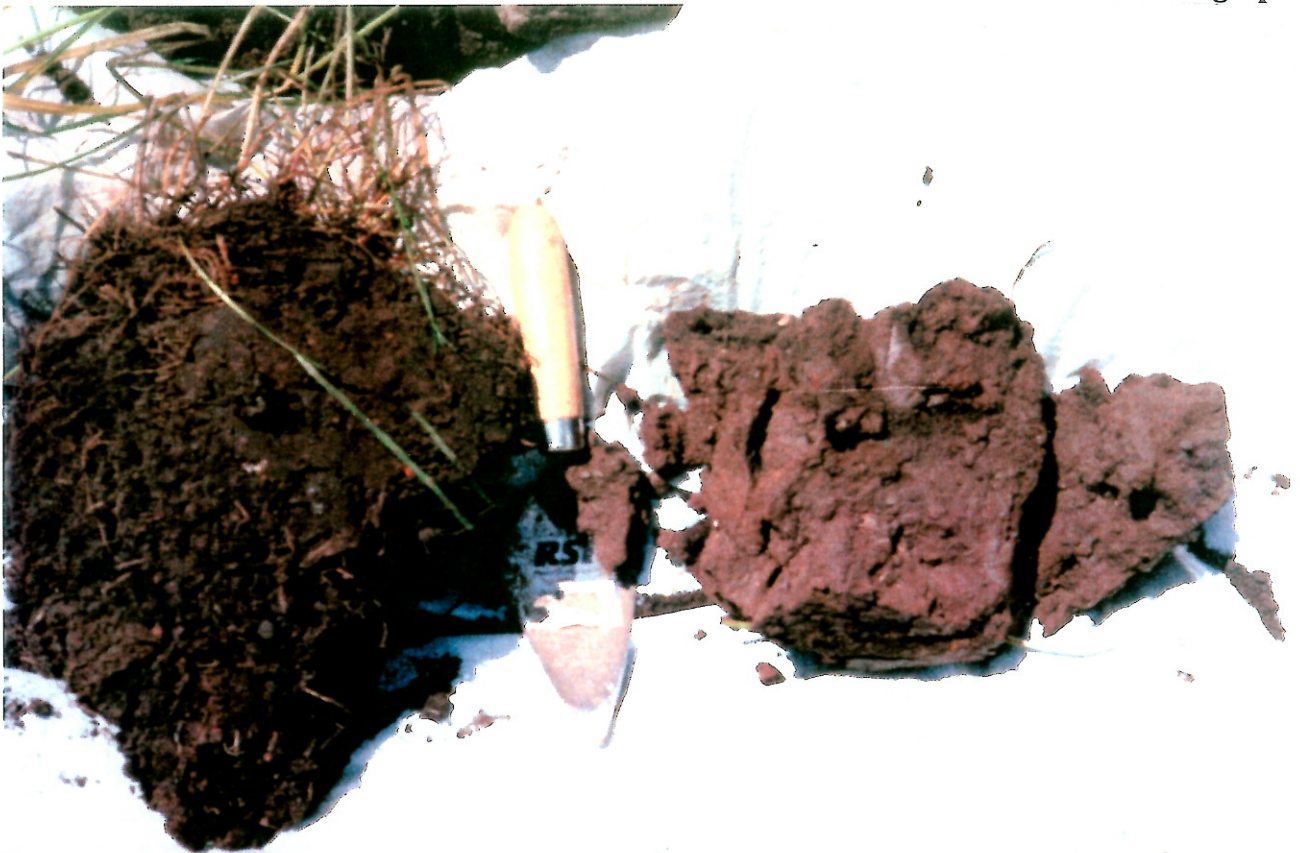
Photograph 2b

Topsoil material (left) contrasted with the heavier, gleyed and poorly structured subsoil material found across the site.

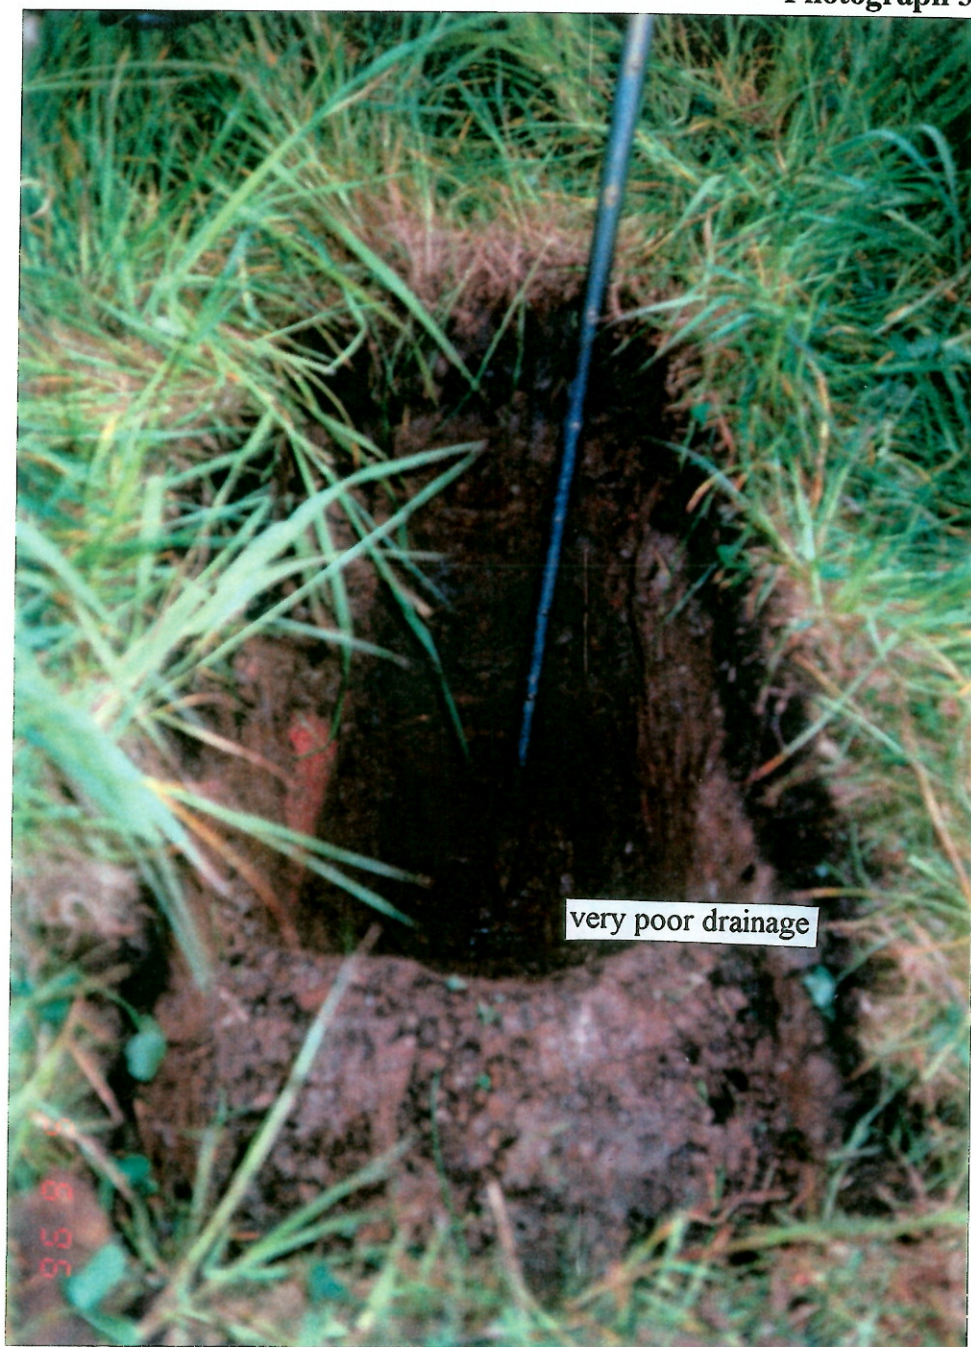
Photograph 3

- 0-10cm Black 10YR21, stoneless, peaty loam.  
Many fine fibrous roots.
- 10-29/35cm Reddish brown 05YR5/4, medium clay loam, with common strong brown 75YR5/6 and grey 10YR5/1 mottles. Massive structure, firm consistence, low porosity, few fine fibrous roots.
- 29/35-70cm Grey 10YR5/1, mixed sandy clay loam, sand and clay with many 55PB mottles. Massive structure.

**PIT 1**

Severely compacted, restored profile.

Heavily gleyed and mixed material  
underlies a thin peaty topsoil layer.

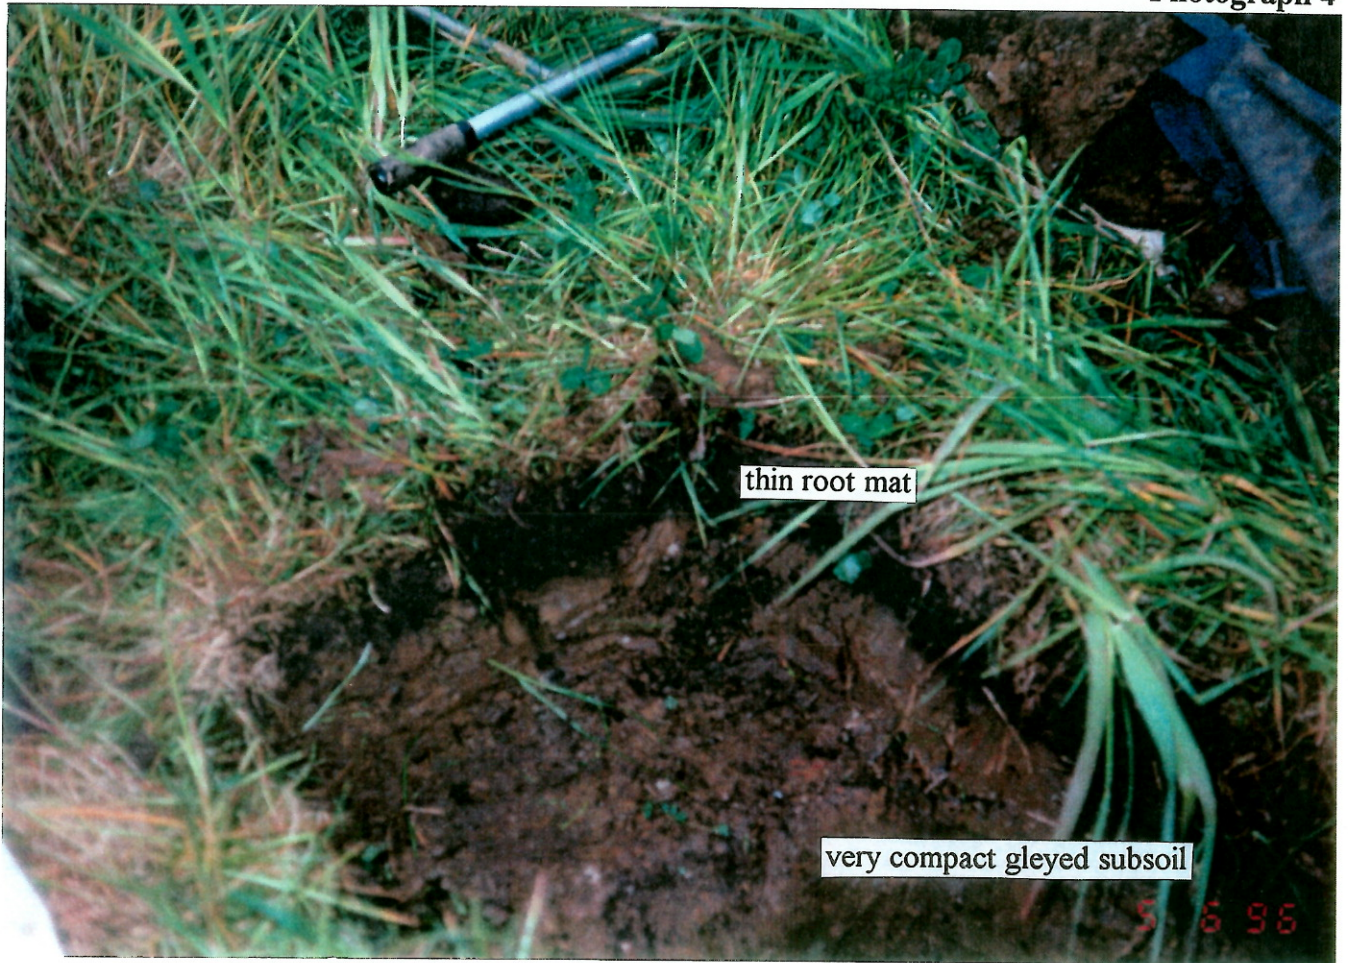
Photograph 4

- 0-10cm Very dark grey 10YR3/1, heavy clay loam, with common strong brown 75YR5/6 mottles. Common roots.
- Brown 75YR4/3 clay, mixed with medium clay loam and foreign material (brick). Massive structure, extremely firm consistence, very low porosity, few fine fibrous roots.

PIT 2

Thin 10cm root mat onto subsoil material. The subsoil material is very mixed (numerous brick fragments were identified), and compacted.

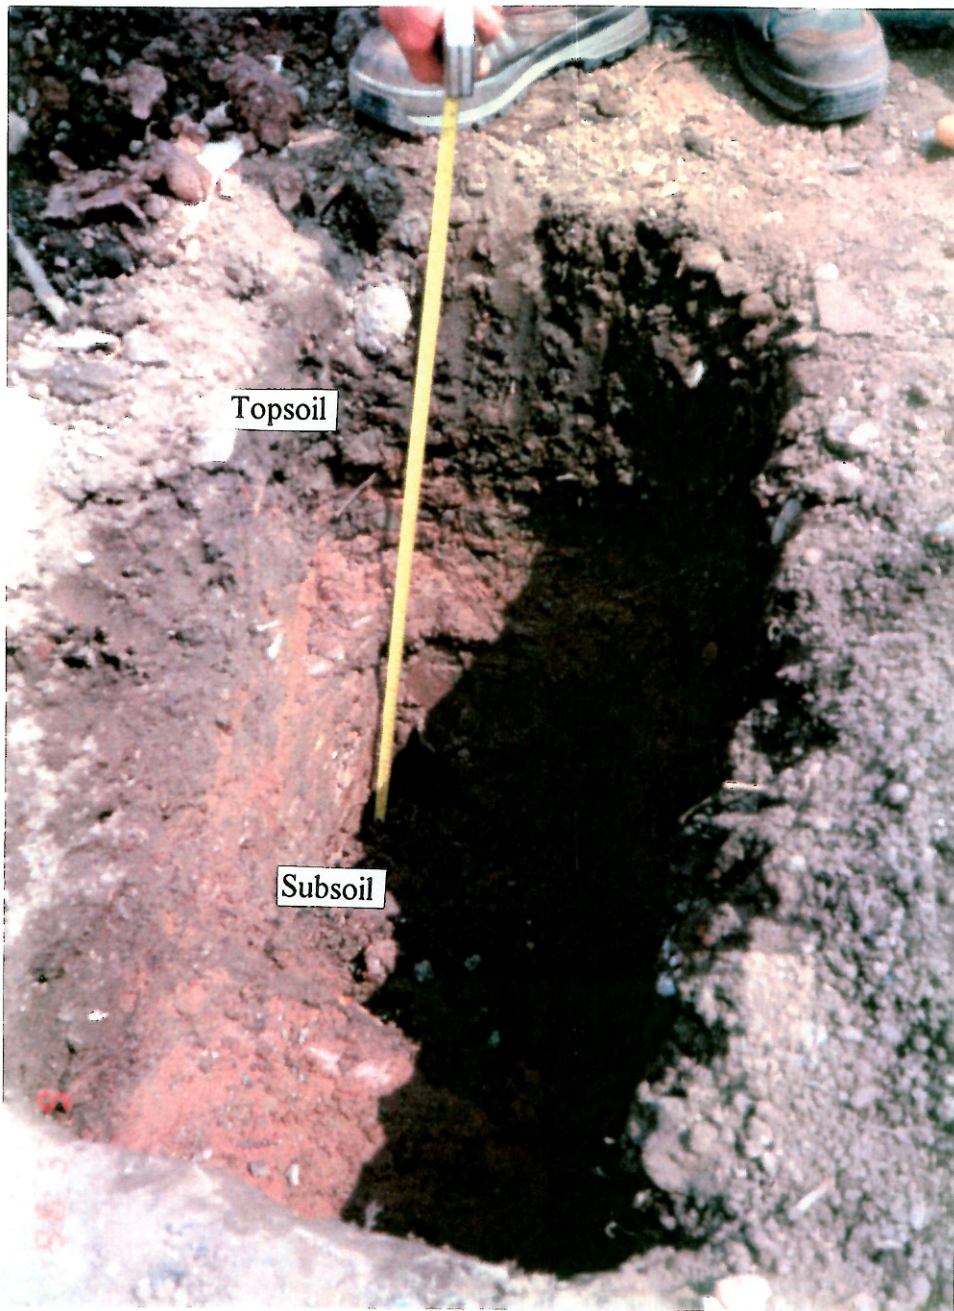
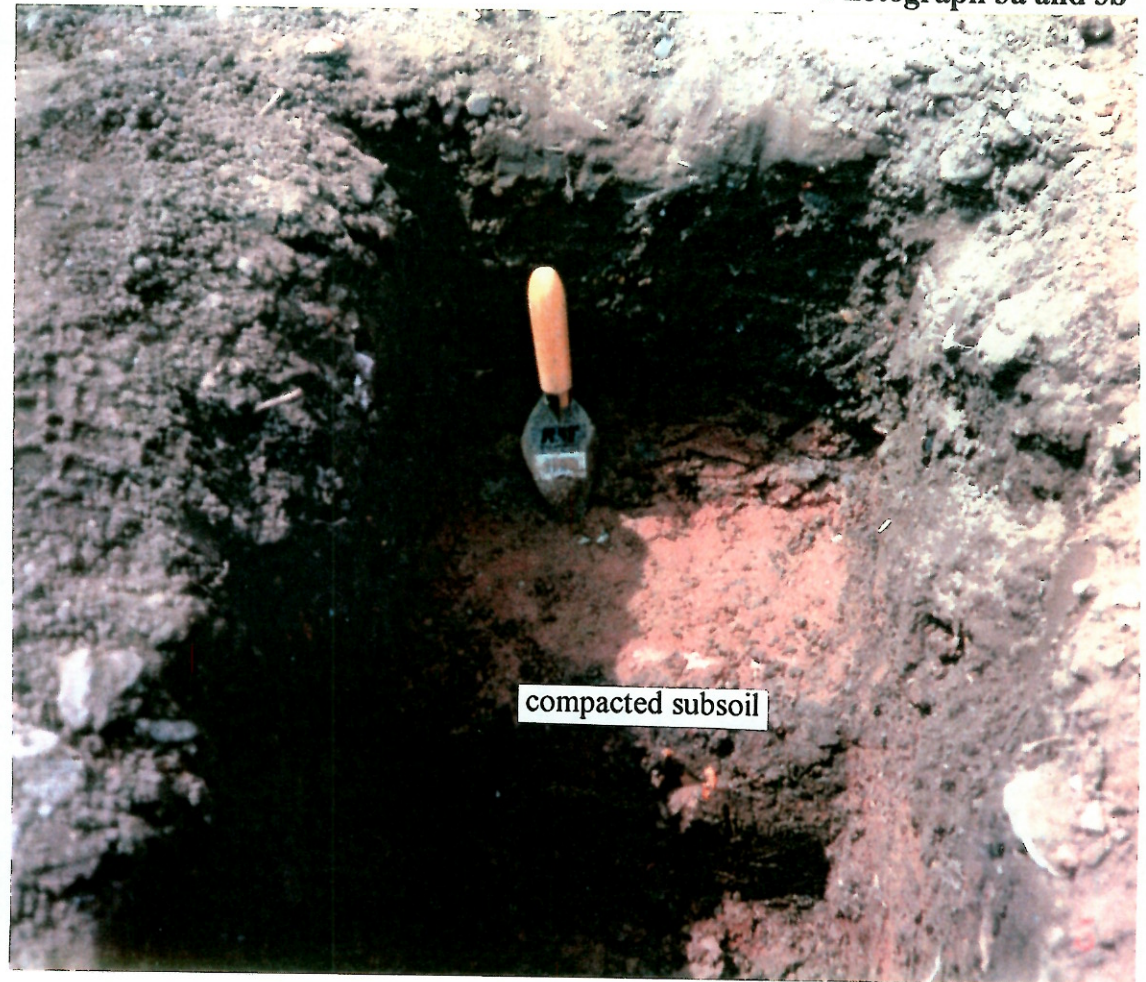
Photograph 5a and 5b

- 0-26cm Very dark grey 10YR3/1, sandy clay loam. High incorporation of foreign material.
- 26-38cm Brown 75YR4/4 medium sandy loam, banded with overlying sandy clay loam
- 38-80cm Brown 75YR4/3 heavy clay loam. Coarse platy structure very firm, very low porosity.

**PIT 3**

The restored profile showing the imported soil material. The 'screened' topsoil incorporated a high percentage of rubbish.

The subsoil is severely compacted.

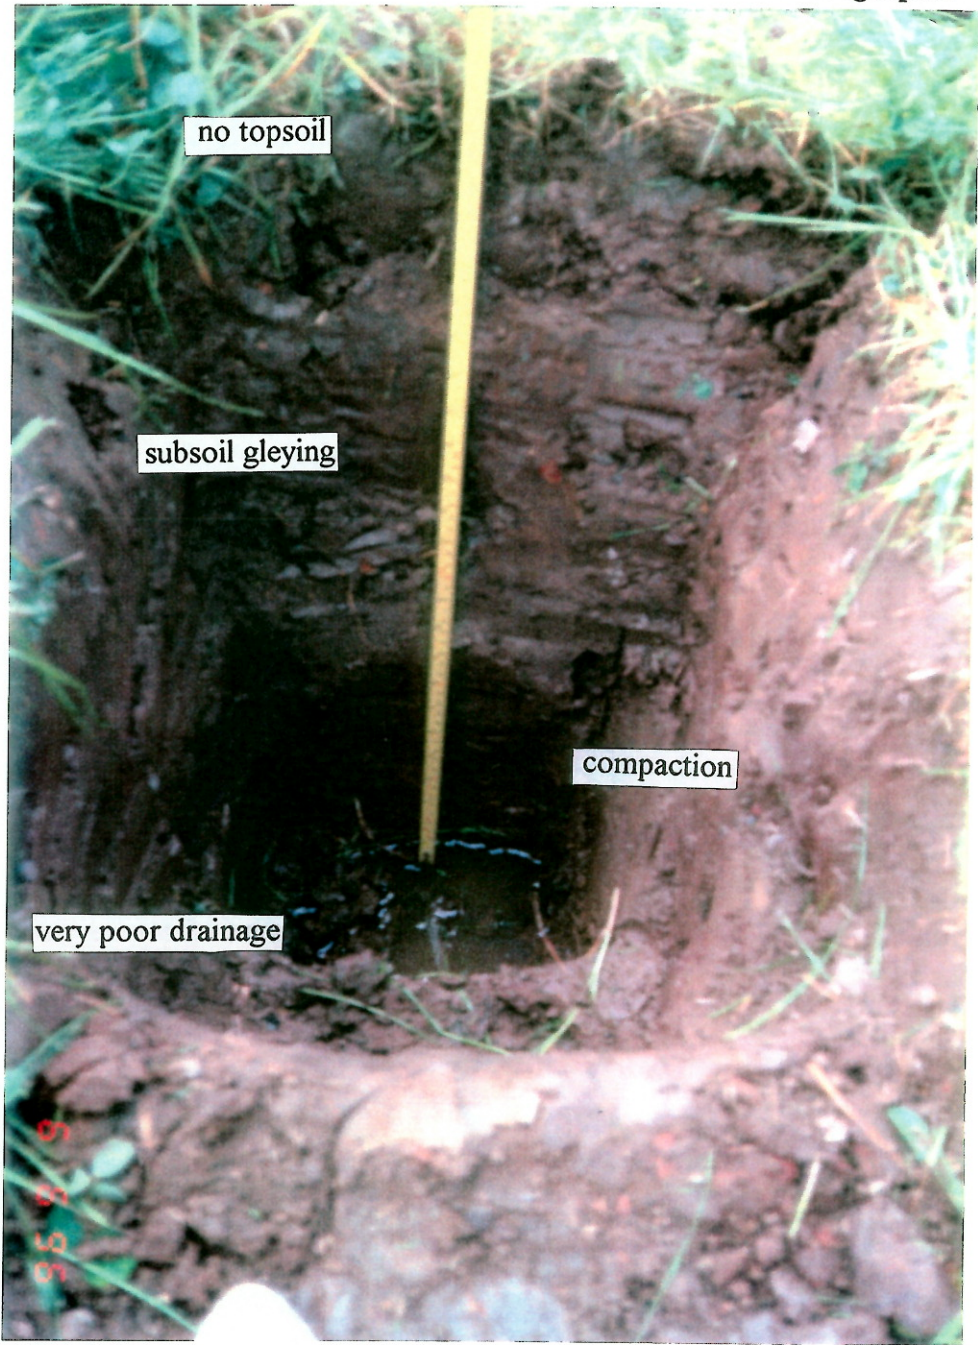
Photograph 6

- 0-70cm Brown 75YR4/3 with common many strong brown 75YR5/6 and grey 10YR5/6 mottles. Massive structure, extremely firm, very low porosity. Rare roots.  
Water at 70cm.  
Soil profile is slightly less compact below 40cm.

**PIT 4**

Identifying a lack of topsoil material. Limited root penetration into the subsoil material and the gley coloration indicate the severity of the soil compaction.

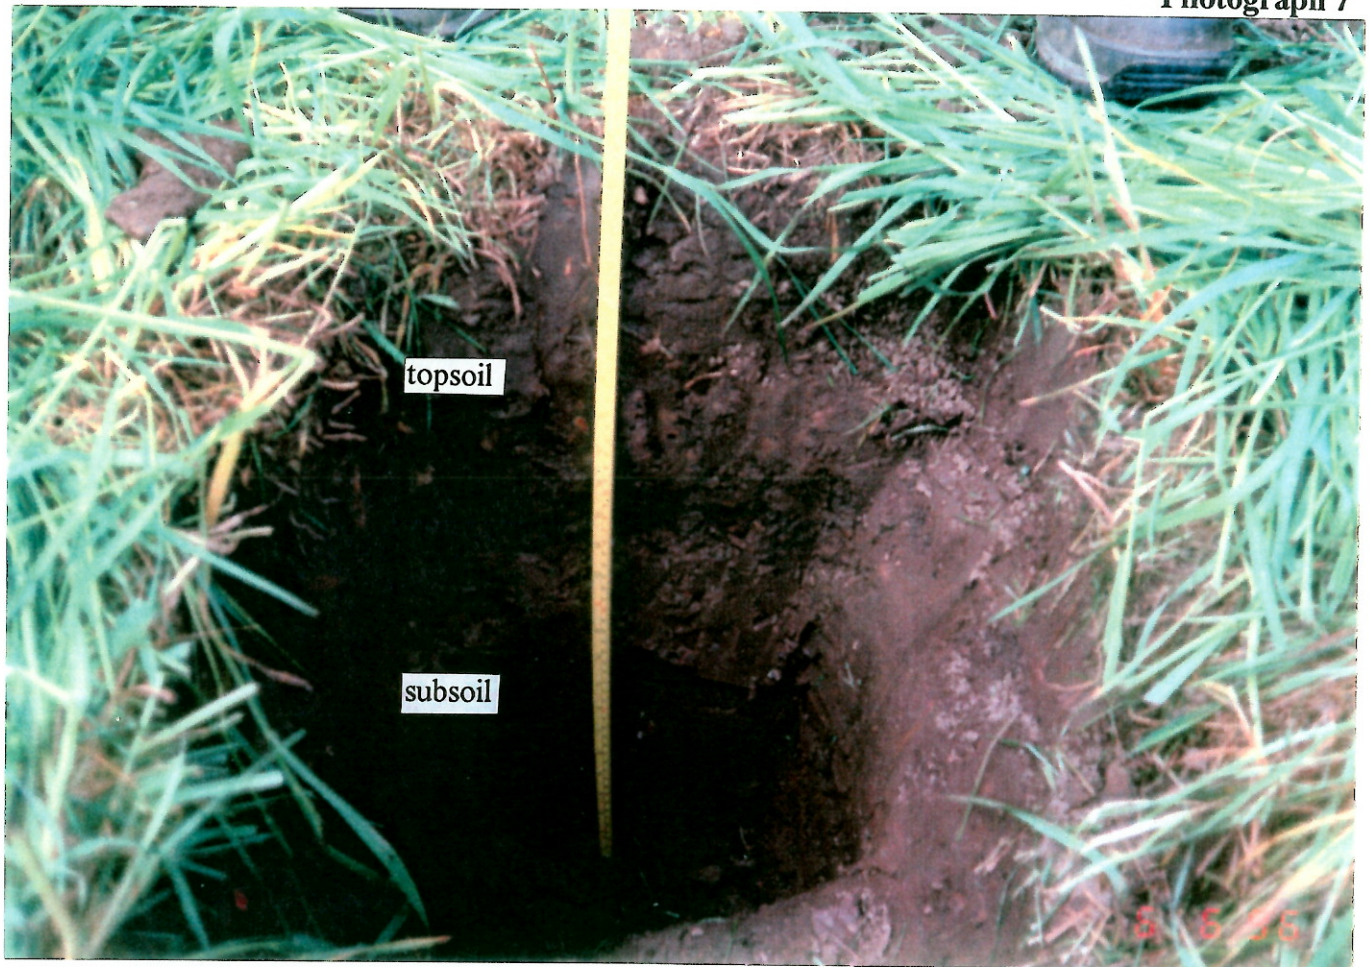
Photograph 7

specified standard is described by soil pit 5 (Appendix 1 and Appendix 3, photograph 7).

**PIT 5**

An example of better restoration.

30cm of a medium clay loam topsoil texture, overlies a heavier subsoil material.

The subsoil material is compacted, however, note the lack of roots through the profile.

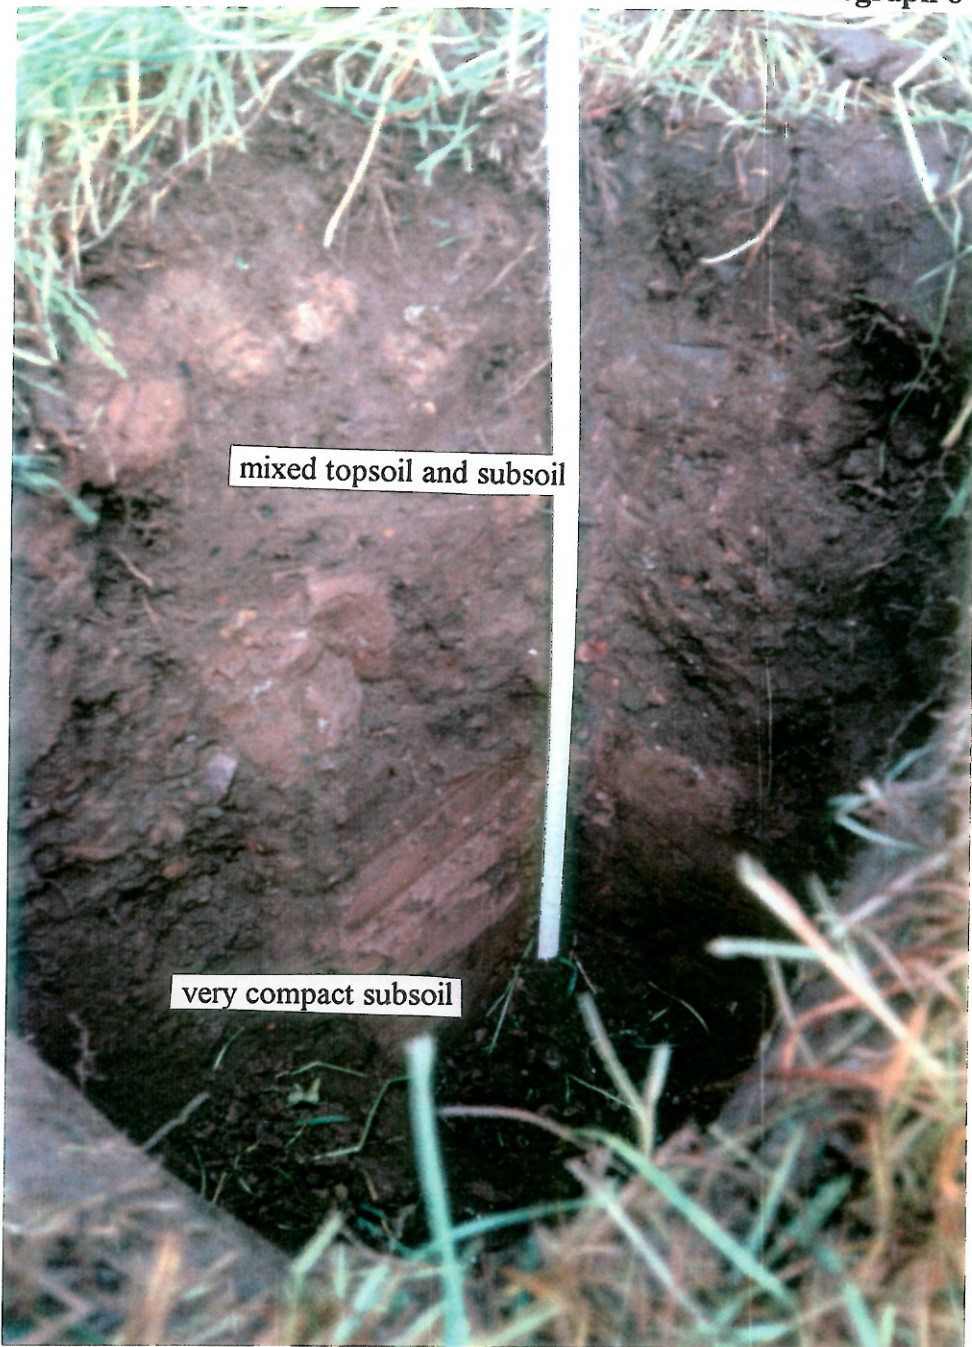
Photograph 8

0-42cm            Very dark grey 10YR3/1 medium sandy loam. Common roots (to 15cm), few roots (15-42cm). Abundant foreign material (brick, wire).

42-80cm            Brown 75YR4/3 medium/heavy clay loam with many yellowish brown 10YR5/6 mottles. Coarse subangular blocky to prismatic structure, extremely firm consistence, very low porosity. Few roots, which ped faces

**PIT 6**

Poor restoration. Topsoil and subsoil materials are mixed and incorporated with other non soil making material (brick, wire).

The soil is severely compacted.

The photograph clearly shows the subsoil material at the surface of the restored profile.

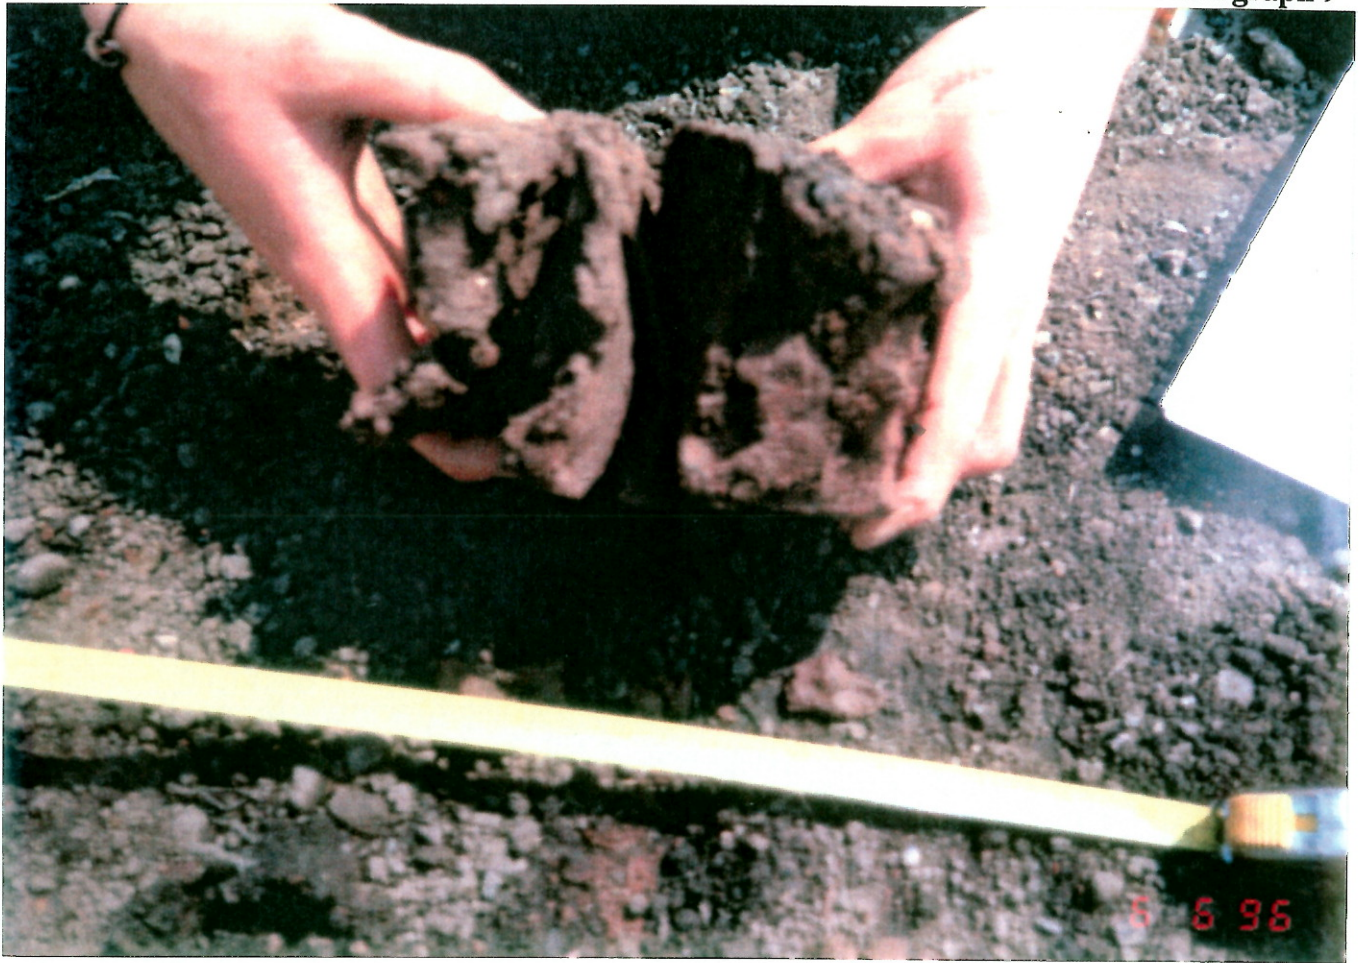
Photograph 9

- 5.4 Soil structure was generally described as massive across the Risley III site, with coarse platy structures identified, (Appendix 3, photograph 9), particularly in the subsoil of the area of subsidence (auger borings 46-49, 51-54 and 57-60). The present soil structural development is the result of poor soil handling and reinstatement during soil stripping and restoration.

Strong platy structures in the compacted subsoils.

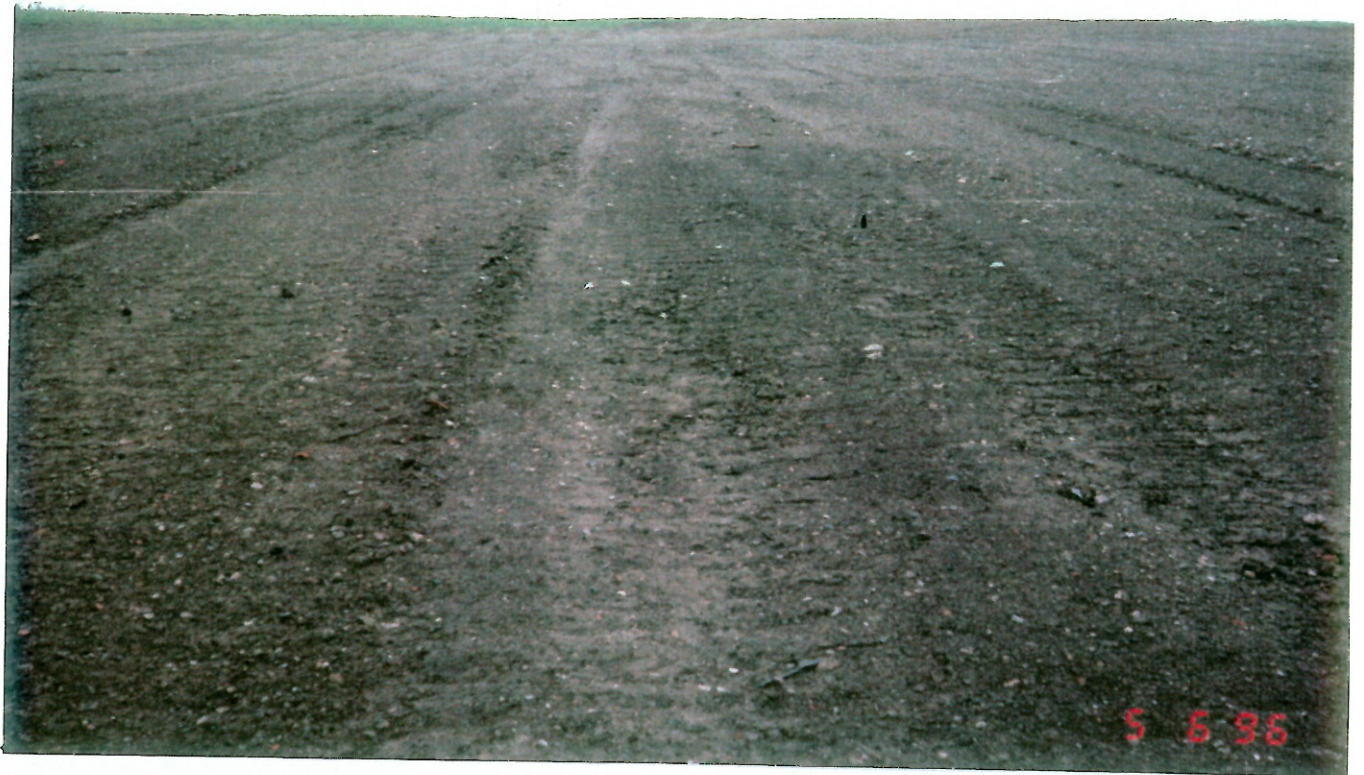
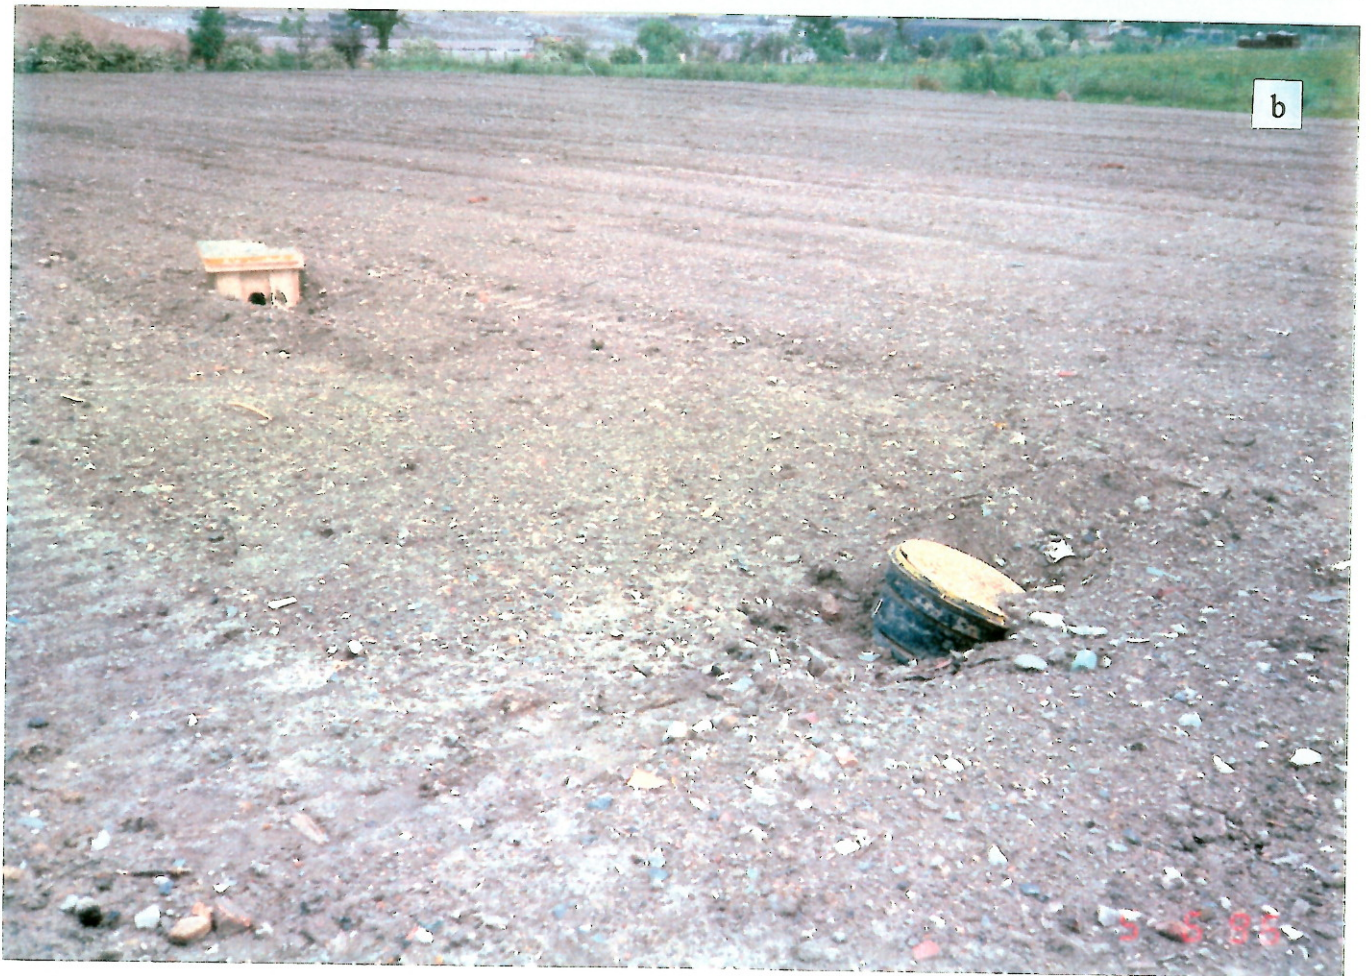
Photographs 10a and 10b

- 5.7 Overall subsoils depths across this area comply with condition 4, but the subsoils are very compact.
- 5.8 In addition to the variation in topsoil depth, the imported "screened" material used for the topsoil in the area was found to be of very poor quality with a high volume of foreign material incorporated in it, (Appendix 3, photographs 10a, 10b, 11a, and 11b).

The area of subsidence recently re-engineered and raised with imported material.

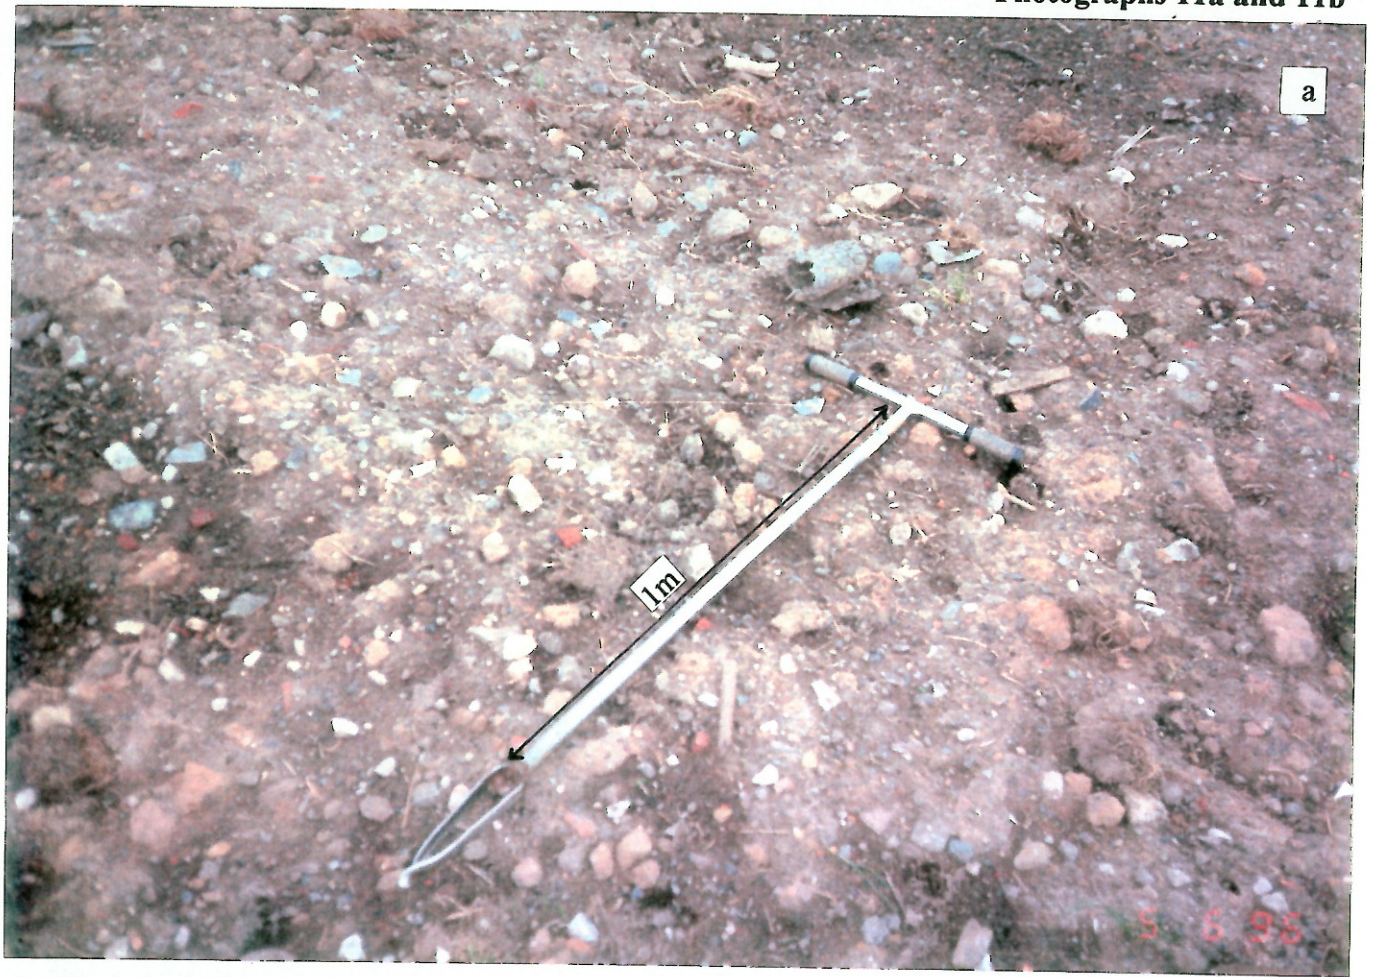
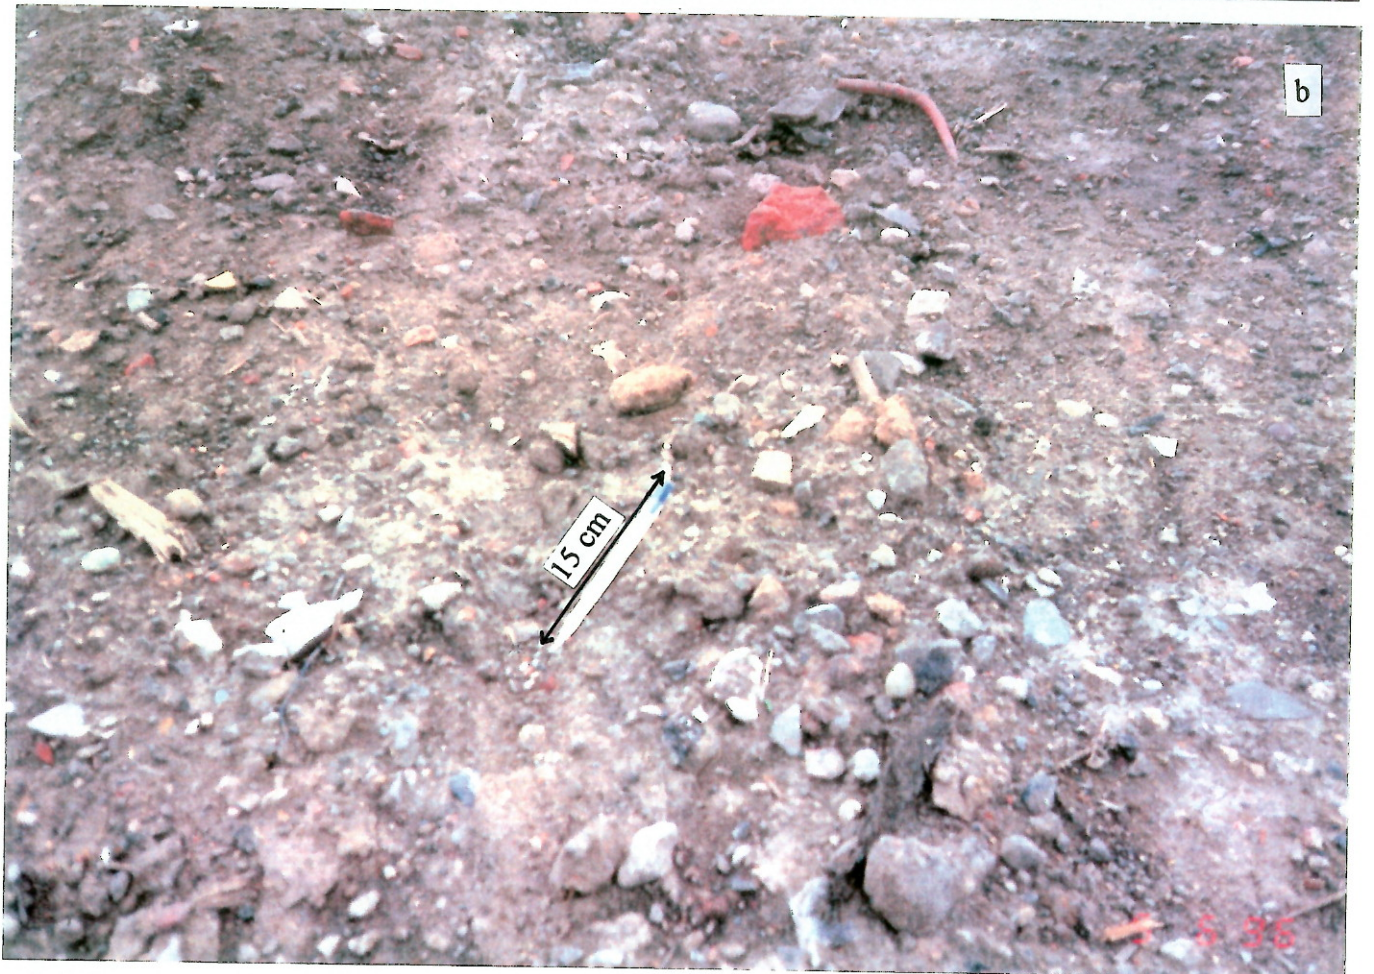
Photographs 11a and 11b

Screened topsoil material (a and b).

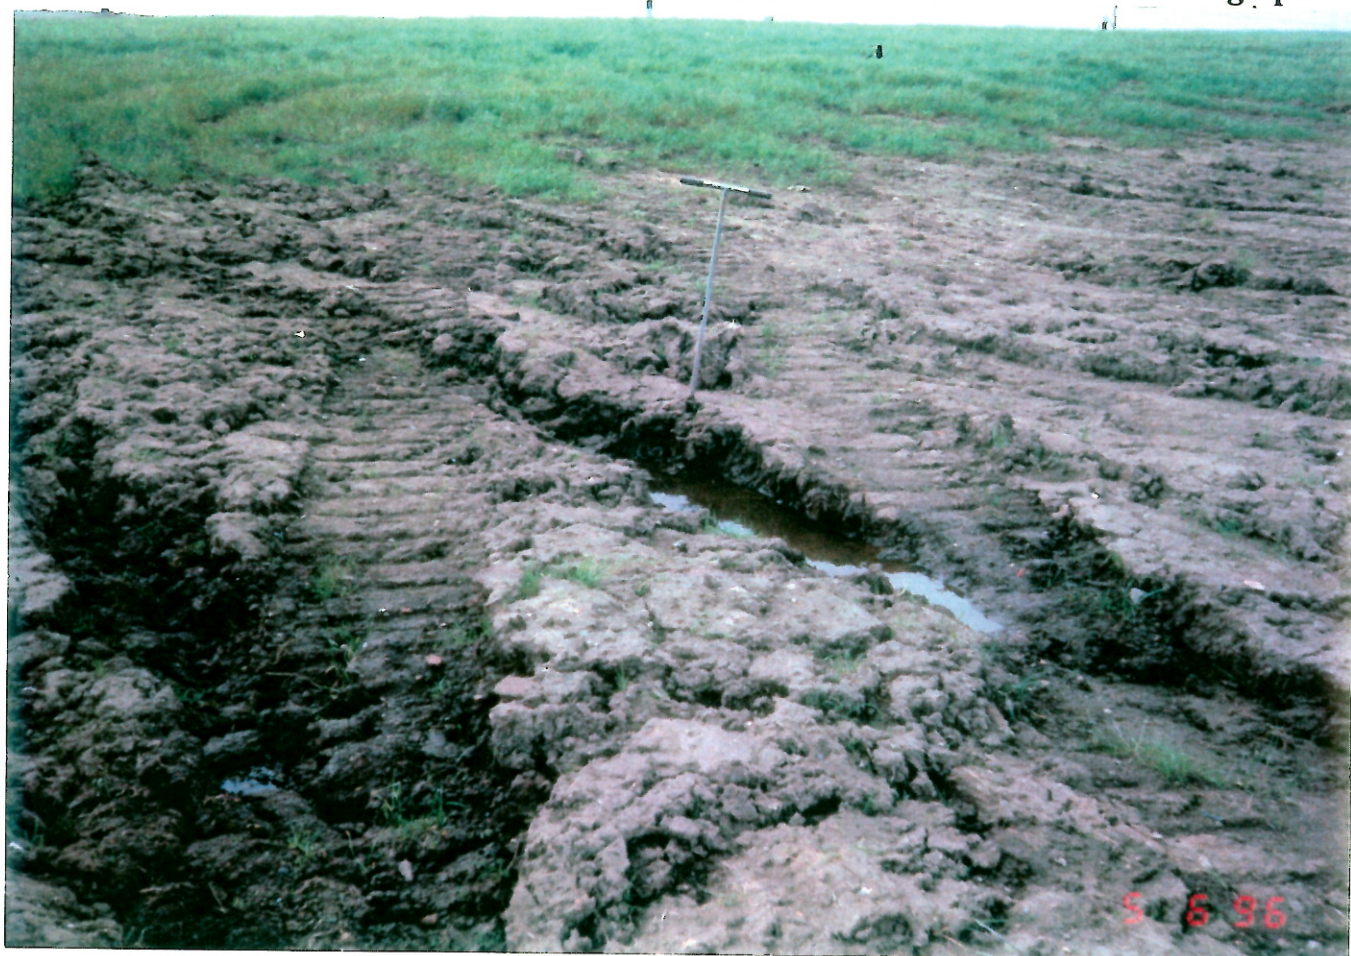
Photograph 12

- 5.9 The replaced topsoil material also showed evidence of a high degree of surface trafficking by machinery, (Appendix 3, photograph 12).

Trafficking of topsoil material.
