Natural England Commissioned Report NECR141

New Forest SSSI Ecohydrological Survey Overview

Annex T: Suburbs Wood

First published 06 March 2014

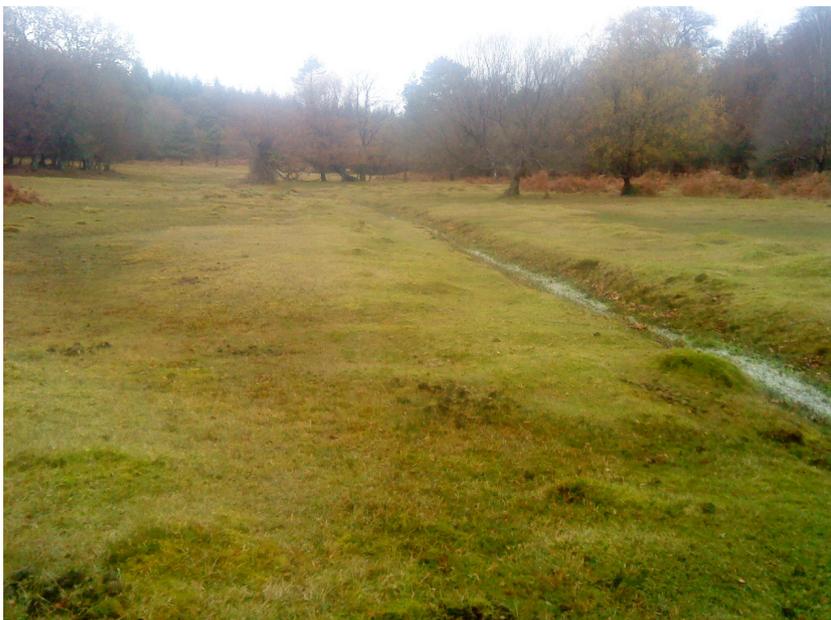
Figure 1-2: Area of Lawn in the centre of the site (NGR 423785, 113030)

No restoration of the lawn areas is recommended as they appear to be reliant on the current drainage and no vestige of the original pre-drainage wetland remains.

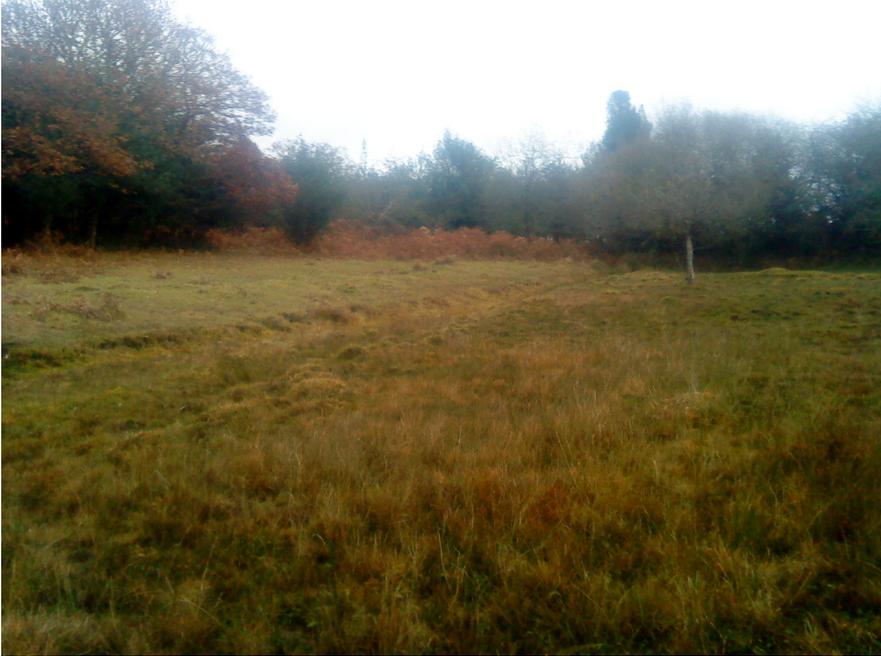
Figure 1-3: Drain at the upper end of the main valley damaging the valley side wetland

There is one area of damage (see Figure 1-6). This is at the top of the main valley, where the lawn drainage channel continues into the valley side wetland. The seepage from the river terrace gravels has overwhelmed the drainage and so a transition between a lawn habitat and an intact valley side wetland has formed. The drain in this area could be infilled or blocked with suitable earth or wooden plugs although this is already happening naturally as the drain silts up. All other areas of lawn are dependant on the drainage so no other restoration is recommended.

Restoration Area	Damage Type	Restoration Proposals	Improvement	Constraints and Issues
Upper lawn	Drain	Infilling or plugging of the drain	Limit drainage of valley side wetland and increase mire area	The drainage may allow some lawn habitat in this upper areas

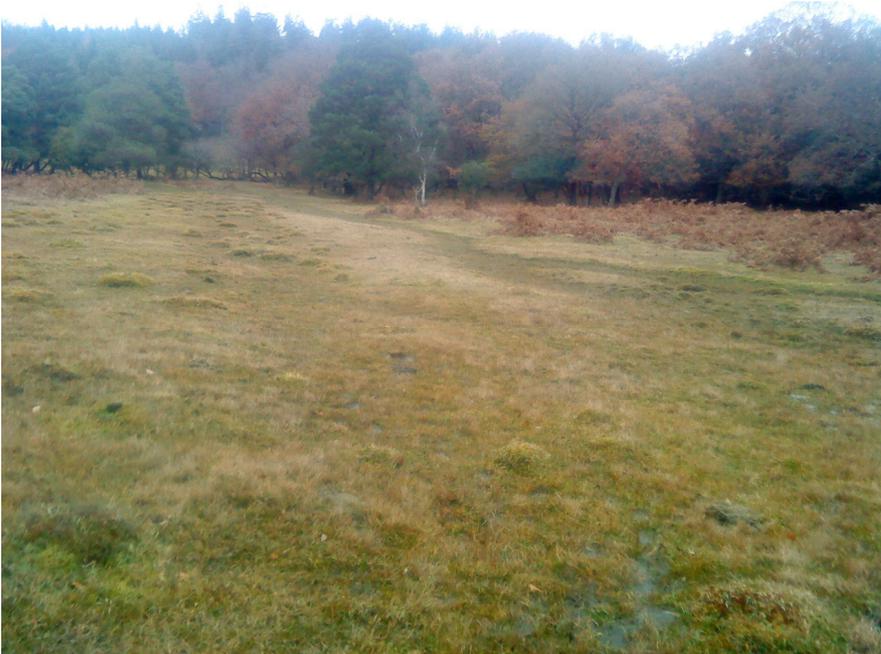
Figure 1-4: Valley side wetland joining the main valley from the south (NGR 423715, 112850)
