Physical and biological monitoring of STREAM restoration projects Year Four Report

Natural England

August 2009 **Final Report** 9S0459

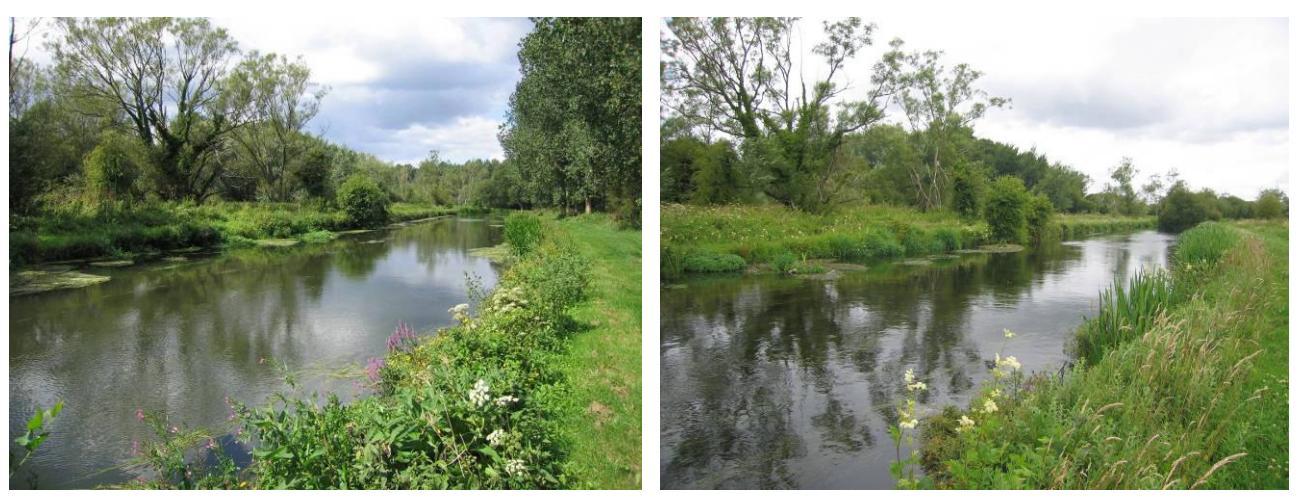
Photo 3.1.1 - AMR01j: Looking upstream of the road crossing. Large Woody Debris deflectors on the right hand bank in 2009.

The restoration works implemented at Amesbury have results in visual differences in the nature of flow and vegetation within the channel and on the floodplain, both upstream and downstream of the A303 road bridge. Upstream of the road bridge felling of poplar trees along the left hand bank (by the landowner) has opened up the floodplain (**Photo 3.1.1a and 3.1.1b**). Large Woody Debris (LWD) deflectors installed on alternate banks have resulted in areas of marginal deadwater and increased vegetation at the channel margins (**Photo 3.1.2a and 3.1.2b**).

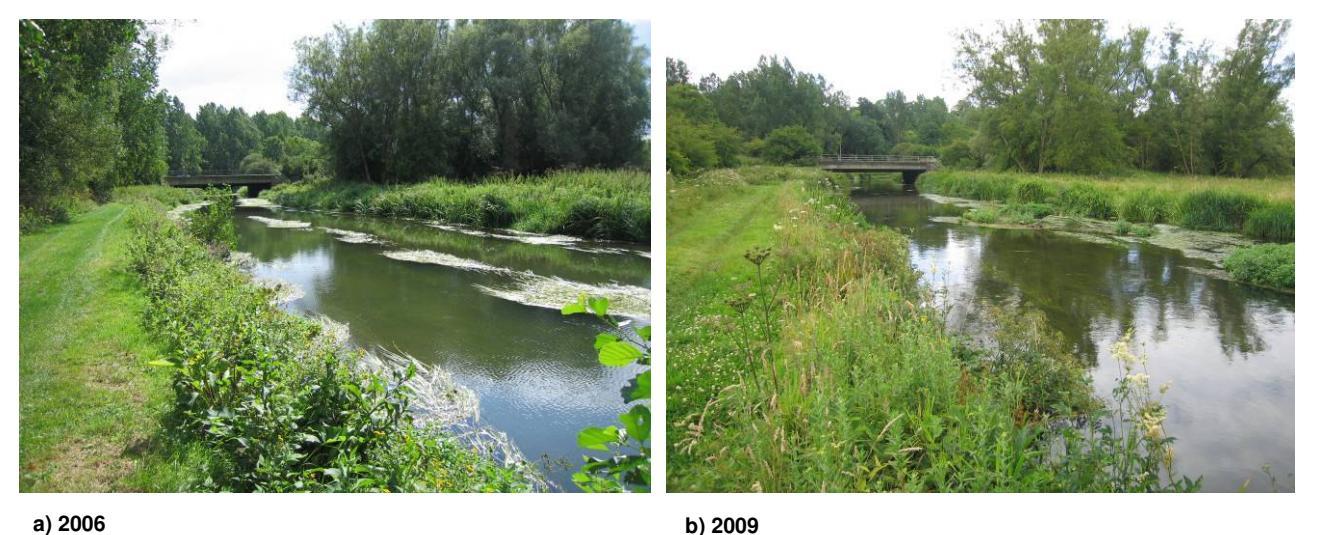
Photo 3.1.2 - AMR01k: Looking downstream to road crossing. Large Woody Debris deflectors on the right hand bank in 2009.

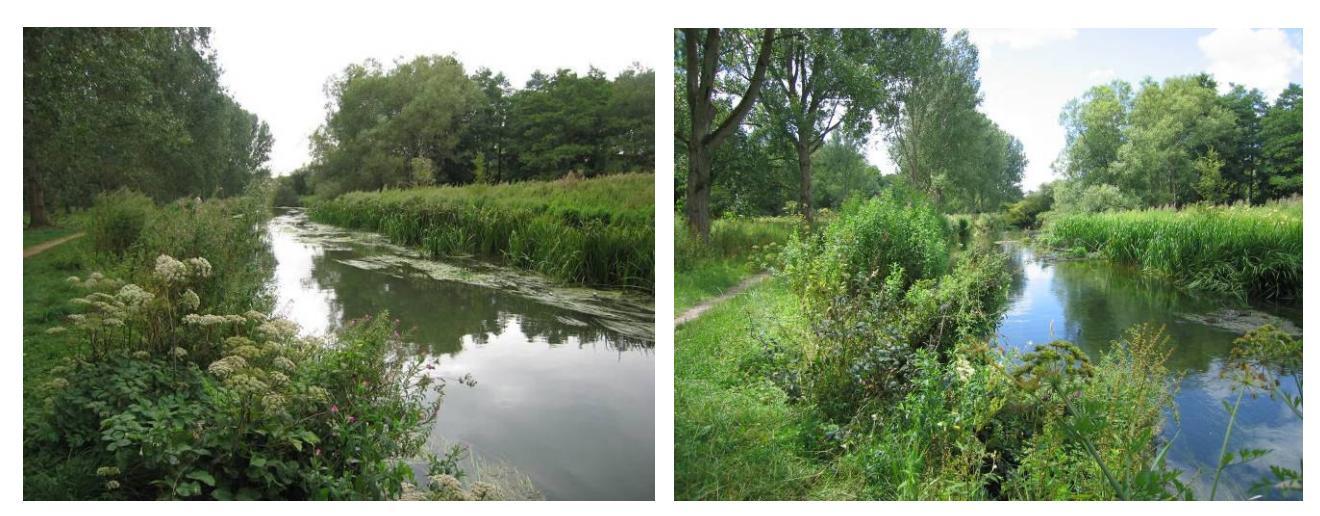
Photo 3.1.3 - AMR02e Looking downstream along glide physical biotope downstream of the road crossing. The public footpath is along the left hand bank.

Downstream of the A303 road bridge selected felling of trees (by the landowner) within the park has also opened up the floodplain and reduced shading (**Photo 3.1.3a and 3.1.3b**). LWD deflectors have also been installed on alternate banks. These are creating areas of marginal deadwater which are encouraging increased vegetation at the channel margins (**Photo 3.1.4a and 3.1.4b**).

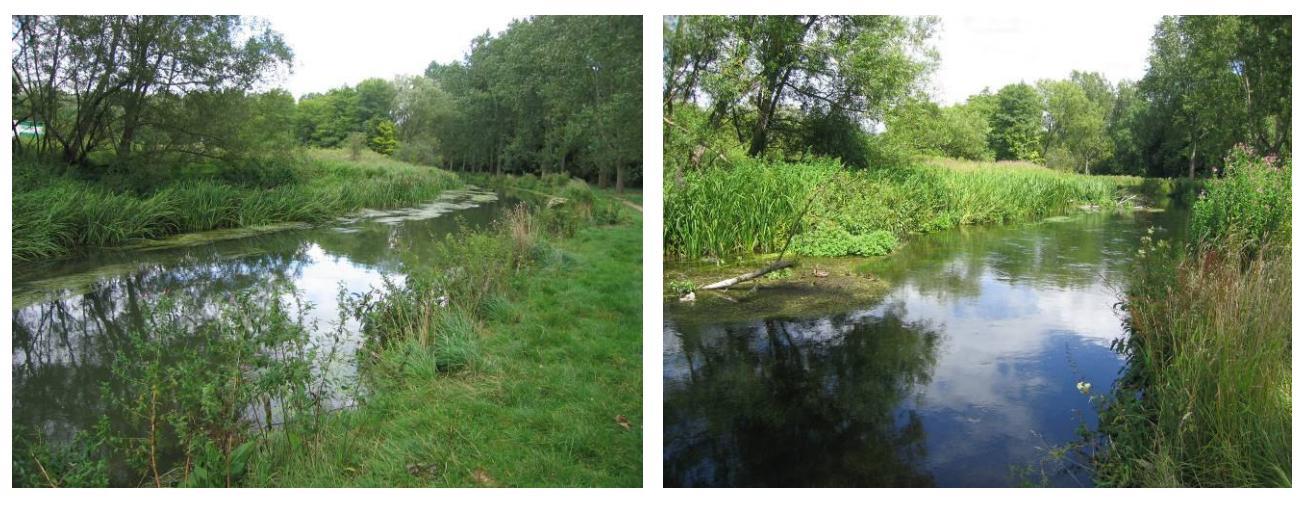
Photo 3.1.4 - AMR02f: Looking upstream. Large Woody Debris deflectors on the right hand bank in 2009.

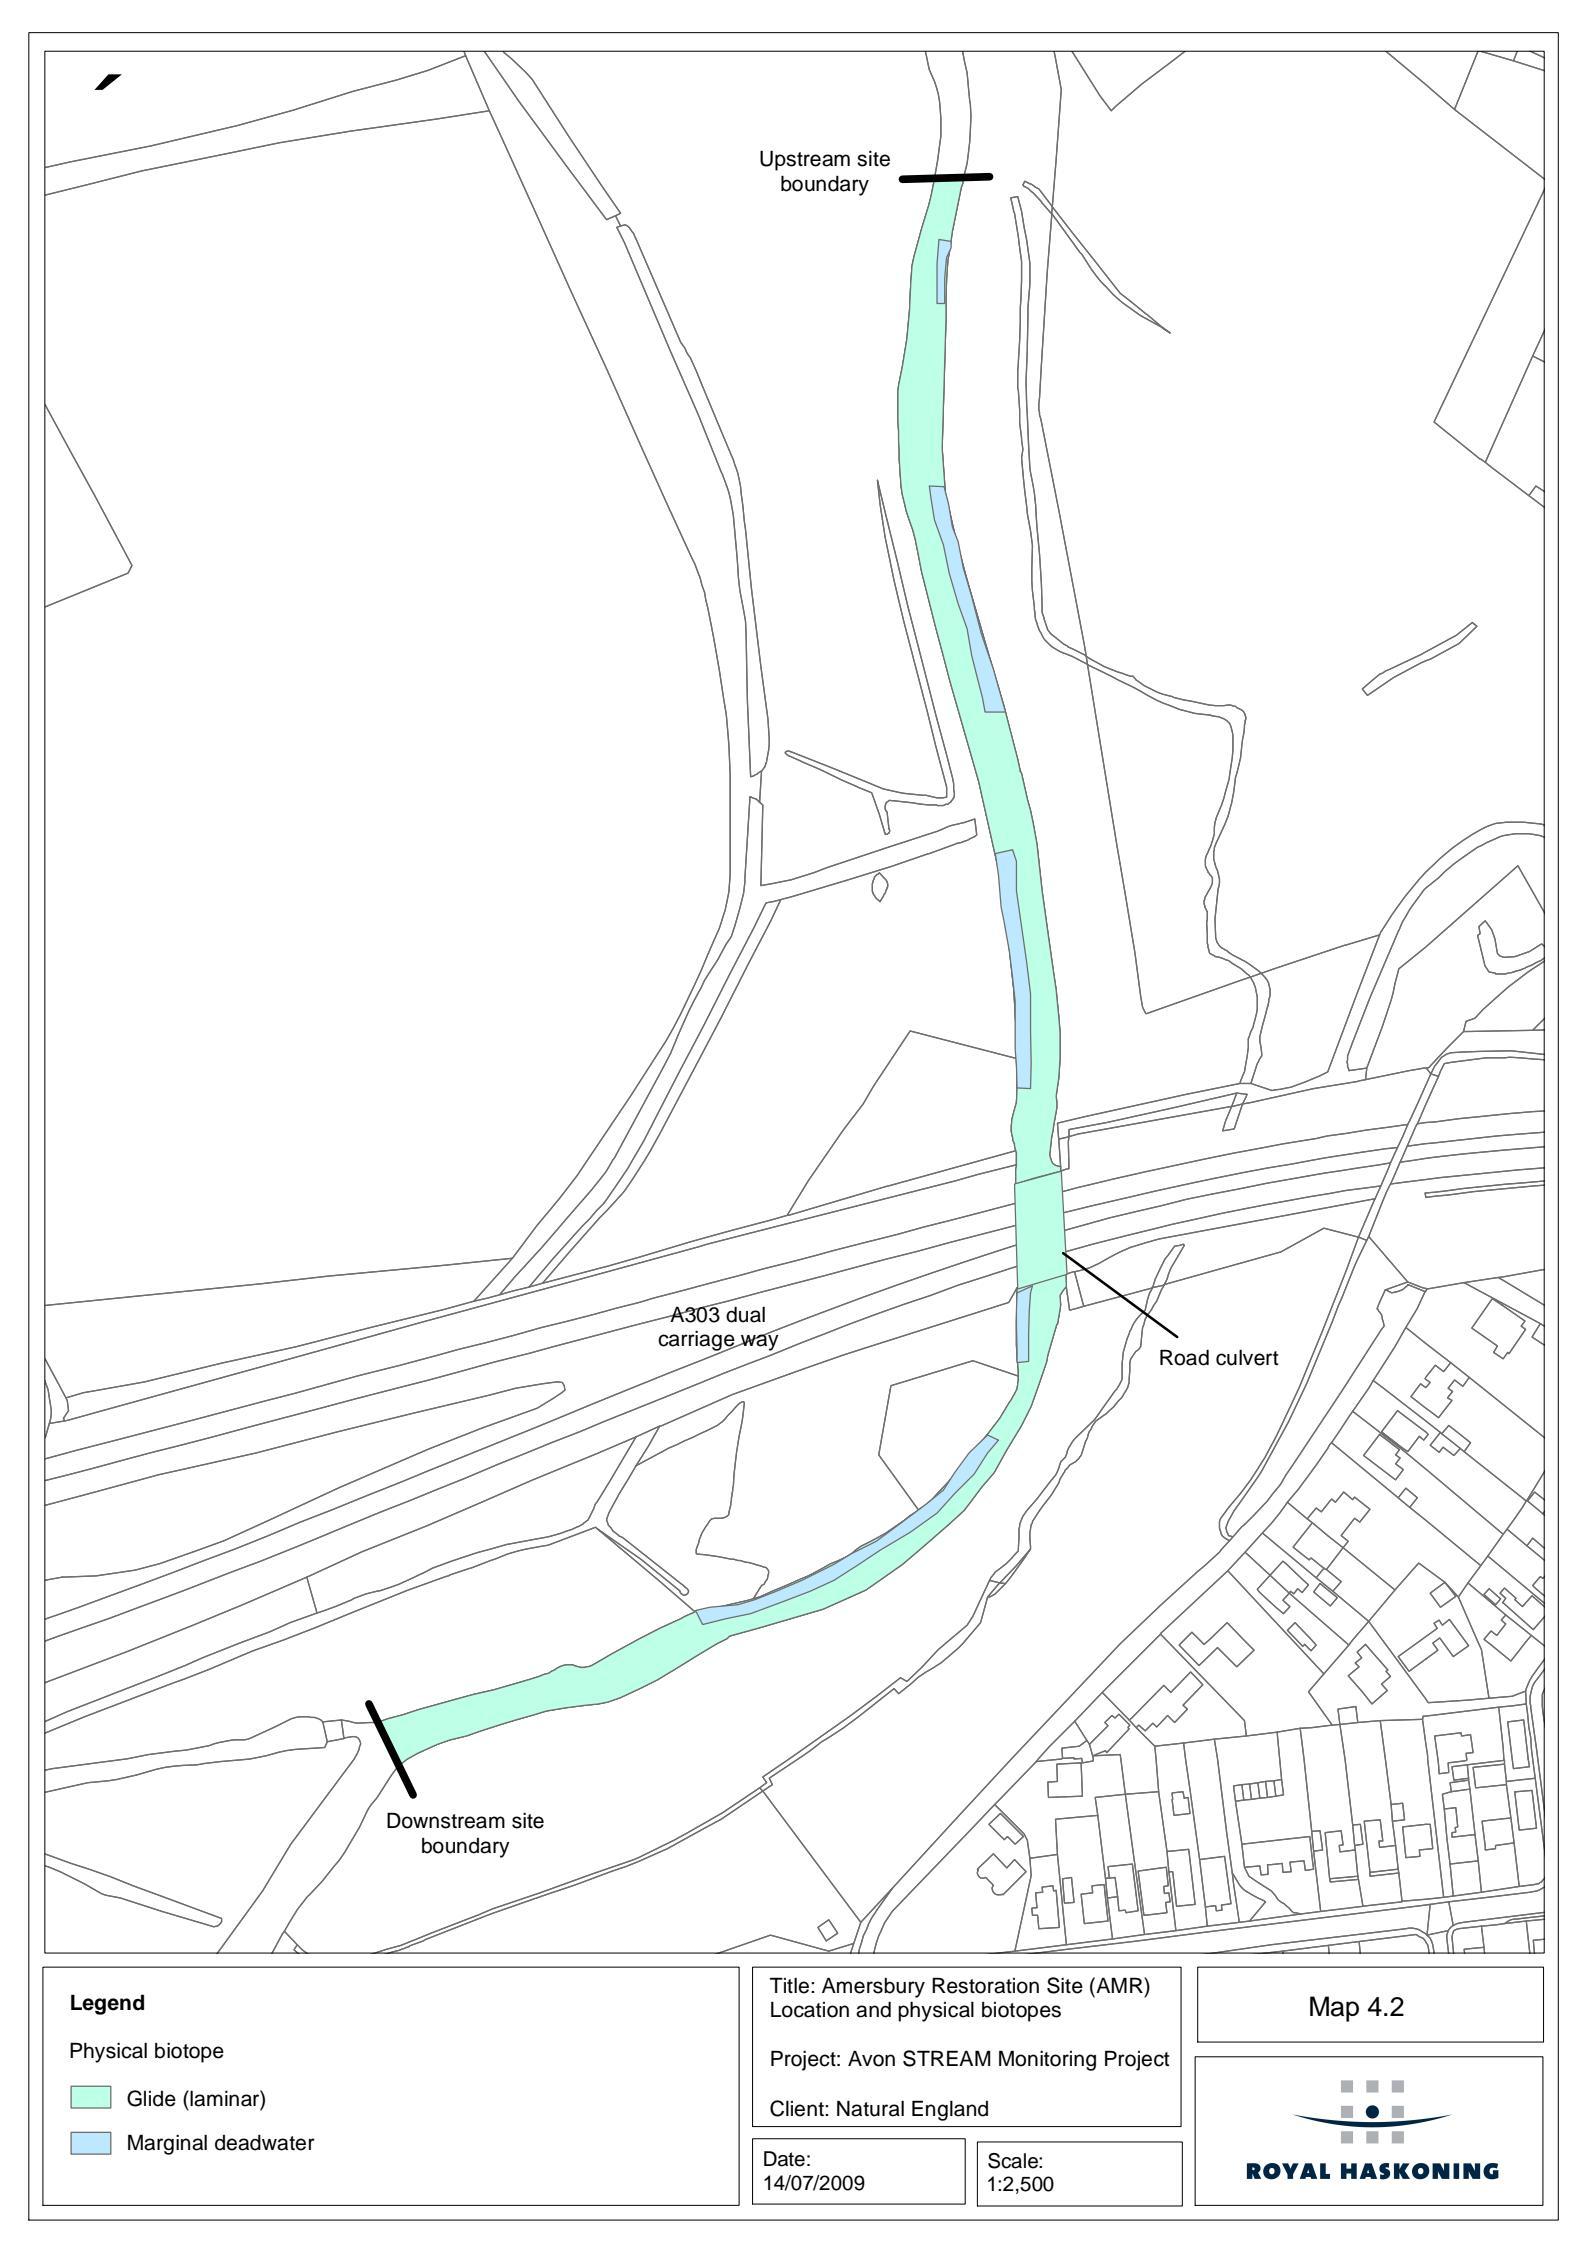
The site consists primarily of a glide which is divided in two by the culvert under the A303 dual carriage way (**Map 3.1**). LWD deflectors installed along alternate banks upstream and downstream of the culvert create areas marginal deadwater immediately downstream of the deflectors. In addition, the deflectors divert flow towards the opposite bank within these areas, creating a slightly sinuous flow path throughout the reach. The bed of the culvert is artificial and is acting as a grade control between the two sections.

The predominant sediment process within the site is deposition of fine sediment due to the overwide / overdeep nature of the modified channel. Sedimentation is particularly occurring at the channel margins and in the lee of the LWD deflectors due to the creation of areas of marginal deadwater.

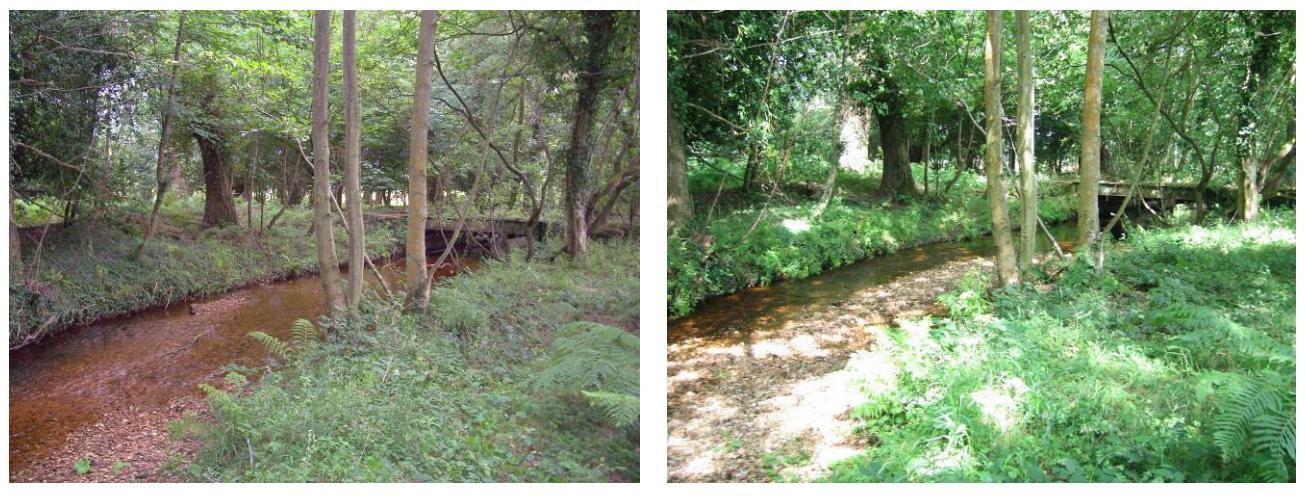
Photo 3.2.1 - DOR01-c: Looking upstream towards footbridge. Point bar on the inside of meander bend.

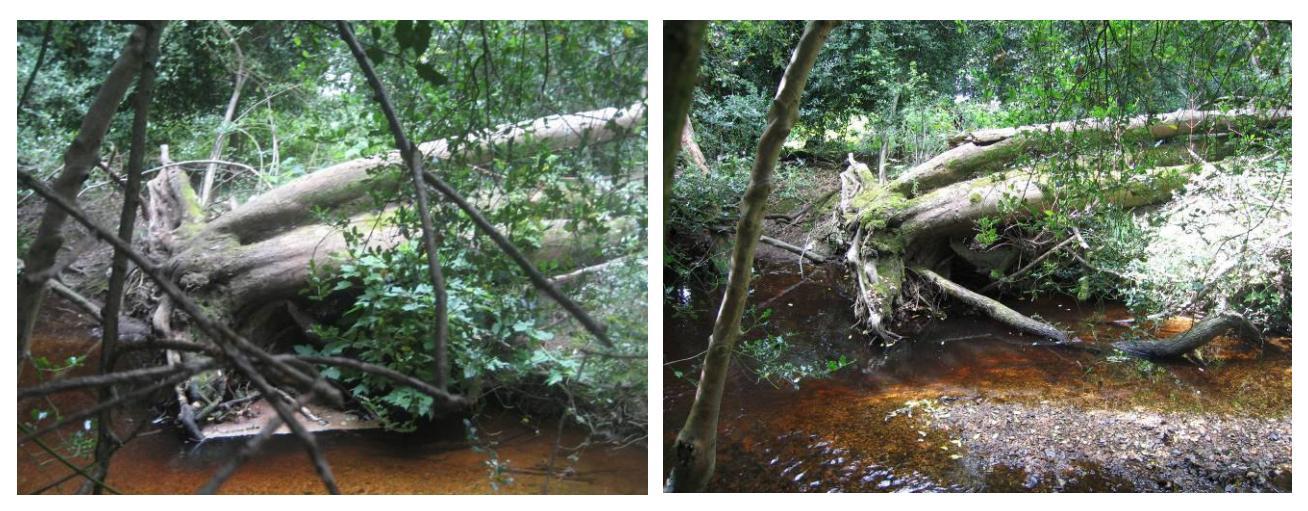
Photo 3.2.3 - DOR01-k: One of several fallen trees remains in the same position.

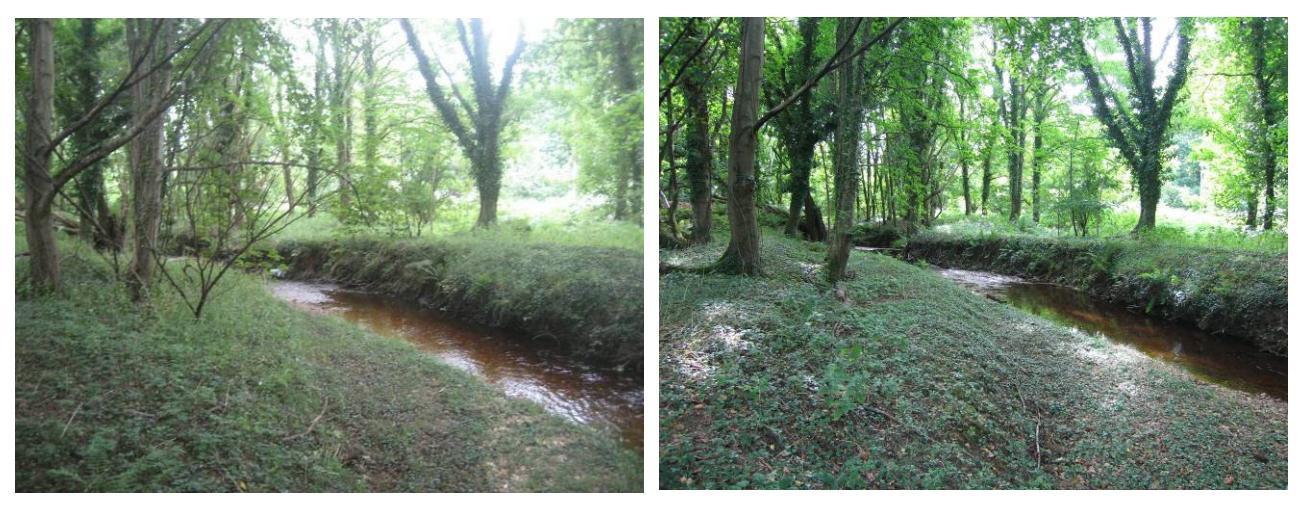
Photo 3.2.4 - DOR01-n: Looking downstream with vegetated bar in the foreground.

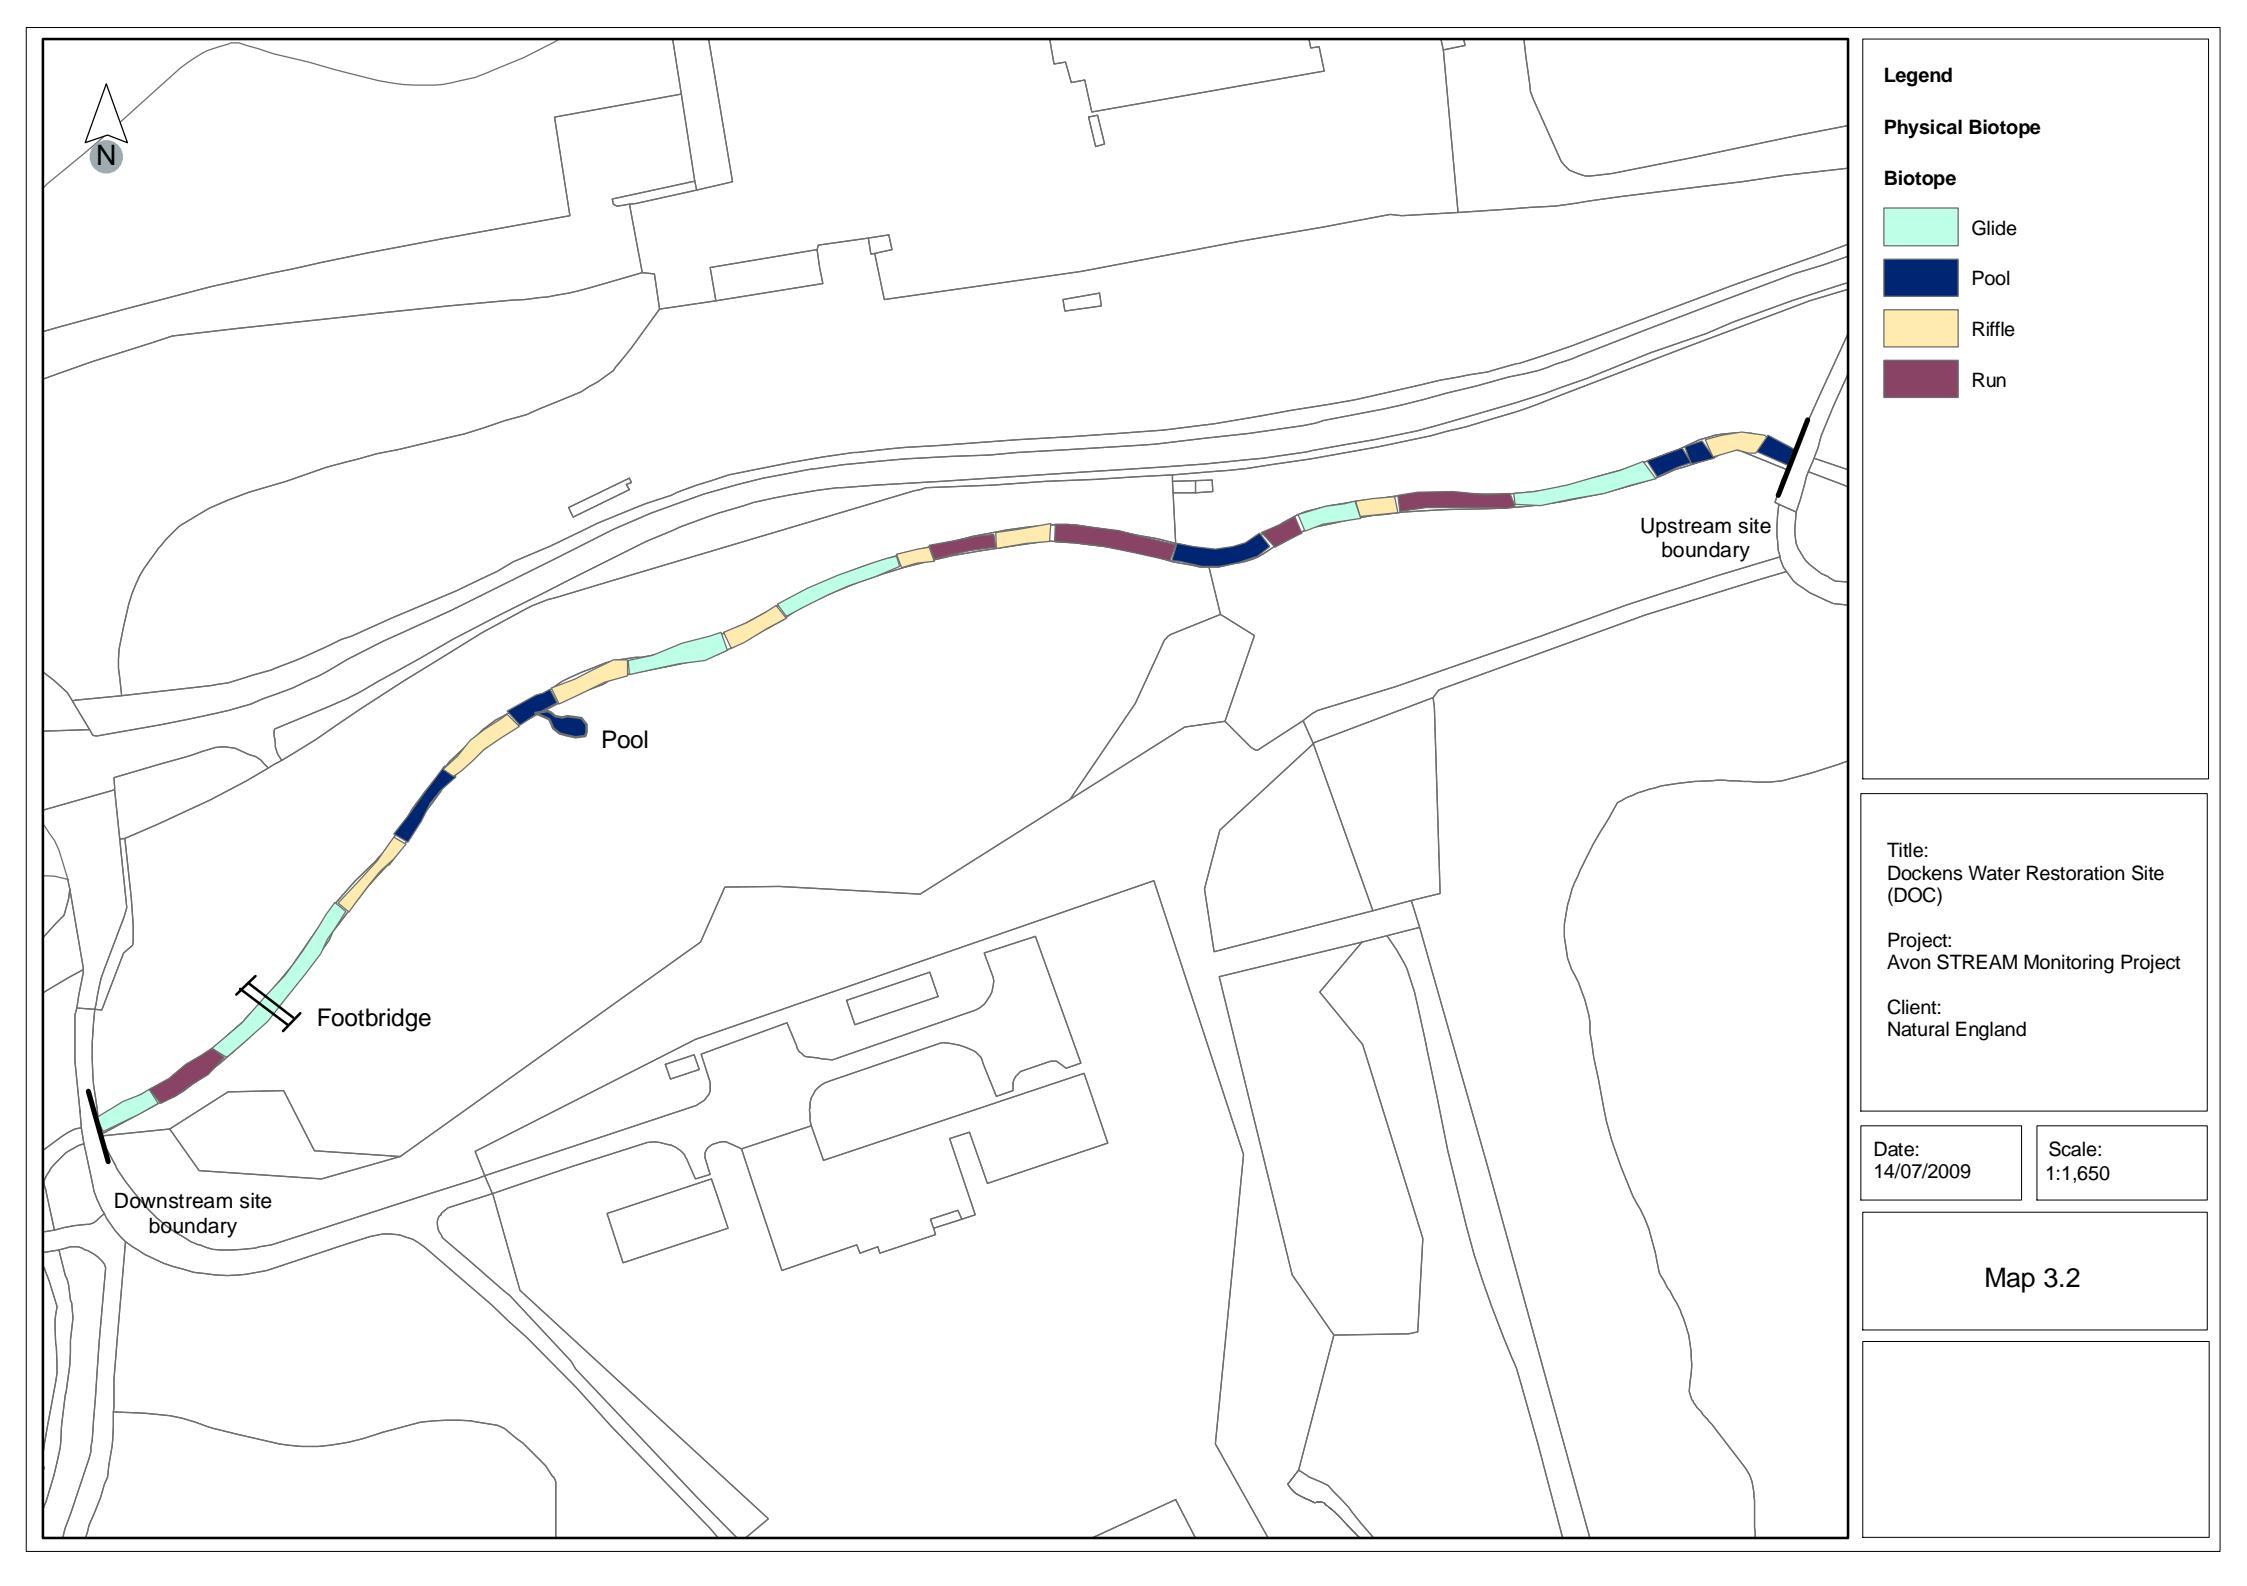
There are few visual differences between the photographs taken in 2007 and those in 2009. The main morphological difference is the construction of a pool / backwater on the left hand bank where the channel was previously embanked. In addition, a new footbridge has been constructed downstream of this pool for public access (see **Map 3.2**).

The channel is morphologically diverse and characterised by a number of different physical biotopes; glides, riffles, runs and pools were observed in sequence throughout the reach (Figure 3.2).
