Natural England Commissioned Report NECR140

New Forest SSSI Geomorphological Survey Overview

Annex O: Ferny Croft South Restoration Plan - SSSI Unit 426

1 Ferny Croft South Restoration Plan - SSSI Unit 426

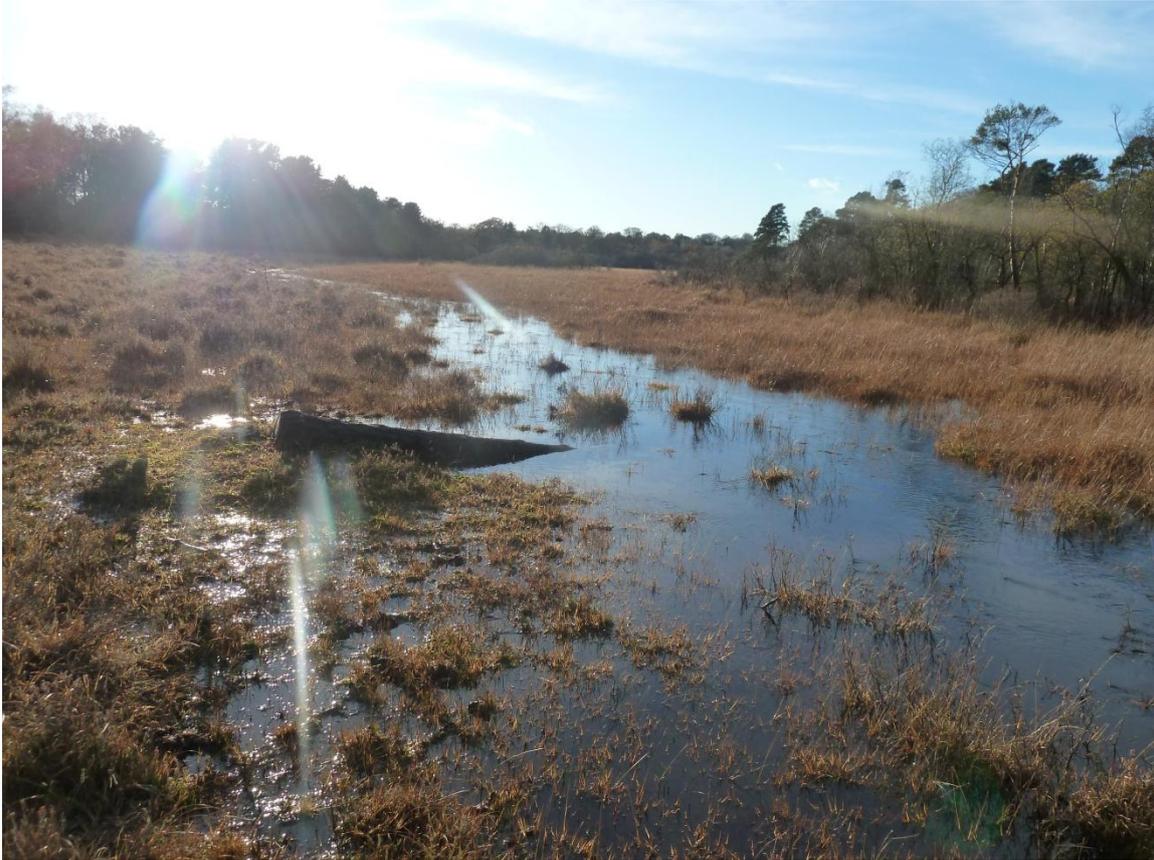
The stream within SSSI Unit 426 is a passive single thread channel (Figure 1-2), switching to sections of poorly differentiated multi branch / spreading networks where floodplain connectivity is improved and gradients are reduced (Figure 1-3). There are generally low inputs of gravel to the stream both locally and from upstream sources, with limited bank erosion and the dominant material on the channel bed is fine sediments / silt (Figure 1-4).

Figure 1-2: Passive single thread channel characteristics

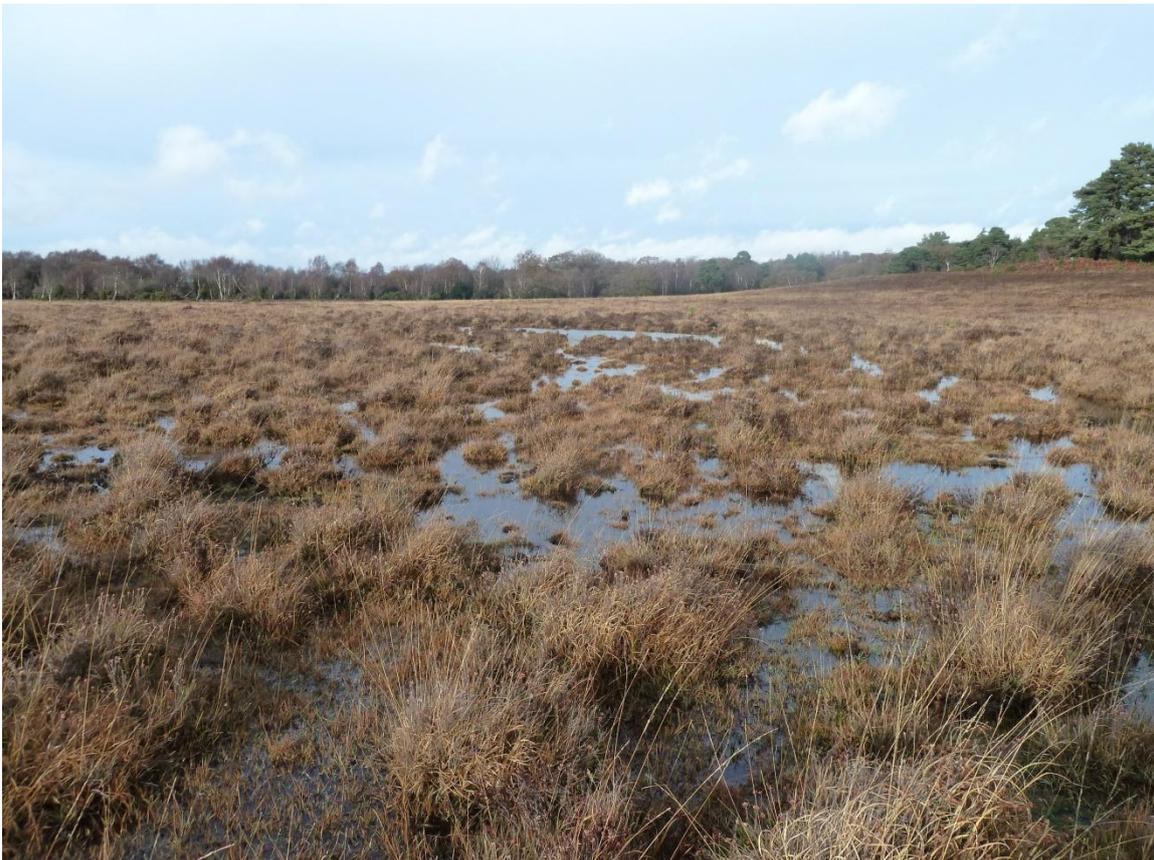
Figure 1-3: Multi branch / spreading sections with Soakways

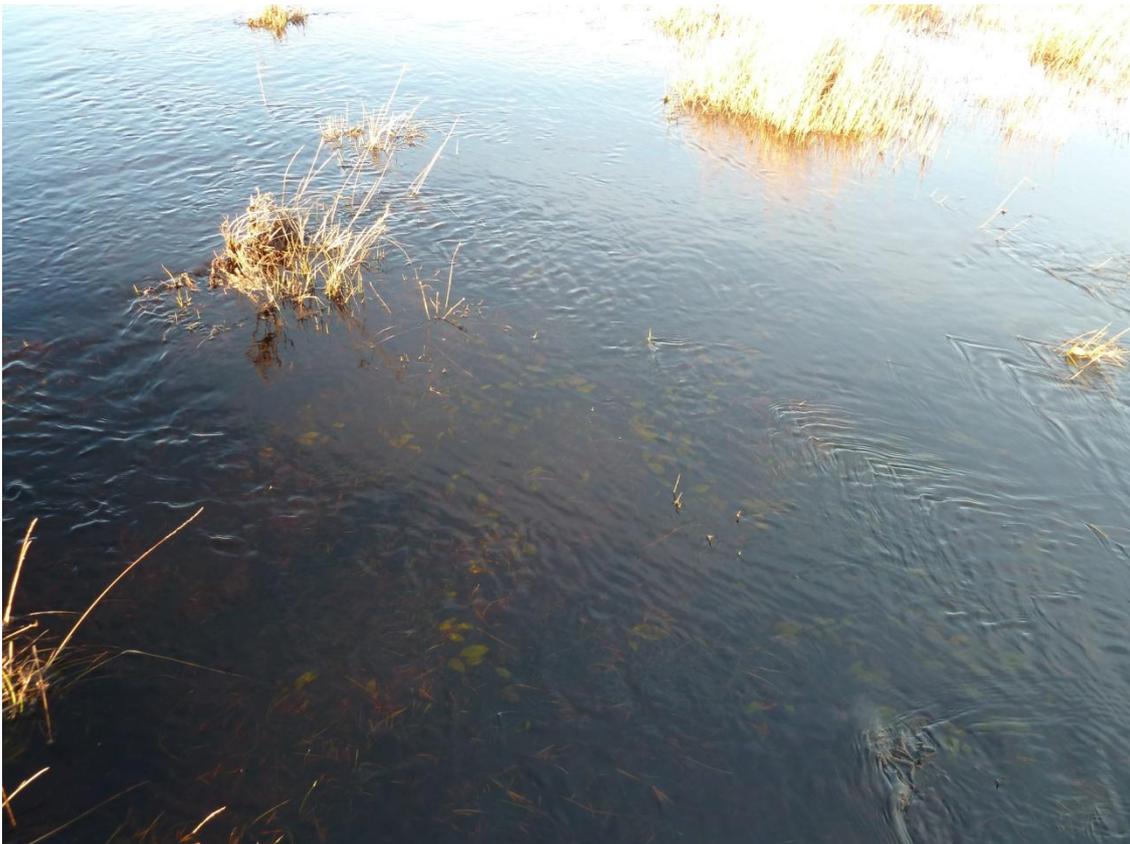
Figure 1-5: Silty bed

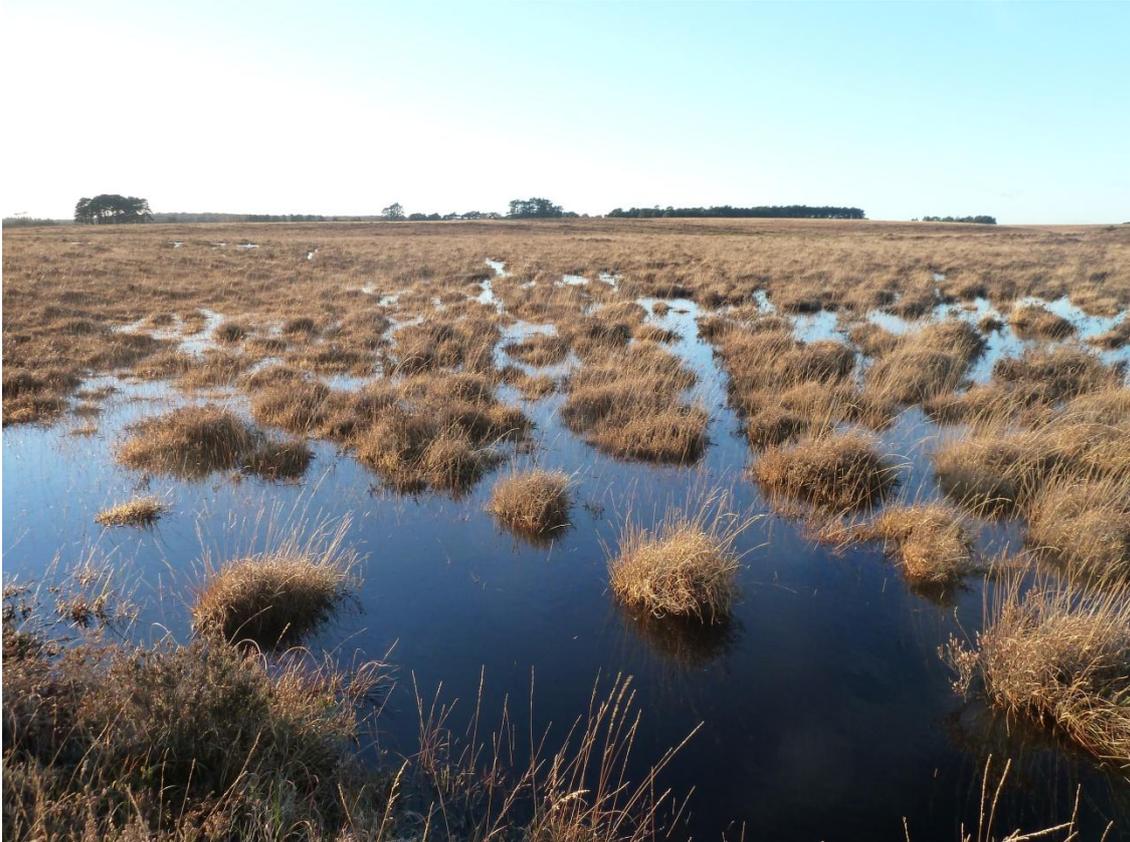
Evidence suggests that there has been little straightening of the main channel, however it is possible that the single thread sections may have been artificially deepened in the past. This does not appear to be significant and floodplain connectivity remains reasonable in the single thread sections. Therefore, incision is not a significant ongoing process within this unit and flow energy is spread across a wide area (Figure 1-6).

Figure 1-6: Water spreading over wide area in *Molinia* Mire (M25a)

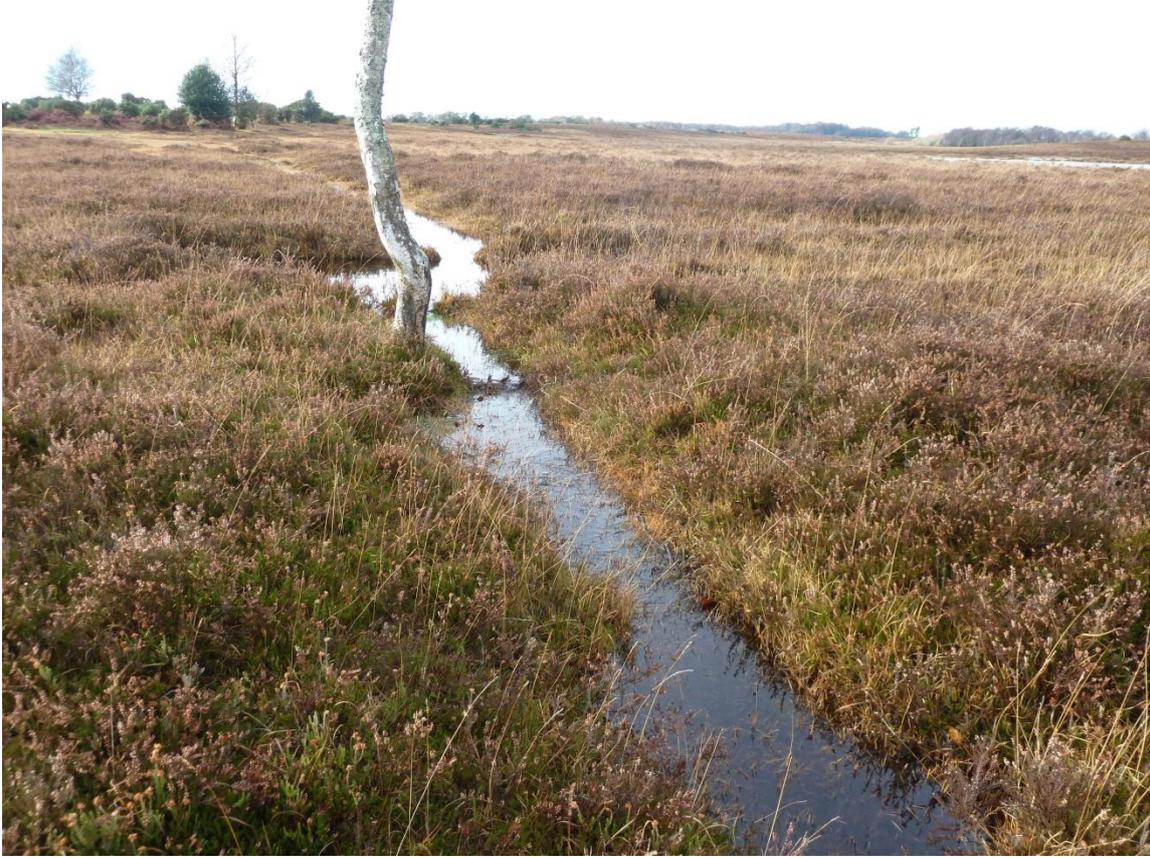
The LIDAR and drainage lines in Appendix A show that there has been artificial straightening / ditching of flows lines and drains flowing into the main channel (Figure 1-7), these areas are also highlighted in Figure 1-4. This may have been a contributing factor to the formation / maintenance of the single thread sections, where flows are concentrated at one point, creating conditions favouring a dominant channel and giving enough excess energy to maintain a single thread channel rather than promoting siltation, similar to the spreading sections within this unit. This flow concentration has also resulted in drier floodplain sections as this flow would normally be spread over a wider area.

Figure 1-7: Straightened / dug drain in wet heath habitat (M16a)

The major straightened / modified drainage channels are identified in Figure 1-12. Other minor modifications could be considered for infilling and Appendix A should be used for reference.

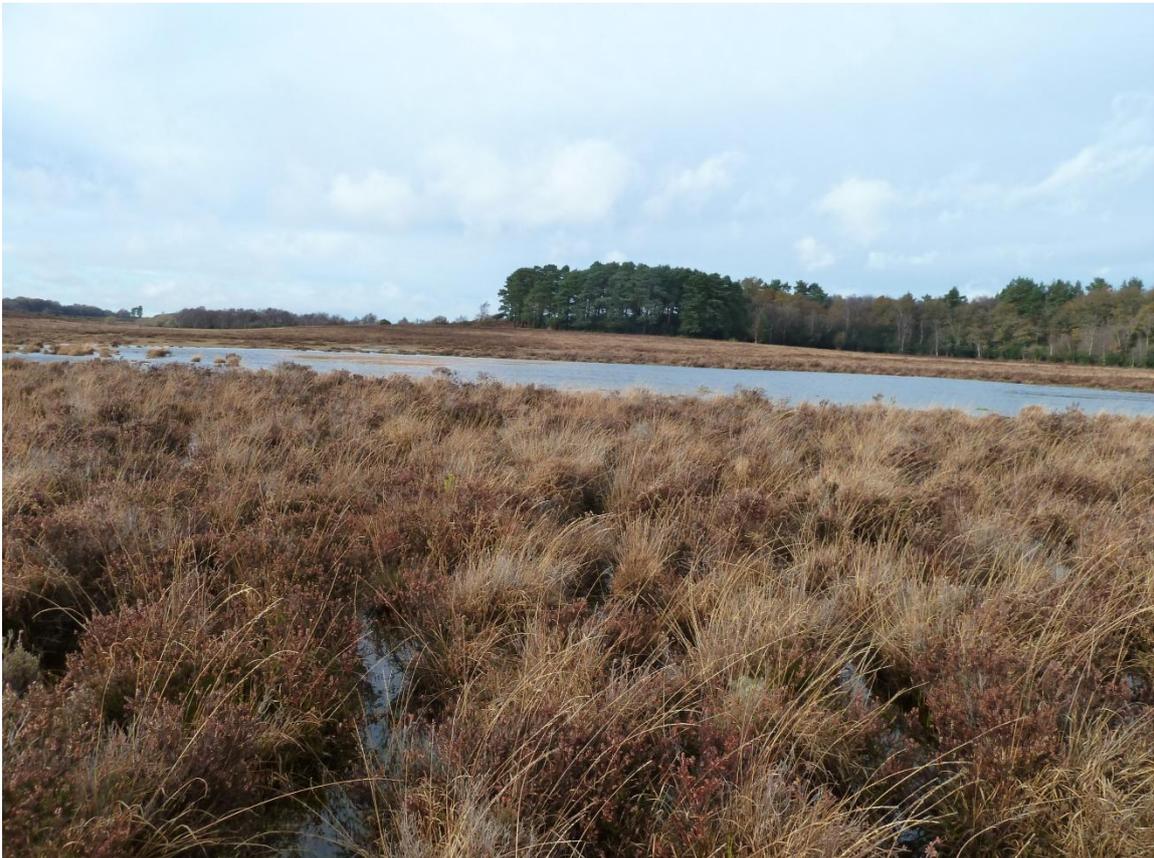
The Starpole Pond is likely to have been artificially created and stores water before entering the Beaulieu River downstream (Figure 1-4 - B and Figure 1-8).

Figure 1-8: Starpole Pond surrounded by Molinia Mire (M25a)

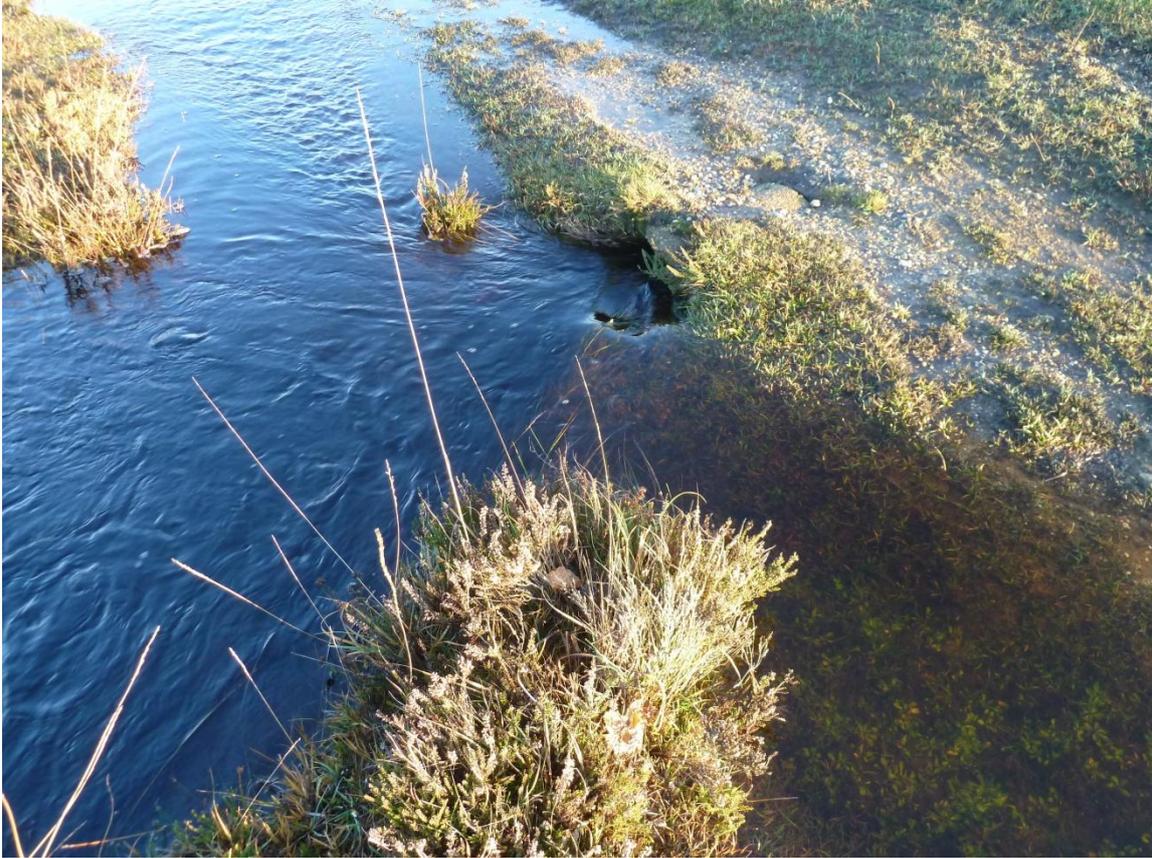
The road at the upstream end of the SSSI unit provides a barrier to flow routes downstream, with water ponding behind it before flowing through a small pipe under the road (Figure 1-9).

Figure 1-9: Pipe underneath road with grazed lawn (M23a) either side of it

Pressure	Impact	Restoration proposal	Hydromorphic improvement	Ecological improvement	Constraints / issues
				diversity of ground flora on floodplain.	
River crossings	Disruption to natural flow regime.	Replace road pipe with more suitable structure such as a concrete circular culvert with potentially associated fencing	Natural flow regime reinstated	<p>Improve diversity of in-channel habitats.</p> <p>Will limit ponding around structures allowing more natural wetland communities to develop</p>	<p>Structures will need to be fit for the purposes of vehicles crossing</p> <p>Fencing may be culturally unacceptable</p>

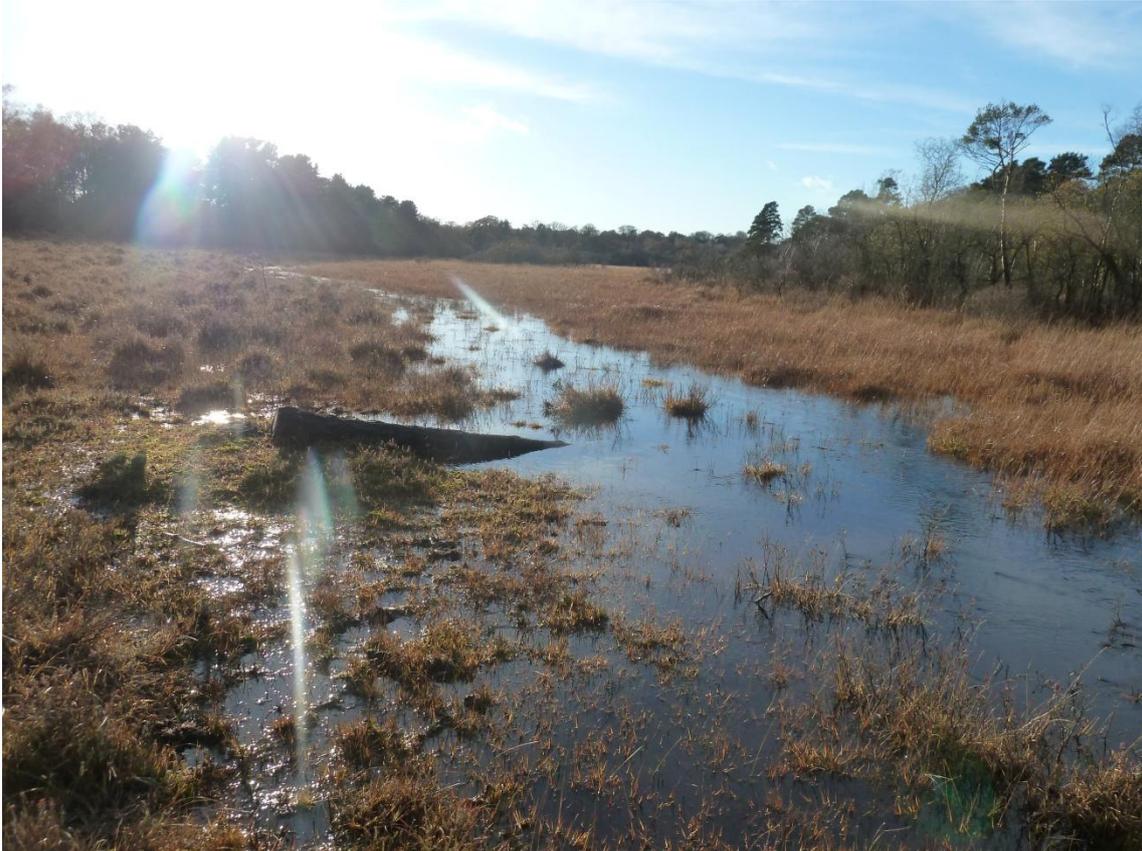
There are no natural woody debris features along the channel due to the surrounding vegetation type. Therefore, restoration options to improve floodplain connectivity further through the single thread sections of the watercourse are likely to involve reach scale channel blocking using heather bailing or possibly consolidated silty berms alongside channel infilling. These will create short lengths of impounded watercourse and multi-branched / spreading networks that will improve floodplain connectivity / wetting. Existing restoration attempts in some locations, for example log blocks, are failing (Figure 1-10).

Figure 1-10: Failing log block at base of valley mire (M21a)

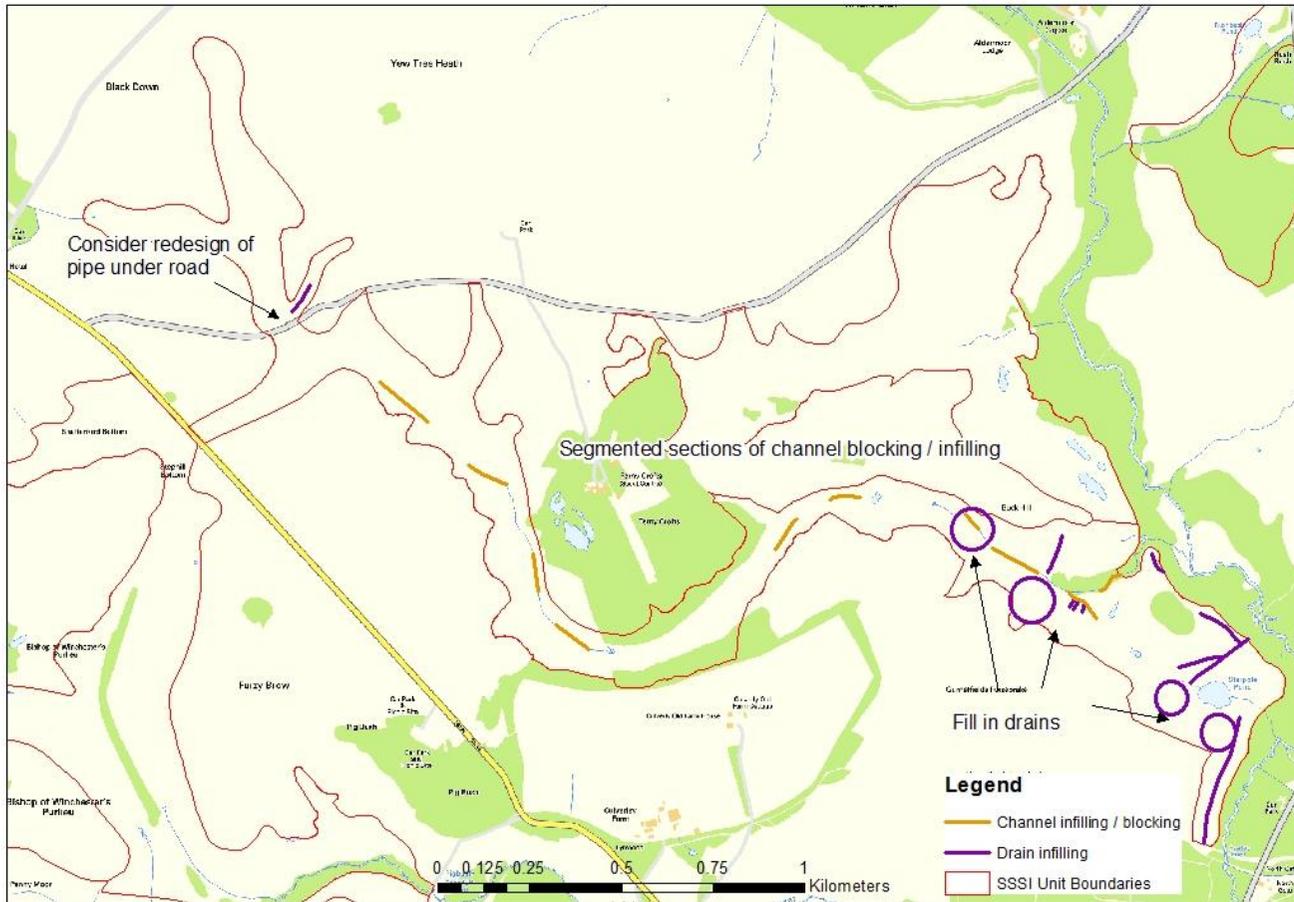
Figure 1-12: Proposed restoration measures for SSSI Unit 426

A summary of the current pressures, unmitigated impacts and restoration proposals is given in Table 1-2 and shown in Figure 1-12.

Channel infilling and berm creation should use materials suitable to existing conditions, i.e. vegetated, consolidated berms. This could be undertaken in segmented sections to negate the need to fill the entire single thread lengths. The impounding influences of the filled / blocked section should result in natural infilling upstream (Figure 1-12).
