Natural England Commissioned Report NECR140

New Forest SSSI Geomorphological Survey Overview

Annex F: Long Beech Restoration Plan - SSSI Unit 112

First published 06 March 2014

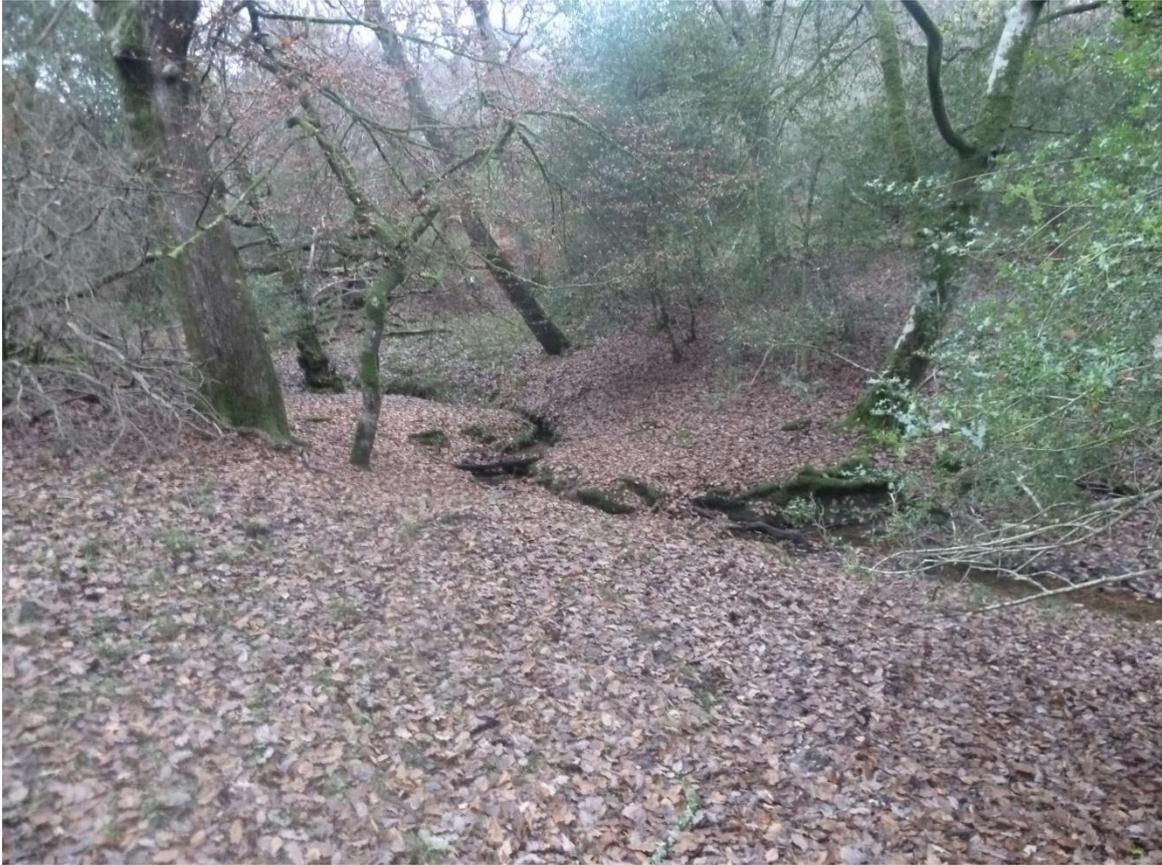
The stream within SSSI Unit 112, Colemeer Gutter, is an active single thread channel (Figure 1-2). The stream is within a relatively confined valley with relatively steep sides, restricting lateral activity to a narrow active band. This has resulted in a poorly developed marginal floodplain (Figure 1-3).

Figure 1-2: Active single thread channel characteristics

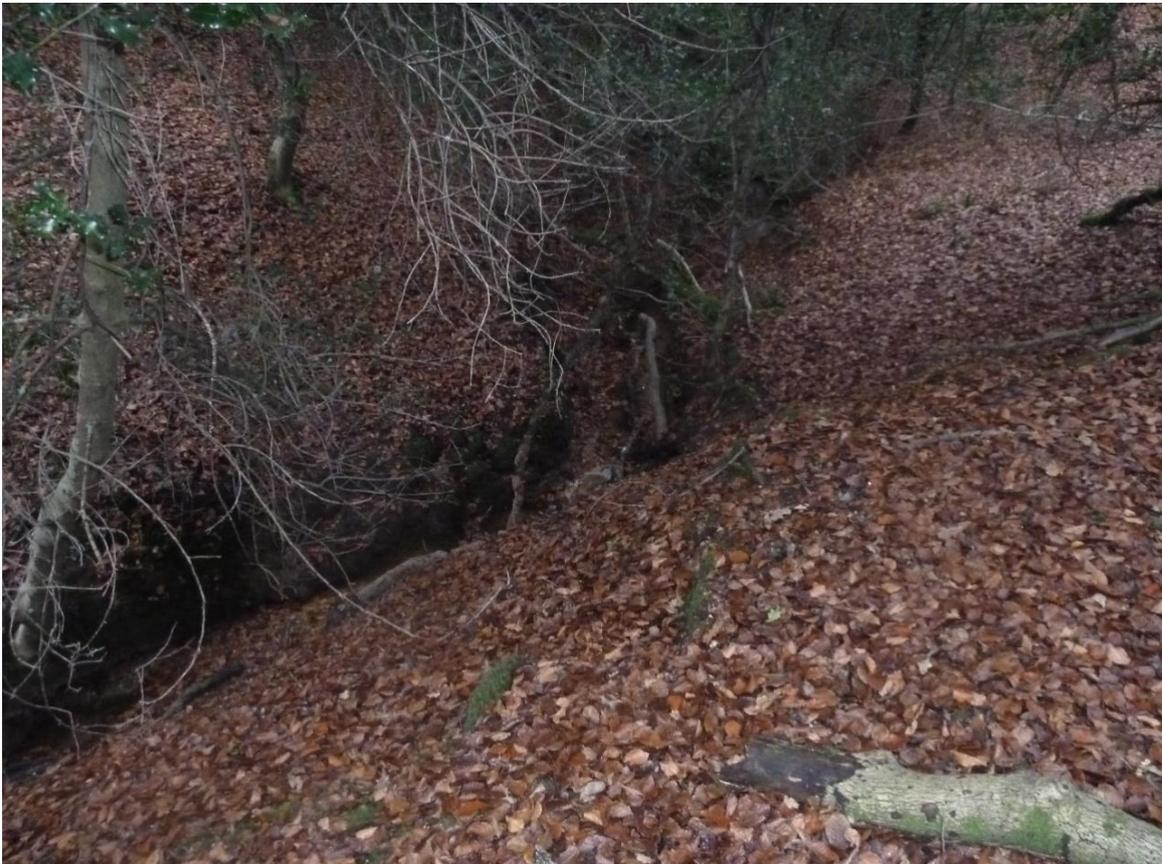
Figure 1-3: Steep banks and confined floodplain, showing some incision

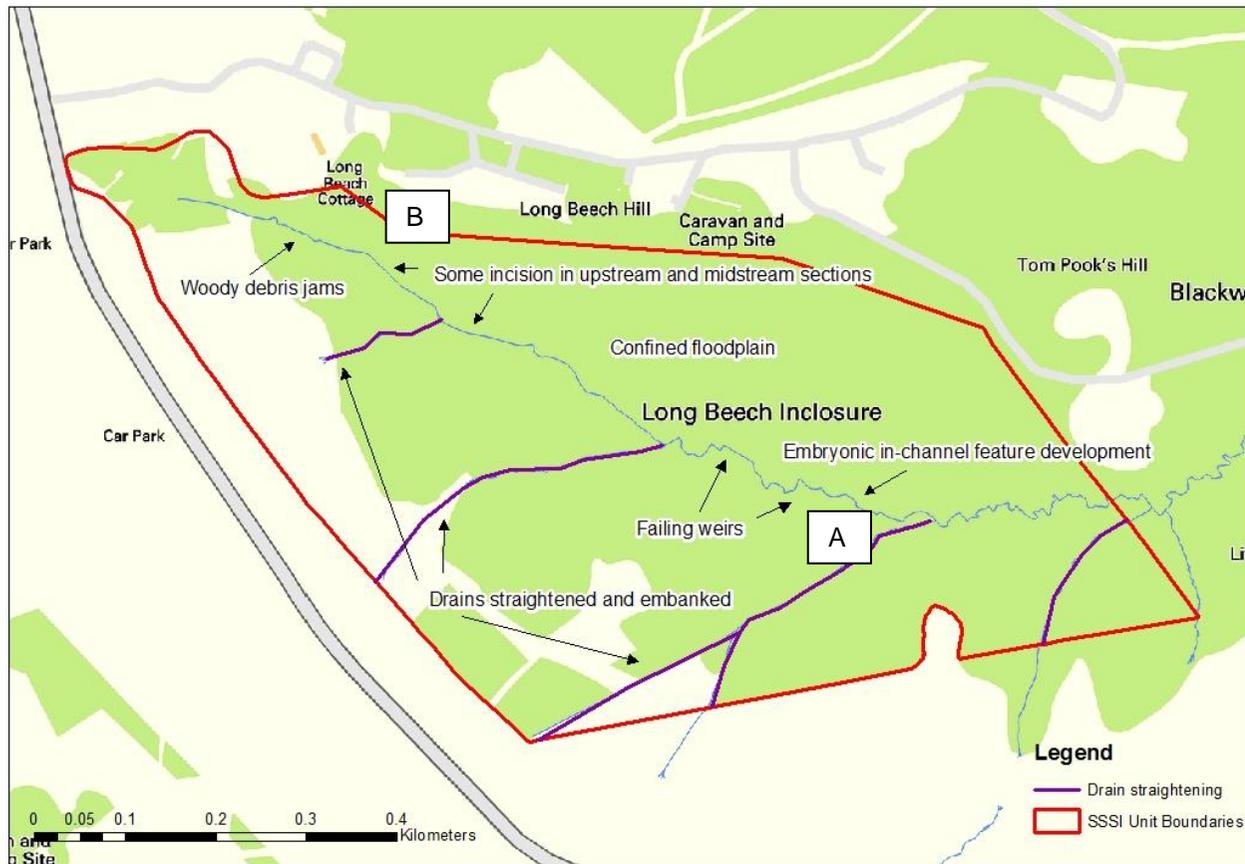
Figure 1-4: Current hydromorphic conditions and pressures

Colemeer Gutter has a moderate gradient in the mid to lower reaches (Figure 1-4 - A) and a steeper gradient in the upper reaches (Figure 1-4 - B), where it is narrower.

The major drains within this SSSI unit show evidence of past straightening and over-deepening, with some sections of embankments along the bank tops. Other minor flow routes and drains do not appear to have been significantly modified, as shown in the flow line maps in Appendix A. The modifications to the main drains marked in Figure 1-4 are likely to be concentrating flows at local points in the main channel, leading to elevated erosive conditions. This is likely to be a contributing factor to the moderate incision within this unit (Figure 1-3). The modified drainage regime, concentrating flows in the main channel, leads to energetic flow conditions that increase erosive energy potential.

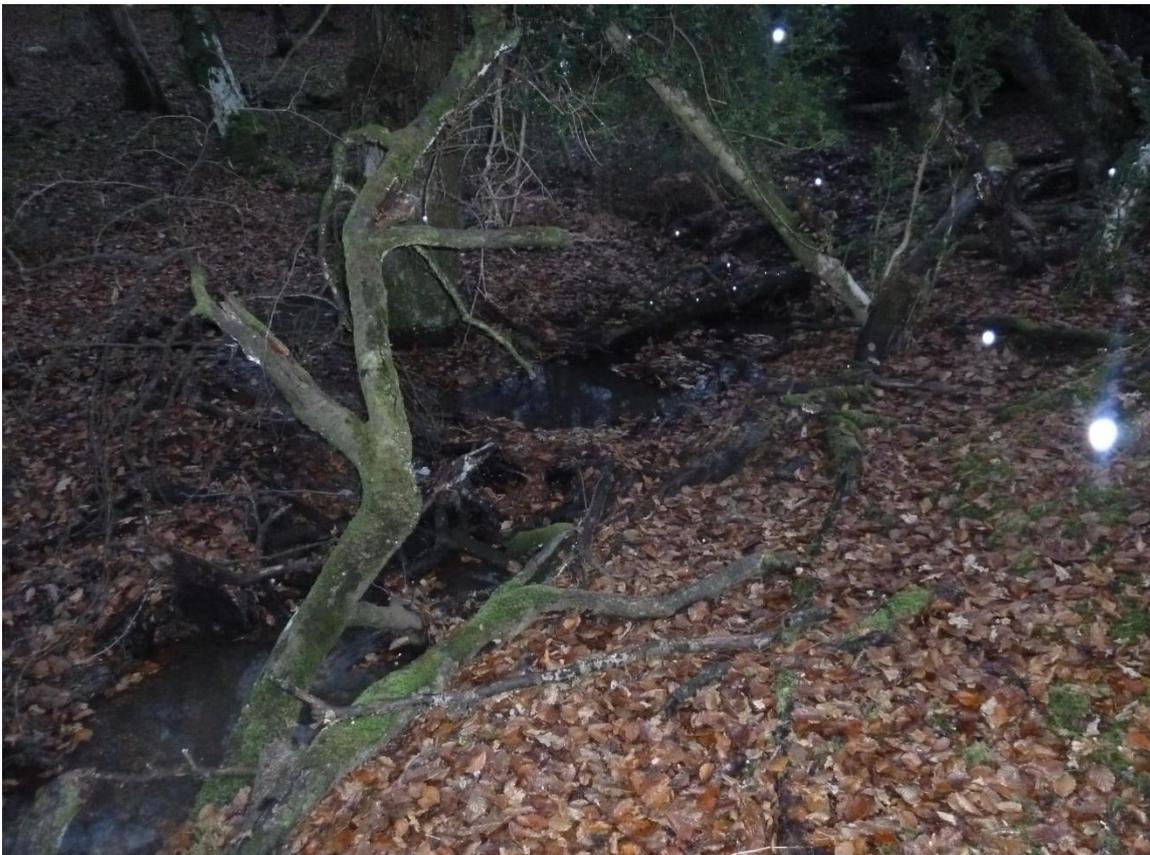
The well wooded riparian corridor (Figure 1-5) has largely prevented excessive lateral erosion, hence erosive energy is focused on some bed incision. This has resulted in variable disconnectivity from the floodplain, although the v-shaped valley means that connectivity levels would naturally be reduced. There are some small floodplain areas at a lower level where improved connectivity may result in multi thread channel development (Figure 1-6). The lowered bed level will have impacted groundwater levels locally however, resulting in drier areas within the floodplain. Widespread incision has also been prevented through the frequent occurrence of natural woody debris jams within the channel (Figure 1-7 and Figure 1-8).

Figure 1-5: Wooded riparian corridor

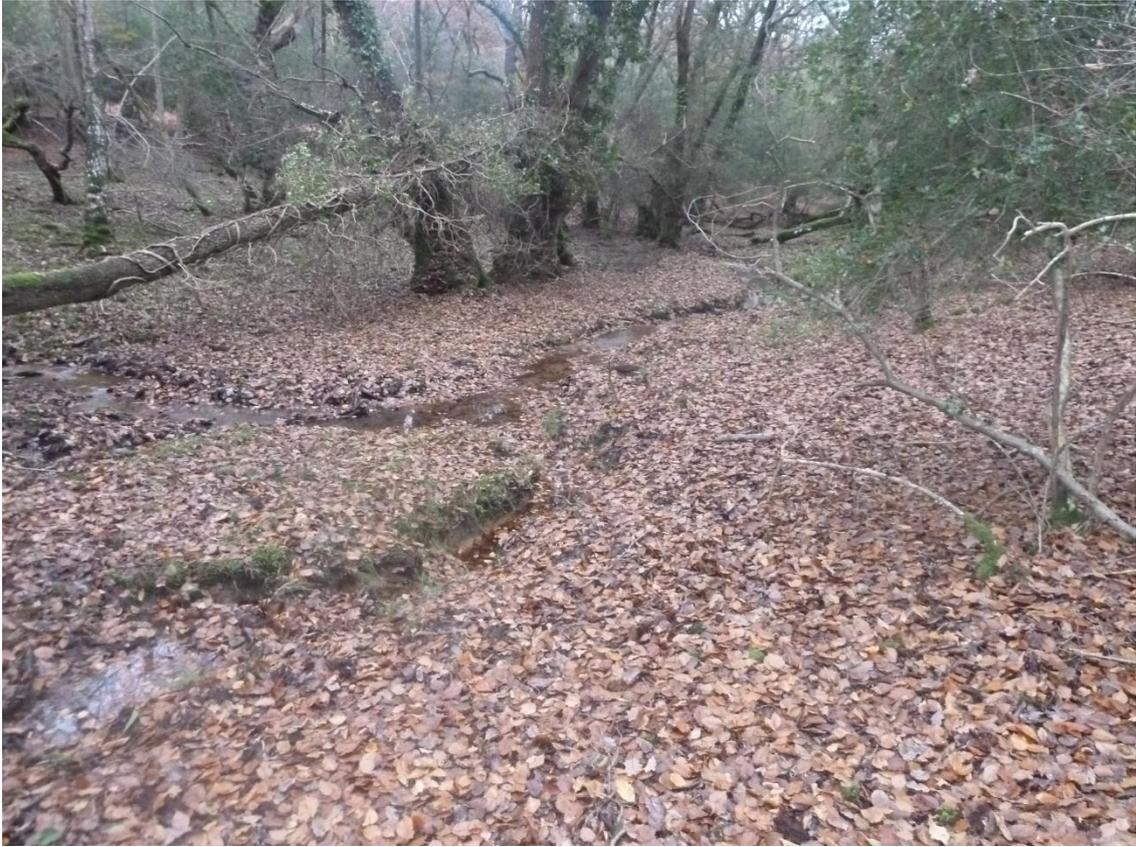
Figure 1-6: Lower, flatter floodplain areas

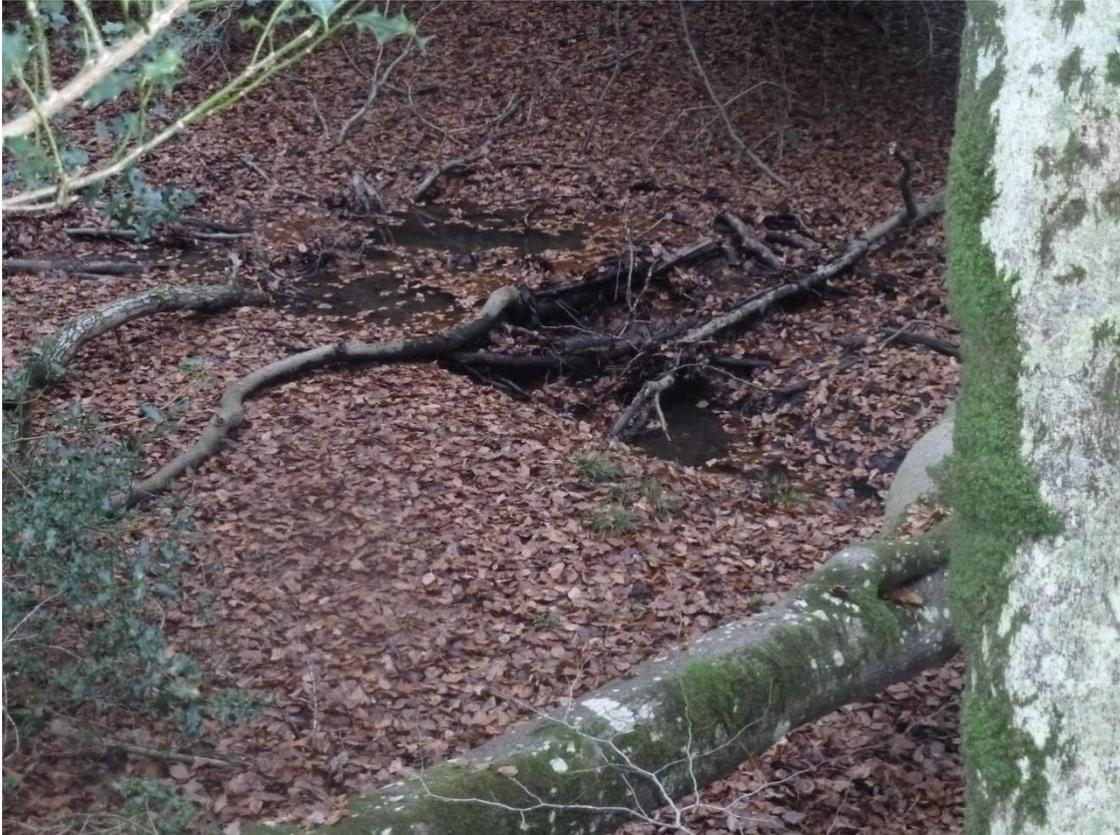
Figure 1-7: Natural woody debris feature

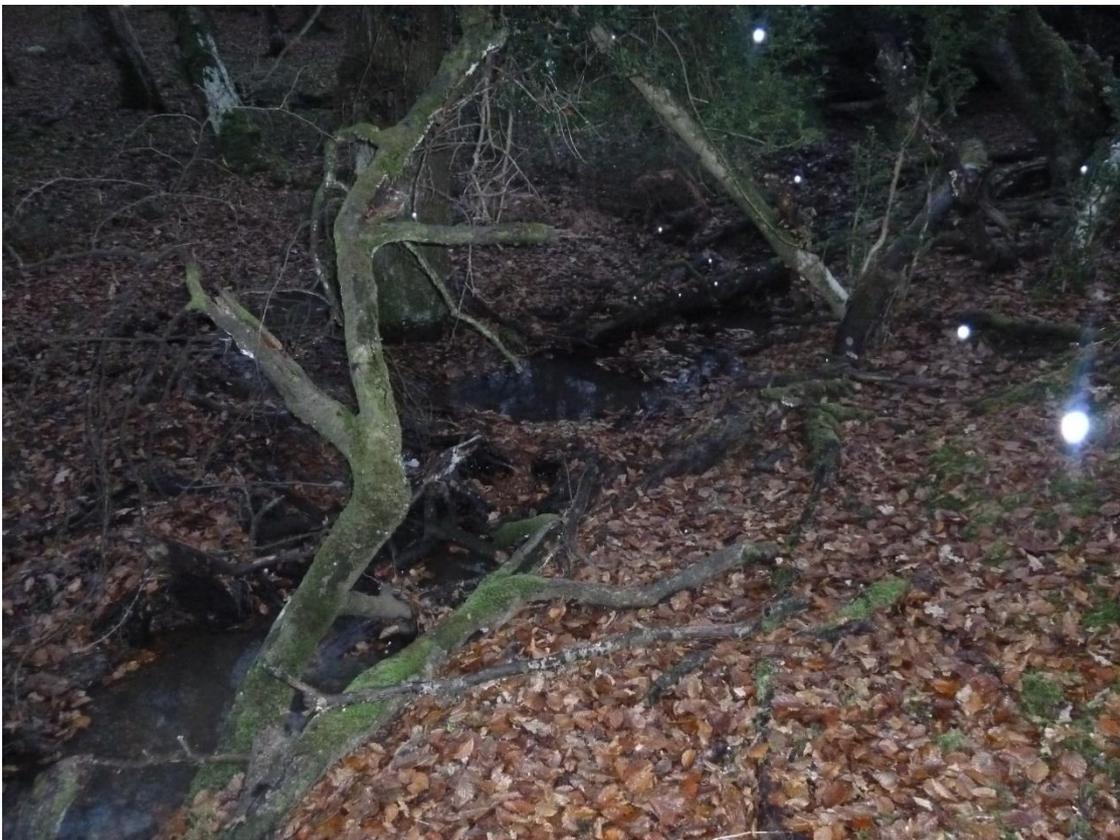
Figure 1-8: Natural woody debris feature

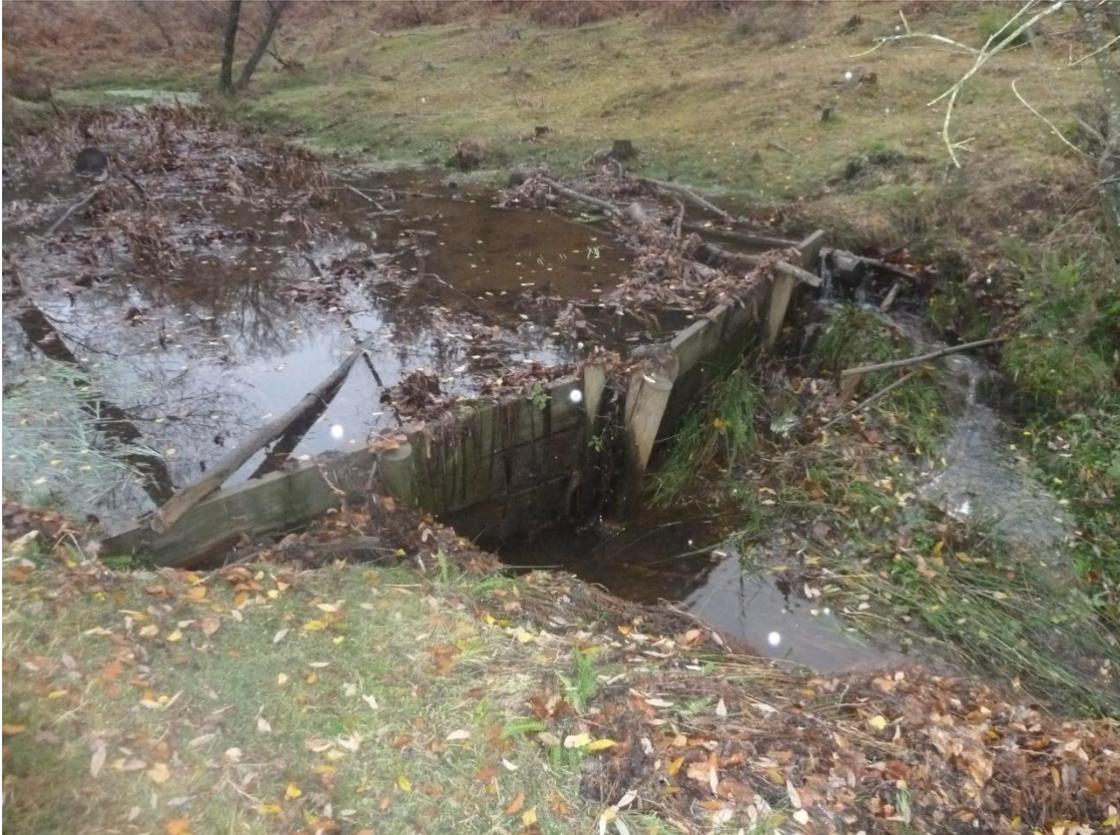
Wooden weirs are located within the midstream section of the unit (Figure 1-9 and Figure 1-10). These were potentially installed to prevent incision by impounding water and raising water levels locally. Some of these are failing (Figure 1-9).

Figure 1-9: Wooden weir structure

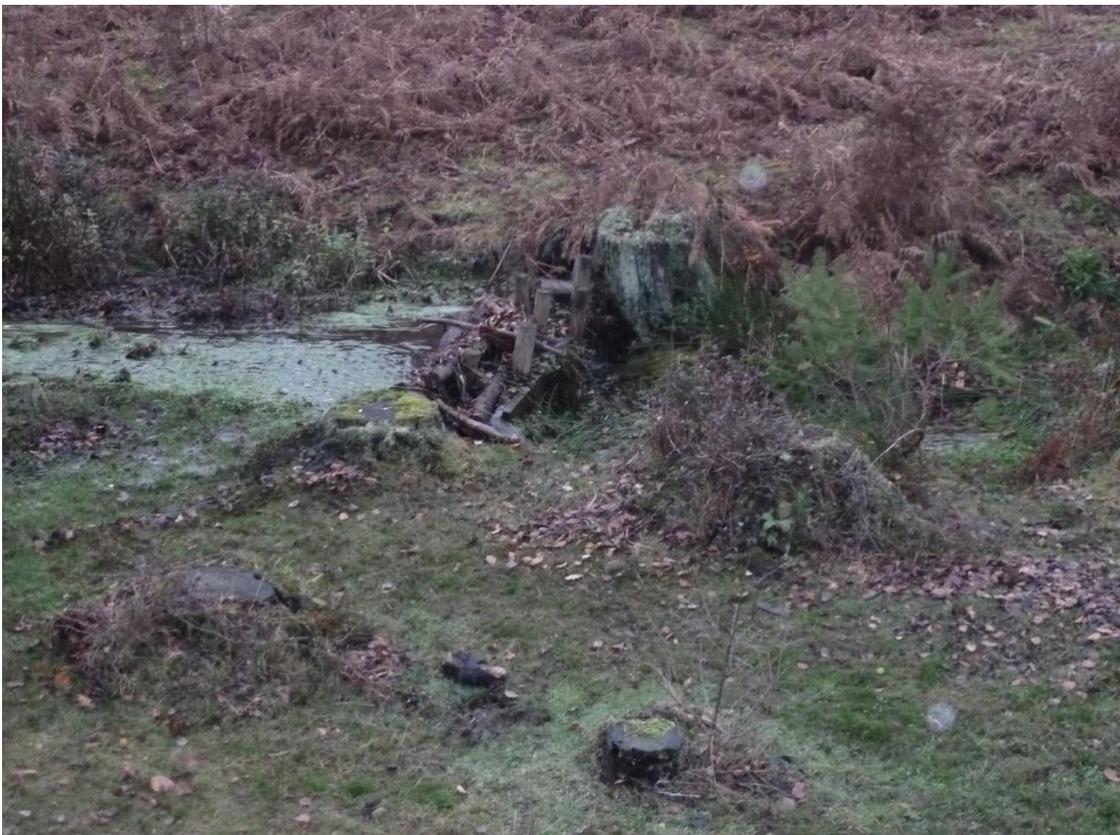
Figure 1-10: Wooden weir structure
