Natural England Commissioned Report NECR140

# New Forest SSSI Geomorphological Survey Overview

Annex Q: Islands Thorns / Amberwood Restoration Plan - SSSI  
Unit 540

# 1 Islands Thorns / Amberwood Restoration Plan - SSSI Unit 540

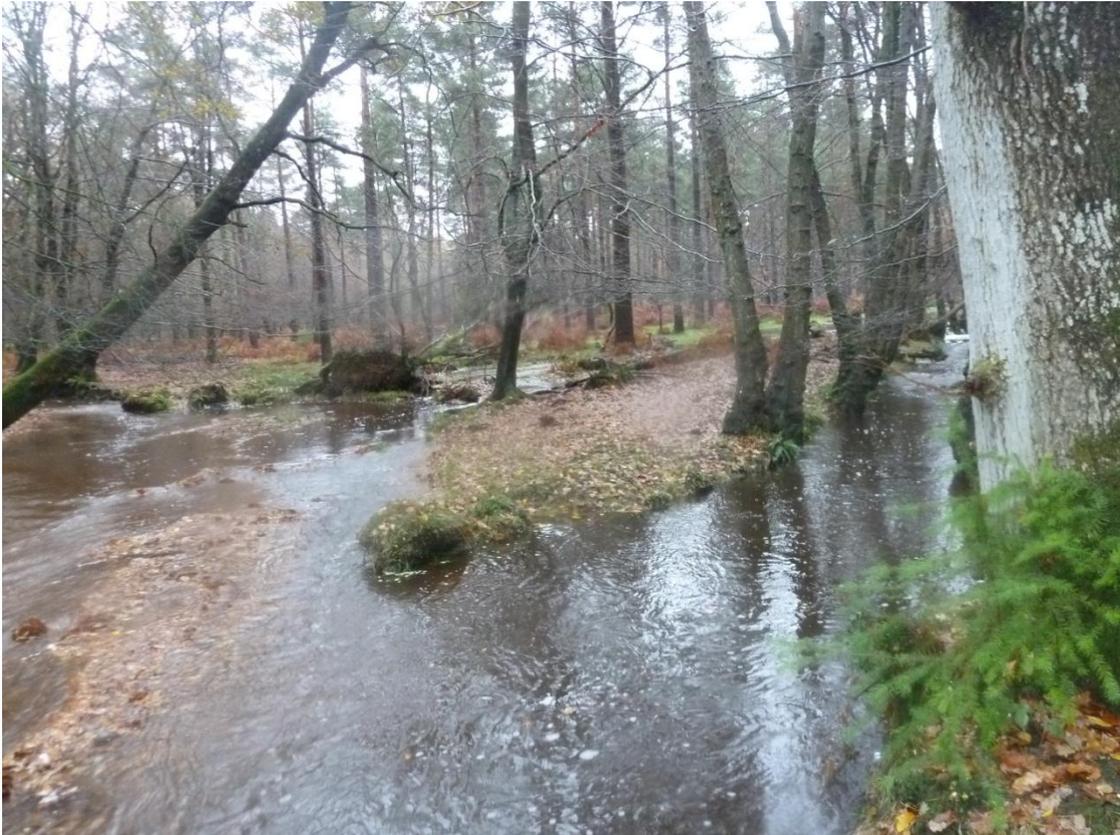
- a weakly lowland anastomosed system at the downstream end of the reach where the stream from the east meets the Latchmore Brook (Figure 1-2);
- an active single thread channel, with some mild characteristics of an actively widening channel type as gravel inputs are strong (Figure 1-3);
- a passive single thread channel.

Figure 1-2: Weak anastomosed channel

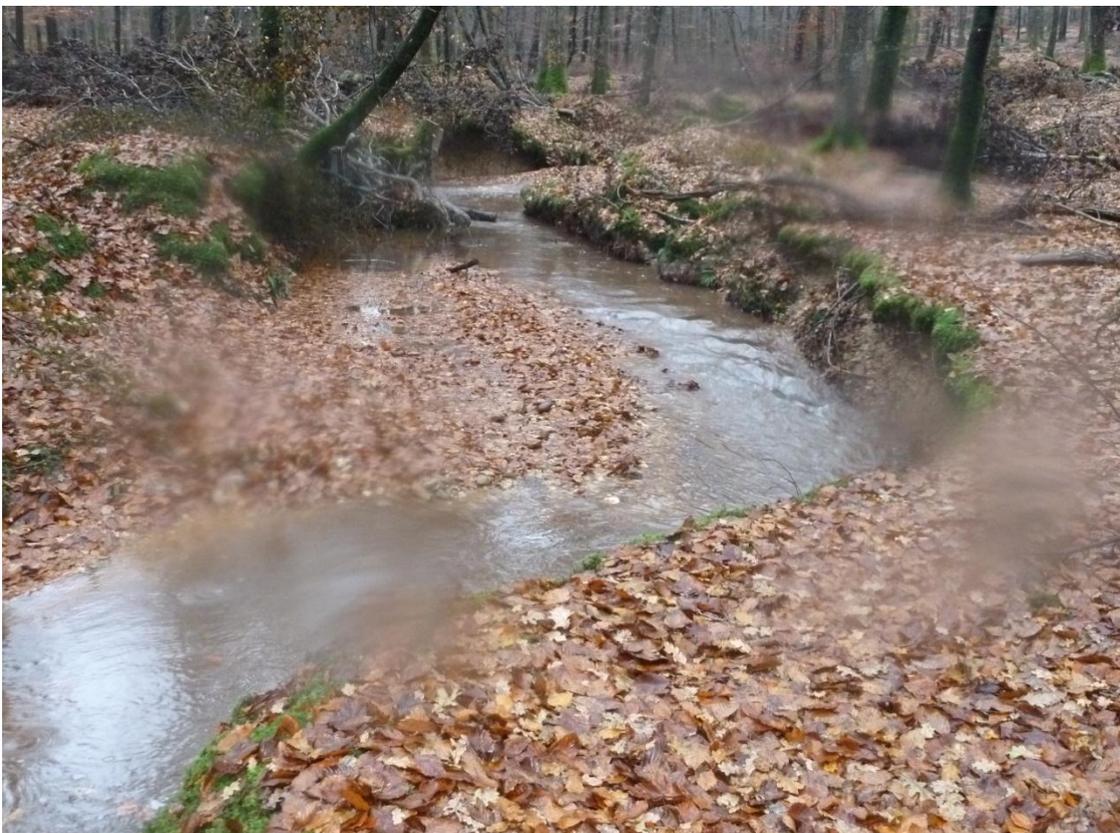
Figure 1-3: Actively widening characteristics in some locations

Often in rivers with moderate to high energy, lateral erosion and widening is also associated with bar deposition concentrating flows around gravel shoals and promoting further lateral activity (Figure 1-3). This is particularly true for the mid to lower sections of this reach of the Latchmore Brook.

The strong supply of gravels has resulted in significant gravel feature growth within the channel in the mid to lower reaches where gradients are shallower in the form of mid channel bars, lateral bars, transverse bars and point bars (Figure 1-3). Poor connectivity with the floodplain means that the pattern of erosion and deposition is exaggerated (as a result of incision and embankments) meaning growth has been enhanced locally, particularly in areas where widening can readily occur.

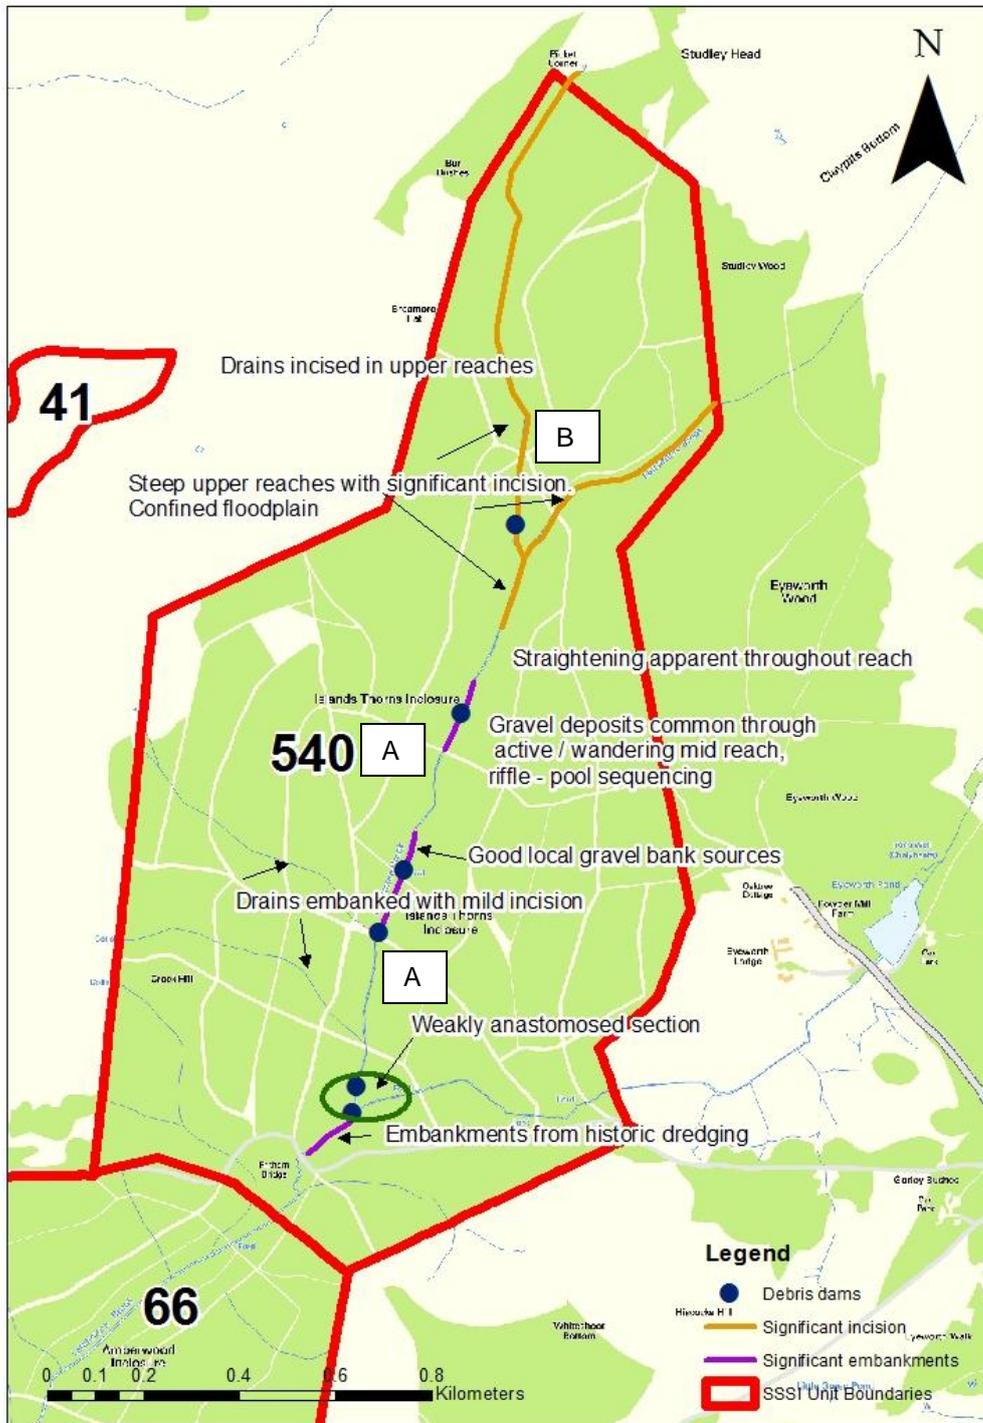
Figure 1-4: Current hydromorphic conditions and pressures

The Latchmore Brook has a moderate gradient in the mid to lower reaches (Figure 1-4 - A) and a steeper gradient in the upper reaches where it is narrower and more incised (Figure 1-4 - B). It has also been subject to channel straightening in the past throughout. Straightening of the watercourse has had a profound effect on the nature and functioning of the river. The length of

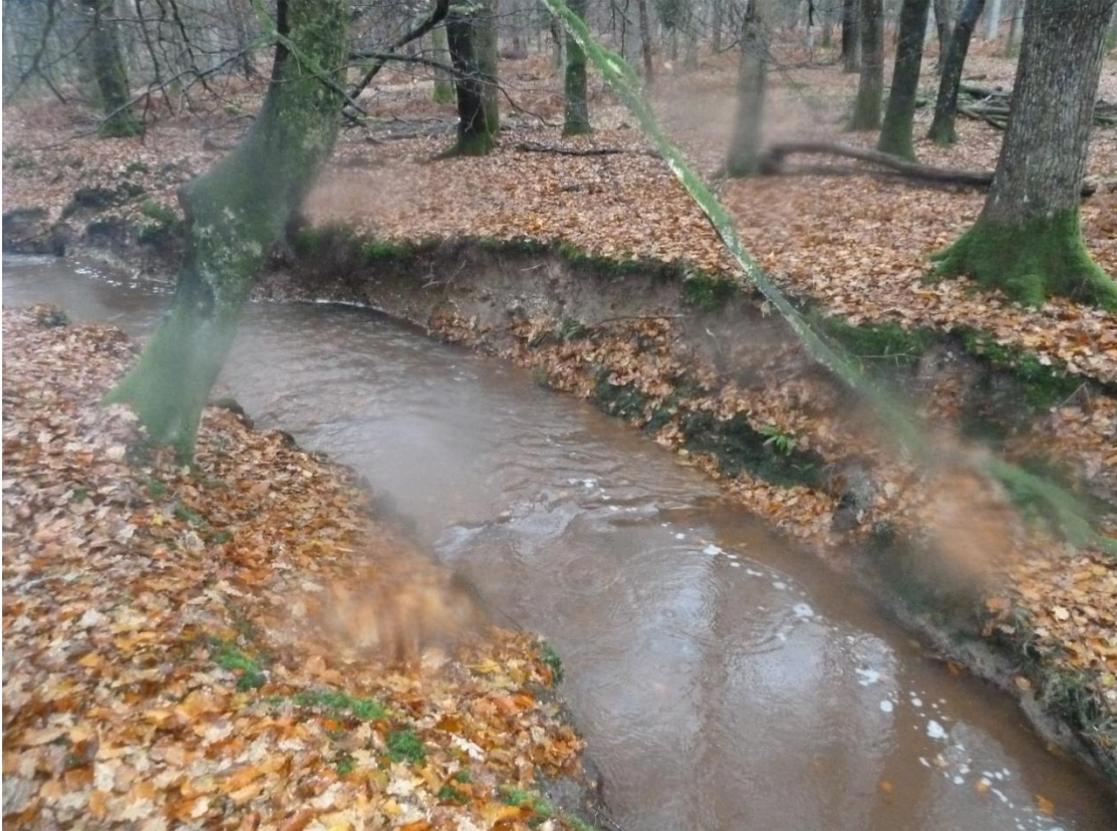
watercourse will have been shortened leading to a steepening of the system and the associated dredging will have over-deepened the channel. This in combination will have increased flood shear stress levels promoting erosion (Figure 1-5).

Figure 1-5: Bank erosion common along reach

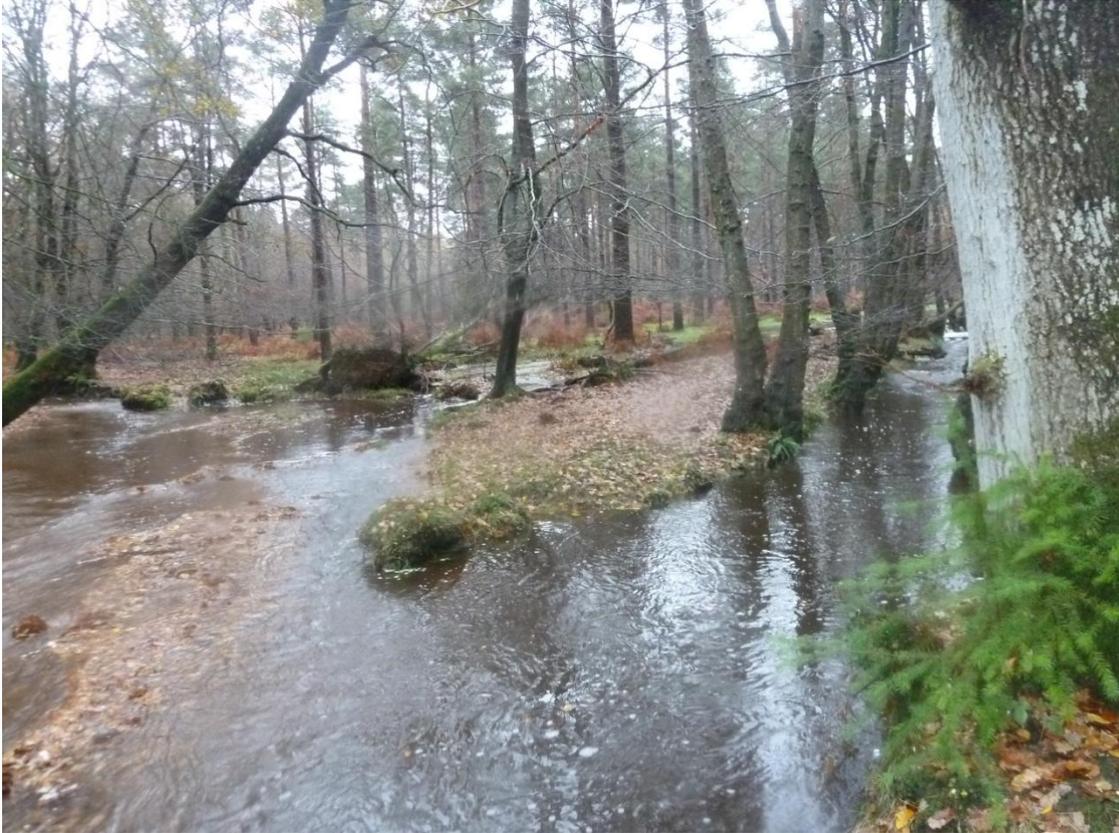
Where the channel banks are stronger (due to the presence of more resistant boulder clays rather than fluvio-glacial gravels or where riparian woody vegetation is dense enough to provide a coherent resistant root mat) erosive energy will have been directed at vertical incision leading to an over-deep channel. Where the banks are less resistant (due to tree clearance, presence of gravels etc.) lateral erosion will also have occurred. This is evident in locally widened sections. Where floodplain connectivity is good, within the wooded downstream section where the two watercourses meet, a multi-thread anastomosed channel network has developed between stabilised wooded areas. Lateral and vertical erosion is reduced through these sections as channels are wetted at different flow levels, spreading erosive energy across a wide area as flow levels increase. Whilst on site, high flow levels showed the mild anastomosed channel network well (Figure 1-2). The success of the anastomosed network is assisted by local debris jams which maintain improved floodplain connectivity (Figure 1-6).

Figure 1-6: Debris jam at anastomosed channel section

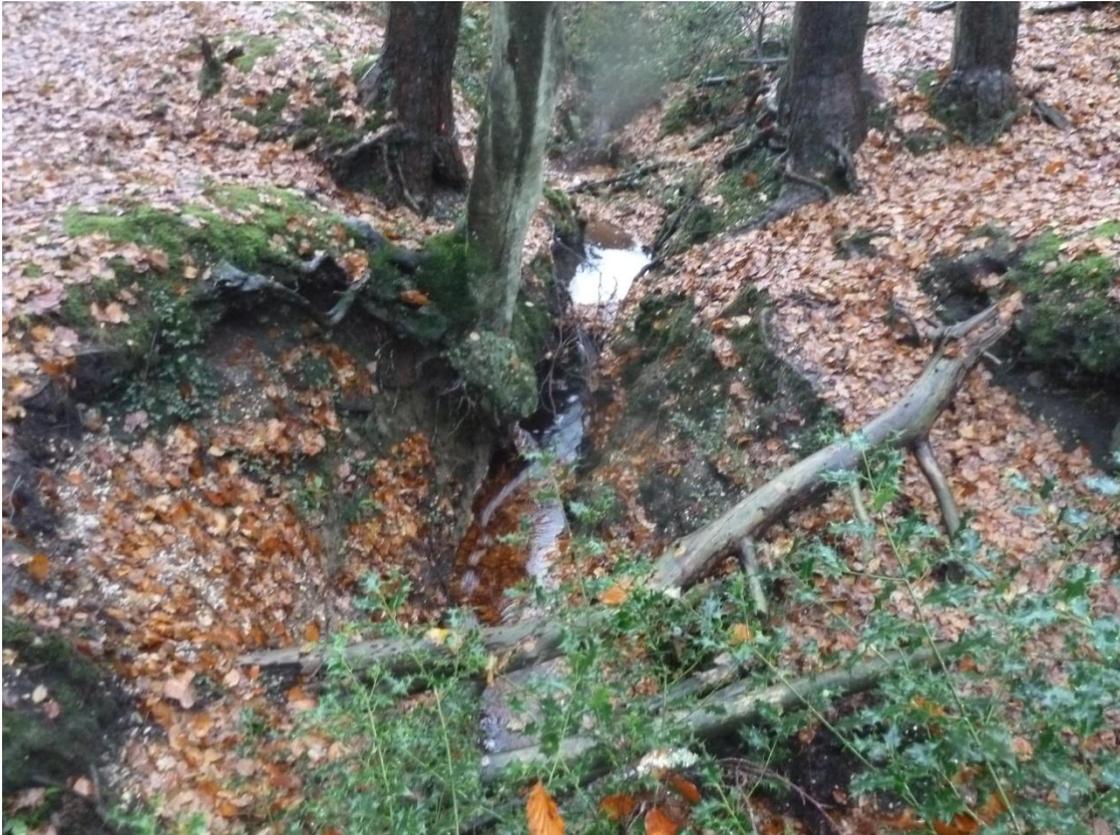
The initial impact of straightening would have been incision along significant lengths of the wooded watercourse (Figure 1-7) and wandering behaviour across areas with erodible banks. This initial incision episode is likely to have caused the knick point development moving through the tributary / drain systems.

Figure 1-7: Upstream significant incision

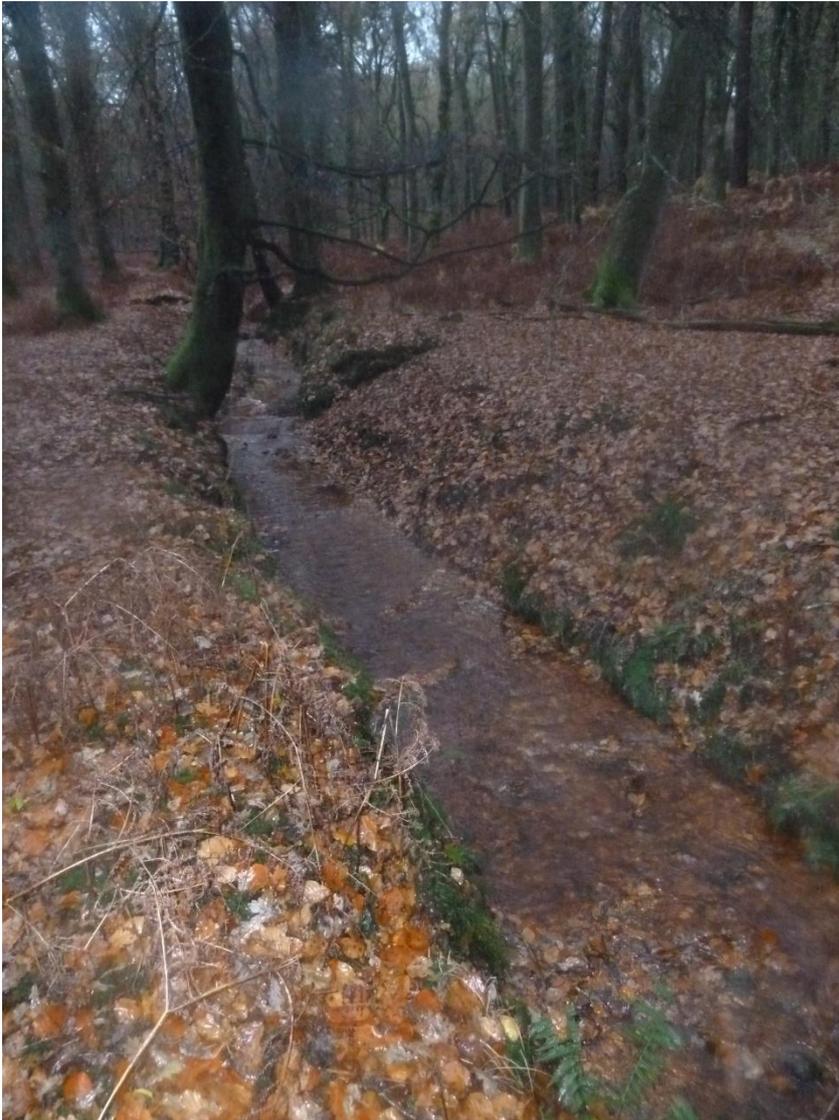
The result of poor floodplain connectivity and the modified flow regime, in a responsive river type, has been vertical incision, particularly in the upper reaches where more cohesive banks and a steeper gradient have focused erosive energy on the channel bed. Ditching of the upper and mid catchment will have impacted on the flood flow regime of the watercourse creating a more responsive system where flood peaks are concentrated and increased and water enters the main channel more efficiently. The degree of artificial drain creation is shown in Appendix A and is impacting significantly on the flow regime. This effectively creates a higher energy system more capable of erosion and sediment transport. This is particularly evident in the upper reaches of this unit where smaller gravels are readily mobilised downstream leaving smaller deposits of larger, often cobble sized, material (Figure 1-8).

Figure 1-8: Smaller larger gravel / cobble deposits in upper reaches

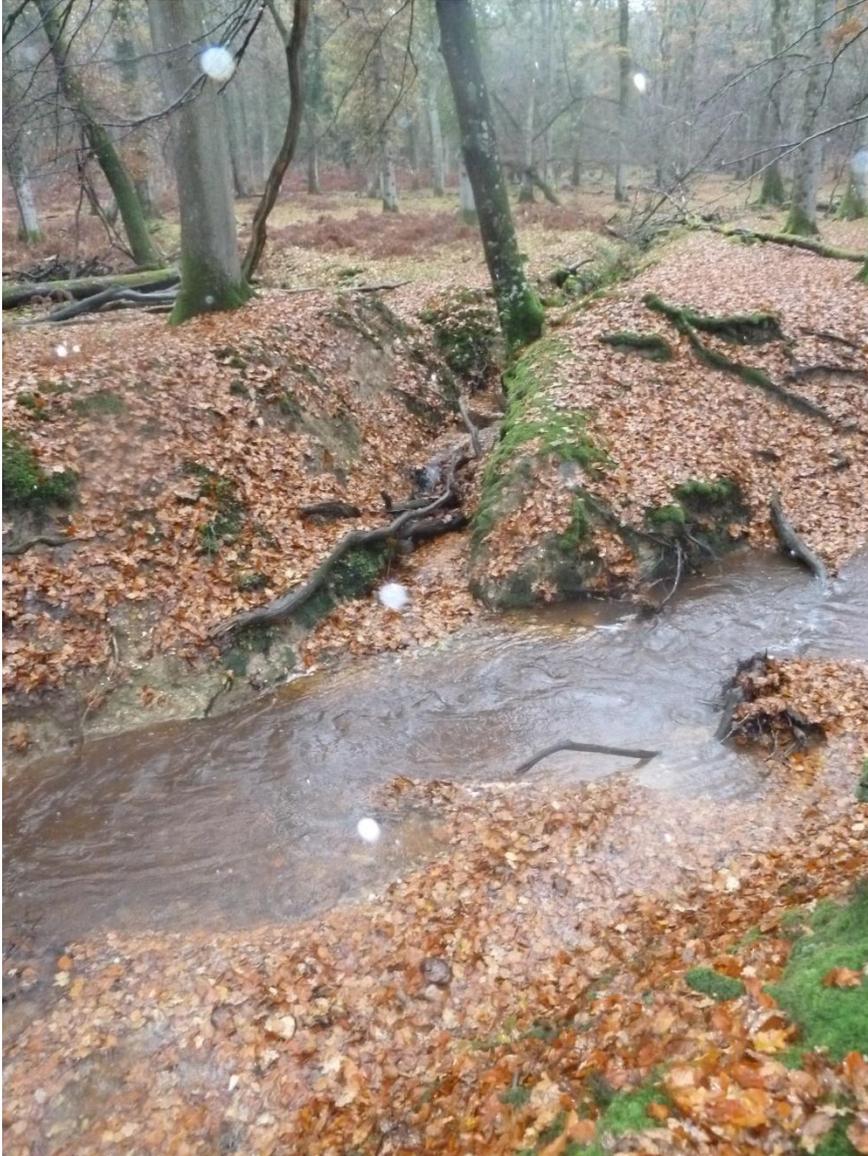
There has been incision up to 3m (from bank top to stream bed level) in the upper reaches of this unit, where the channel is significantly narrower than mid to lower reaches. Erosive energy is contained within the banks rather than spread across the floodplain at higher flows resulting in bed erosion. This creates oversteep banks that are prone to collapse (Figure 1-7) through undercutting, as well as further reducing floodplain connectivity. This is exaggerated in some locations by the presence of embankments on the bank tops, which are particularly evident in the lower reach of this unit, downstream of the anastomosed section. As a result of incision in the brook, connecting drains are also incised in some locations. The incision within the drains is also impacted by embankments on the bank edge of the drains (Figure 1-9).

Figure 1-9: Incision in upper reach drain, showing embankments

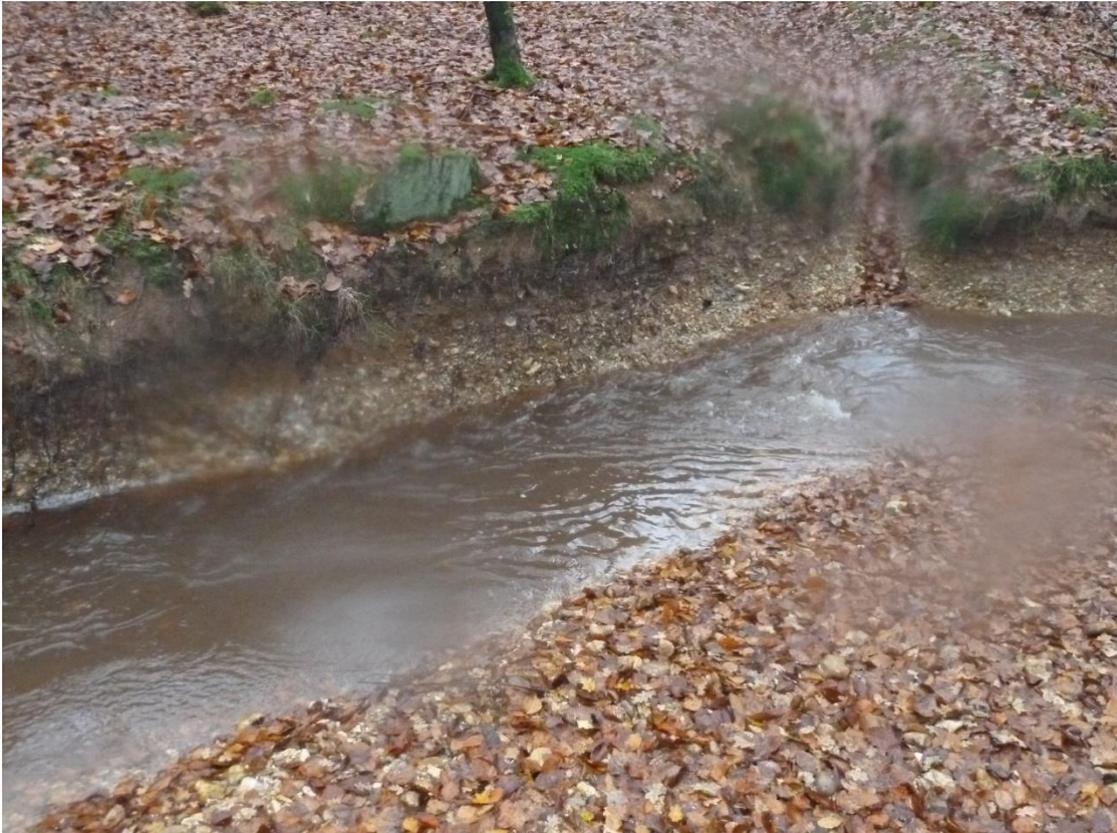
Gravel supply (there are significant gravel sources within the river banks, Figure 1-10, locally and upstream sources are particularly important for gravel features in the mid to lower reaches) is strong and this, combined with flow regime alterations through surrounding drains, as well as historic tree clearance, give responsive channel conditions.

Figure 1-10: Local gravel bank sources

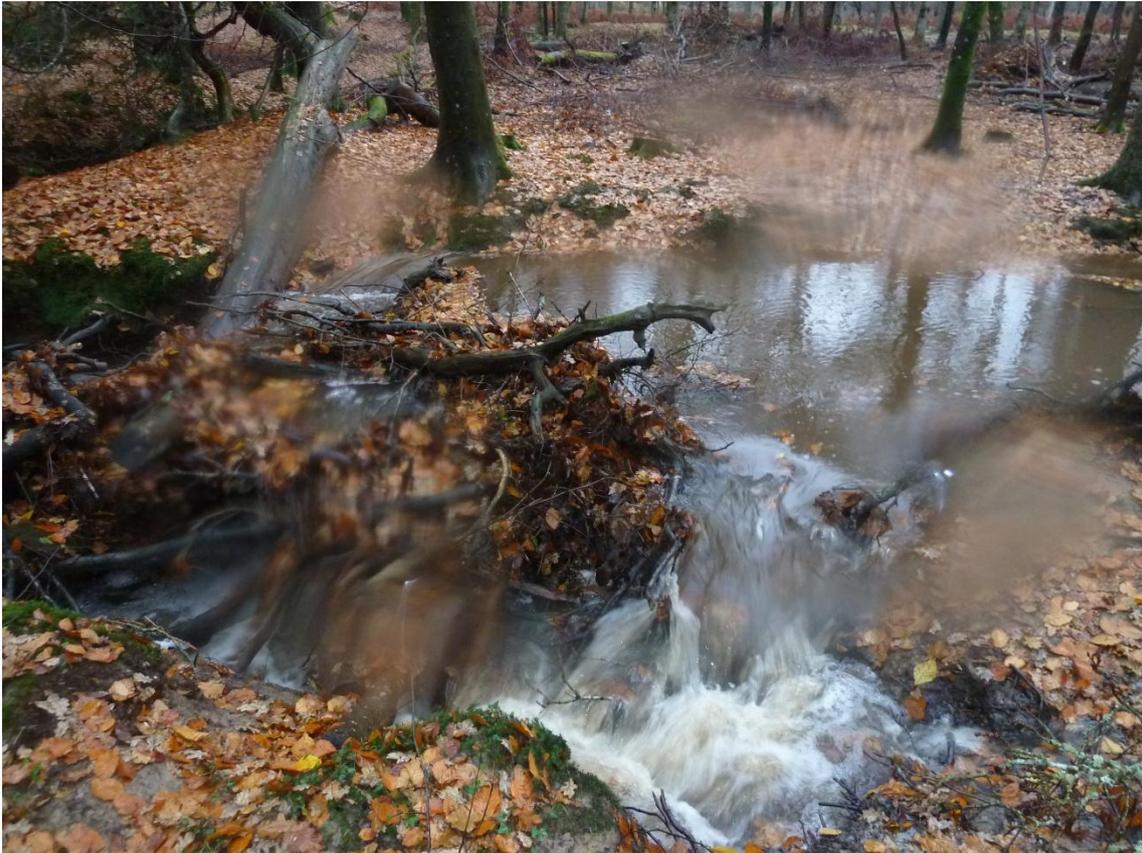
Natural woody debris features are common along the channel, particularly in the mid to lower active sections, which have often been created as a result of local bank erosion / collapse (Figure 1-11). These create short lengths of impounded watercourse that does improve floodplain connectivity significantly, as is clearly seen in the mild anastomosed section of this reach. These provide useful analogue features for the restoration plan.

Figure 1-11: Natural woody debris jams

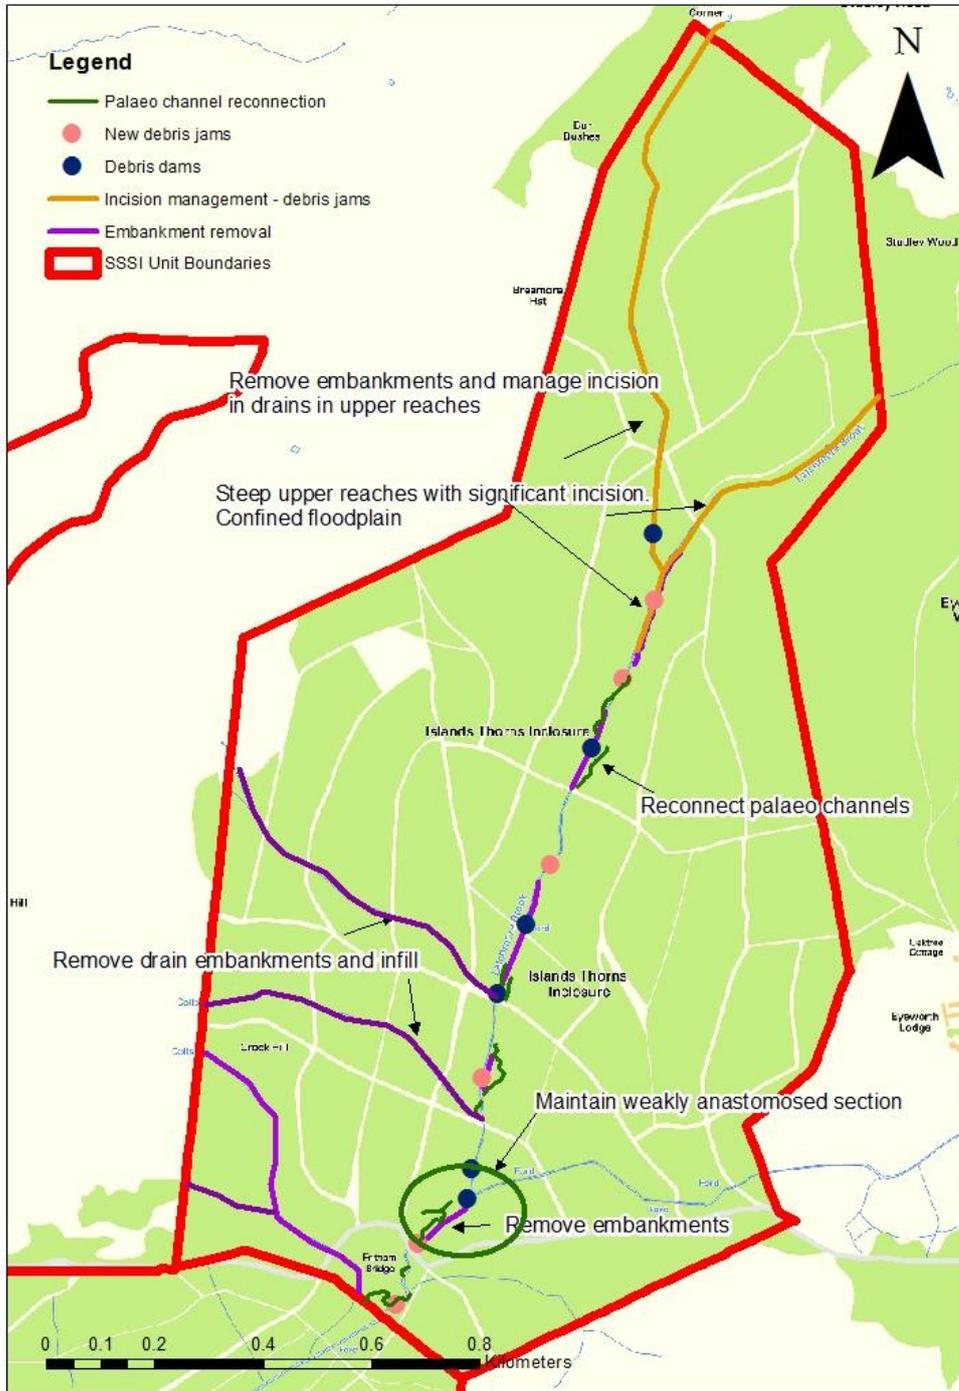
Figure 1-13: Proposed restoration measures for SSSI Unit 540

Significant palaeo channels have been identified in Figure 1-13 and show where reconnection could be possible through some of the proposed restoration measures in Table 1-2. These have been identified from the audit and supplied LIDAR. Reconnecting these whilst maintaining the existing channel will encourage anastomosed network development.

A summary of the current pressures, unmitigated impacts and restoration proposals is given in Table 1-2 and shown in Figure 1-13.

The major straightened / modified drainage channels are identified in Figure 1-13. Other minor modifications could be considered for infilling and Appendix A should be used for reference.
