# New Forest SSSI Geomorphological Survey Overview

Annex K: Spring Wood Riverine Woodland Restoration Plan -  
SSSI Unit 371

# 1 Spring Wood Riverine Woodland Restoration Plan - SSSI Unit 371

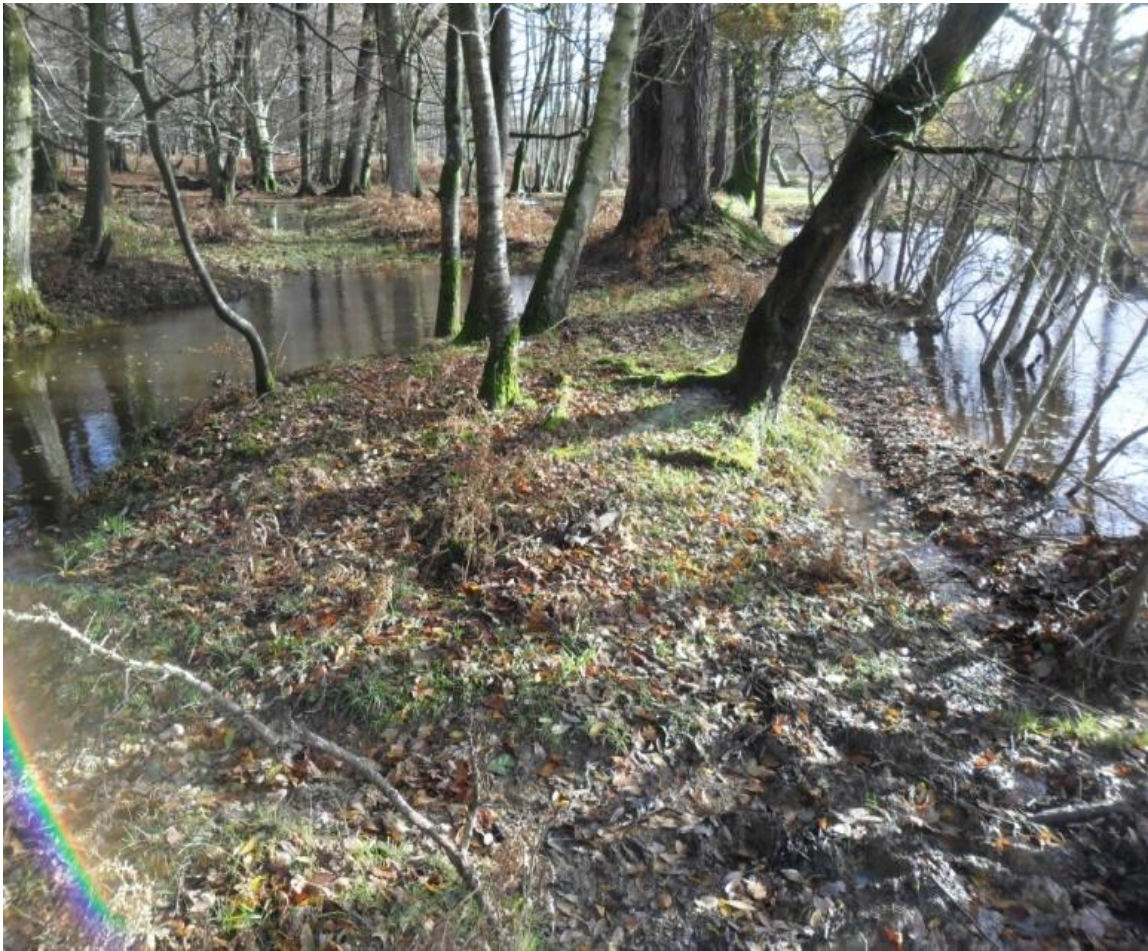
- a weakly lowland anastomosed system, particularly in the lower reaches where debris jams have created better connectivity, activating a multi-thread system at higher flows (Figure 1-2);
- an active single thread channel, with some lateral activity (Figure 1-3);
- an engineered, straightened single thread reach (Figure 1-4).

Figure 1-2: Weak anastomosed channel network

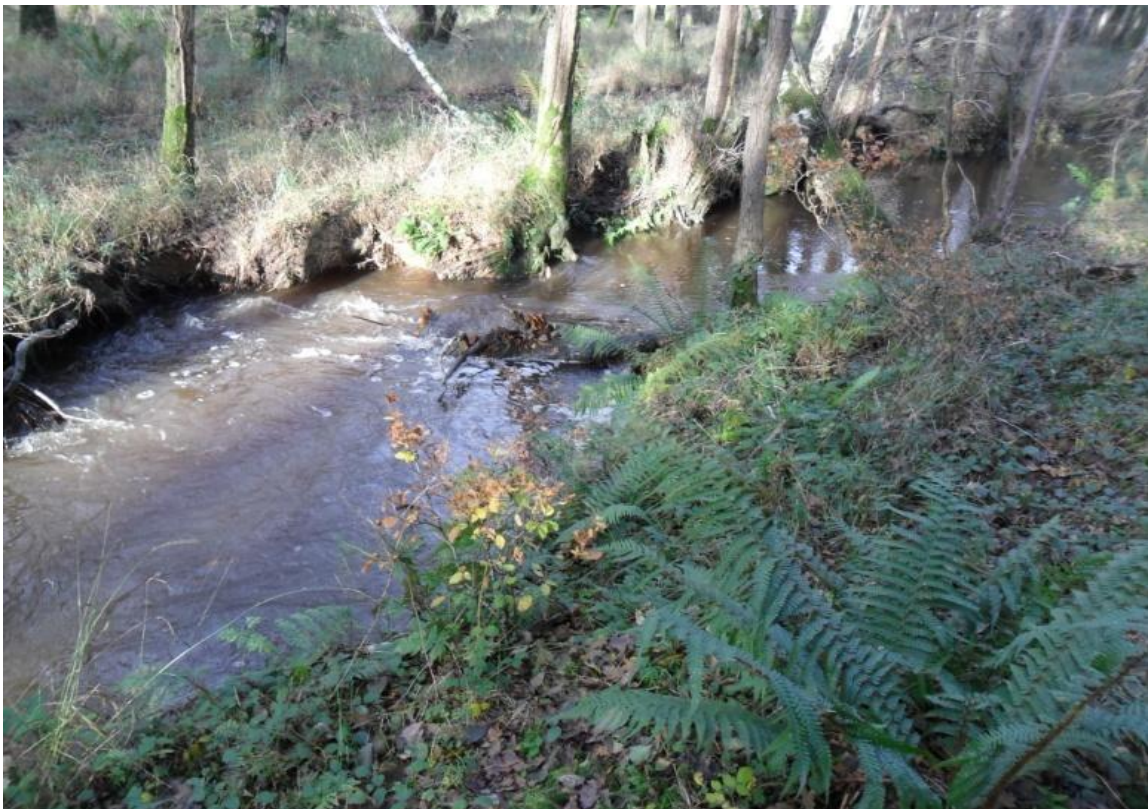
Figure 1-3: Active single thread channel

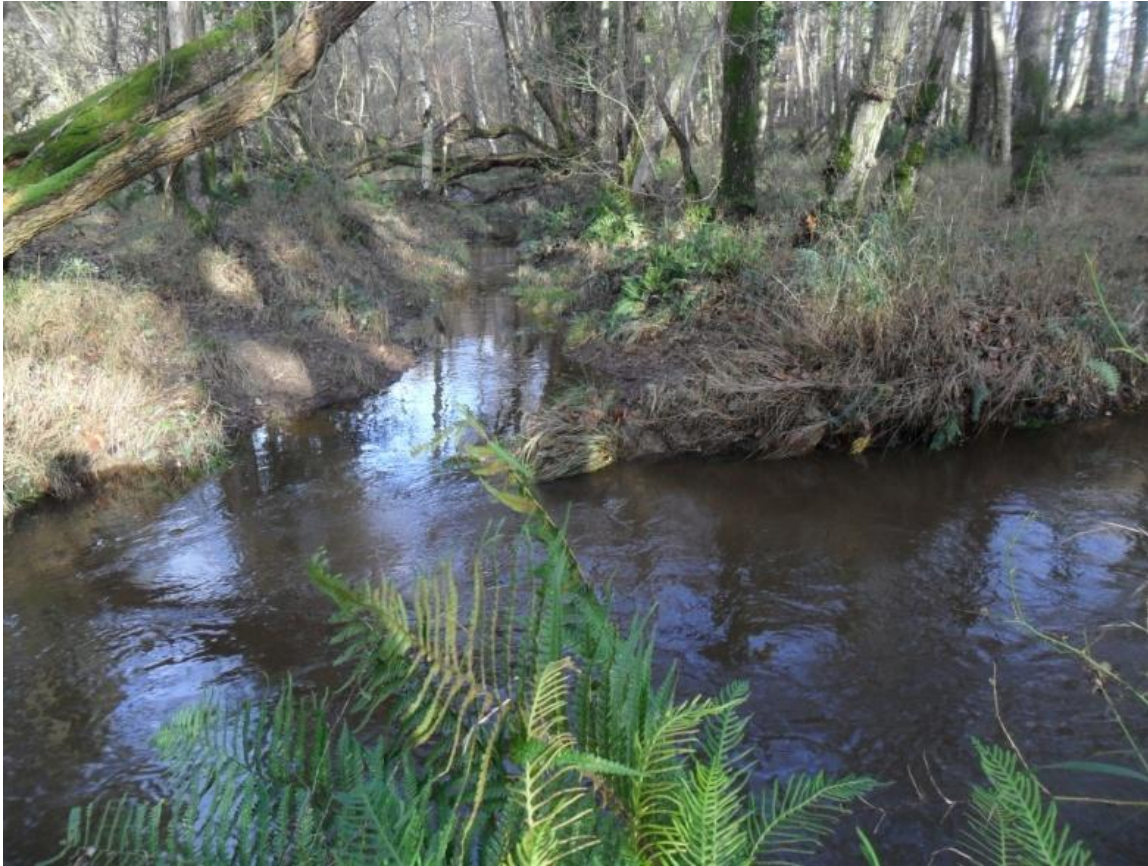
Figure 1-4: Straightened artificial channel

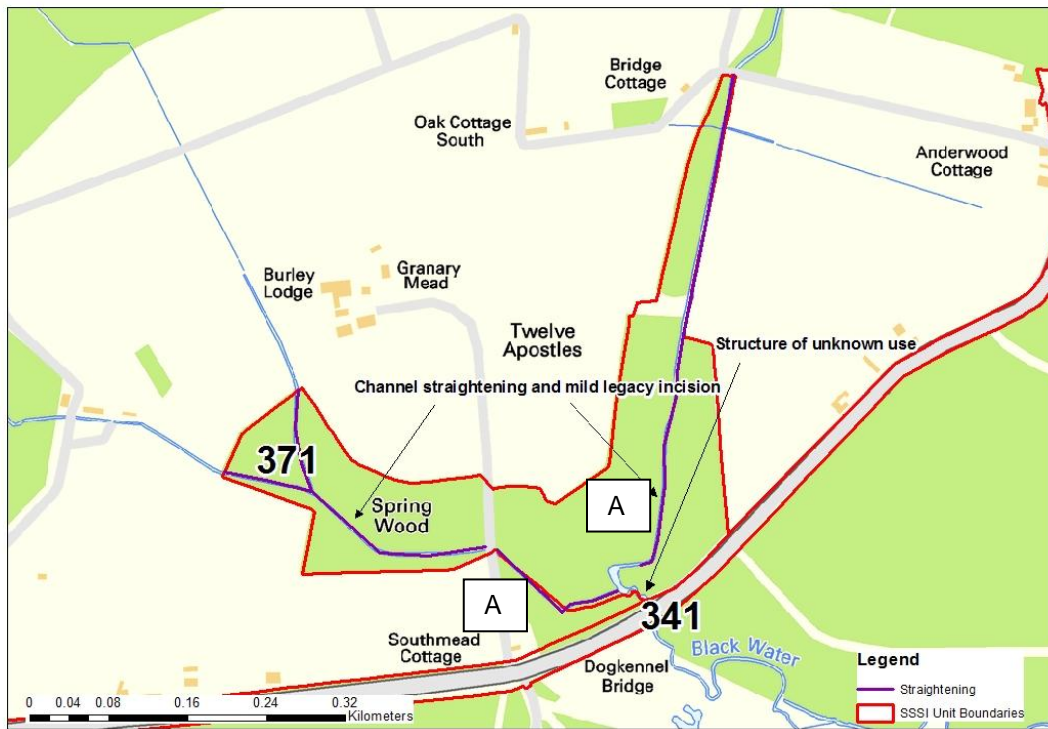
The source of the River Blackwater is from Blackensford Brook to the east and two unnamed headwater streams to the west which join at Dogkennel Bridge. This unit is supplied with fine and medium gravels from upstream and actively transports this sediment through to the main River Blackwater. An engineered structure of unknown use is present close to Dogkennel Bridge and should be considered for removal. Figure 1-5 summarises the existing hydromorphology and pressures impacting Unit 371.

Figure 1-5: Current hydromorphic conditions and pressures

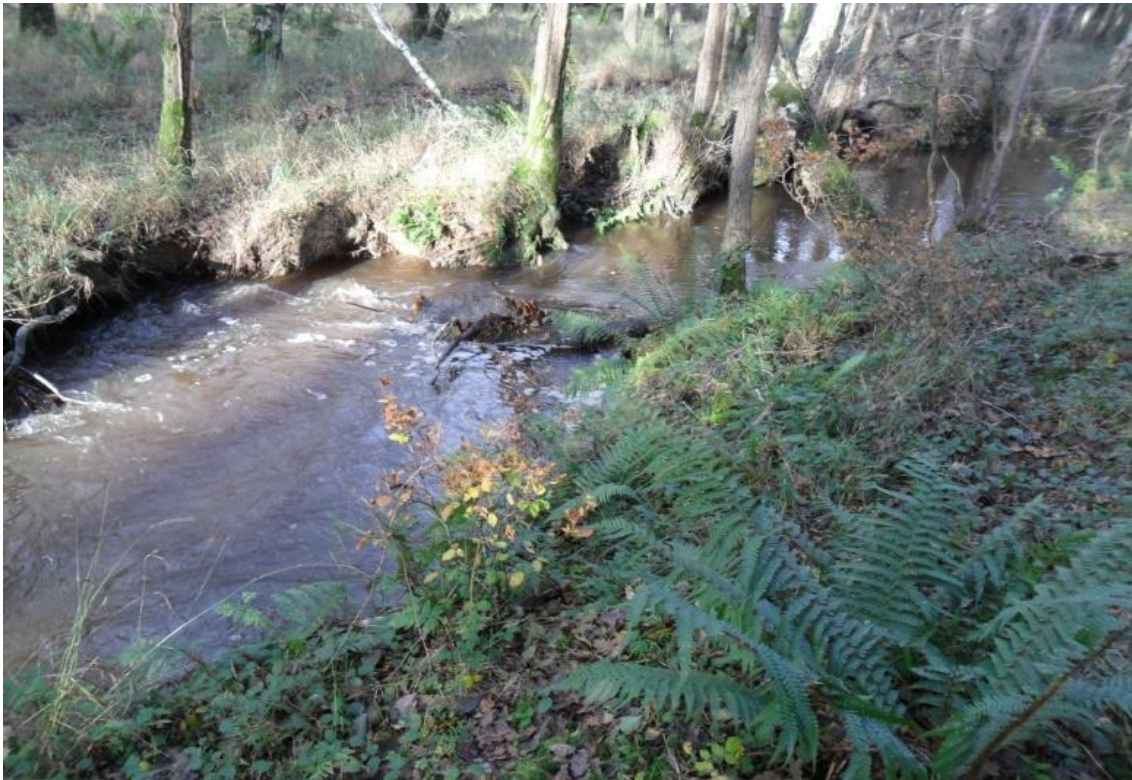
Figure 1-6: Local channel incision

Where riparian woody vegetation is dense enough to provide a coherent resistant root mat erosive energy will have been directed at vertical incision leading to a slightly over-deepened channel. Floodplain connectivity is improved where woody debris dams pond water upstream creating a multi-thread anastomosed channel network. Restoration should look to increase the frequency of wetting of these channels. Natural woody debris features are relatively common along the channel (Figure 1-9) and in places have blocked the straightened reaches causing flow to partially reoccupy the original channel course increasing hydromorphic diversity locally.

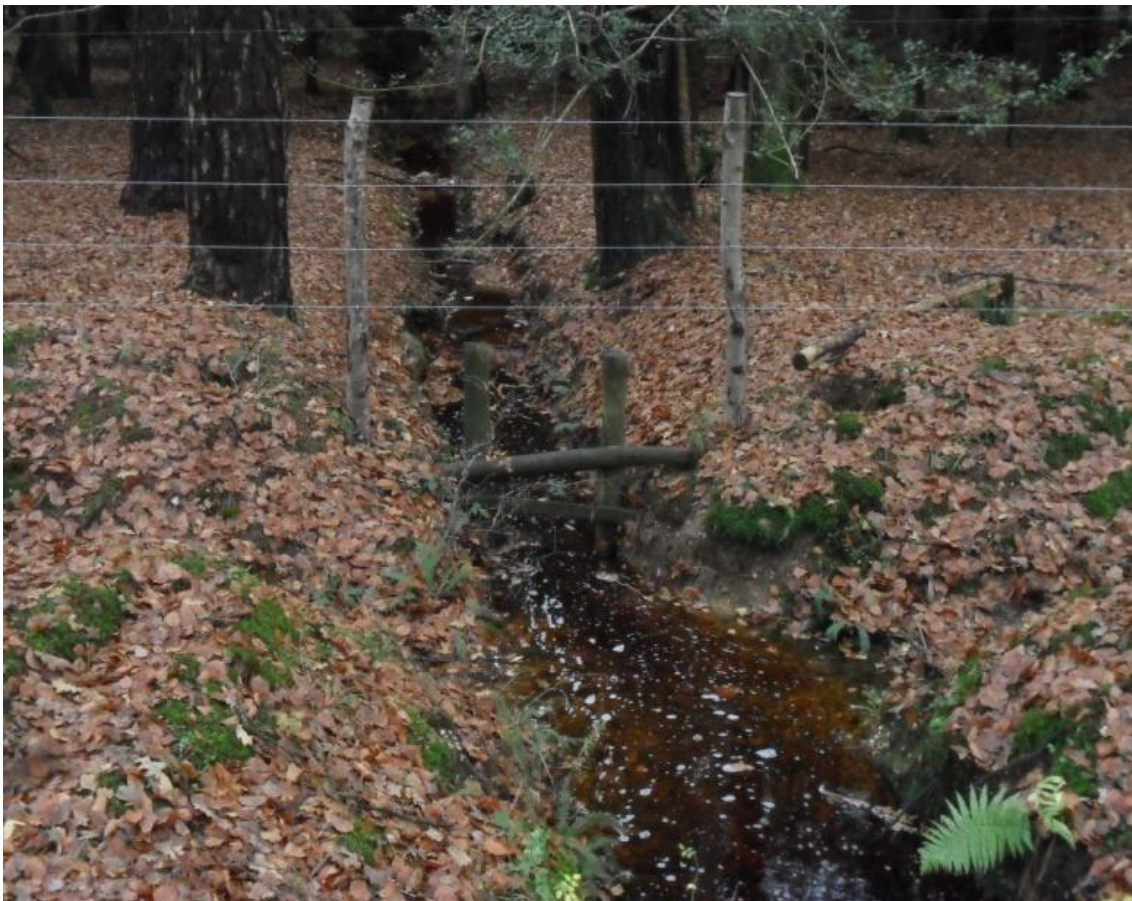
Figure 1-7: Stable local drainage

Drainage into the SSSI is stable and management of the drains themselves will not be required if they are retained. Drainage channel infilling is recommended.

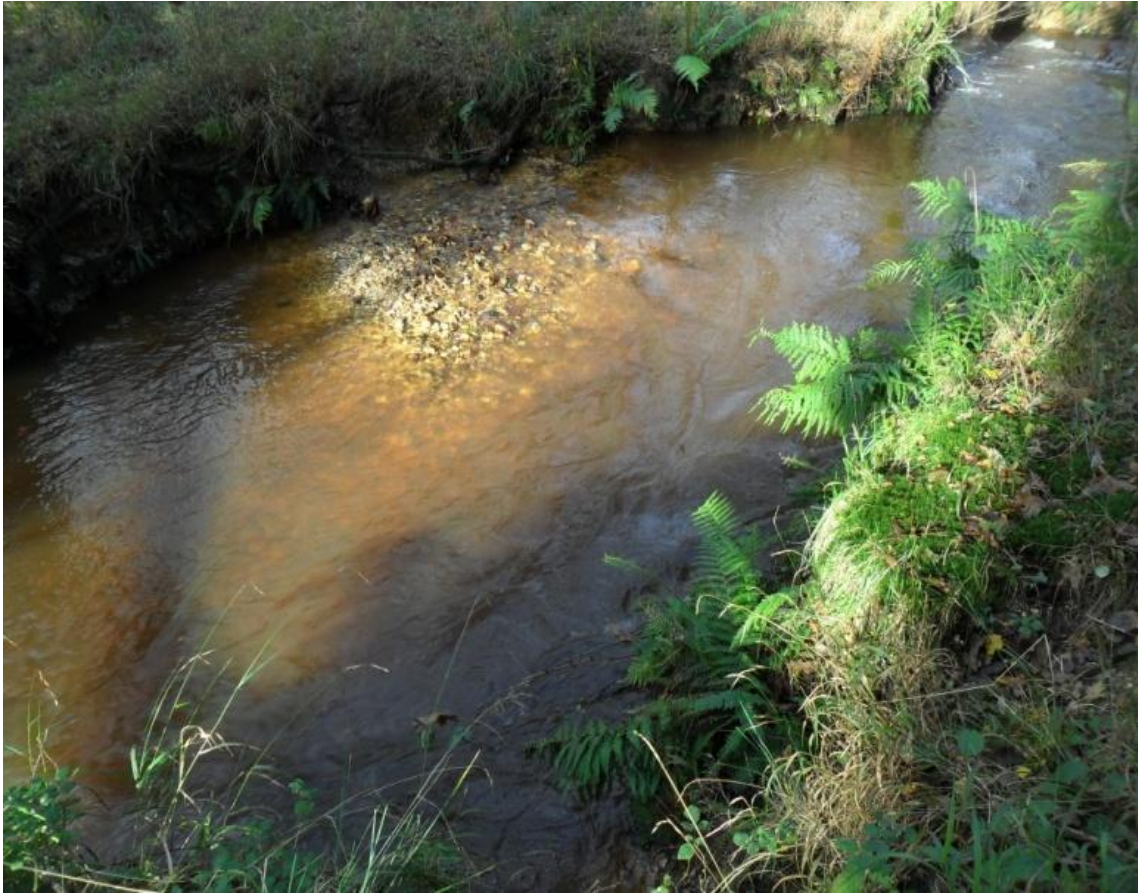
Gravel supply appears moderate and coarse sediment storage in the reach is minimal with few shoals apparent (Figure 1-8).

Figure 1-8: Local gravel shoaling

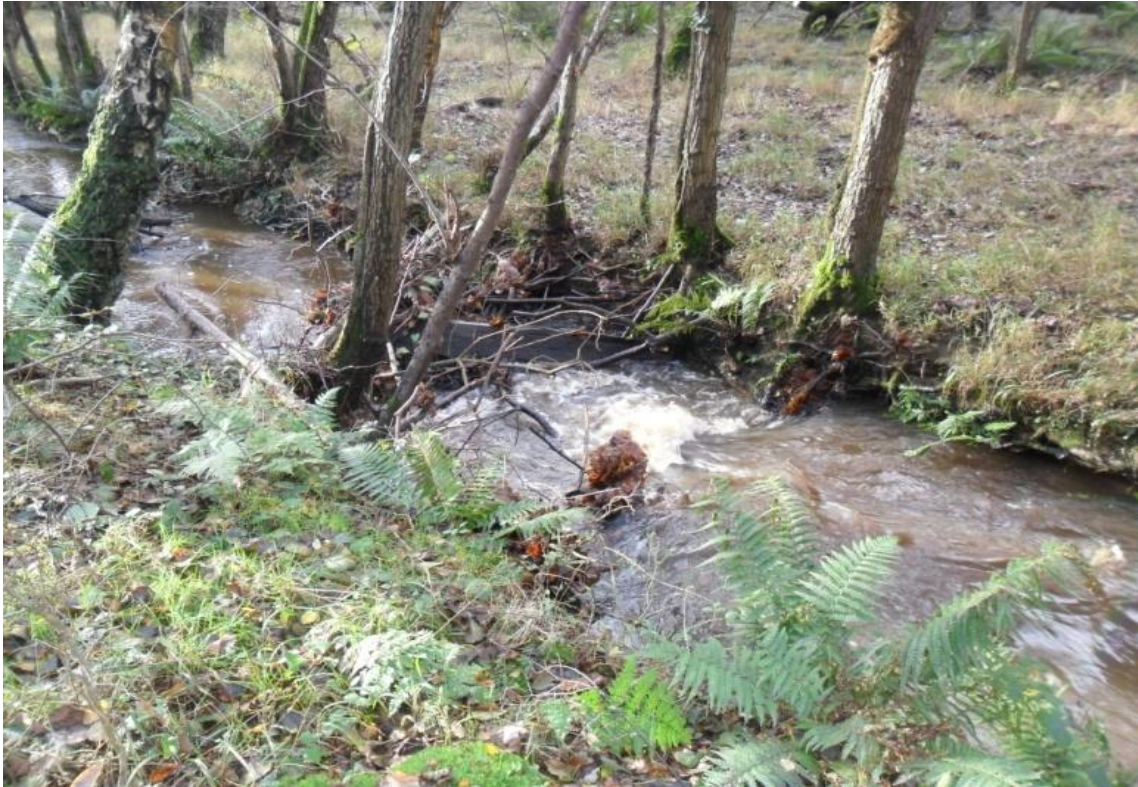
Figure 1-9: Natural woody debris jams

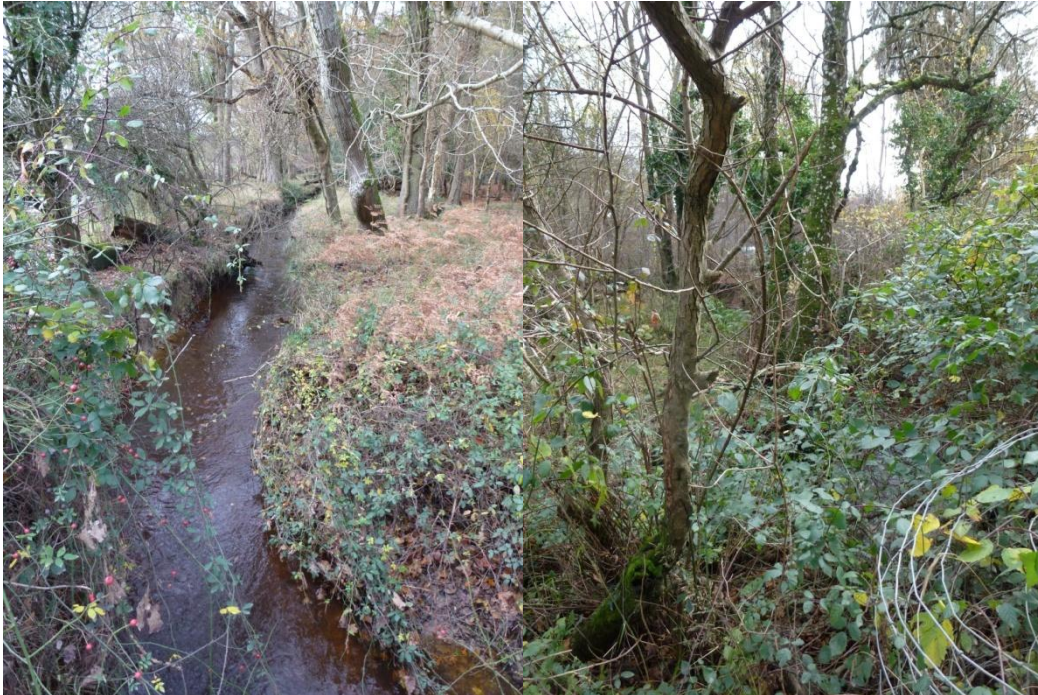
Figure 1-11: Spring Wood: East of Burley Lodge Lane (left) and West (right)

To the east of the lane to Burley Lodge, the woodland character is very different (Figure 1-10). Here the woodland floor is criss-crossed with drains which are now incised and flowing freely. The ground flora is more varied and the area is fenced-off from both people and livestock: indeed it is clear that the former are discouraged from entering the wood. The ground is very uneven and this leads to differential levels of waterlogging and all this has led to a greater variety in the ground flora here than upstream. Wood spurge *Euphorbia amygdaloides* is common here, especially near the Lyndhurst Road. Within this compartment the stream from Spring Wood (Black Water) is confined within a large drainage channel and eventually joins the Blackensford Brook channel (which is also straight) after it cuts its way along the designation boundary to its confluence with the Blackensford Brook at Dogkennel Bridge. In this area Alder *Alnus glutinosa* is the dominant woodland tree and there are a few palaeochannels as well as a large lawned area, separating two sections of woodland upstream on the Blackensford Brook.
