West Penwith Ecohydrological Investigation and Characterisation – Site Visit Report

Phase 3 2020-21

Natural England Research Report NECR402

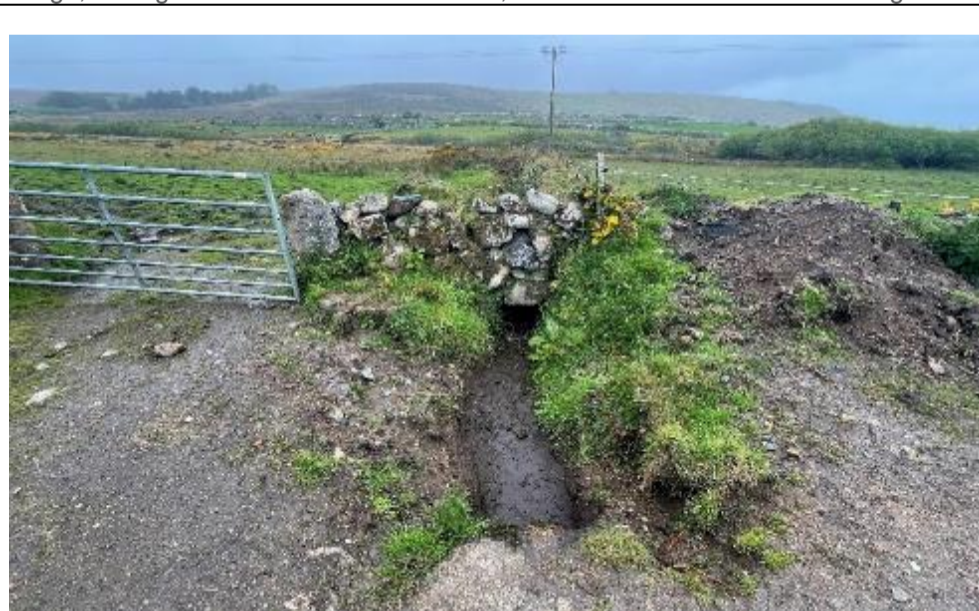
1.05 – Flow pathway leading from semi-natural rough ground on the right of the image, through the culvert under the track, to the mire on the left of the image.

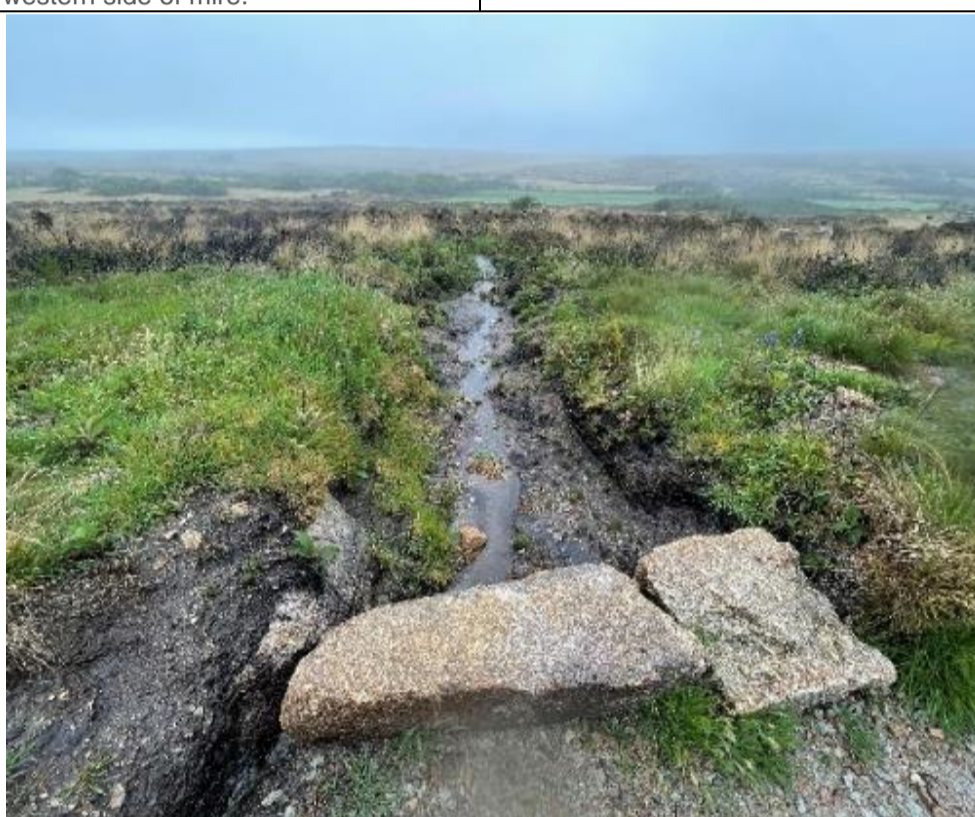
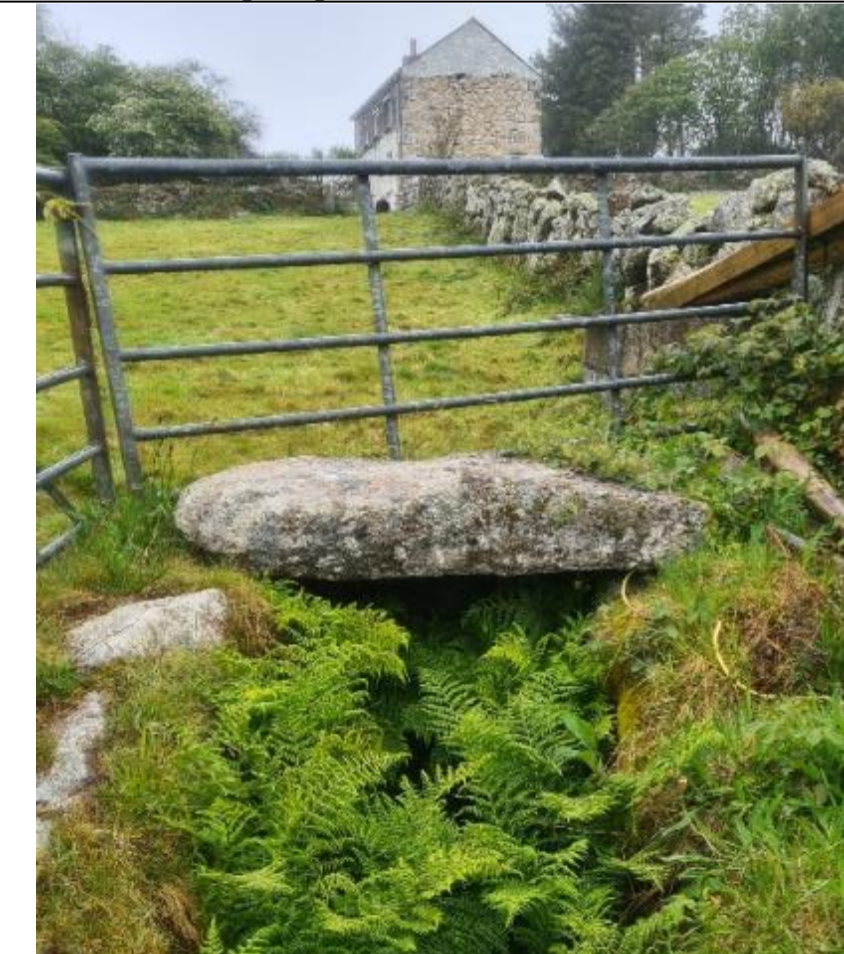
1.10 – Water flowing along track and down ditch towards the mire as an artificial flow pathway.

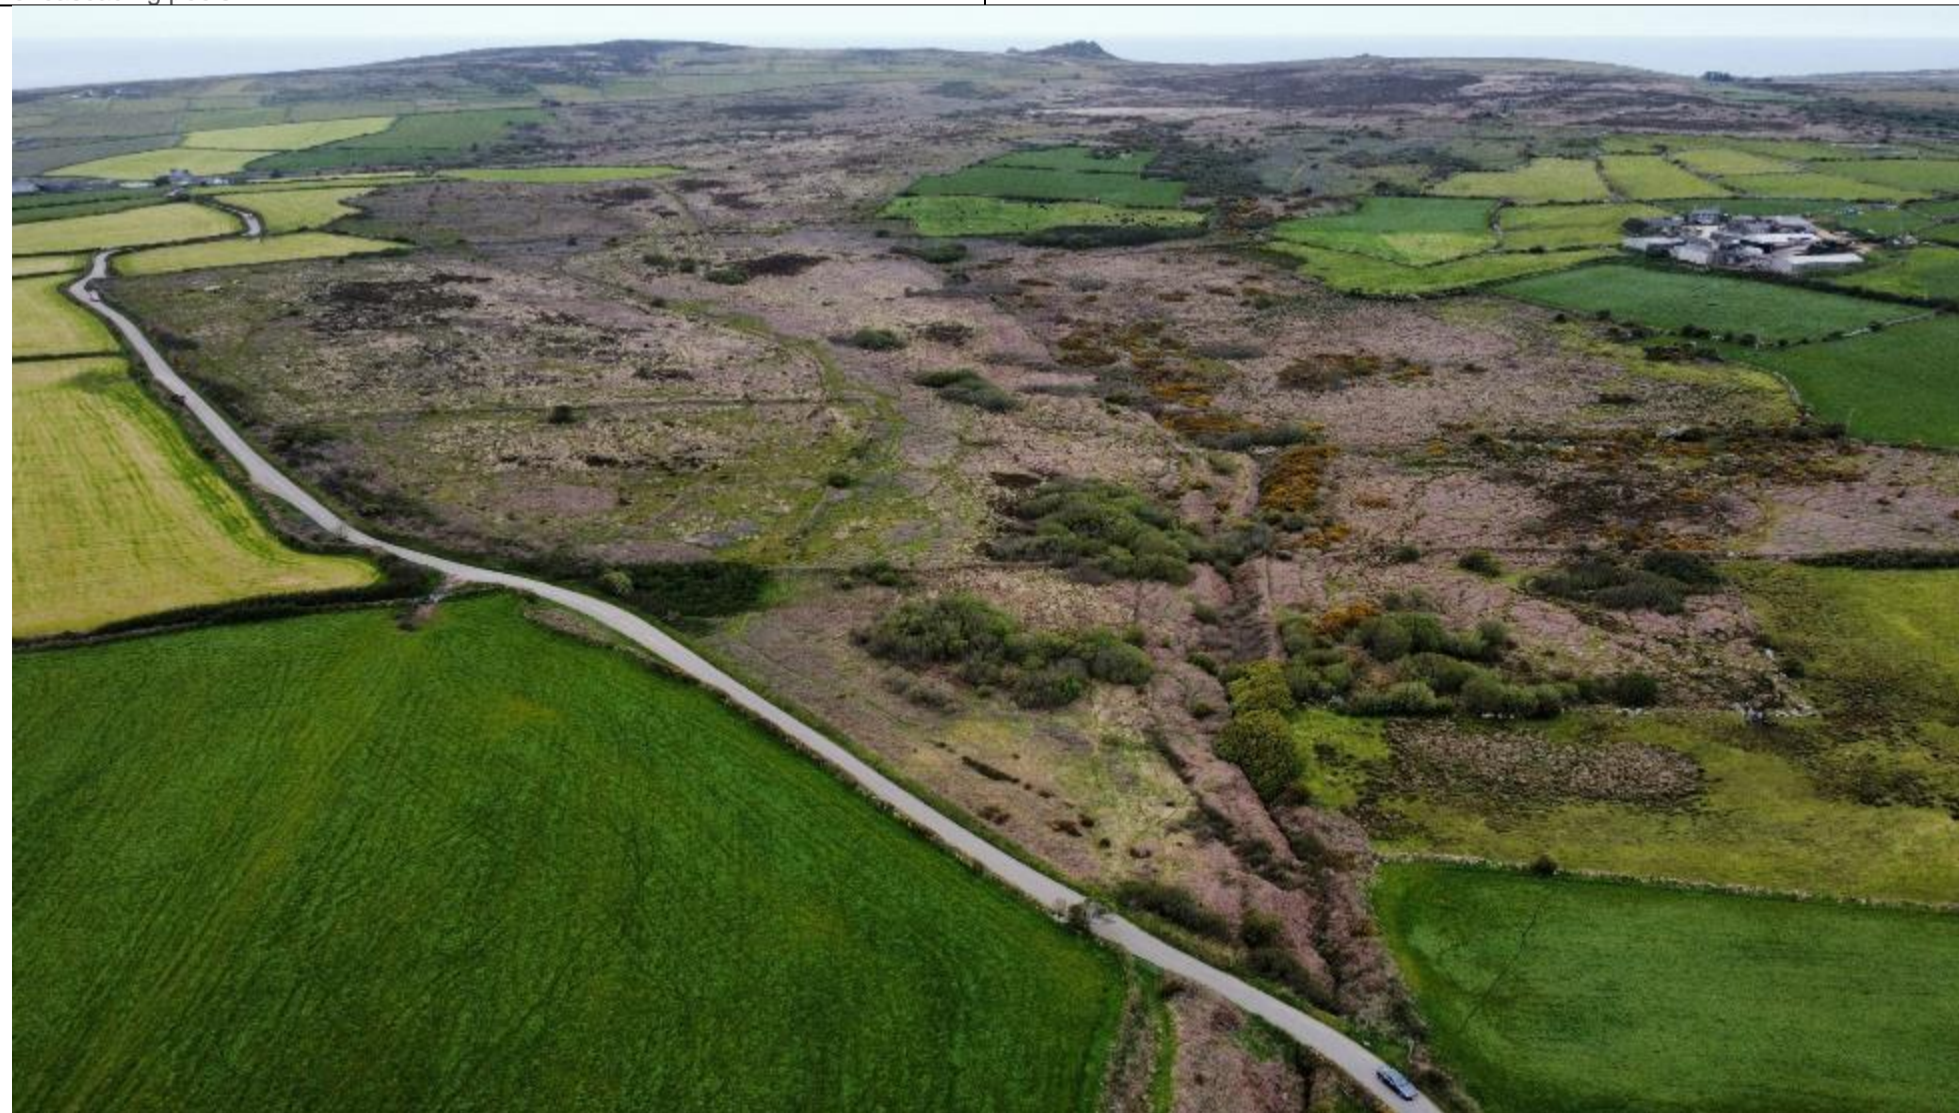
2.14 –UAV photograph of Bosiliack catchment flying north, upstream along the watercourse. Location of photograph not shown on map.

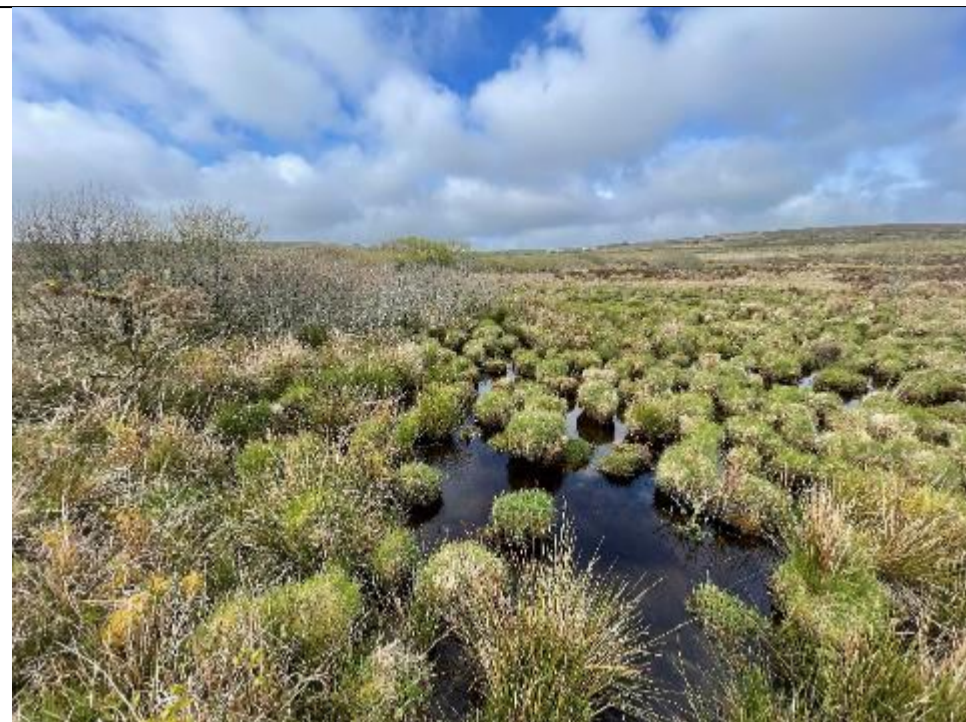
3.08 – View of artificially deepened and straightened watercourse to the south of mire habitat.

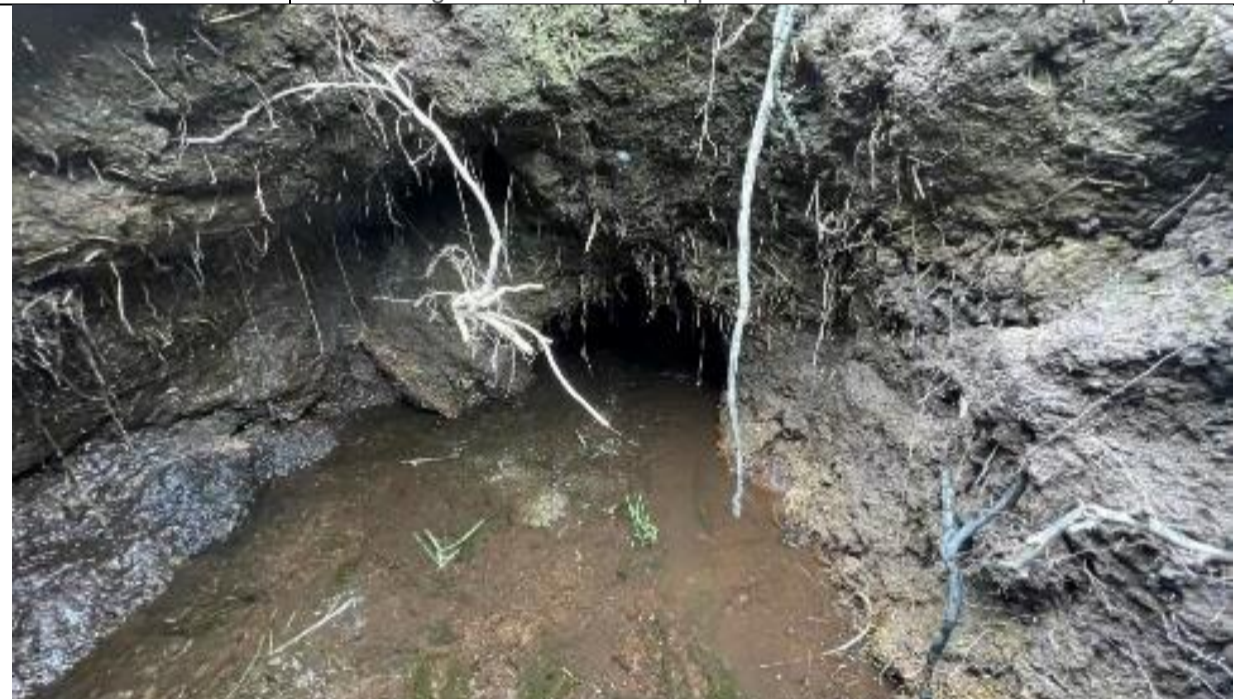
4.12 – Detail of large peat pipe from within chamber.

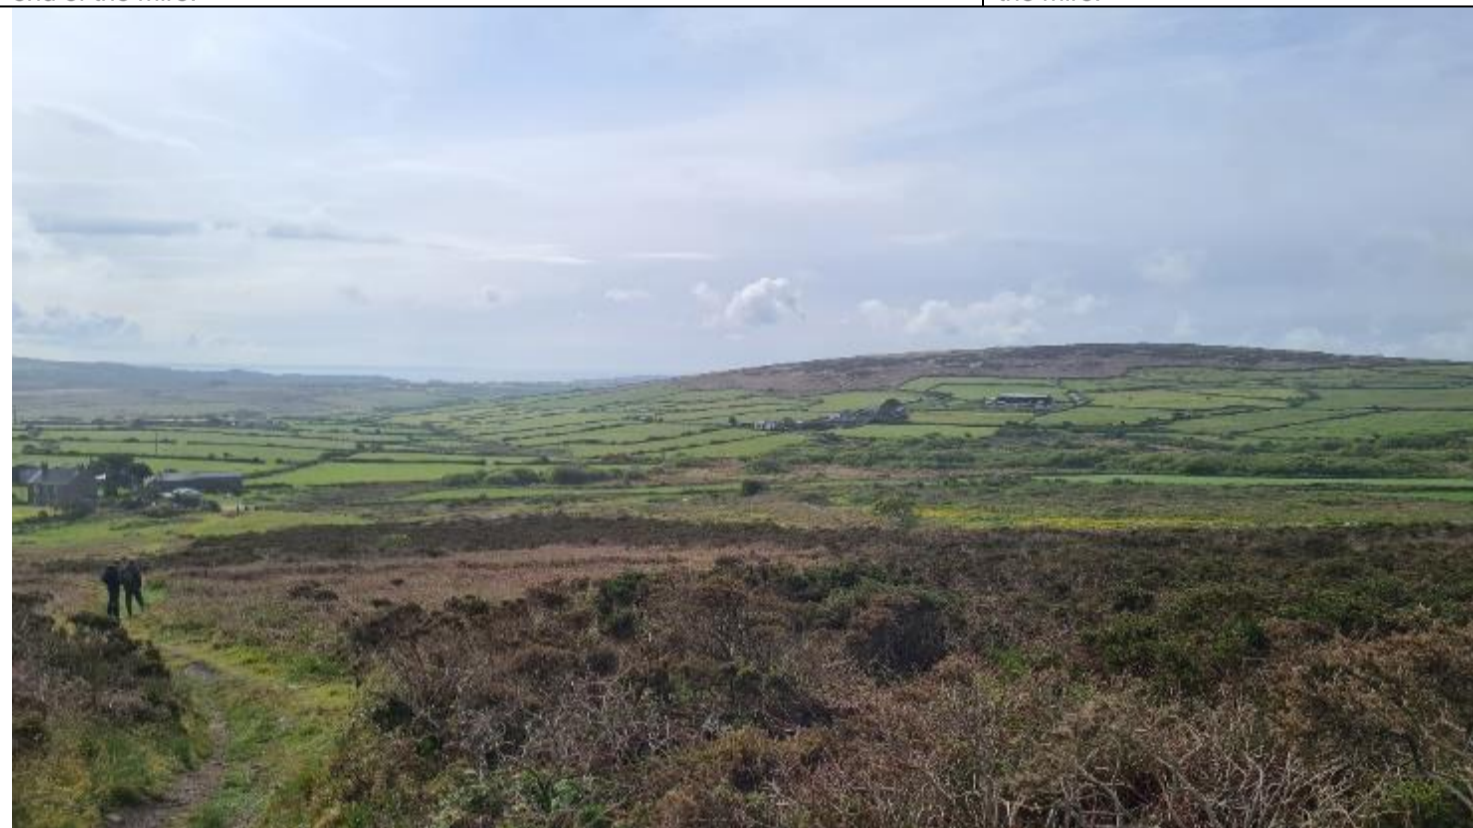
5.05 – Flow pathway leading through semi-natural vegetation to Trehylls Farm on the left hand side of the photograph.

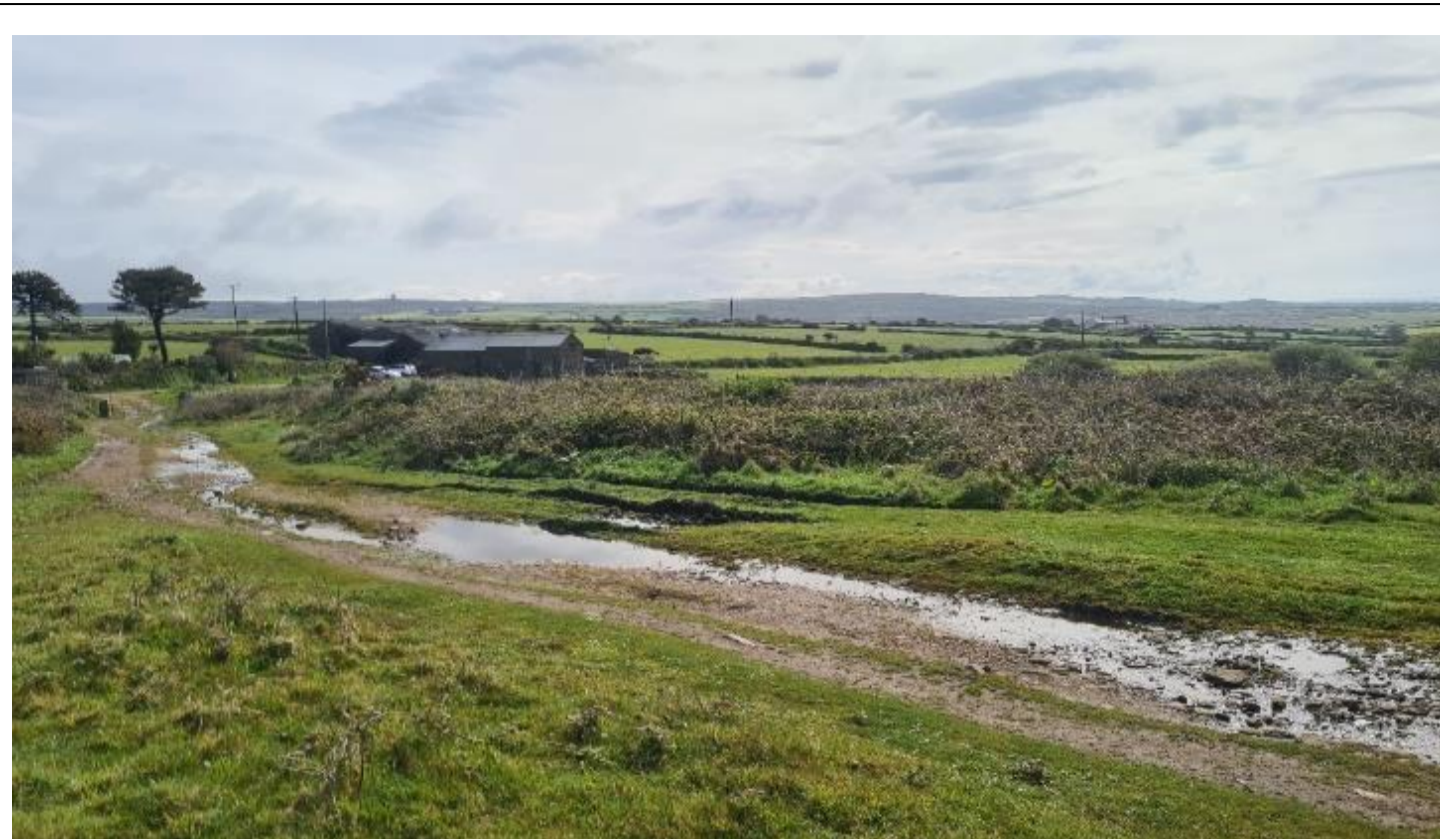
5.07 – Track intercepting water from northern flow pathways and redirecting it towards Trehyllys Farm.

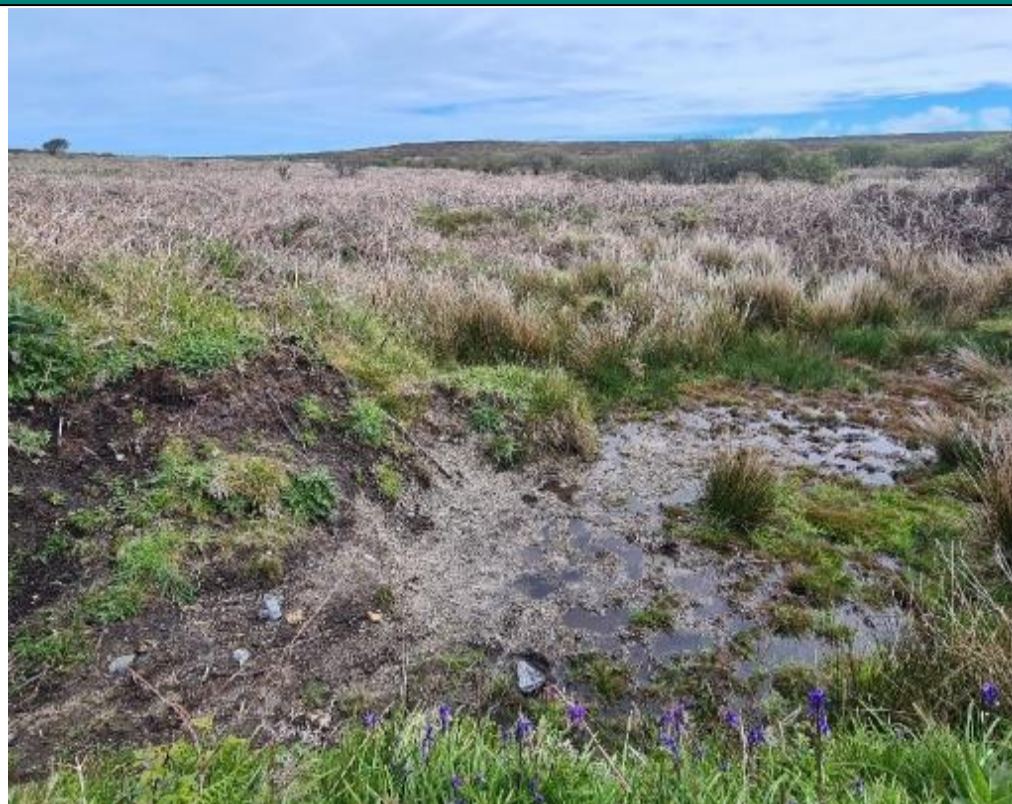
9.03 – Example of seepage feeding the northern mire habitat. The exposed profile on the left of the photograph reveals a top layer of darker peat organic material with lighter coloured gravels at the base of the profile at the height of the water table.

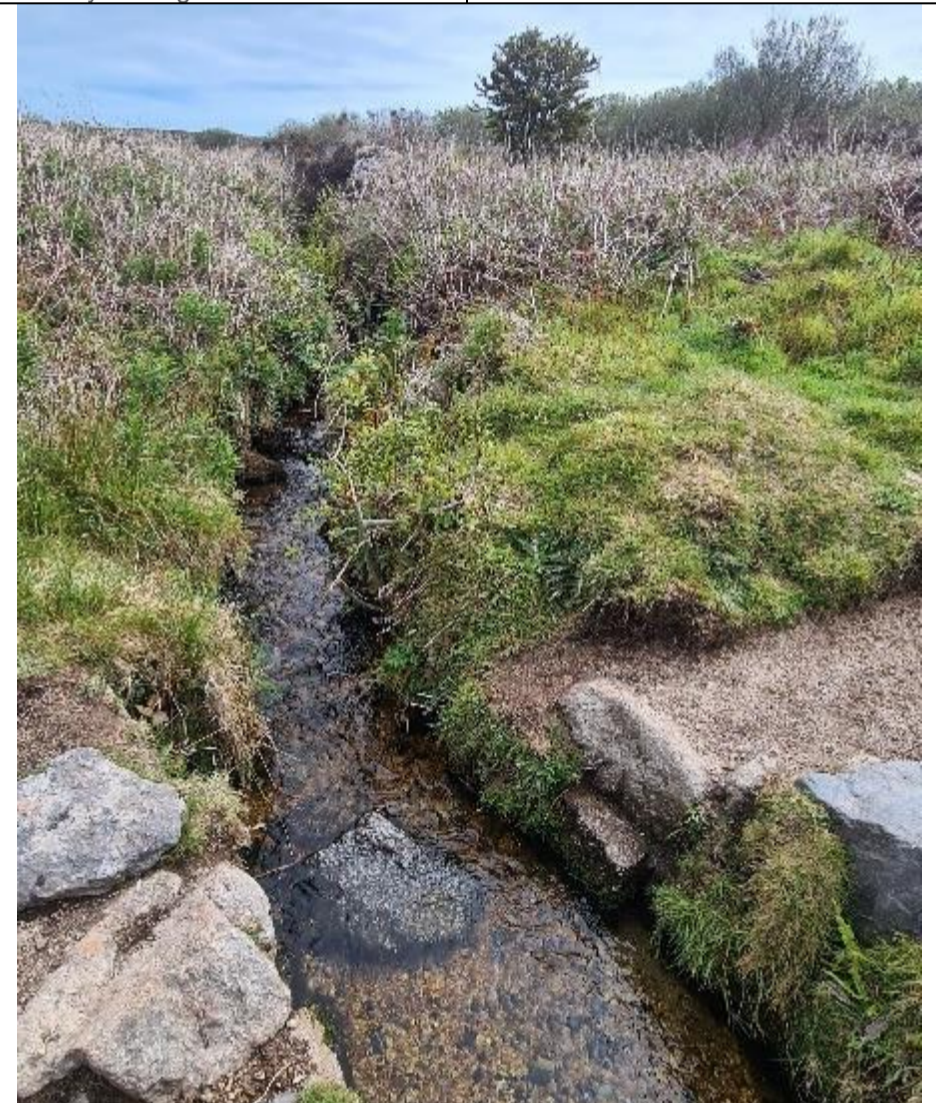
9.04 – Watercourse in the upstream section of the mire with drier bracken habitat on either bank. Photograph taken looking upstream highlighting the incised trapezoidal cross-section.

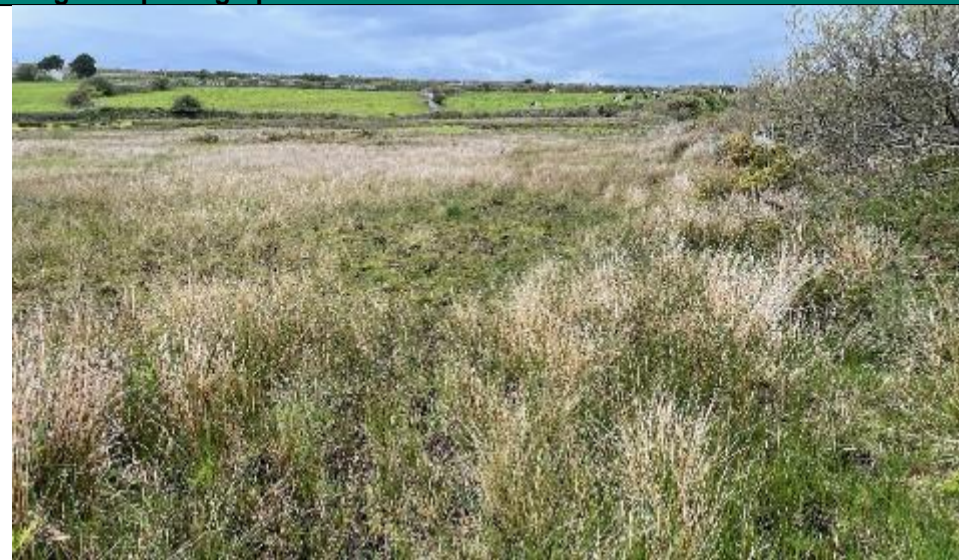
11.01 – Rush pasture in poor condition in the western section of the mire. Evidence of ground poaching by cattle.

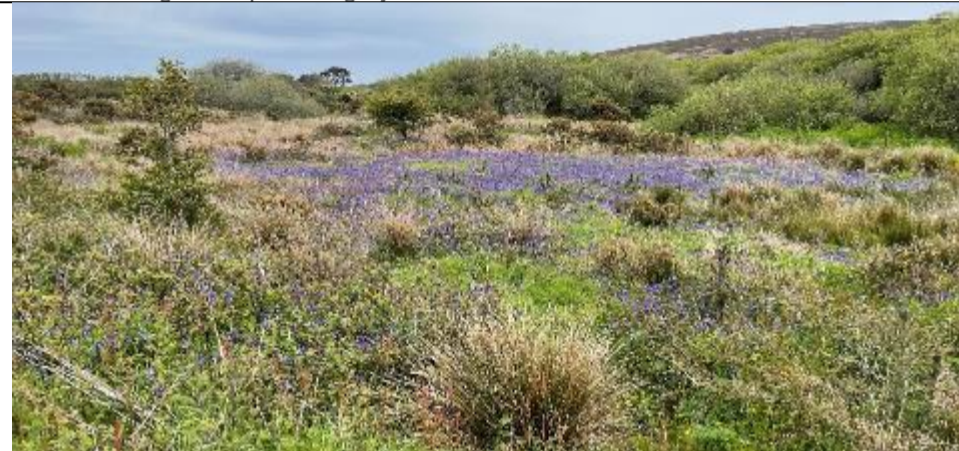
11.03 – Rush pasture in poor condition in eastern section of mire.

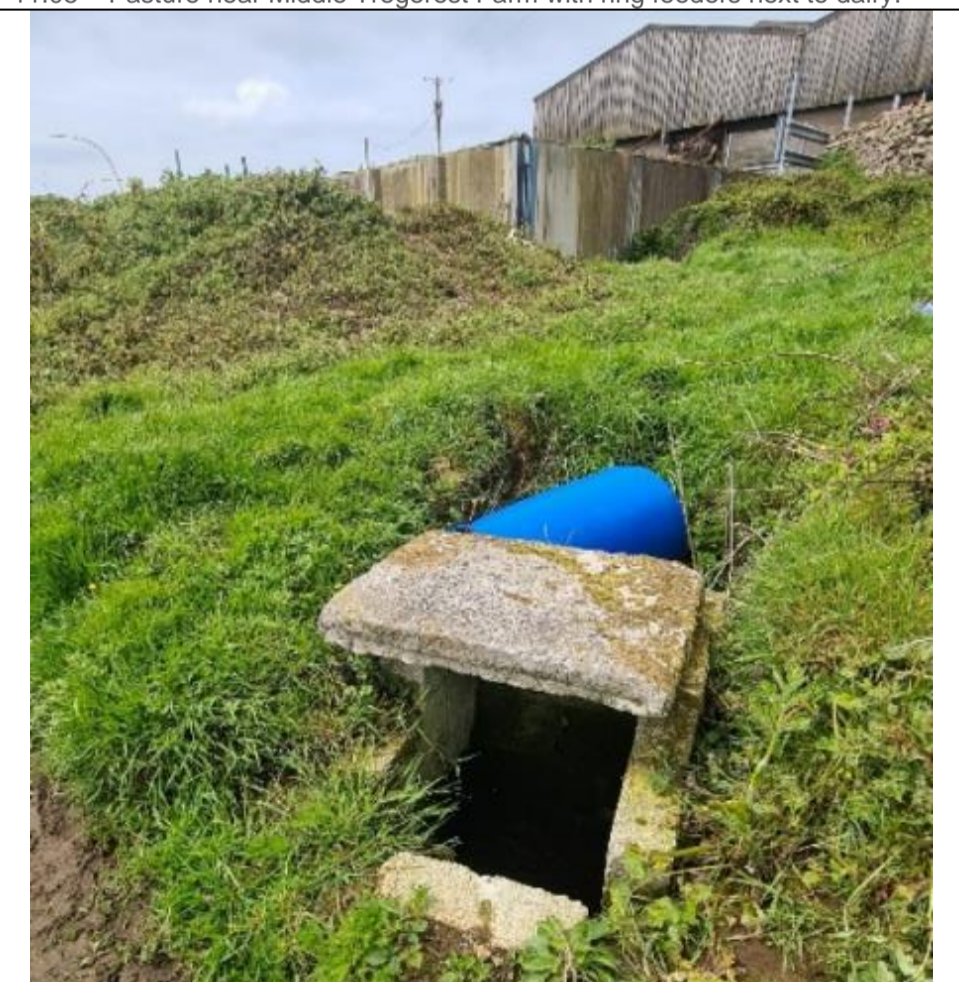
11.07 – Drain at bottom of slurry tank (slurry tank in background) with brown water dripping into an underground pipe.

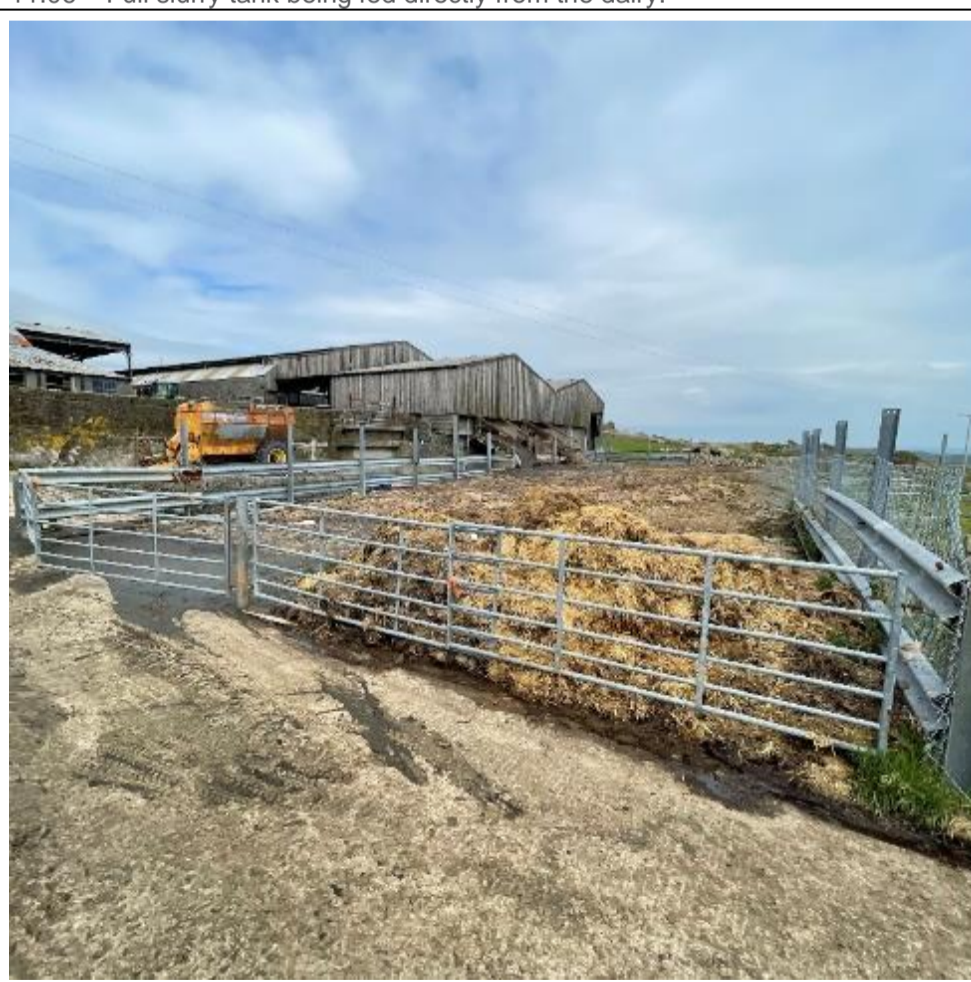
11.08 – Run-off from yard flowing towards fields.

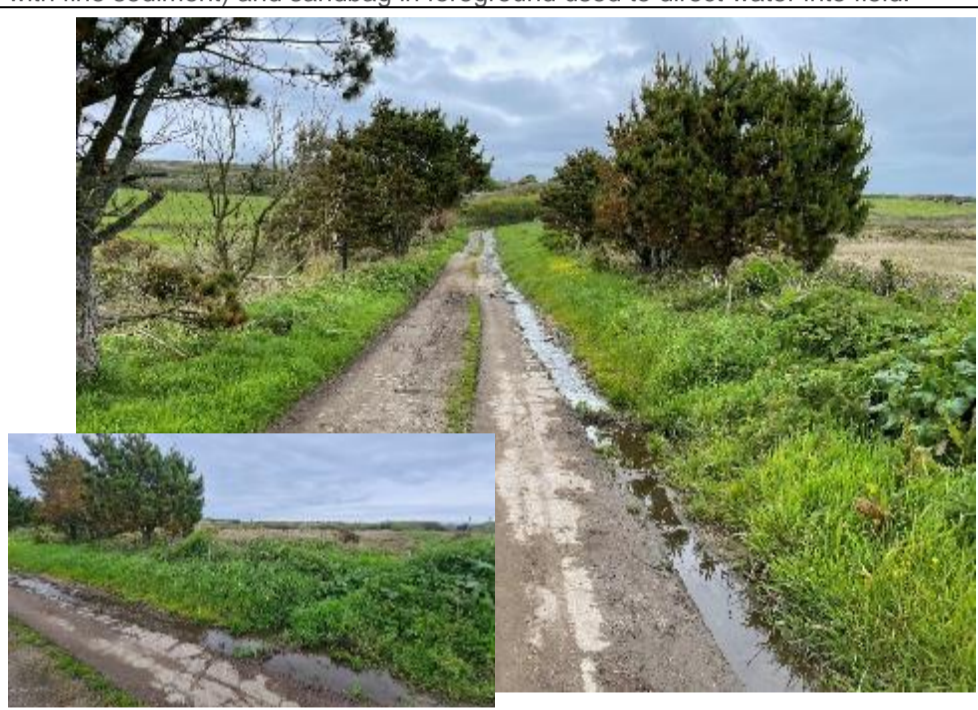
11.12 – Water from track flowing and into ditch (inset) that flows alongside mire habitat (pale vegetation in background).

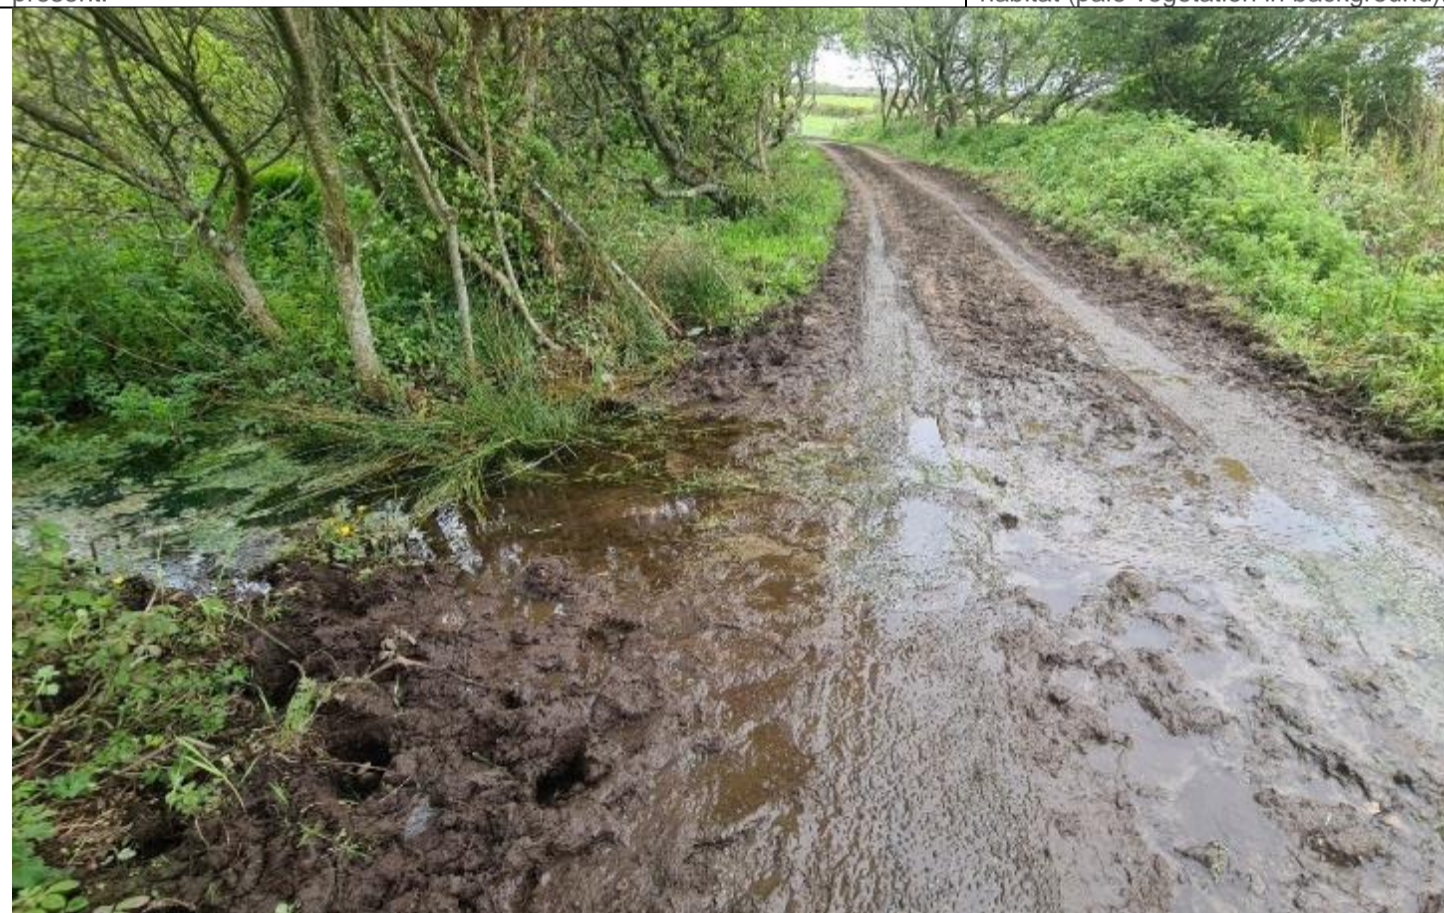
11.13 – Water from spring (behind trees to left of photograph) crossing track covered with farm material. Water leads to ditch that runs alongside the mire. Algae can be seen growing on the water to the left and on the track.
