# New Forest SSSI Ecohydrological Survey Overview

## Annex I: Soldier's Bog

First published 06 March 2014

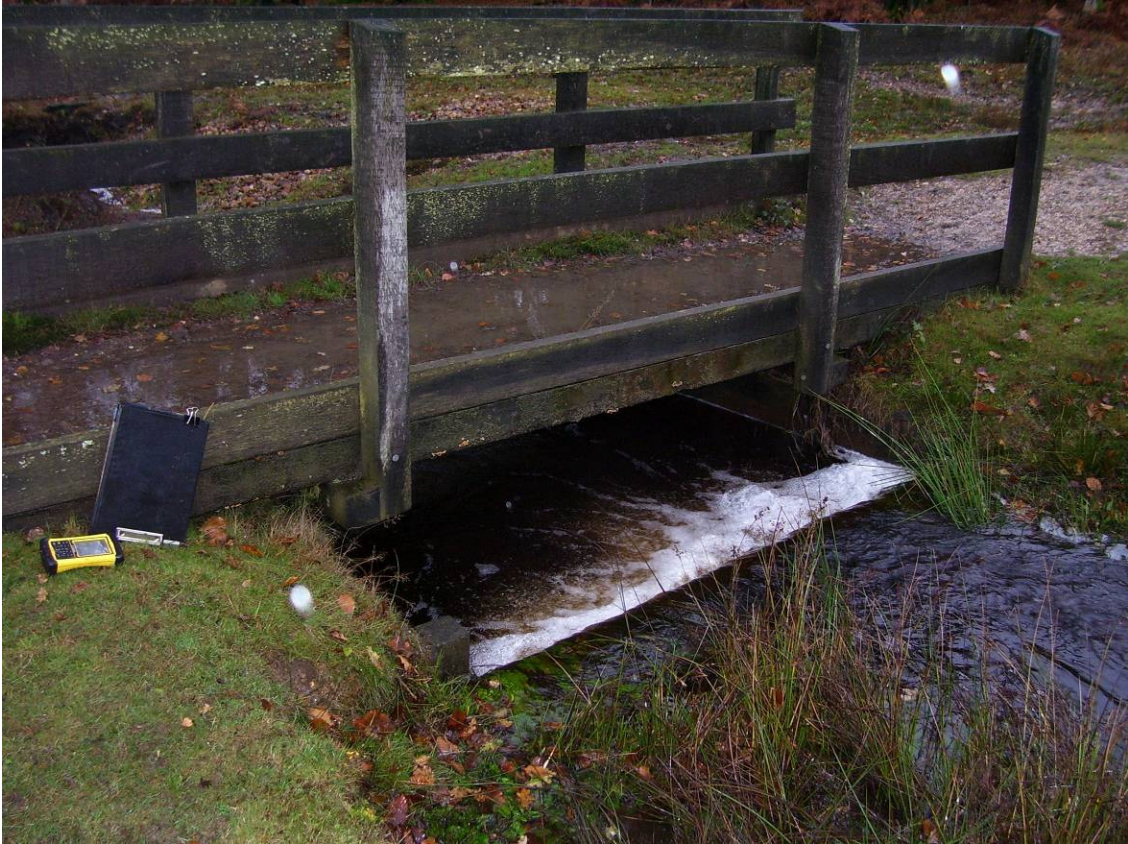
**Figure 1-3: Weir and footbridge near the southern end of the site (NGR 423054 107280)**

The southernmost stream segment has been straightened where it leaves the southern boundary of the site. Where the stream is crossed by a footbridge there is a small weir. The stream is fairly incised close to the southern boundary of the site and there is evidence of localised bank failure (Figure 1-4). It is understood that gravel has been artificially emplaced within the channel as part of restoration works, as discussed above.

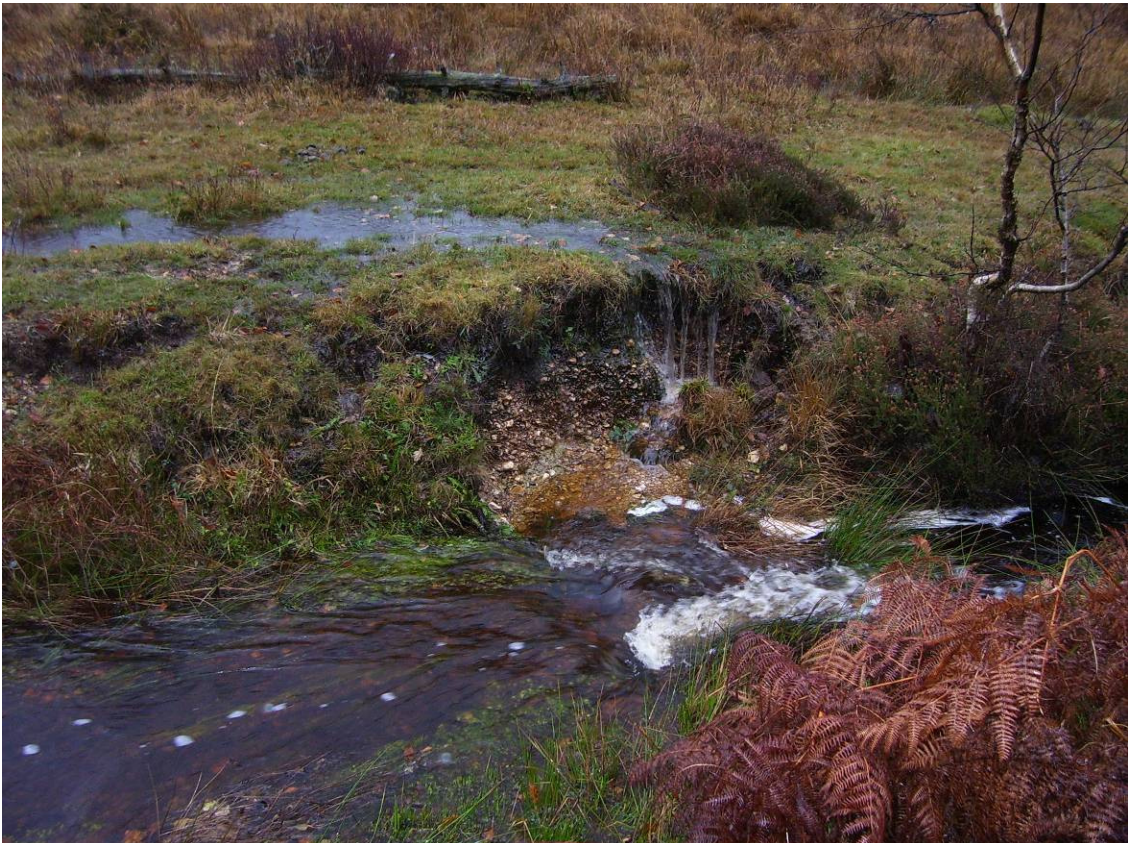
**Figure 1-4: View of main watercourse at southern end of site showing bank erosion (exposing alluvial gravels) and also surface runoff entering the channel (NGR 423063 107176)**

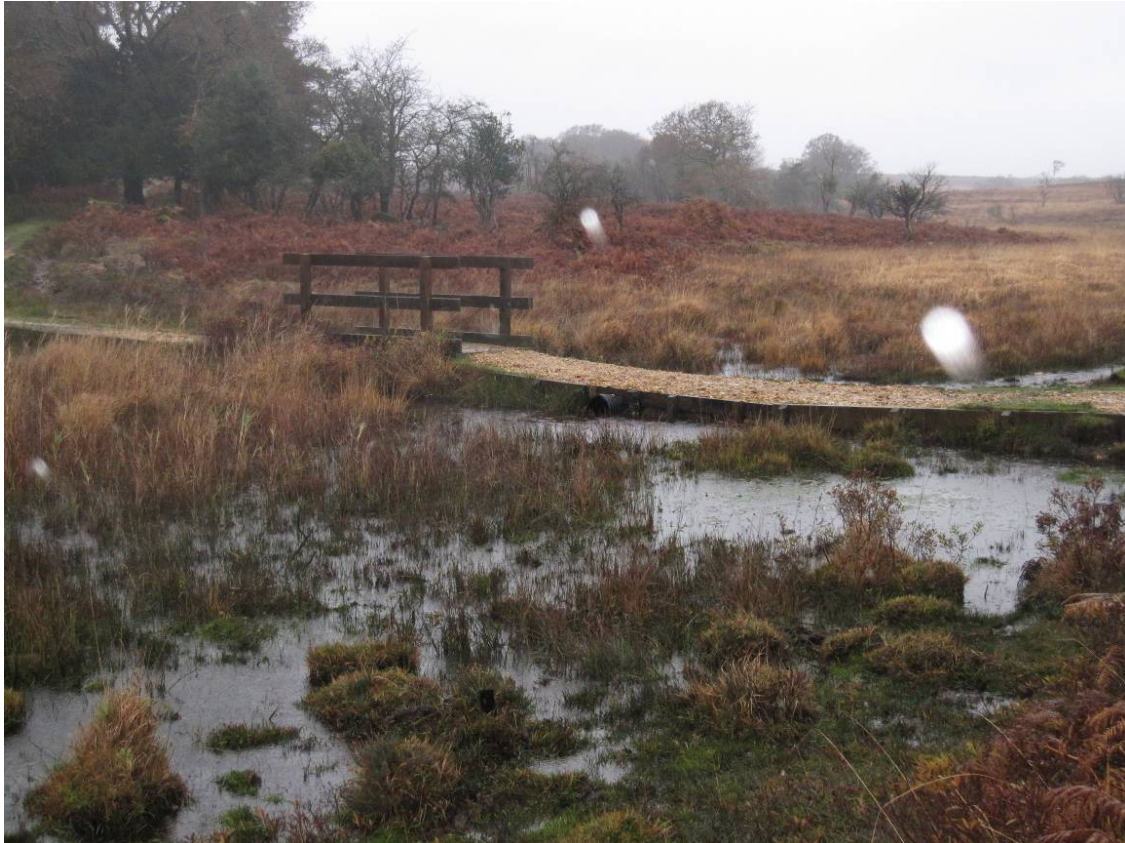
A number of footpaths cross the valley within this unit. Where the northernmost and central footpaths cross the stream, water has ponded significantly with the metalled tracks and the undersized culverts acting as impediments to flow. The ecology of the habitats in these localised ponded areas has been significantly impacted upon, with valley mire and wet heath habitats being locally replaced by pools of standing water (i.e. the mire habitat has been

impacted through inundation). Within these pools, species including Bog Pondweed *Potamogeton polygonifolius*, a Water-starwort *Callitriche sp.*, Floating Sweet-grass *Glyceria fluitans*, Marsh St. John's-wort *Hypericum elodes*, Water Horsetail *Equisetum fluviatile*, Round-leaved Crowfoot *Ranunculus omiophyllus* and Floating Club-rush *Isolepis fluitans* are present and these habitats resemble those of the soakways (M29). Footpath erosion is a localised issue in the unit, often associated with waterlogging, both upstream and downstream of the crossing points.

**Figure 1-6: Ponding of water around footpath**

In localised areas around the two most northern footpaths in the unit (not shown in Figure 1-9), the tracks and current culverts appear to be causing an impediment to water movement down the valley. This has led to ponding of water on the ground surface up and downstream of the footpaths, leading to a replacement of wet heath and valley mire habitat with standing water and a bog pool-type community. In order to remove this impediment to flow and allow the wet heath or mire habitats to redevelop, consideration should be given to modifying the footpaths and culverts, for example through creating boardwalk sections or by upsizing the culverts.

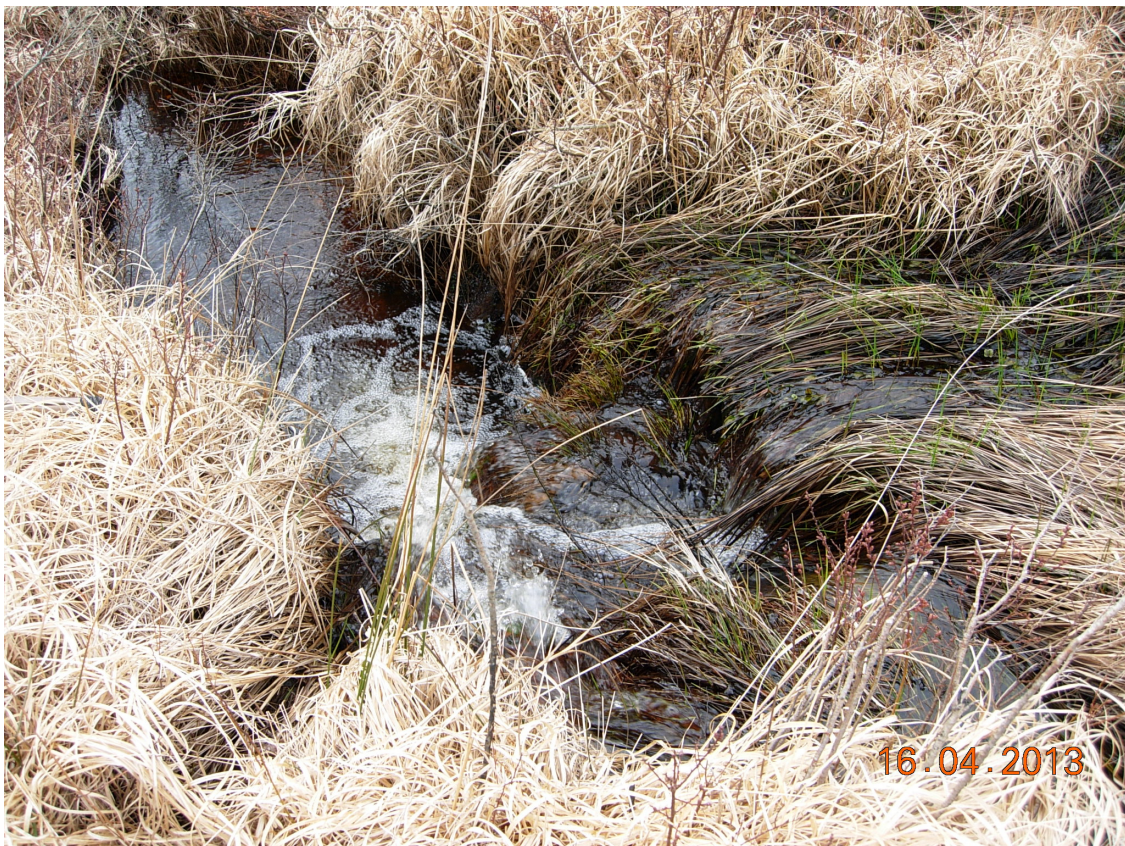
A small knick point (c.0.2 to 0.3 m high) is present within the lower part of the stream system (Figure 1-7). This knick point was not observed during the main site walkover (probably as a result of high water levels) but was noted in a preliminary visit undertaken by JBA and Natural England staff. The eastern side of the channel has a spoil bank running along much of its length (Jennifer Thomas, Natural England, pers. comm. 23rd April 2013), suggesting that artificial drainage activity has been undertaken in the past. On the eastern side there is "extensive tussocky growth of *Molinia*, which is often indicative of rapid changes in water level commonly associated with drainage. By contrast, on the western side...are extensive areas of open water and bare peat indicating erosion of mire vegetation." (Jennifer Thomas, Natural England, pers. comm. 24th April 2013).

**Figure 1-7: Eroding knick point (approximate NGR 422960 107490; photograph courtesy of Jennifer Thomas, Natural England)**

The small knick point described in Section 1.4 cuts into an area of swamp (with fringing mire) in the southern part of the site (see Figure 1-9 for location). It is a small feature and has thus far done little damage. However, it would be prudent to take measures to prevent it from growing in size and extending upstream. Such measures could take the form of staked heather bales within the channel and/or channel infilling/re-grading.

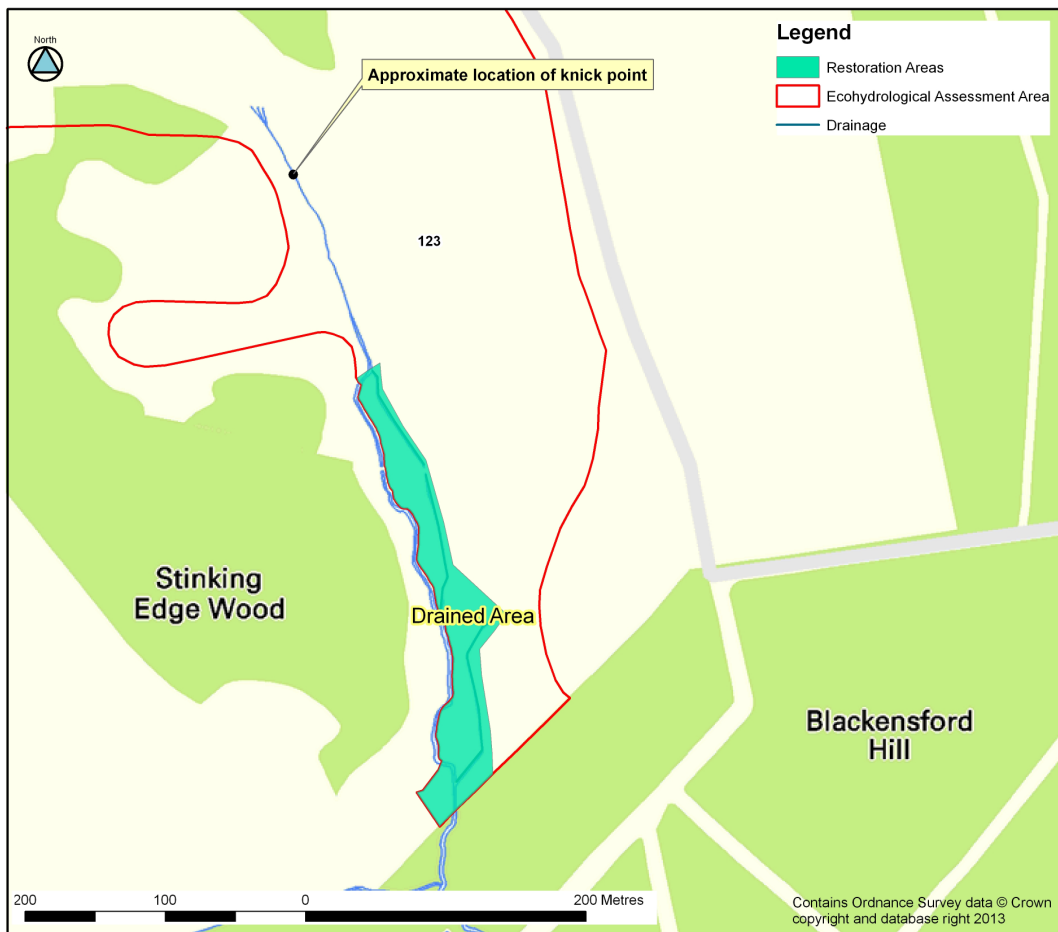
Figure 1-9: Restoration Areas Map (N.B. footpath modification areas not shown - see text)

There is one area in the southern part of the site in which straight drainage channels have been cut, probably to improve the land between the drains and the main watercourse for grazing (see Figure 1-9). Here valley mire is replaced by wet dwarf shrub heath and marsh/marshy grassland. The area is still wet (i.e. the drains are not very effective), and represents only a small proportion of the total area of the site. However, blocking or infilling of the drainage ditches could be considered as a means of restoring wet heath or valley mire in this location, through increasing ground water levels locally.
