Natural England Commissioned Report NECR140

# New Forest SSSI Geomorphological Survey Overview

**Annex P: Wootton Riverine Woodland - SSSI Unit 539**

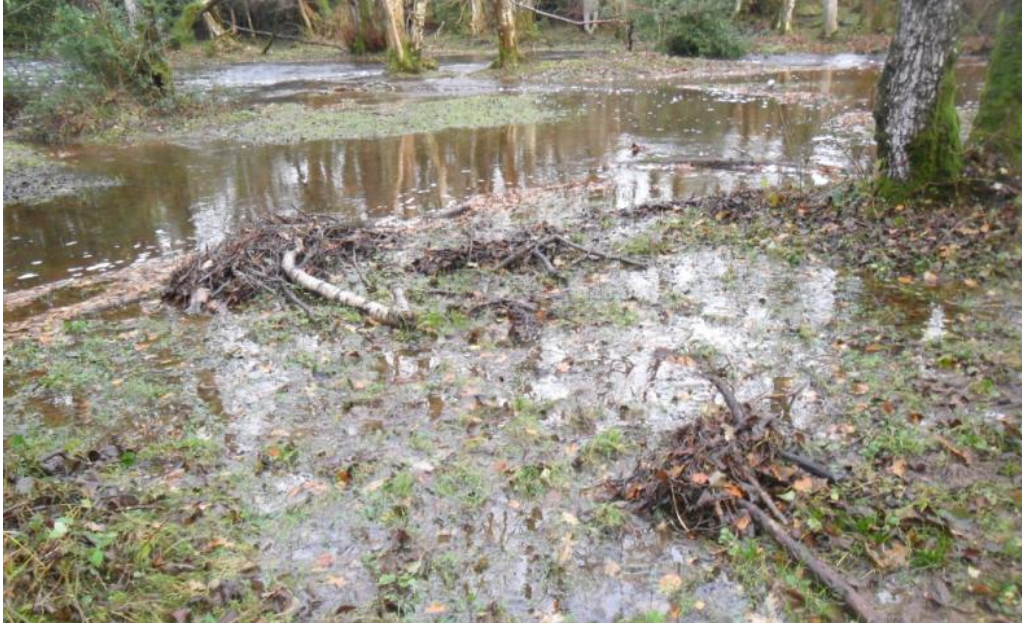
The Wootton Riverine Woodland SSSI unit 539 may be broadly characterised as a lowland mixed single thread system (Figure 1-2) with some higher flow anastomosing evident (Figure 1-3 and Figure 1-10 - A). The channel has a moderate gradient and is actively transporting gravel resulting in local erosion and deposition. It has also been subject to major channel straightening in the past, altering the nature and functioning of the river (Figure 1-10 - B). This has concentrated flows in a single channel leading to increased erosive energy. The initial impact of straightening would have encouraged incision along significant lengths of the wooded watercourse which can instigate knick point development along tributary channels and drainage ditches. This was not apparent from the walkover survey in this SSSI unit.

Figure 1-2: Anastomosed channel type along the Avon Water

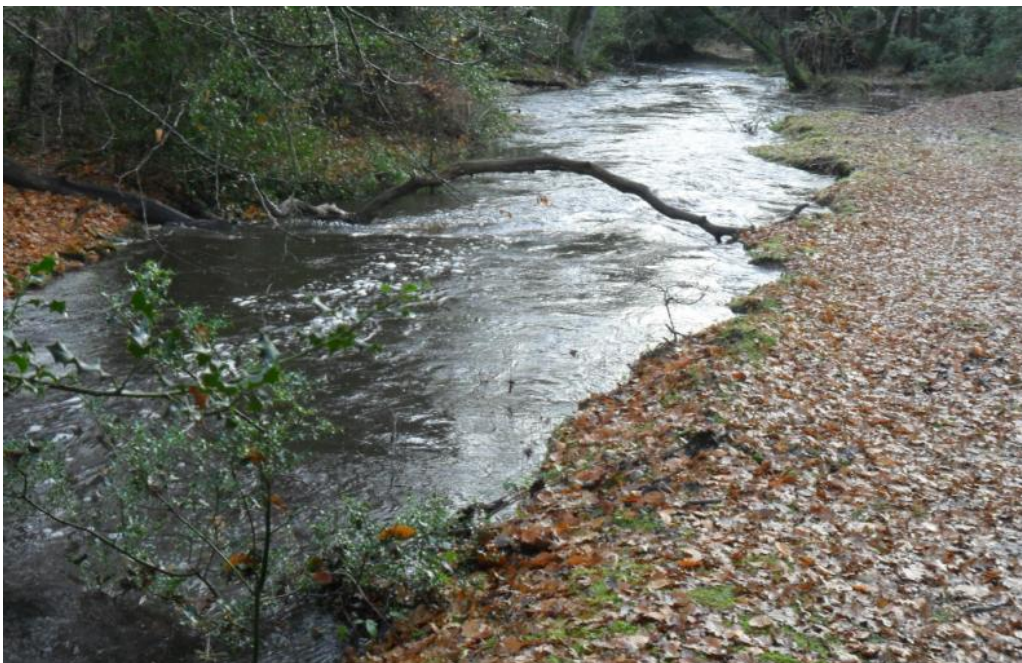
Figure 1-3: Active single thread channel type along the Avon Water

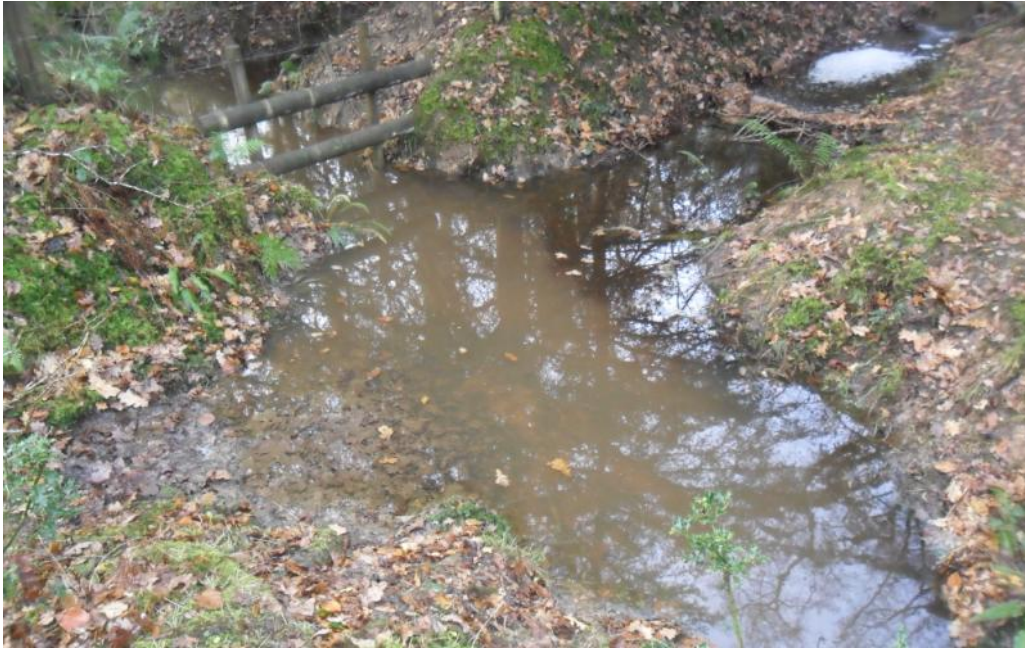
A large number of ditches drain forestry areas. Many of these were ponded and heavily silted (Figure 1-4). The degree of artificial drain creation is shown in Appendix A and is impacting significantly on the flow regime. Many of these drains have low embankments associated with them, often these run perpendicular to the main flow impacting on natural anastomosing processes and concentrating flow back into the main channel (Figure 1-5). More formal main channel embankments appear further upstream and are impacting strongly on natural channel functioning (Figure 1-6) and creating a strongly incised channel in the upper reaches of the

Figure 1-4: Silted drains entering the Avon Water

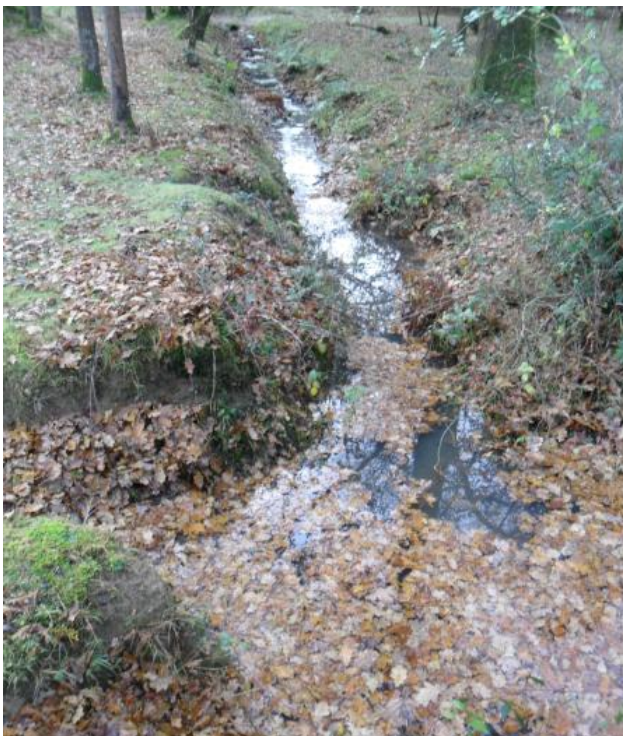
Figure 1-5: Embanked drains impacting on floodplain functioning

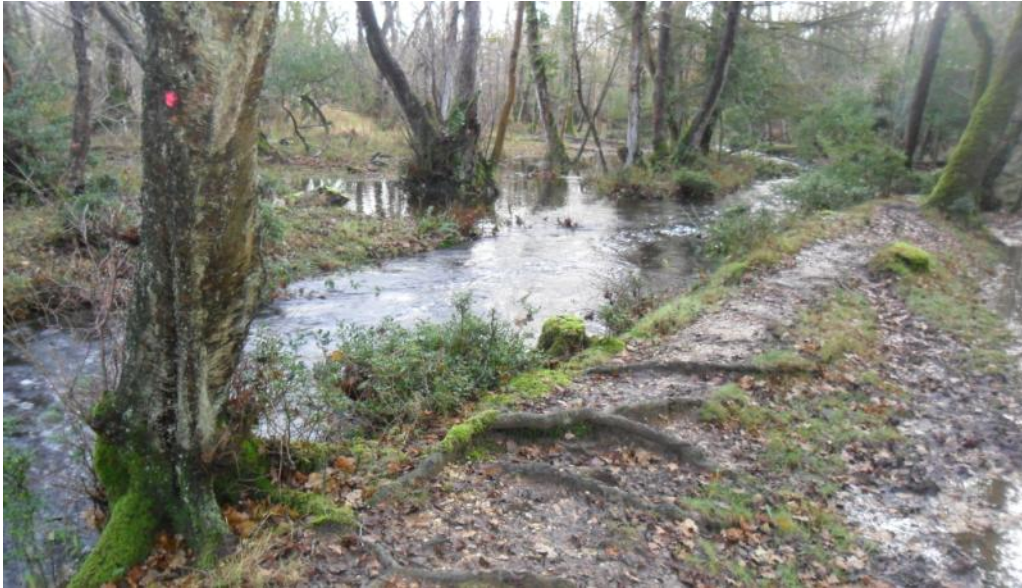
Figure 1-6: Main channel embankments altering channel-floodplain connectivity.

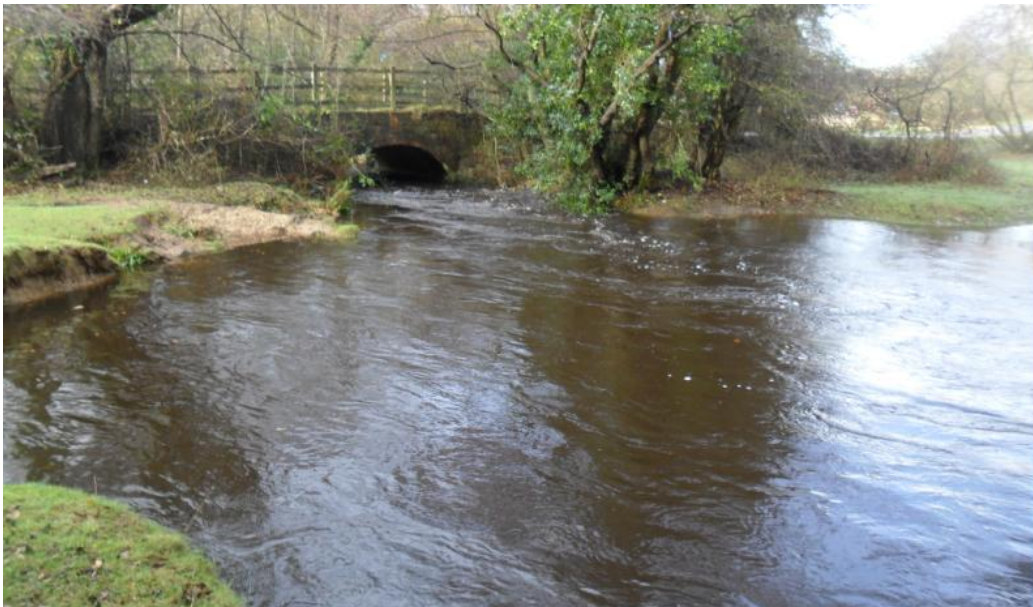
SSSI. Bridges and crossings are also altering the nature of the channel and floodplain locally, confining flow to a single often revetted channel and creating focussed scour problems (Figure 1-7)

Figure 1-7: Flow concentration and hydromorphic alteration at Wooton Bridge.

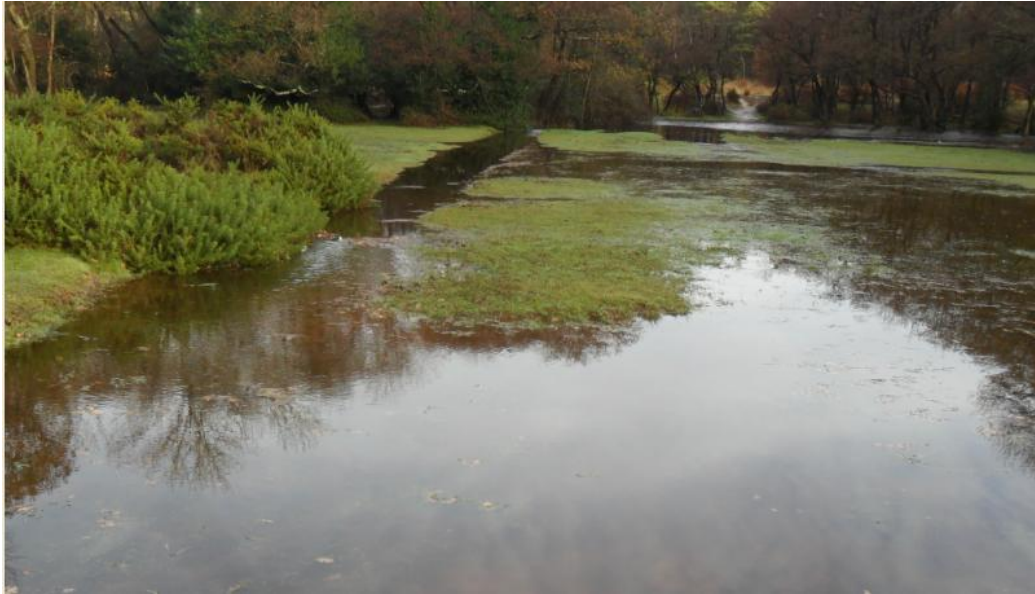
Surface and groundwater flows have also been altered as a result of the incision, infilling and spoil dumping (embankment creation). Some sections of the immediate floodplain have become drier than natural and these areas have generally been exploited for livestock linked to clearing of the riparian woodland (Figure 1-8)

Figure 1-8: Floodplain riparian woodland clearance along the Avon Water.

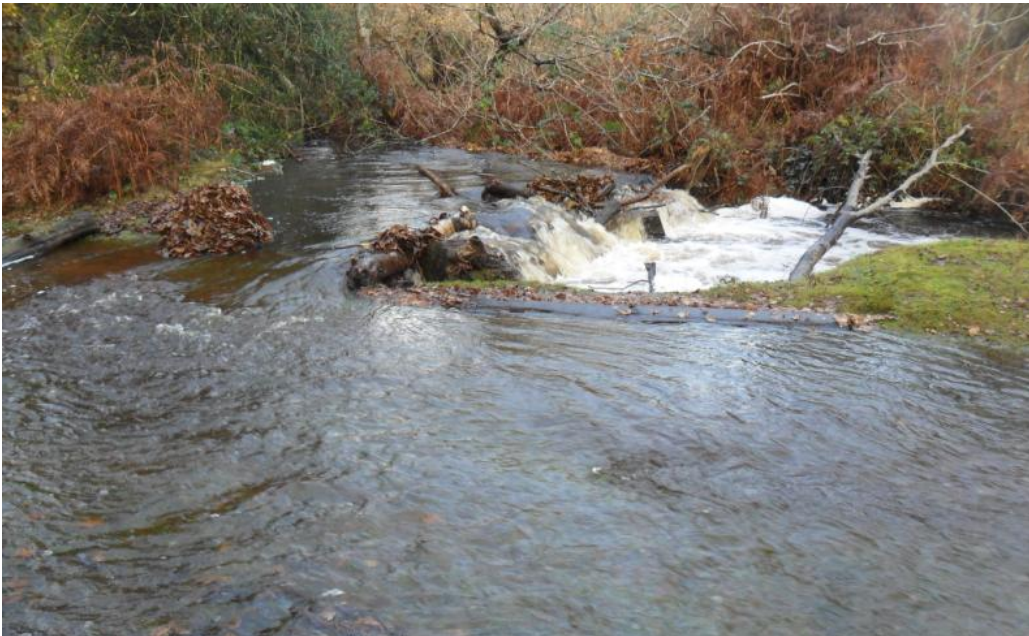
Previous restoration has occurred in the upper reaches with debris dam installation to encourage flow out of the main channel (Figure 1-9). These are presently functioning but look likely to suffer outflanking in the near future.

Figure 1-9: Introduced debris dams on the Avon Water.

Debris jams must extend into the adjacent banks to ensure longer term functioning.
