# Mapping of Seafloor Debris in Intertidal Seagrass, Solent Maritime SAC

September 2024

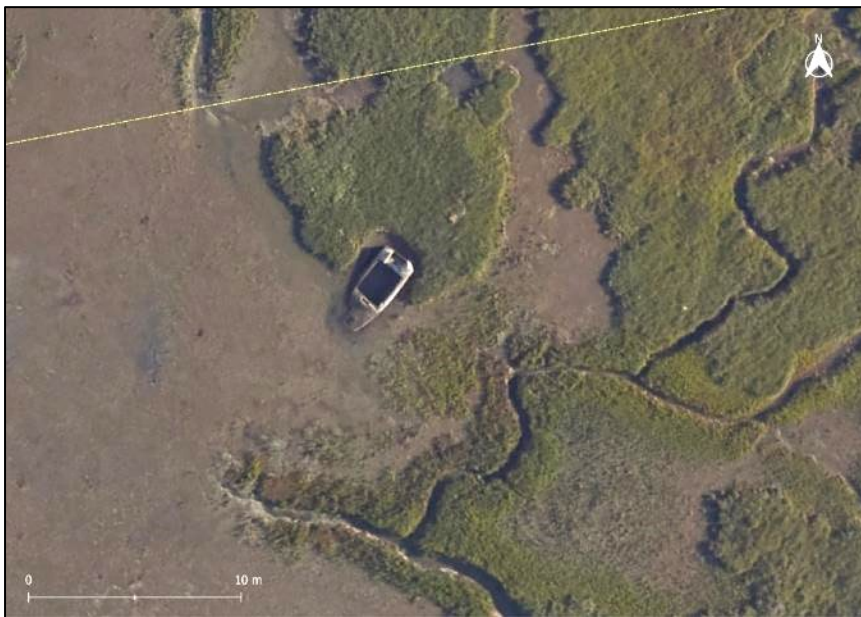
**Figure 8. Small abandoned boat in salt marsh. The boat actively erodes seafloor as evidenced in the image.**

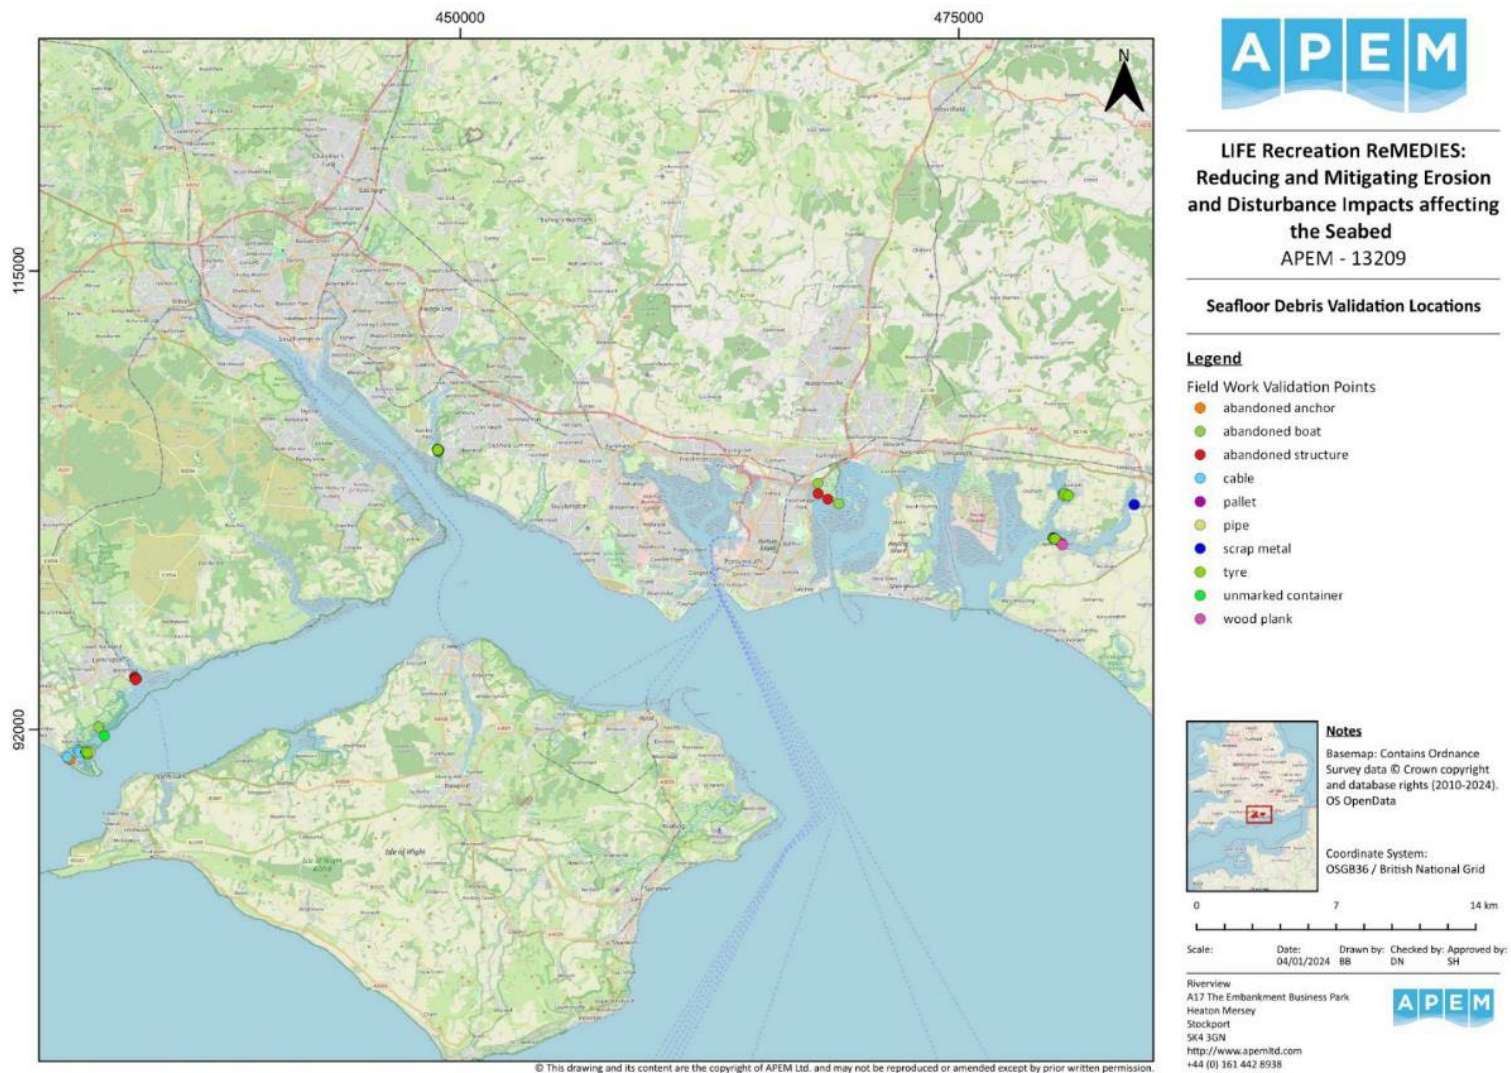
Figure 20. Field work validation localities.

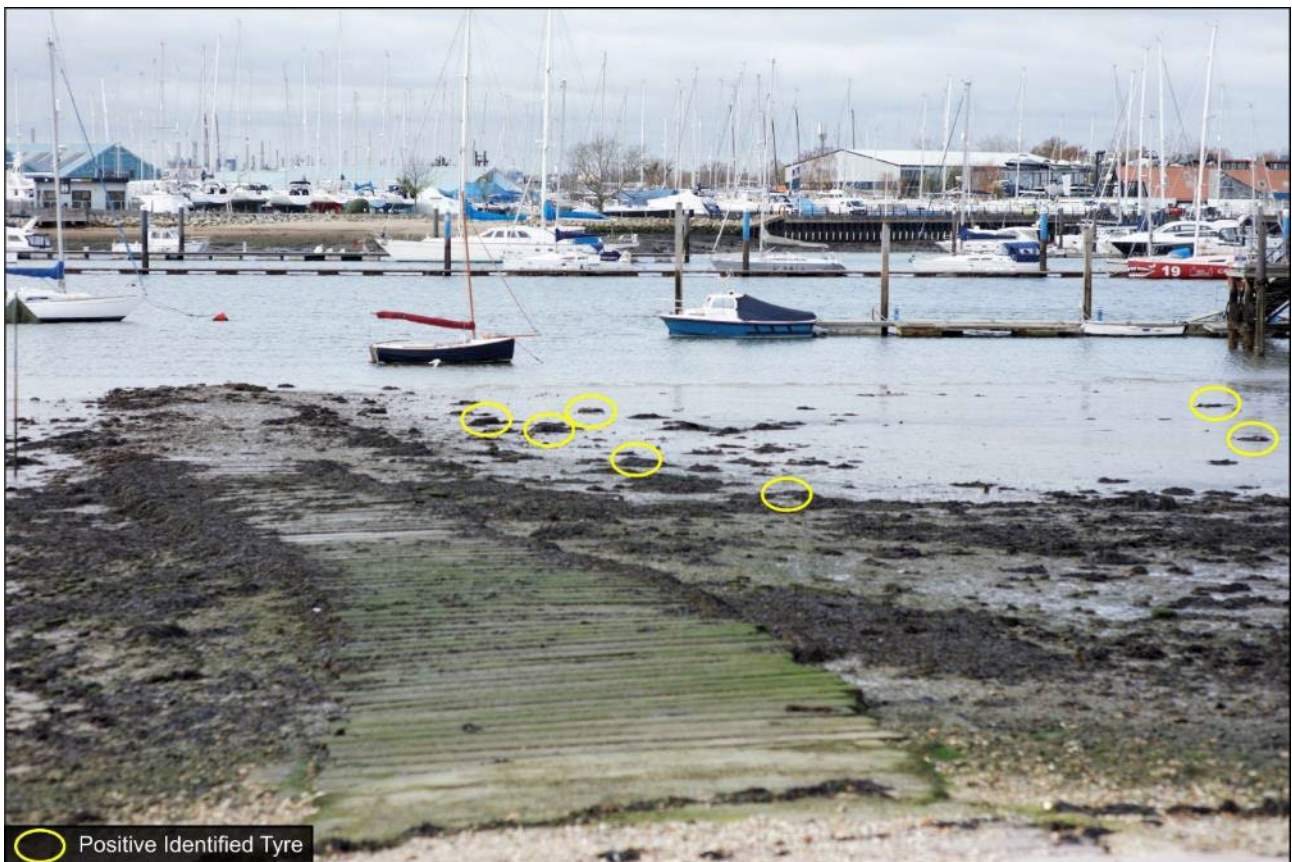
Figure 21. Overview of tyres identified from a photograph captured during the ground survey.
