New Forest SSSI Geomorphological Survey Overview

Annex B: Latchmore Shade Restoration Plan - SSSI Unit 48

1 Latchmore Shade Restoration Plan - SSSI Unit 48

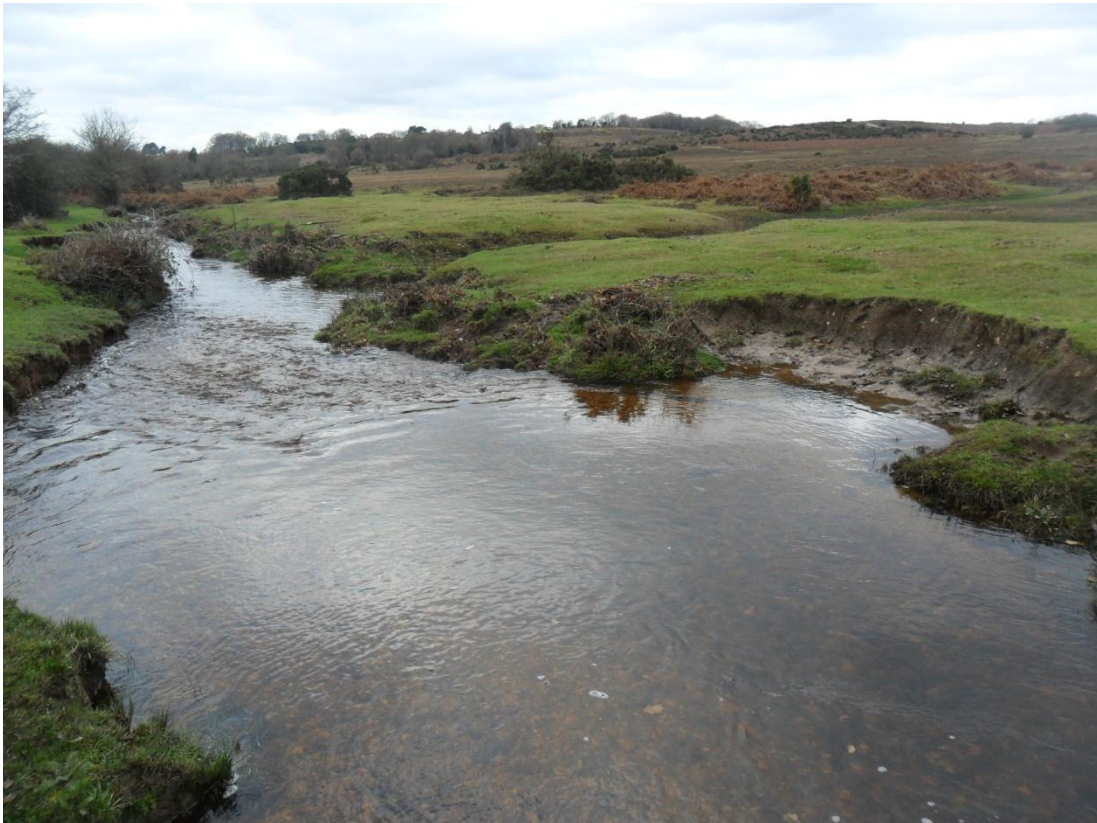
Figure 1-3: Mildly incised single thread reach of Latchmore Brook SSSI Unit 48.

- A weakly anastomosing lower course characterised by a wooded local floodplain and multi-channel flow network (Figure 1-2).
- A single thread, mildly incised channel running through floodplain woodland with disconnected palaeo-channel features including a well defined sinuous single thread channel on the left bank (Figure 1-3).

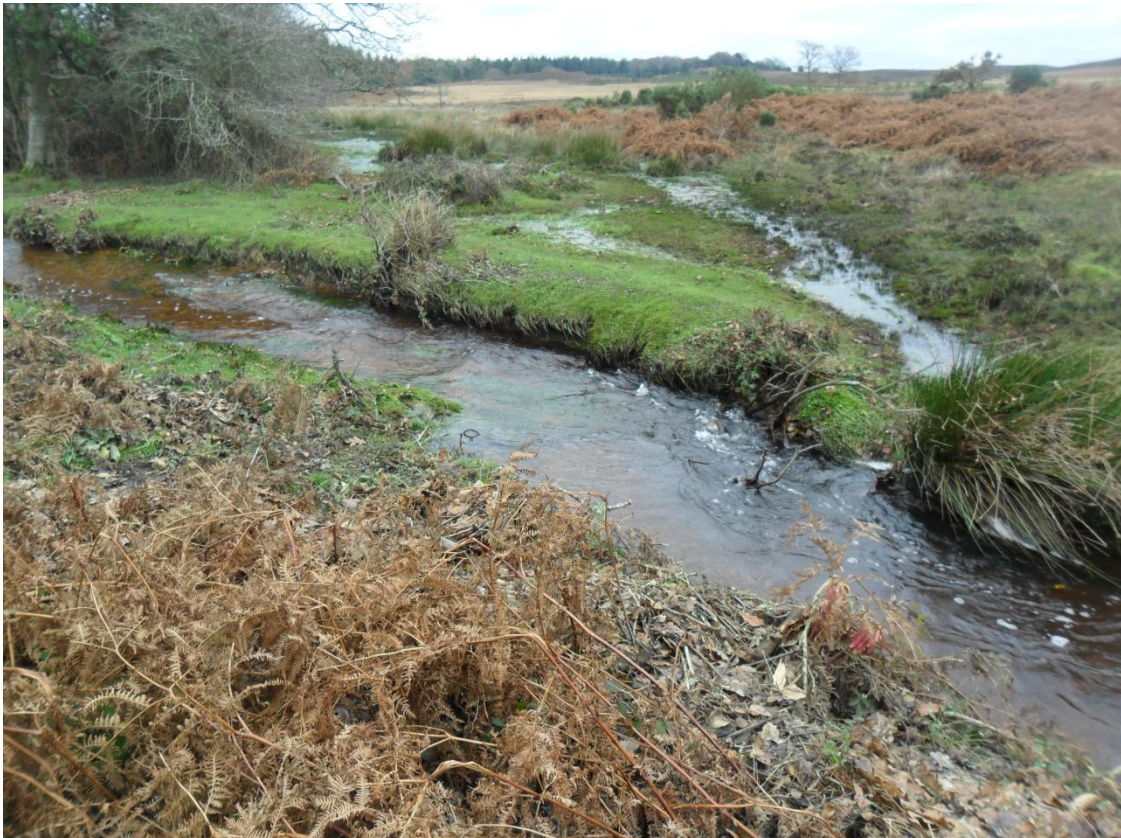
Figure 1-5: Prominent palaeo-channel associated with Latchmore Brook SSSI Unit 48.

- A second incised, single thread reach again with abundant mobile gravels accumulating as mid channel bars and riffles. Floodplain palaeo-channels are prominent in places (Figure 1-5).

Significant palaeo channels have been identified along the reach and reconnection could be possible through some of the proposed restoration measures in Table 1-2. These have been identified from the audit and supplied LIDAR. Reconnecting these whilst maintaining the existing channel will encourage anastomosed network development.

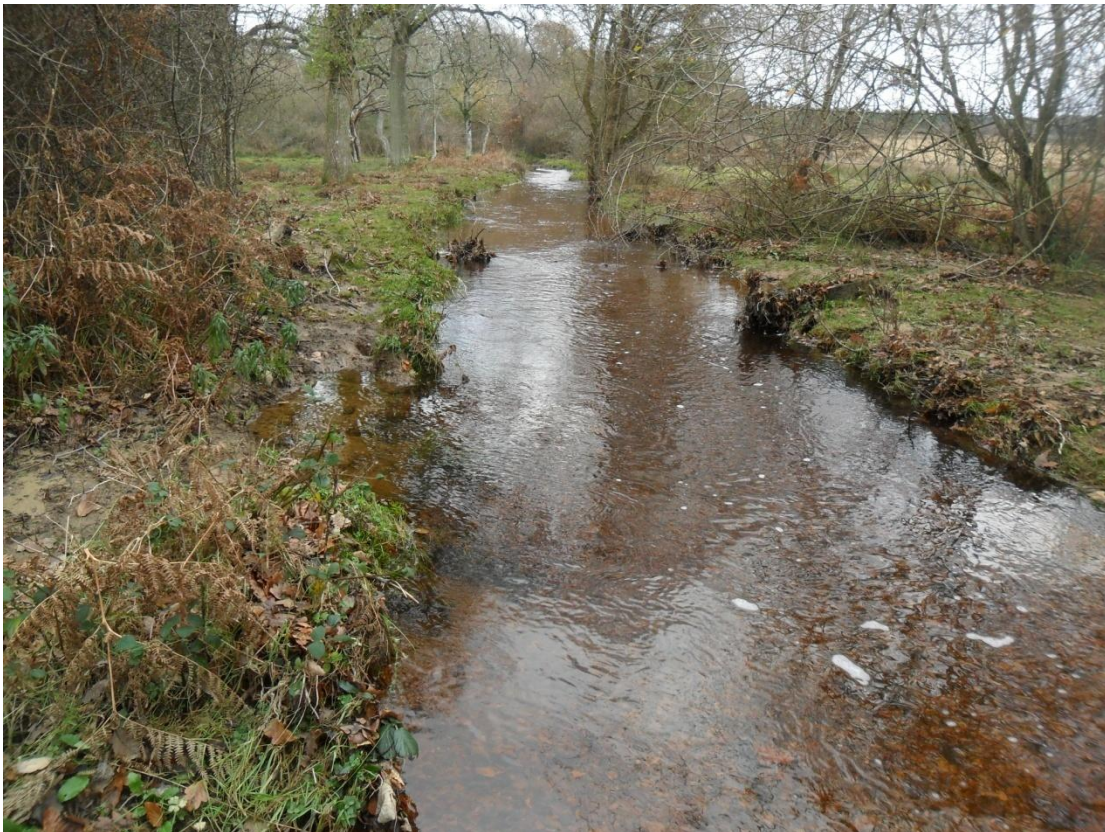
Figure 1-7: Forested single thread reach of Latchmore Brook SSSI Unit 48.

- A third incised single thread reach with some mobile gravels and areas of exposed boulder clays, accumulating as mid channel bars and riffles. Floodplain palaeo-channels are prominent in places. This channel type extends into the plantation woodland where the channel has also been straightened historically and a prominent left bank palaeo-channel can be traced (Figure 1-7).

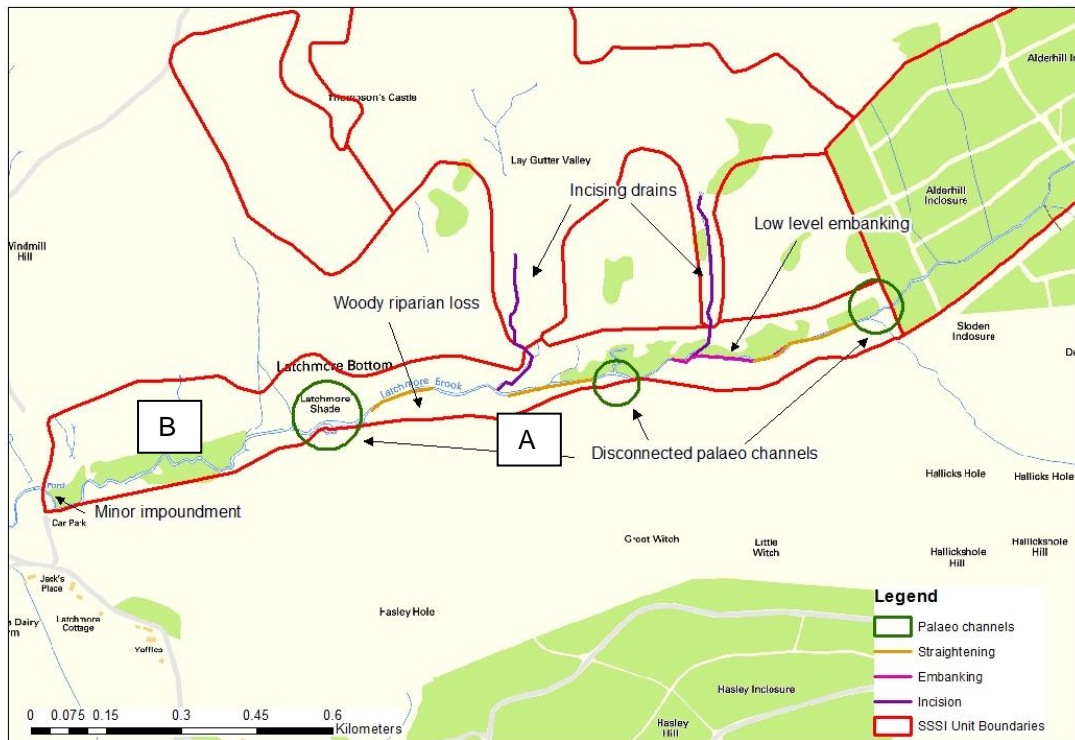
Figure 1-8: Current hydromorphic conditions and pressures

The source of Latchmore Brook is at Studley Head and Horny Ridge to the east and flows through SSSI units 540 and 66. Unit 48 is supplied with gravels from upstream and from local bank erosion and remobilisation of instream gravel deposits. The combination of a steep watercourse, strong gravel supply, historic channel straightening, riparian tree clearance and local grazing pressures creates a dynamic and responsive watercourse sensitive to perturbation. Figure 1-8 summarises the existing hydromorphology and pressure impacting unit 48.

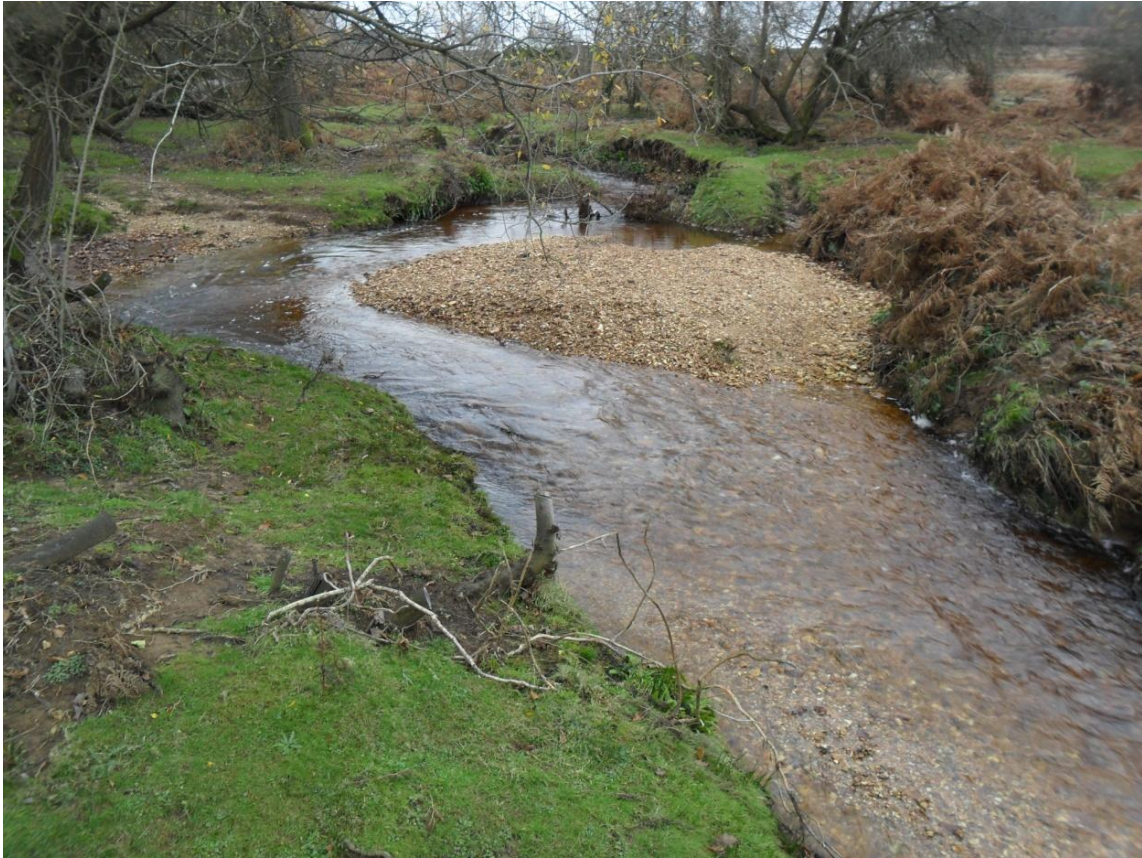
Figure 1-9: Local flow concentration and bank erosion linked to gravel bars on Latchmore Brook.

The natural anastomosed channel network has been extensively modified through the SSSI unit with historic channel straightening along considerable lengths of the watercourse. The channel has reacted to this straightening by initially cutting down into the bed, creating an incised single channel. This will have increased flood shear stress levels promoting local erosion, particularly where flows are concentrated around in-channel bars (Figure 1-9). Subsequent resupply of gravels from upstream has resulted in a general over-filling of the channel in the middle reaches (Figure 1-8 - A) to create a shallow plane bed system, leading to frequent floodplain inundation. This channel state is not stable and will be subject to a renewed period of scour and disconnection as part of the general damped erosion/deposition cyclic response to the straightening.

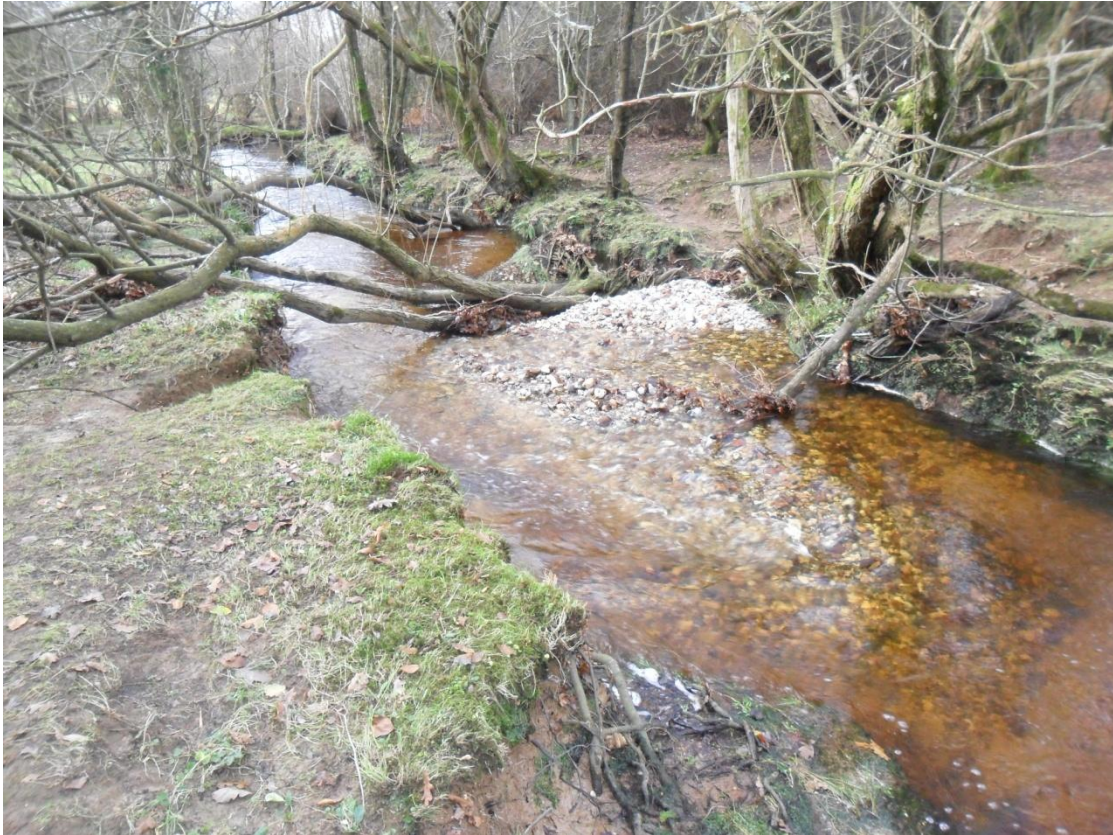
Figure 1-10: Woody Debris on Latchmore Brook.

Floodplain connectivity improves through anastomosed reaches within the wooded lower section (Figure 1-8 - B) of the SSSI, although several channels remain disconnected from the main channel. Whilst on site, high flow levels had activated some of the anastomosed channels within the floodplain, however, restoration would look to increase the frequency of wetting of these channels (Figure 1-2). The anastomosed network is assisted by debris jams which have provided local improved floodplain connectivity (Figure 1-10).

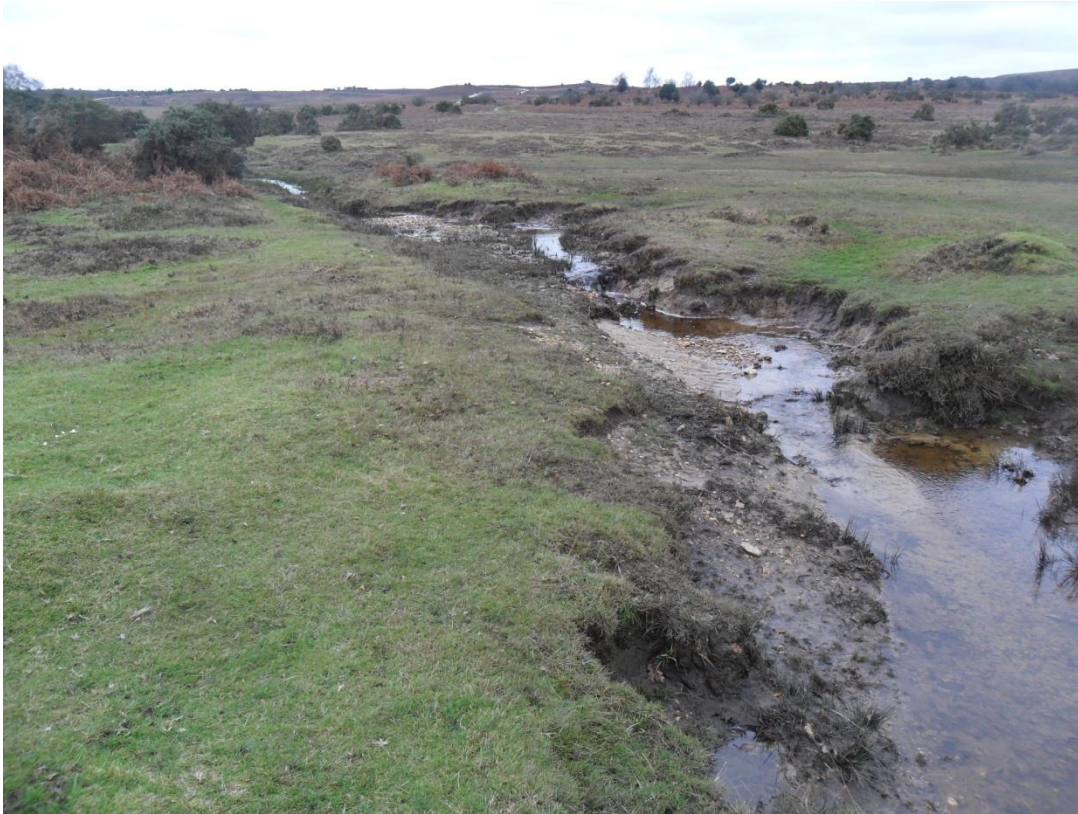
Figure 1-11: Knick point erosion on the tributary channels of Latchmore Brook.

This initial incision episode linked to the channel straightening has also caused multiple knick point development moving through the tributary / drain systems on the right (north) bank of the river (Figure 1-11). The impact has been variable with the channels to the east displaying general stability whilst those coming off of the west of Latchmore Mire and Thompsons Castle SSSI units are far more unstable. In these channels incision into mineral deposits is severe and active and must be addressed using suitable gully control techniques. Where incision is extending into valley mire a different approach is required. Repairs are suggested to the fluvio-glacial mineral ridge that formed the original control on the mire together with associated organic infill of the upper watercourse to restore predominantly subsurface and diffuse surface flow. The drainage pattern influencing the SSSI reach is shown in Appendix A.

Similarly the impacted tributary / drain systems are responding to a series of knick points along their courses and themselves display multiple cut and fill sequences. Alterations to the Latchmore Brook will not impact on the current knick points which must be restored independently.

Tributary instability issues must be addressed independently using appropriate measures linked to channel energetics.
