Physical and biological monitoring of STREAM restoration projects

Year Three Report

Natural England

April 2009

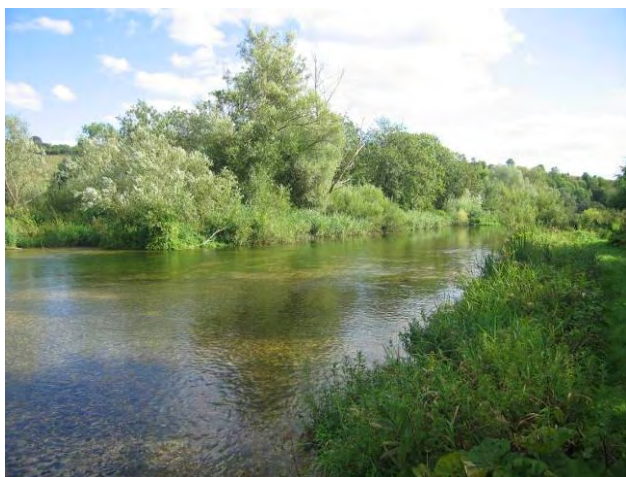
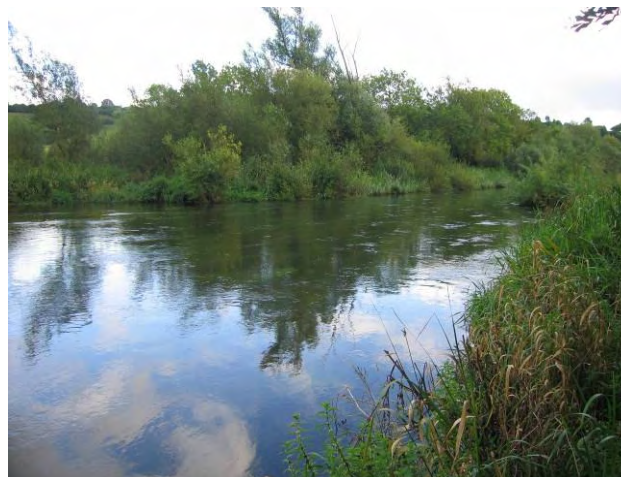
Photo 3.1.1 - UWC MS01c: Towards the upstream end of site UWC, looking downstream.

In 2006, a number of runs were observed within reach UWC with rippled flow and a visible gravel bed (**Photos 3.1.1a and 3.1.3a**). In 2008, at the same locations, glides were observed with rapid but smooth flow (**Photos 3.1.1b and 3.1.3b**). This difference in physical biotope is related to the increased depth of water, acting to “drown out” the run features. A similar difference was evident in runs throughout the reach.

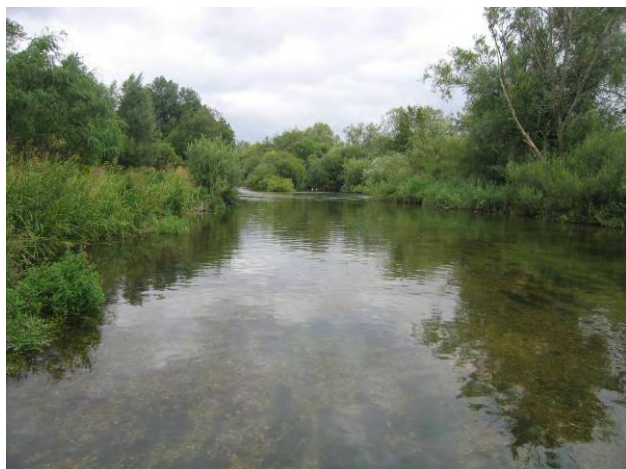
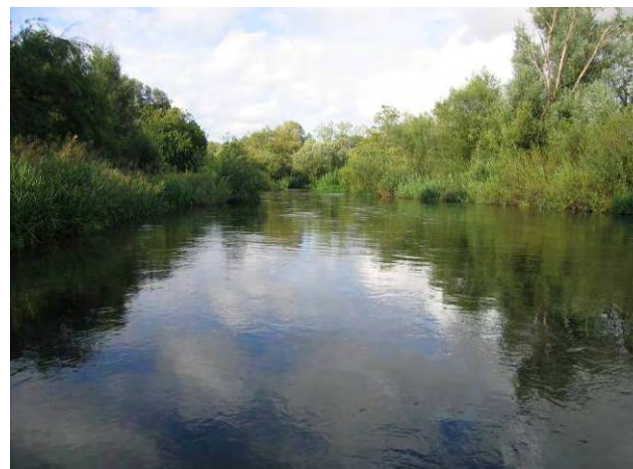
Photo 3.1.2 - UWC MS03: Glide biotope towards middle of site UWR, looking upstream.

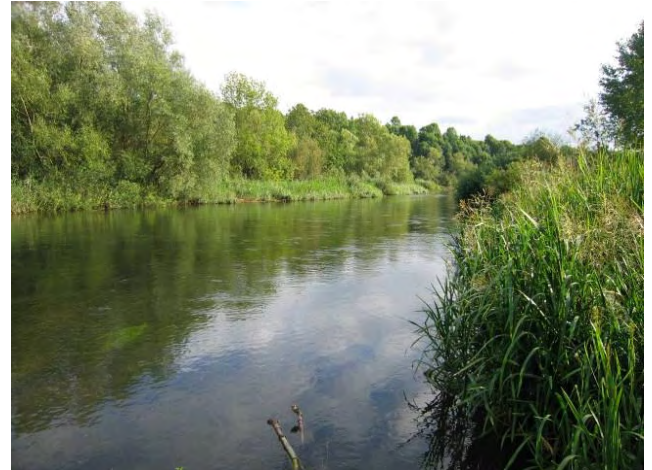
Photo 3.1.3 - UWC MS04c: Glide biotope towards downstream end of site UWC, looking downstream

Although no restoration works were undertaken within reach UWC, there are significant visual differences at the control site comparing post-restoration photographs and those taken during the pre-restoration survey. These differences largely relate to the increased discharge and higher water levels during the 2008 survey. The difference in water level is illustrated in **Photo 3.1.1a and 3.1.1b**. The fisherman's bench which was on the bank top in 2006 is in the river channel and partly submerged in 2008. Channel narrowing measures implemented prior to 2006 were also observed to be submerged and being undermined by higher flows. It was also more difficult to see gravel on the bed of the river due to the increased depth of water (**Photo 3.1.3a and 3.1.3b**).

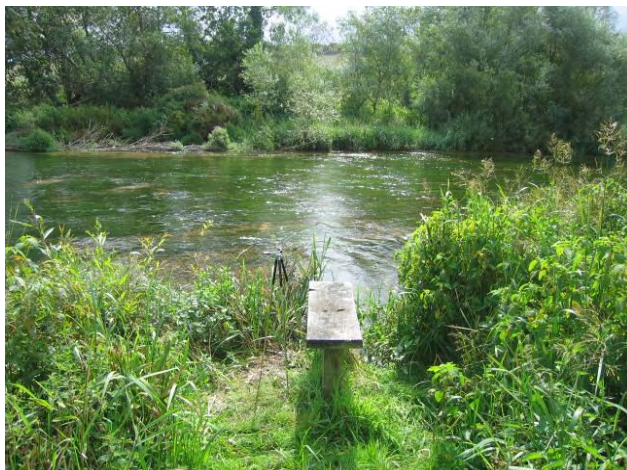
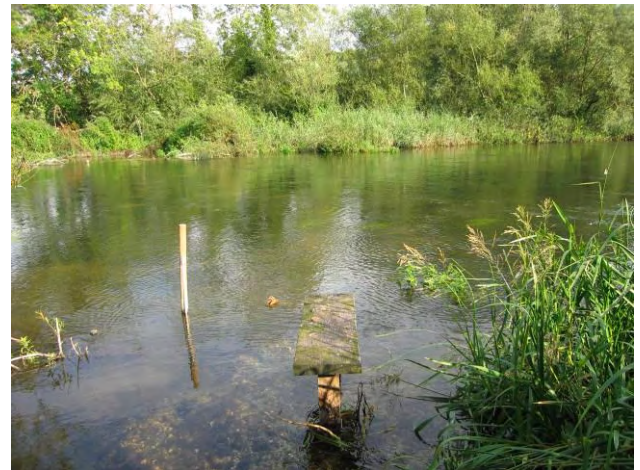
Photo 3.1.4 - UWC MS04e (2006): Run biotope towards downstream end of site UWC, looking across channel

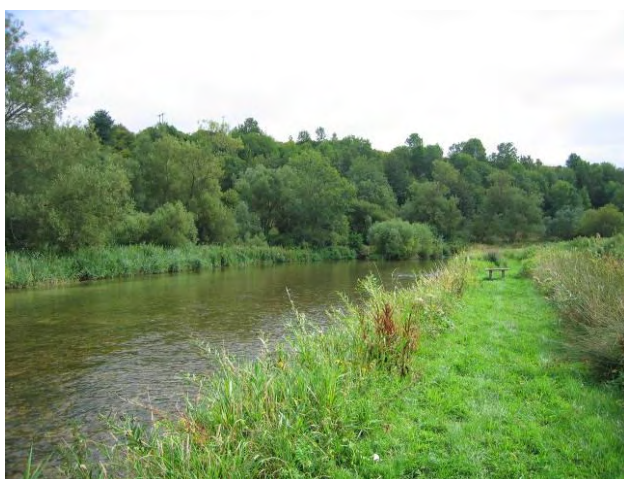
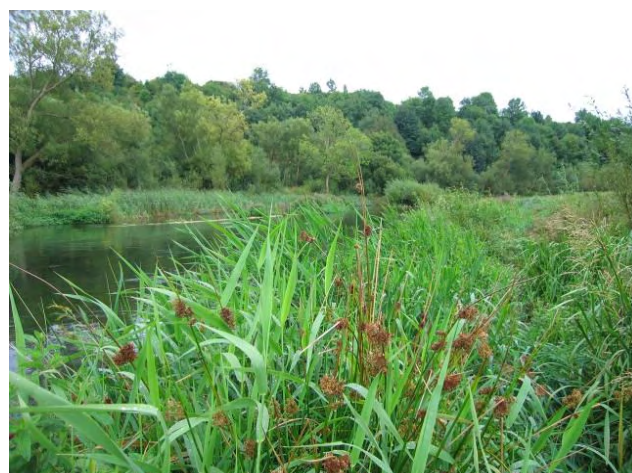
Photo 3.2.1 - UWR01-MS01c: Glide biotope at upstream end of site UWR, looking downstream.

Another notable visual difference is the increase in marginal wetland vegetation, as particularly evident in comparing **Photos 3.2.1a** and **3.2.1b**. These differences relate to increased discharge and water levels in the two year period preceding the 2008 survey. The difference in water level is illustrated particularly clearly in **Photos 3.2.2a** and **3.2.2b** where the bed of the river is less visible in 2008.

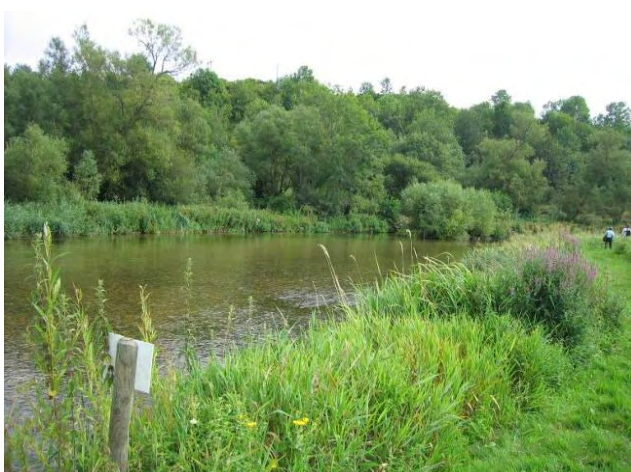
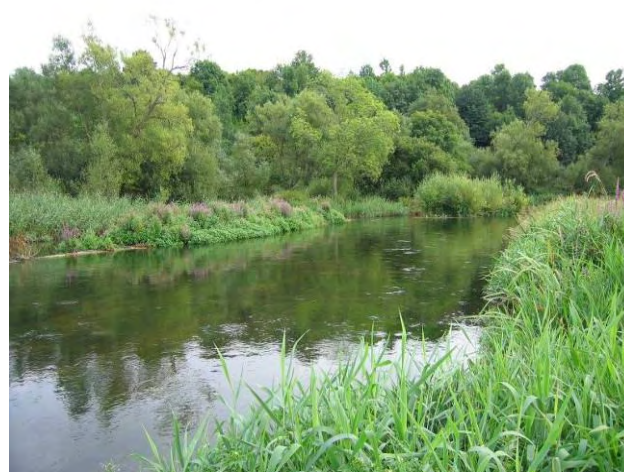
Photo 3.2.2 - UWR01-MS02c: Upstream end of site UWR, looking downstream.

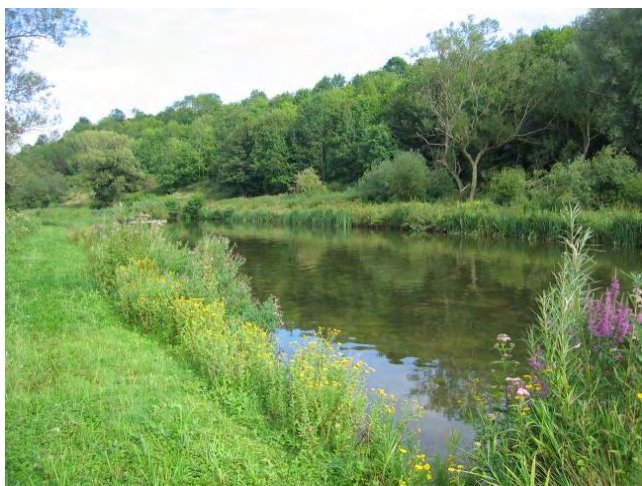
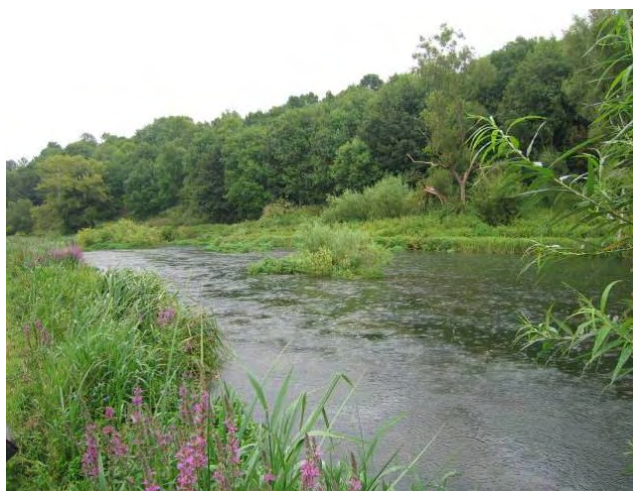
Photo 3.2.3 - UWR01-MS04a: Glide biotope at downstream end of site UWR looking upstream.

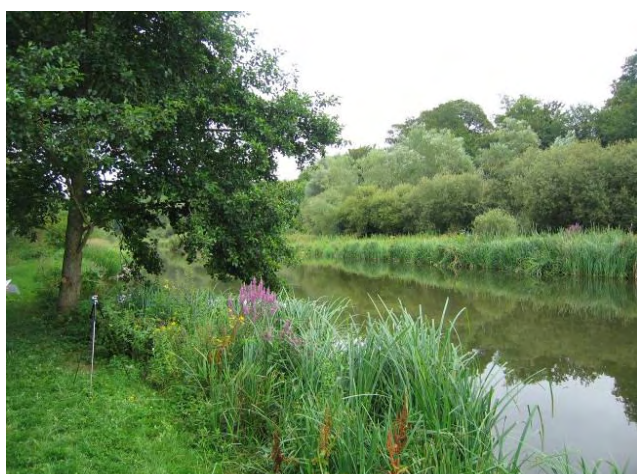
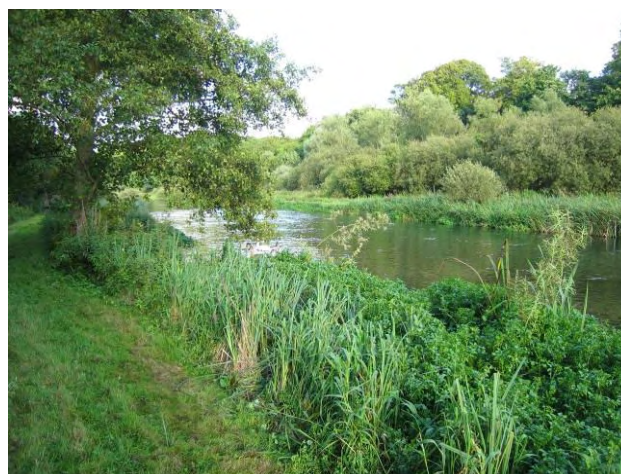
Photo 3.2.4 UWR01-MS05e: Glide biotope at downstream end of site UWR looking upstream.

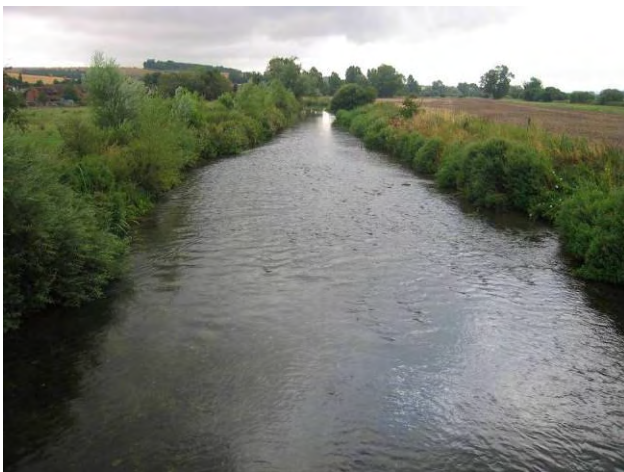
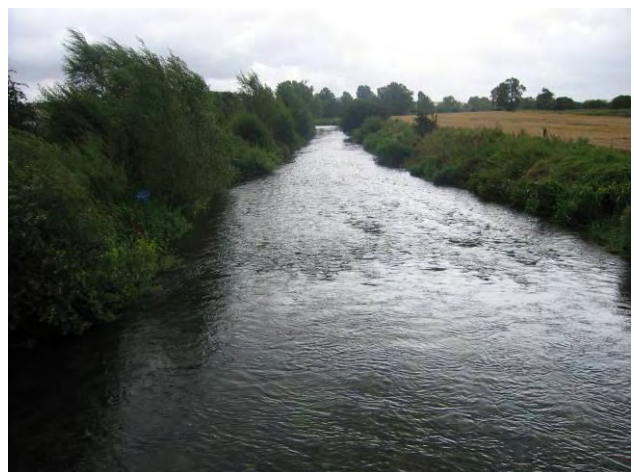
Photo 3.3.1 - SHC01a: Looking downstream from footbridge over "riffle" and glide physical biotopes.

Willow trees used in previous restoration measures have also grown significantly since 2006 (**Photos 3.3.1a and 3.3.1b**).

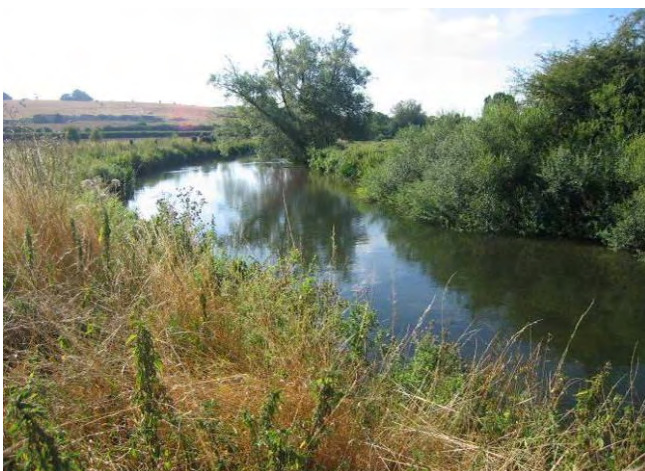
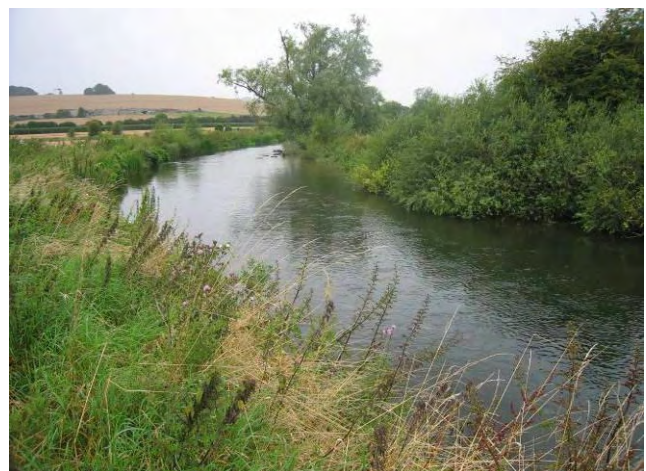
Photo 3.3.2 - SHC02 - MS04a: Towards downstream end of site SHC looking upstream to undermined

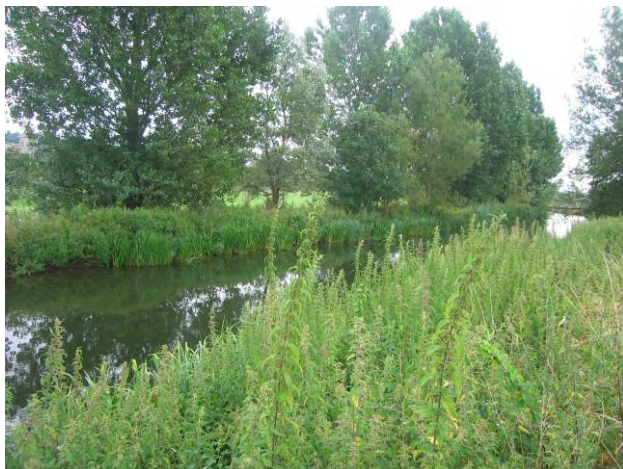
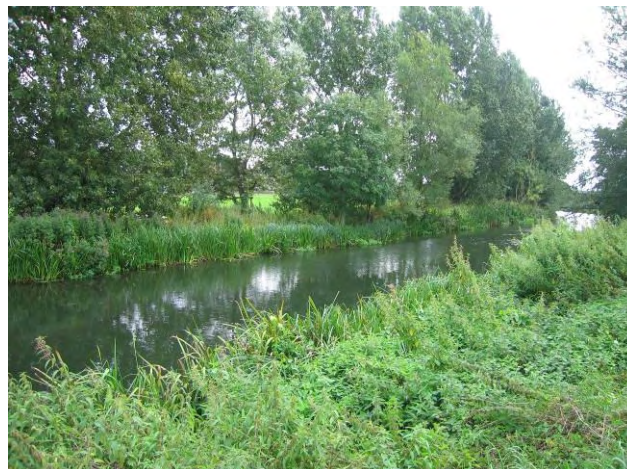
Photo 3.3.3 - SHC02e: Looking across deep channel towards private gardens on left hand bank.

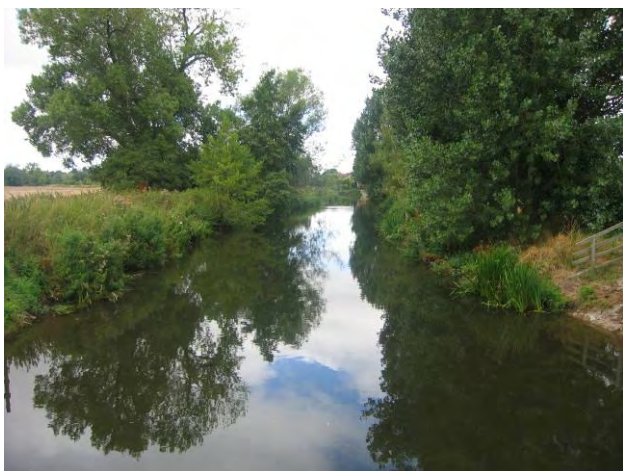
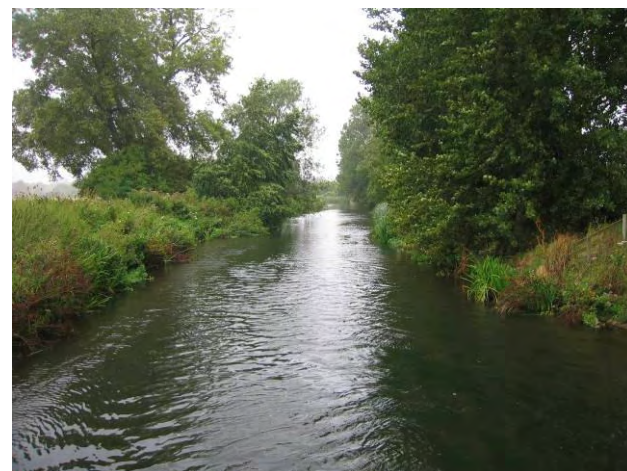
Photo 3.3.4 –SHC02f: Looking from the gauging weir at South Newton upstream.

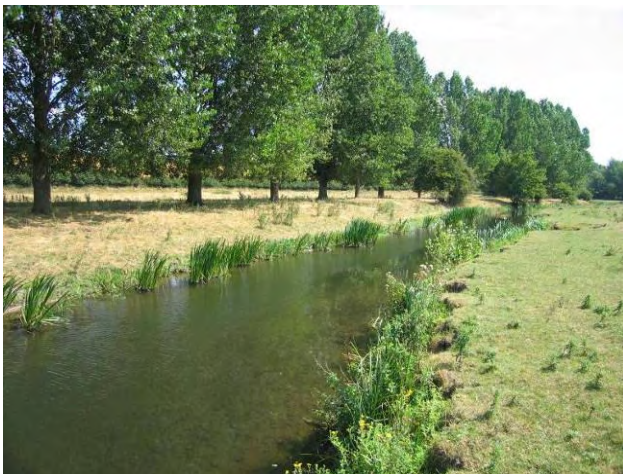
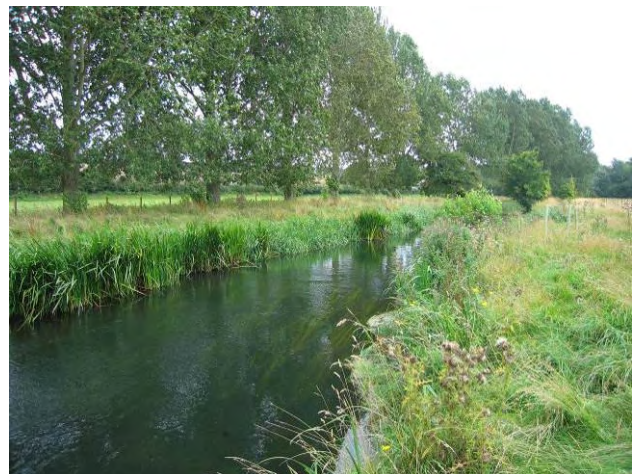
Photo 3.4.1 - SHR02f: Looking downstream along uniform glide section downstream of the Seven Hatches structure.

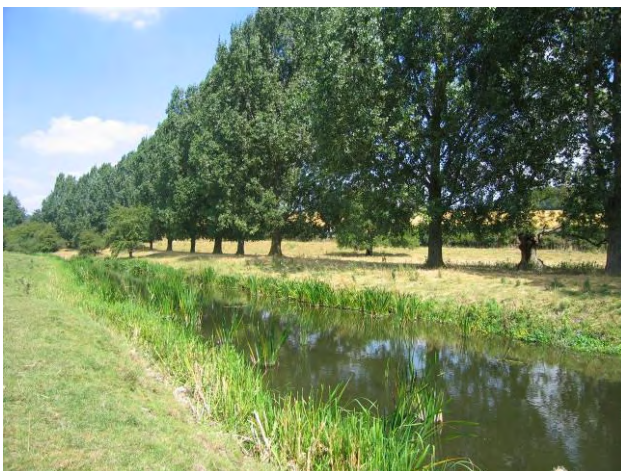
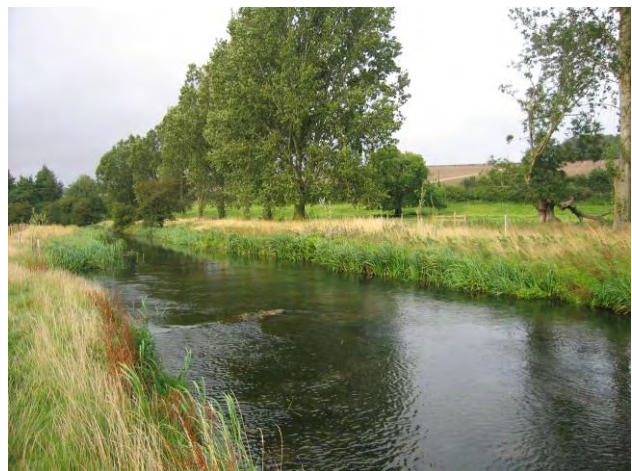
Photo 3.4.2 - SHR02 MS03a: Looking upstream at new riffle

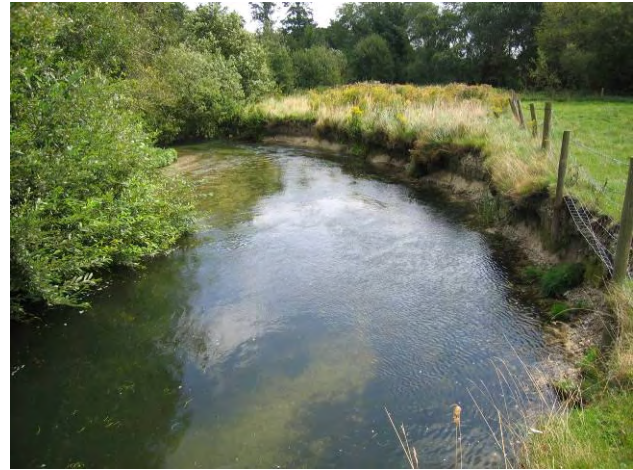
Photo 3.4.3 - SHR03e: Looking downstream along glide with eroding right hand bank

Evidence of erosion downstream of the railway crossing is illustrated in **Photo 3.4.3a and 3.4.3b** and further downstream flow becomes uniform as evident in **Photo 3.4.4a and 3.4.4b**.

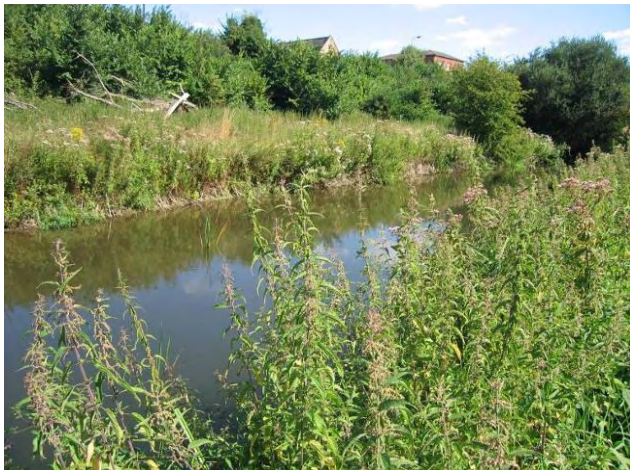
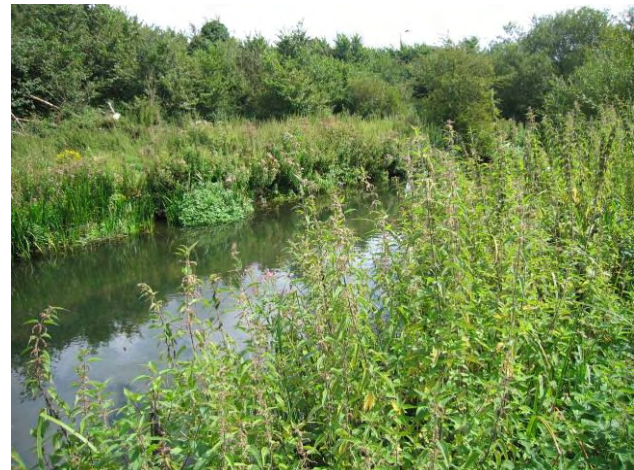
Photo 3.4.4 - SHR04g: Looking downstream along uniform glide downstream of the first railway crossing.

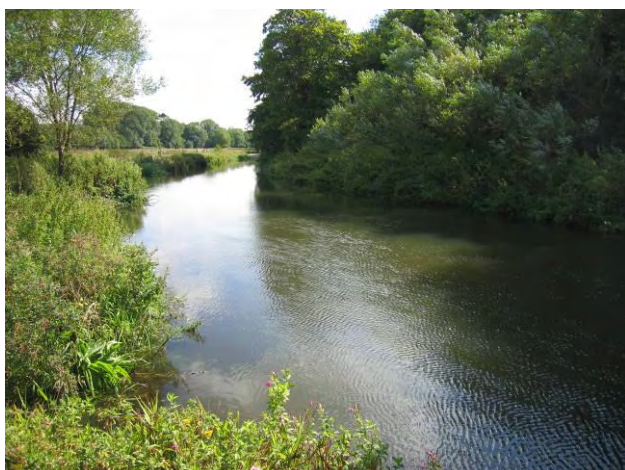
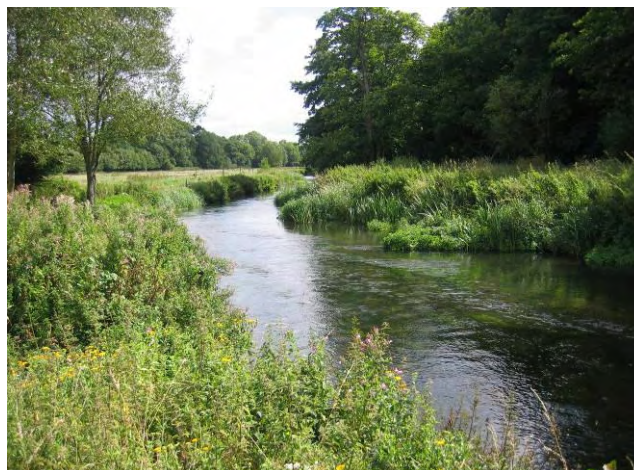
Photo 4.1.1 - FOR01b: Looking downstream from start of restoration reach

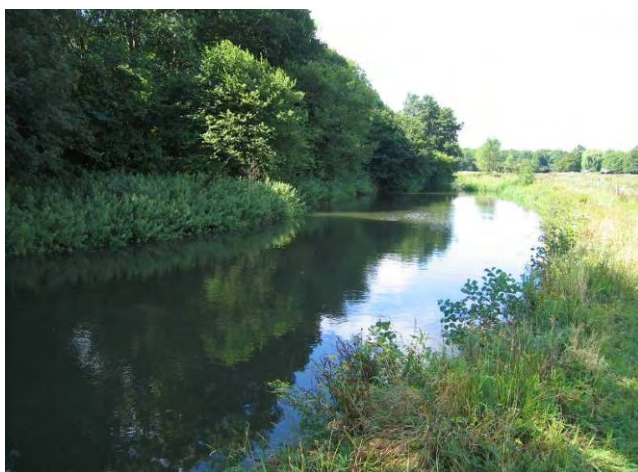
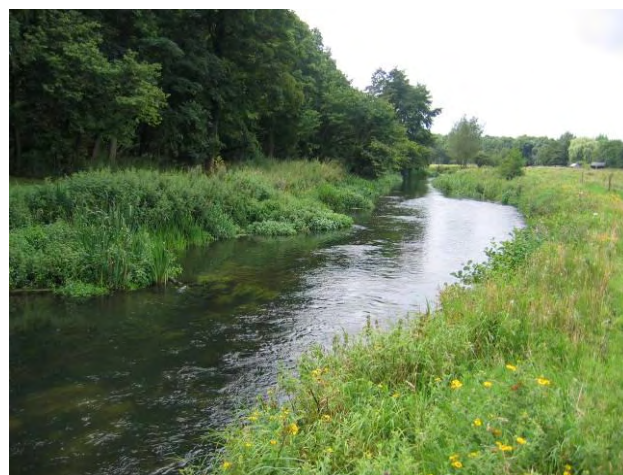
Photo 4.1.2 - FOR01h: Looking upstream along the glide physical biotope with broadleaved woodland along the right hand bank.

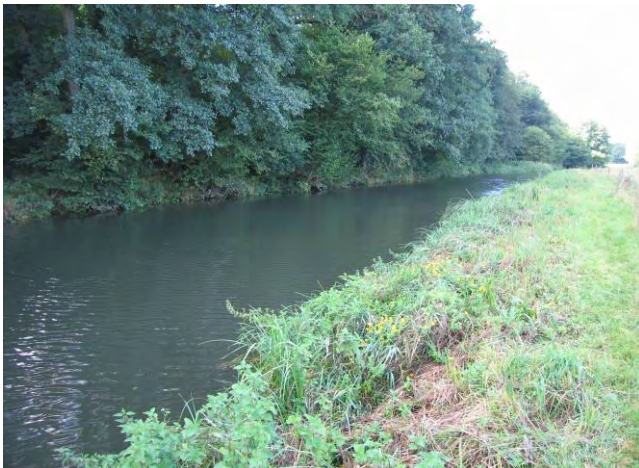
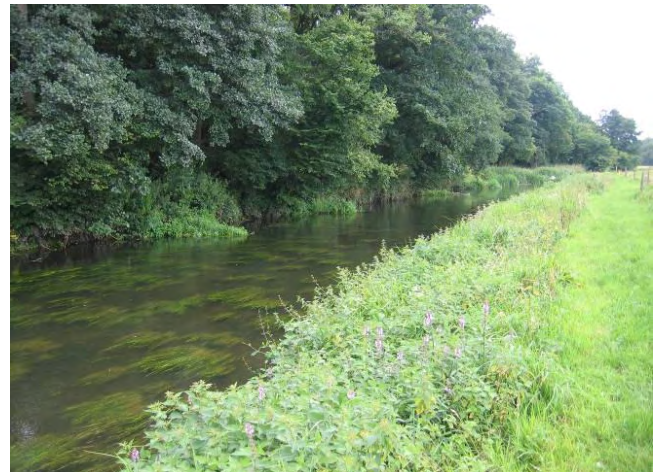
Photo 4.1.3 - FOR01k: Looking upstream along glide section.

In-channel vegetation has visibly increased in coverage within the reach, as illustrated in Photos 4.1.3a, 4.1.3b. Channel narrowing, as evident in Photos 4.1.4a and 4.1.4b where a 'V' shaped groyne has been introduced, has also helped to increase marginal vegetation coverage within the hydrological transition zone.

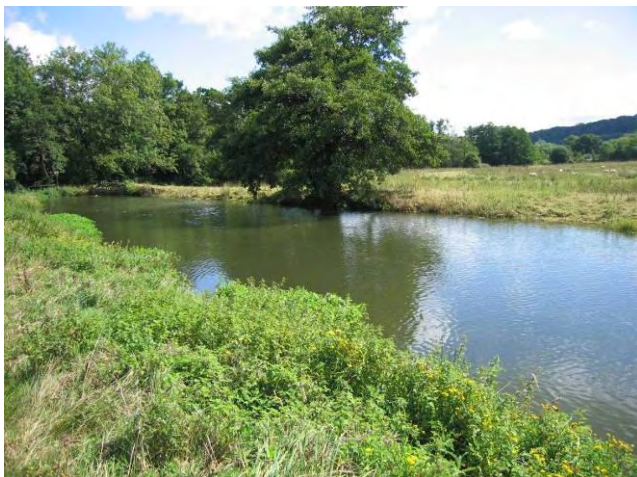
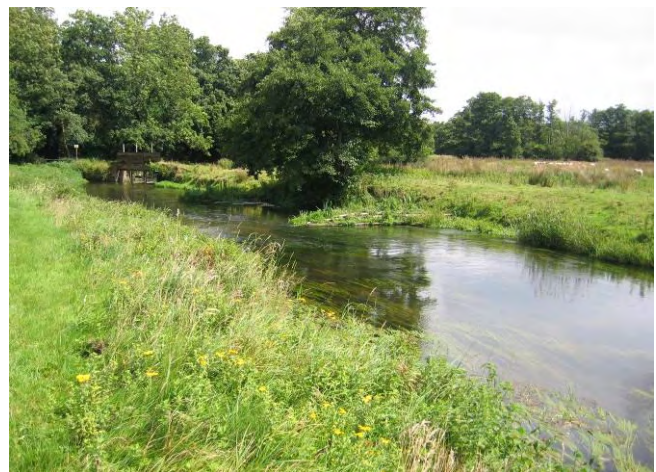
Photo 4.1.4 - FOR01s: Looking downstream towards Iron Hatches

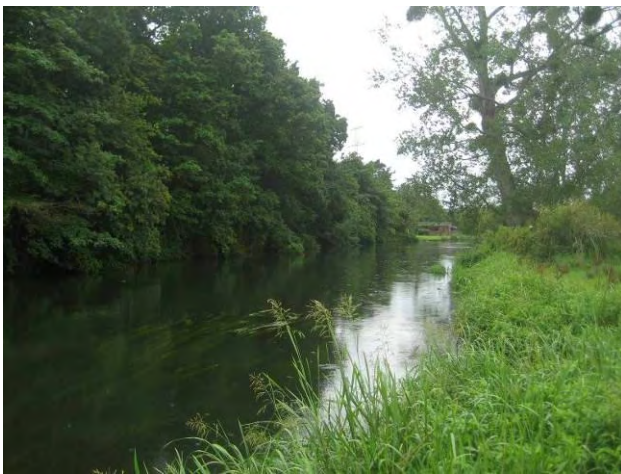
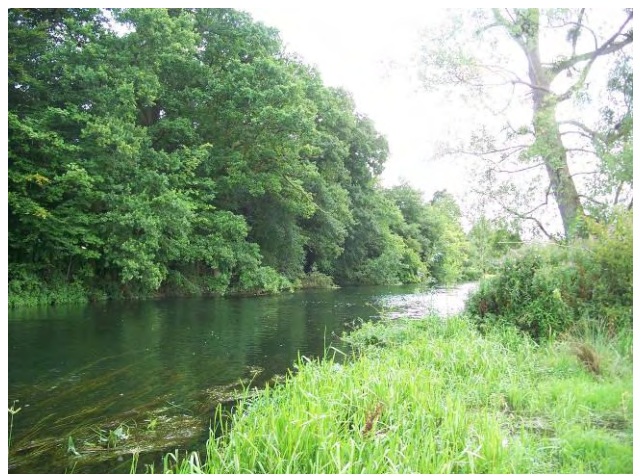
Photo 4.2.1 - HAR01e: Looking downstream along the glide with broadleaved woodland along the left hand bank.

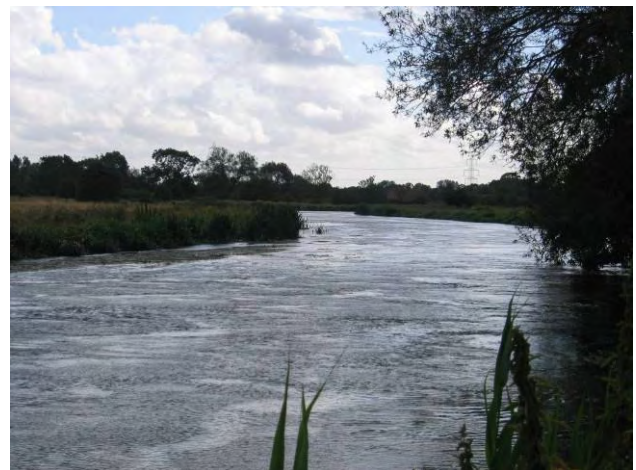
Photo 4.2.2 - HAR01s: Looking downstream along the glide

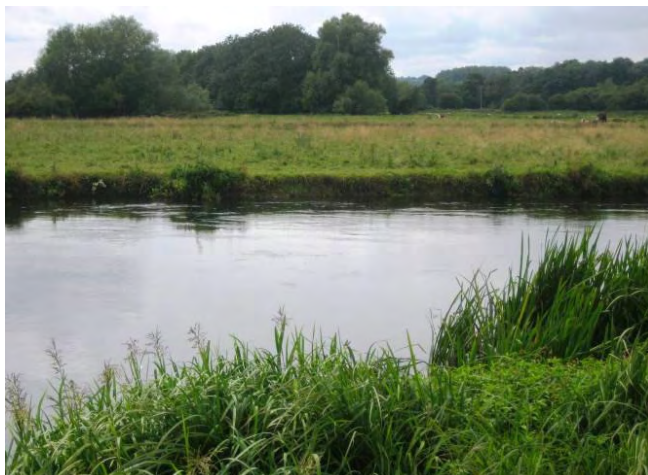
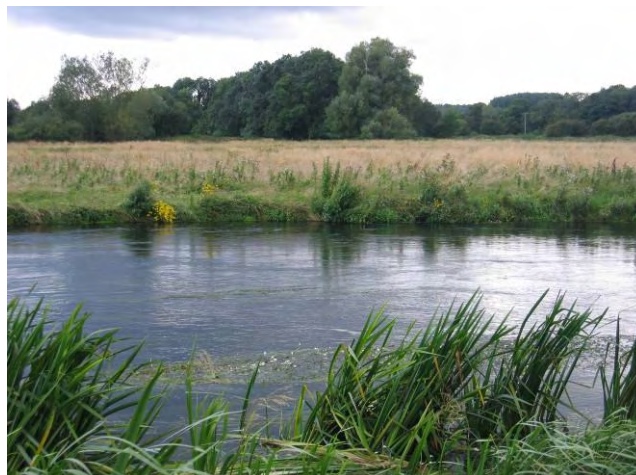
Photo 4.2.3 - HAR02c: Looking across channel at eroding bank

Flow levels at the time of the 2008 survey were particularly high, as evident in all of the photographs. This prevented direct observation of the impacts of the implemented restoration works, which were consequently submerged. Water-logged conditions along the right hand bank also made access difficult. Visual differences included greater flow velocities, with fast, rippled glides at the upstream end of the site (**Photos 4.4.2a and 4.4.2b**). The eroding bank shown in **Photos 4.4.3a and 4.4.3b** appears to have been stabilised by increased vegetation.

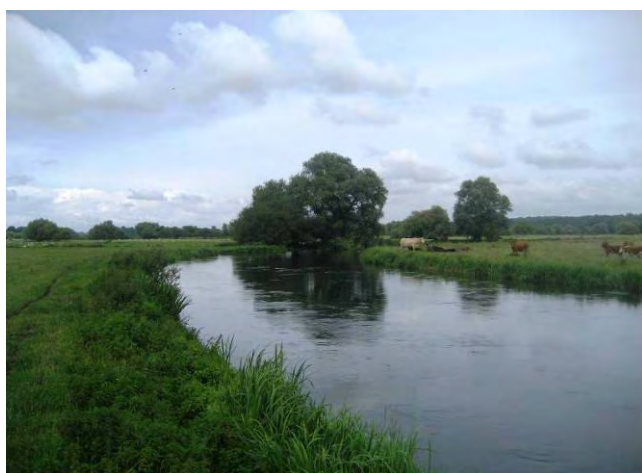
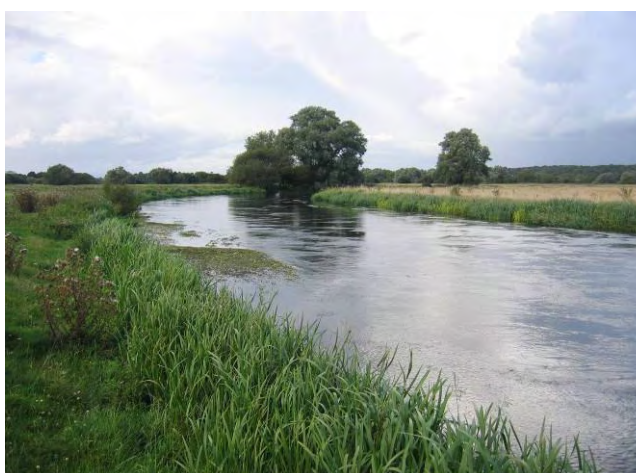
Photo 4.2.4 - HAR02f: Looking upstream along the glide from the downstream boundary.
