Natural England Commissioned Report NECR141

New Forest SSSI Ecohydrological Survey Overview

Annex O: Norley Mire

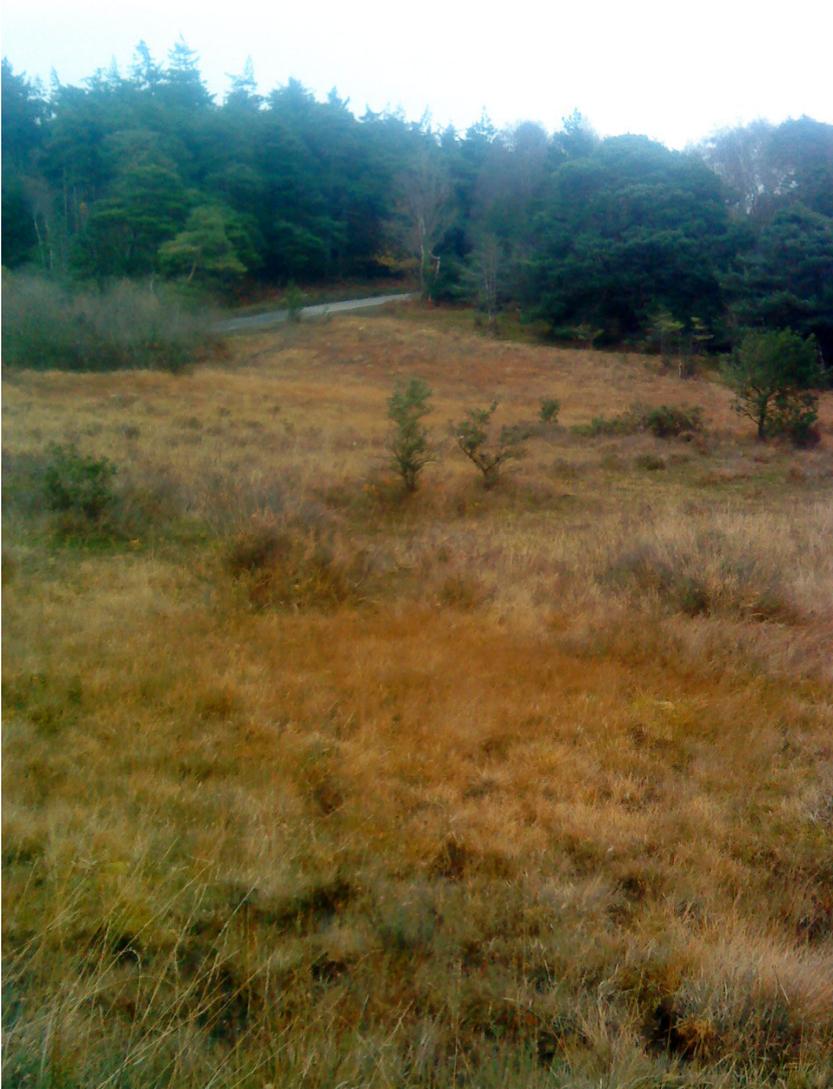
Figure 1-2: Eastern Valley (NGR 434950, 097890)

This site lies on the edge of a plateau. Two small valleys are incised into the plateau edge. The relative position of the seepage face that supports the wetland in the two valleys affects the distribution of the wetlands. In the eastern valley, the seepage face is high up the valley side and so there is a steep valley side wetland. In the bottom of the valley is a valley bottom wetland with significant peat deposits forming a peat dome. A small drain has been cut through the centre of the peat mass. As the valley enters a plantation the drainage is more effective and the peat body has been completely destroyed.

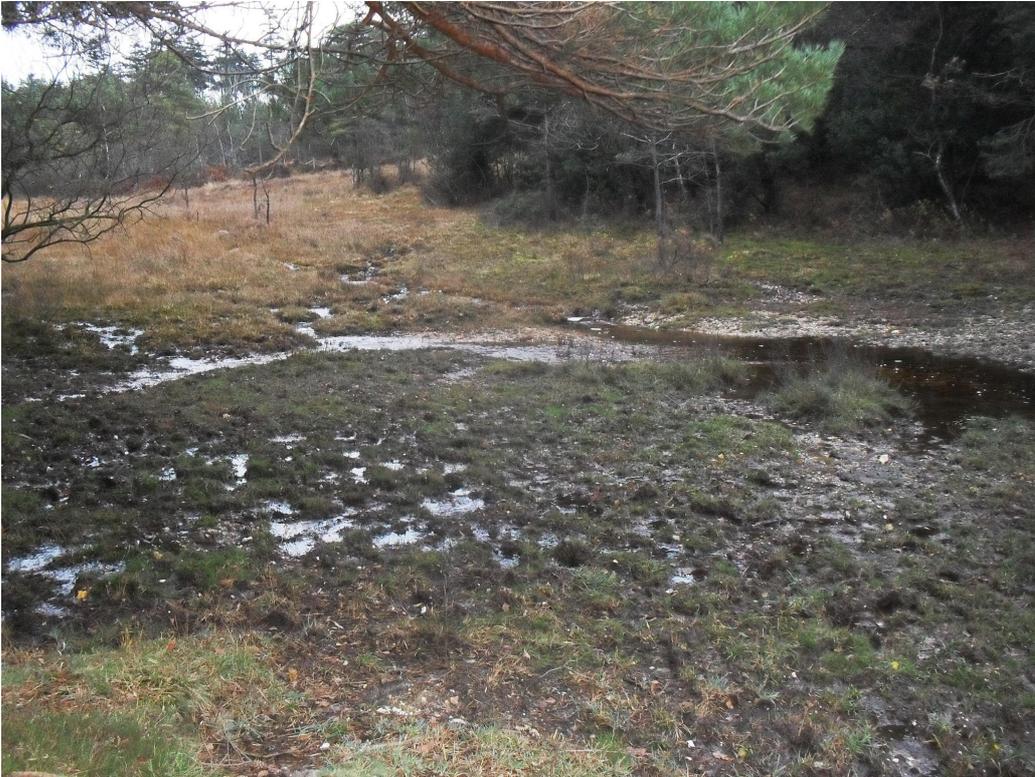
Figure 1-3: The bottom of the Eastern valley as it enters the forestry and the peat mass peters out due to drainage (NGR 434999, 097859)

At the top of the eastern mire, there is a large area of pooling right beside Norleywood Road, which was in good condition. The valley mire habitat continues south towards a large area of mixed woodland (See Figure 1-4 below), with a small drain cuttings through it. Where it enters the woodland, the drain becomes larger and the peat has been eroded away. The current status of this area is degrading due to the level of drainage present. This area in particular has been subject to cattle poaching which has further damaged the mire habitat (see Figure 1-3).

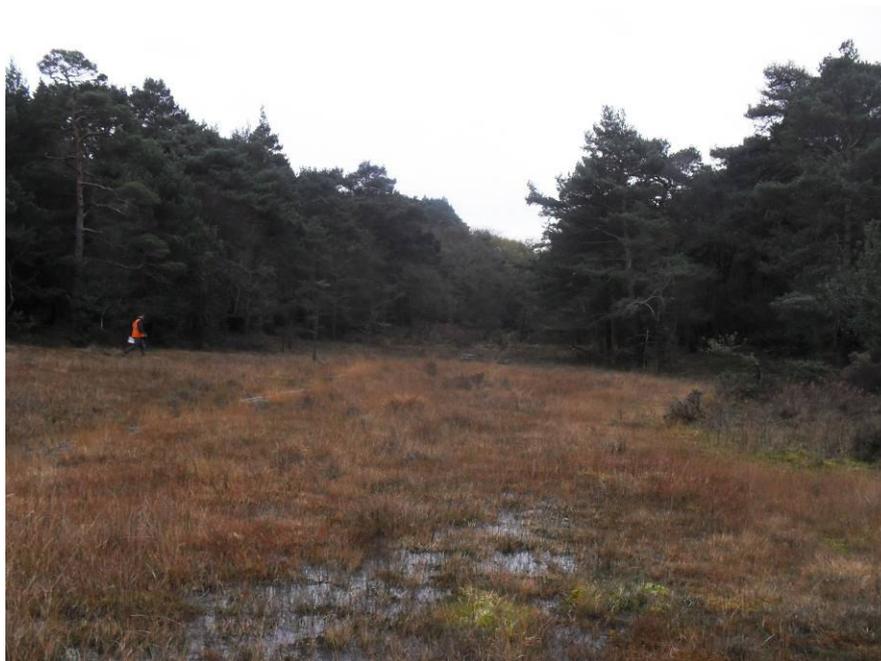
Figure 1-4: View from Norley Wood Road down eastern valley mire (with cut drain) towards woodland (NGR 434990, 097926)

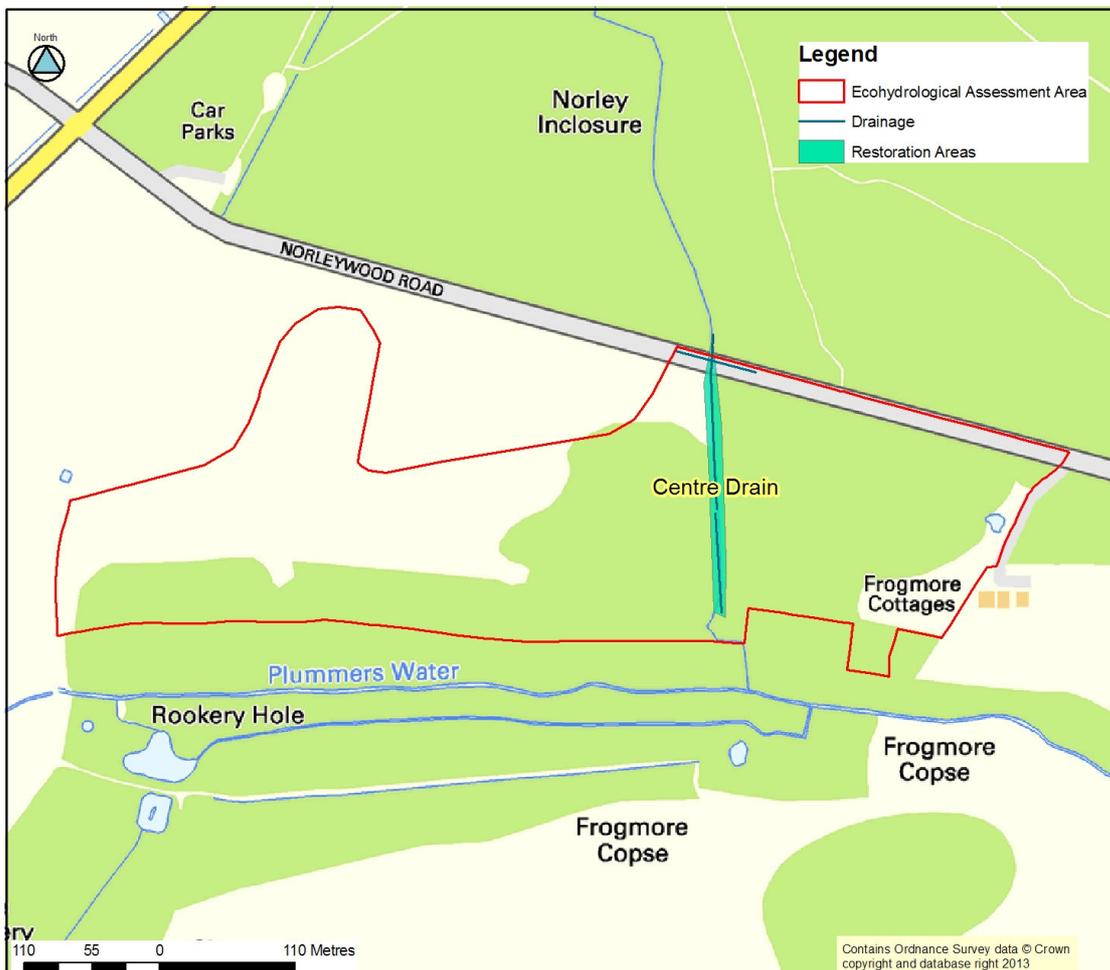
Figure 1-6: Restoration Areas Map

There is one area of significant damage (see Figure 1-6). The valley bottom wetland in the eastern valley has a small drain cut through the middle. This drain should be infilled, possibly with heather bales, with wooden dam supports built into the infilling and the water diverted across the mire surface to restore the quality and extent of the mire habitats. As the valley enters the area of forestry, the drainage has been more effective and the mire completely removed. There are possibilities for wetland creation in this area too (through removal of forestry, earth bunds and infilling the drains).

Area		Proposals		
Centre Drain	Small centre drain through mire	Infilling drain with heather bales	Stop drainage and degradation of mire habitat. Increase in quality and extent of adjacent mire and wet heath habitats	Drain is an outfall of the road drainage system
Centre Drain in East of Unit	Poached Ground	Grazing management	Prevents sensitive mire habitat becoming trampled and damaged continuously	May be constrained by current grazing rights

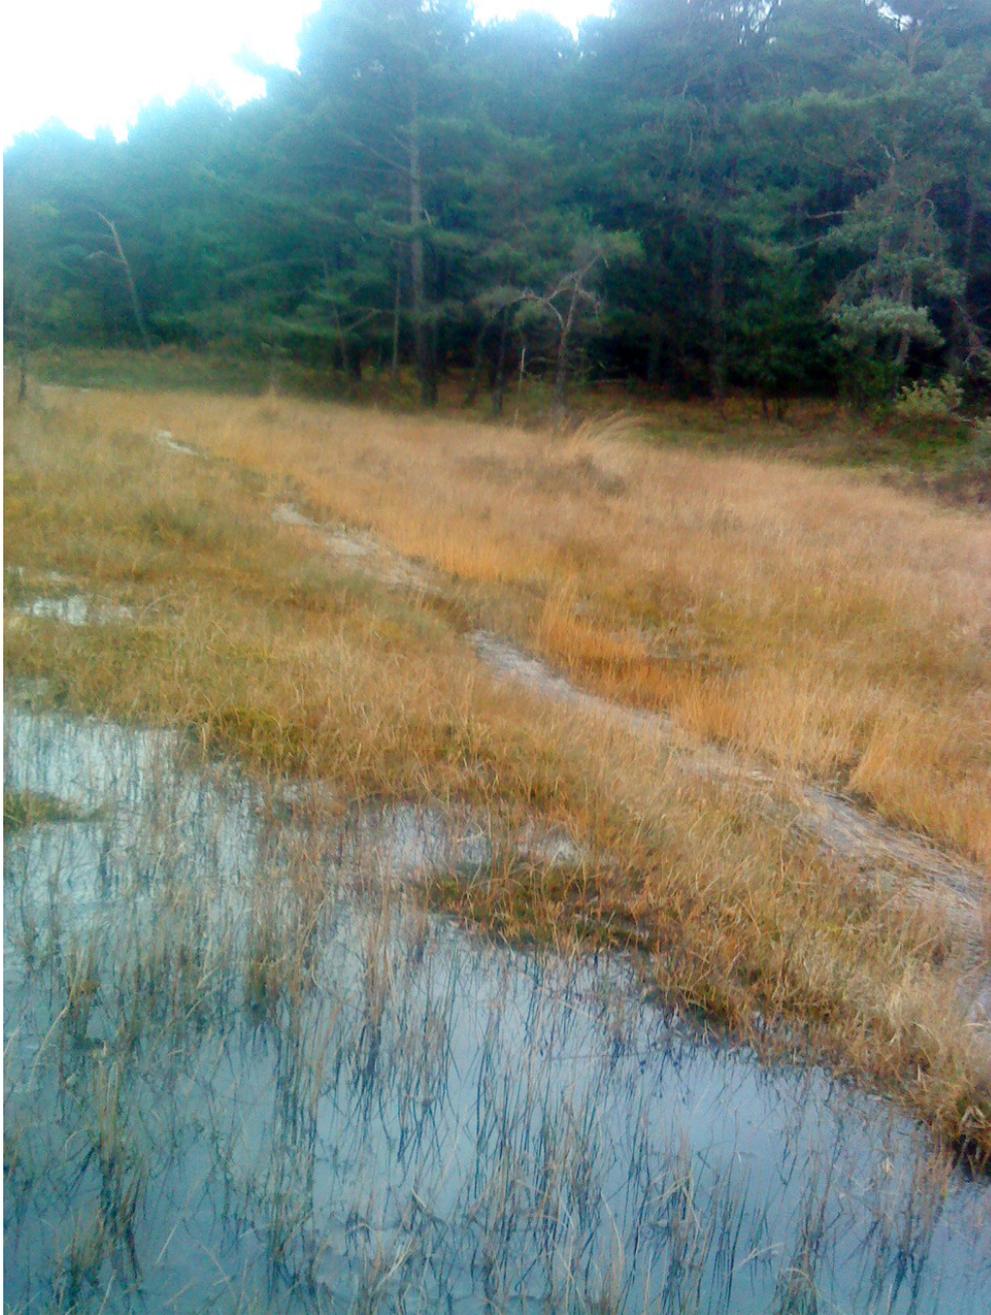
Figure 1-7: Drain cutting through the peat deposits in the eastern valley bottom wetland

The cut drain through the east of the site is compromising the mire and small raised bog habitat (which surrounds it) and, as a result, the immediate area is becoming drier, resulting in wet heath habitats forming instead. These are likely to become increasingly drier and scrubbed over without active intervention. This is already apparent in the form of minor scrub encroachment presently invading the west of the site. Poaching is also an issue on this site and some areas have been heavily grazed by both cattle and ponies.
