Natural England Commissioned Report NECR141

# New Forest SSSI Ecohydrological Survey Overview

Annex W: Denny Bog and Penny Moor

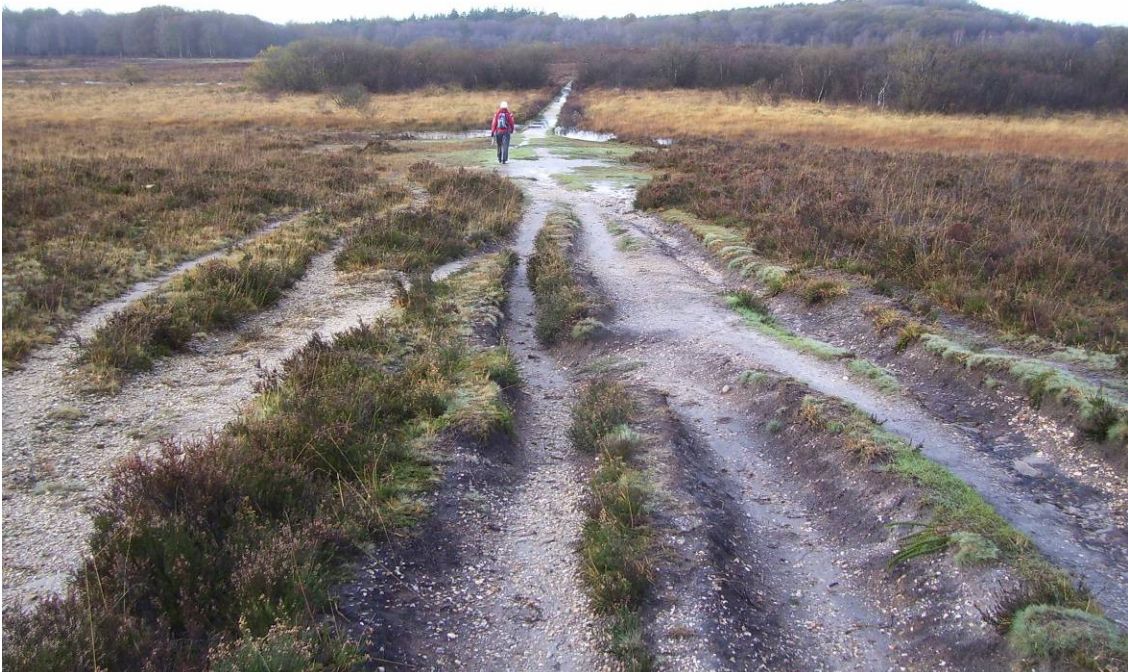
**Figure 1-5: Footpath erosion on the lower slopes of Furzy Brow at the eastern edge of the EcoHAA (NGR 435584 104799, looking south-west towards the valley mire of Denny Bog East)**

Footpaths	Erosion	Monitor erosion and, if necessary, re-surface the problem section(s).  Also assess if footbridges/ boardwalks are resulting in the localised ponding of water, potentially impacting on mire communities. Possibly increase size of culvert pipes and/or raise bridges/boardwalks.	Protection of valley side habitats from erosion.	
Localised areas throughout unit	Scrub encroachment (Scot's Pine)	Monitoring, and removal if scrub encroachment becomes extensive	Removal of Scot's Pine which have potential to invade mire and wet heath habitats, leading to further drying.

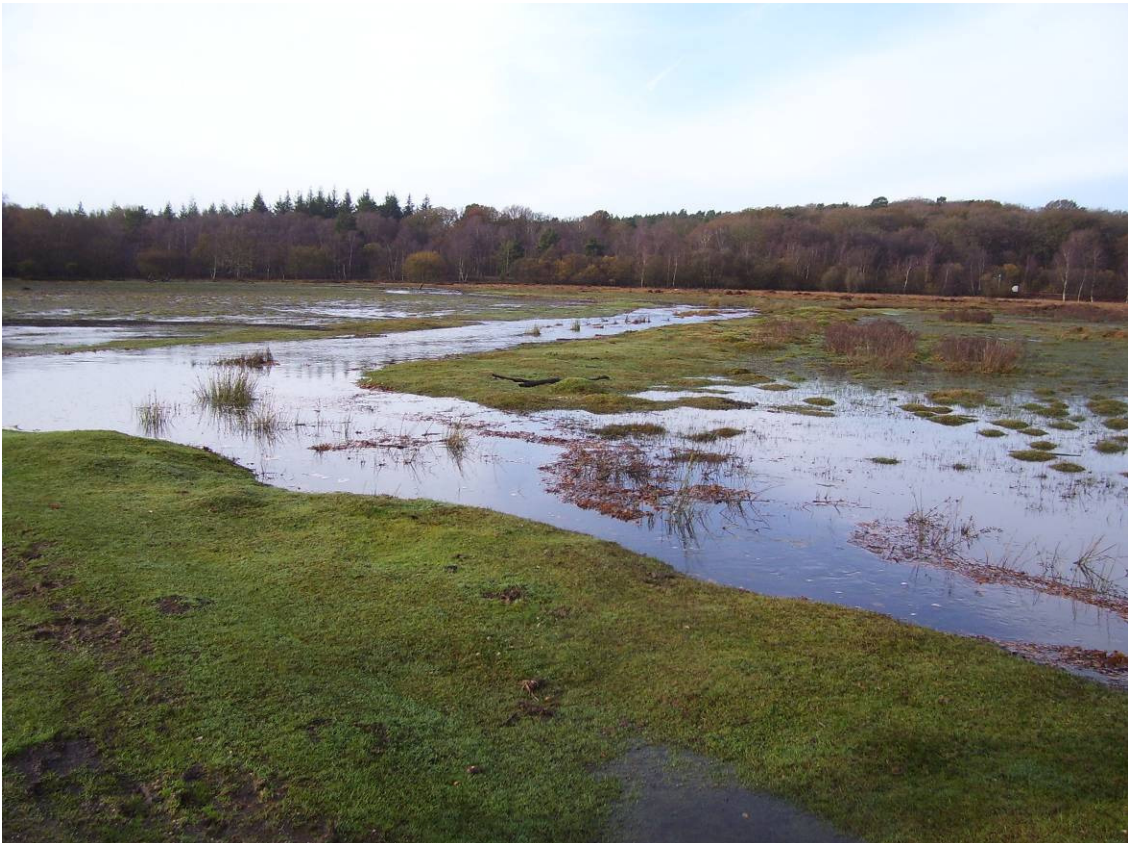
Artificial drainage ditches are common within, and adjacent to, Denny Bog and Penny Moor. In the part of Denny Bog to the west of the railway line, drainage and grazing have produced extensive "lawn" areas. Stephill Bottom does not contain artificial drainage.

**Figure 1-7: Marshy grassland - "lawn" - on Penny Moor (NGR 435289 104528, looking west)**

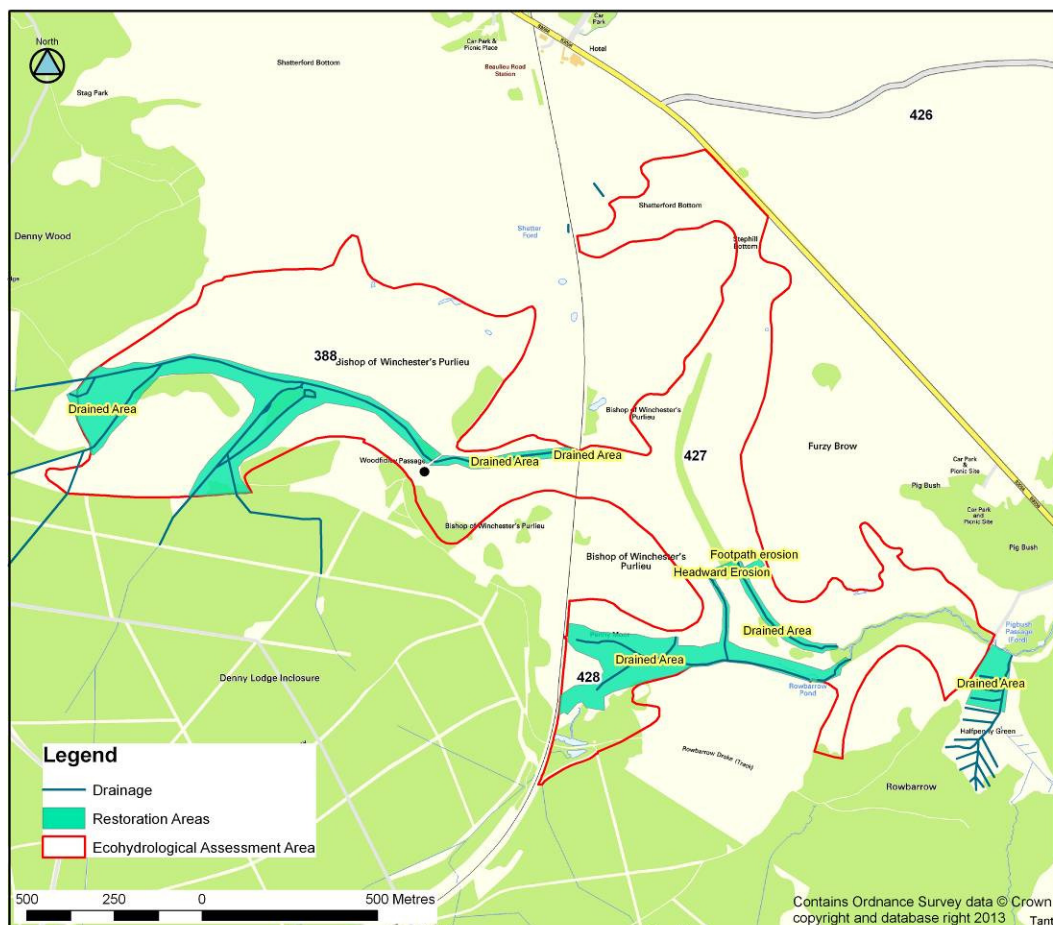
Figure 1-11: Restoration Areas Map

There are a number of areas of significant damage within Denny Bog and Penny Moor (see Figure 1-11). Most relate to drainage. In the western part of Denny Bog there are extensive "lawn" areas developed where valley mire has been destroyed by drainage and grazing. In Denny Bog East the upstream end of the surface water drainage system has undergone headward erosion. Just beyond the south-eastern boundary of Denny Bog East is an area of herringbone drainage that may be affecting water levels within the unit: this has been highlighted on the Restoration Areas Map. Footpath erosion is an issue locally.

It is understood that some restoration work has already been undertaken on Denny Bog, with heather bales being used to combat headward erosion in the eastern part of the bog<sup>2</sup>. It is recommended that the situation be monitored to determine the success of the restoration. If erosion continues then further preventative measures will be required. These could include the use of staked heather bales (where flows are not too energetic), the installation of wooden weirs and/or the infilling or re-profiling of the channel. The engineering design of suitable measures would need to be based on a detailed study beyond the scope of this report.
