River Mease SSSI/SAC Restoration Plan

Technical Report

March 2012

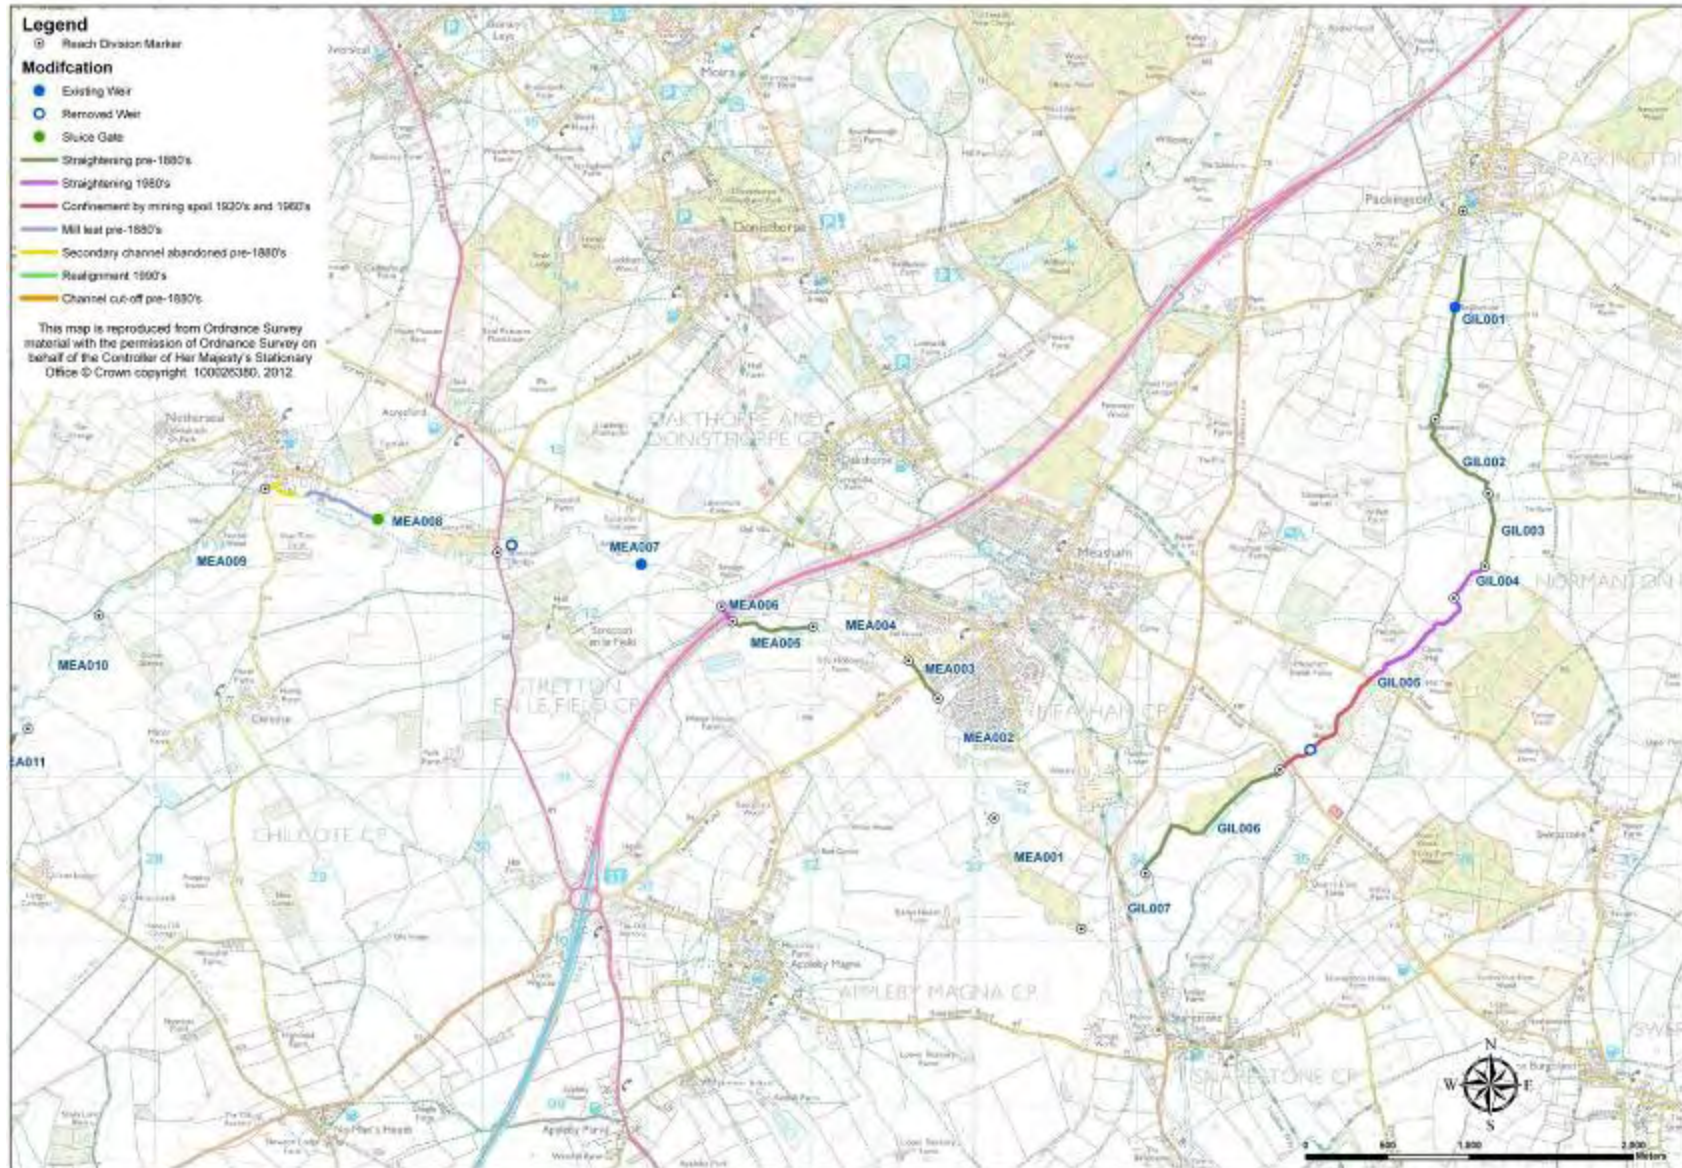
Figure 4.2: (a) Site specific river channel modifications along the upper half of the River Mease SSSI/SAC

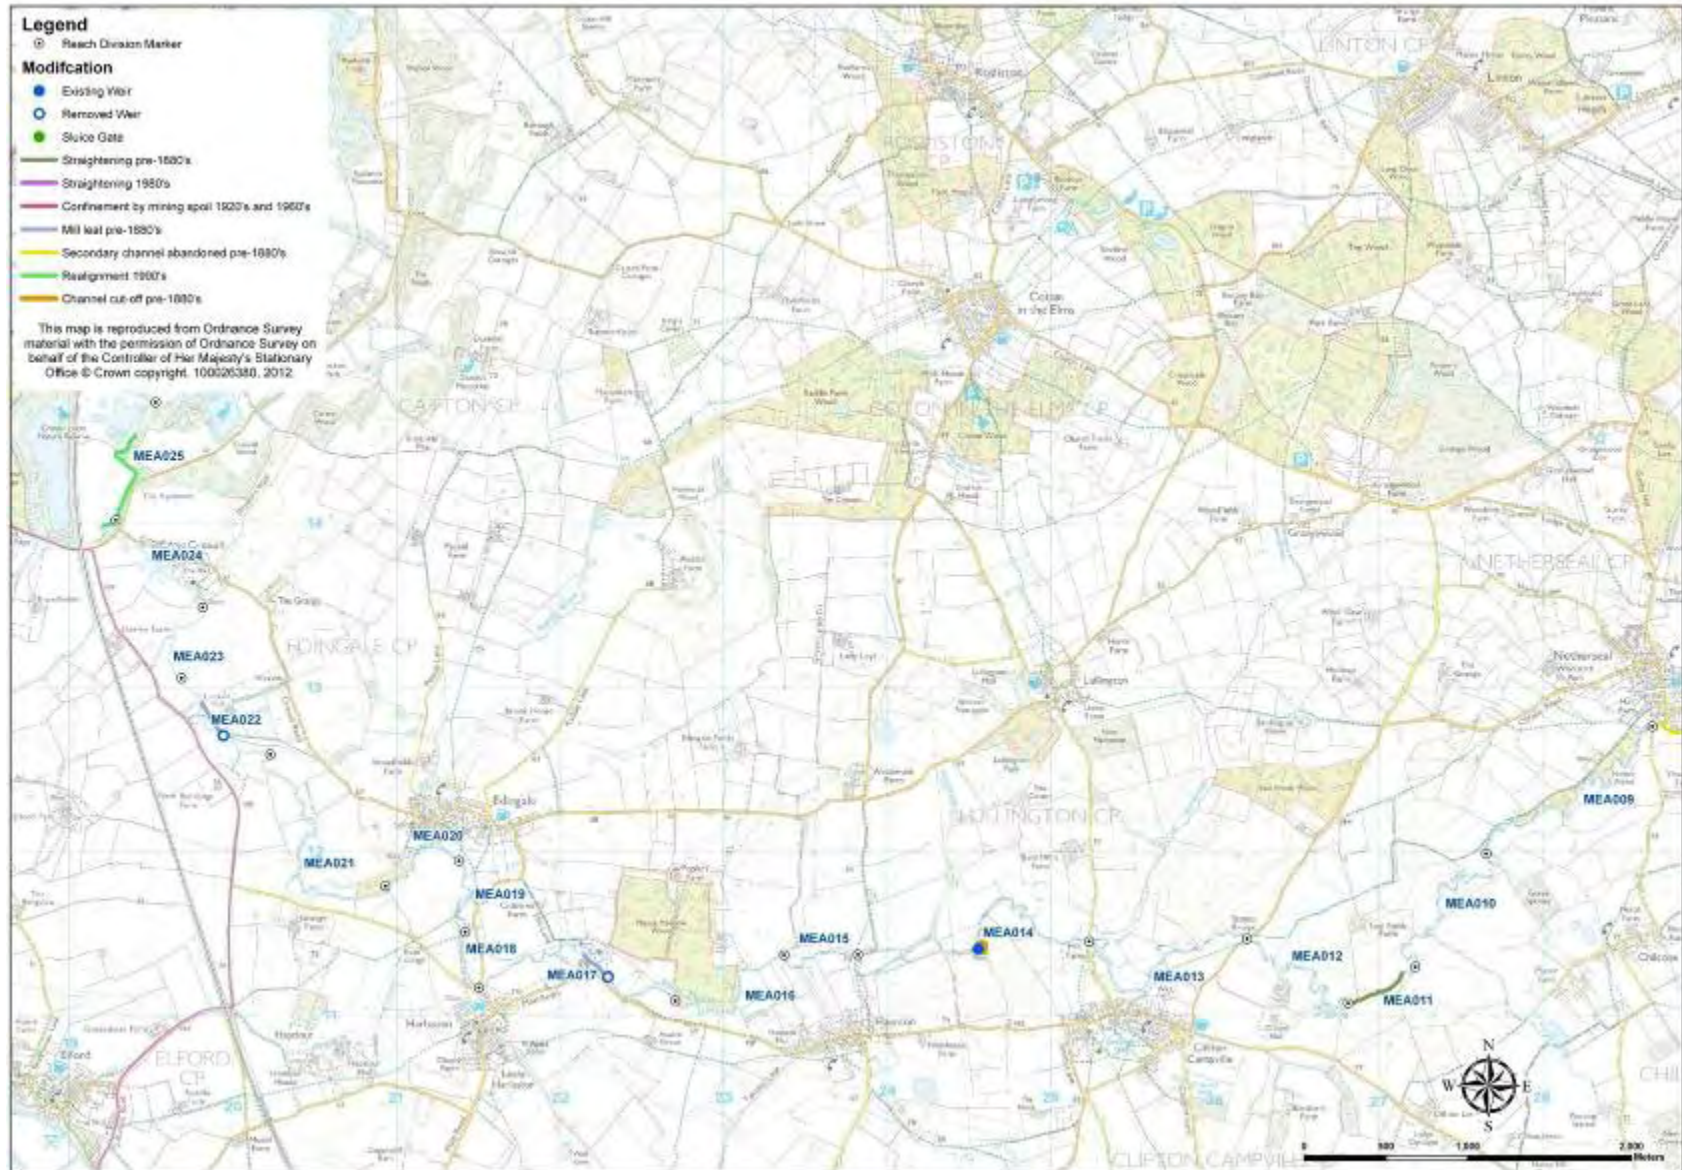
Figure 4.2: (b) Site specific river channel modifications along the lower half of the River Mease SSSI/SAC

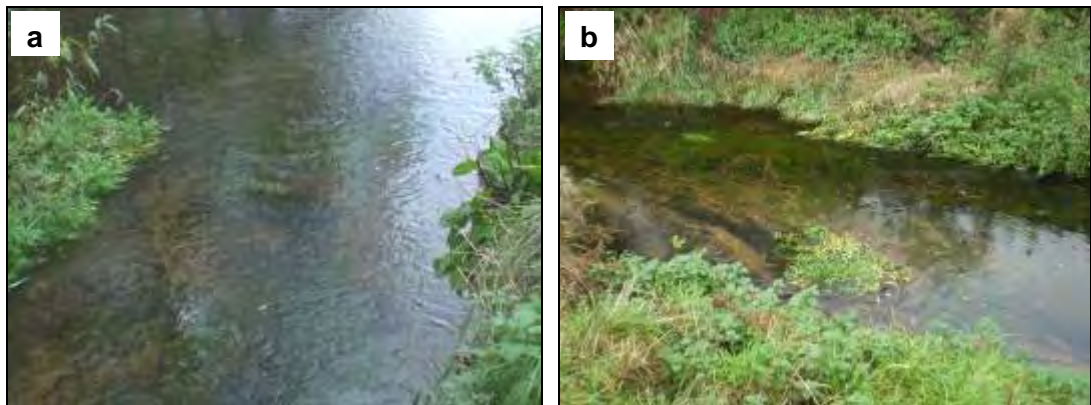
Figure 5.2: Examples of localised instances of fine sediment (sand) accumulation on the bed of the channel (a) MEA012 and (b) MEA014

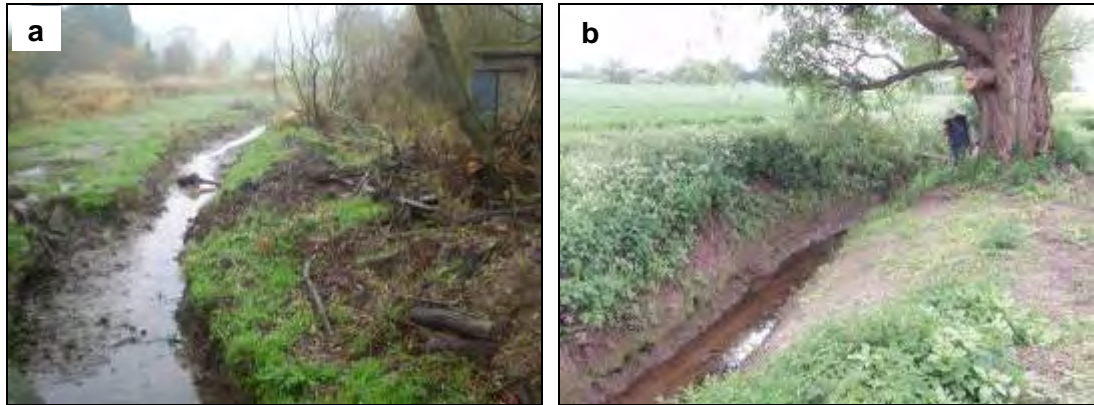
Figure 5.3: Ditch-like tributaries which act as point sources of fine sediment along reaches (a) GIL005 and (b) MEA002 (Photograph b courtesy of the Environment Agency)

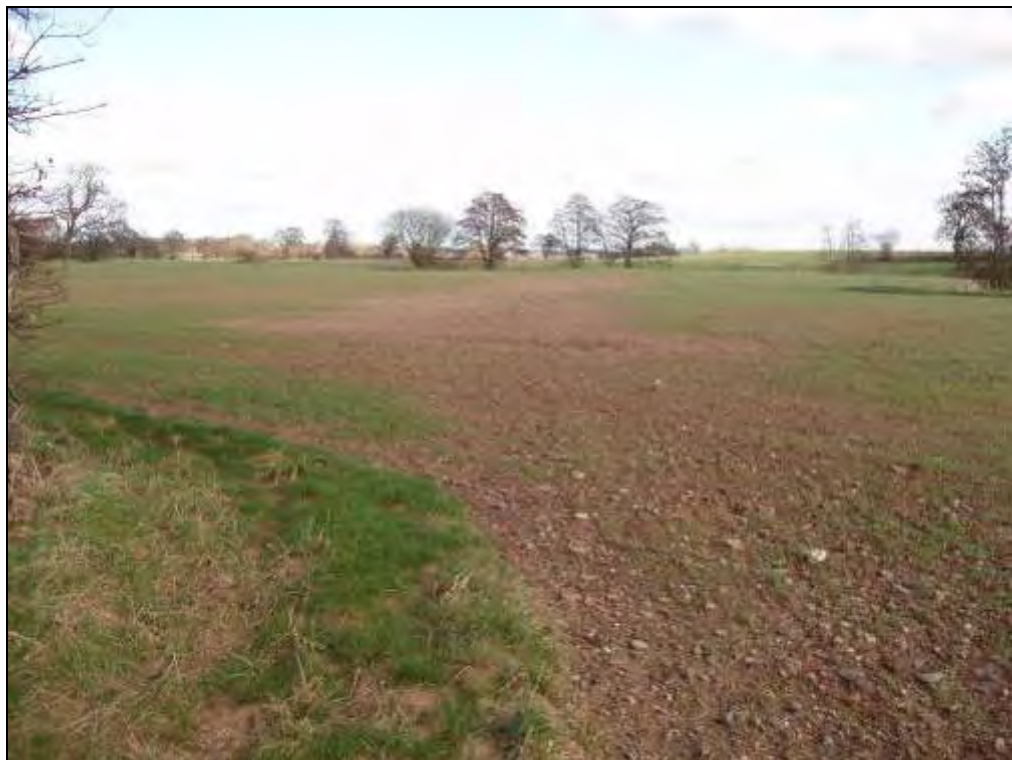
Figure 5.4: Evidence of flow across the floodplain, note the upper layer of the soil appears to be been subject to preferential erosion of fine material leaving gravel particles exposed (Photograph courtesy of the Environment Agency)

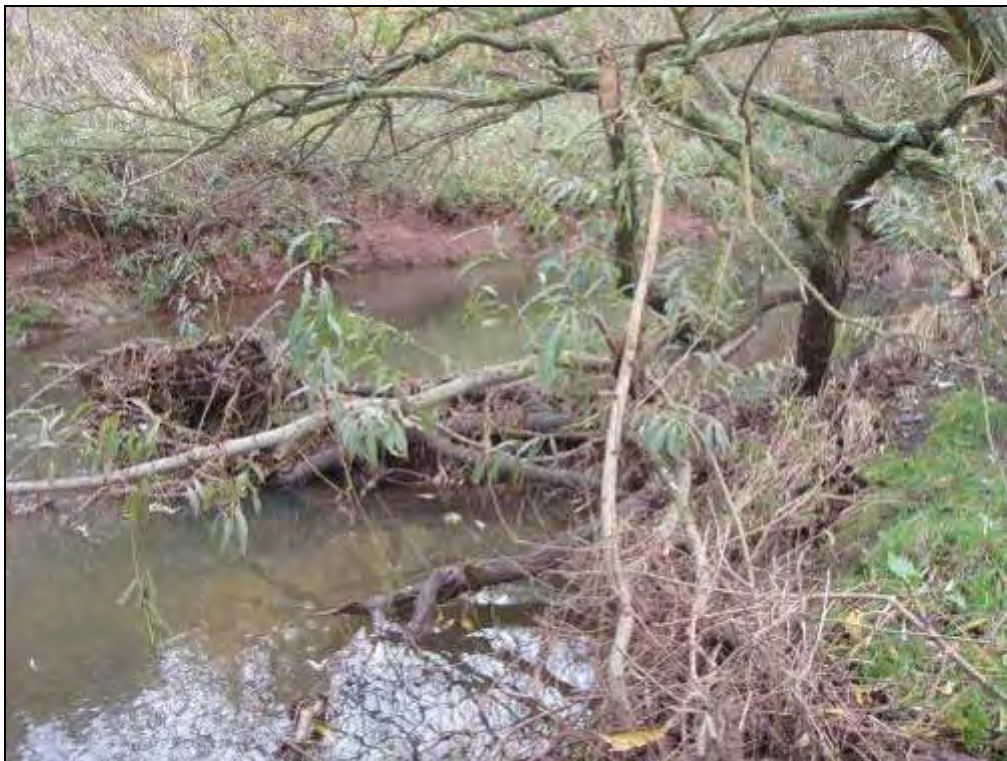
Figure 5.6: Example of an accumulation of woody debris within the channel in reach MEA025 (Photograph courtesy of the Environment Agency)

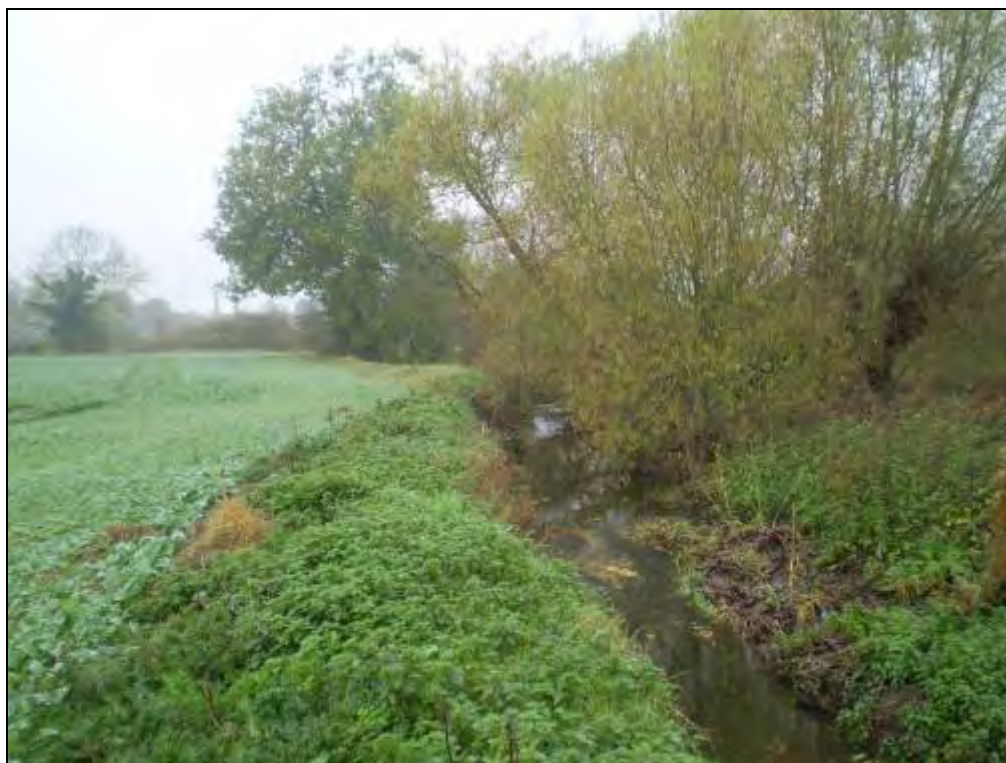
Figure 5.7: Low informal embankment along a section of Gilwiskaw Brook in reach GIL006

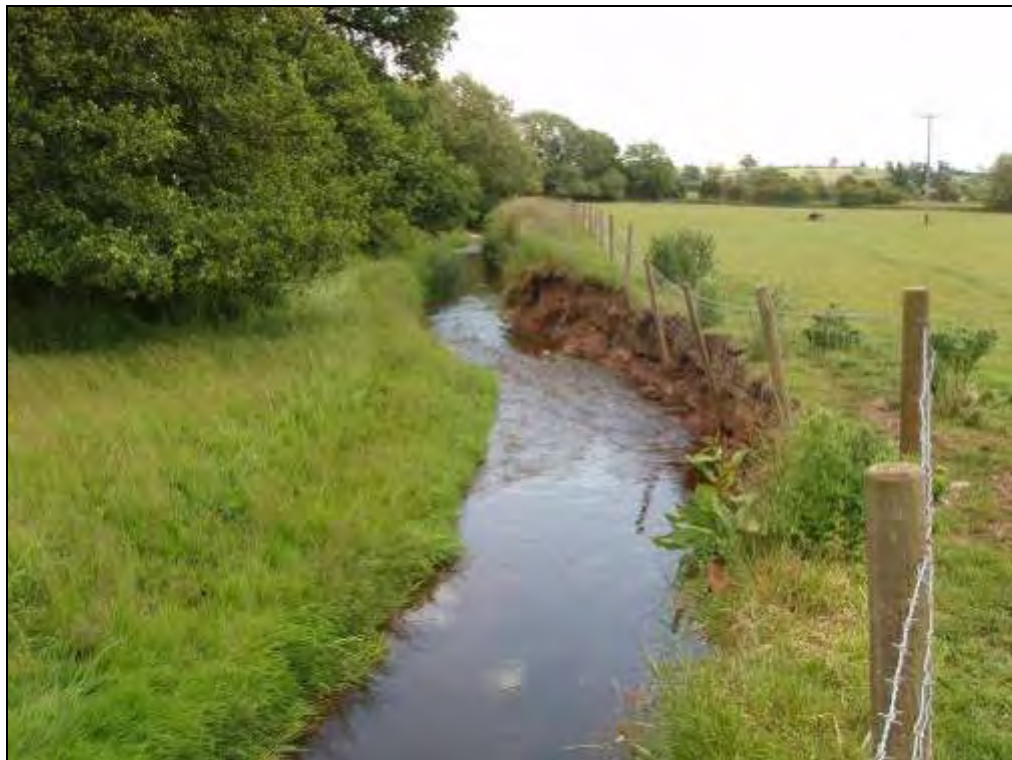
Figure 5.8: Active channel adjustment (bank erosion, riffle formation and increased channel sinuosity) along Gilwiskaw Brook (reach GIL002) (Photograph courtesy of the Environment Agency)

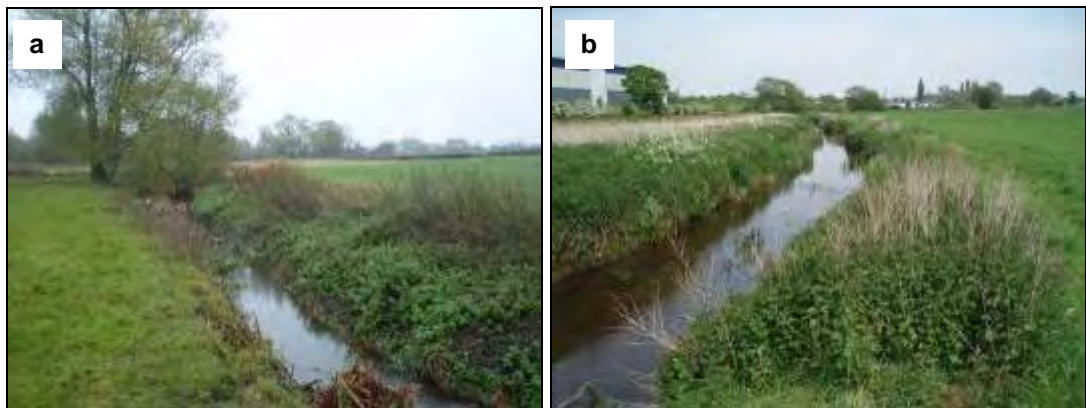
Figure 5.9: Examples of sections of channel with uniform cross-section indicative of past re-sectioning (a) reach MEA002 and (b) MEA005 (Photograph b courtesy of the Environment Agency)
