Natural England Commissioned Report NECR141

New Forest SSSI Ecohydrological Survey Overview

Annex K: Ma 5 Wet 5 Part 2

First published 06 March 2014

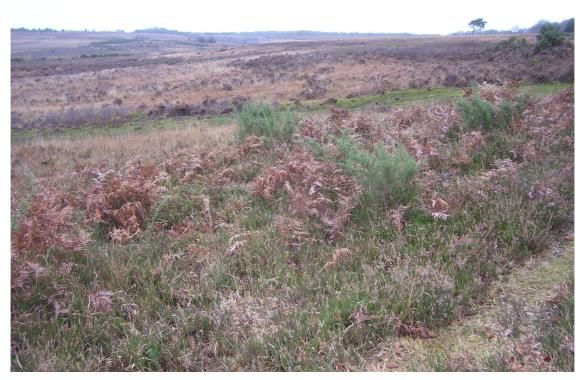
Figure 1-2: General view of one of the valley side mires showing the break in slope associated with the edge of the river terrace deposits, which are marked by brown heather (NGR 425236 109941)

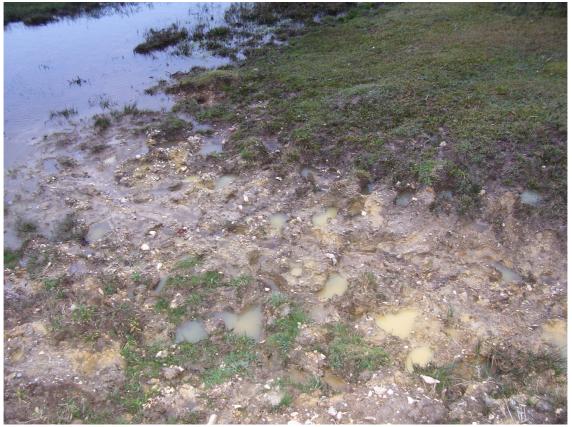
Figure 1-3: Poached ground; footpath crossing Withybed Bottom at the eastern edge of the site (thin mantle of stony head overlying Barton Clay) (NGR 425524 110566)

Monitoring of the poached areas, particularly the east of Withybed Bottom and around the stream in the area west of Highland Water, should also be undertaken to ensure the areas of localised damage do not increase.

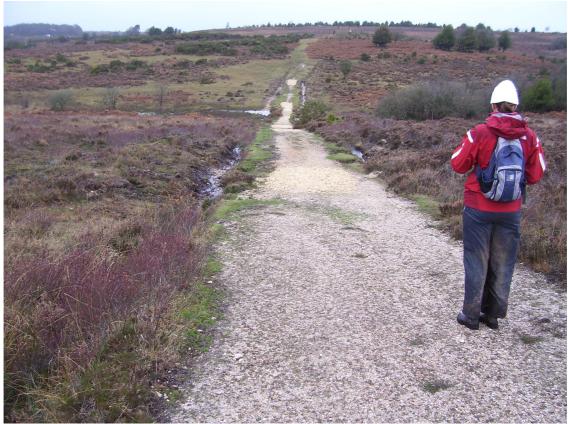
Figure 1-4: View of footpath crossing Withybed Bottom showing small track-side drainage ditches (NGR 425601 110510, looking northwest)

At the north-eastern edge of Withybed Bottom, a footpath forms the unit boundary. There are small open drainage ditches here on each side of the track (Figure 1-4).

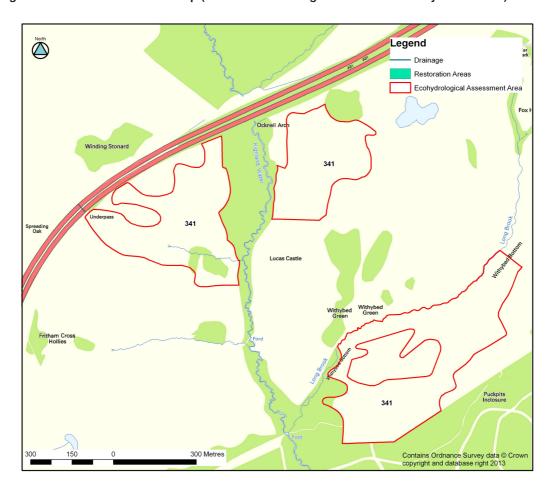
There are no areas of significant hydrological damage (see Figure 1-6):

Figure 1-6: Restoration Areas Map (minor track drainage not shown in Withybed Bottom)

Within Withybed Bottom, particularly in the south-western portion, Scot's Pine seedlings are beginning to encroach into wet heath areas; control of this should be undertaken to prevent further encroachment and degradation of habitats.

Restoration Area	Damage Type	Restoration Proposals	Improvement	Constraints and Issues
Withybed Bottom	Scot's Pine encroachment	Scrub clearance	Removal of Scot's Pine which could result in localised drying of wet heath and mire habitats impact on communities present	None identified
