New Forest SSSI Geomorphological Survey Overview

Annex R: Dockens Water Woods Restoration Plan - SSSI Unit
545

First published 06 March 2014

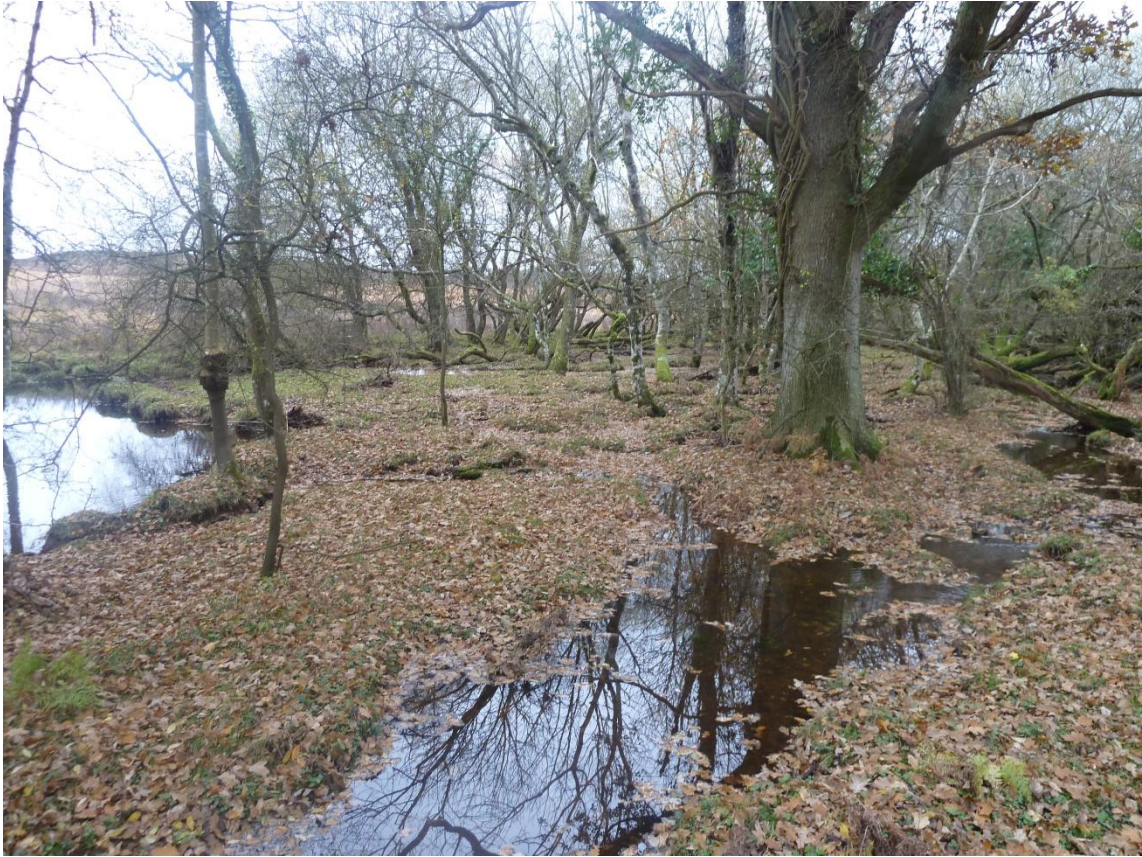
- short lowland anastomosed sections (Figure 1-2), particularly in the mid to lower reaches e.g. Splash Bridge and some sections just downstream of this;
- active single thread channels between anastomosed sections with a good gravel supply, this is the dominant channel type (Figure 1-3).

Figure 1-2: Anastomosed channel section

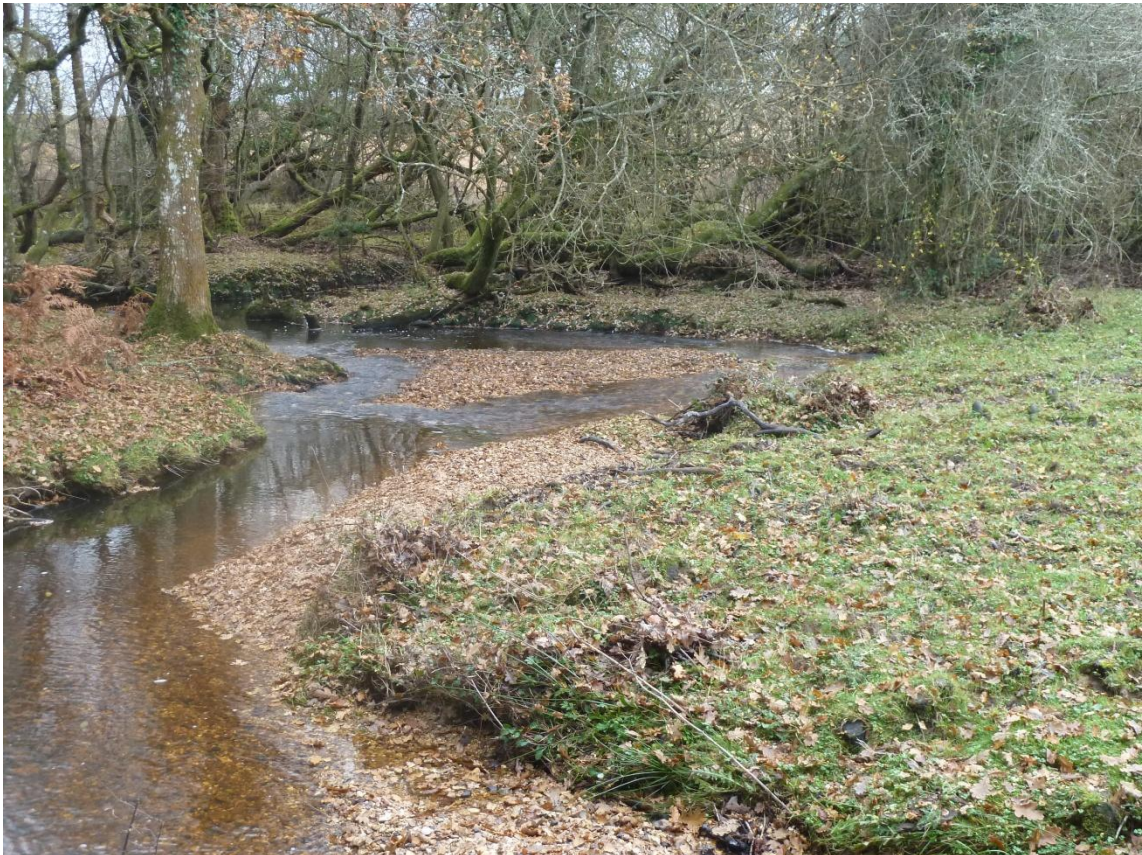
Figure 1-3: Active single thread characteristics

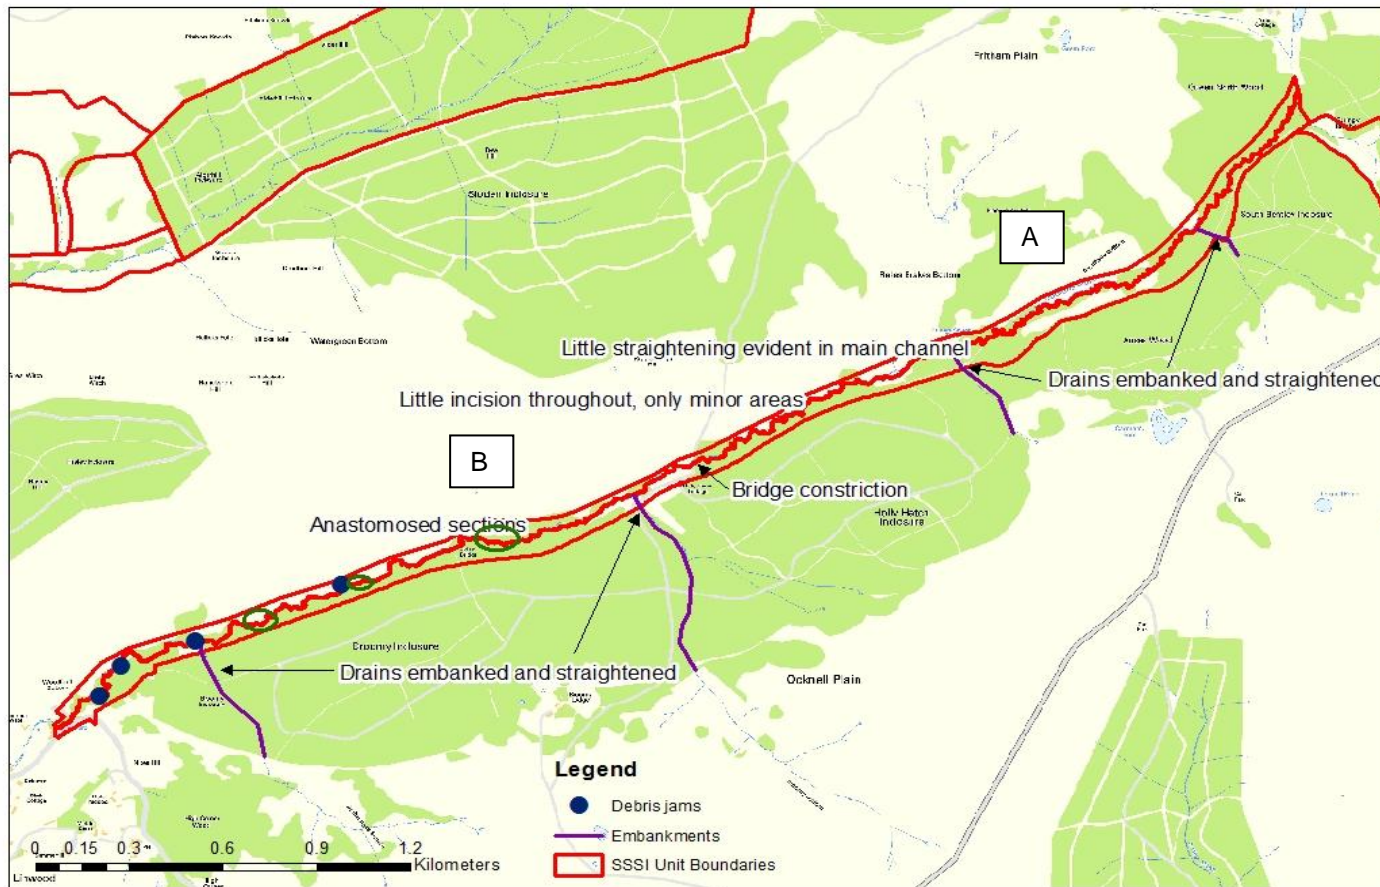
Figure 1-4: Current hydromorphic conditions and pressures

The Dockens Water has a moderate gradient, particularly in the upper active single thread reaches (Figure 1-4 - A). The gradient is shallower through the short anastomosed section (Figure 1-4 - B). Some sections may have been modified / straightened in the past, although this does not appear to be widespread. This may account for the limited incision seen within this unit throughout in combination with the limited bankside embankments and generally good floodplain connectivity. This results in flood water spreading over a wide area, reducing in channel flood shear stress levels and erosive potential. However, bank erosion does still naturally occur at higher flows, particularly on the outside of bends where flows are concentrated on the outer banks and where gravel shoal deposits encourage channel asymmetry and widening (Figure 1-5).

Where floodplain connectivity is good, within the wooded sections, a multi-thread anastomosed channel network has developed between stabilised wooded areas (Figure 1-4 - B). Lateral and vertical erosion is reduced through these sections as channels are wetted at different flow levels, spreading erosive energy across a wide area as flow levels increase. Whilst on site, high flow levels showed the anastomosed channel network well (Figure 1-2). The success of the anastomosed networks is assisted by local natural debris jams which maintain improved floodplain connectivity (Figure 1-7).

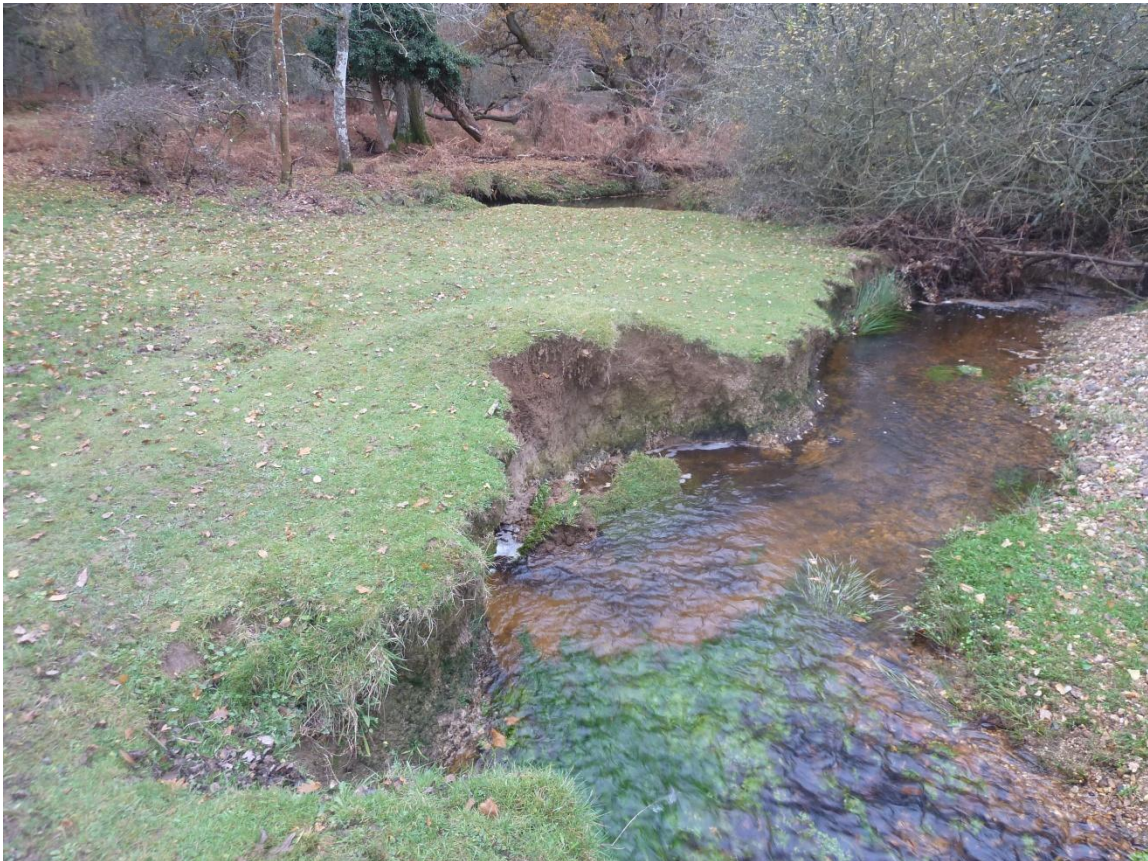
Figure 1-5: Bank erosion associated to gravel bar growth

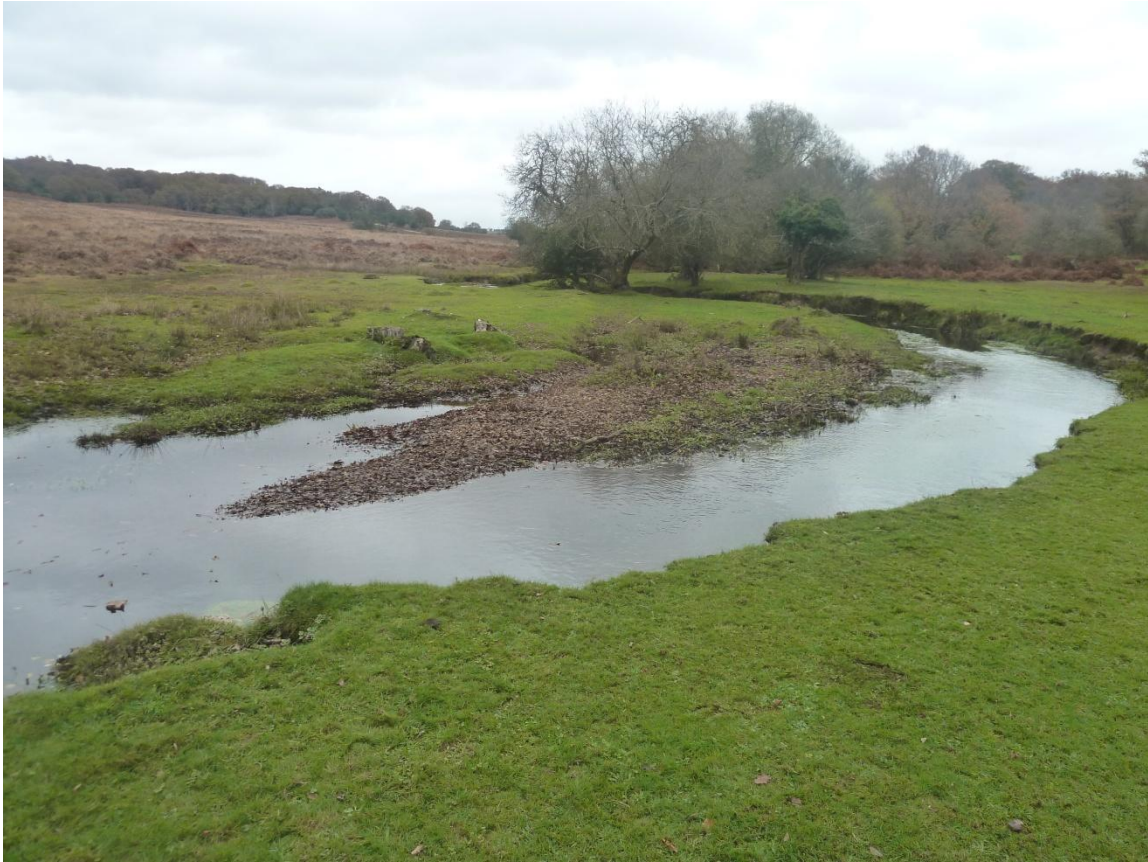
Figure 1-6: Bank erosion associated to gravel point bar growth at a meander

Where the channel banks are stronger (due to the presence of more resistant boulder clays rather than fluvio-glacial gravels or where riparian woody vegetation is dense enough to provide a coherent resistant root mat) limited erosion occurs and it was clear from the audit that erosion was certainly more widespread in the heavily grazed sections where bank cohesion is limited due to a lack of a resistant deep root mat (Figure 1-6).

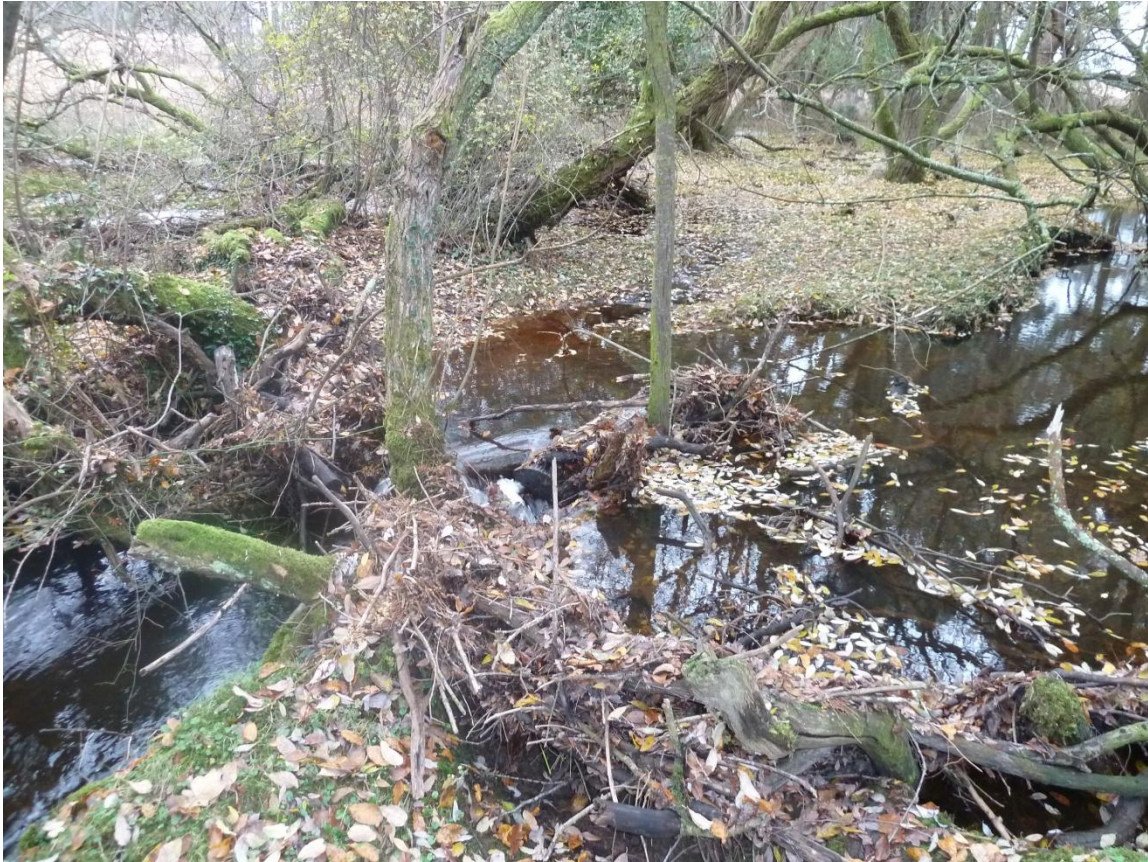
Figure 1-7: Debris jams

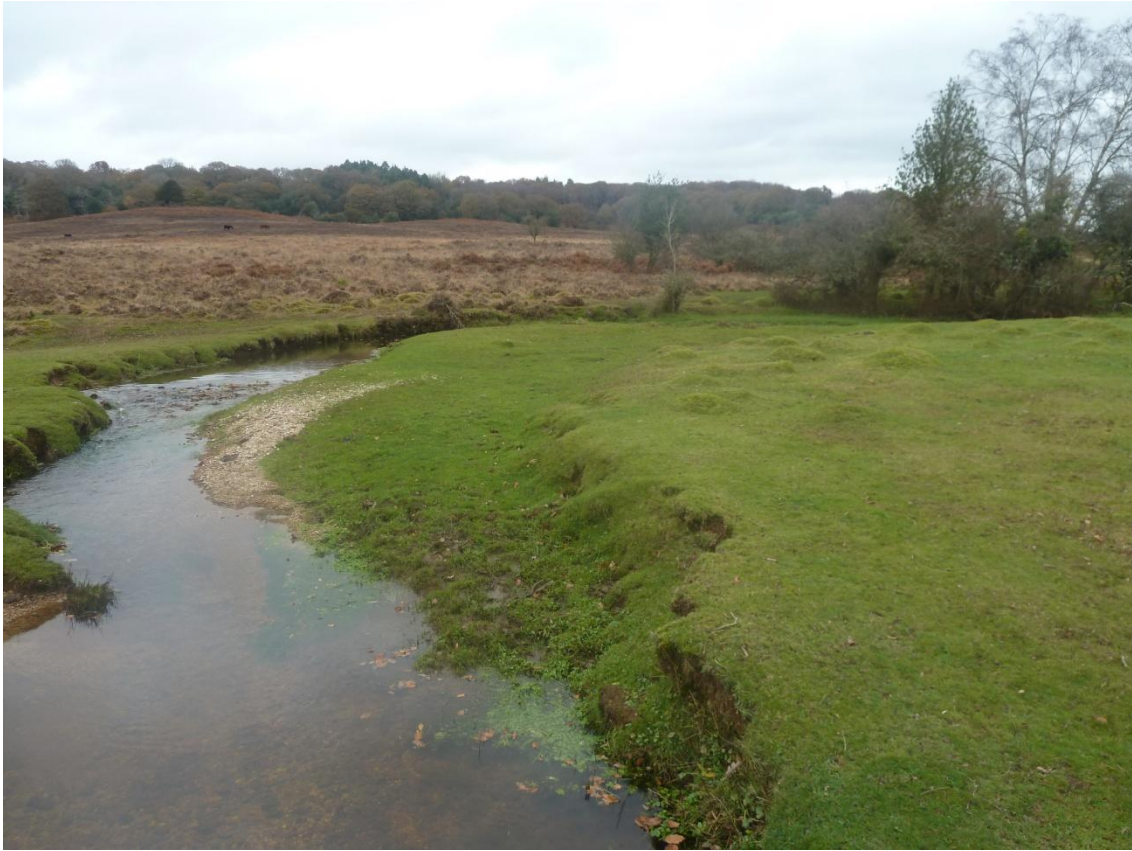
Often in rivers with moderate to high energy, lateral erosion and widening is also associated with bar deposition concentrating flows around gravel shoals and promoting further lateral activity (Figure 1-3). This is particularly true for the active single thread sections of the Dockens Water, where continual bar growth has result in channel widening and migration (Figure 1-8).

Figure 1-8: Progressive bar development and channel widening

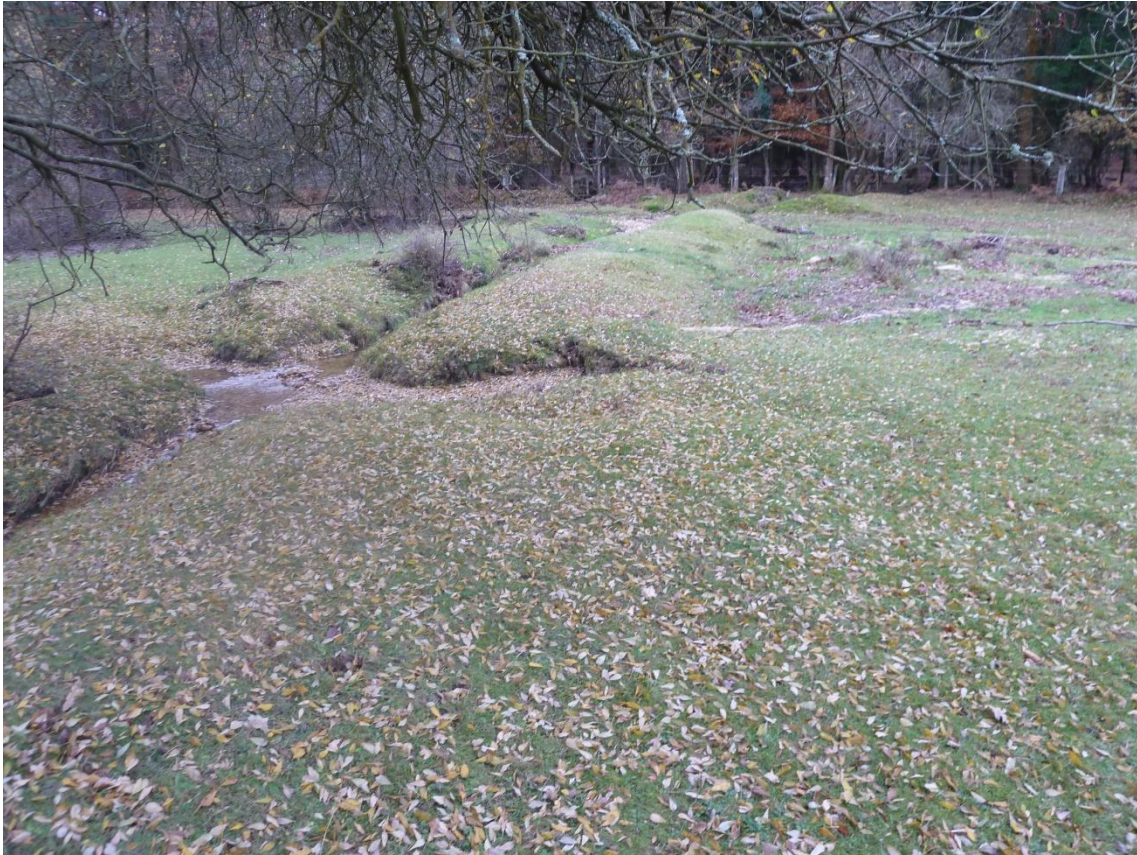
There are numerous drains and ditches over both banks within the unit, some of which have clearly been artificially modified through straightening, embanking and deepening (Figure 1-9). This will have impacted on the flood flow regime of the watercourse creating a more responsive system where flood peaks are concentrated and increased and water enters the main channel more efficiently. The degree of artificial drain creation / modification is shown in Appendix A and is impacting on the flow regime, particularly where drains flowing parallel to the watercourse collect surrounding inflows and concentrate them in the main channel at one point. There is some minor incision in a few of the drains and the connectivity to the floodplain has been significantly impacted through embanking, creating drier surrounding floodplain conditions lowering groundwater levels.

Figure 1-9: Artificial drain showing straightening and embankments

Groundwater levels have also been altered as a result of the deepening and spoil dumping (embankment creation). Sections of the immediate floodplain have become drier than natural in some of the sections of this unit.

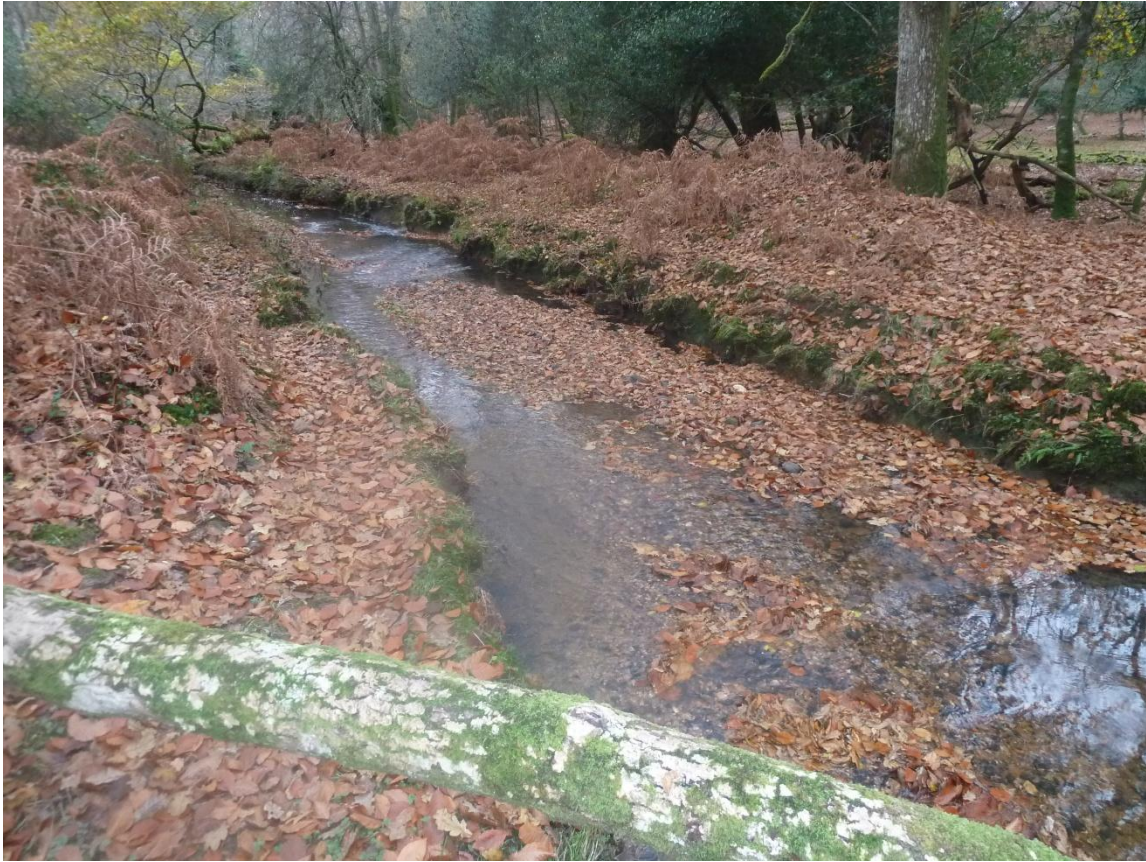
The strong supply of gravels has resulted in significant gravel feature growth within the channel in the throughout and particularly where gradients are shallower in the form of mid channel bars, lateral bars, transverse bars and point bars (Figure 1-3). The good connectivity to the floodplain provides conditions where deposition is promoted, forming dynamically stable features. In the upper reaches, features are generally composed of larger gravels and cobbles (Figure 1-10) due to the steeper gradient and higher energy flow conditions with most of the smaller gravels transported downstream.

Figure 1-10: Larger gravel / cobble features in upper reaches

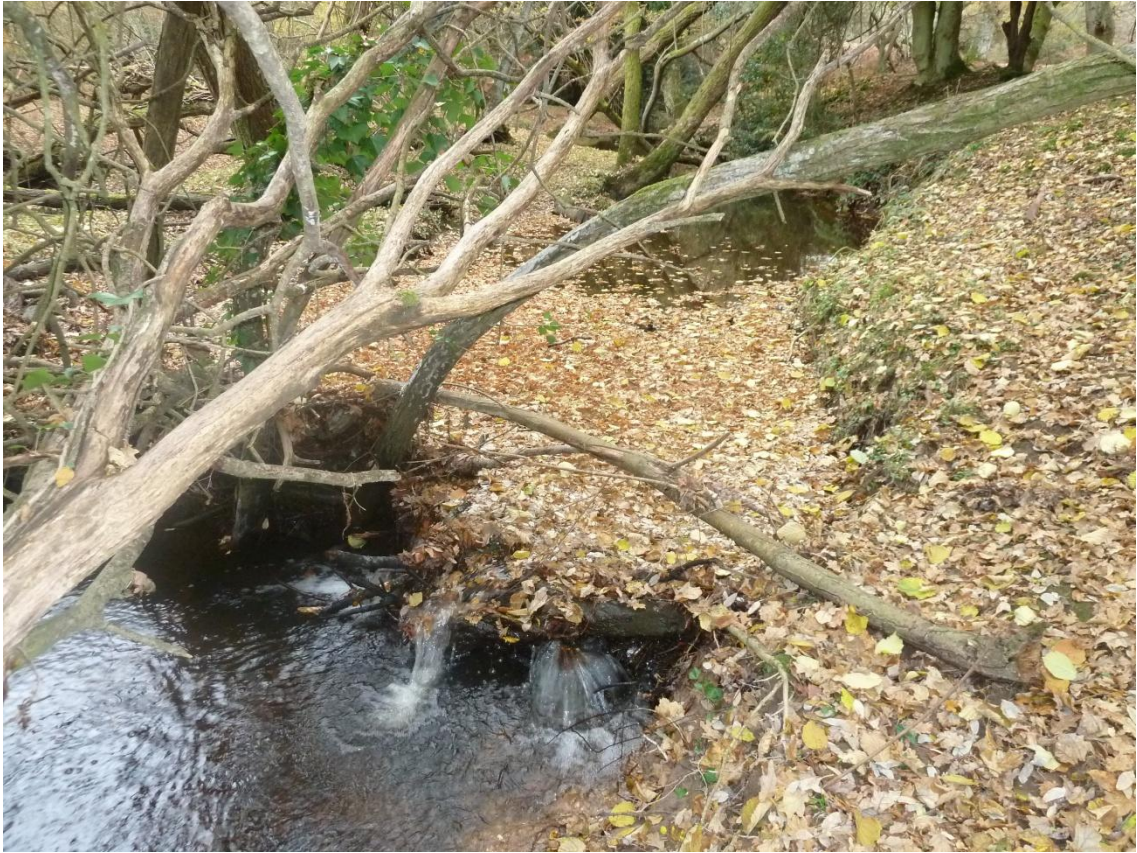
Natural woody debris features are common along the channel, particularly in the mid to lower sections, which have often been created as a result of local bank erosion / collapse (Figure 1-11). These create short lengths of impounded watercourse that does improve floodplain connectivity significantly, as is clearly seen in the anastomosed sections of this unit. These provide useful analogue features for the restoration plan.

Figure 1-11: Natural woody debris jams

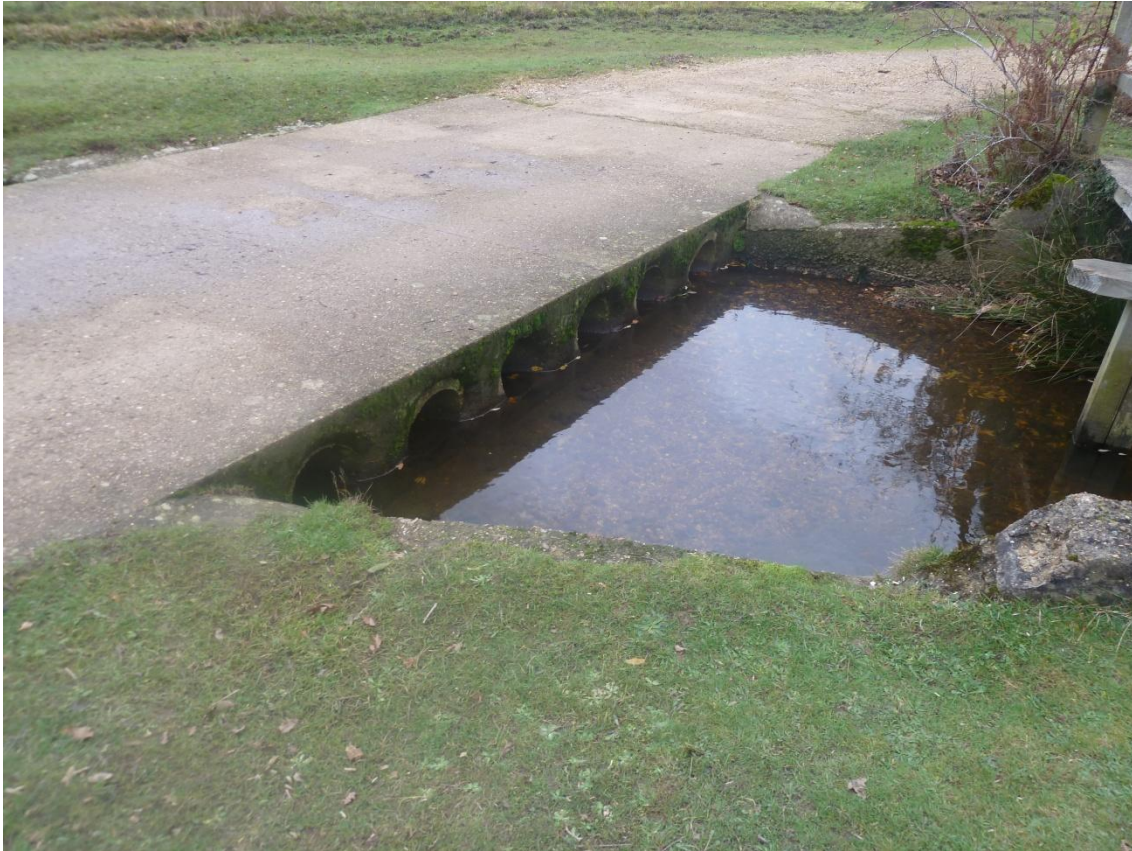
One of the bridge structures within the unit has been identified for improvement / replacement (see Table 1-2), close to Holly Hatch Cottage, which is currently creating a constriction to channel development and is interrupting the flow and sediment regime due to the pipe design (Figure 1-12).

Figure 1-12: Bridge at Holly Hatch Cottage

Flood risk may need to be considered here due to location of Holly Hatch Cottage close to the watercourse and a Flood Risk Assessment may be required.

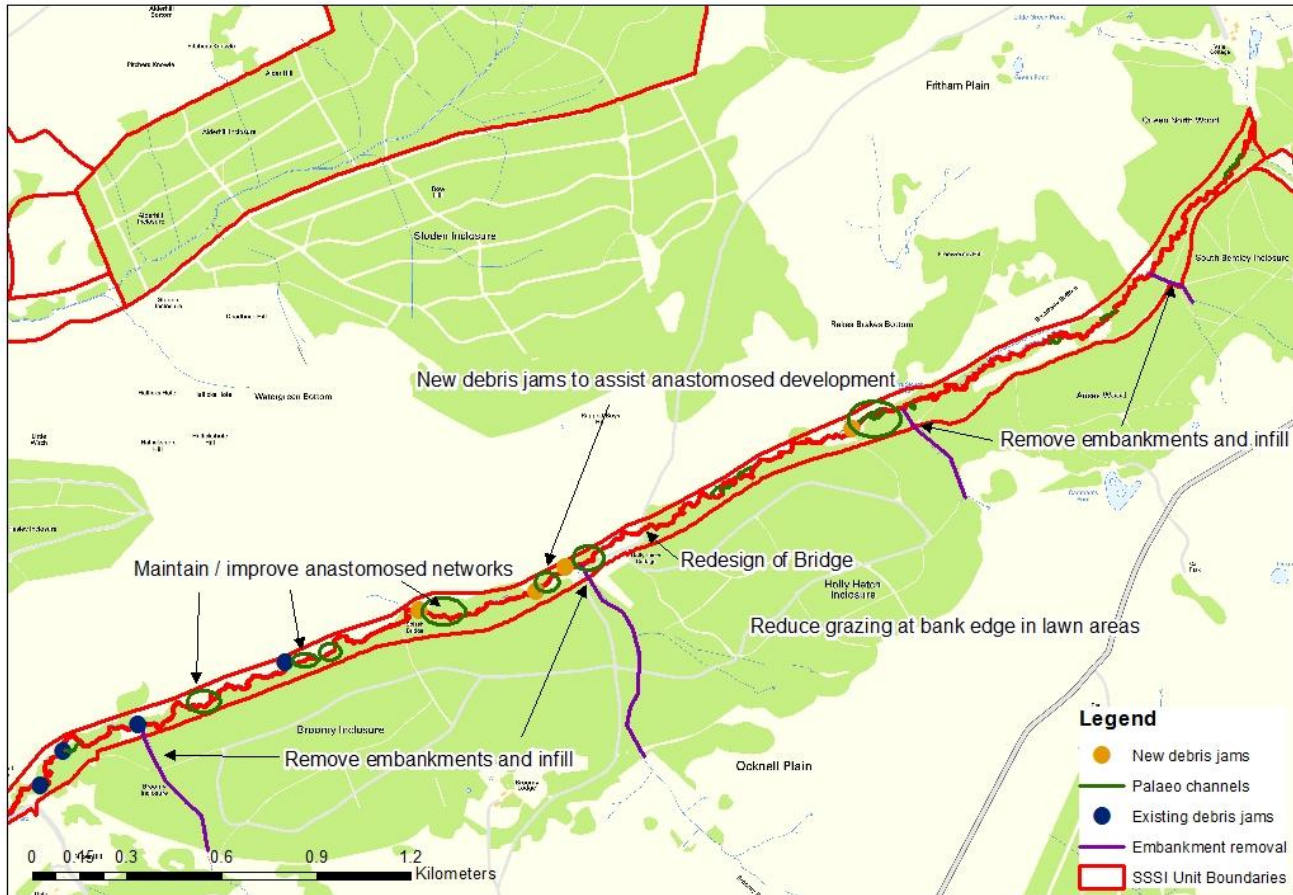
Figure 1-15: Proposed restoration measures for SSSI Unit 545

Palaeo channels have been identified in Figure 1-15 and show where reconnection could be possible through some of the proposed restoration measures in Table 1-2. These have been identified from the audit and supplied LIDAR. Reconnecting these whilst maintaining the existing channel will encourage further anastomosed network development.

A summary of the current pressures, unmitigated impacts and restoration proposals is given in Table 1-2 and shown in Figure 1-15.

- Palaeo channel reconnection, alongside embankment removal will create improved morphological features;
- Improved anastomosed channel network development through the use of woody debris jams to improve floodplain connectivity will improve hydromorphological diversity and encourage naturalisation;
- Better floodplain connection through water level raising and artificial drain restoration;
- Opportunities to increase the area and improve the quality of bog woodland, wet grassland and wet heath habitats within the floodplain.

The major straightened / modified drainage channels are identified in Figure 1-15. Other minor modifications could be considered for infilling and Appendix A should be used for reference.
