# New Forest SSSI Geomorphological Survey Overview

Annex C: Amberwood / Alderhill Restoration Plan - SSSI Unit  
66

# 1 Amberwood / Alderhill Restoration Plan - SSSI Unit 66

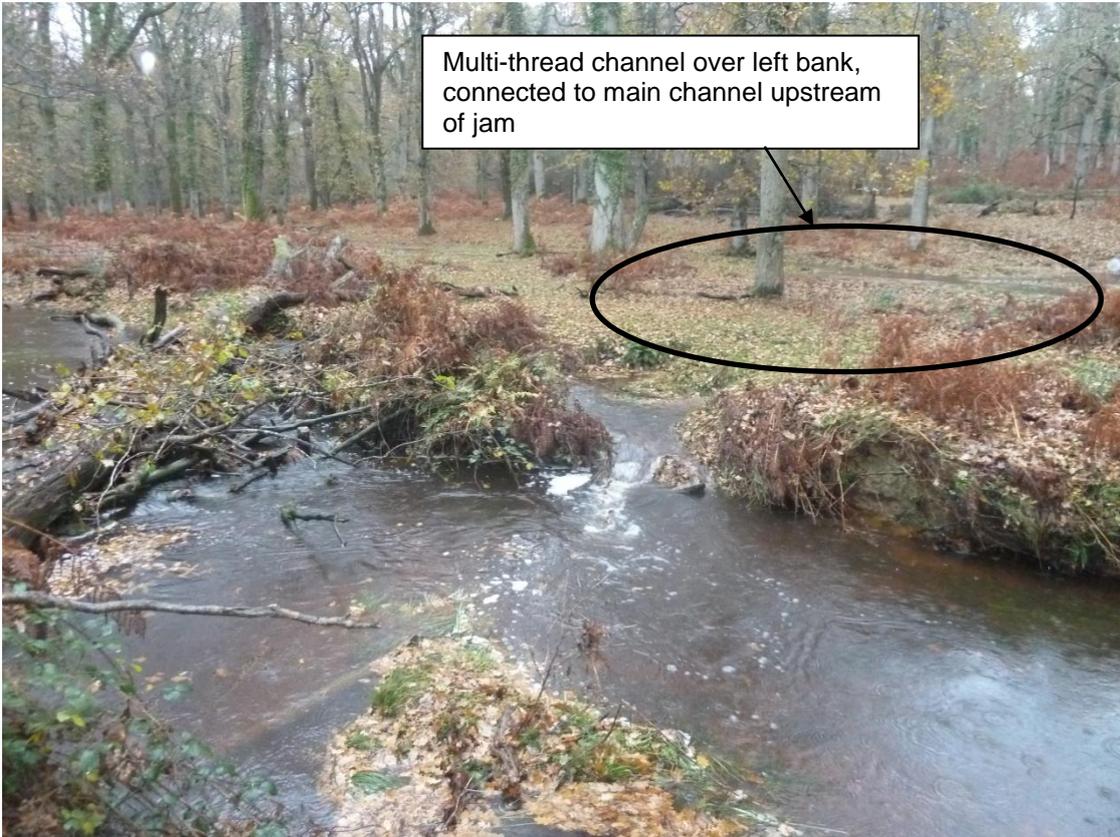
- a weakly lowland anastomosed system, particularly in the mid to upper reaches where debris jams have created better upstream connectivity, activating a multi-thread system at higher flows (Figure 1-2);
- an active single thread channel, with some characteristics of an actively widening channel type where banks are erodible and gravel inputs are strong (Figure 1-3);
- a passive single thread channel where bank cohesion is higher.

Figure 1-2: Weak anastomosed channel at debris jam

Where the channel banks are stronger (due to the presence of more resistant boulder clays rather than fluvio-glacial gravels or where riparian woody vegetation is dense enough to provide a coherent resistant root mat) erosive energy will have been directed at vertical incision leading to an over-deep channel, this is particularly true in the downstream section of unit 66 (Figure 1-4 - B). Where the banks are less resistant (due to tree clearance, presence of gravels etc.) lateral erosion will also have occurred. This is evident in locally widened sections, particularly in the upper sections of Unit 66 (Figure 1-4 - A). Where floodplain connectivity is improved, within the wooded upper section, a multi-thread anastomosed channel network is evident, although this is presently disconnected significantly from the main channel. Whilst on site, high flow levels had activated some of the anastomosed channels within the floodplain, however, restoration would look to increase the frequency of wetting of these channels (Figure 1-2). The anastomosed network is assisted by debris jams which have provided local improved floodplain connectivity (Figure 1-2).

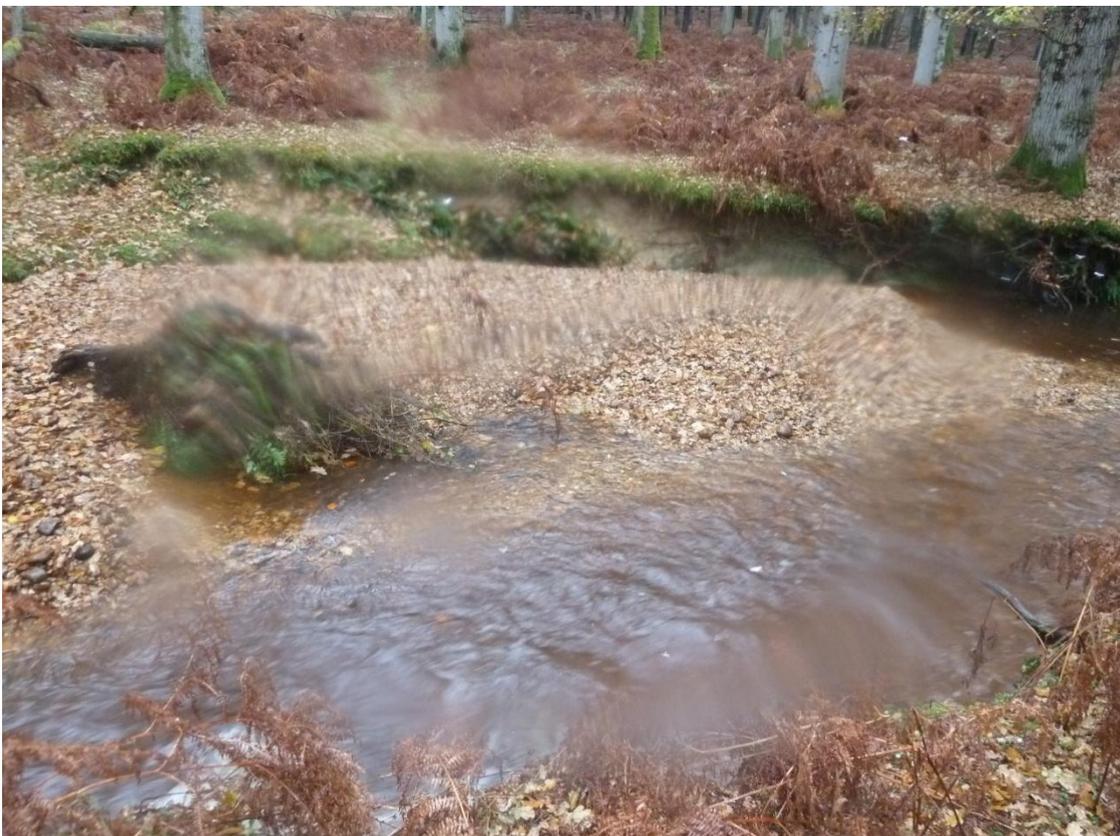
Figure 1-3: Actively widening characteristics in some locations

Often in rivers with moderate to high energy, lateral erosion and widening is also associated with bar deposition concentrating flows around gravel shoals and promoting further lateral activity (Figure 1-3). This is particularly true for the upper sections of this reach of the Latchmore Brook.

The strong supply of gravels has resulted in significant gravel feature growth within the channel in the upper reaches where gradients are shallower in the form of mid channel bars, lateral bars, transverse bars and point bars (Figure 1-3). Poor connectivity with the floodplain means that the pattern of erosion and deposition is exaggerated (as a result of incision and embankments) meaning growth has been enhanced locally, particularly in areas where widening can readily occur.

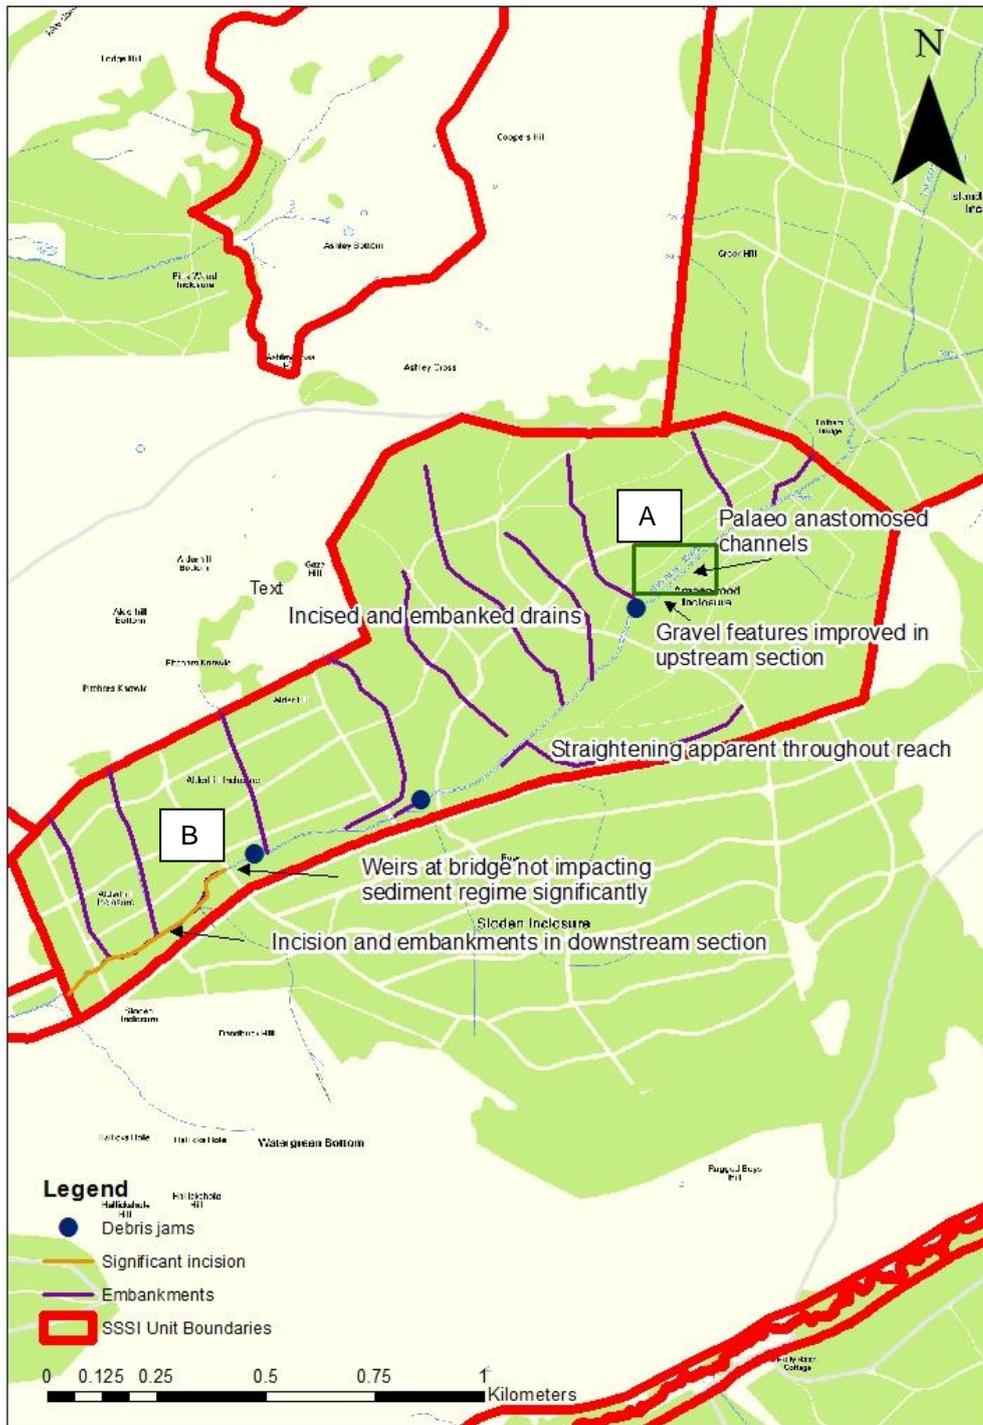
Figure 1-4: Current hydromorphic conditions and pressures

The gradient of this middle reach of the Latchmore Brook is reduced compared to upstream Unit 540. The gradient visibly reduces in the upper section of this unit where gravel features are improved and where anastomosed palaeo channels exist in the local floodplain (Figure 1-4 - A), albeit currently disconnected. It is also clear that significant channel straightening has been

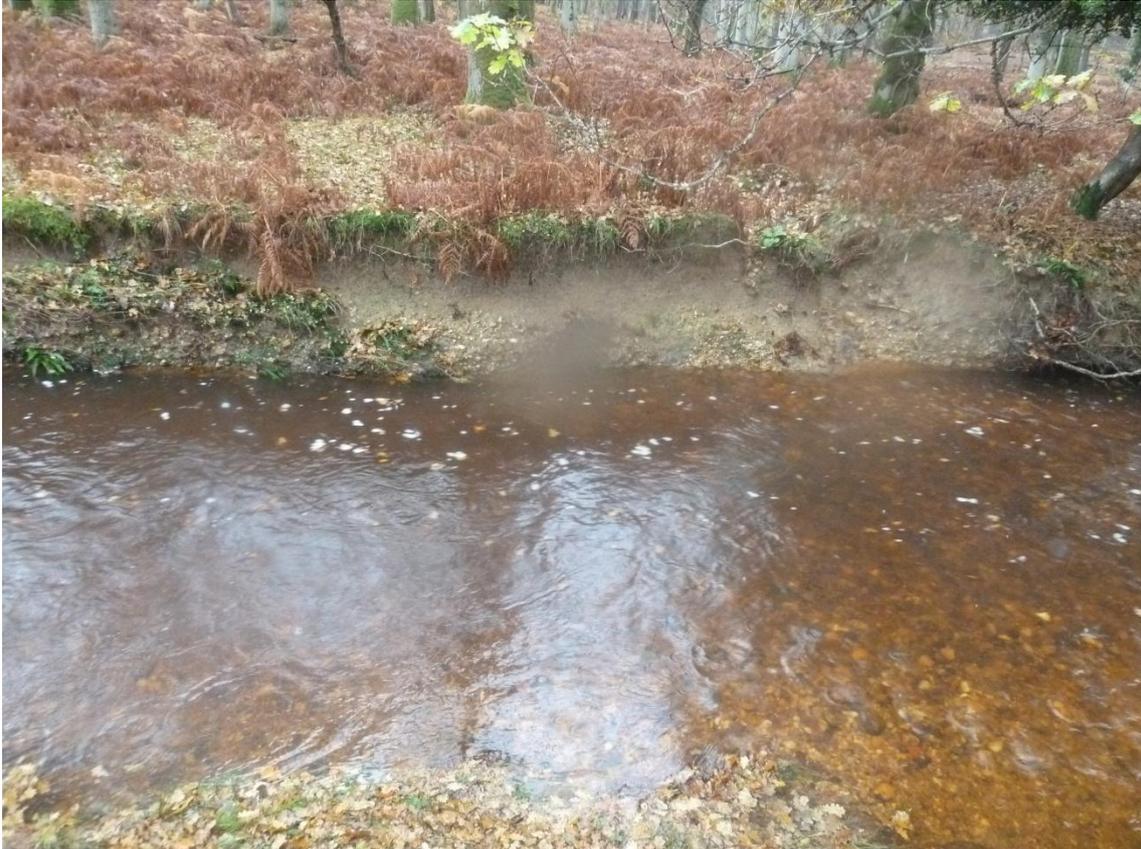
undertaken (from maps and LIDAR) in the past along the majority of the reach. Straightening of the watercourse has had a profound effect on the nature and functioning of the river. The length of watercourse will have been shortened leading to a steepening of the system and the associated dredging will have over-deepened the channel. This in combination will have increased flood shear stress levels promoting erosion (Figure 1-5).

Figure 1-5: Bank erosion along reach

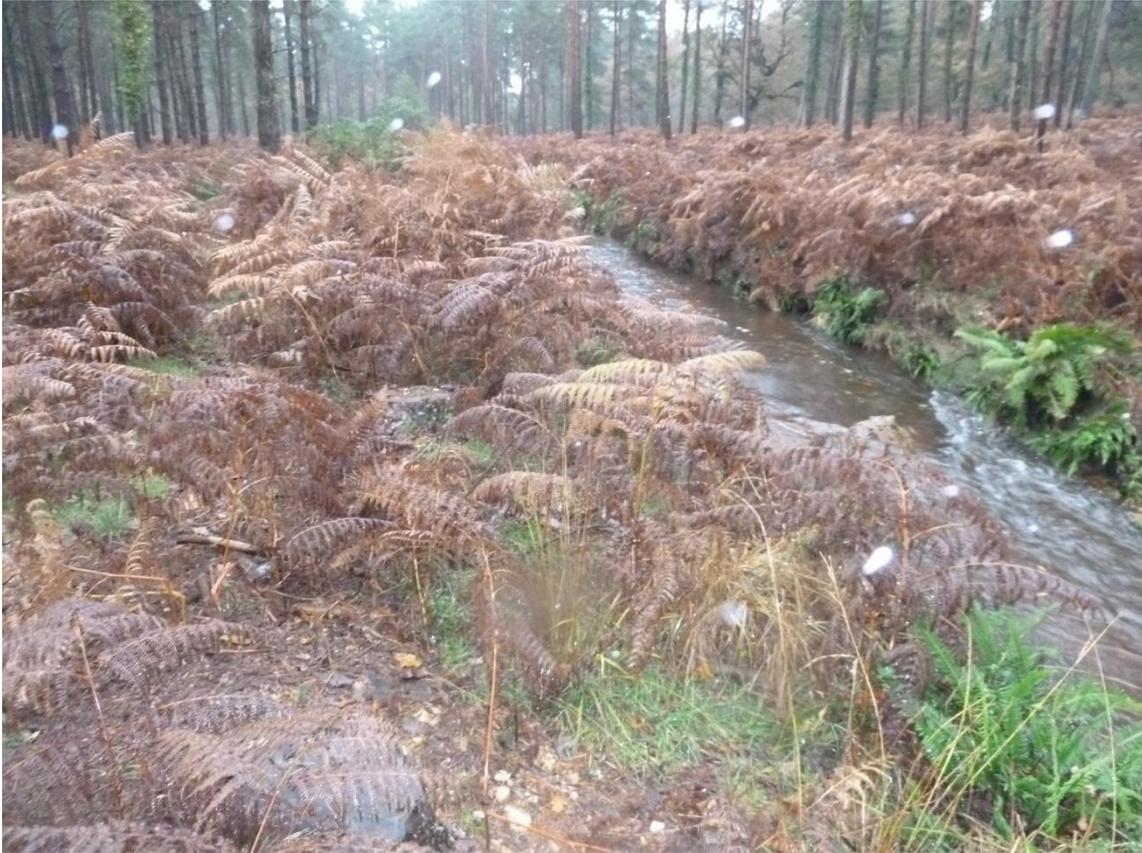
The initial impact of straightening would have been incision along significant lengths of the wooded watercourse (Figure 1-6) and widening across areas with erodible banks. This initial incision episode is likely to have caused the multiple knick point development moving through the tributary / drain systems (Figure 1-7).

Figure 1-6: Downstream incision

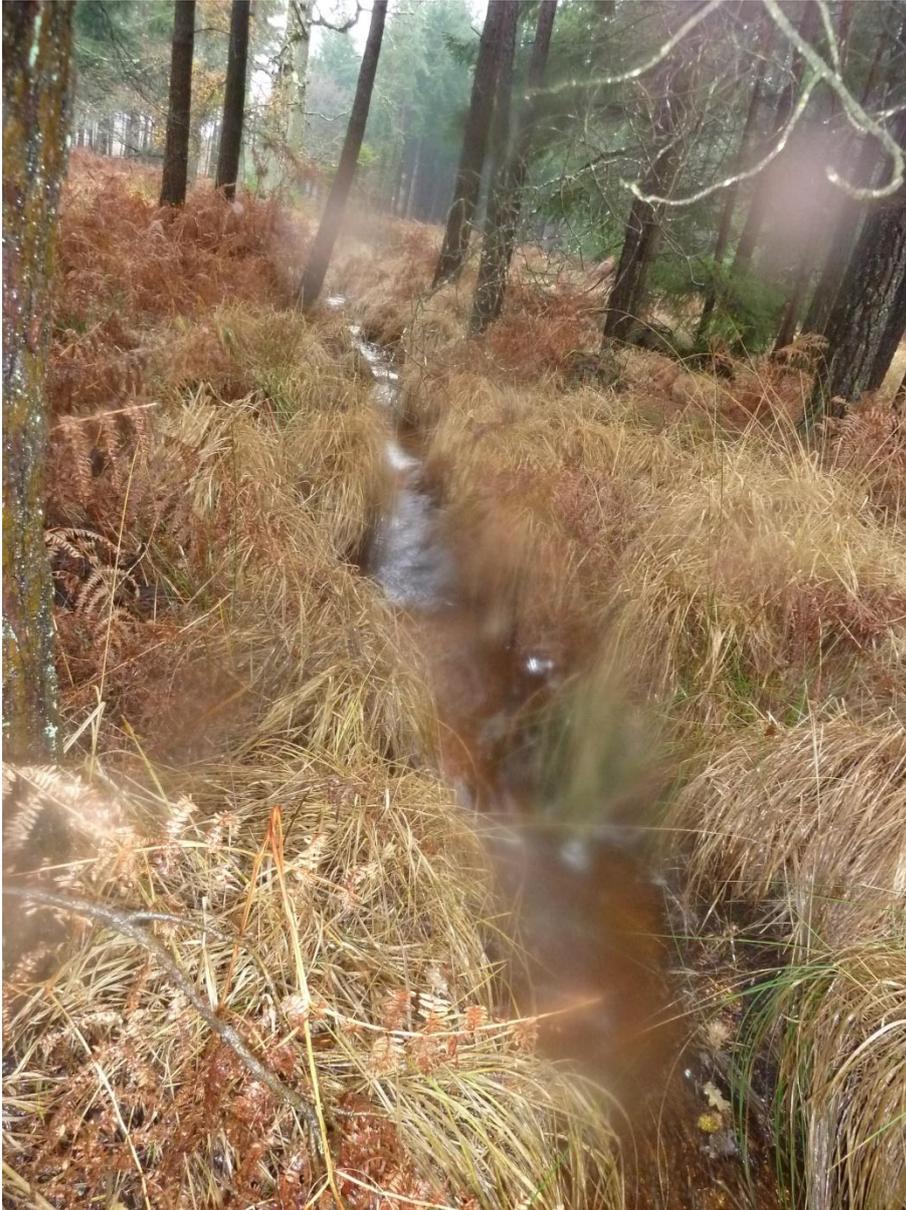
There has been some incision in the mid to lower reaches of this unit where erosive energy is contained within the banks rather than spread across the floodplain at higher flows resulting in bed erosion. This creates oversteep banks that are prone to collapse as a result of undercutting, as well as further reducing floodplain connectivity. This is exaggerated in some locations by the presence of embankments on the bank tops, which are particularly evident in the lower reach of this unit. As a result of incision in the brook, connecting drains are also incised in some locations. The incision within the drains is also impacted by embankments on the bank edge of the drains (Figure 1-7).

Figure 1-7: Incision in right bank drain, showing embankments

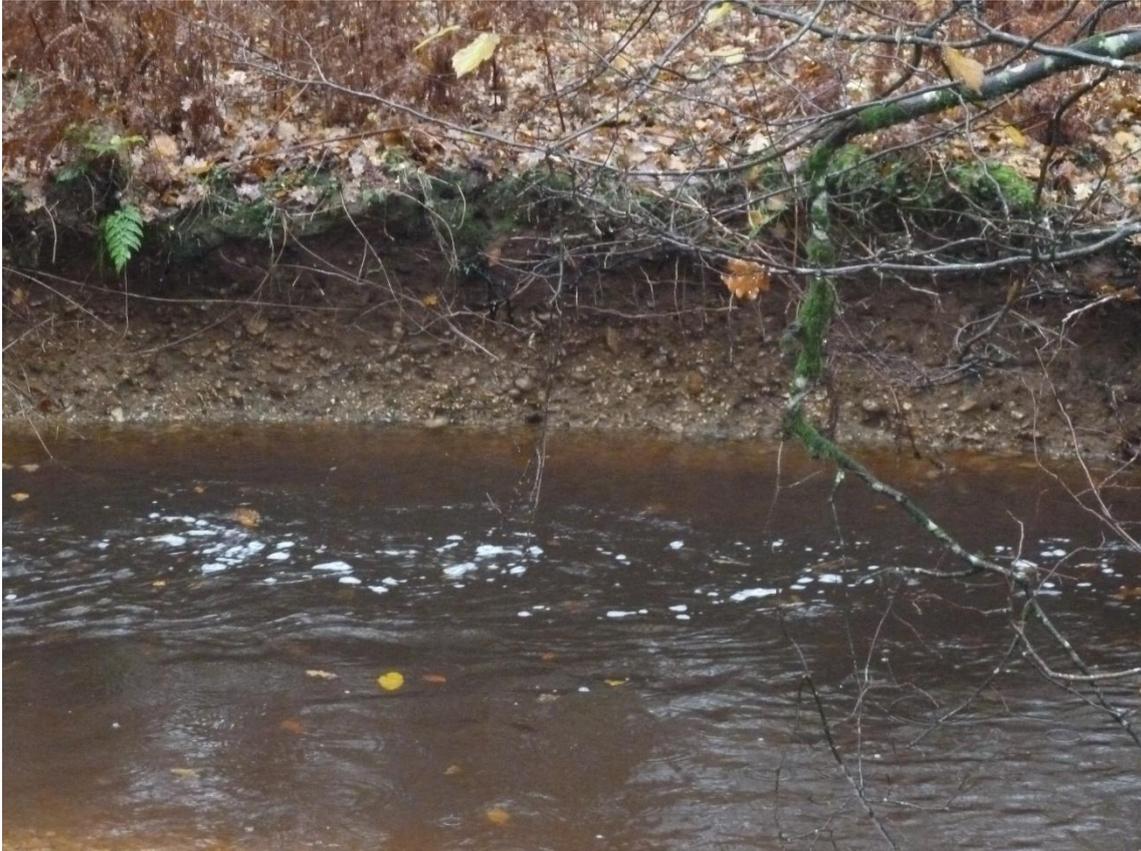
Gravel supply (there are significant gravel sources within the river banks, Figure 1-8, locally and upstream sources are particularly important for gravel features in the upper reaches) is strong and this, combined with flow regime alterations through surrounding drains, as well as historic tree clearance, give responsive channel conditions.

Figure 1-8: Local gravel bank sources

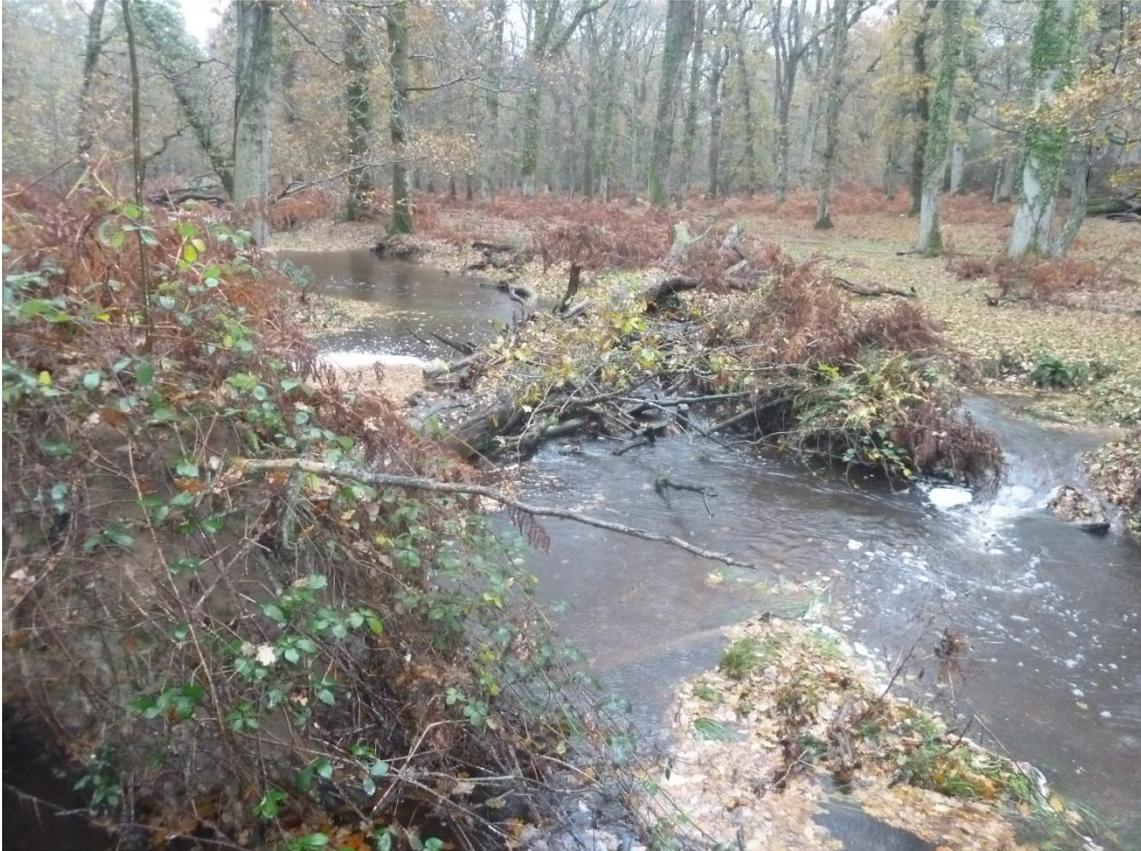
Natural woody debris features are relatively common along the channel, which have often been created as a result of local bank erosion / collapse (Figure 1-9). These create short lengths of impounded watercourse that do improve floodplain connectivity significantly. These provide useful analogue features for the restoration plan.

Figure 1-9: Natural woody debris jams

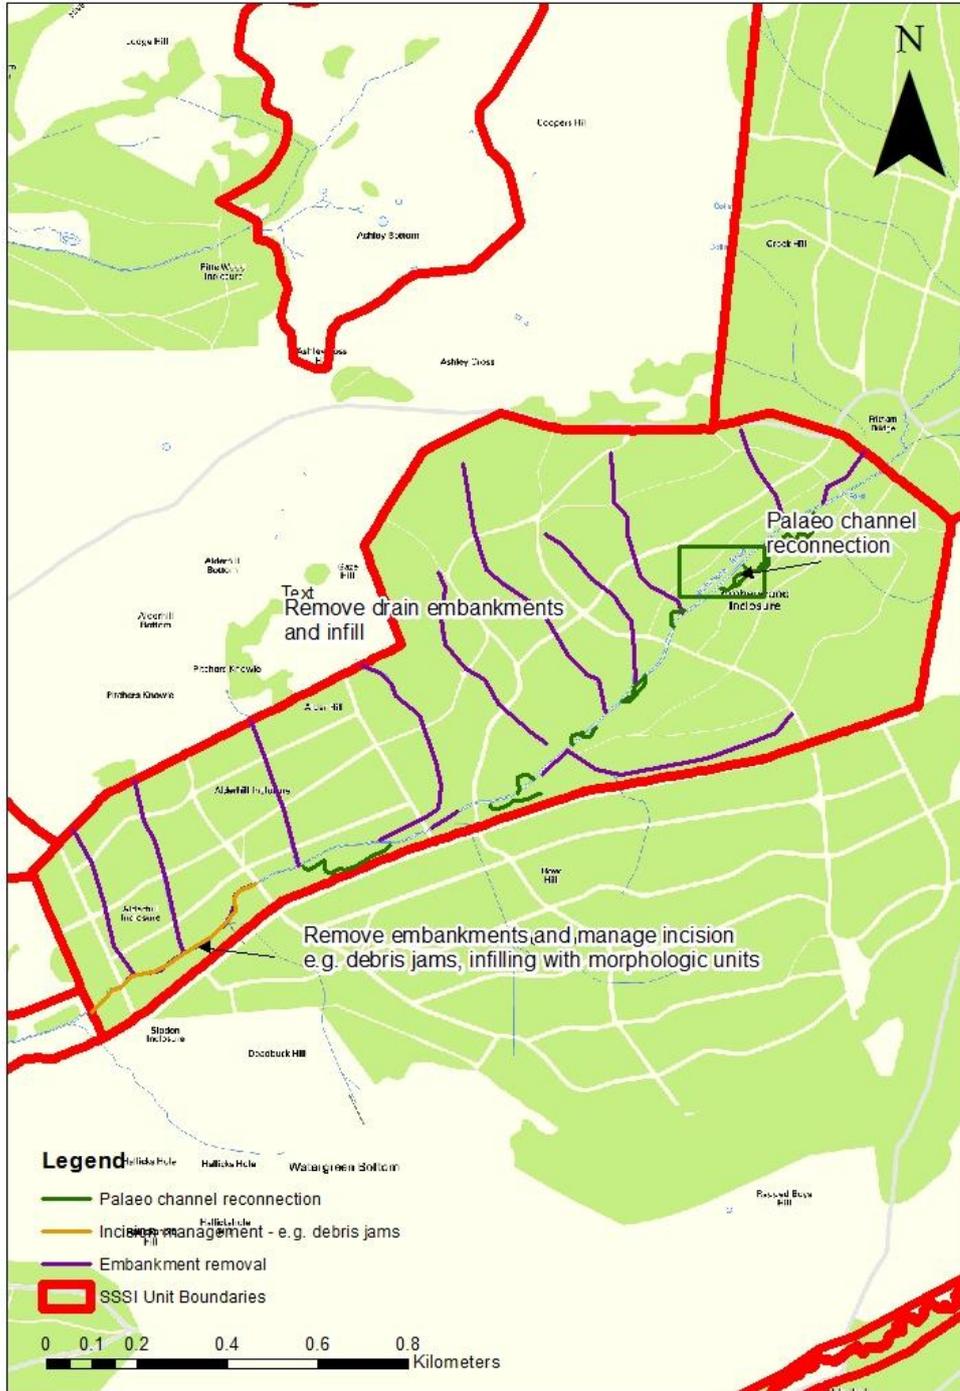
Figure 1-11: Proposed restoration measures for SSSI Unit 66

Significant palaeo channels have been identified in Figure 1-11 and show where reconnection could be possible through implementing some of the proposed restoration measures in Table 1-2. These have been identified from the audit and supplied LIDAR. Reconnecting these whilst maintaining the existing channel will encourage anastomosed network development.

A summary of the current pressures, unmitigated impacts and restoration proposals is given in Table 1-2 and shown in Figure 1-11.

The major straightened / modified drainage channels are identified in Figure 1-11. Other minor modifications could be considered for infilling and Appendix A should be used for reference.
