# River Axe SSSI

## Condition Assessment

May 2025

Natural England Research Report NERR150

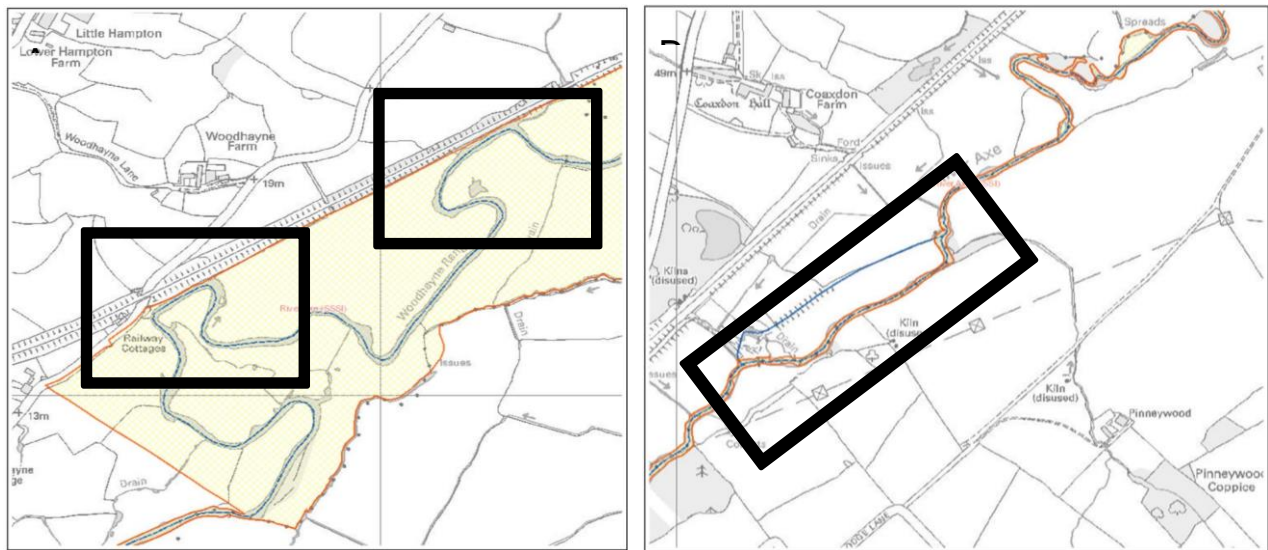
The physical habitat of the River Axe has been modified including reinforcements & re-sectioning from historic WWII defences, transport infrastructure & historic re-alignment, as detailed below in-channel structures. This is reflected in the results for habitat modification scores, which fail to achieve the target required of over 65% of condition monitoring sites achieving the semi-natural HMS Class 1.

**Figure 6 Aerial images. A. Laterally constrained movement due to Railway line. B. Historically straightened section 'Mill Race'**
