Natural England Commissioned Report NECR140

New Forest SSSI Geomorphological Survey Overview

Annex L: Parkhill Lawn (Pondhead) Restoration Plan - SSSI
Unit 386

1 Parkhill Lawn (Pondhead) Restoration Plan - SSSI Unit 386

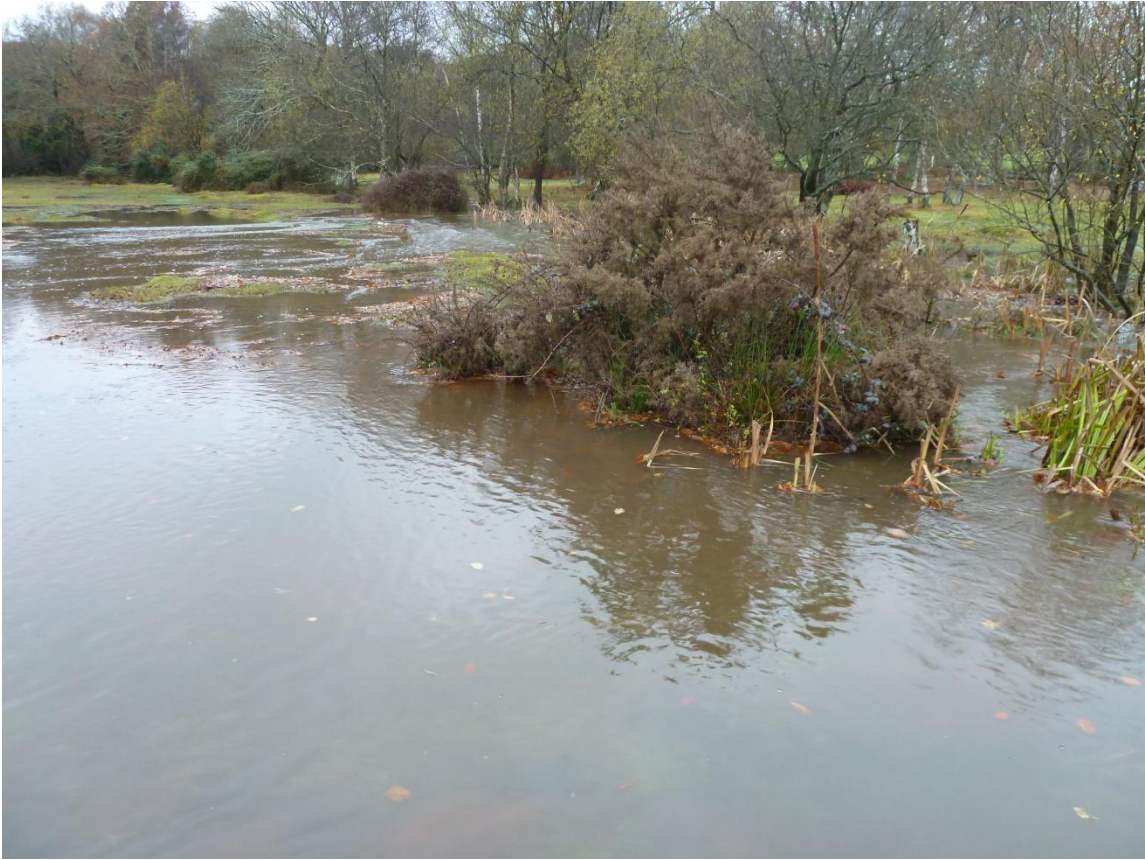
The stream within SSSI Unit 386 is a combination of an active single thread and passive single thread channel subject to moderate gravel inputs (Figure 1-2). Gravel features are generally embryonic and poorly developed.

Figure 1-2: General channel characteristics in flood conditions

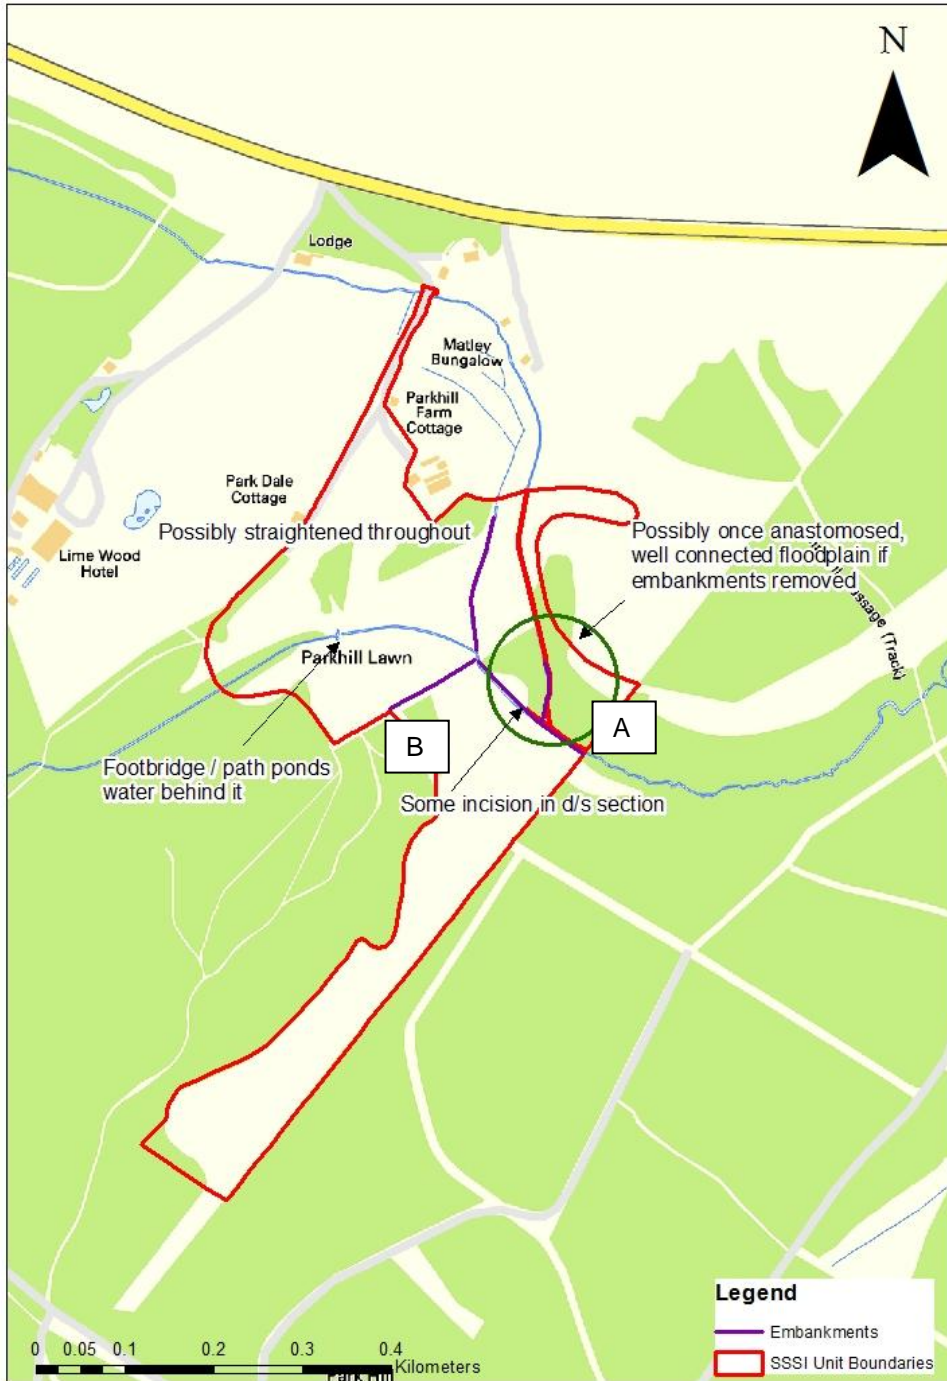
Figure 1-3: Current hydromorphic conditions and pressures

The straightening, deepening and embanking of the downstream section of this unit (Figure 1-3 - A) may have disrupted a previous anastomosed channel type as the left bank floodplain would be well connected if the embankments were removed and incision managed (Figure 1-4). The left bank floodplain is also wooded which lends itself to anastomosed channel development. However, no clear palaeo-channels have been identified from the LIDAR.

The embankment located over the right bank, upstream of the confluence with the first drain (Figure 1-3 - B) prevents any water spilling out of the channel from flowing into the fields beyond it (Figure 1-5). This is concentrating flow back into the main channel, which is likely to be a factor causing the mild incision in the downstream section of the stream, in combination with the other artificially modified channels.

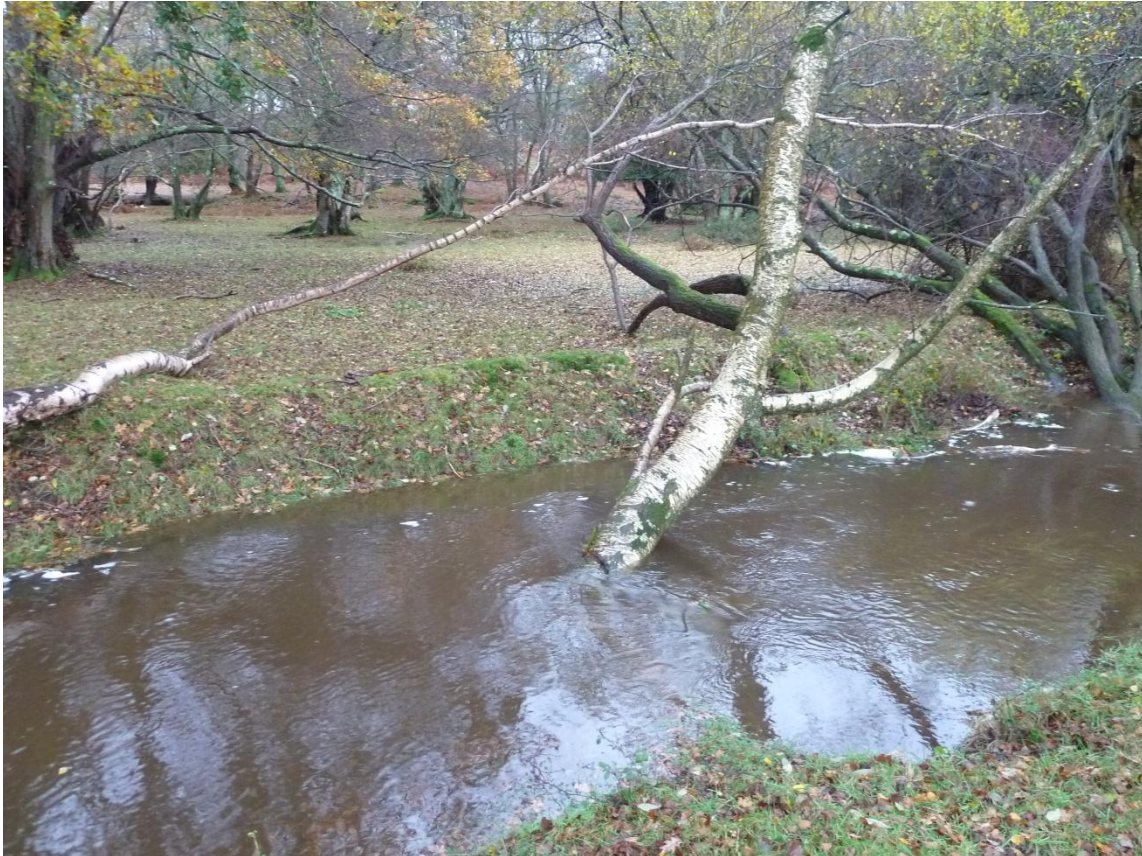
Figure 1-4: Downstream channel conditions - showing embanking and left bank wooded floodplain

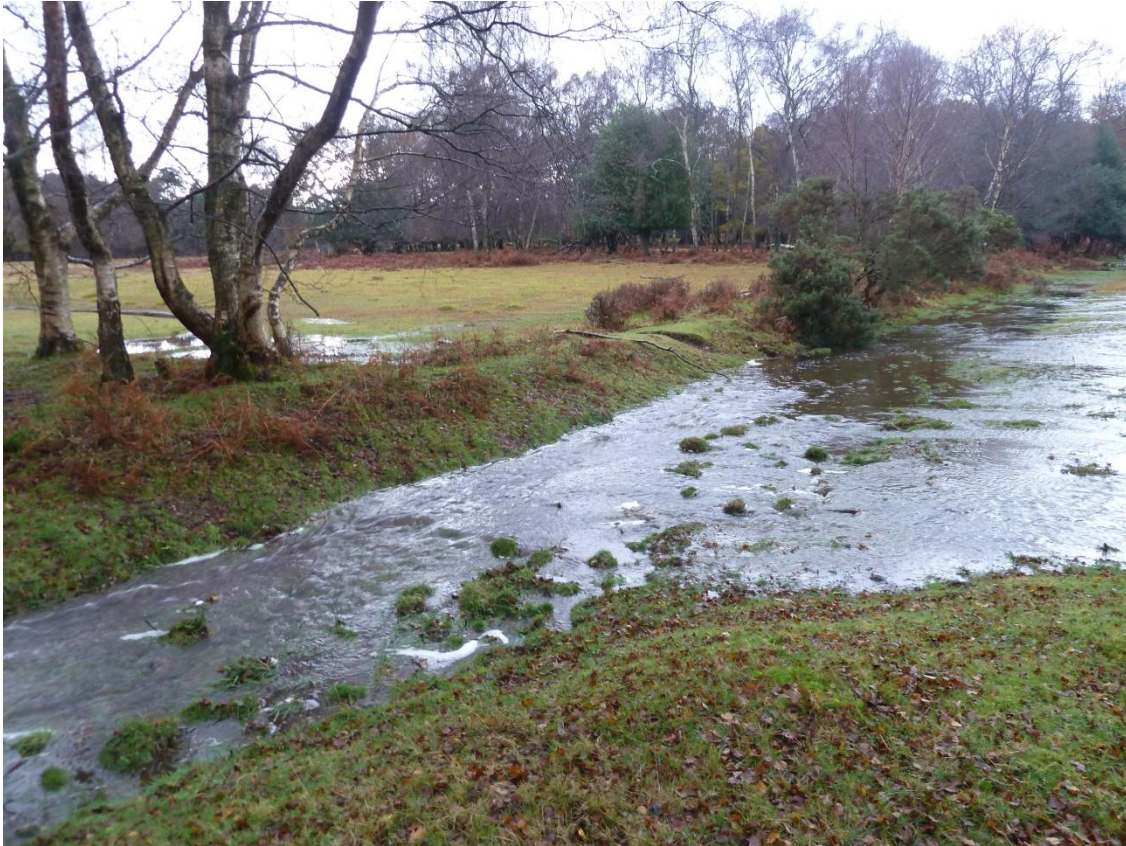
Figure 1-5: Right bank embankment providing obstacle to natural overland flow route

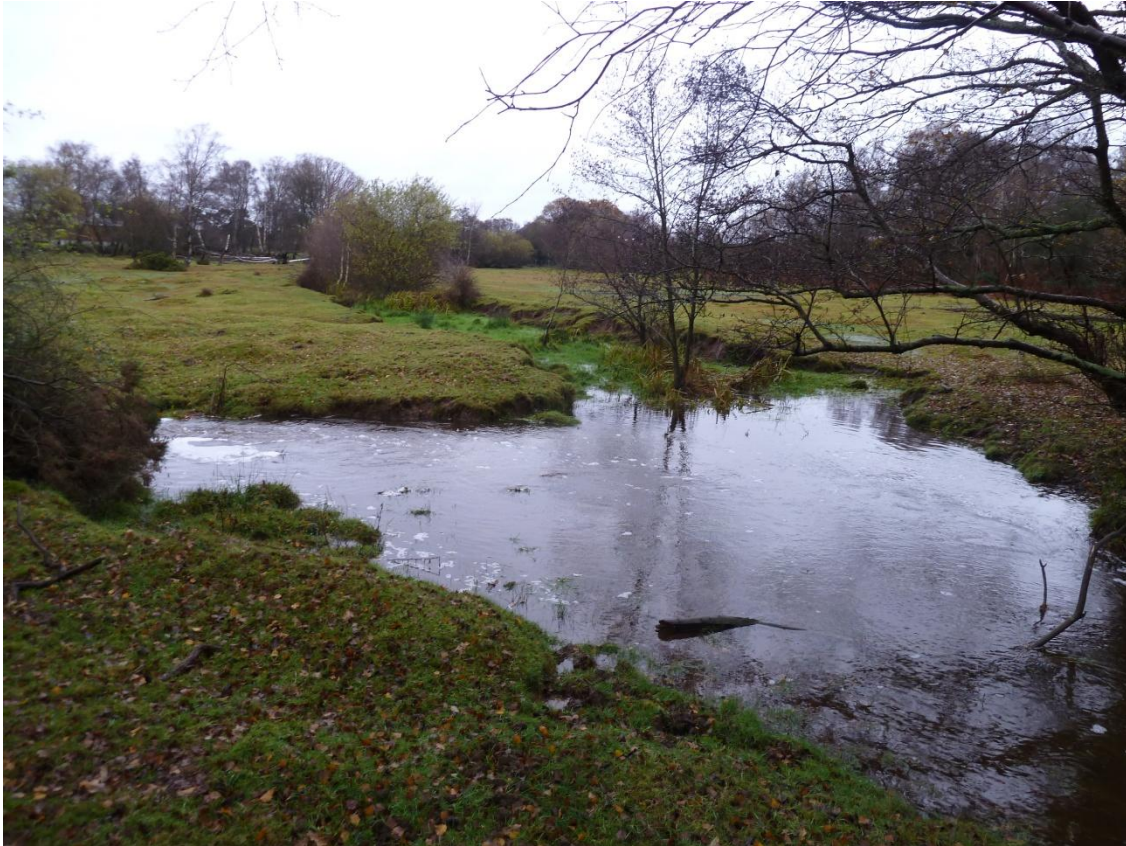
Artificial drainage modification will have impacted on the flood flow regime of the watercourse creating a more responsive system where flood peaks are concentrated and increased and water enters the main channel more efficiently. The degree of artificial drain creation is shown in Appendix A and is impacting significantly on the flow regime. This effectively creates a higher energy system more capable of erosion and sediment transport. The two major drains within the unit have been artificially modified through straightening, dredging and embanking. This is having a significant impact on the natural flow regime (Figure 1-6).

Figure 1-6: Left bank drain showing straightening and embanking
