Natural England Commissioned Report NECR141

New Forest SSSI Ecohydrological Survey Overview

Annex E: Common Moor

First published 06 March 2014

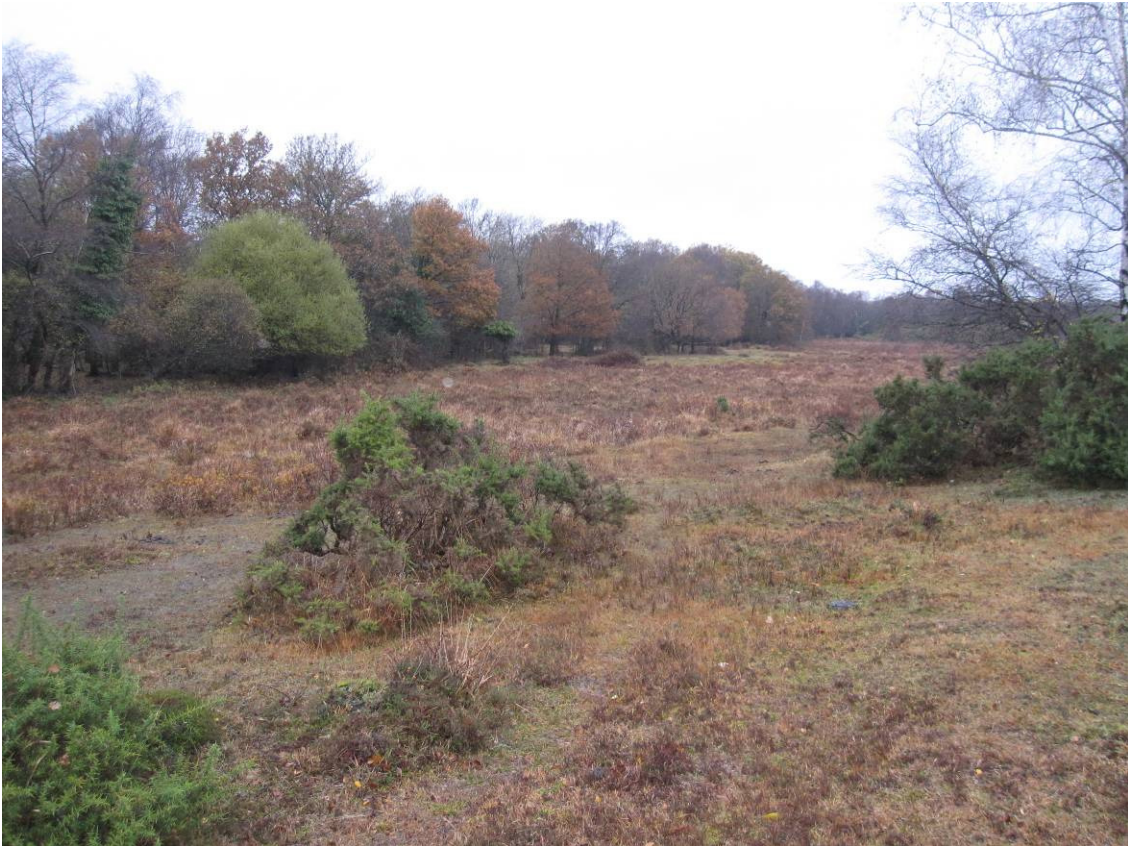
Figure 1-2: General view of the eastern part of Common Moor (NGR 420698 104664, looking northwest)

Common Moor occupies a shallow valley containing Mill Lawn Brook. The wetlands take the form of valley mires developed on the western side of the valley. Here the ground slopes gently eastwards or south-eastwards towards the brook. Drainage ditches occur along, and adjacent to, the south-western corner of the site, but do not appear to be adversely affecting the site hydrology to any great extent: *Sphagnum denticulatum* occurs close to the boundary ditch, which is poorly maintained. Mill Lawn Brook has been diverted and held back by weirs to form a large garden pond in the south-eastern corner of the site. Runoff from track drainage along the eastern edge of the site has the potential to enter the site, but this is on the opposite side of Mill Lawn Brook to the valley mires and is, therefore, unlikely to pose a water quality problem.

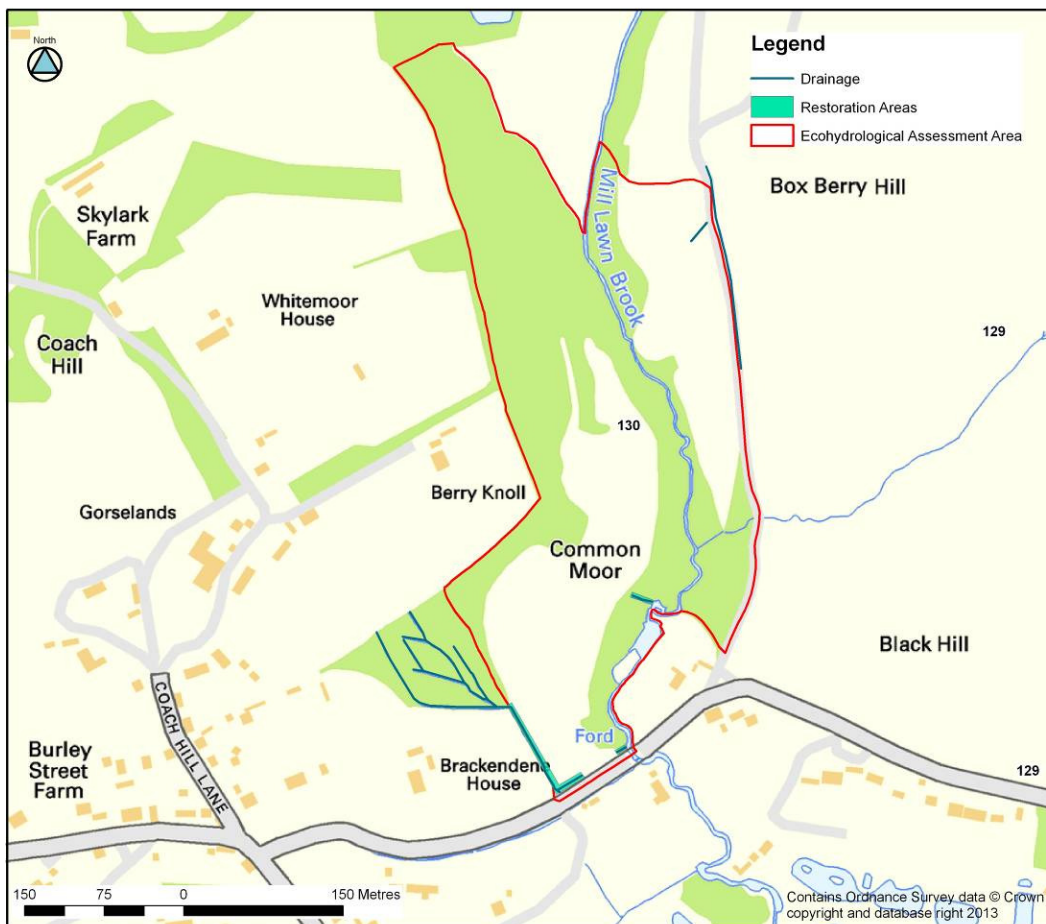
Figure 1-5: Restoration Areas Map

Some areas around the edges of the southern mire have been subject to artificial drainage (see Figure 1-5). The drainage ditches do not appear to be having a serious impact on water levels within the mire, but could potentially be blocked in order to restore a more natural hydrological regime, and to help improve the quality of (and potentially extend areas of) mire and wet heath habitat. Water level monitoring (see Section 1.7 below) would provide a more complete understanding of the influence of drainage on the mires and help determine the usefulness of ditch blocking.

Restoration Area	Damage Type	Restoration Proposals	Improvement	Constraints and Issues
Drained Areas (see Figure 1-5)	Artificial Drainage	Block drains	Create a more natural hydrological regime. Improved quality and potentially extent of mire and wet heath communities	Artificial drainage is not a major issue on this site, so any gains would be modest.
