Natural England Commissioned Report NECR140

New Forest SSSI Geomorphological Survey Overview

Annex M: Cowleys Heath East Restoration Plan - SSSI Unit 422

First published 06 March 2014

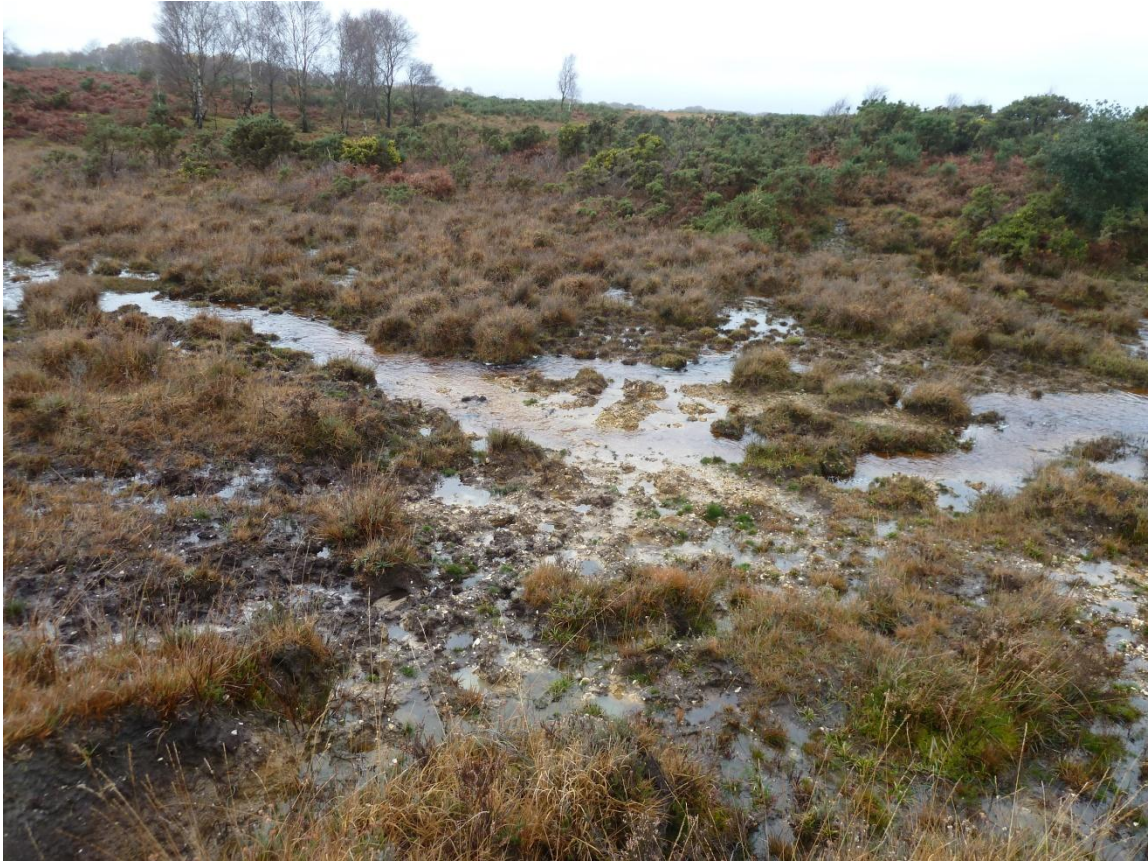
Figure 1-2: Passive single thread channel characteristics - note fine sediment and poaching

The unit in the middle to upper reaches has a generally low gradient (Figure 1-5 - A), particularly in the multi-thread / spreading sections where there is no clear dominant channel and water spreads over a wide area. In the single thread sections, the gradient is still generally low (although does steepen downstream), with some minor locally energetic reaches across riffles where gravel bed sections are exposed (Figure 1-6). Outside of these locally energetic areas, the bed is generally silt dominated due to the low gradients and diffuse sediment inputs (Figure 1-7). Fine sediment inputs to the channel are increased due to poaching and grazing within the unit (Figure 1-2).

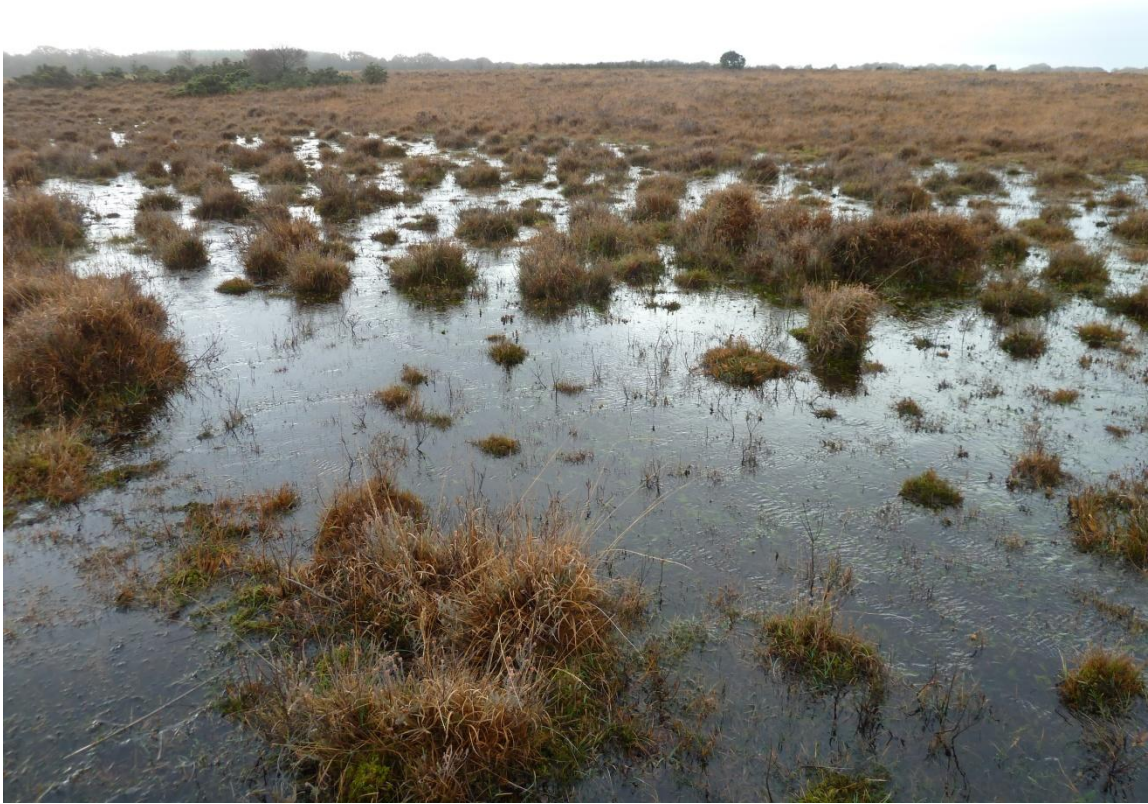
Figure 1-3: Multi branch / spreading sections in M25a Molinia mire with M29 Soakways

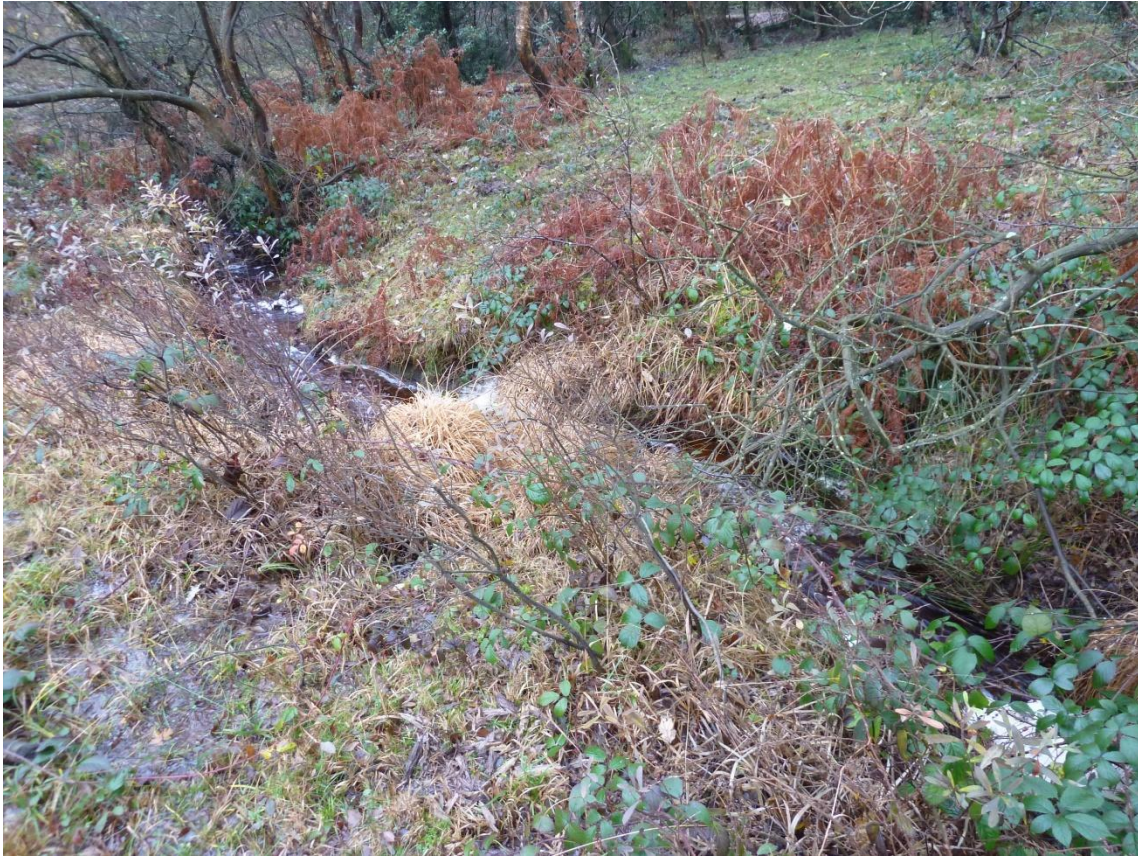
Figure 1-4: Active single thread stream section downstream

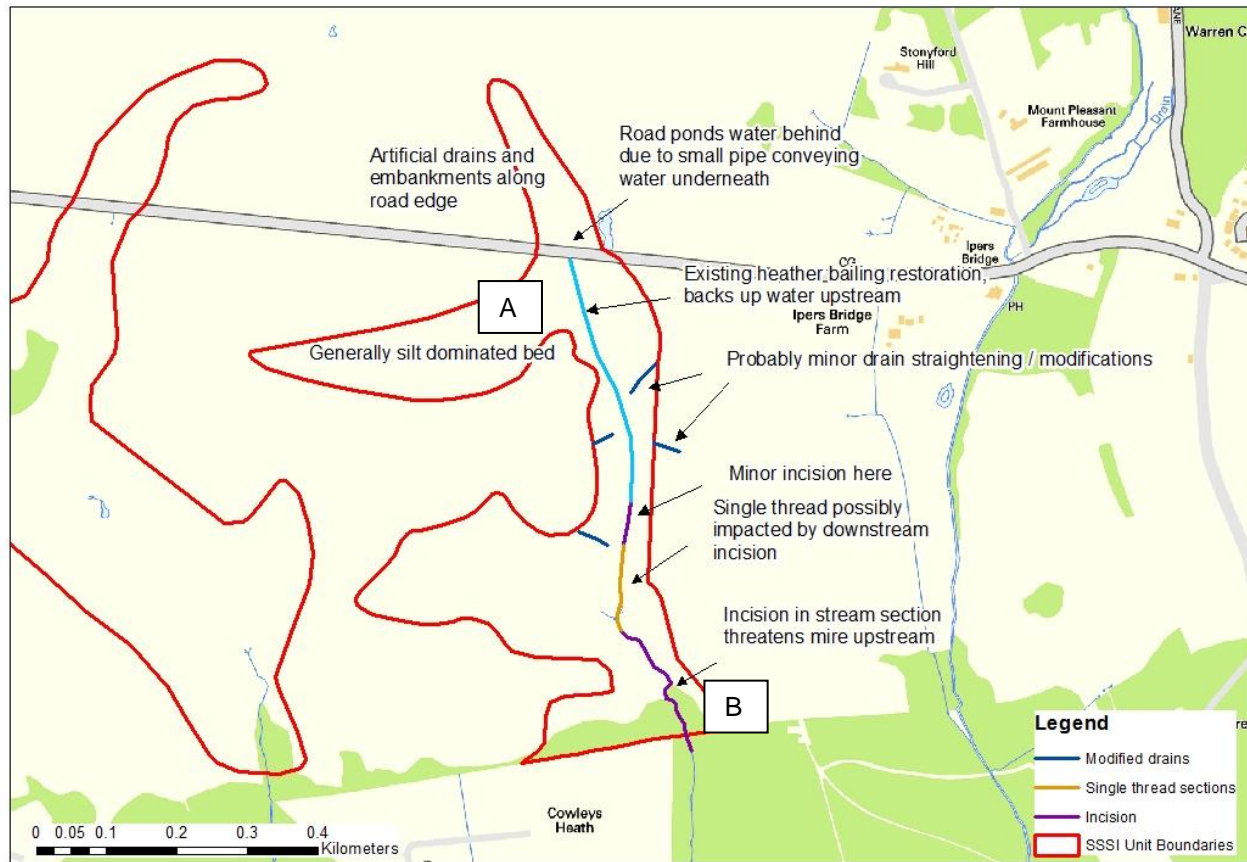
Figure 1-5: Current hydromorphic conditions and pressures

The LIDAR and drainage lines in Appendix A show that there is likely to have been some minor modification to the drainage flow routes, mainly through some drain straightening as shown in Figure 1-5 and possibly an artificially modified drain between units 422 and 423.

Targeted restoration of natural drainage paths should refer to Appendix A and Figure 1-5.

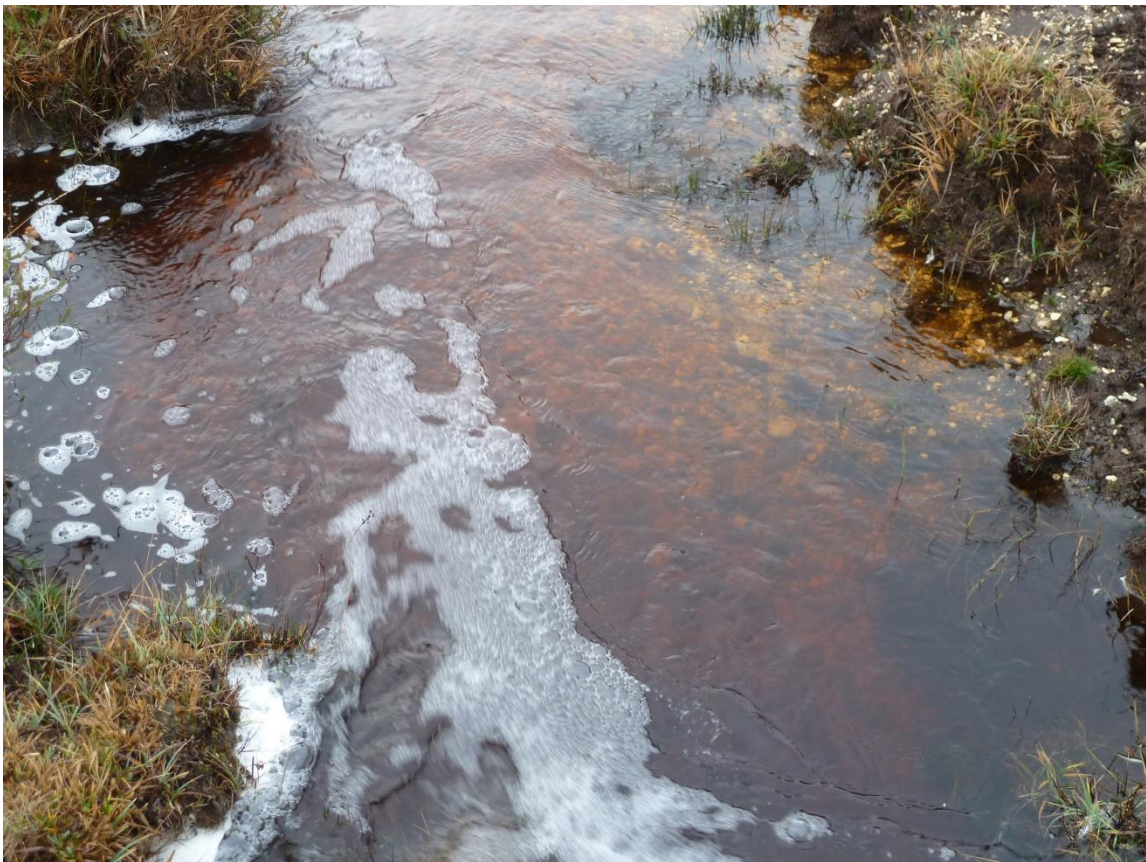
Figure 1-6: Small gravel bed sections downstream of the heather bailing

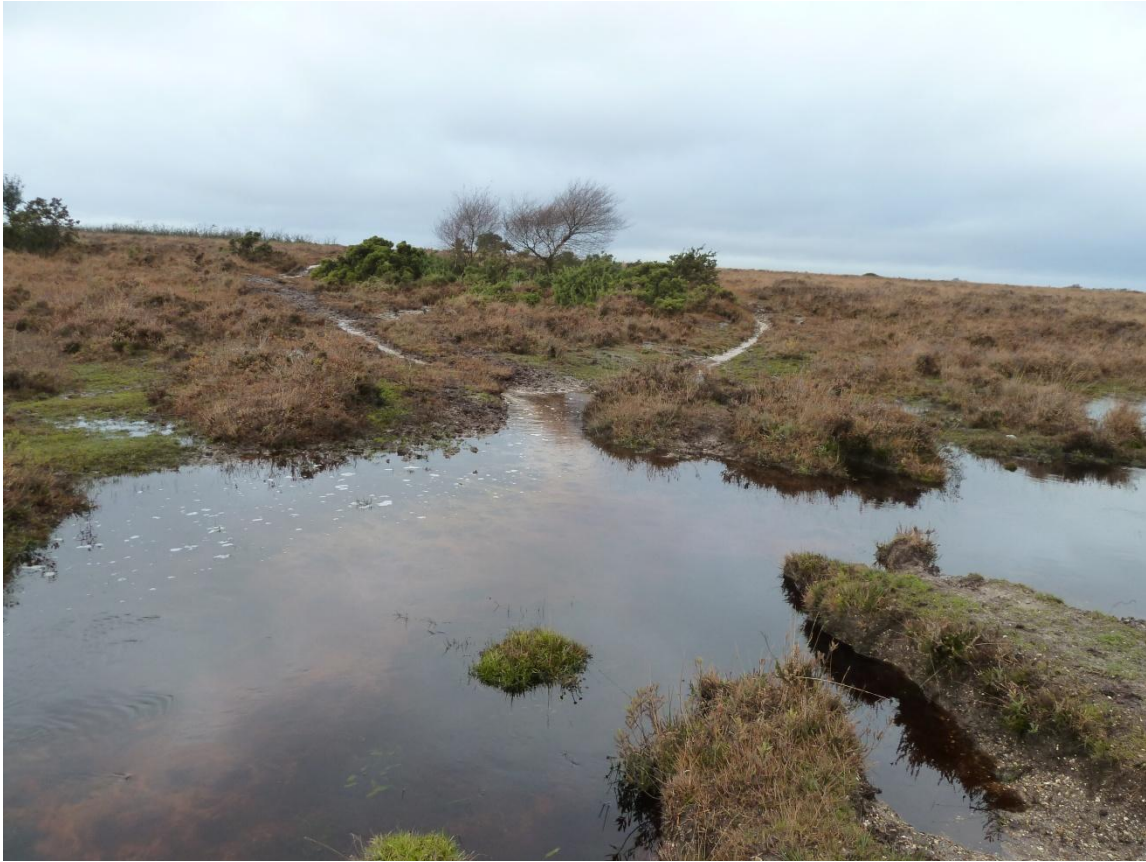
Figure 1-7: Silty bed channel characteristics

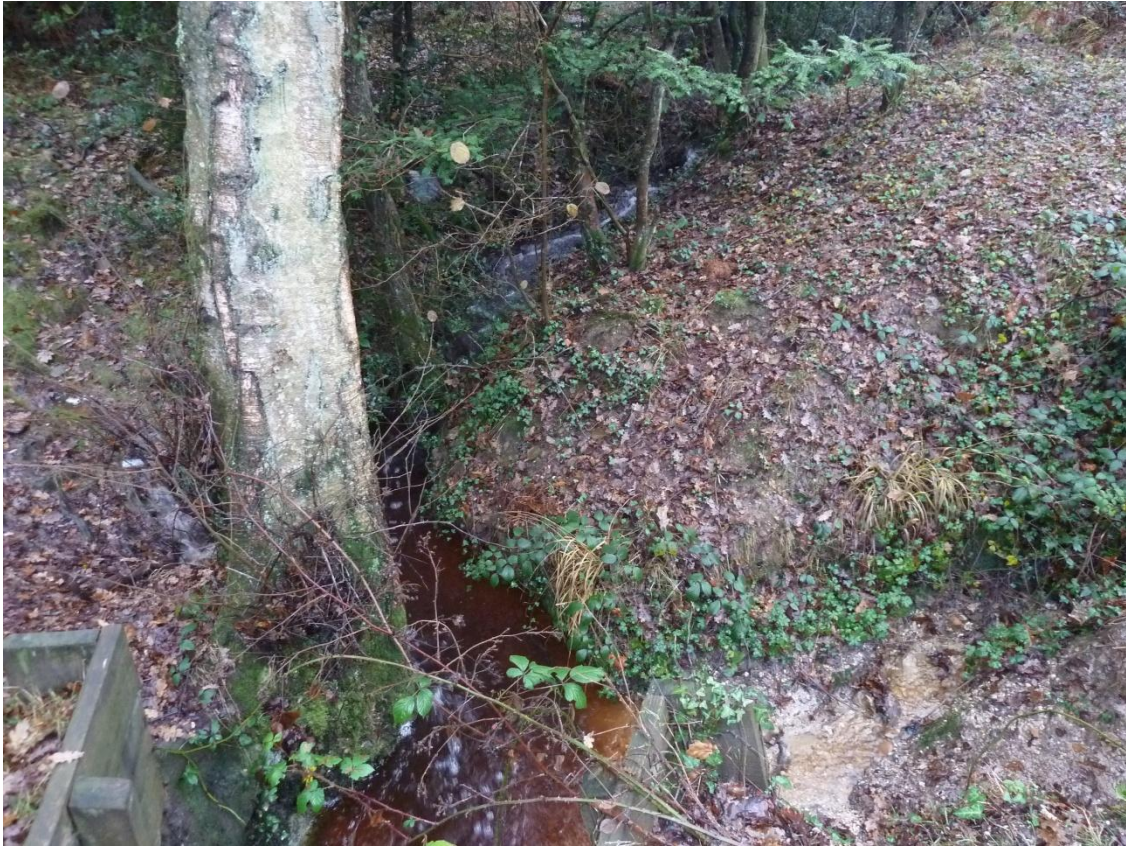
Figure 1-8: Vegetated banks and confined floodplain in downstream stream section of this unit

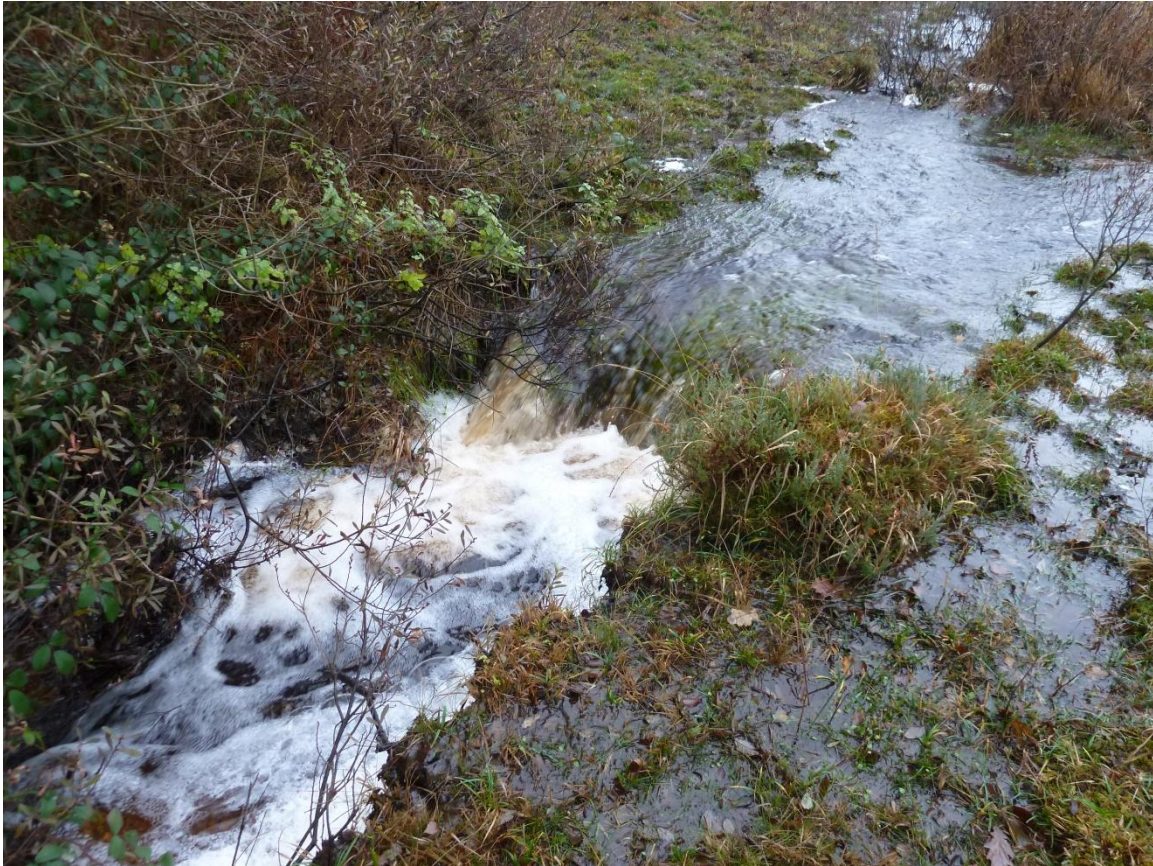
Figure 1-10: Knick point erosion in downstream stream section

Control of knick points along the incised lower reaches where the channel flows through mineral deposits is equally problematic and requires alternative techniques to staked heather bales used previously. Complete or substantive channel infilling with an organic porous base and mineral top layer could be attempted in the most severely eroding areas. This would be a radical approach and requires detailed design which is outside of the scope of this report.

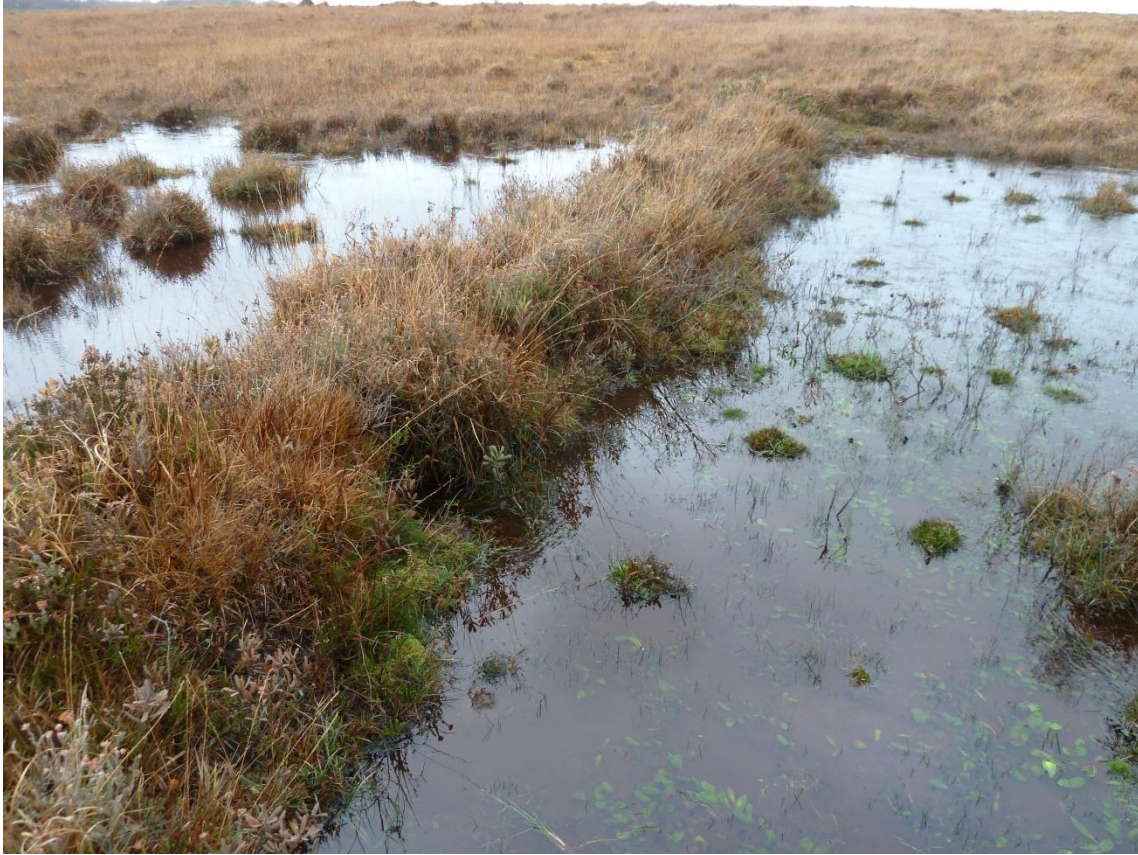
Existing restoration measures to raise water levels within the mire section use heather bailing across the channel to provide an impoundment. These are currently in a reasonable condition but may be prone to deterioration in the longer term (Figure 1-11). Woody debris jams could be used to manage the incision in the downstream single thread reaches as these would naturally occur in the wooded riparian corridor in this area.

Figure 1-11: Heather bailing restoration measure

Monitoring of the condition of the existing heather bailing restoration should be undertaken.

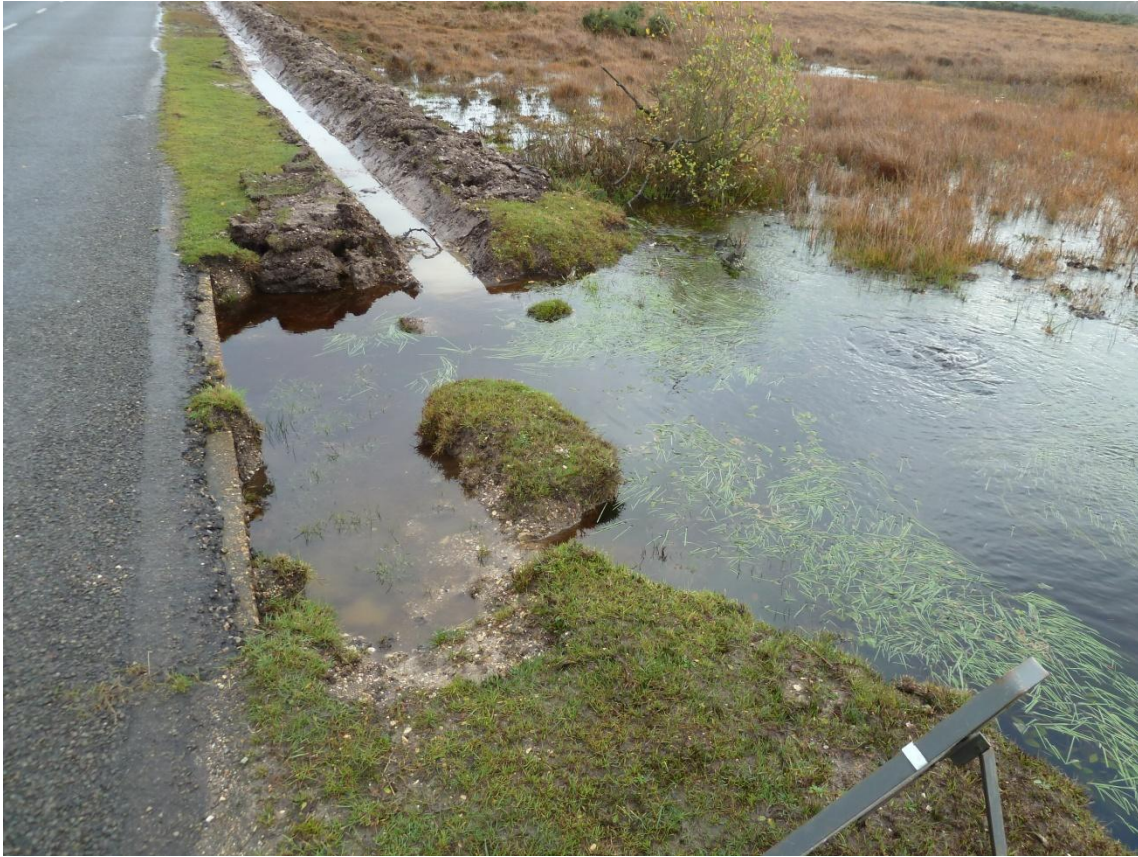
The artificial drains along the road (Figure 1-12) do impact the natural flow routes through the SSSI unit (from upstream to downstream), often concentrating flows at certain points into the surrounding drainage network. There is no evidence of this causing significant incision at present, although this may be a risk in the longer term. The structure that conveys flow underneath the road (believe to be a small pipe) results in ponding of water upstream of the road due to the backwater effects of the structure and limited conveyance capacity (Figure 1-13).

Figure 1-12: Road drains concentrating flows into the SSSI unit

An engineering assessment would be required for modification to any structures under the road.

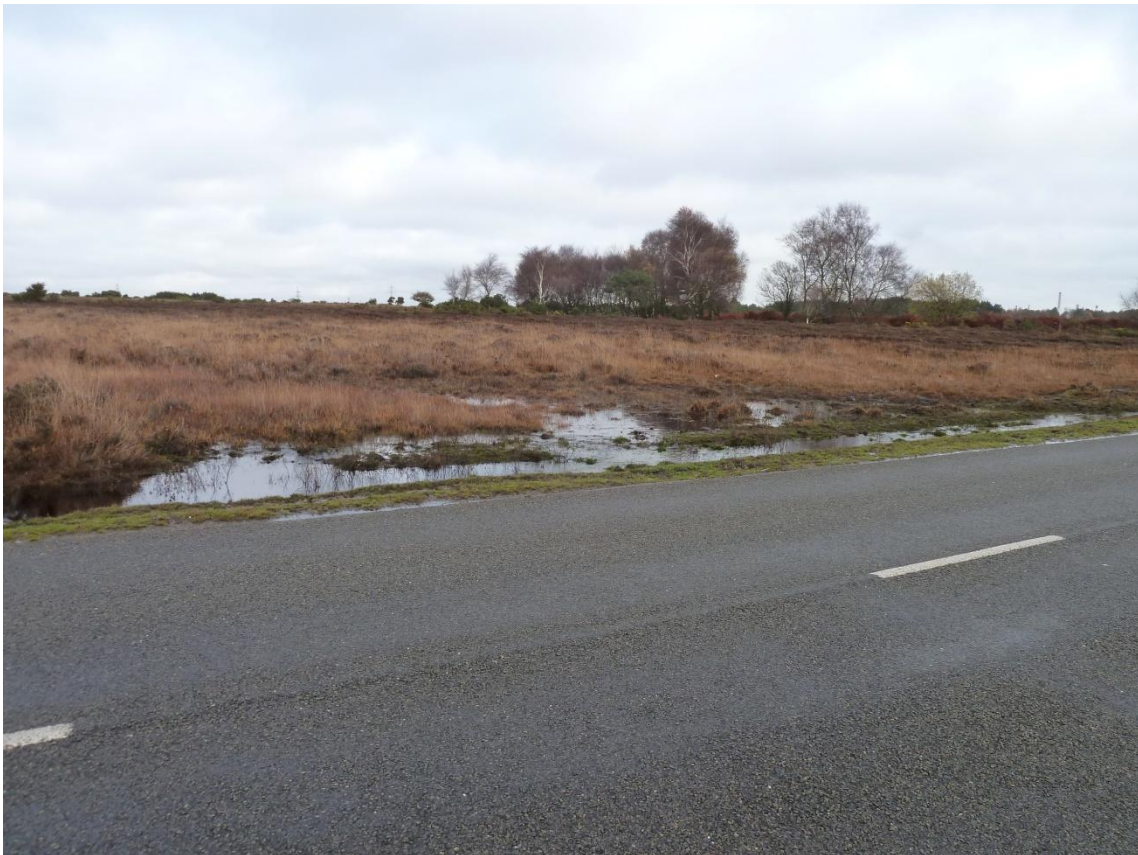
Figure 1-13: Ponding upstream of the road
