Natural England Commissioned Report NECR141

# New Forest SSSI Ecohydrological Survey Overview

Annex R: Lay Gutter Valley

First published 06 March 2014

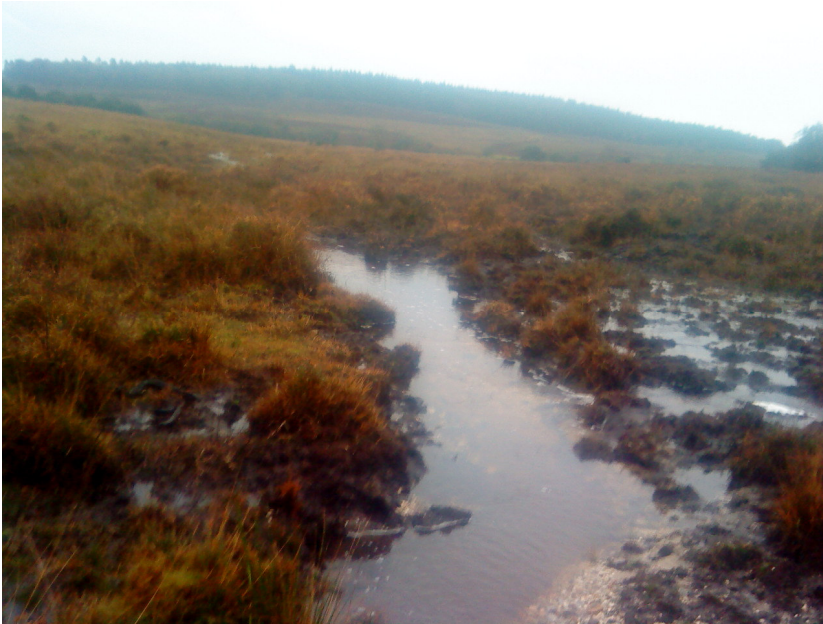
There are three small valleys within the site descending from the edge of a plateau. Within the valleys are three valley bottom wetlands supplied by water from seepage faces high up the valley sides. In the centre of the middle valley, at a narrow crossing point is an area of gulleying and erosion (see Figure 1-2). It appears that there has been some restoration attempted in this area. In the lower part of the middle valley the mire widens and forms a quag mire with a slight peat dome. The western valley bottom wetland stops halfway down the valley just upstream of the boundary of the SSSI (see Figure 1-3 and Figure 1-4). At this point the valley has been subjected to drainage and there is a degree of headwater erosion of the drainage path into the SSSI. There is some evidence of attempts to restore this area (e.g. staves in the channel), however, these measures have not been effective. Nevertheless, even though the stakes and bales have been lost, the bottom part of the valley mire has been stabilised and headward erosion has slowed. That said, the valley mire is now drained by soakways across its surface which now discharge over a small peat cliff as a waterfall into the incised channel downstream (Figure 1-3) where the damming took place and, as a result, the peat mass of the valley mire here is in danger of being damaged.

**Figure 1-2: Crossing point and Erosion at in upper part of the middle valley bottom wetland (NGR 418990, 113165)**

- **Gulley Area** - restoration works have already been undertaken in this area in the past. From the site walk-over it was difficult to access whether the dams and plugs were deteriorating under the erosive power of the gulley or the gulley had improved since the installation of the restoration works. It is therefore recommended that the efficacy of these works be reviewed. Replacement of dams, with a series of well constructed tiered wooden planks or plastic sheet piling dams may be required.

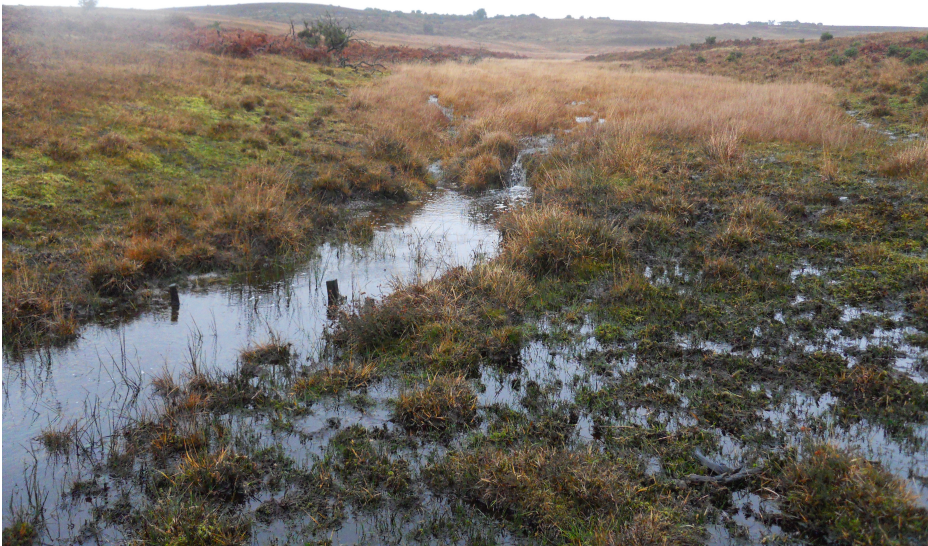
**Figure 1-3: Headwater Erosion at the base of the western valley bottom wetland (note tops of staves in the channel in the foreground) (NGR 418476, 113053)**

The large areas of mire are in good condition and composed of the M21a valley mire community. Butterwort *Pinguicula vulgaris* can be found here along with Common Sundew *Drosera rotundifolia* and many species of *Sphagnum*, including *Sphagnum papillosum*. These mires are associated with soakways that flow over the top and around them. These streams do not cut into the peat and, where this is still the case, the mires are still in a pristine condition. These mires themselves are semi-continuous as you move downstream and presumably have formed behind small constrictions in the valley sides or raised areas within the stream platforms. Typically they are connected by the M29 soakway communities and, as a result, form a continuous mire complex at the base of the valley as you move downstream and this is the situation when the unit boundary is reached. Here, as is mentioned above, the stream has been incised and headward erosion is taking place exacerbated by poaching and erosion where animals and people cross the stream. The result of this is that the soakways have been transformed into a single-thread stream that is actively cutting into its bed and upstream. This has already led to the loss of some of the mire communities, leaving a rump of isolated patches of *Sphagnum auriculatum* at the base of and *Erica cinerea* on top of eroded *Molinia* tussocks. This headward erosion has now reached a large area of valley mire that extends into the SSSI and this is currently being drained by the soakways on its surface that discharge via a 1m waterfall over a peat cliff into the eroding single-thread stream.

Downstream of the above there are a number of further nick points in the stream that are the focus of additional headward erosion, and again outside of the unit, there is a large lawn area which has been subject to extensive drainage activity. It is at this point the stream enters Unit 48.

- Below the above and at the various nick points in this stream, a series of plastic sheet pile dams should be installed with very low crest heights, only 15cm or so in each case. Ideally these should be positioned so that the water pouring over the crest falls into the next pool created by another plastic dam downstream, cascading downstream until the original bed of the stream is encountered;

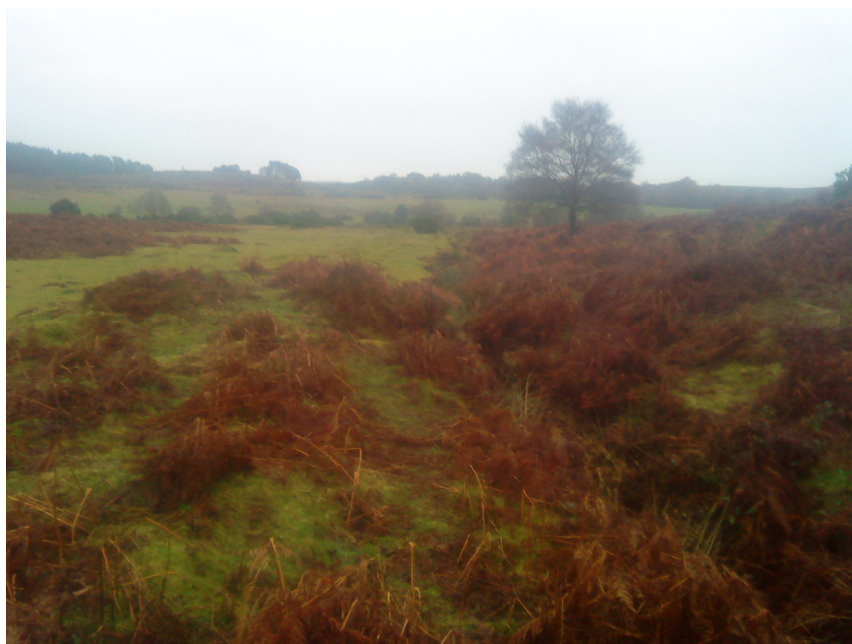
Figure 1-4: Effective draining of western valley bottom wetland downstream of the SSSI unit (NGR 418522, 112868)

- **Drained valley** - a large dam or bund structure will now be required to prevent further headward erosion into the valley mire upstream. This should consist of a concrete structure with a sloping downstream face to prevent erosion and undermining of the structure.

- The rest of the drained valley provides potential for the extension and restoration of the valley bottom wetland; however restoration objectives need to be created for this area. For example, in the lower part of the valley, mire has been replaced by lawn so management decisions are required to assess the value of restoration.

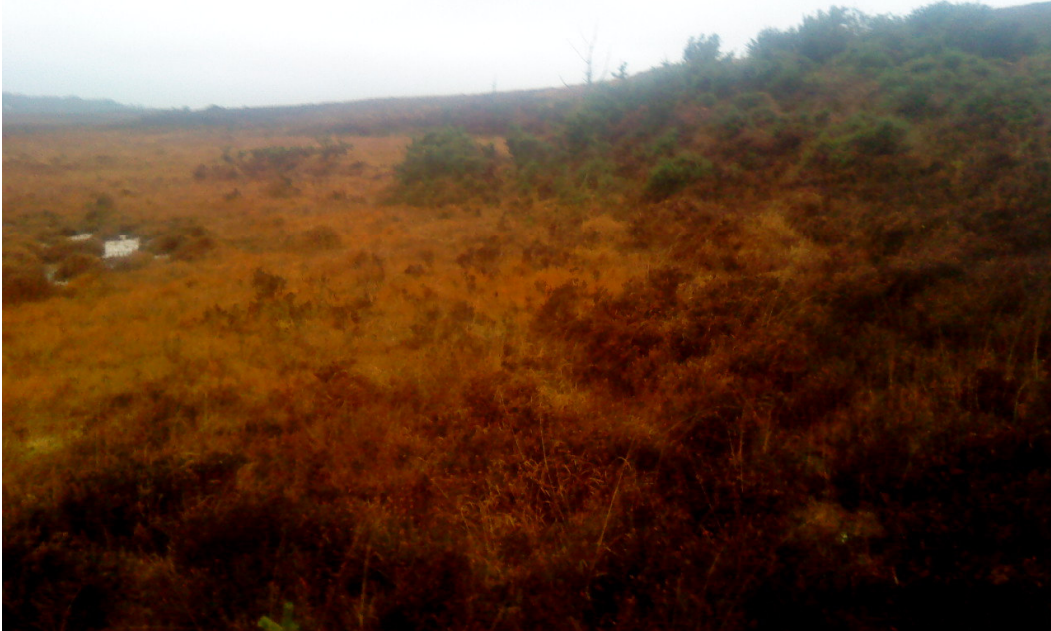
At the junction of the head deposits and the bedrock, a seepage face forms which supports a flush dominated slope over the bedrock (see Figure 1-5). The upper part of this slope is underlain by the Selsey Sand Formation which might act as a weak aquifer supplying water to this slope; however the seepage from the head deposits appears to be the main source of water. The lower part of the sites and the majority of the valley bottom wetlands are underlain by the Poole Formation which appear to act as an aquitard (no springs, or seepages were observed on the valley sides bordering the valley bottom wetlands).

Figure 1-5: Seepage face at junction of head and underlying bedrock (NGR 419480, 113165)

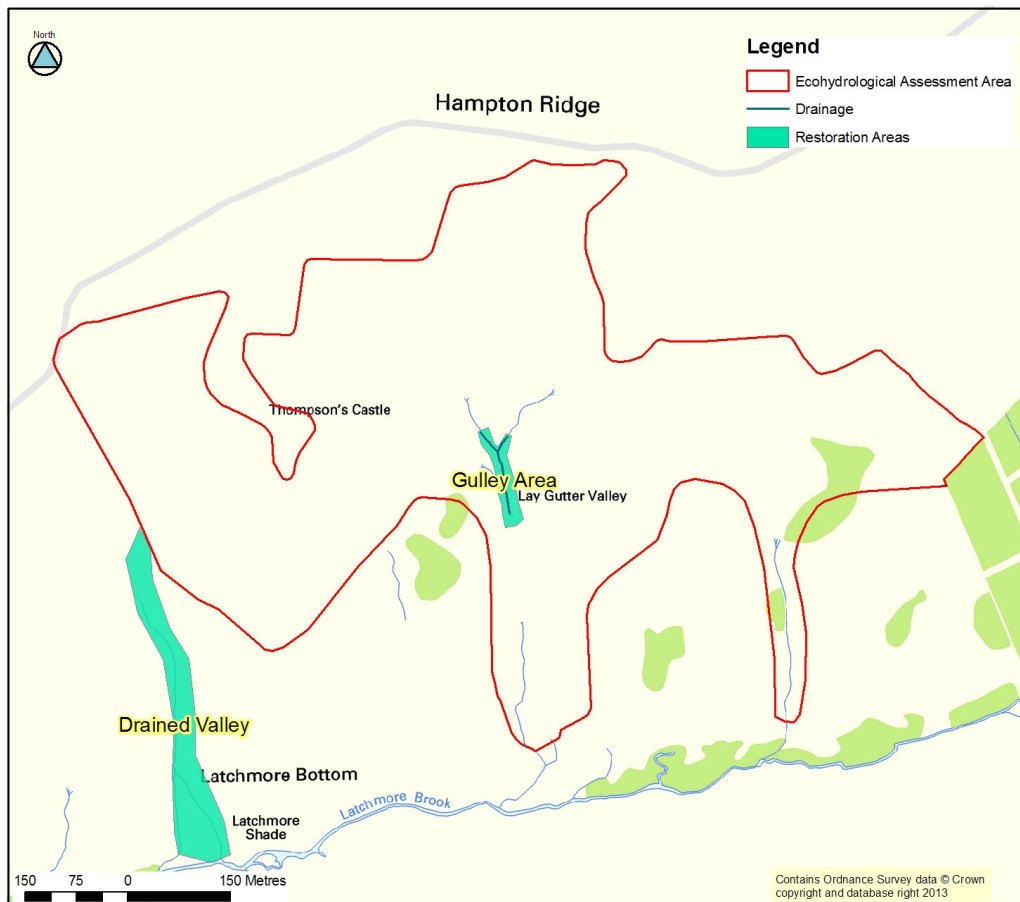
Figure 1-7: Restoration Areas Map

There are two areas of significant damage (see Figure 1-7):

- Gully Area - poaching at a narrow crossing point in this valley bottom wetland has led to the development of a gully;
- Drained Valley - downstream of the site artificial drainage has led to the removal of the valley bottom wetland. There is some headward erosion into the SSSI.

Restoration should focus on two areas:
