New Forest SSSI Geomorphological Survey Overview

Annex A: Black Gutter Bottom Restoration Plan - SSSI Unit 35

1 Black Gutter Bottom Restoration Plan - SSSI Unit 35

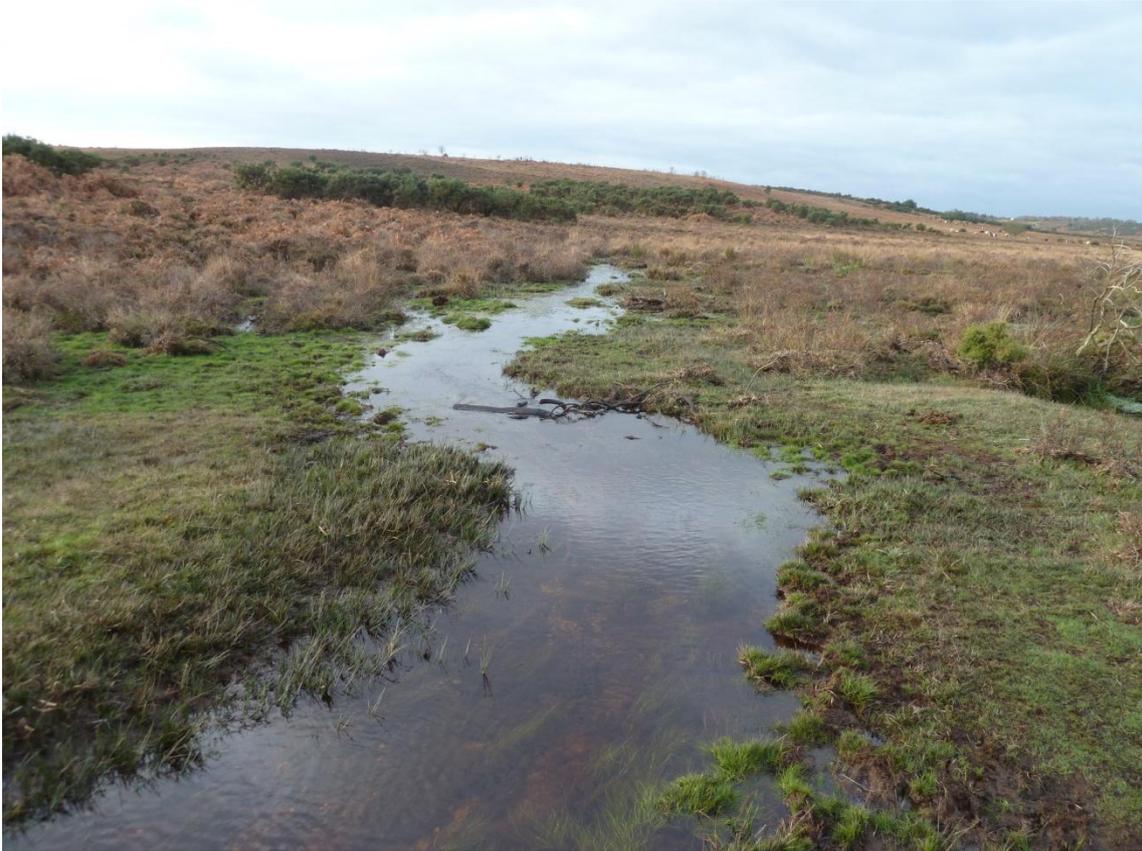
Figure 1-2: Passive single thread channel characteristics

The stream within SSSI Unit 35 is mainly passive single thread channel (Figure 1-2) with some sections of multi branch / anastomosed networks where floodplain connectivity is improved and gradients are reduced (Figure 1-3). There are generally low inputs of gravel to the stream locally and from upstream sources, with limited bank erosion. Some sections display a weak riffle - pool sequence and gravel bed condition is improved where significant narrowing has occurred in single thread section (Figure 1-5).

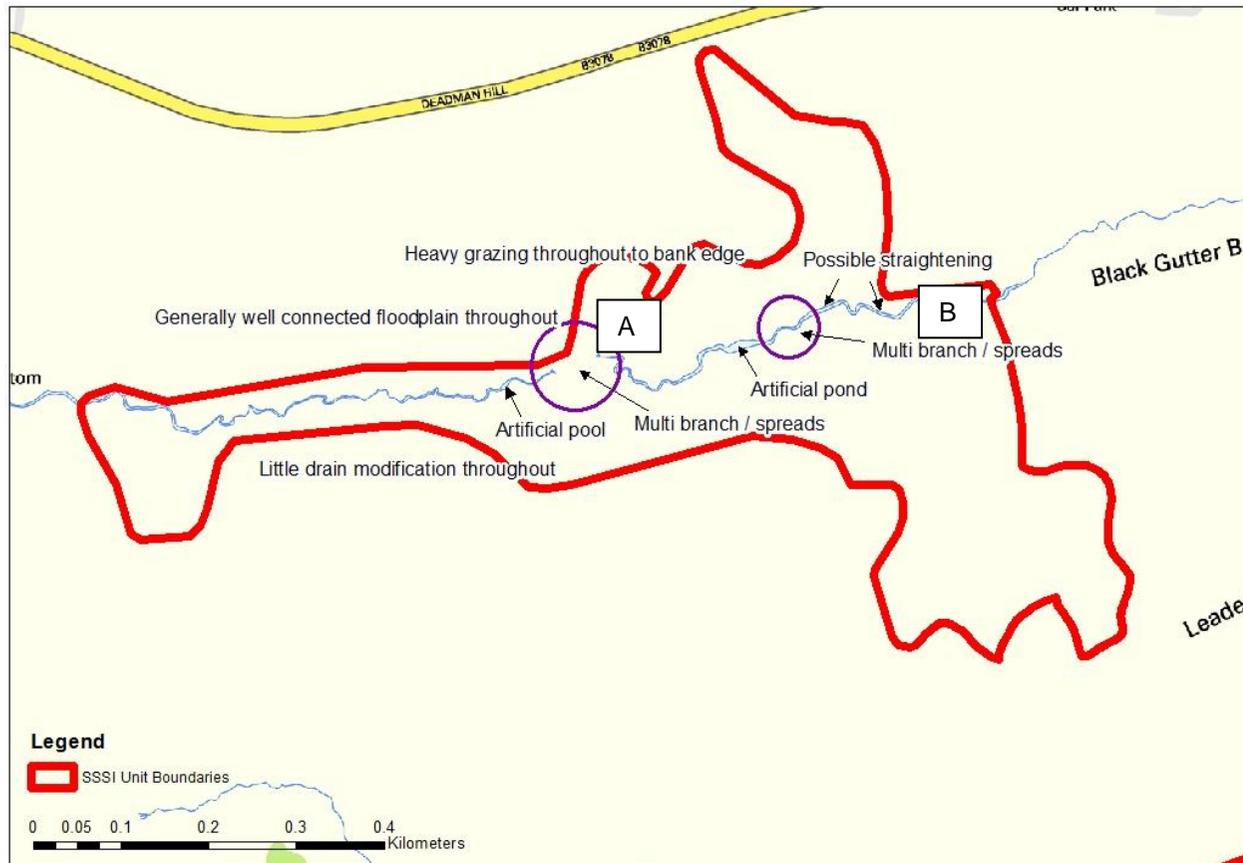
Figure 1-5: Current hydromorphic conditions and pressures

The source of the stream is Black Gutter Bottom and Leaden Hall. Figure 1-5 summarises the existing hydromorphology and pressure impacting unit 35.

The stream has a generally low gradient, particularly in the multi-thread / branched sections (Figure 1-5 - A) where there is no clear dominant channel and spreads over a wide area. In the single thread sections, the gradient is still low, with only minor local increases at riffles where flows are energetic enough to uncover clean gravels. This is assisted by channel narrowing at the riffles (Figure 1-4). Outside of these locally energetic areas, the bed is generally silt dominated due to the low gradients (Figure 1-6). As a result of the generally low gradients and in combination with little incision, bank erosion is limited.

There is little evidence of significant channel straightening, either from the audit or the LIDAR. Only minor sections have been identified in the upper section of unit, shown in Figure 1-5 - B. This, in combination with no bankside embankments, limited evidence of historic dredging (aside from the pond) and limited artificial drainage, means that incision is not an ongoing process and flows are well connected to the floodplain meaning energy is spread over a wide area, often finding flow routes between *Molinia caerulea* tussocks (Figure 1-7).

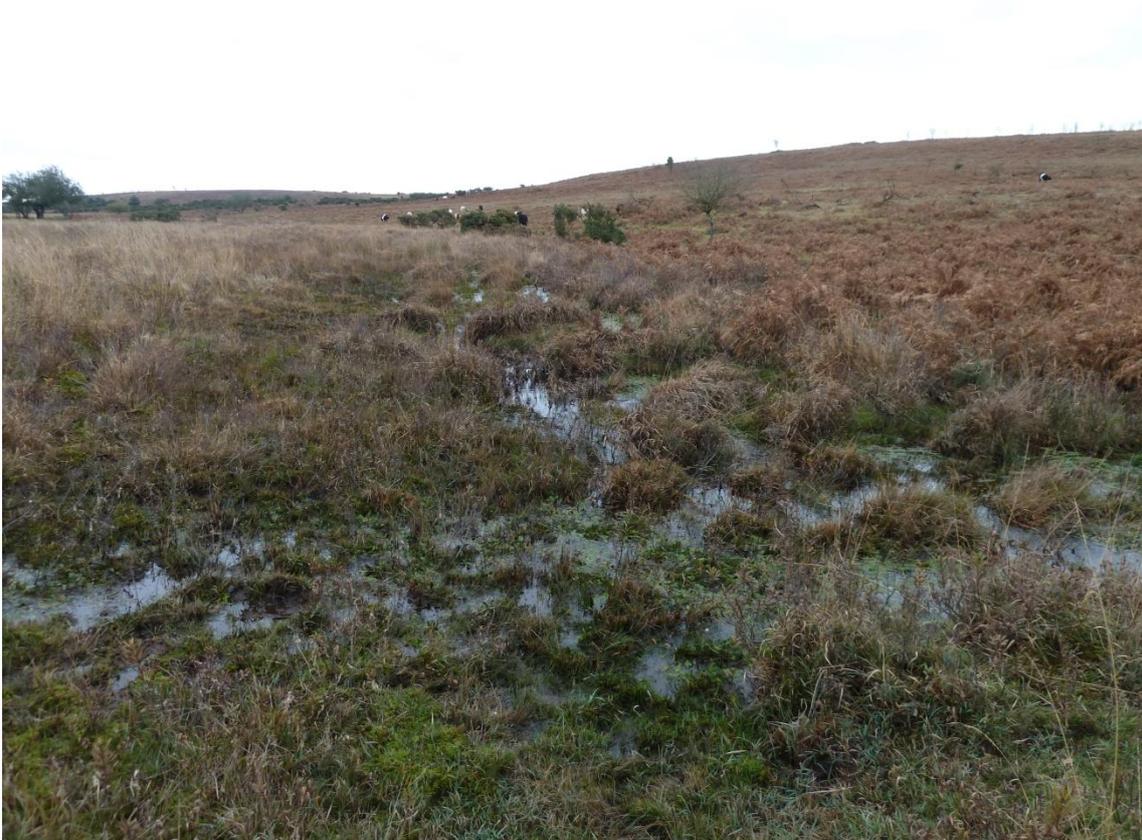
Figure 1-7: Water spreading over wide area (Soakway)

In some locations the single thread channel is more disconnected than others resulting in drier floodplain areas with associated impacts on vegetative assemblages (see section 1.4).

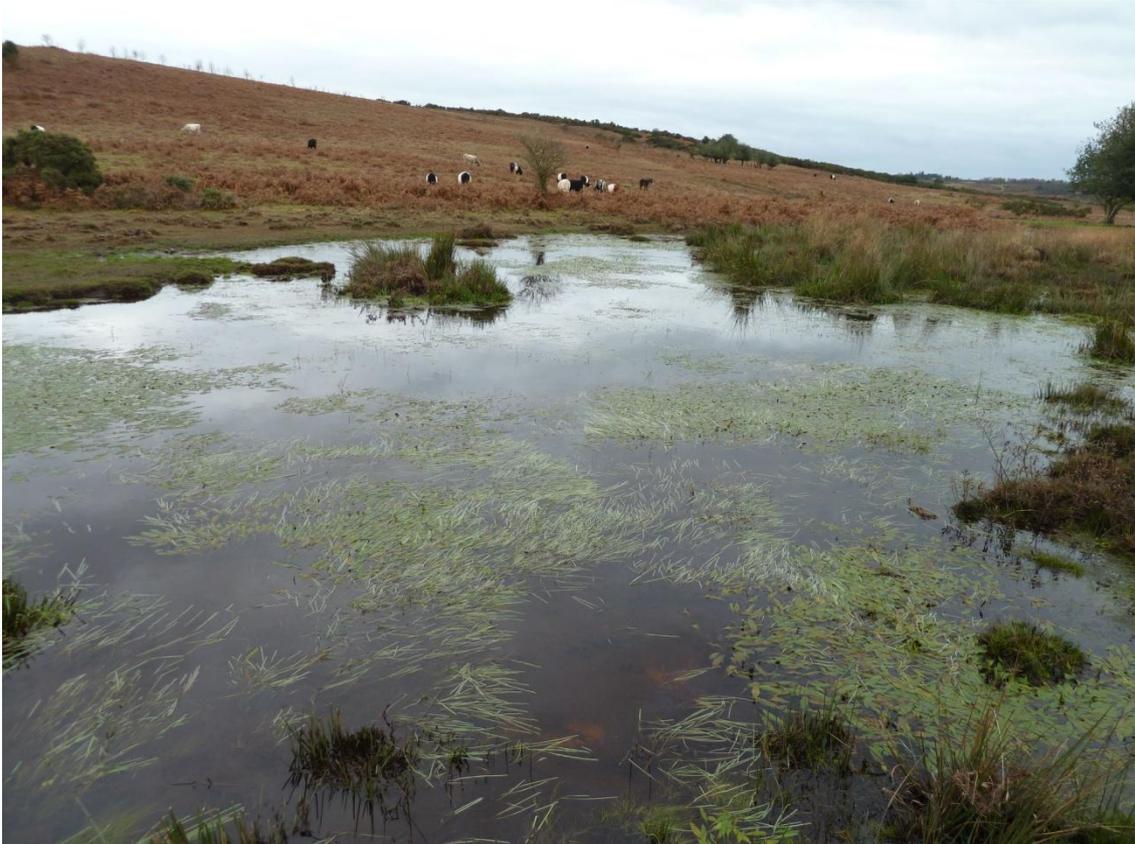
Figure 1-8: Artificial pond

Fine sediment inputs to the channel are increased due to poaching and grazing up to the channel banks. Several points are used by cattle for crossing and drinking and this may have been a reason for the creation of the pond in the upper section of the unit (Figure 1-8). The pond is acting as a sediment sink and is disrupting the continuity of sediment and flow downstream.

- Bed and associated water level raising through channel infilling and blocking using heather bailing or consolidated berms) to create spreading sections of channel and to improve floodplain diversity;
- Water level raising will improve groundwater levels locally;
- Restored natural flow and sediment regime through artificial pond infilling.

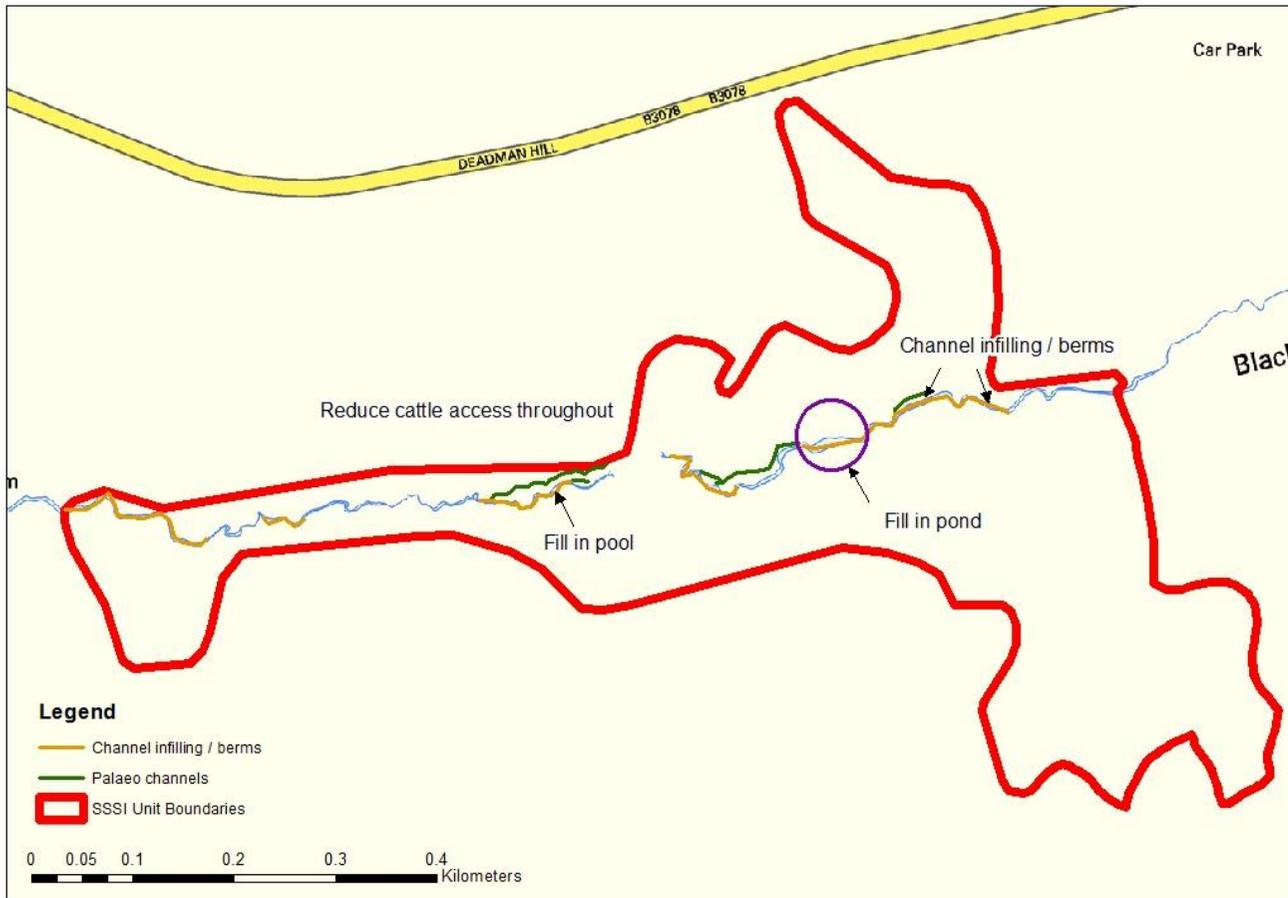
Figure 1-10: Proposed restoration measures for SSSI Unit 35

Some minor palaeo channels have been identified in Figure 1-10. These have been identified from the audit and supplied LIDAR. Reconnecting these is unlikely to provide significant hydromorphological and ecological gains.

A summary of the current pressures, unmitigated impacts and restoration proposals is given in Table 1-2 and shown in Figure 1-10.
