Natural England Commissioned Report NECR141

# New Forest SSSI Ecohydrological Survey Overview

Annex D: Dibden Bottom and Noads Mire

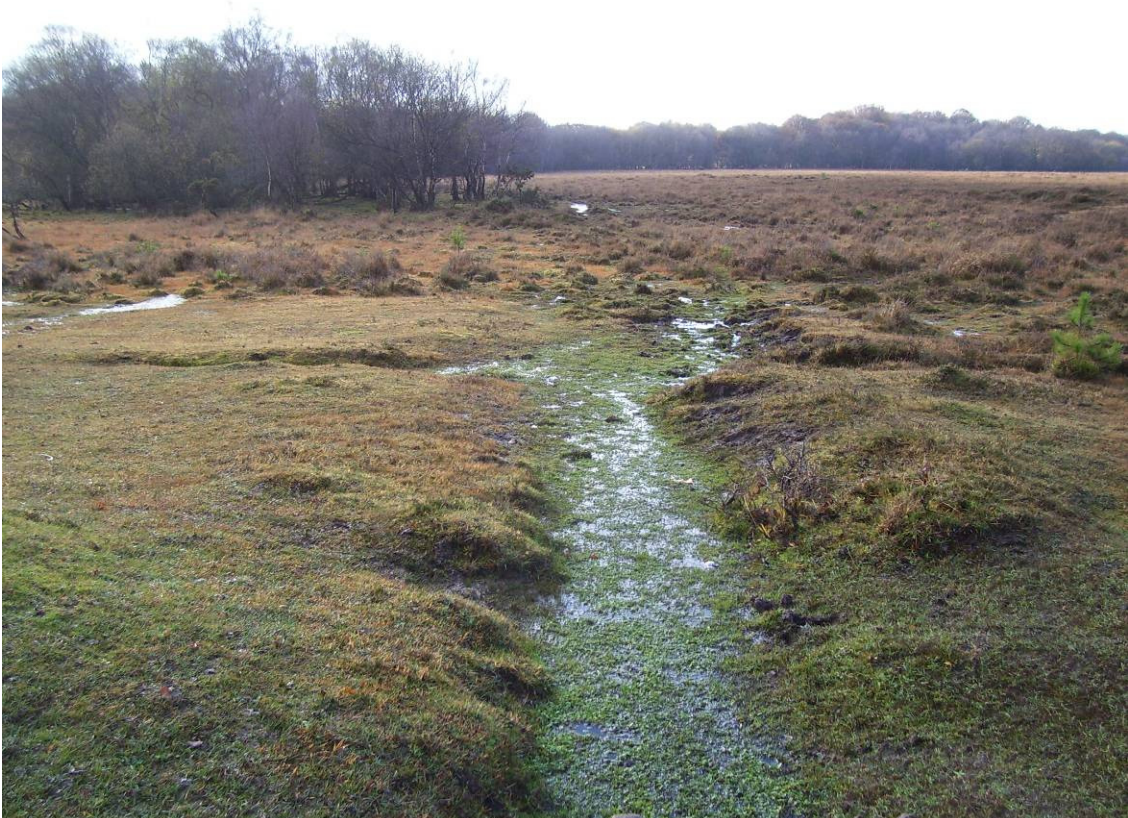
**Figure 1-3: View towards small quaking bog fed by "issues" in the northern part of the site - water from a drainage ditch is piped under a road, where it flows onto the bog (adjacent to Unit 417, NGR 438847 107318)**

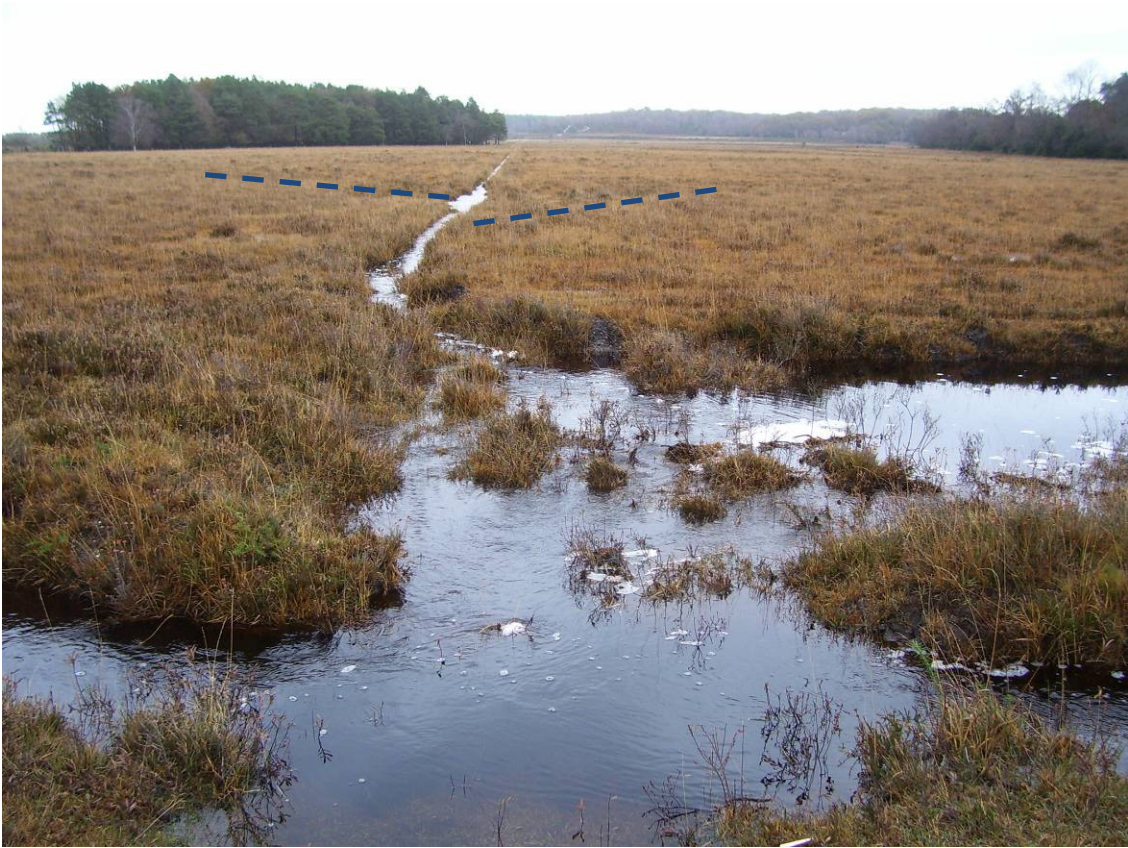
**Figure 1-4: Area of herringbone drainage adjacent to the central part of the site (adjacent to Unit 418, NGR 438679 105942, looking east-northeast)**

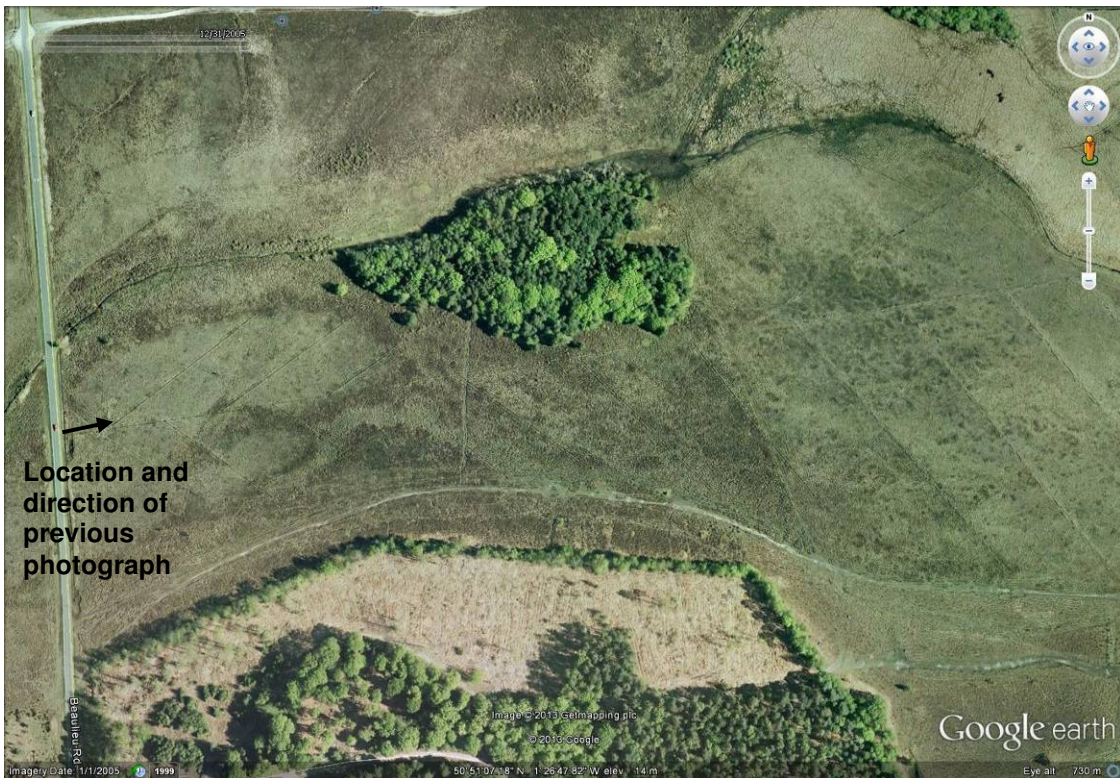
**Figure 1-5: Aerial photograph showing herringbone drainage adjacent to Unit 418 in the central part of the site (Google Earth)**

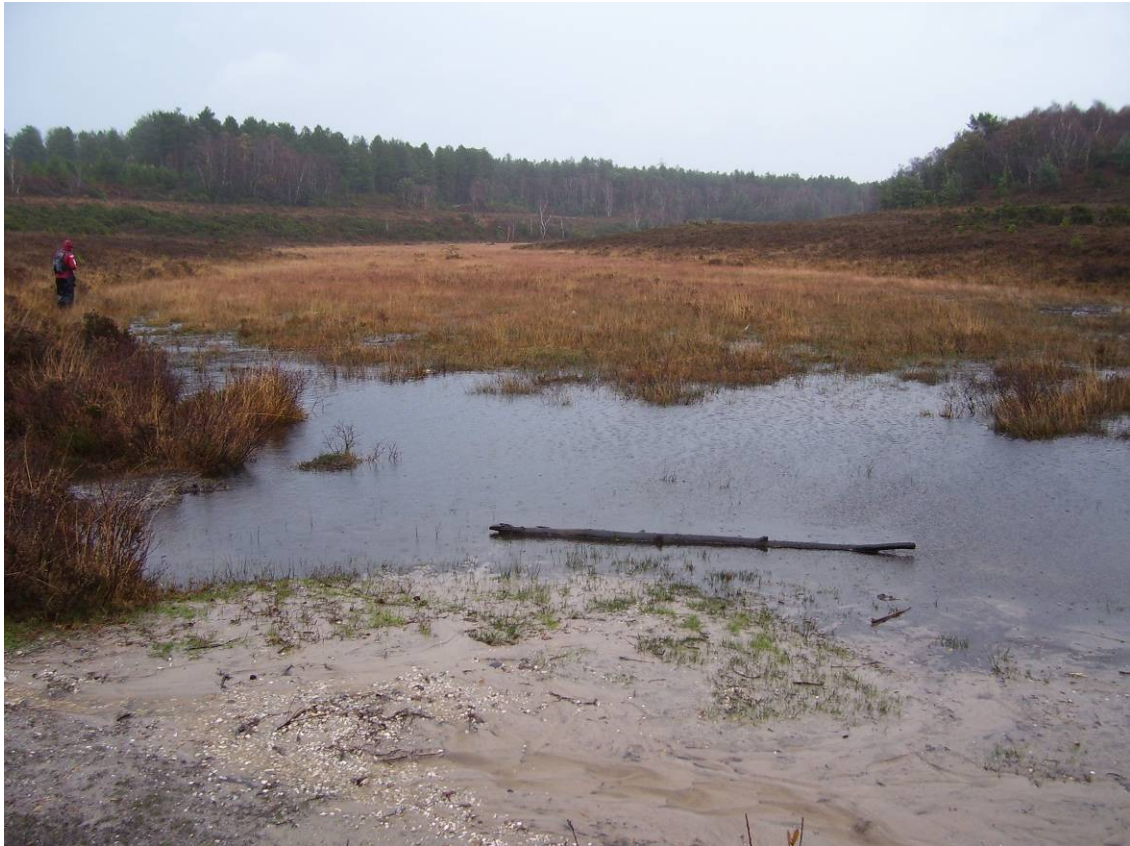
**Figure 1-6: View of valley mire in the central part of the site, showing slight doming of the peat within the valley bottom (Unit 418, NGR 439729 106139, looking east-northeast)**

In the eastern part of the site are well-developed valley mires containing significant thicknesses of peat (see Section 1.5). The peat locally displays very slight doming of its upper surface (Figure 1-6).

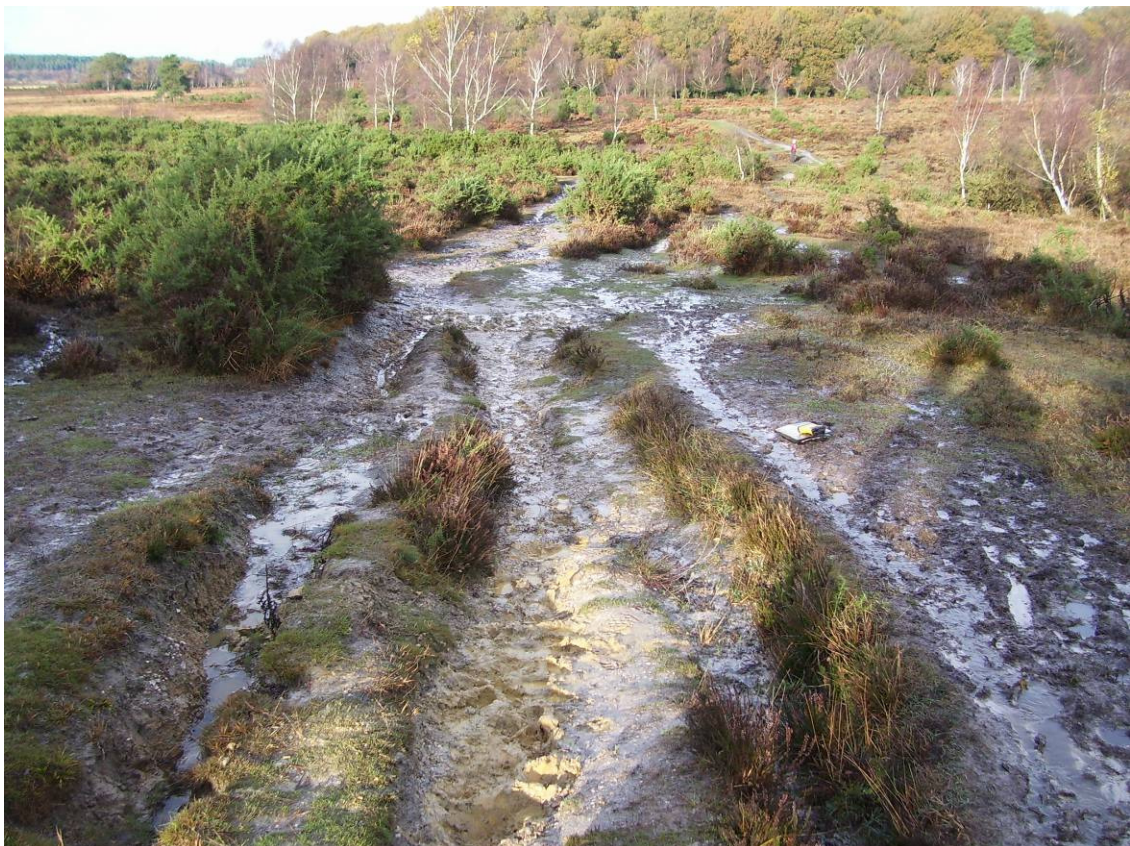
**Figure 1-7: Eroded footpath in the southern part of the site. Orange/buff/grey sandy clay of the Headon Formation is exposed in the deeper ruts (Unit 419, NGR 439723 105227, looking north).**

Footpath erosion was noted to be particularly severe in the centre of the site, where the main footpath crosses the southernmost watercourse.

Straightening and deepening of natural drainage channels/pathways from the mires will have improved the efficiency of drainage, potentially lowering groundwater levels in and adjacent to the mires. Footpath erosion is severe at the fording point where the main footpath crosses the southernmost watercourse.

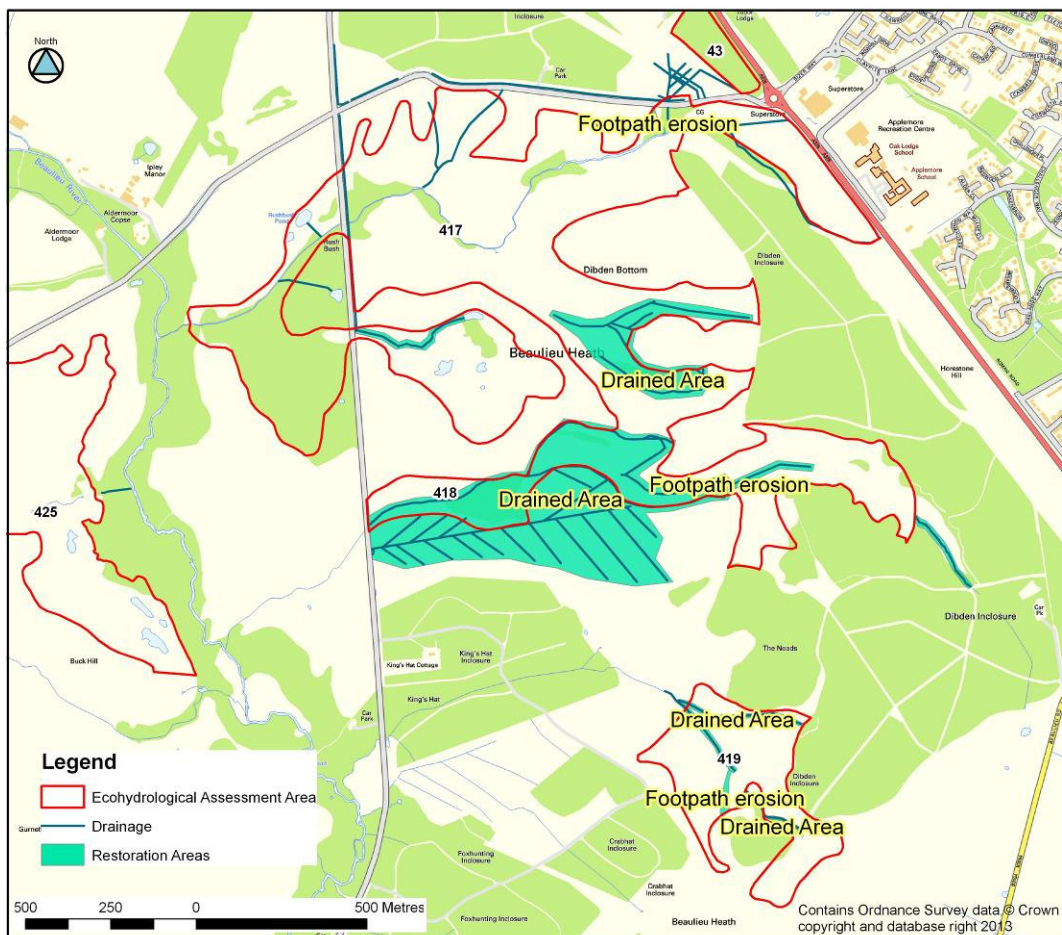
Figure 1-15: Restoration Areas Map

There are several areas of hydrological damage (see Figure 1-15). In most cases the damage relates to artificial drainage. However, locally there is also damage related to footpath erosion and potentially a footbridge ponding water and causing an impediment to flow.

Note that Figure 1-15 does not distinguish between restored and non-restored areas. It shows those areas potentially in need of restoration or further restoration.

It is understood that restoration work has already been undertaken at Dibden Bottom (in two phases: December 1999 and January 2001) and that this involved raising water levels by blocking drains in valley mire and wet heath areas. It is recommended that the effectiveness of this restoration be assessed using water level monitoring data (see next section). Depending on the findings of this assessment, further restoration work may be required.
