Natural England Commissioned Report NECR140

# New Forest SSSI Geomorphological Survey Overview

Annex J: Wick Wood Riverine Woodland - SSSI Unit 368

# 1 Wick Wood Riverine Woodland - SSSI Unit 368

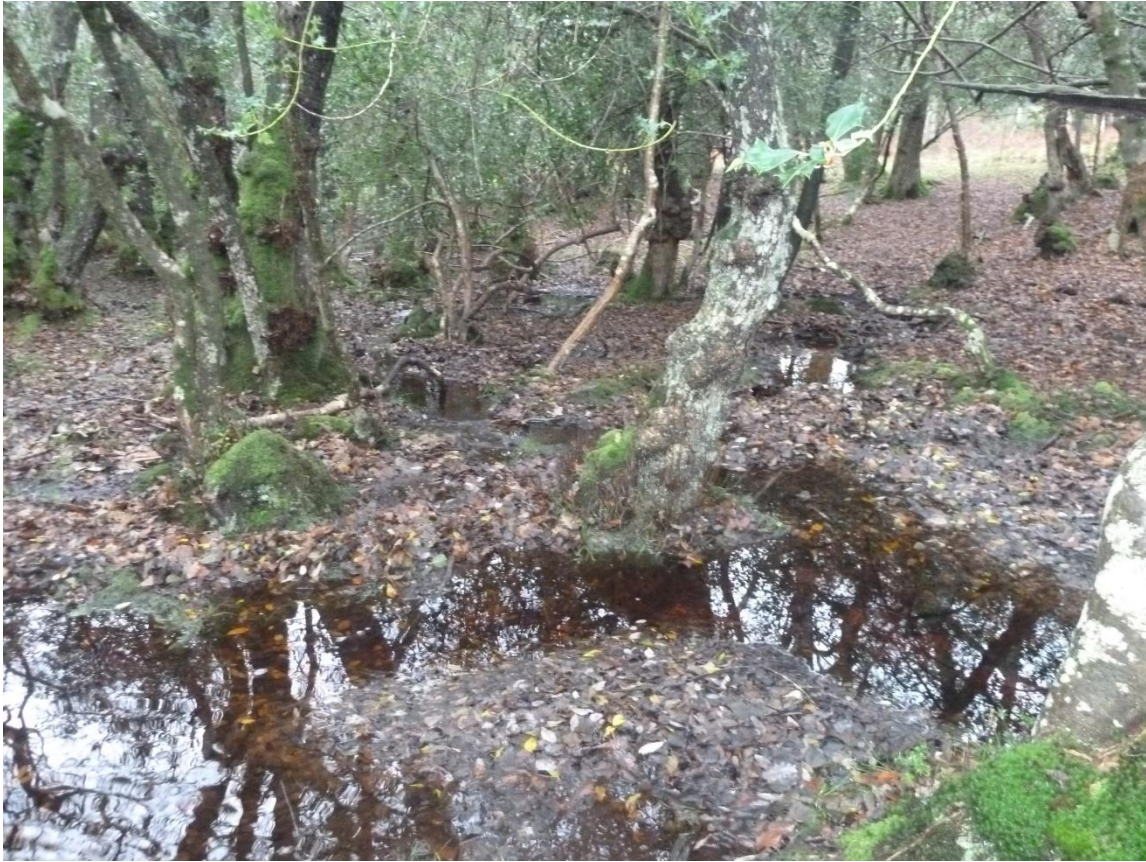
The Wick Wood Riverine Woodland SSSI unit and Bagshot Gutter is characterised by a lowland anastomosed system (Figure 1-2) in the upper reaches and an active single thread system in the lower reaches (Figure 1-3). The stream becomes more single thread downstream of the confluence with the Bagshot Gutter from the west at approximately the midpoint of the unit.

Figure 1-2: Anastomosed channel type along the Bagshot Gutter upper reaches

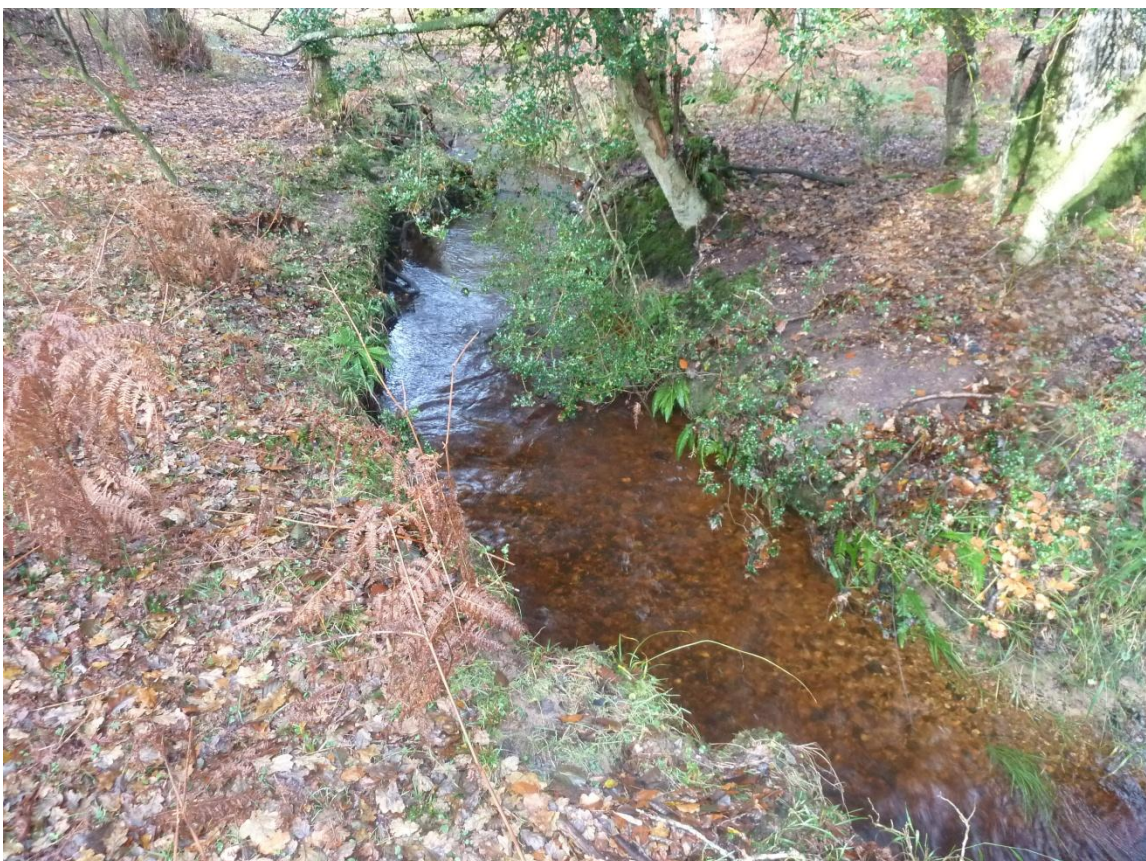
Figure 1-3: Active single thread channel type along the Bagshot Gutter lower reaches

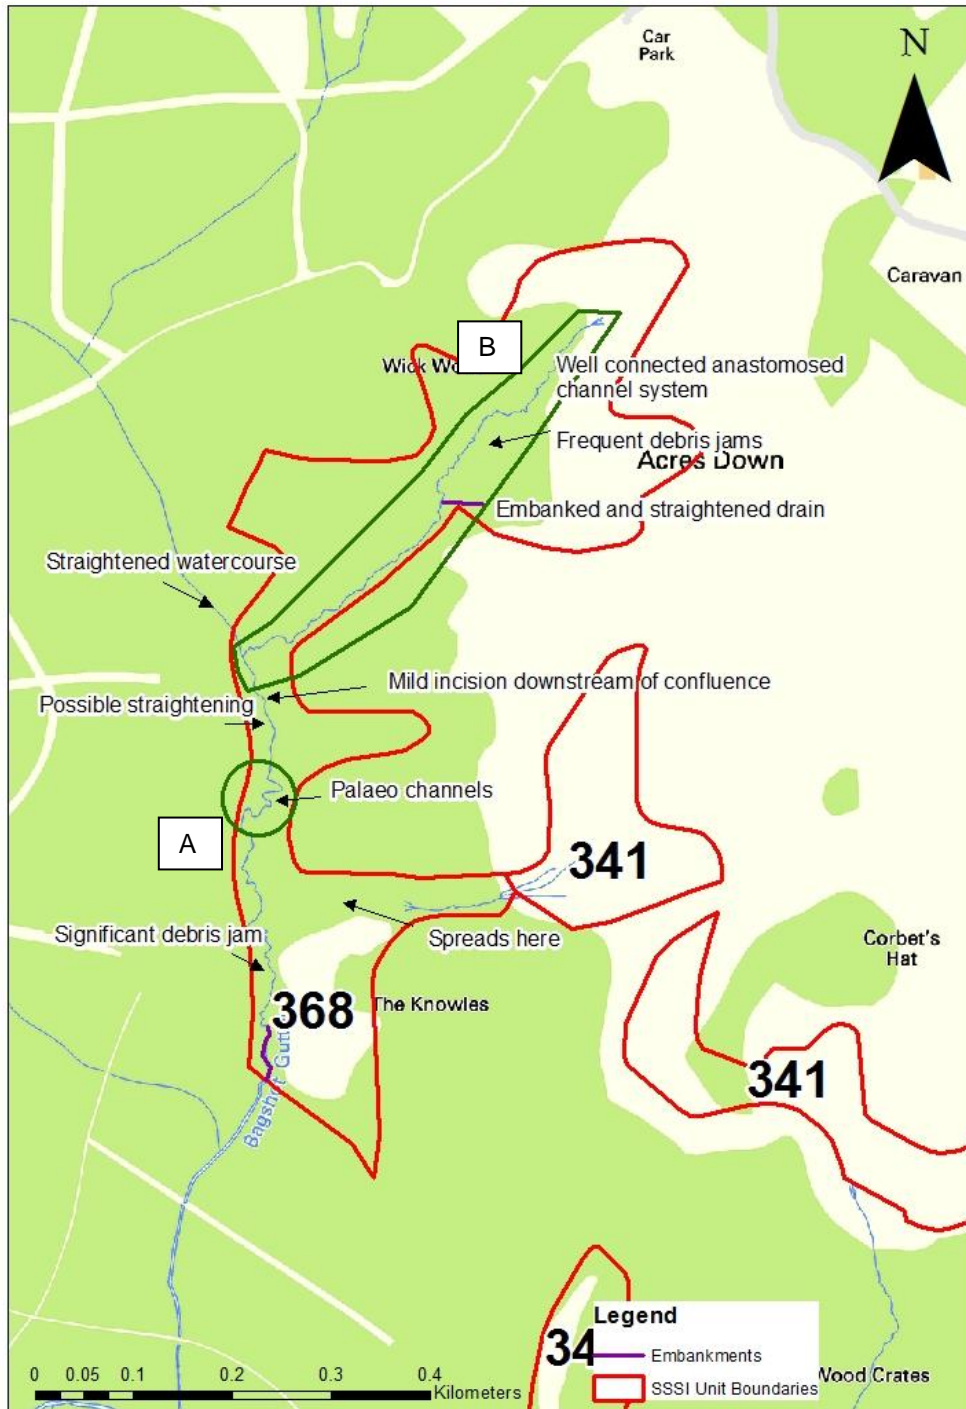
Figure 1-4: Current hydromorphic conditions and pressures

Some straightening has probably been undertaken in the downstream single thread section (Figure 1-4 - A), alongside over-deepening through dredging and some embankment creation on the bank tops (there are some palaeo features within the floodplain locally that were identified during the audit and from LIDAR, these are shown in Figure 1-11). This has created some

In the upper anastomosed reach (Figure 1-4 - B), multiple channels were active during the survey with distinct hydraulic differences between the dominant channel and subordinate channel network (Figure 1-7). The sub channel network is very well connected at this location and this should be maintained as part of the restoration for this unit. This can also be used as an analogue for restoration downstream.

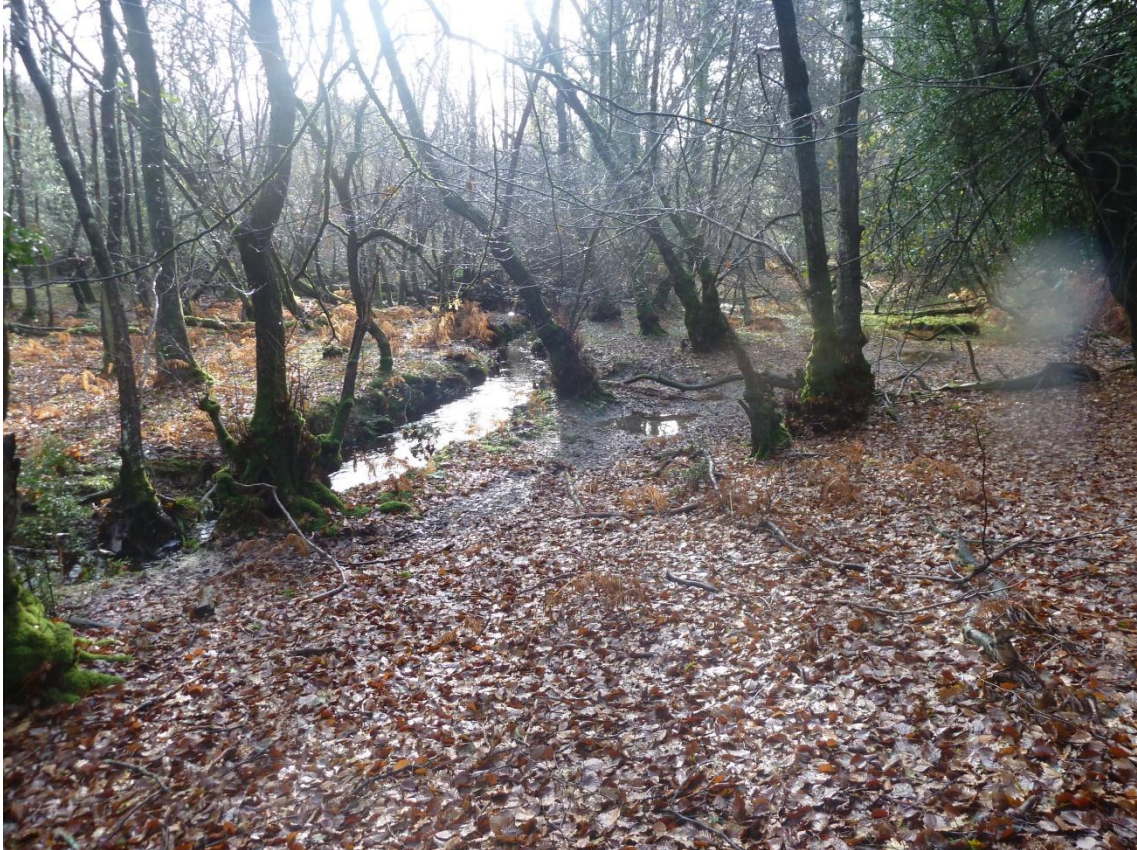
incision (Figure 1-5), due to the moderate gradient and energetic flows, within this downstream section (below the confluence with the main Bagshot Gutter) with artificially concentrated flows in the single channel leading to increased erosive energy. However, incision is not extreme as the drains remain relatively unaffected and the stream in the upper reaches of the unit is not impacted at present.

Figure 1-5: Mild incision in downstream reach

Despite the historic straightening a well wooded riparian corridor has restricted excessive lateral erosion (Figure 1-5), however, bed incision has occurred leading to variable disconnection from the floodplain. Widespread incision has also been prevented through the frequent occurrence of natural woody debris jams within the channel (Figure 1-6).

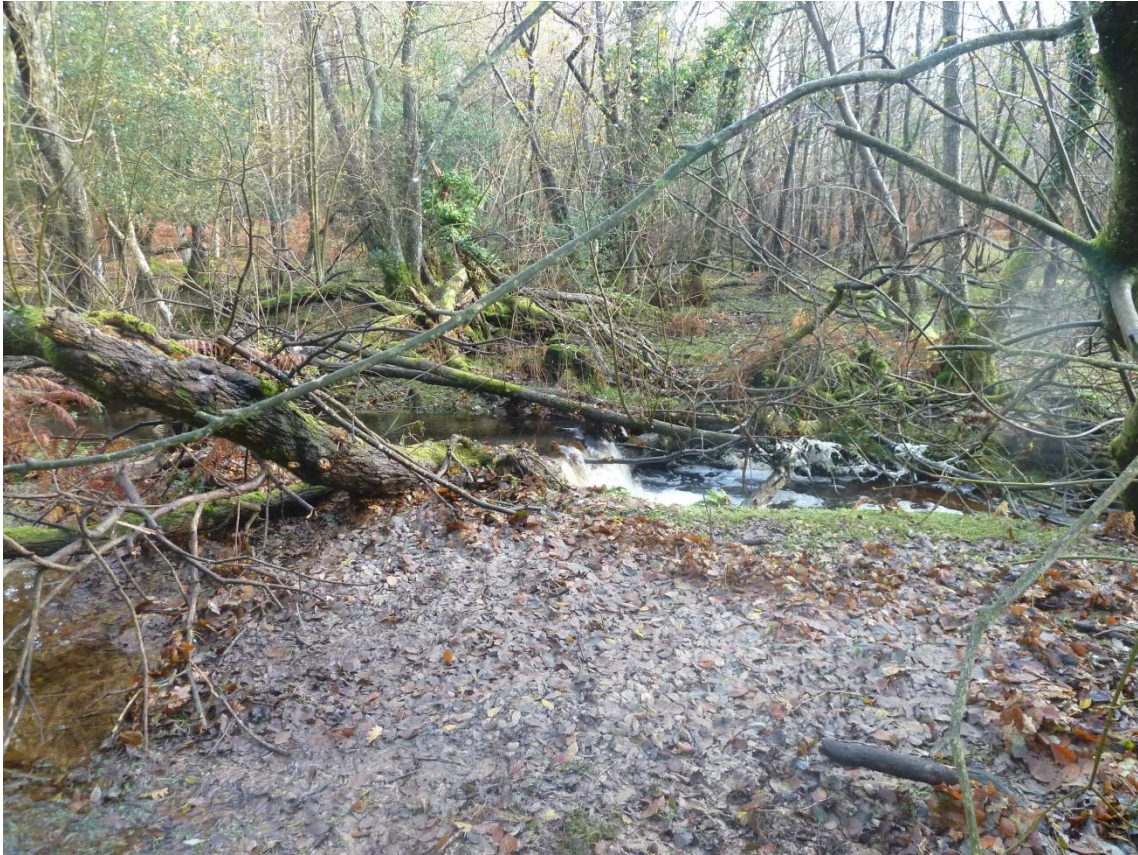
Figure 1-6: Woody debris jams in downstream reach

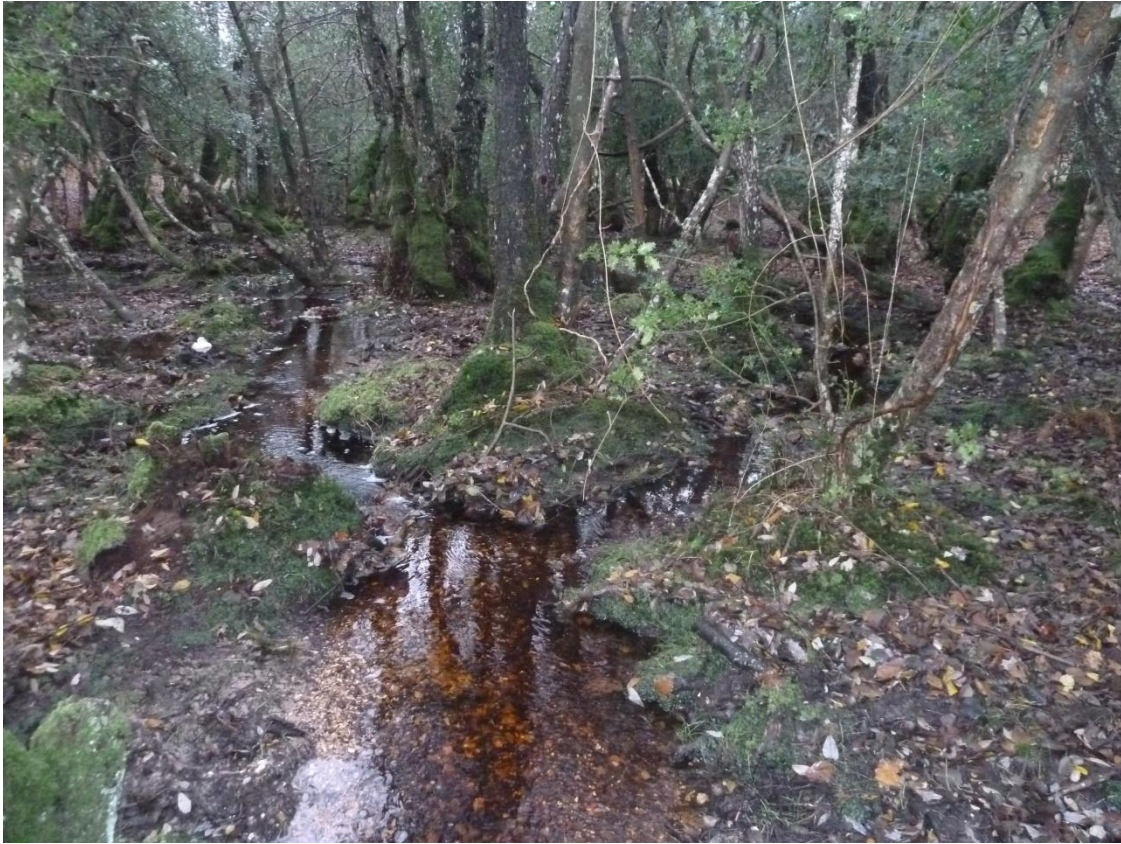
Figure 1-7: Anastomosed network in upper reach

The riparian woodland is well developed along the SSSI unit and is presently acting to concentrate flood flows along anastomosed sub-channels creating and helping to maintain hydraulic, morphologic and habitat diversity in the upper reaches (Figure 1-7).

The upstream anastomosed system must not be impacted as part of any restoration works as this is a successfully functioning channel network at present.

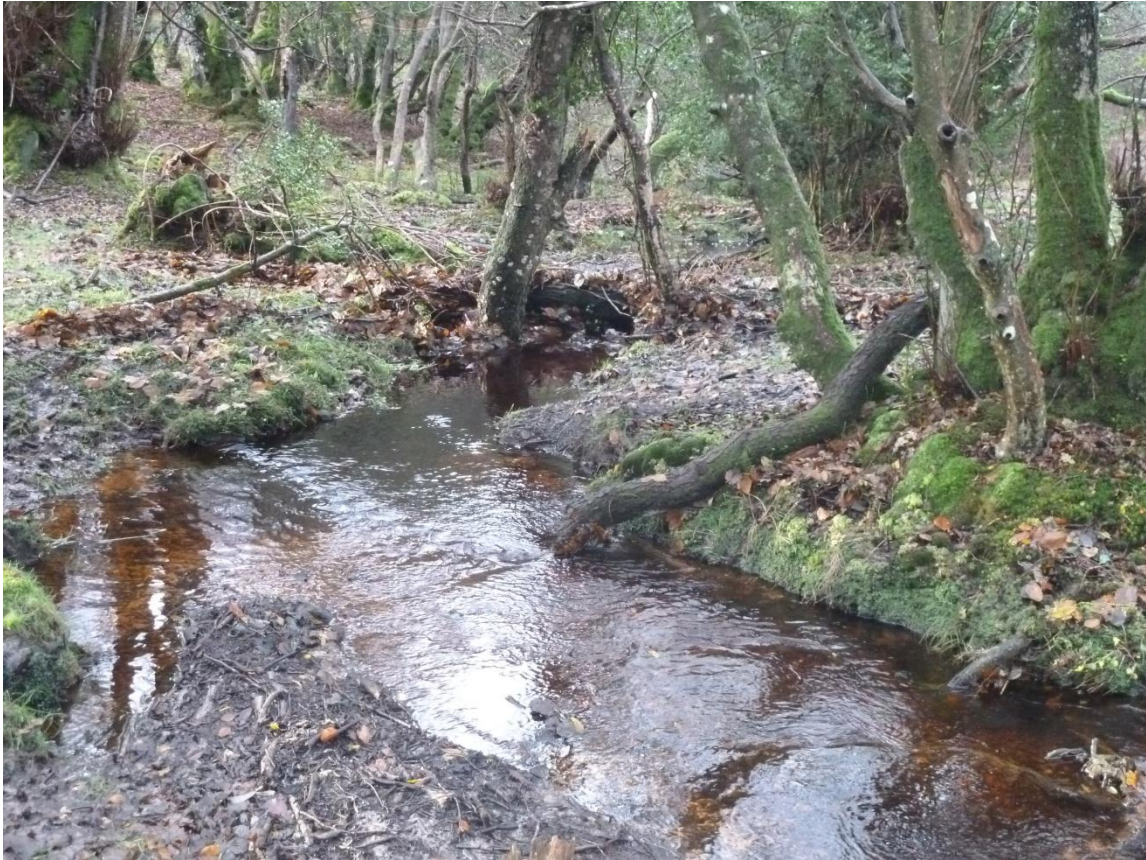
Natural woody debris features, both live and dead, are also common in the anastomosed reach. These create short lengths of impounded watercourse and promote flow spreading, improving floodplain connectivity and inundation frequency significantly (Figure 1-8).

Figure 1-8: Woody debris jams in upper anastomosed wet woodland (W1) section

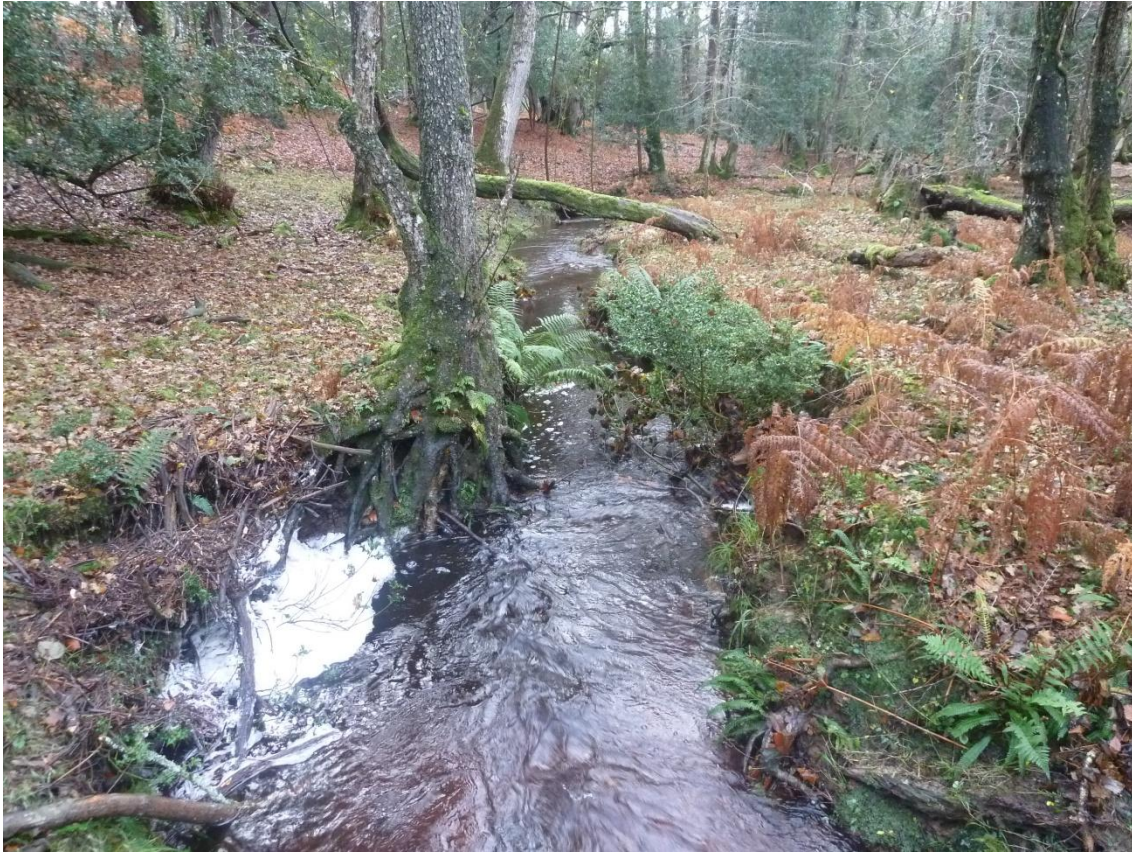
Riffle - pool - run sequencing has developed (Figure 1-9) throughout the unit as a result of the moderate gravel supply and moderate gradient. Gravel bars and berms are generally only small, functionally developed features throughout as a result of the transporting conditions created by the incision and restricted floodplain connectivity.

Figure 1-9: Riffle - pool - run development
