New Forest SSSI Geomorphological Survey Overview

Annex H: Harvest Slade Bottom Restoration Plan - SSSI Unit
126

1 Harvest Slade Bottom Restoration Plan - SSSI Unit 126

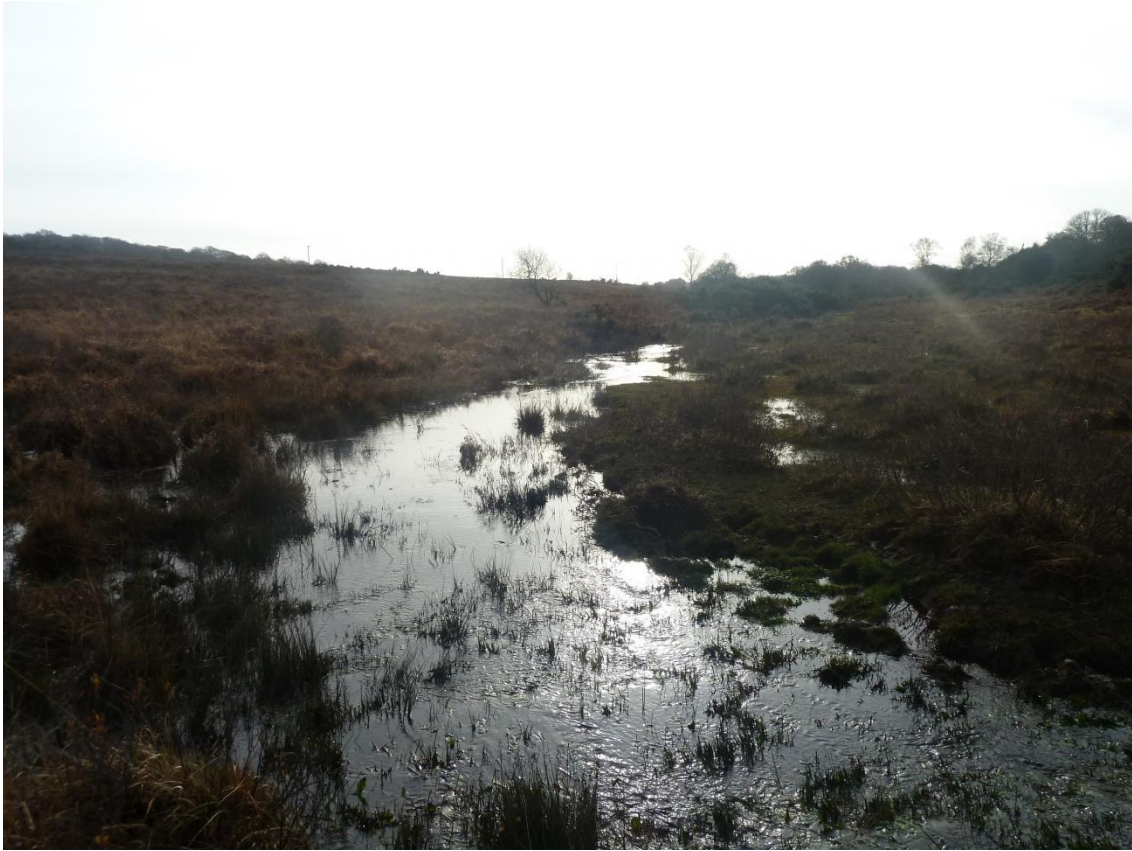
The stream within SSSI Unit 126 is a mainly a passive single thread channel (Figure 1-2), switching to sections poorly differentiated of multi branch / spreading networks where floodplain connectivity is improved and gradients are reduced (Figure 1-3). There are generally low inputs of gravel to the stream locally and from upstream sources, with limited bank erosion and the dominant material on the channel bed is fine sediments / silt (Figure 1-5), with only small sections of exposed gravel bed (in the single thread sections in upstream mire area). In the downstream section, the stream is more active, with evidence of incision (Figure 1-4).

Figure 1-2: Passive single thread channel characteristics corresponding with Soakway habitat M29

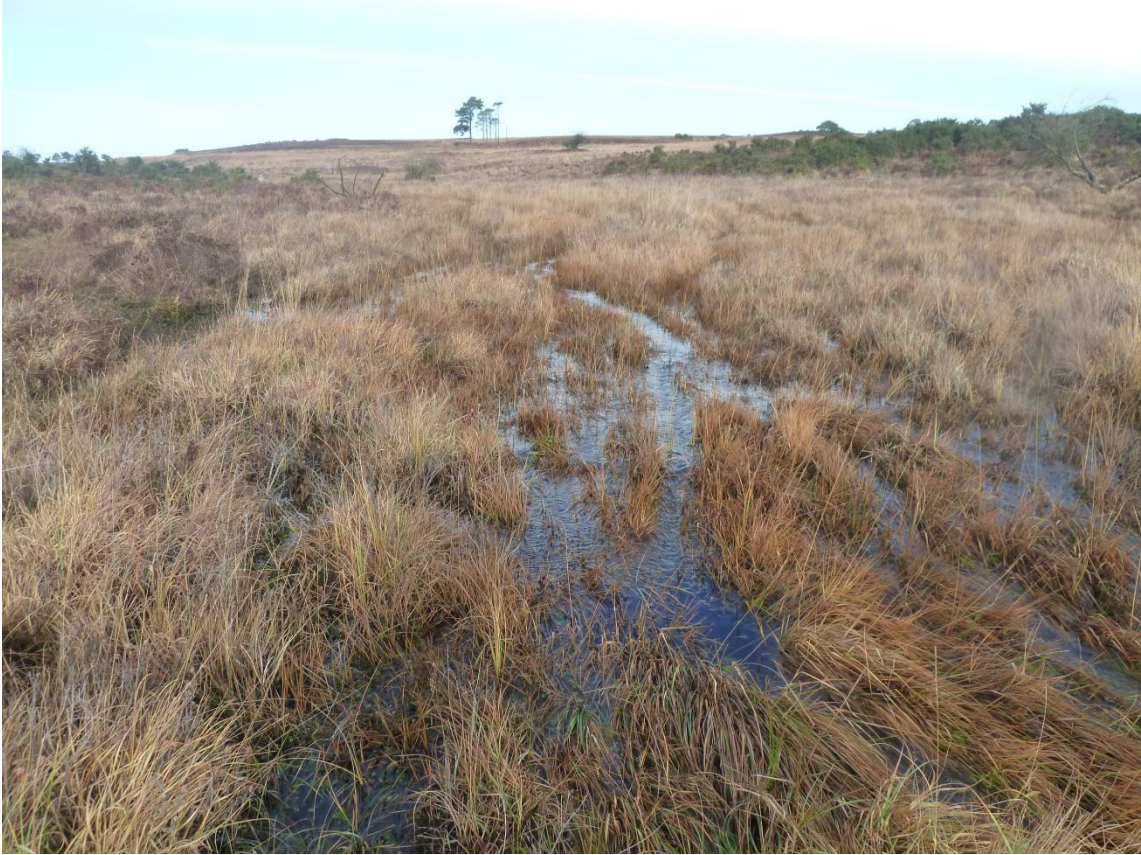
Figure 1-3: Multi branch / spreading sections on valley mire M25a

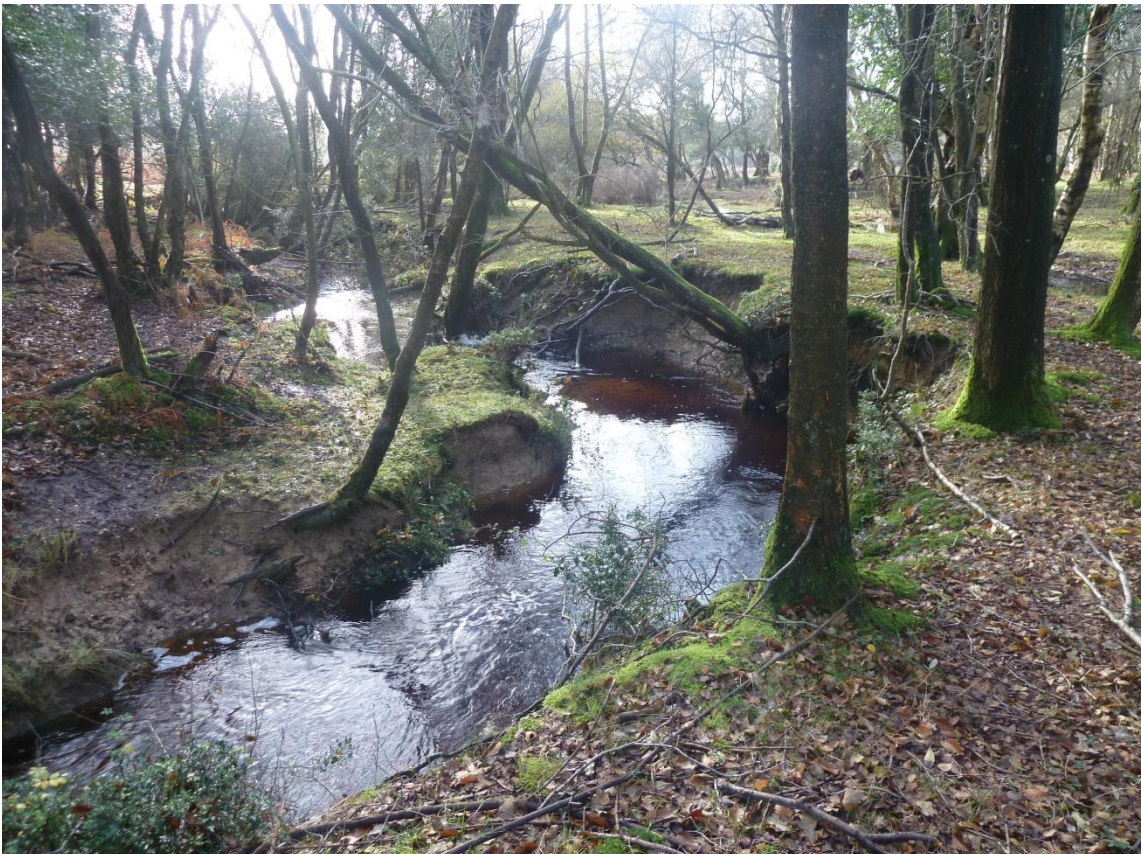
Figure 1-4: Active, incised, sinuous, single thread stream section downstream

Incision is a continuing process in the downstream single thread reaches and threatens to migrate further upstream if not managed. This would threaten the mire areas of this unit through bed and water level lowering, groundwater lowering and consequential floodplain drying

Woody debris jams to manage knickpoint erosion downstream must extend into the adjacent banks to ensure longer term functioning.

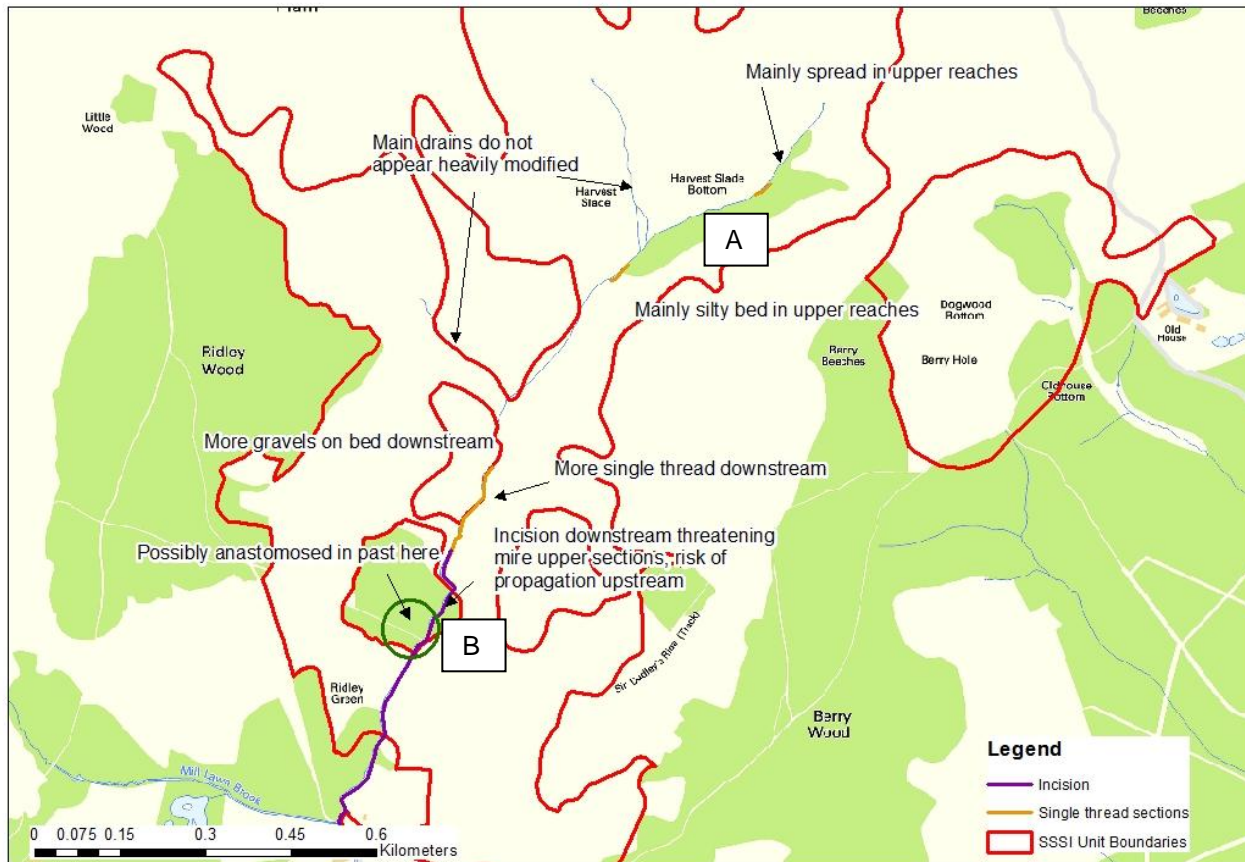
Figure 1-5: Current hydromorphic conditions and pressures

The stream / flow route in the middle to upper reaches has a generally low gradient (Figure 1-5 - A), particularly in the multi-thread / spreading sections where there is no clear dominant channel and spreads over a wide area. In the single thread sections, the gradient is still generally low (steepening downstream). Functional riffles, where occasional gravel bed sections are exposed in the downstream single thread reaches, display a local gradient increase (Figure 1-6). This single thread section where gravels are more apparent, is likely to have been impacted by flow concentration from surrounding drains and downstream incision, maintaining the single thread characteristics at this point. Outside of these locally energetic areas, the bed is generally silt dominated due to the low gradients (Figure 1-7) and diffuse supply. As a result of the generally low gradients and in combination with little incision, bank erosion is limited. Fine sediment inputs to the channel are increased due to poaching and grazing up to the channel banks.

The straightening and deepening of the downstream section of this unit may have destroyed a previous anastomosed channel type as the right bank floodplain would be well connected if the incision was managed. This remnant anastomosed system now appears to be disconnected from the main channel for the majority of flows. Some possible anastomosed palaeo-channels have been identified from the LIDAR (Figure 1-5).

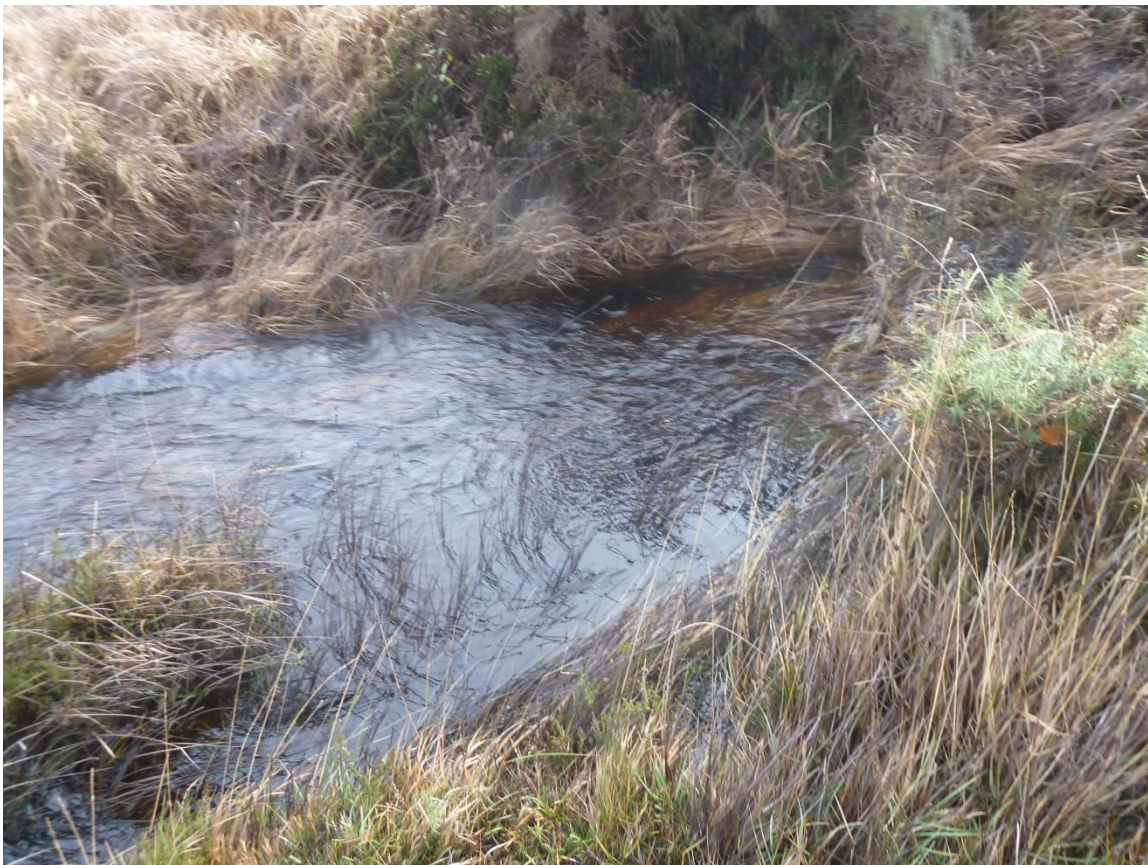
Figure 1-6: Small gravel bed sections downstream

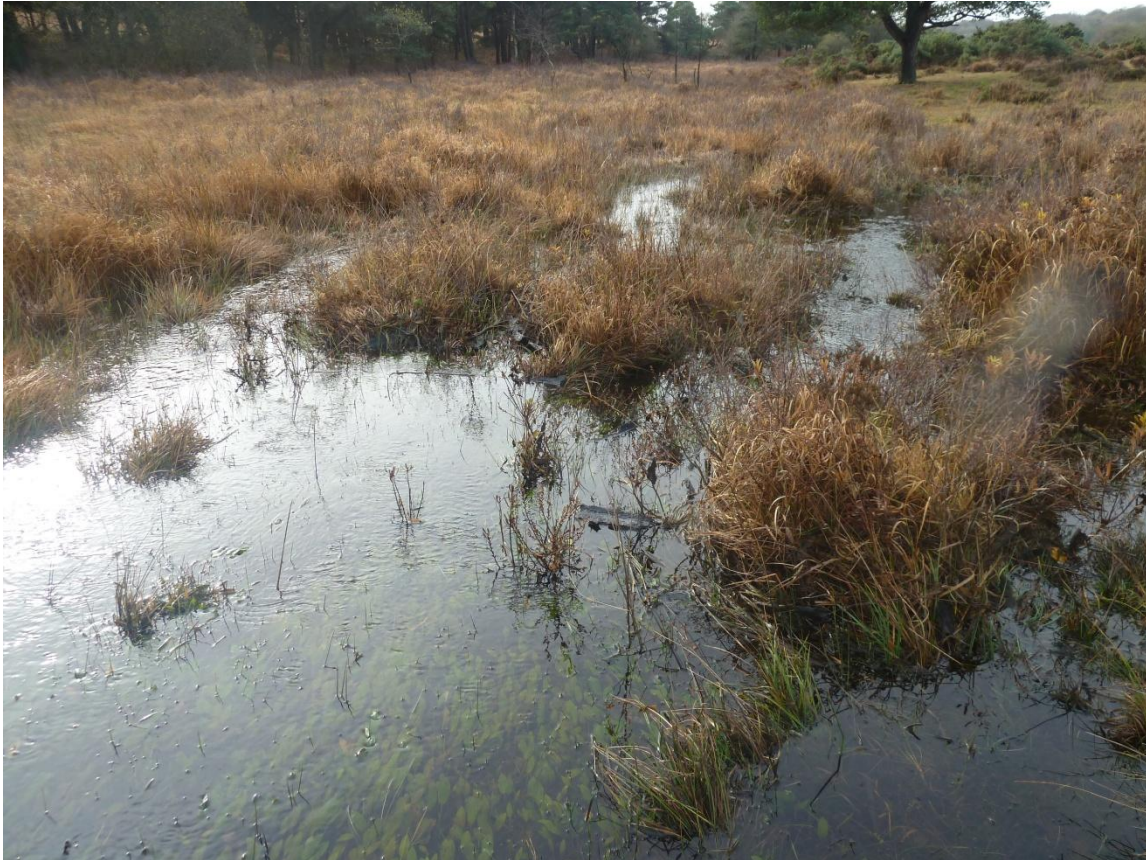
Figure 1-7: Vegetated, fine sediment dominated bed in valley mire habitat (M29, M25a)

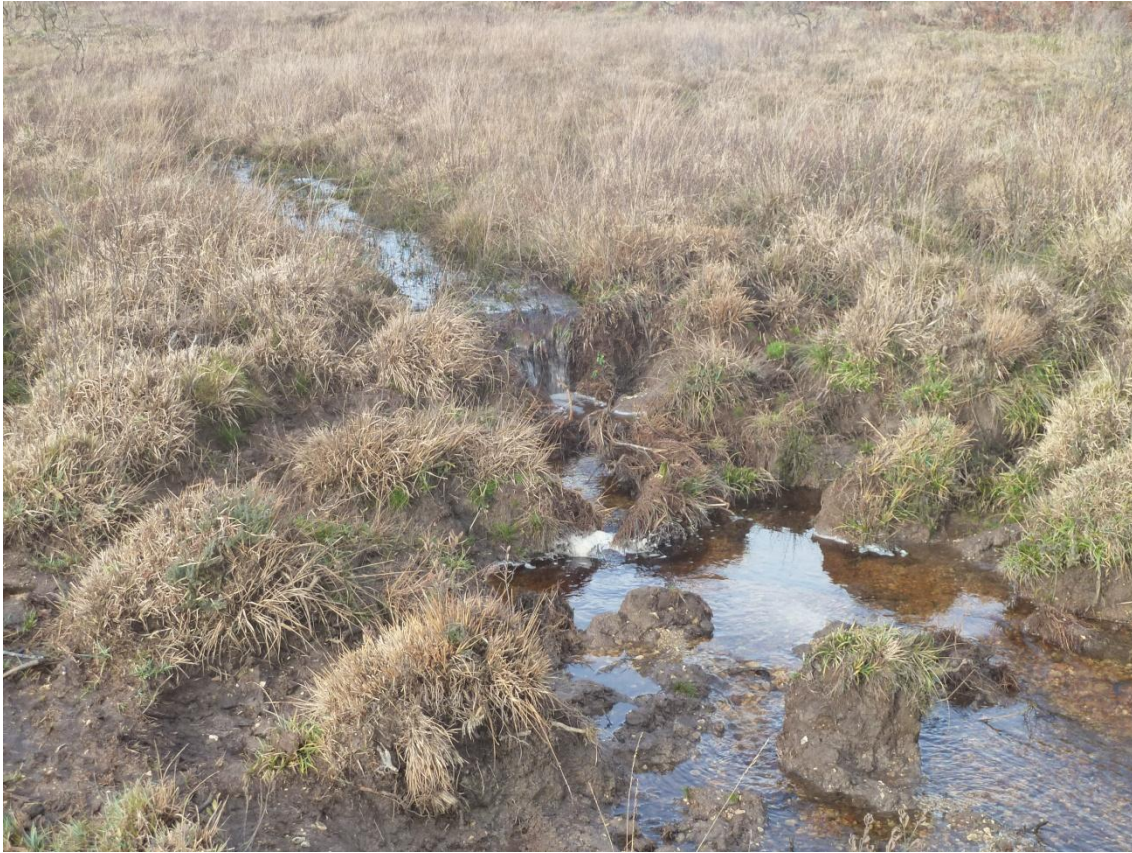
The LIDAR and drainage lines in Appendix A show that there is likely to have been some modification to the drainage flow routes, mainly through concentration of flows into the major drains, which then concentrate inflows to the main channel at certain location. This may be a contributing factor to the formation / maintenance of the single thread sections, where flows are concentrated at one point, giving enough excess energy to maintain a single thread channel rather than silting up to form channels similar to the spreading sections within this unit. One of the main drains, on the right bank towards the upstream end, shows signs of a knickpoint forming, which may need to be treated as part of the restoration works to prevent it migrating upstream (Figure 1-8).

Figure 1-8: Right bank drain knickpoint

The channel in the middle and upper reaches is presently relatively stable as a result of limited incision, straightening, embanking and good floodplain connectivity. The minor incision in the right bank drain in the upper reaches may propagate upstream if not mitigated.

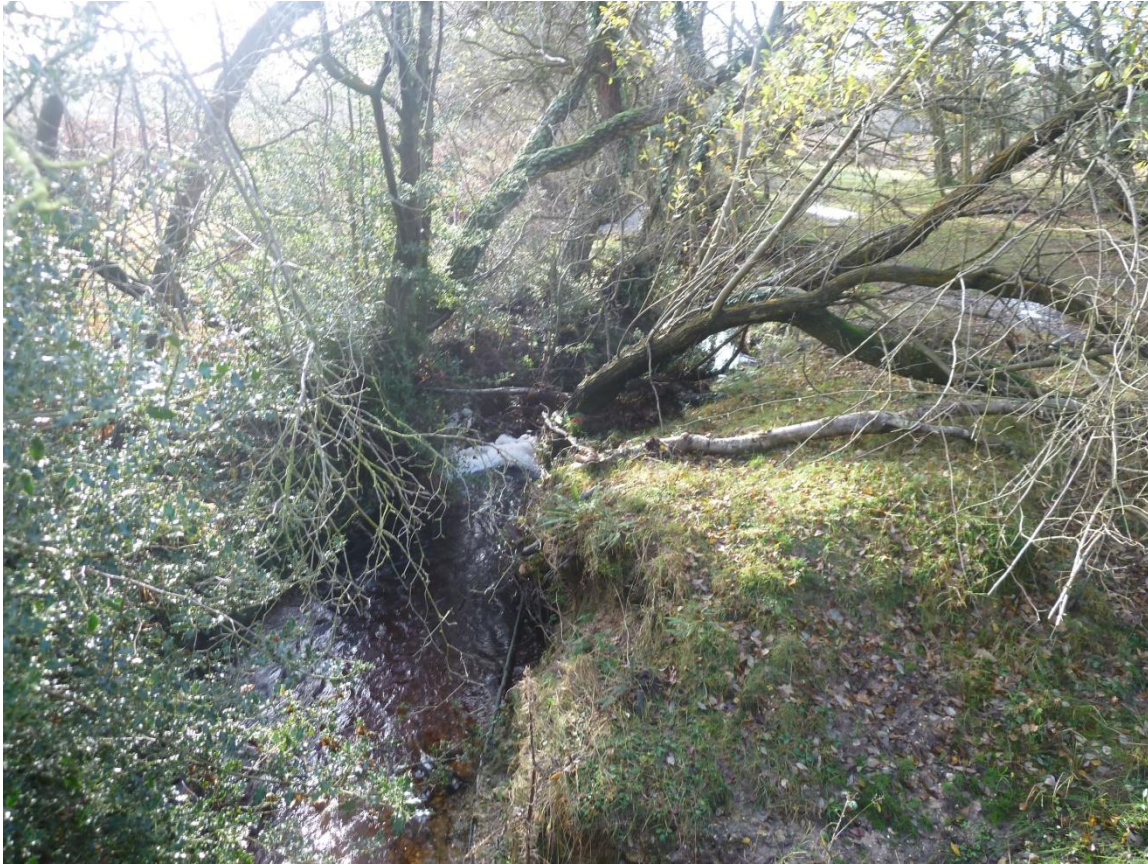
Figure 1-9: Natural woody debris jams in downstream reach

There are no natural woody debris features along the channel due to the surrounding vegetation type in the middle and upper reaches. Therefore, restoration options to improve floodplain connectivity further through the single thread sections of the watercourse are likely to involve channel blocking using consolidated silty berms (which naturally occur through the reach) alongside channel infilling. These will create short lengths of impounded watercourse and multi-branched / spreading networks that will improve floodplain connectivity / wetting. Woody debris jams could be used to manage the incision in the downstream single thread reaches as these naturally occur in the wooded riparian corridor in this area (Figure 1-9).
