Natural England Commissioned Report NECR141

New Forest SSSI Ecohydrological Survey Overview

Annex P: Longdown Mire

First published 06 March 2014

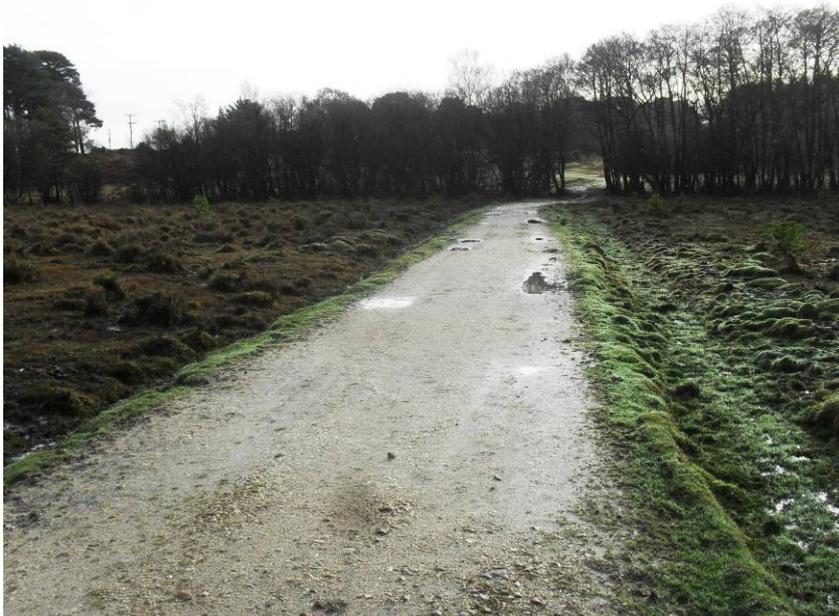
The site occupies the head of two valleys separate by a narrow ridge. Within the western valley are two small valley bottom wetlands and in the eastern valley there is one. Drainage has impacted all three within scrub colonising two of them (Figure 1-2).

Figure 1-2: Track leading down to line of scrub formed along the valley bottom wetland due to drain (NGR 435790, 109105)

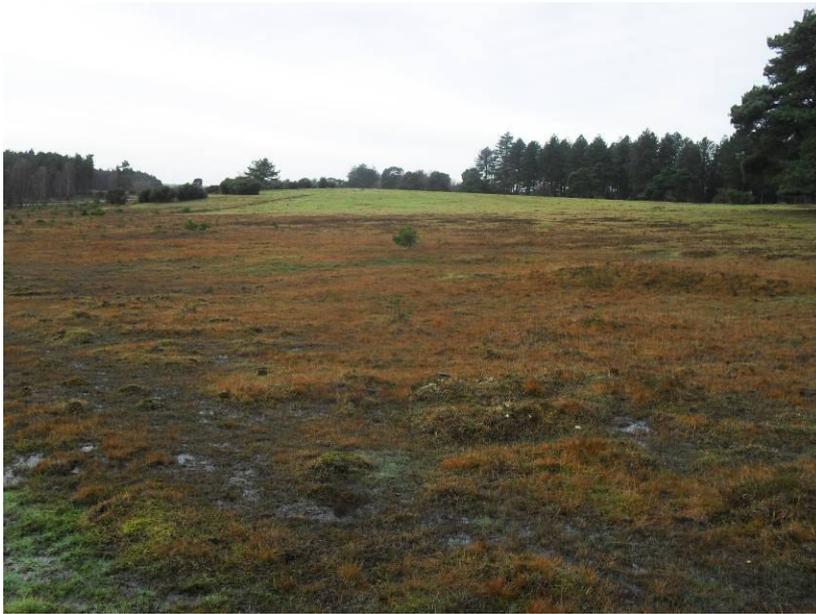
Surrounding the valley bottom wetlands are flush dominated valley side wetlands (supply mechanism discussed below) (see Figure 1-3). Some very small drains occur on parts of these areas but do not seem particularly effective. In the eastern part of the western valley, the footpath that runs along the top of the site drops to a lower elevation. Here it intercepts flush waters and focuses it into culverts. The valley side wetland below this point is damaged as water is focused into narrow bands, rather than across the whole surface (see Figure 1-4).

Figure 1-3: Western valley side wetland with small drain in foreground (NGR 425455, 109435)

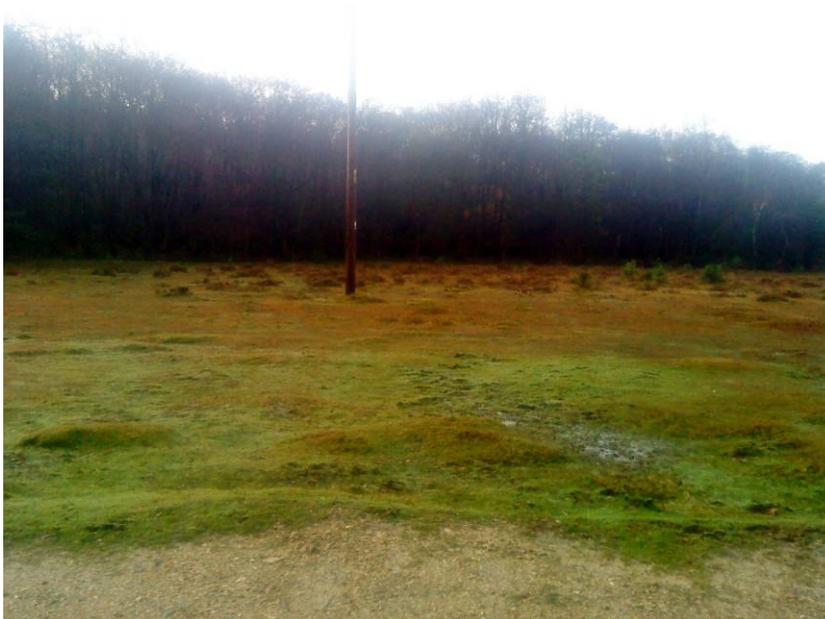
Figure 1-4: Track along the top of the western valley side wetland intercepting and channelling flush waters through culverts (NGR 435585, 109305)

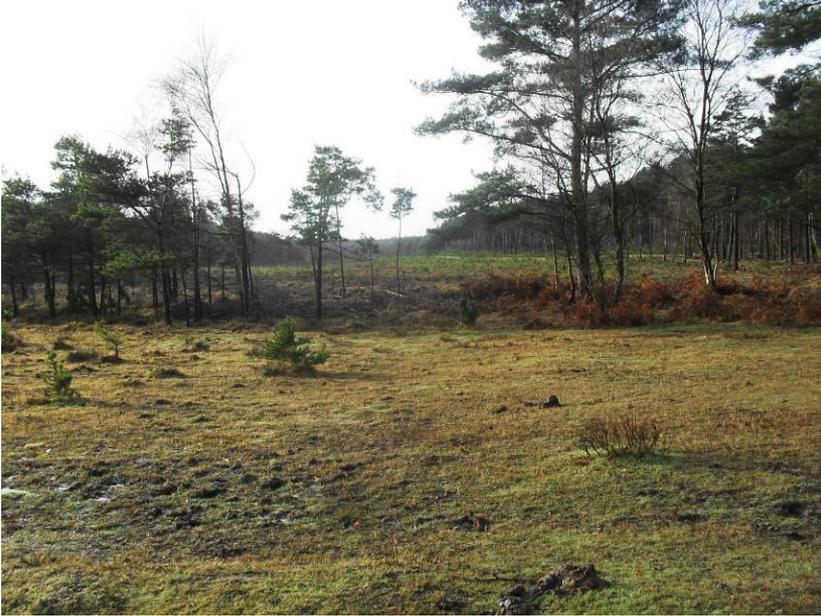
Downhill of the site in both valleys, open ground is replaced by forestry and felled forestry. The planting of conifers and the drainage associated with them has removed any wetland from these areas which would have continued on from the site (see Figure 1-5).

Figure 1-5: Abrupt change to an area of felled forestry in the eastern valley (NGR 435820, 109030)

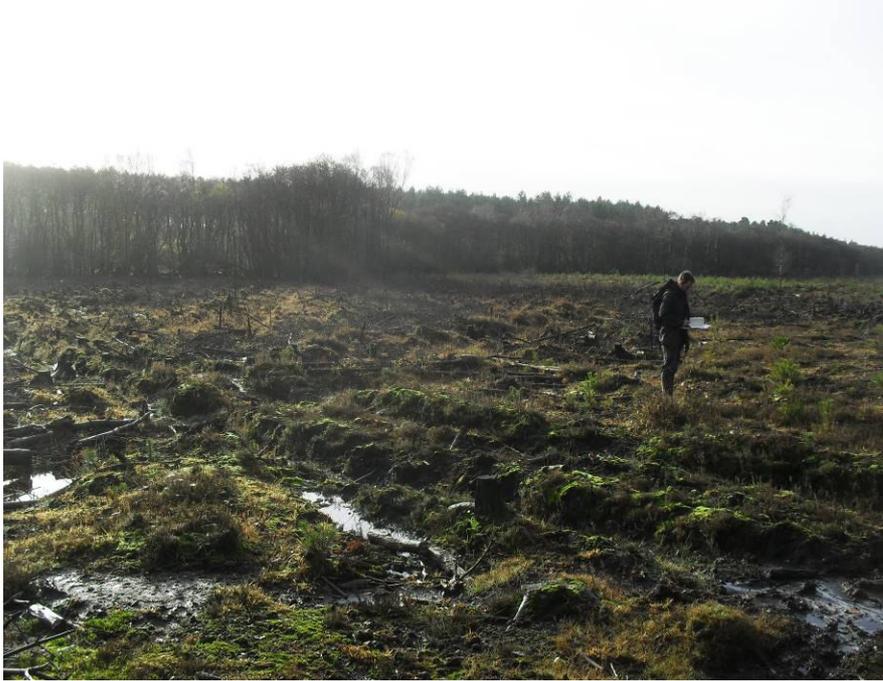
Further east is another area of felled woodland which extends beyond the Unit boundary (Figure 1-6). This area again, is a mixture of both drier and slightly damper habitats with multiple large drains cut through the centre of it.

Figure 1-6: Area of felled woodland far south-east boundary (NGR 435805, 109000)

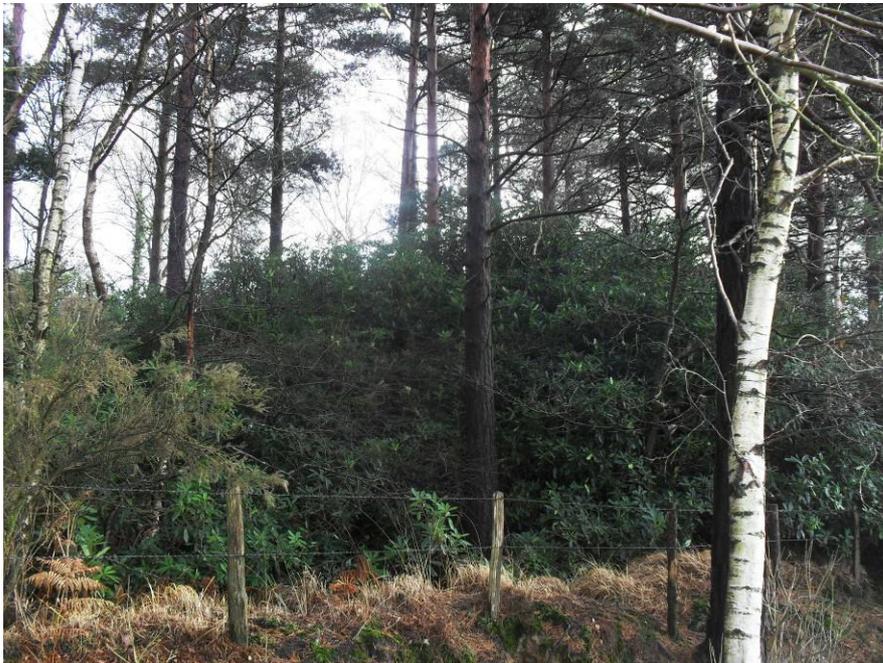
The north of the site (just outside the boundary) is dominated by Rhododendron *Rhododendron ponticum* with a few seedlings beginning to infringe on the Unit itself (Figure 1-7 below).

Figure 1-7: Rhododendron stands along northern boundary (NGR 435480, 109395)

Scrub encroachment of Scot's Pine seedlings and Rhododendron was recorded across the Unit. The extent of Rhododendron encroachment within the Unit itself was relatively minor. However, there are extensive stands located on the northern boundary of the Unit, which do pose a significant threat as it is more than likely they will begin to colonise the Unit at some point, particularly with the current drier conditions as a result of the drainage issues. The northern boundary should be monitored in the future with regard to Rhododendron encroachment.

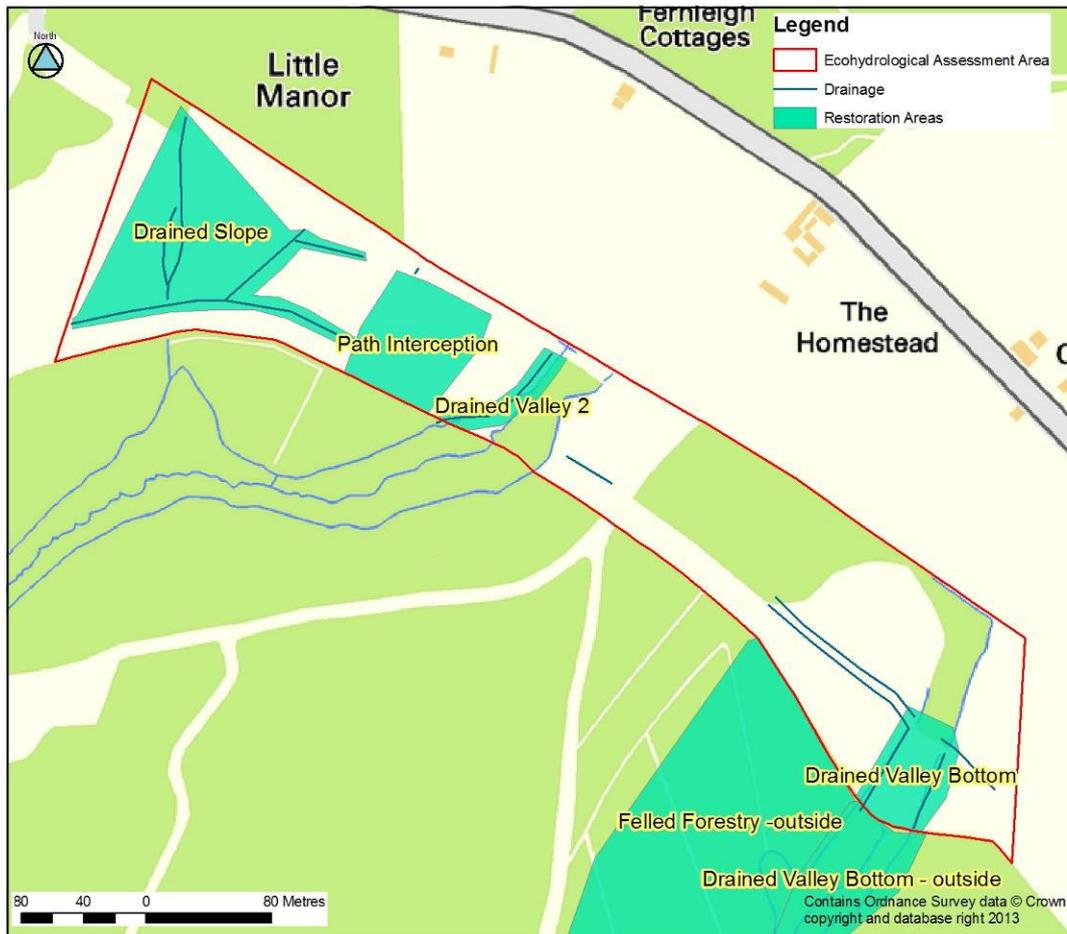
Figure 1-9: Restoration Areas Map

There are 4 areas of damage within the unit and two areas just outside the unit boundary which will also be discussed (see Figure 1-9):

- Drained Slope - in this area there are a small number of drains on the valley side wetland. These are intercepting flush water to an extent and so drying out areas of the flushed slope;
- Path Interception - in this area the path that runs the length of the site is intercepting flush water channelling into culvert. The ground surface below the path therefore does not have water spread over its whole surface;
- Drain Valley Bottom - in this area some choked drains have led to the replacement of a mire area with scrub. This area continues outside the survey area boundary along the valley to the south;
- Drained Valley 2 - in this area a single drain has led to the replacement of a valley bottom mire with scrub.

- Drained slopes - where effective these drains should be blocked with earth plugs or infilled;
- Path Interception - as the line of the path is at the top of the site along this section, it appears impossible to move the path above the seepage face. The path however could be replaced with a path of more permeable material which would allow the flush water to pass through it, from north to south. This material would ideally be formed of imported uncompacted granular material such as a DTp type 1 hardcore;
- Scrub clearance - particularly of the pine that is encroaching into several areas across the site. Control of Rhododendron stands (or at least monitoring of them) should be a priority to prevent further encroachment into mire and wetland areas;
- Grazing control - there are poaching issues particularly associated with the wetter areas of the site which are most prone to damage.

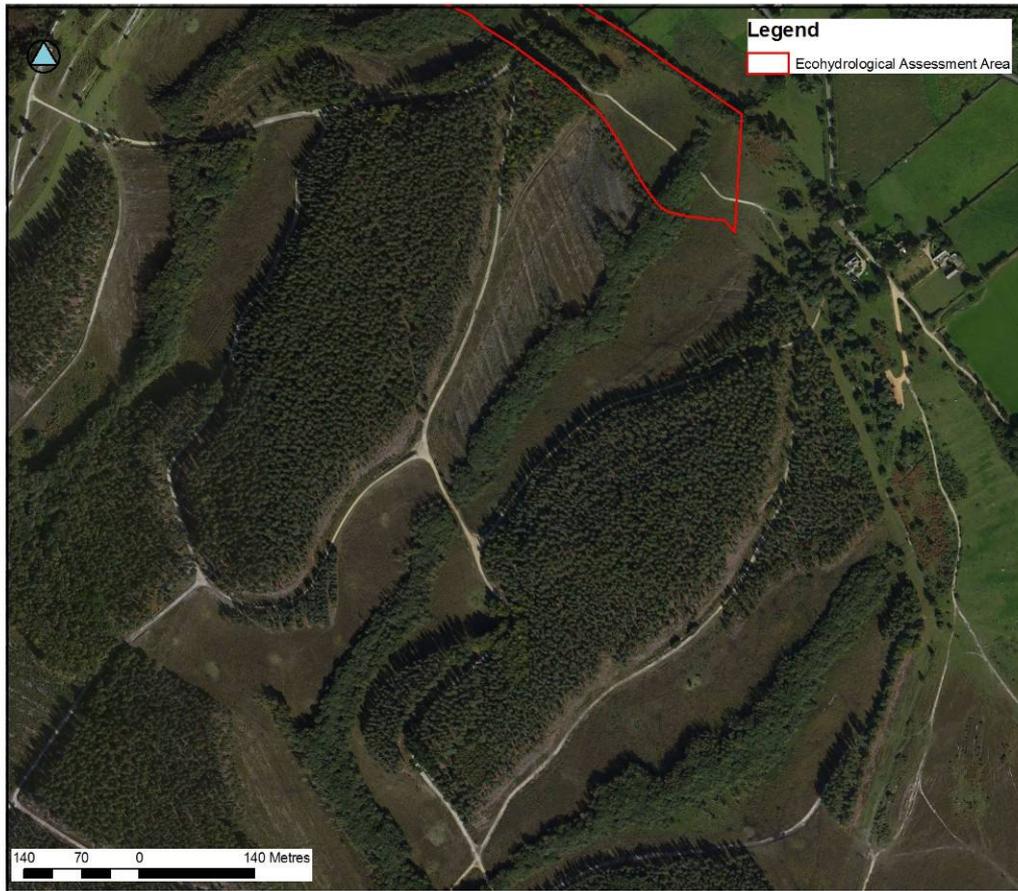
Figure 1-10: Scrub Dominated Valley Bottom Wetland downhill of the Eastern Valley of the Site

Restoration works in the valley bottom areas should be developed in concert with plans for areas downstream of the site. There may be only small value in blocking drainage in the upper parts of these valley bottom mires without continuing the work further downhill. This is most true for the eastern valley bottom wetland where, from aerial photography, a scrub covered drained mire appears to continue for at least 1km downhill of the site (see Figure 1-10). As a result, no restoration plans for the valley bottom wetlands are presented here as further survey work is required.
