# Border Mires: Active Drainage Mapping Project

Border Mires, Kielder – Butterburn Special Area of  
Conservation (SAC)

# Border Mires Active Drainage Mapping Project

## Final Report

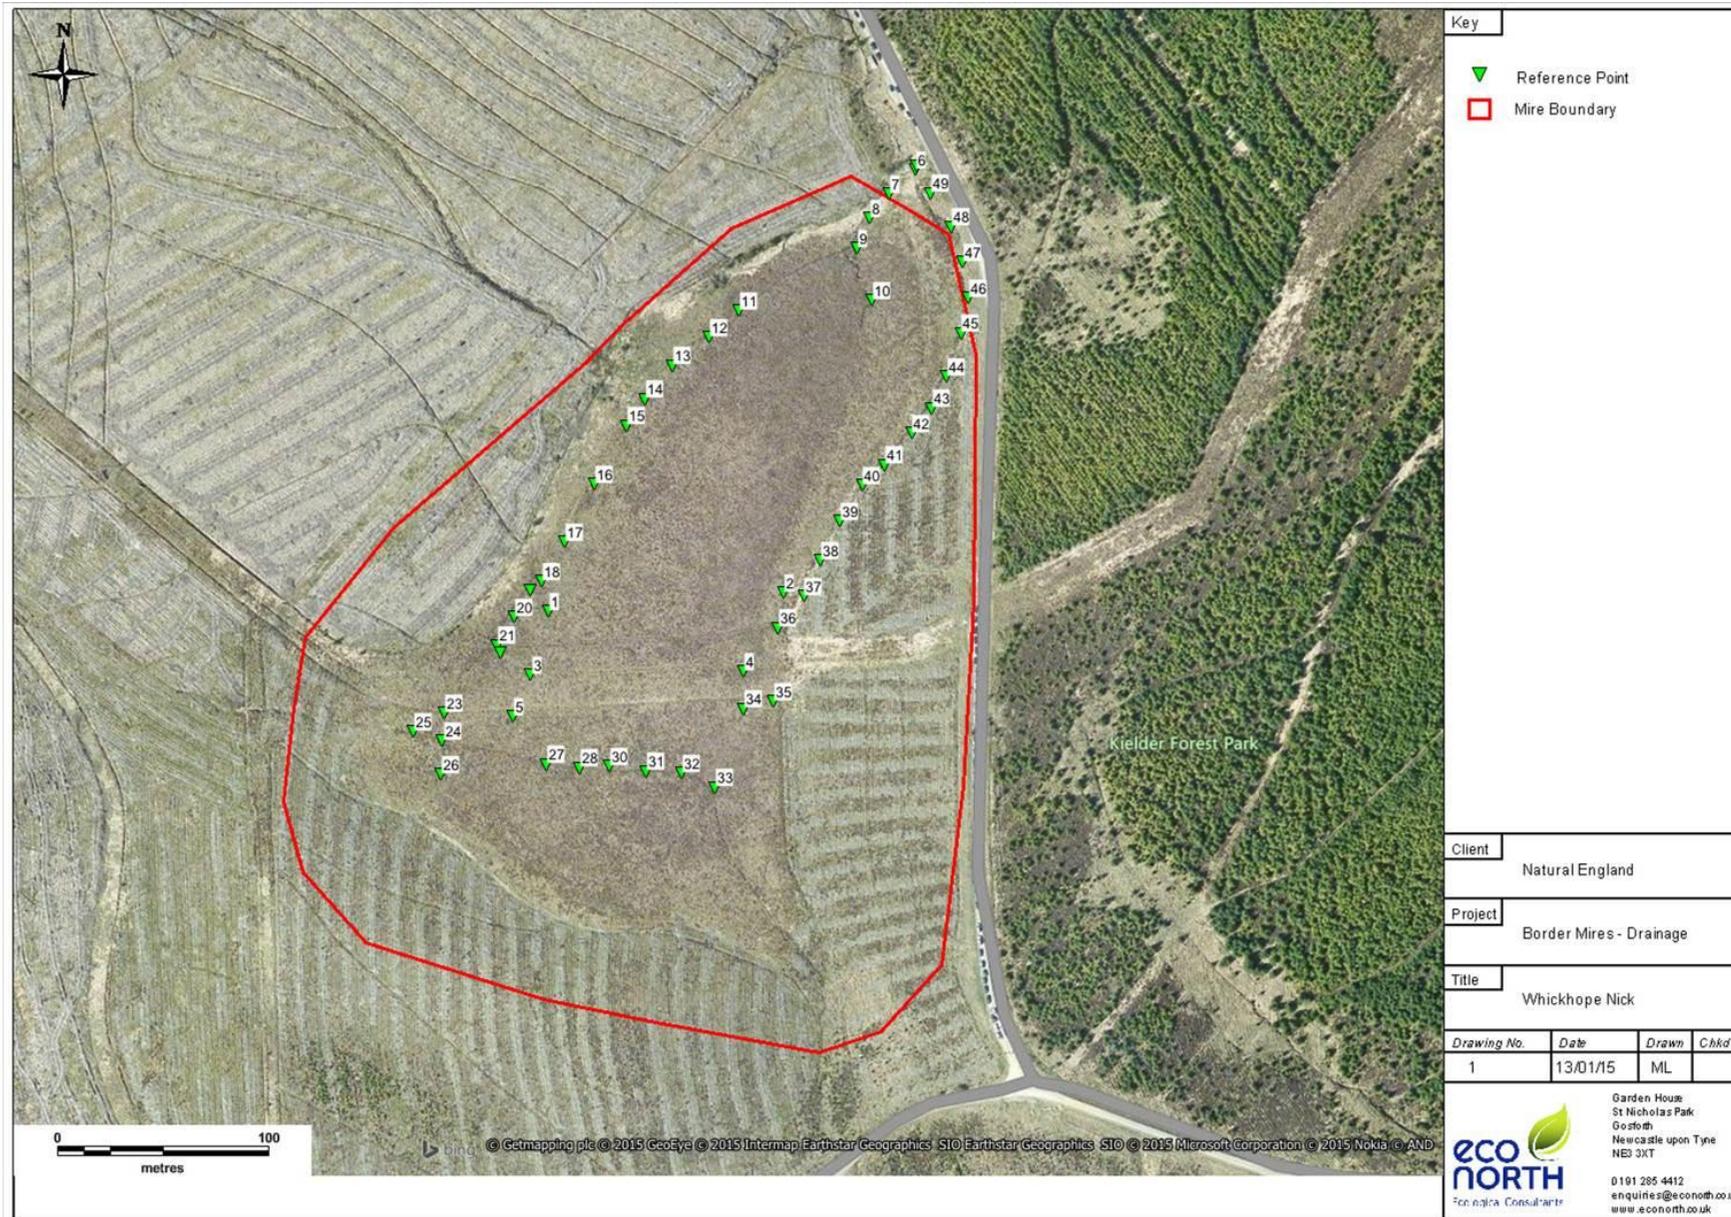
Title	Whickhope Nick
-------	----------------

Good central mire with a lot of failing dams and drains on perimeter.

Many dams failing on all boundaries, along perimeter drains, should be addressed to improve mire

Open drains are functional (i.e. hold water) but could be improved to support areas where dams are failing.

Ref Point	Notes
1	Intact ditch
2	Slight fail of same drain as 1
3-4	Drain blocked and functional along length (W/E direction, approx. 140m)
5	Drain E/W is fully blocked and functional
6-9	Dams failed on these drains at these points
10	Open drain
11-17	Dams failed – to be addressed
18-19	Open drain
20	Dam failed on this open drain, some flow recorded here
21-22	Open drain
23-25	Dam failed (as point 24)
26-28	Open drain
29	Dam failed (as point 24), point hidden behind point 28 on map
30-31	Open drain
32-33	Dam failed
34-35	Open drain
36-39	Dam failed
40	Open drain
41-45	Dam failed
46	Open drain
47-50	Dam failed

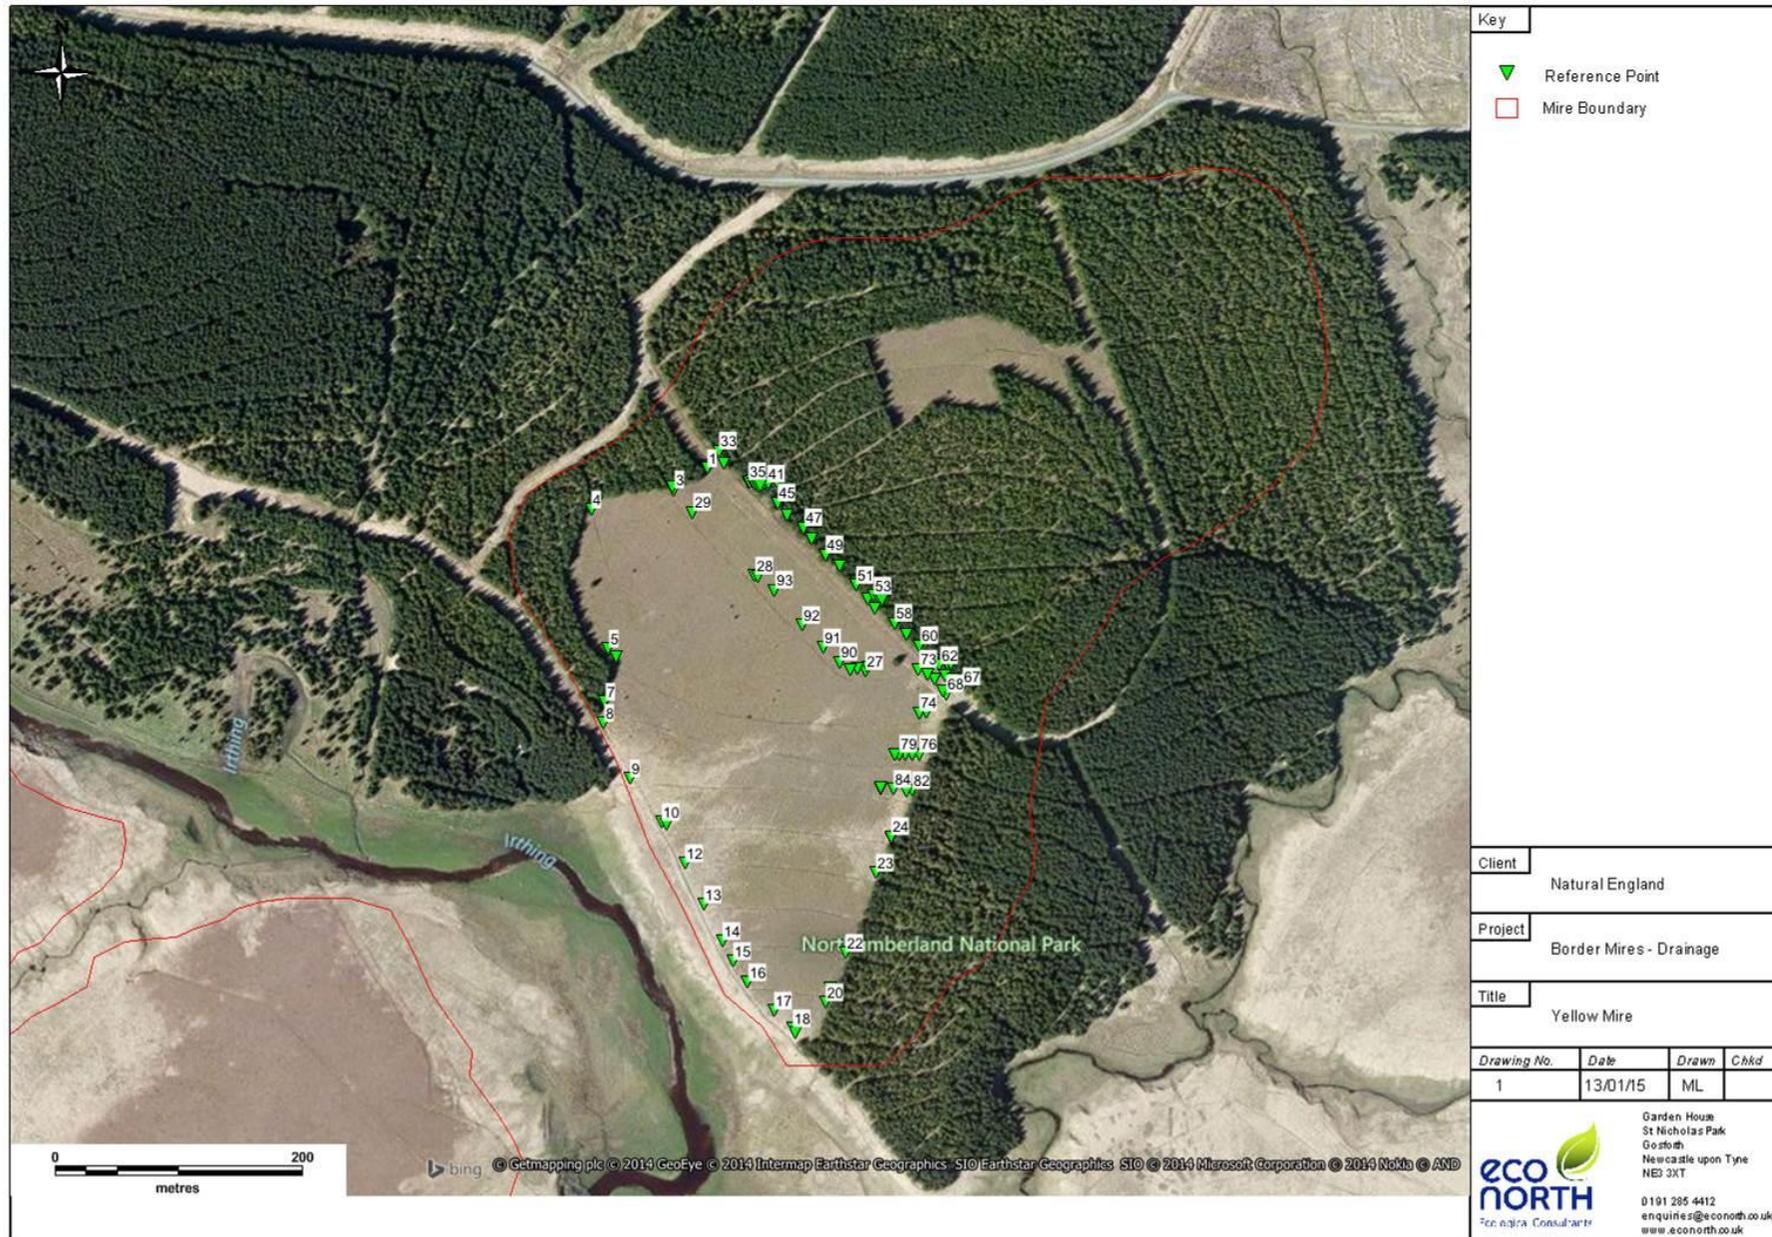
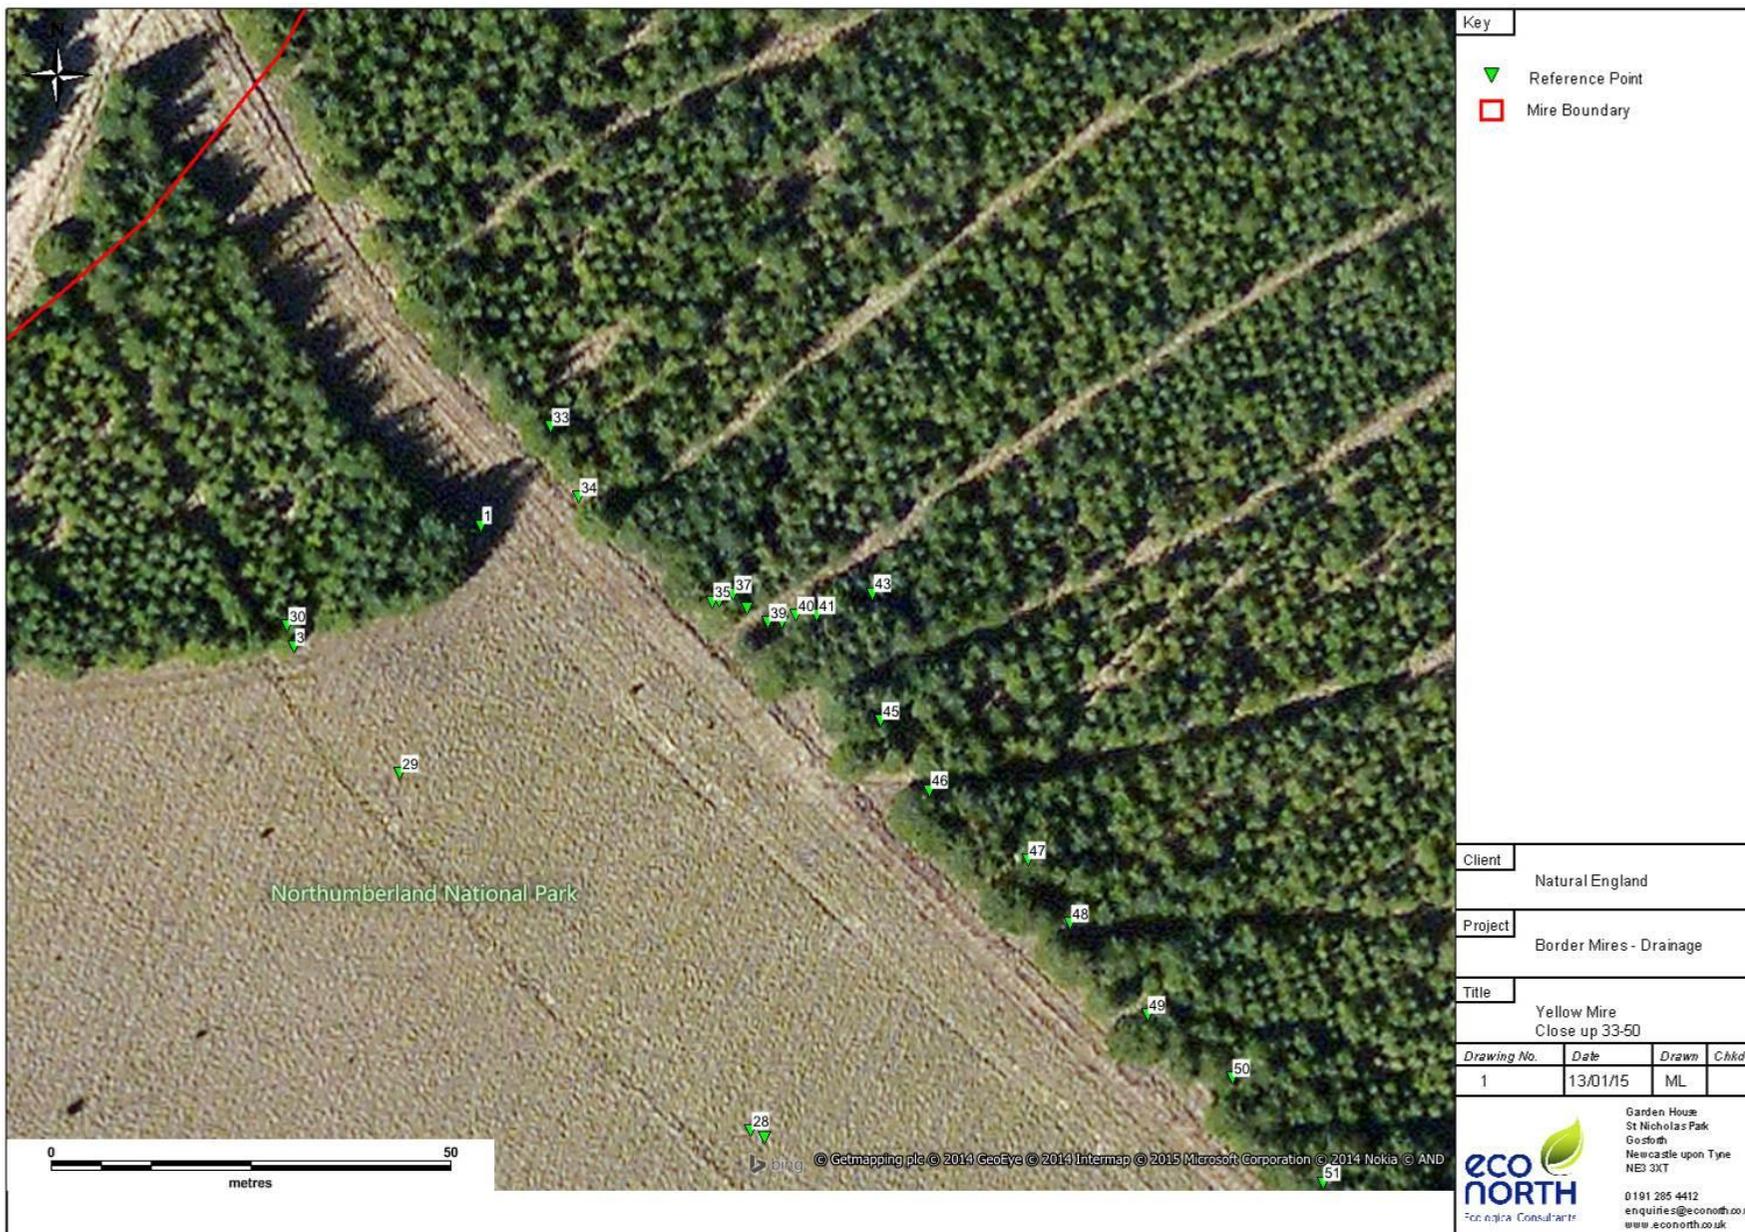
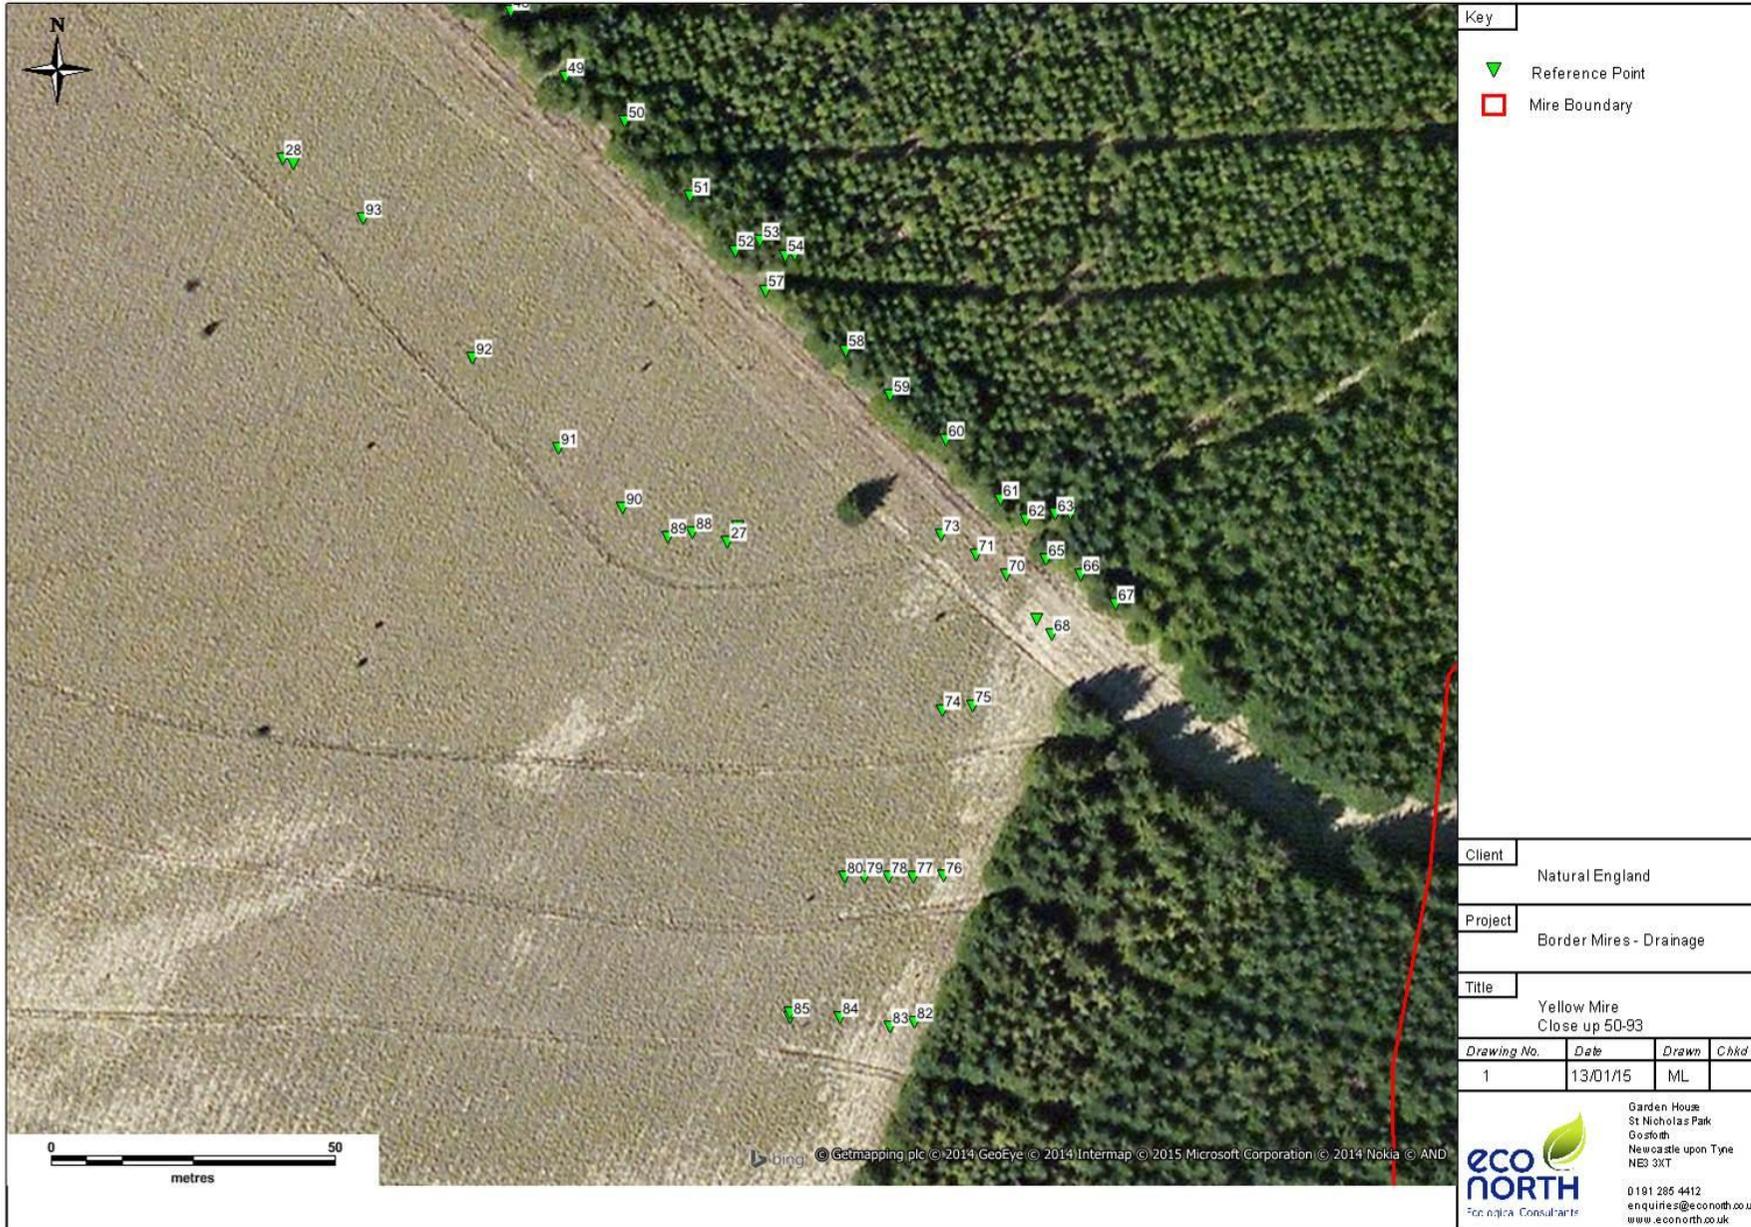
<b>Client</b>	Natural England
<b>Project</b>	Border Mires - Drainage
<b>Title</b>	Yellow Mire

A number of large active drains here mainly towards the southern and western boundaries.

The central section at the northern edge also has an active drain that could be dammed to hold water better.

Ref Point	Notes
1-2	Perimeter drain - blocked and holding water, some flow present. Partially active drain. Blocked with moss. Extends into forestry in places, extends for likely to be whole of stand
3-7	Active drain
8-10	Drain is functional and holding water here
11-14	Active drain
15	Perimeter drain- active - flowing east
16	Active drain
17 & 18	Drain is functional and holding water
19-21	Active drains – Flowing water at these points on map
22	Drain is functional and holding water
23	Active flow in drain at this point
24 & 25	Drain is functional and holding
26-30	This drain is active (i.e. flowing) at the points on the map (see detail on ref points 87-94 also)
33-67	Perimeter drain – blocked and holding water, some flow present. Partially active drain. Blocked with moss. Extends into forestry in places, extends for likely to be whole of stand.
68-71	Drain holding water, clogged with mosses and grasses runs parallel to perimeter drain. No noticeable flow

72	Plastic dam – effective – holds water
73	Drain holding water, clogged with mosses and grasses runs parallel to perimeter drain. No noticeable flow
74-75	Drain - very effective in holding water, with dams maturing into moss tussocks and pools.
76-81	Drain functional, holding water and has strong mossed tussocks
82-86	Drain partially flowing, blocked with moss and grass in places however slight flow (active) at points on map
87-94	Blocked with sedges with some flow along length (active / flow points at ref points 26-30)

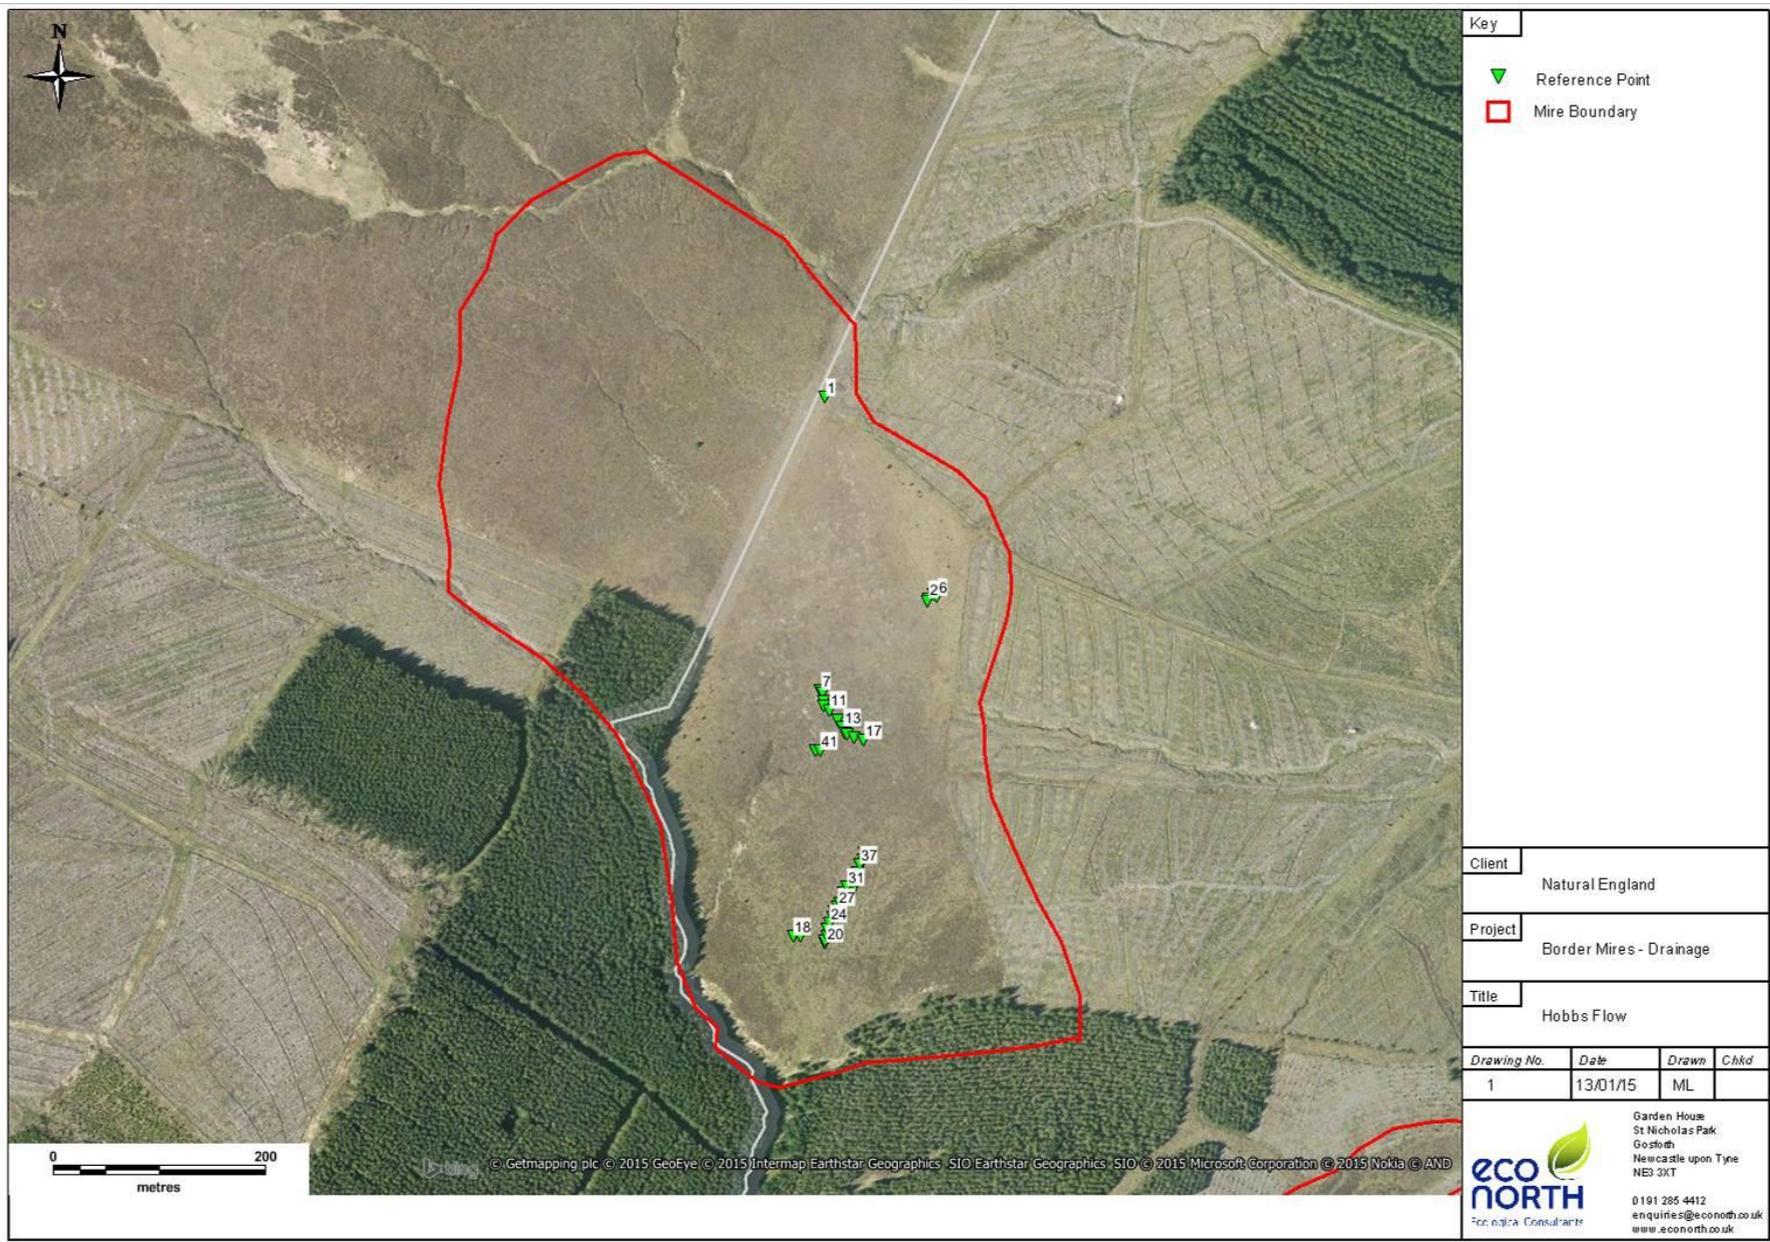
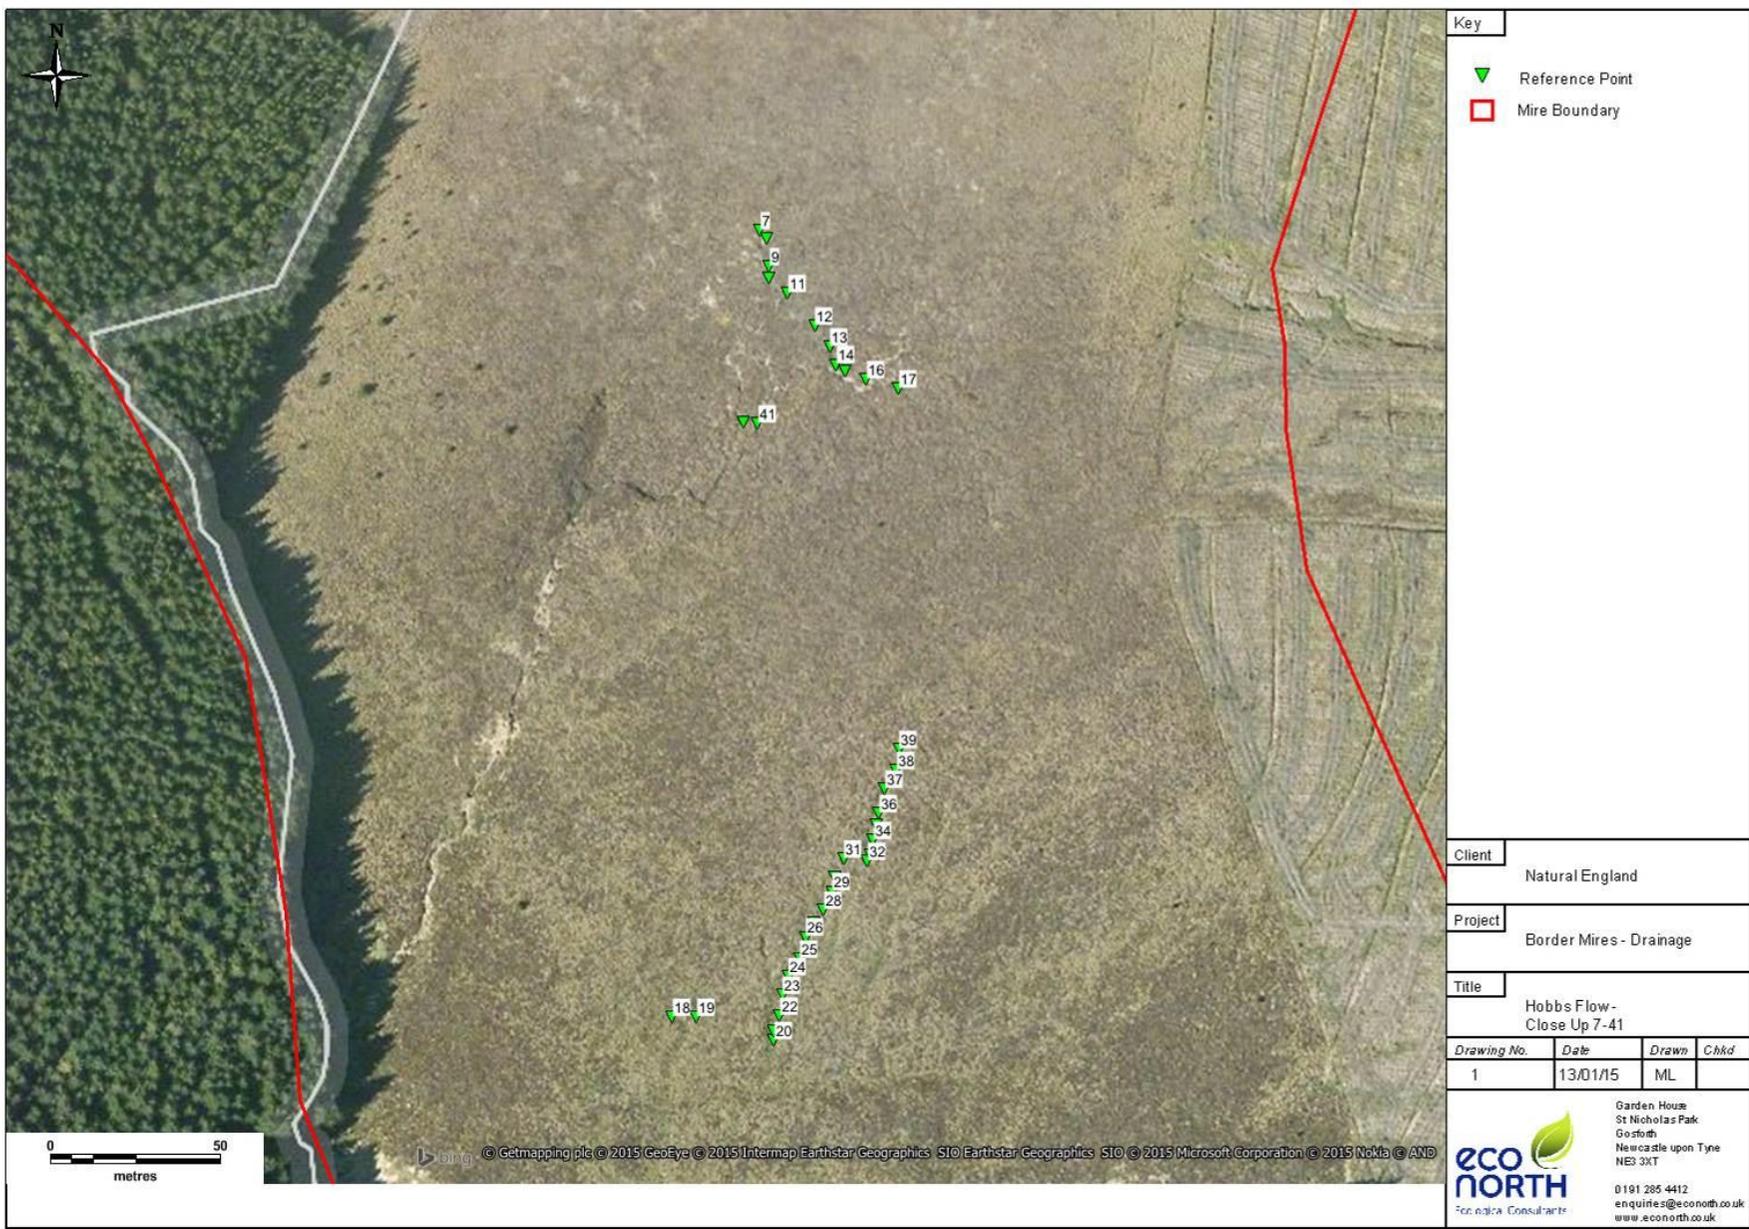
Visible drains on the aerial - these are mostly active and not dammed. There is potential to dam these to improve mire.

Relatively good mire habitat on NW section - not all could be walked as heavy fog reduced visibility.

<b>Ref Point</b>	<b>Notes</b>
<b>1</b>	Mire boundary
<b>2-3</b>	Small empty drain with no standing water - potential to hold water
<b>4</b>	Flowing drain – active
<b>5</b>	Start
<b>6</b>	End
<b>7 -11</b>	Active drain
<b>13 -16</b>	Active drain
<b>18</b>	Active drain
<b>19</b>	Active drain
<b>20-31</b>	Active drain
<b>32-41</b>	Active drain

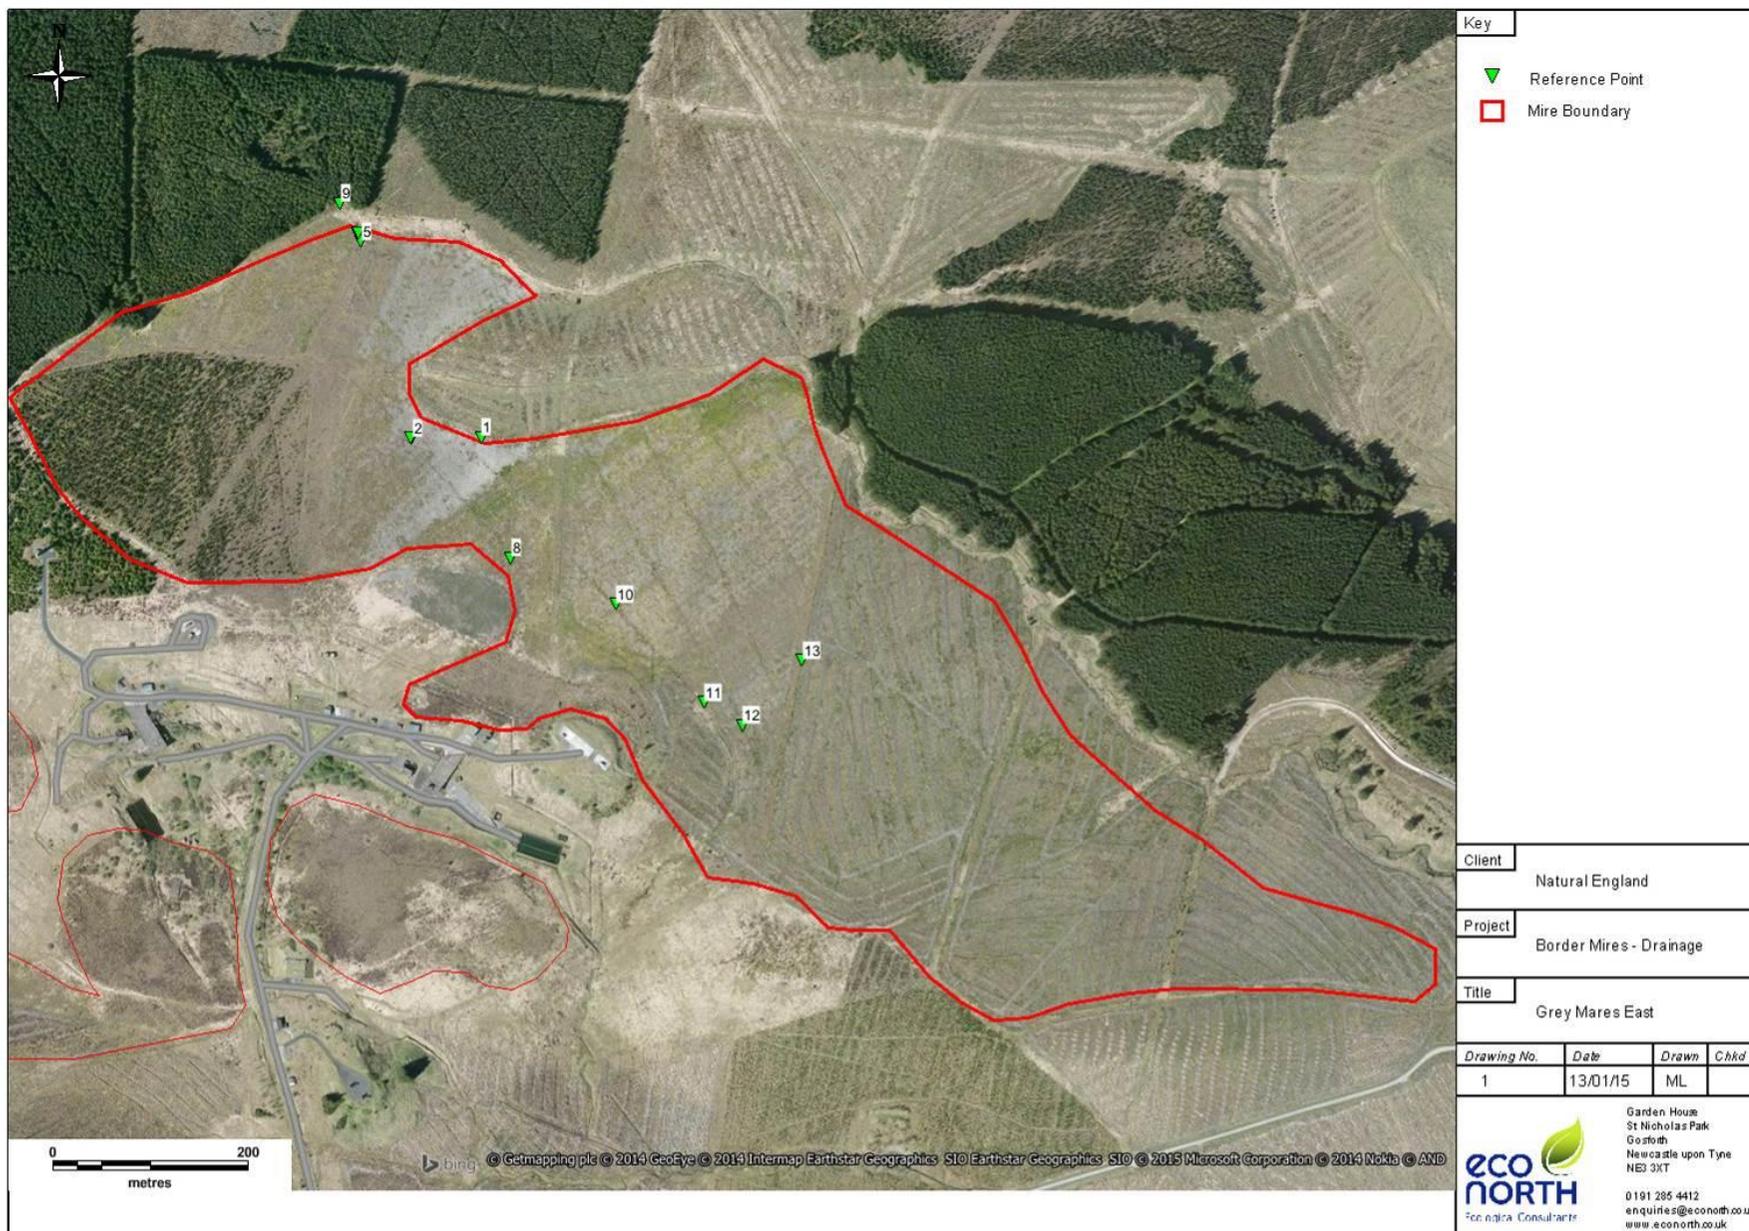
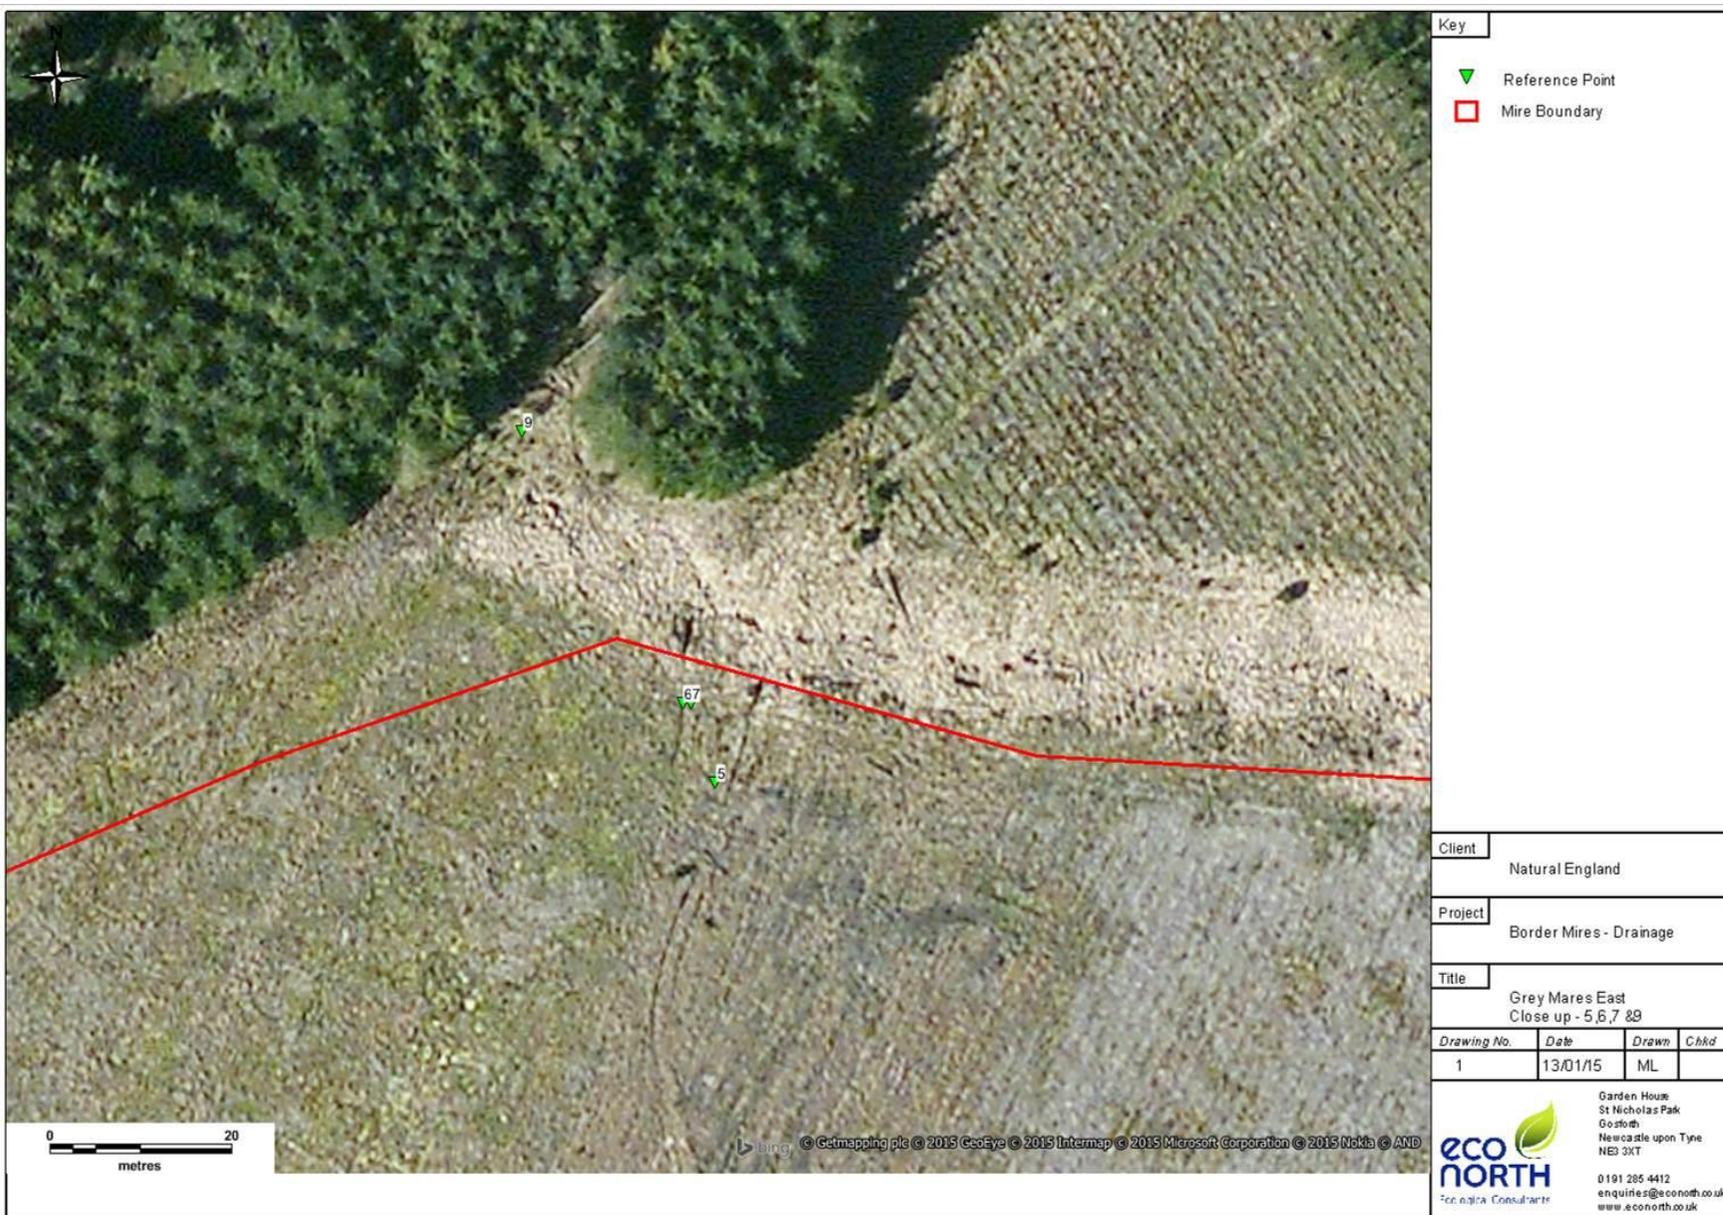
West of Grey Mares East is wet, holds water well. All drains were full with no flowing water and sphagnum covered. Some water was pooling in places with sphagnum covering.

Hill to the north of the west section is dry with little mire habitat.

Unable to access the south eastern section of this mire where the habitat was unsafe to cross. Semi-mature trees and felled tree debris made it unpassable. See point 13 for notes.

Ref Point	Notes
1-2	Functional drain
3	Active drain lined up N/W to S/E
4	Functional drain
5	Active drain with slow flow N/S
6	Functional drain
7	Active drain - slow flow and very deep, flowing from south to north / west and towards burn
8	Functional drain - holds water well and is a perimeter drain
9	Water flowing from west from mire to natural burn at edge of forestry. Could be dammed to hold water flowing from mire
10	Drain well plugged and holding water
11	Active drain same drains as ref point 10 but not plugged here and actively flowing
12	Drain blocked here and pooling to the west. A drain found to the east of this point is empty and could hold water if dammed further east.
13	Convergence of drains that border the mire habitat. Plantation woodland to east has been cut but regen is dense and could not be walked through, not mire habitat beyond this point and could not be surveyed
