# Border Mires: Active Drainage Mapping Project

Border Mires, Kielder – Butterburn Special Area of  
Conservation (SAC)

# Border Mires Active Drainage Mapping Project

## Final Report

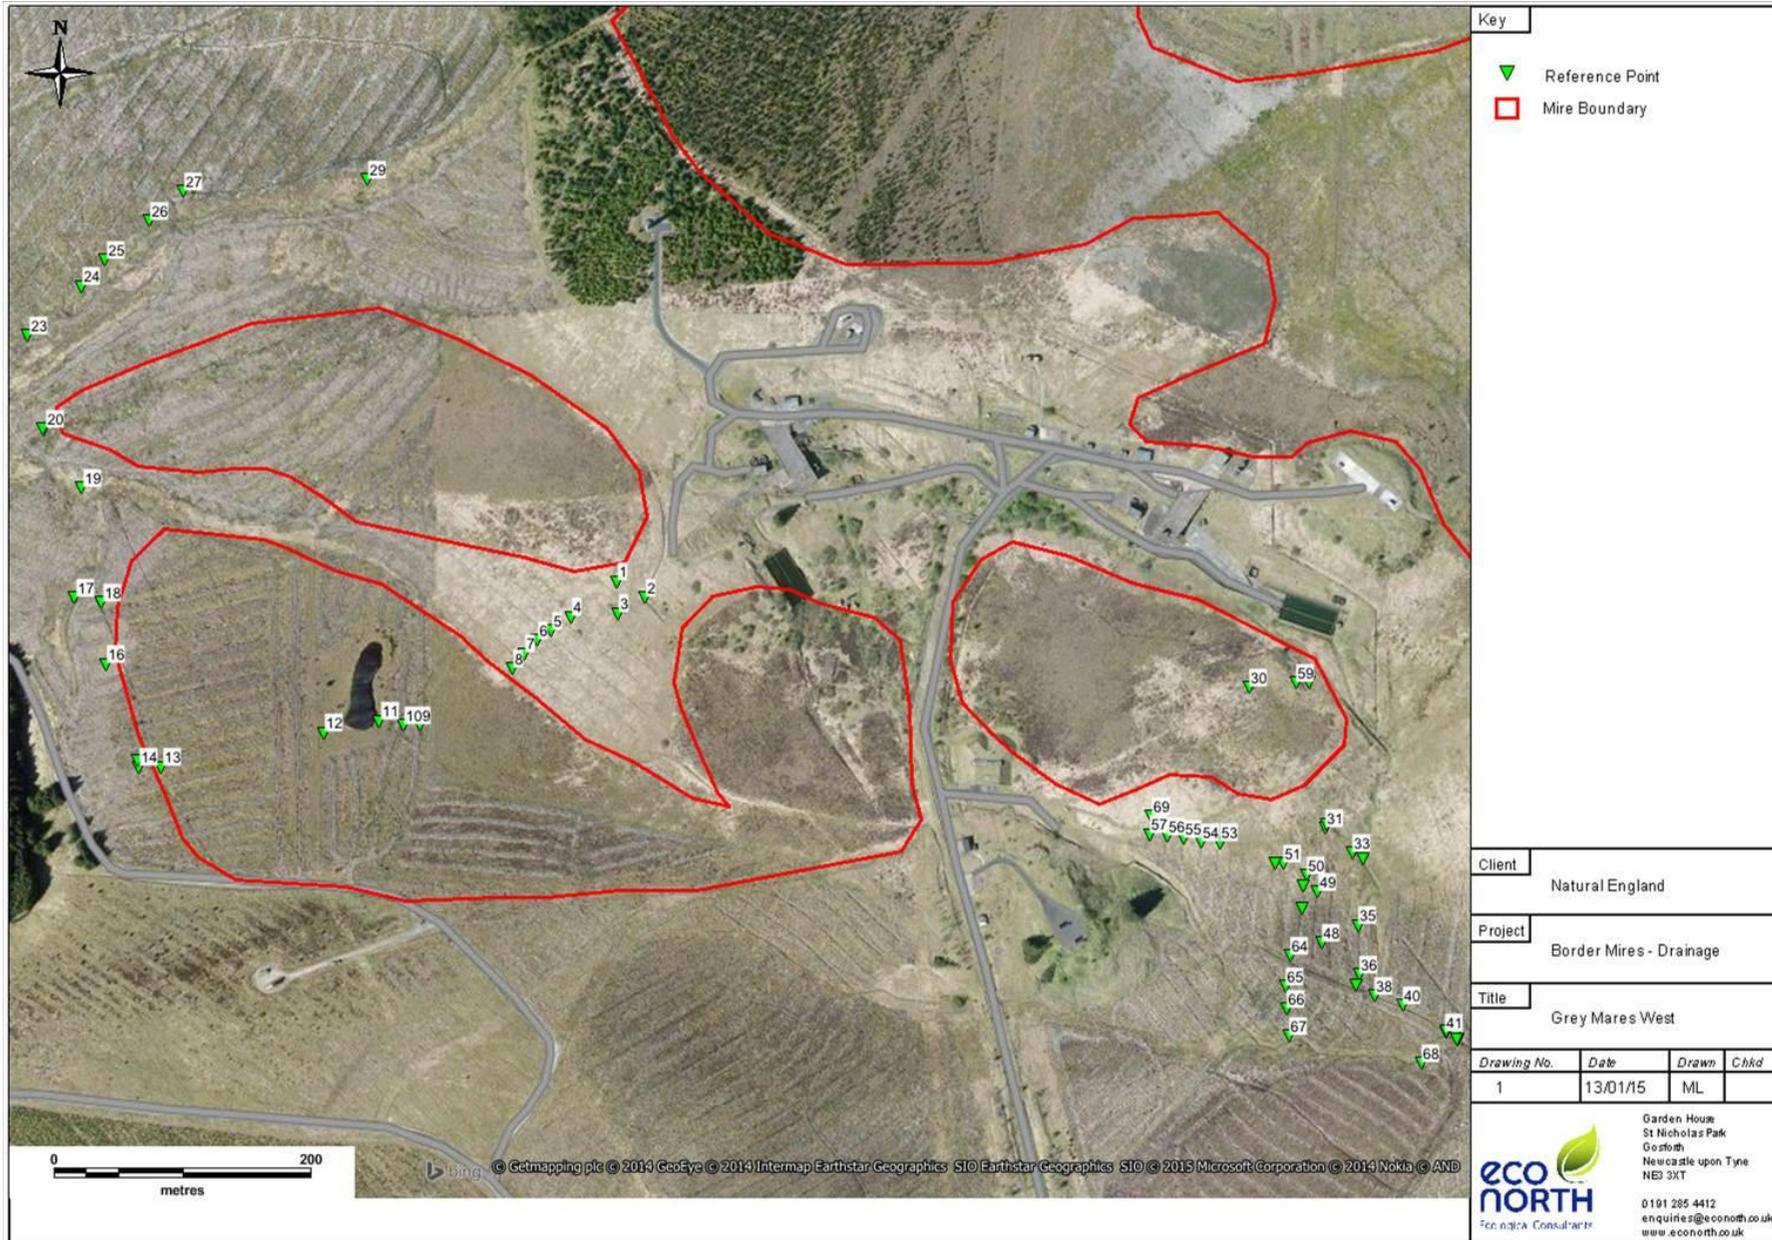
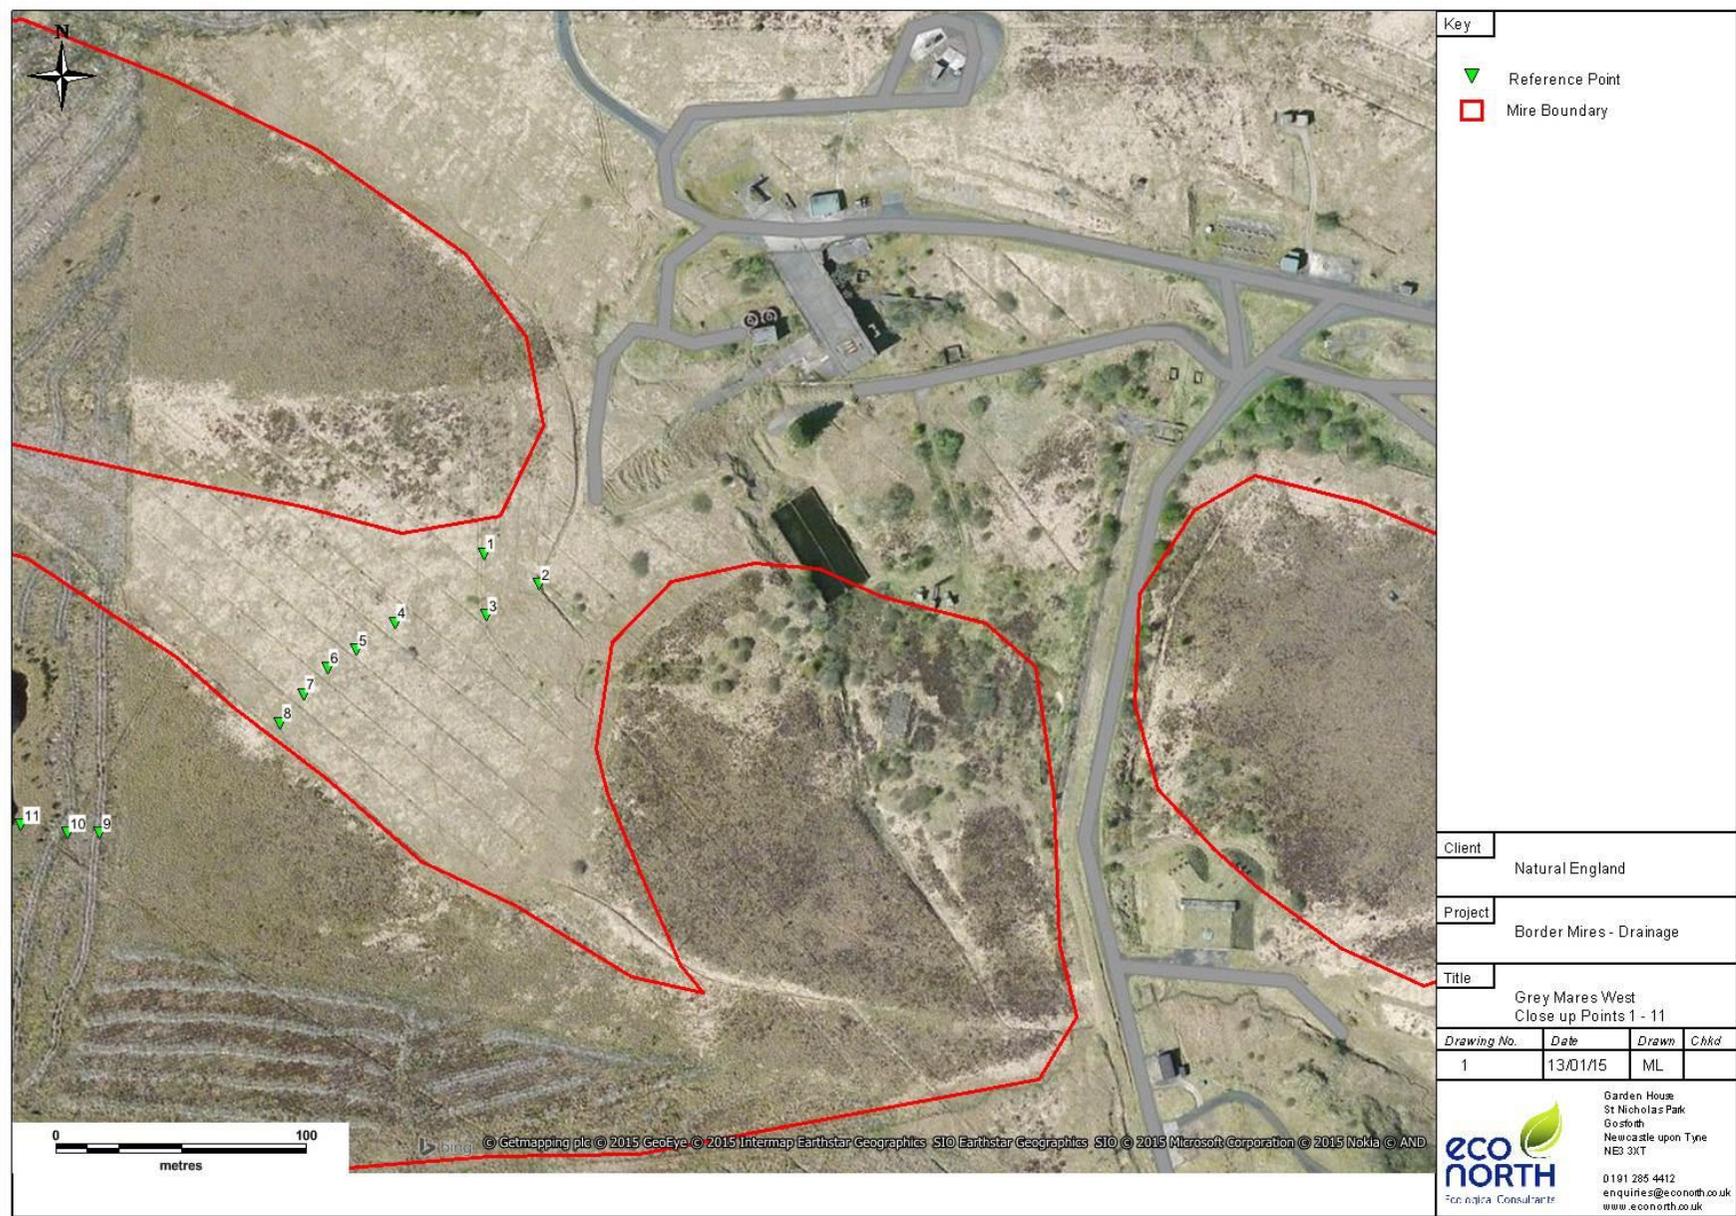
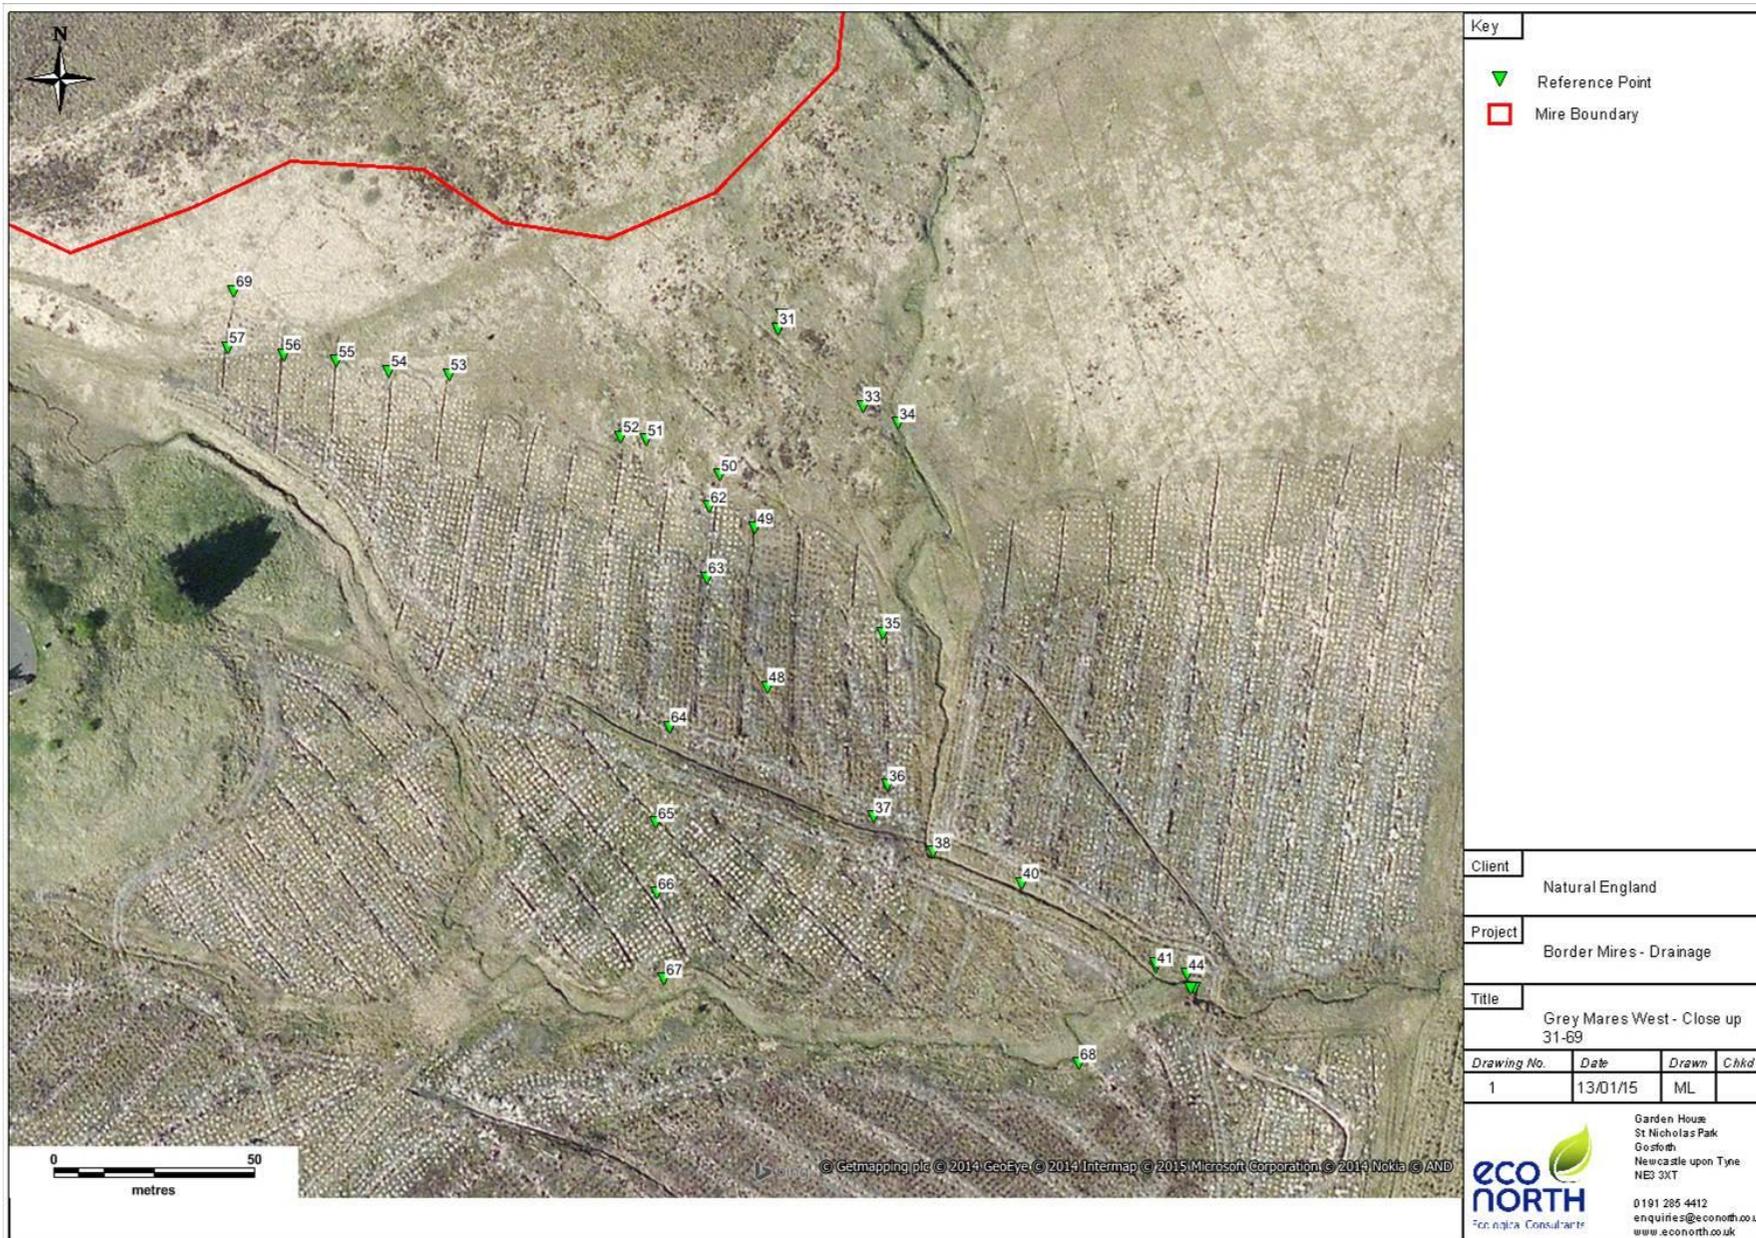
<b>Summary</b>	
<p>Many drains are outside the mires and these were checked for possibility of activity.</p>	
<p><b>Points 1-29</b> Perimeter drain is wet and holds some water. Mire is quite dry – drains leading to perimeter drain (and also perimeter drain) could be blocked to allow water to pool on mire.</p>	
<p><b>Points 30-39</b> Habitats here are more like wet grassland than mire, a lot of water likely draining to perimeter stream. Tussocky habitat with some moss but also grass and thistles, active streams and drains to southern area likely taking a lot of water and could be dammed to create a wetter habitat in the mire.</p>	
<p>Where forest tracks are evident, these are all old plantation and covered with dead wood with some mossy tussocks however drains not holding a lot of water and could be dammed to create a better central mire habitat</p>

Ref Point	Notes
1	Drain E/W direction shallow approx. 200m in length. Could hold more water if dammed along length
2	Active point on perimeter drain - likely flow from other drains on site that are draining to here. These other drains could be dammed along length to hold more water on the mire
3	Drain running N/S is shallow (as ref point 1) but sounds of flowing water likely to perimeter drain
4-7	As point 3 - drains not holding much water - grass and rush covered – could be dammed
8	Same drain layout as 4-7 but holds more water - change of habitat here to more wet. Less grass and more moss as you move west
9	Moving to old plantation that has been felled, not good mire habitat but is relatively wet moving west, potential to advance to mire in time
10	Active drain E/W and meet a N/S drain – both could be dammed
11	Pond with very wet surrounding
12	Open pools, some are dry, around this part. Could hold water

13	Active drain N/S direction, shallow drain little water within could be dammed
14	Confluence of drains active - flowing towards road maybe under to stream on other side in woodland

<b>Ref Point</b>	<b>Notes</b>
<b>15</b>	Good drain filled with moss for approx. 40m (N/S), holding water i.e. functional
<b>16</b>	Moving west drier habitat, higher slope, water from here likely drains to west and north many furrows between point 15-16 (see aerial image) all similar type, quite dry and could hold more water along length
<b>17</b>	Drain running N/S water filled likely water from surrounding drains (i.e. those on E/W direction) draining to here as these are dry (See point 16)
<b>18</b>	Shallow drain deep sided, N/S direction for approx. 100m (joins Point 14)
<b>19-20</b>	Active drain E/W direction, likely all drains further south are leading to here and flowing west and then corners to point 20
<b>21</b>	Active flow running E/W likely towards stream at point 22
<b>23</b>	Active drain heavy flow
<b>24</b>	Otter evidence - anal jelly and feeding remains on active stream at base of small hill

<b>25</b>	Drain leading to point 23 - not active flow but could hold more water
<b>26</b>	Wet habitat some moss heavy rush stream (point 23) drain flowing around base of hill - hill is quite dry with heather and grass
<b>27</b>	Drain from west active flow to ref point 23 stream/ drain
<b>28</b>	Wet area approx. 3m wide some active flow
<b>29</b>	Some drains in this area are not active nor hold a lot of water – can be dammed. Drains all seem to lead to stream at base of hill (East) stream is heavy flow, these drains could be blocked. This area is quite grassy and not very mire like
<b>30&amp;31</b>	Drains not active, i.e. holding water, functional
<b>32</b>	Slightly active drain, adjacent to drain at 31
<b>33</b>	Drain not active, functional
<b>34</b>	Active stream – perimeter
<b>35</b>	Slightly active drain – can be dammed
<b>36</b>	Drain not active – functional
<b>37</b>	Active drain – can be dammed

<b>38</b>	Drain not active – functional
<b>39</b>	(adjacent to point 40)Active drain – could be dammed here and further north to hold more water to aid mire development to the west
<b>40-42</b>	Drain not active, functional
<b>43</b>	Active drain – may be dammed as with point 39
<b>44-47</b>	Drain not active – functional
<b>48</b>	Active drain – may be dammed to stop flow to perimeter drain
<b>49-57</b>	Active drains, flowing – all could be dammed to hold water from flowing from mire to perimeter drain.
<b>58</b>	(hidden under point 30 on map) Dry tussocks - top layer (heather etc.) in this area, with some wet underneath, little sphagnum
<b>59</b>	Active stream from direction of RAF base flow is N/S direction
<b>60</b>	Failed wooden dam on stream (Pic ref GMW3 POI3)
<b>61</b>	(adjacent to point 31 on map) Drain shallow leads to stream (N/W – S/E

<b>Ref Point</b>	<b>Notes</b>
	direction, 40m approx. ) no active flow but could hold more water if blocked
<b>62</b>	Drain in same direction as 61 (100m approx.) – deep no active flow with only shallow water – drain could be dammed
<b>63</b>	Functional dam at this point, drain is as described in 62 (100m approx.)
<b>64</b>	Active flow from here to stream to south
<b>65</b>	Active drain flow to S/E can be dammed to hold water further north
<b>66</b>	Active section of drain same direction as ref point 65 parallel drain
<b>67</b>	Perimeter stream active flow E/W direction meandering to N/S direction
<b>68</b>	Pools along stream edge on S side more than N side, wetter on southern side
<b>69</b>	Shallow drain slightly active (as point 57) - lined up N/S direction (linked to active stream to South). If dammed would hold water to support mire to the north

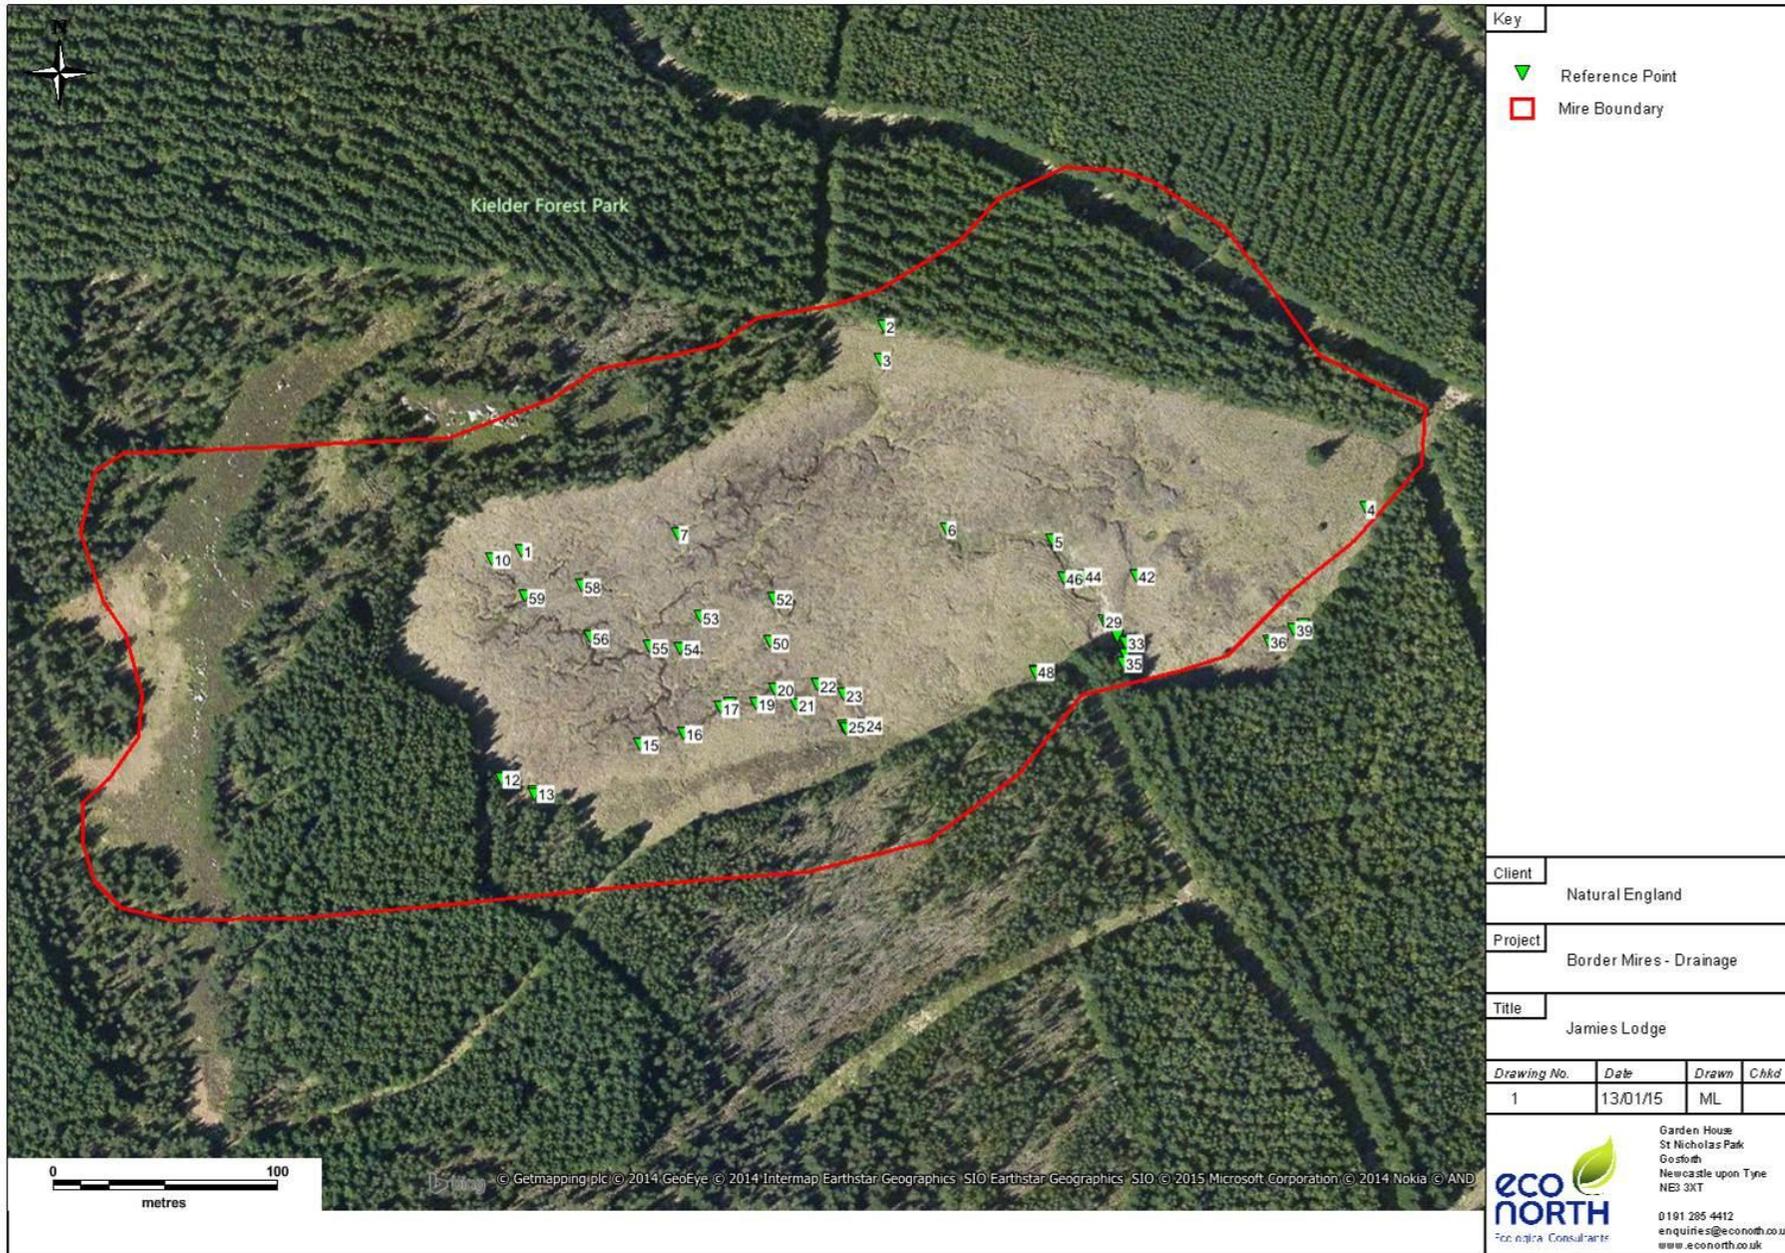
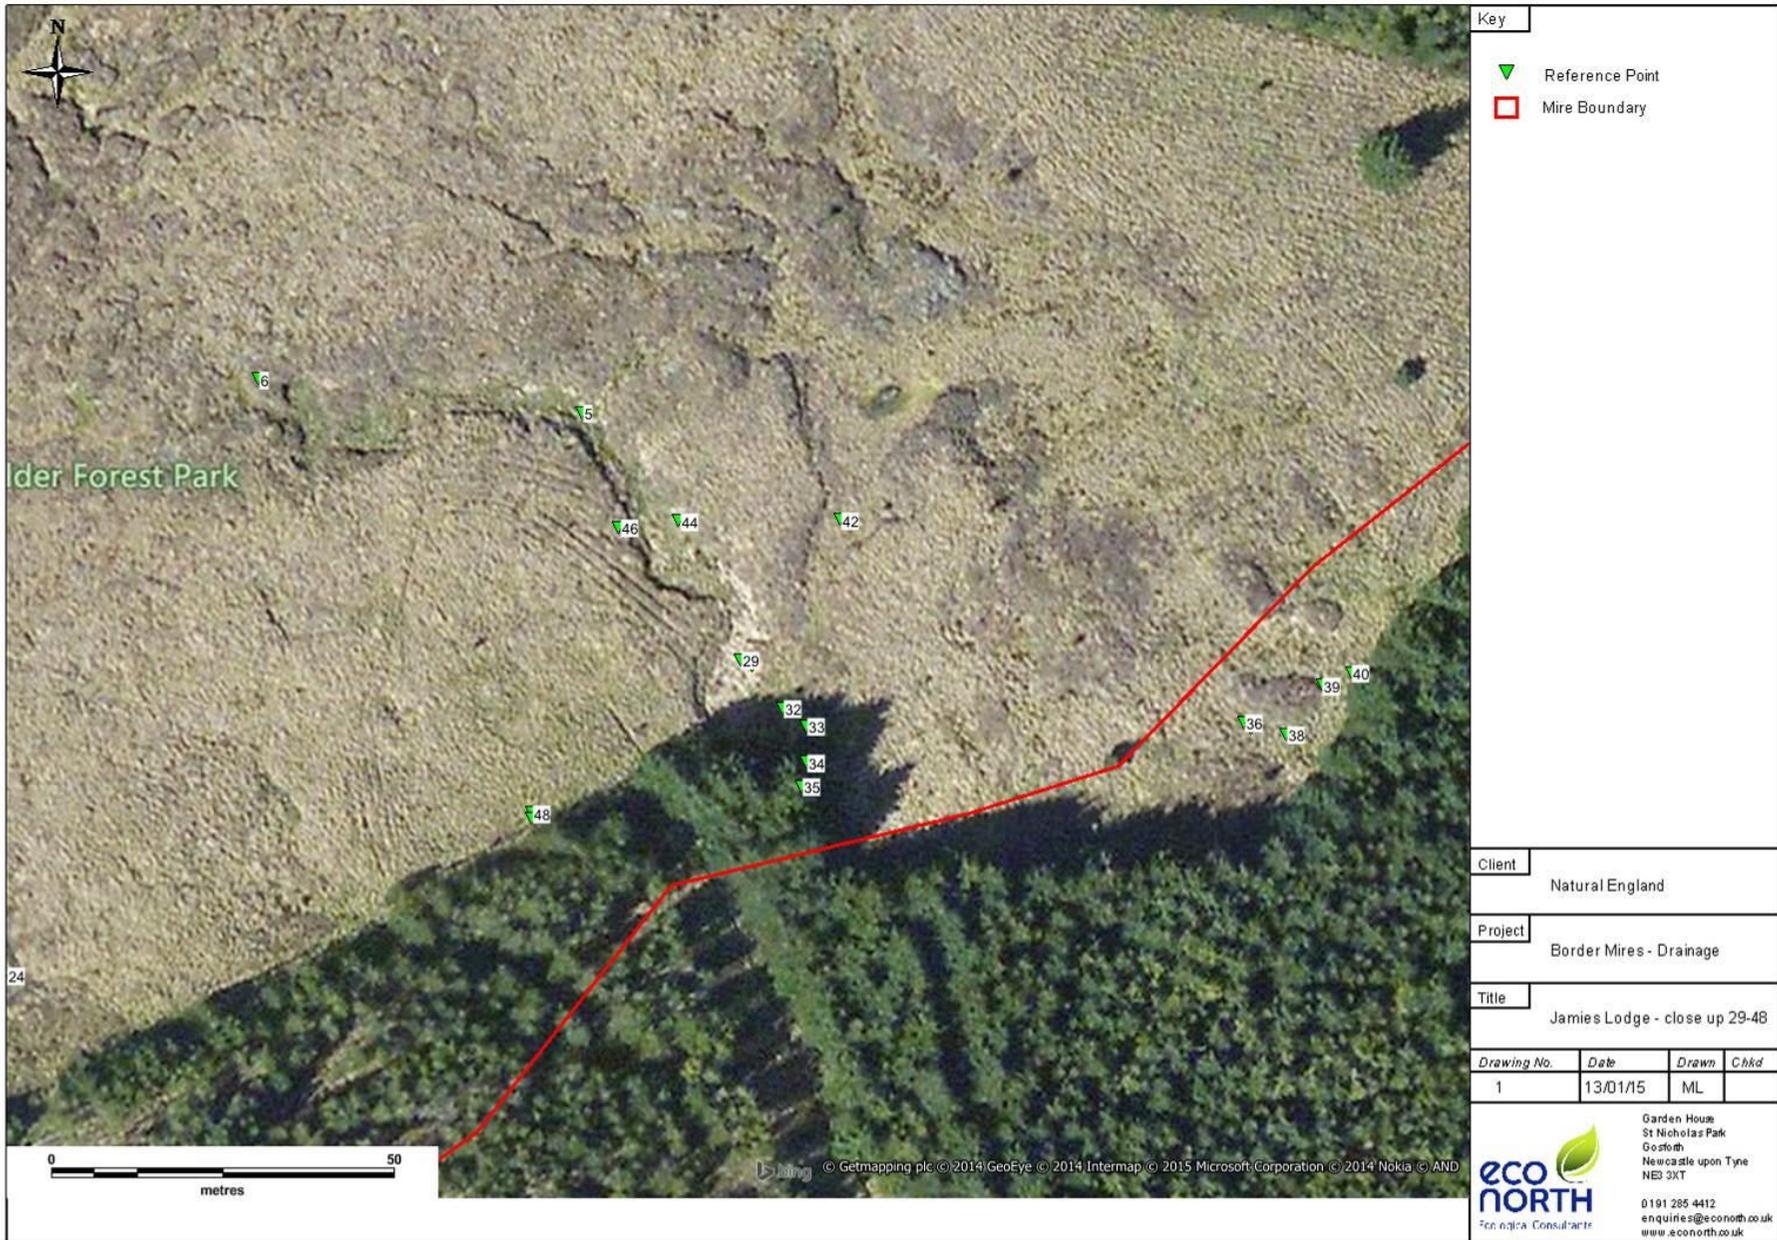
<b>Summary</b>	
<p>Jamie’s Lodge has some slumps and on a couple of occasions the water appeared to disappear under ground.</p> <p>There are a lot of slumps visible on Jamie’s Lodge with channels running though. The mire habitat atop the slumps is good however and overall the site is not dry and represents some good wet habitat.</p> <p>The channels at Jamie’s Lodge suggest that in wetter times the water flows through.</p> <p>There is also a lot of pooling water that is spreading, especially in the centre and west of the site and around pools.</p>

<b>Ref Points</b>	<b>Notes</b>
1	N/W direction, likely drains from surrounding area no obvious flow but could hold water if dammed
2-3	Active drain from ref point 2 to ref point 3. Flowing from treeline north-south direction, goes underground at ref point 3
4	Drain running along old forest boundary from N/S direction across mire edge, no water within but is moss covered, no active flow heard. Has potential to hold water if dammed
5-6	Active drain from ref point 5 to ref point 6 large cavern at ref point 6 land has slumped
7	Channels that may flow when not frozen over, i.e. active. These appear natural however, therefore should they be dammed?
<b>8 &amp; 9</b>	<b>Start / End Point</b>
10	Open drain – not flowing but could hold more water if dammed
11-12	Open pools of water – some spread from here to surrounding areas
13	Open drain – not flowing but could hold more water if dammed
14-15	Open pools of water – some spread from here to surrounding areas

16	Drain with active flow
17-25	Open drain – not flowing but could hold more water if dammed
26	Sink hole
27-29	Open drain – not flowing but could hold more water if dammed
30	Active drain
31-35	Open drain – not flowing but could hold more water if dammed
36	Active drain
37-40	Open drain – not flowing but could hold more water if dammed
41	Drain not active
42	Open drain – not flowing but could hold more water if dammed
43	Active drain
44	Open drain – not flowing but could hold more water if dammed

<b>Ref Points</b>	<b>Notes</b>
<b>45</b>	Active drain
<b>46</b>	Open drain – not flowing but could hold more water if dammed
<b>47</b>	Drain not active
<b>48</b>	Open drain – not flowing but could hold more water if dammed
<b>49</b>	Side drain active
<b>50</b>	Open drain – not flowing but could hold more water if dammed
<b>51-54</b>	Open pools of water – some spread from here to surrounding areas
<b>55</b>	Active drain
<b>56</b>	Open drain – not flowing but could hold more water if dammed
<b>57</b>	Active drain
<b>58-59</b>	Open pools of water – some spread from here to surrounding areas

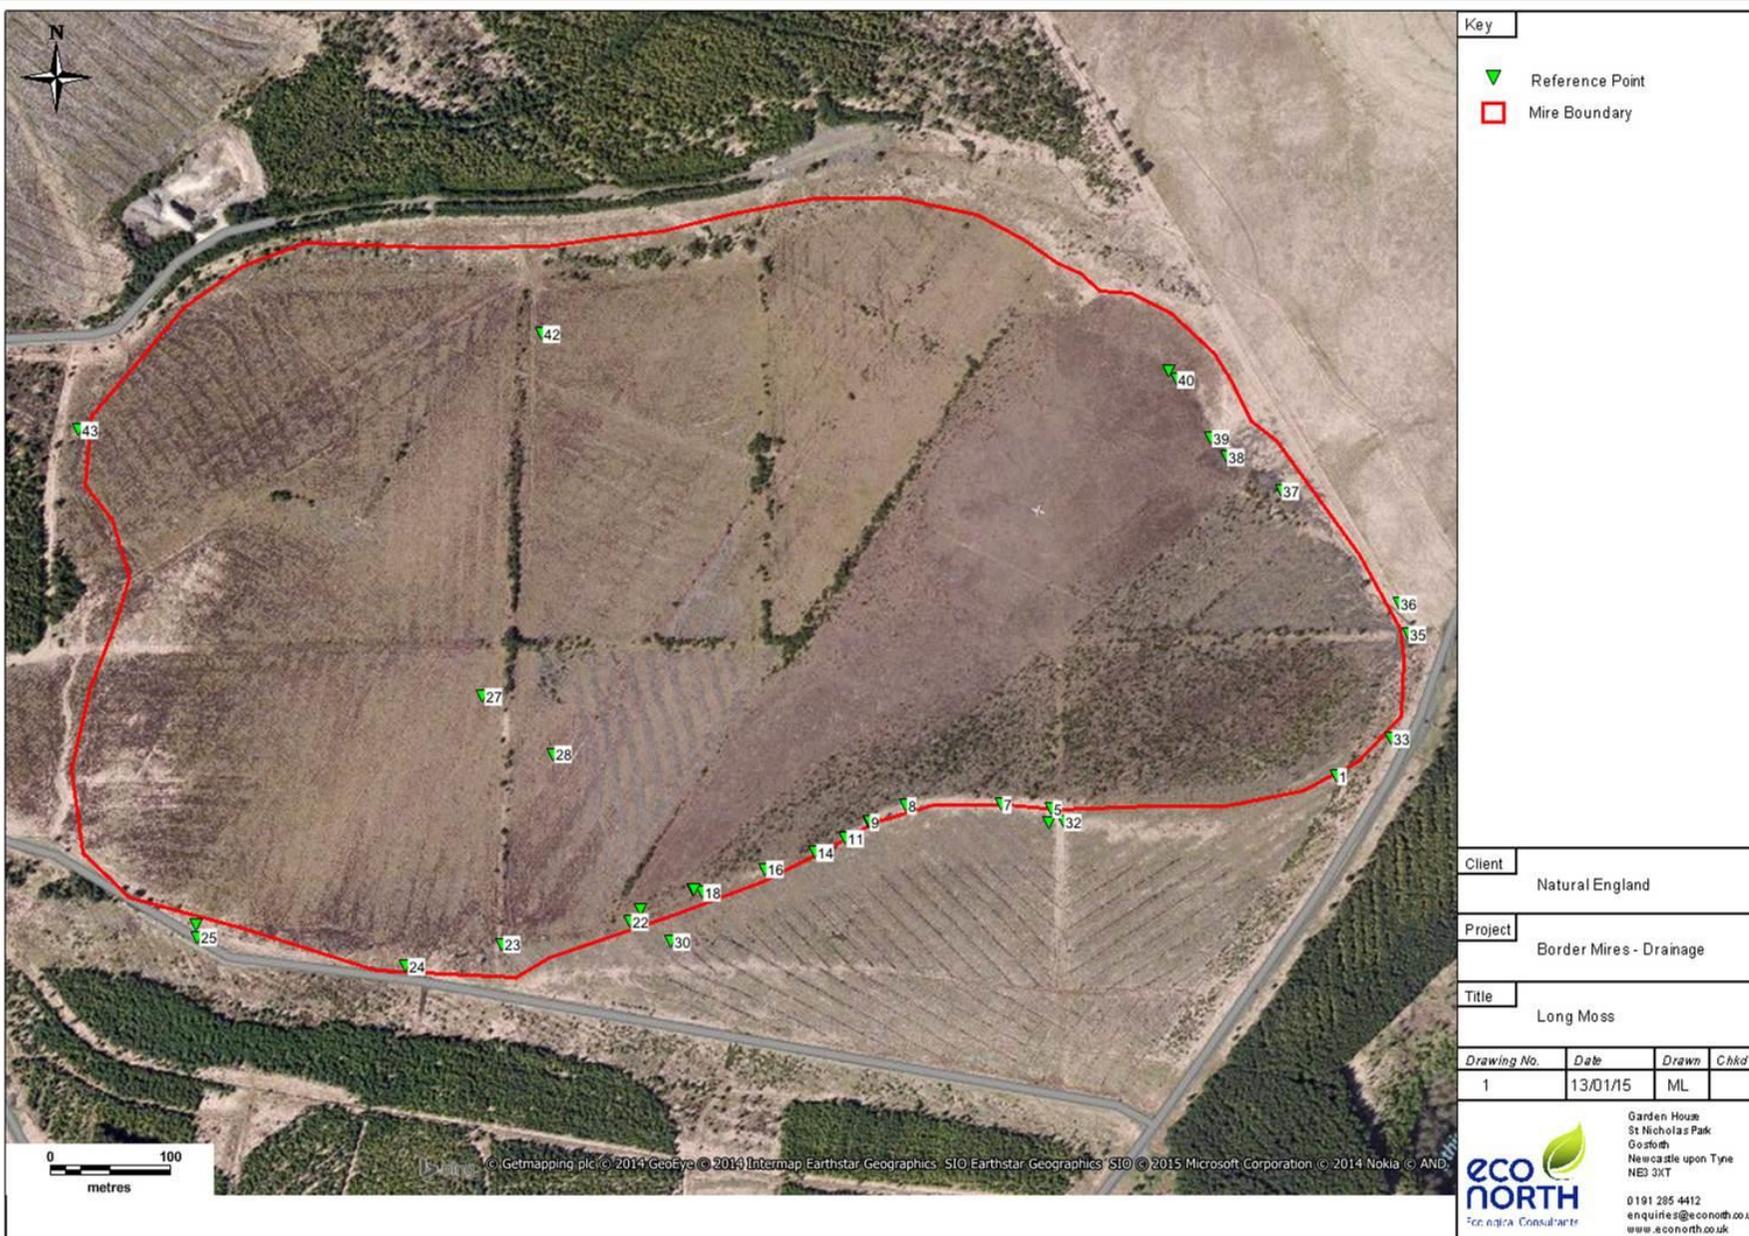
This mire is an example of leaving forestry debris to colonise as mire. The main habitat is quite wet underfoot with heather and moss tussocks.

Perimeter stream is very active and fast flowing - likely a lot of mire water is flowing to here, could block / dam drains on eastern boundary to hold water on mire.

There is a lot of tree regeneration in this mire also - considered to remove this, some trees are now quite mature - approx. 5yo?

Ref Point	Notes
1-2	Drain not active
4	Active drain
5	Drain not active
6-8	Active drain
9	Drain not active
10	Dammed drain - functional
11-12	Drain not active
13	Dammed drain - functional
14-18	Drain not active
19	Dammed drain - functional
20	Drain not active
21-22	Dammed drain - functional
23-26	Active drain
27	Slightly active drain
28	Slightly active drain
29	Active drain
30	Drain not active
31-32	Active drain
33	Drain not active
34	Active drain
35	Active drain flowing E to river outside mire boundary
36	Perimeter stream active flow
37	Active drain running to stream at perimeter cannot track it as it is covered in vegetation

<b>Ref Point</b>	<b>Notes</b>
<b>38</b>	Drain is full but active flow towards perimeter drain - same every metre approx. where there is active flow west to perimeter stream - confluence of N/S drain and E/W drains
<b>39</b>	Last of west flowing drains these can all be dammed to hold water from flowing to stream
<b>40-41</b>	As ref point 38 active drains flowing towards west from n/s direction
<b>42</b>	Flush with rushes dominating from here curving east to treeline to north
<b>43</b>	Perimeter drain here, functional, holding water and is deep surrounding areas also holding a lot of water but also much heather and grass, not sphagnum dominated

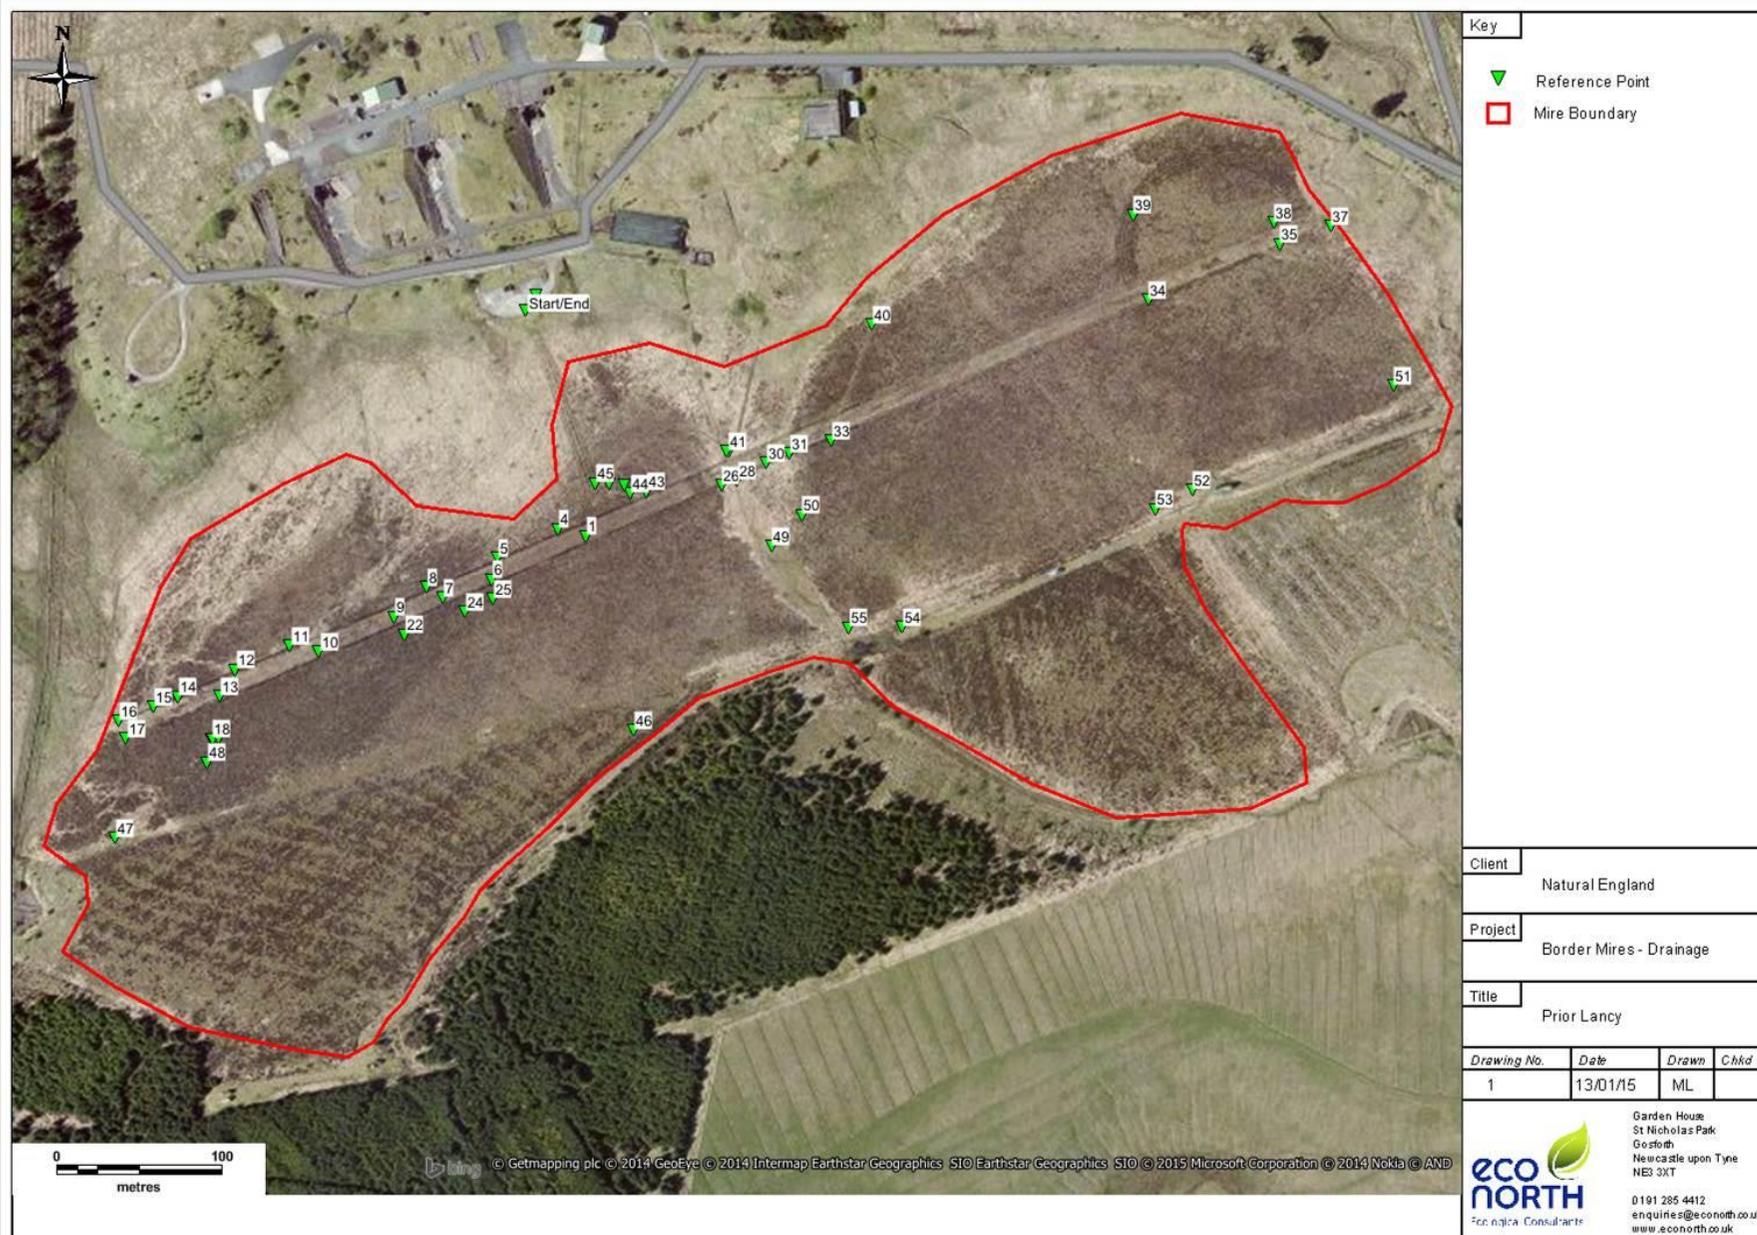
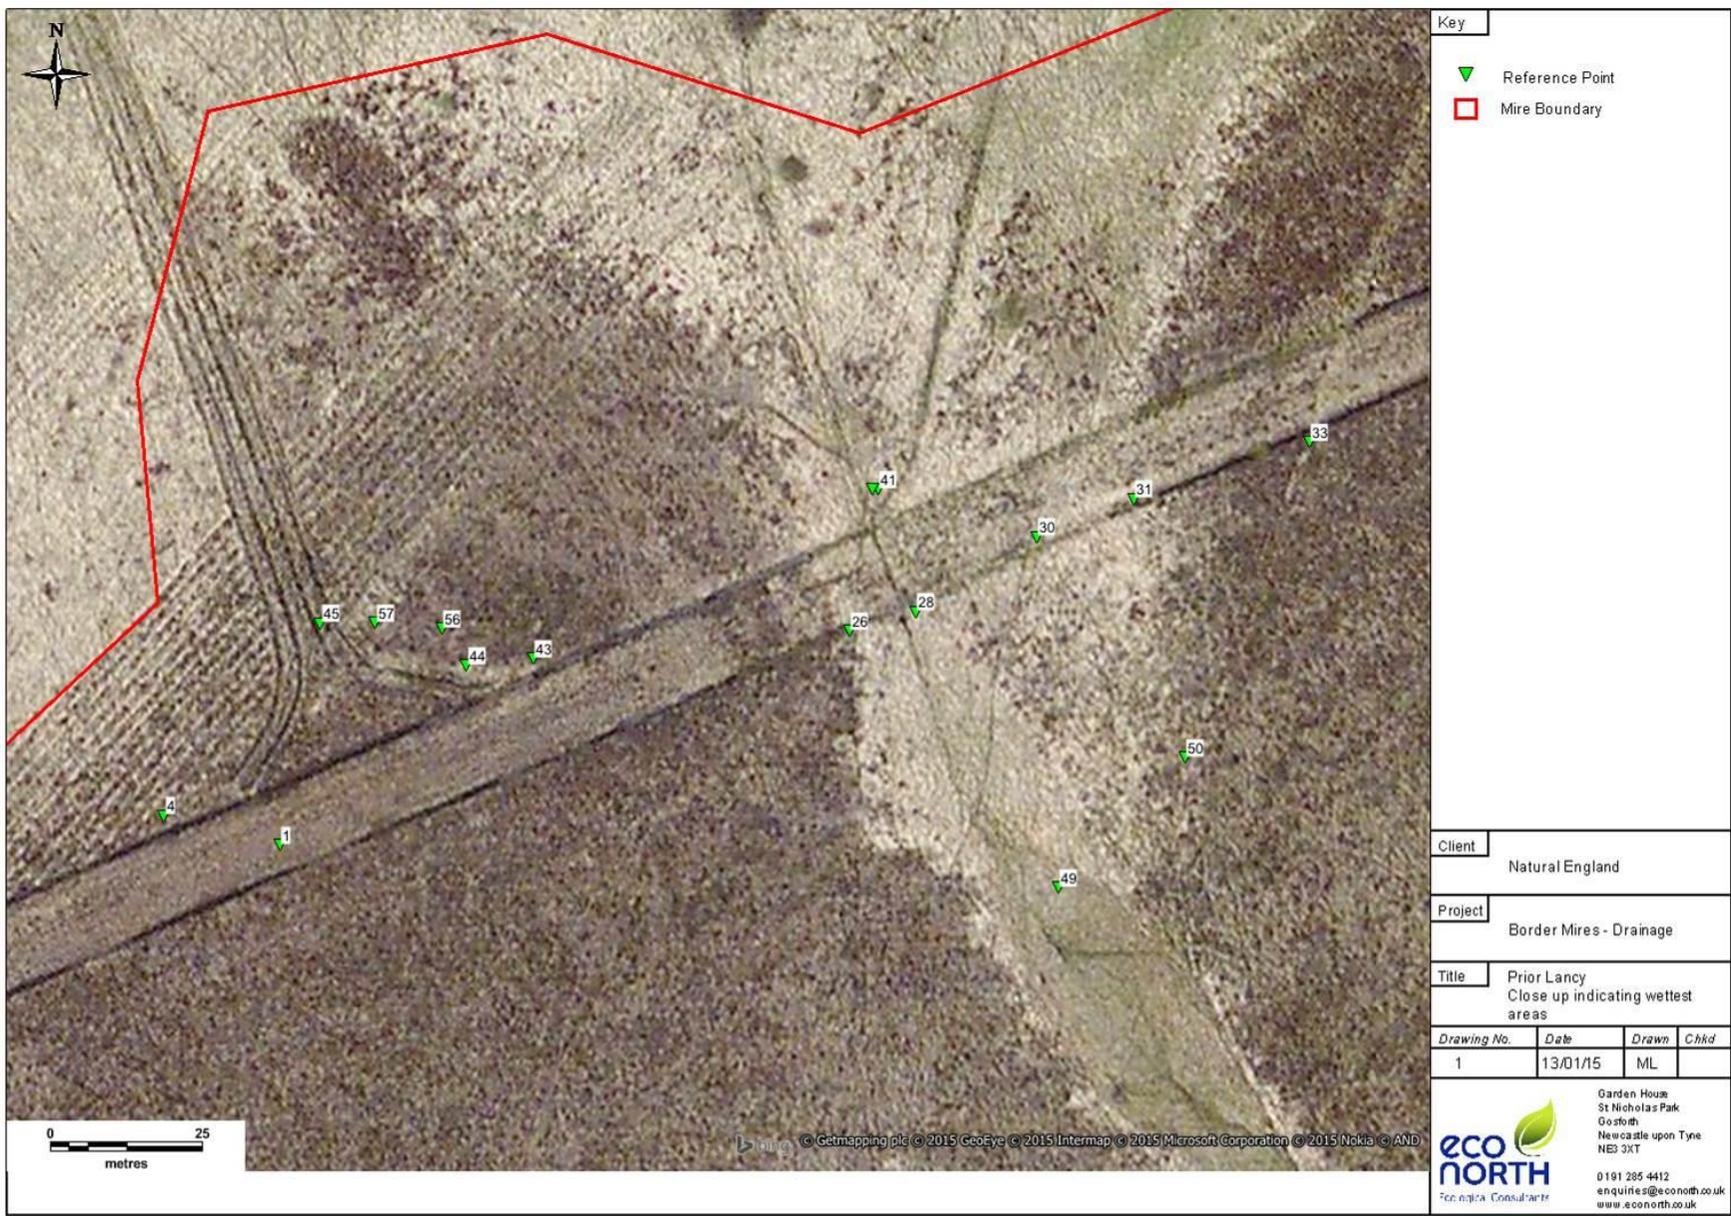
Client	Natural England		
Project	Border Mires - Drainage		
Title	Prior Lancy

<u>Summary</u>	
Tussocky mire no good central wet area, cross-leaved heath and heather dominate with some moss underfoot. Somewhat wet.	
Old runway seems well dammed up (2 parallel drains along length) with only failing dams towards west (see notes) some open pools also present	
<b>Points 43-45 &amp; 56-57</b> Active flow in this area with failing dams – issue to be addressed

Ref Point	Notes
1-4	Open drain - functional
5	Failed dam
6-11	Functional dams on parallel drains on runway
12-14	Failed dams on parallel drains on runway
15	Functional dam
16	Active drain
17	End of parallel drains – water holds here
18-21	Open drains running N/S - functional holding water, some shallow (see point 48)
22-25	Functional dams on drains, holding water within (drains running N/S and parallel to each other for approx. 400m)
26	Open drain – functional, not flowing (N/S direction crossing runway for approx. 90m)
27	Functional dam on drain at point 26
28	Open drain – functional – holding water well central drain, N/S direction crossing runway
29	Failed dam on drain adjacent to point 28
30	Functional dam
31	Open drain – functional, holds water
32	Failed dam on a side drain next to point 31
33	Active drain running NE/SW direction (same drain as points 40 and 50)
34	Functional dam
35	Open drain - functional

36	Failed dam on side drain from point 35 (point 36 hidden under point 35 on map)
37	Flush area, not mire
38	Functional dam
39-40	Active drains that could be dammed to hold more water
41	Open drain – functional, holding water
42	Active drain directly adjacent to functional drain (point 41) and could be

Ref Point	Notes
	dammed to stop flow
43	Open drain – functional, holding water
44-45	Active drains to be dammed along length. Drain is old forestry line and curves from point 44 to 45 and continues north
46	Perimeter drains(2) in parallel to tree line both dry, holding a little water at end, moss covered, could hold more water, i.e. would benefit from being dammed
47	Wet central section (western end of site) but not good mire - see pic (POI2 PL) - grass and moss dominate. Could be improved
48	2 parallel deep drains shallow not holding much water
49	Wet flush with active stream and deep pools visible on aerial
50	Deep shallow drain difficult to follow as very tussocky - small bit of flow likely flowing to stream in flush
51	Remnants of a wet flush on boundary relatively dry not holding much water
52	Blocked drain functioning but adjacent areas quiet dry
53	Same drain as ref point 52 but less water here, up to ref point 53, appears drier further west same on South of track at edge of old forestry

54	Lake permanent likely drains water from surrounding land and drains adjacent to track
55	Active flow over failing dam, flow from central flush (ref point 49) to lake (ref point 54)
56	Failing dam
57	Active flow from car park direction
