# Border Mires: Active Drainage Mapping Project

Border Mires, Kielder – Butterburn Special Area of  
Conservation (SAC)

# Border Mires Active Drainage Mapping Project

## Final Report

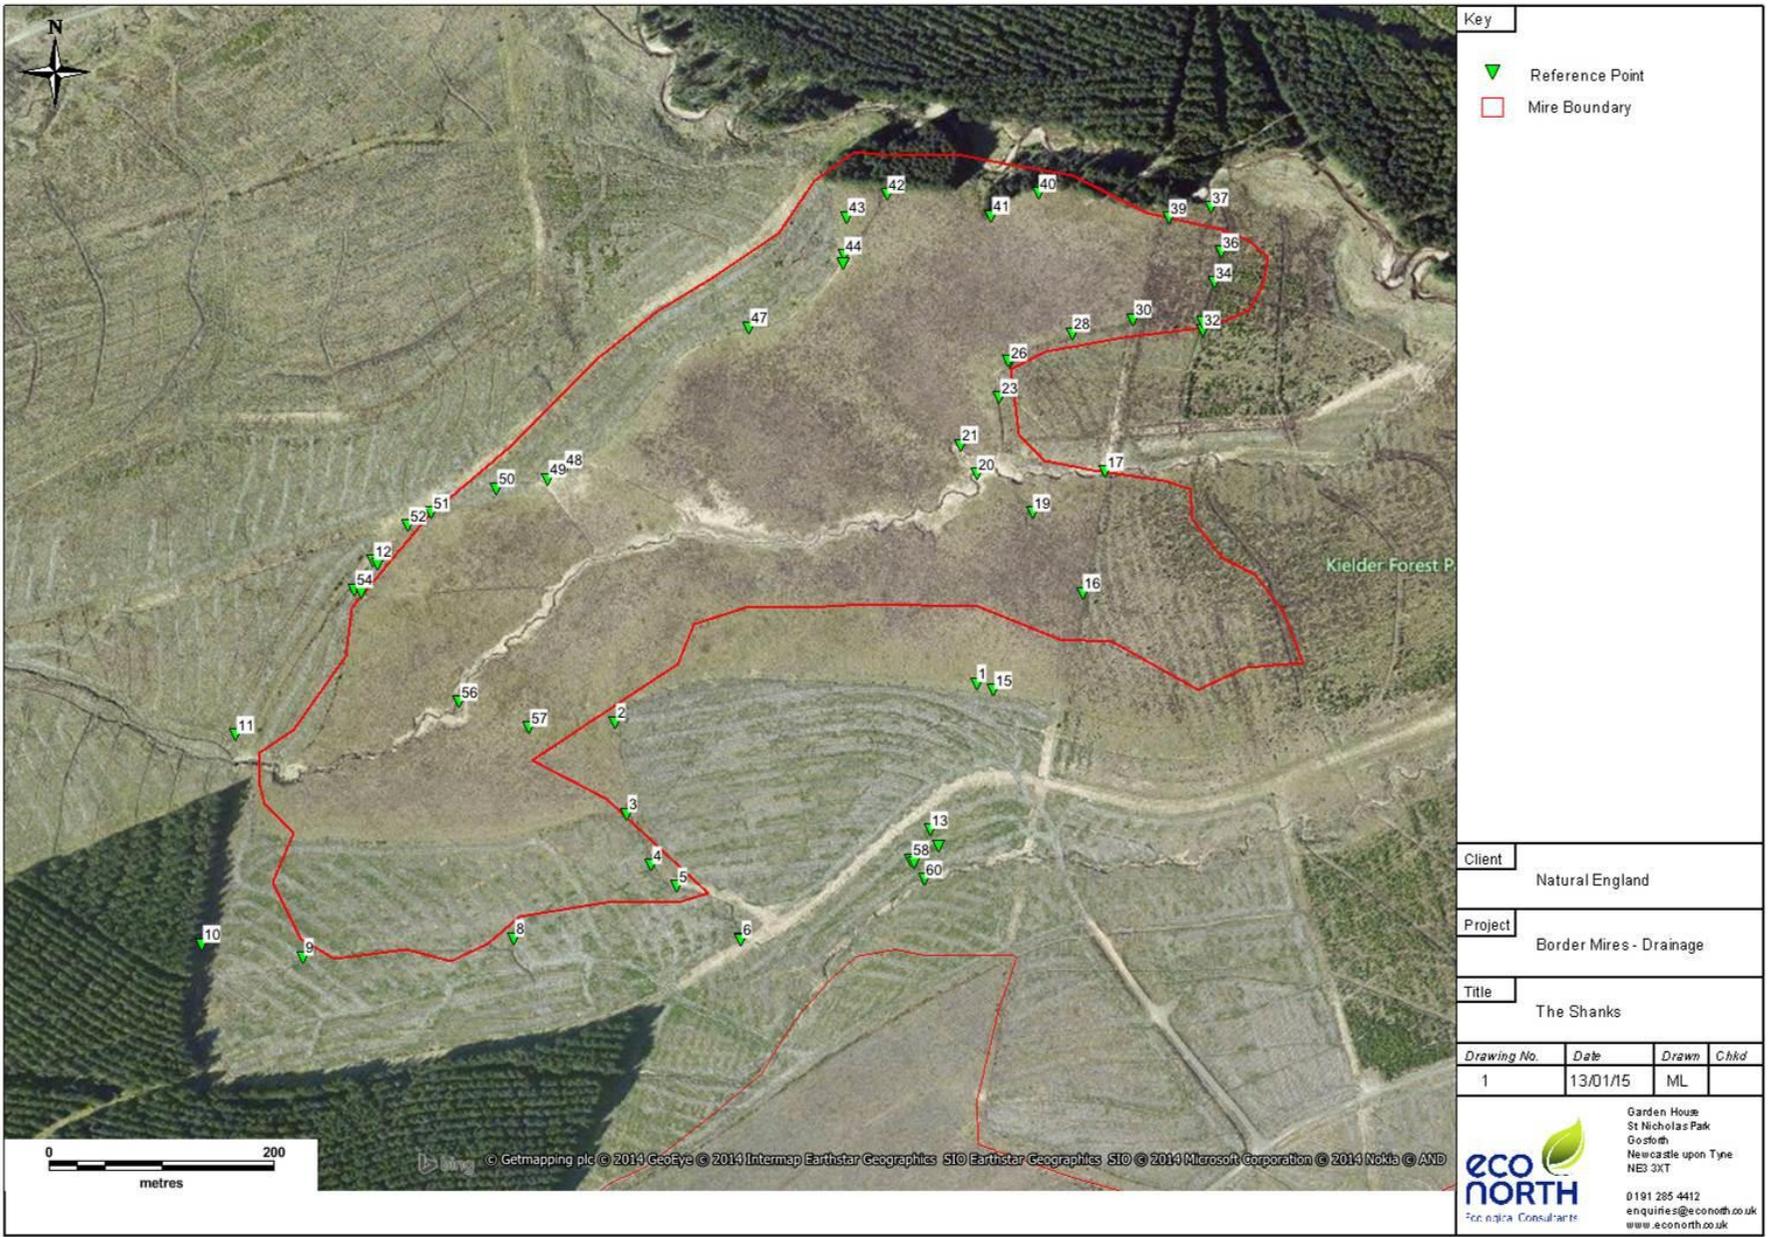
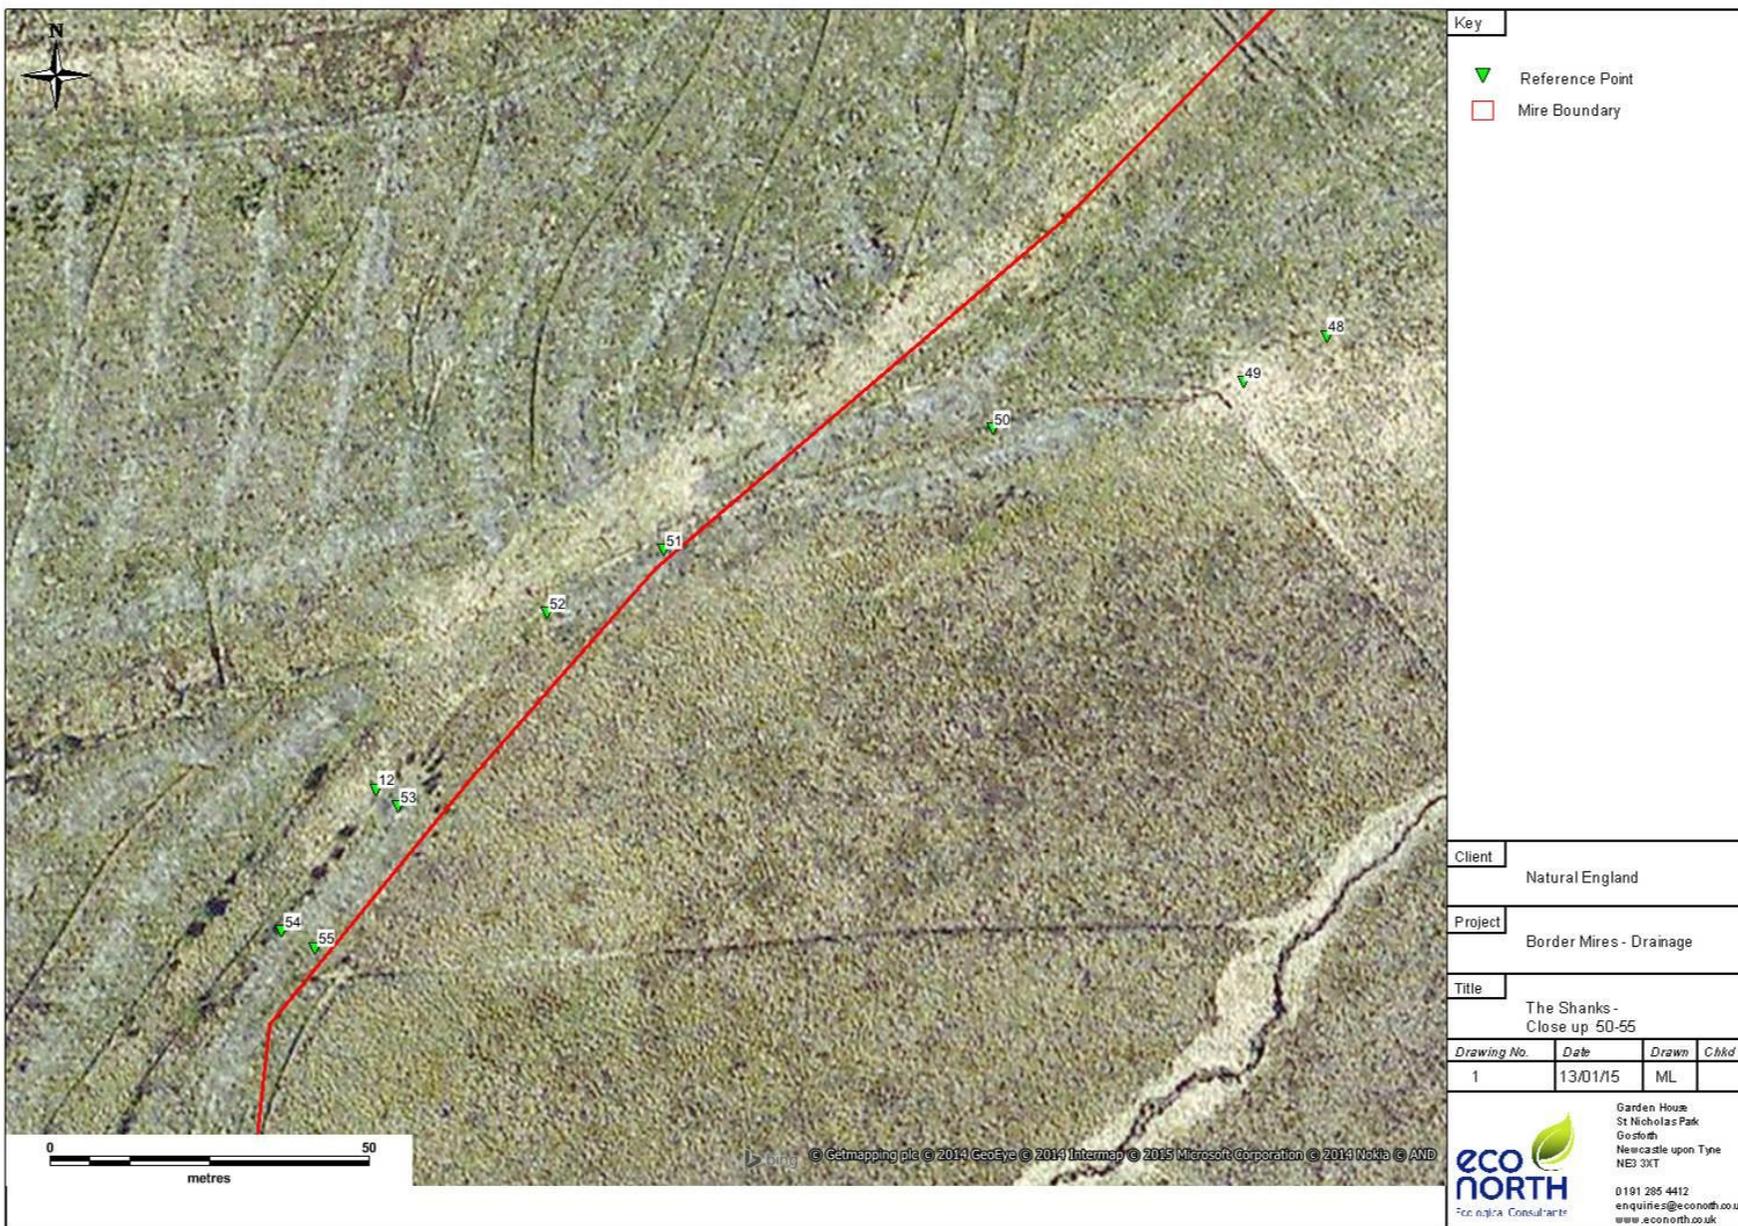
<u>Summary</u>	
<b>Reference points 2-7</b> Active drains at south flowing to perimeter drain	
<b>Reference points 11-12</b> From the confluence of the burn walking between two drains both are moss filled but not very high i.e. only holding some water and most likely flowing to the burn. Recommend block one or two of these parallel drains to hold water but still feed the burn i.e. not blocking all drains. Many parallels to length walked from confluence to north.

Ref Point	Notes
1	Perimeter drain with plugs that appear to hold water, moss filled, holds water further north east - drain runs in N/E / S/W direction
2	Perimeter drain bends around to south has plugs but not holding a lot of water, could hold more, some brash covers it
3	Drain is deep and shallow with water, not full but covered with cotton grass and moss in places has some plugs lines north / south direction for approx. 180m
4	Active drain lined in a w/e direction flowing towards drain at ref point 3
5	As ref point 4 - parallel to ref point 4 runs to drain at ref point 3 and is flowing, is active
6	Parallel to Ref point 4 runs to drain at Ref point 3 and is flowing, is active
7	(hidden under point 6 on map) Parallel to Ref point 4 runs to drain at Ref point 3 and is flowing, is active
8	Drain active - branches N/S to E/W direction for approx. 200m towards ref point 9
9	There are some plugs in the drain further west which appear functional with pools behind further east this drain is active and flowing (towards ref point 8)

10	Perimeter drain along length of tree line functional holding water with moss and not shallow no obvious flow
11	Drains flowing fast from North to burn flowing east
12	2 drains lined west / east very mossy no standing water and no flow, could hold more water – likely?
13	Active drain flowing west to east
14	Active drain - perimeter drain flowing west to east
15	Plugs are functional along southern edge (as point 1)
16	Active drain, N/S direction to point 17 and to burn / stream
17	Drain to burn / stream – some flow
18	Flowing stream (at Point 17, hidden on map)
19	Active drain flowing north to stream 40m approx. length
20-22	Drain active and flowing to burn with flush surrounding, joining at point 20
23-25	Drain – active to burn N/S direction for approx. 50m (hidden under point 23 on map)

<b>Ref Point</b>	<b>Notes</b>
<b>26-29</b>	Drains not active (E/W direction)
<b>30</b>	Drain is active at this point from point 29
<b>31</b>	Drain holding water
<b>32</b>	Side drain is active
<b>33</b>	Main drain is active
<b>34</b>	Drain with slight flow
<b>35-36</b>	Side drain is active from main drain (along point 33 and 34)
<b>37</b>	Drain not active here
<b>38</b>	Side drain is active
<b>39-44</b>	Active drain along forest edge and then in N/S direction
<b>45</b>	Drain is less active at this point
<b>46-47</b>	Active drains to point 48
<b>48</b>	Drain not active – holds water at this point
<b>49</b>	Drain is active to main burn / stream S/E direction, flush area
<b>50-55</b>	Active drains in N/S direction mostly
<b>56</b>	Burn / stream
<b>57</b>	Drain
<b>58-59</b>	Active drain
<b>60</b>	Burn / stream

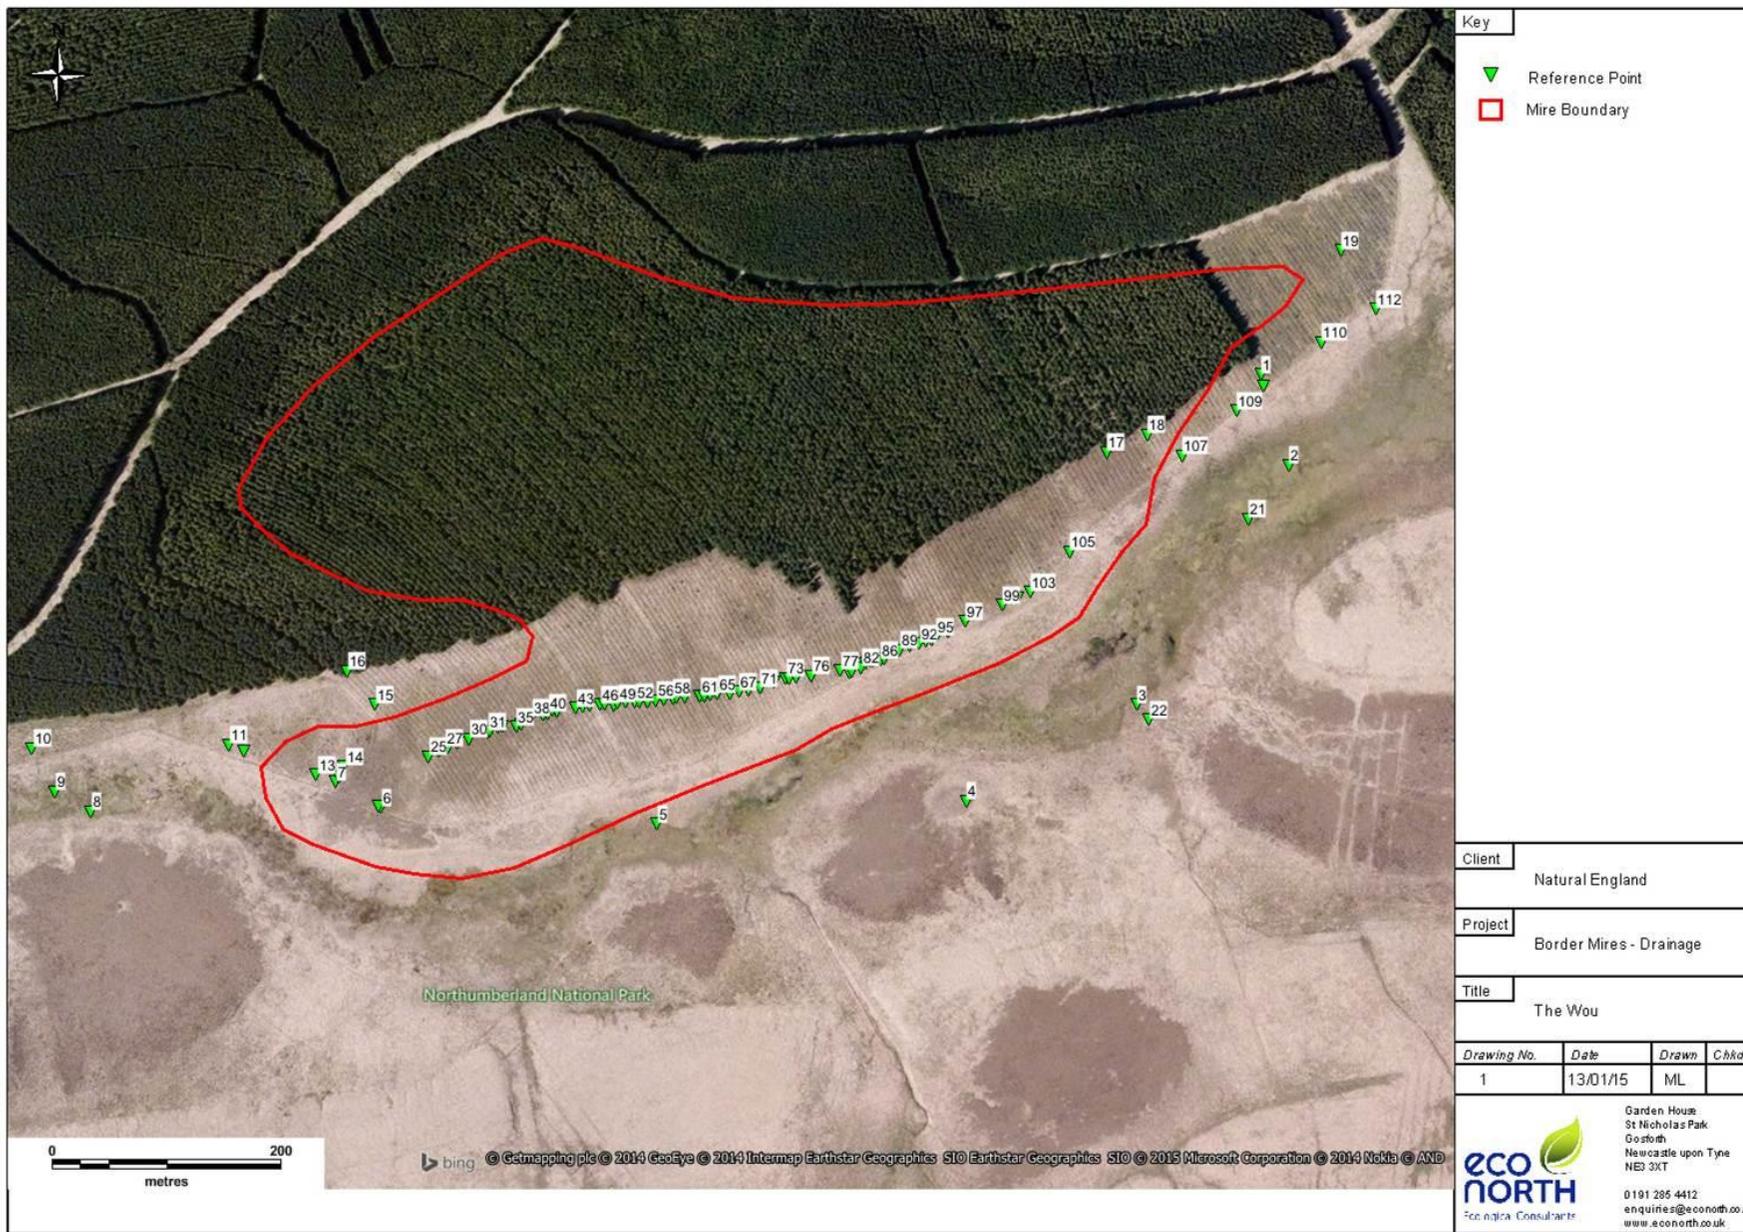
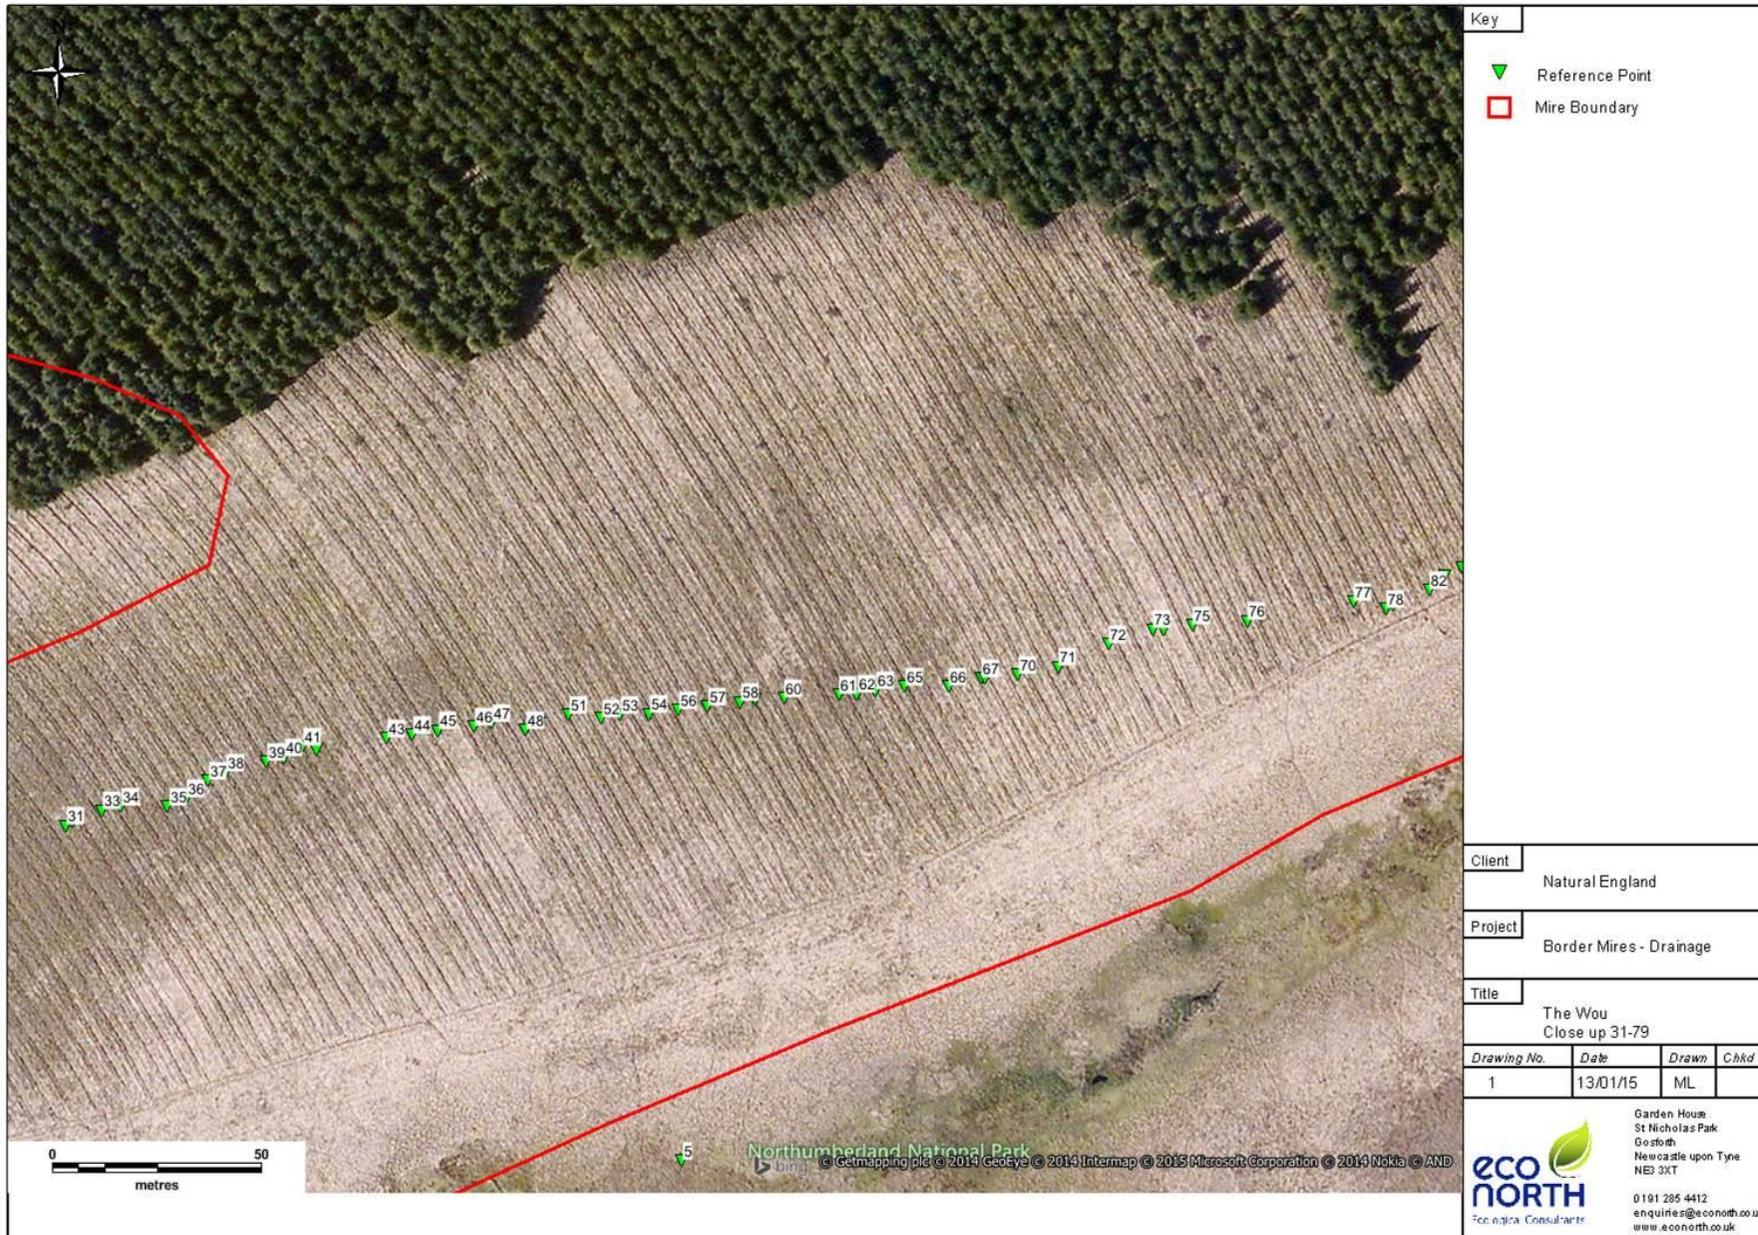
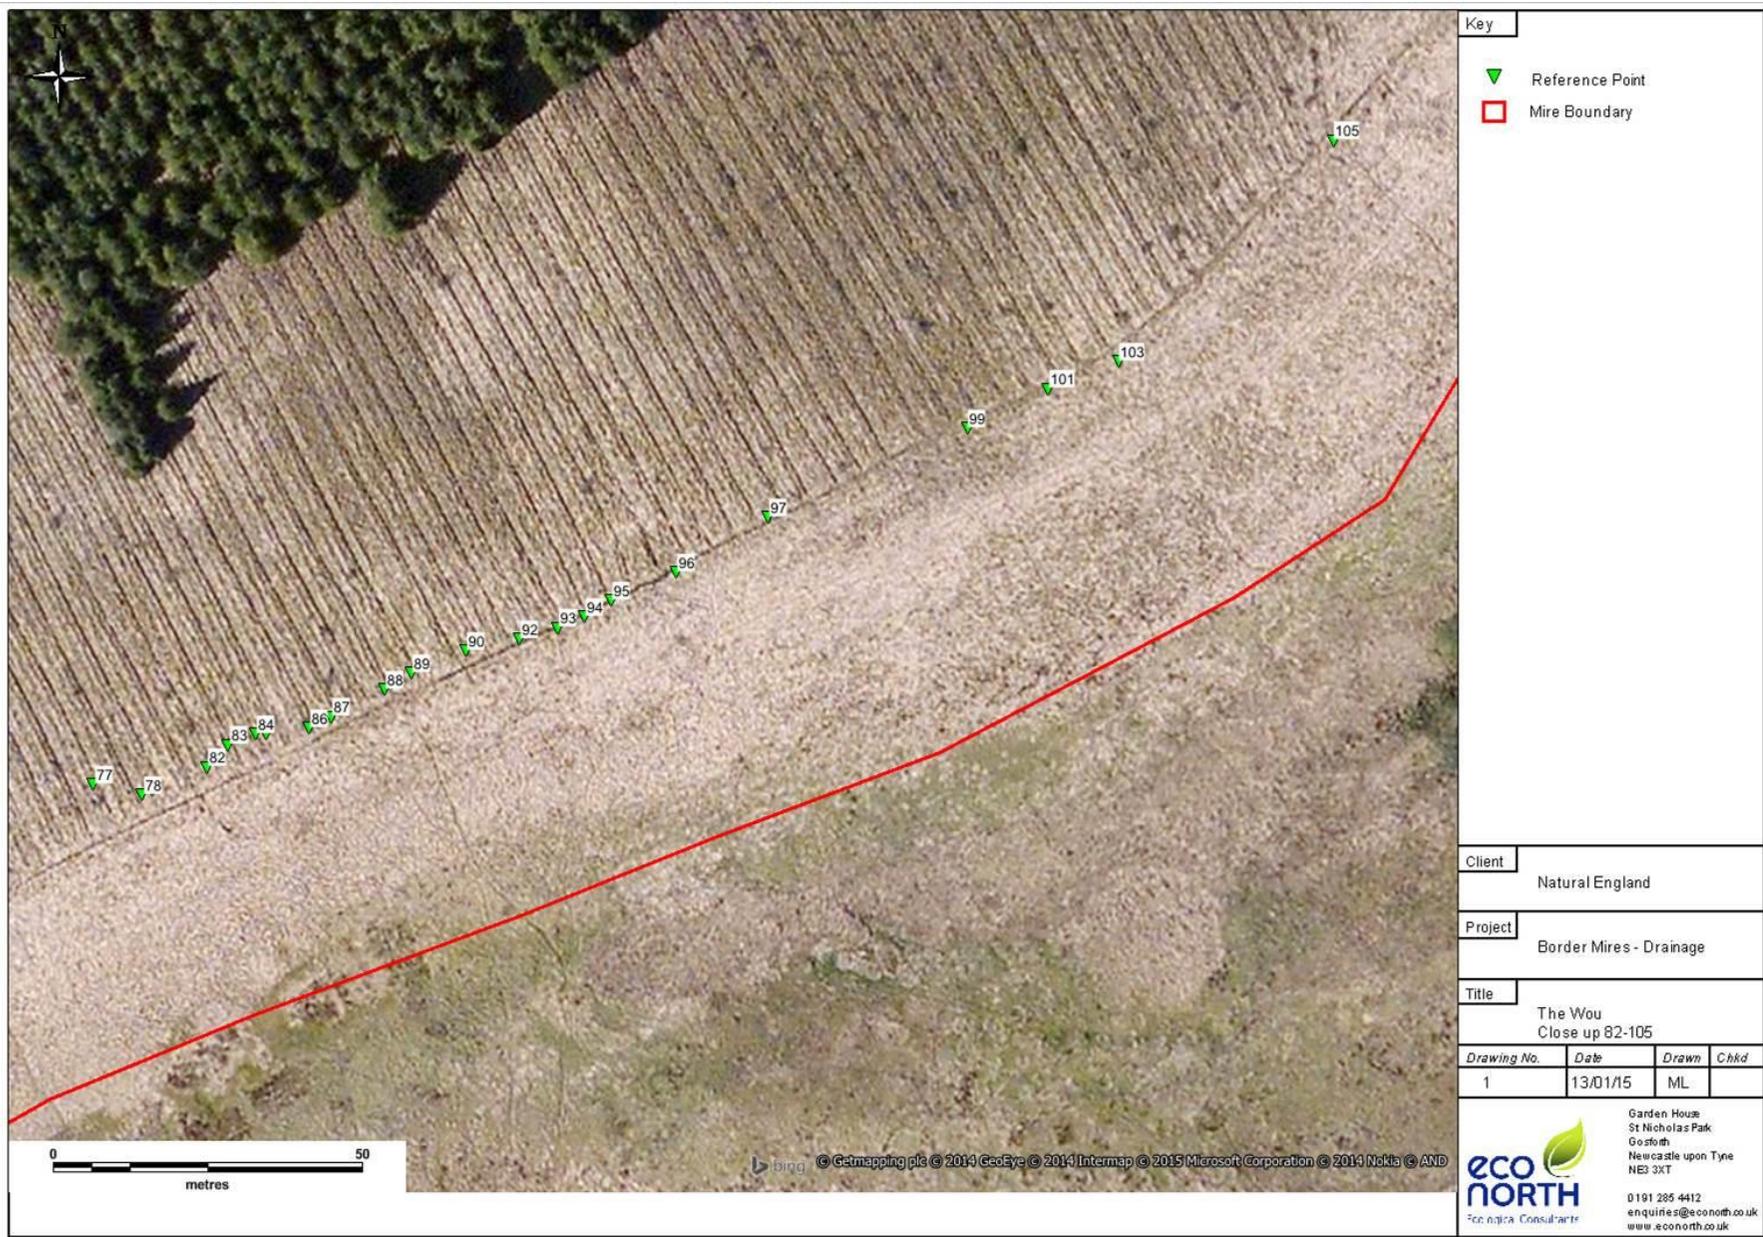
<u>Summary</u>	
<p>The Wou has a large flush / marsh area in the centre. Water may drain to here from surrounds, slight gradient. All plough lines to the north are of similar composition - wetter closer to the trees, some standing water within but drains are not filled. Potential for these to be filled if some were blocked up to create spread of water coming from tree line.</p>

Ref Point	Notes
1	Drain parallel to the tree line. 3ft deep approx. and 0.5m wide. drains perpendicular to drain 1 up to tree line
2	Marshy standing water not walked through for drains approx. 4ft deep
3	Marshy deep water maybe draining from the south
4	Animal run with standing water possibly a drain - not active
5	Dry run between rush maybe water pools in central bit from surrounding hills and flows to burn to the west. Generally flat however with no obvious flow
6	Drain with shallow water at base parallel to fence E/W direction
7	Drain shallow as 6 and lined up towards tree line from ref point 6 not active i.e. not flowing
8	Molina / reed habitat with rushes, pond like habitat
9	Wet stand of water no obvious flow from a source
10-12	Drain quite moss filled running between fence and tree line parallel no flowing water to ref point 11 approx. starts again at ref point 12 back to ref point 6
13	Drain running from ref point 12 to trees first one along this stretch from trees

14-16	Large drain from ref point 12 towards tree line, dry not holding a lot of water runs to tree line. Slightly dry at ref point 15 then runs to ref point 16. Some plough lines hold water near the tree line but dry up further south
17	Drain blocked at ref point 17 holding water behind on tree side quite dry on South side
18	Ref point 18 as ref point 17 holds water to north dry to south
19	Blocked with trees / branches but no pooling water, drain in N/S direction, could hold more water if dammed
20	Active drain
21	Flush
22	Slightly active drain - some water within
23	Drain not active
24-29	Slightly active drains all parallel to each other in N/W / S/E direction
30	Active drain (N/W / S/E direction) parallel to others on map

<b>Ref Point</b>	<b>Notes</b>
31-79	Open drains but not active, could hold more water if dammed by treeline
80-97	Main drain active here, runs W/E direction along southern end of drains 29-79 for length of mire (same drain as at point 1)
98	Dam failed (point hidden under point 97 on map)
99	Drain holds water here, although likely there is slight flow around failed dam
100-103	Obvious active flow in drain again at this point
104	Area up on a high point
105	Functional drain – holding water in a N/S direction across main perimeter drain
106	Active drain - flow to the east
107-109	Functional drain, holding water, running East / West direction
110	As point 19
111	Active drain (point is hidden under point 110 on map). Drain is lined up in an E/W direction (not N/S as Point 110)
112	As point 19
