# Border Mires: Active Drainage Mapping Project

Border Mires, Kielder – Butterburn Special Area of  
Conservation (SAC)

# Border Mires Active Drainage Mapping Project

## Final Report

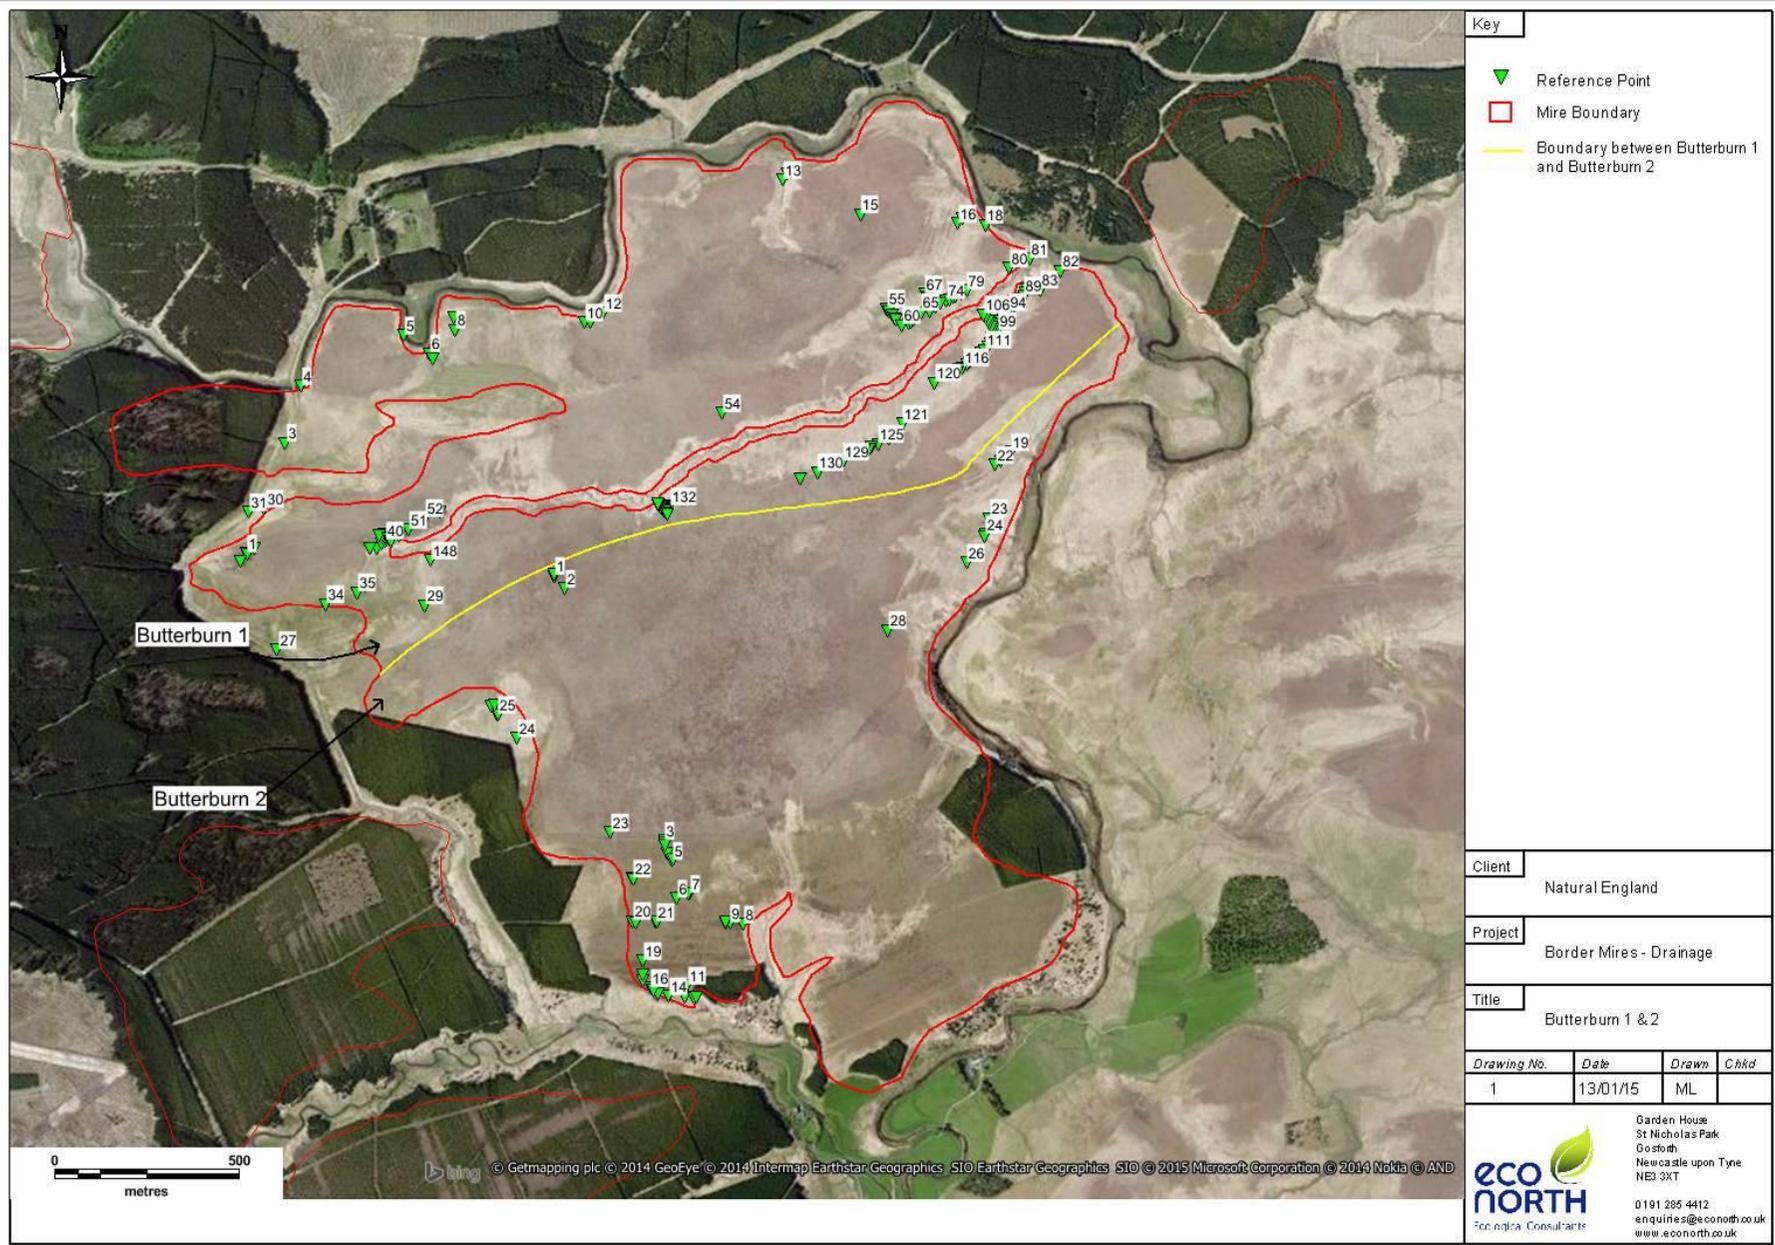
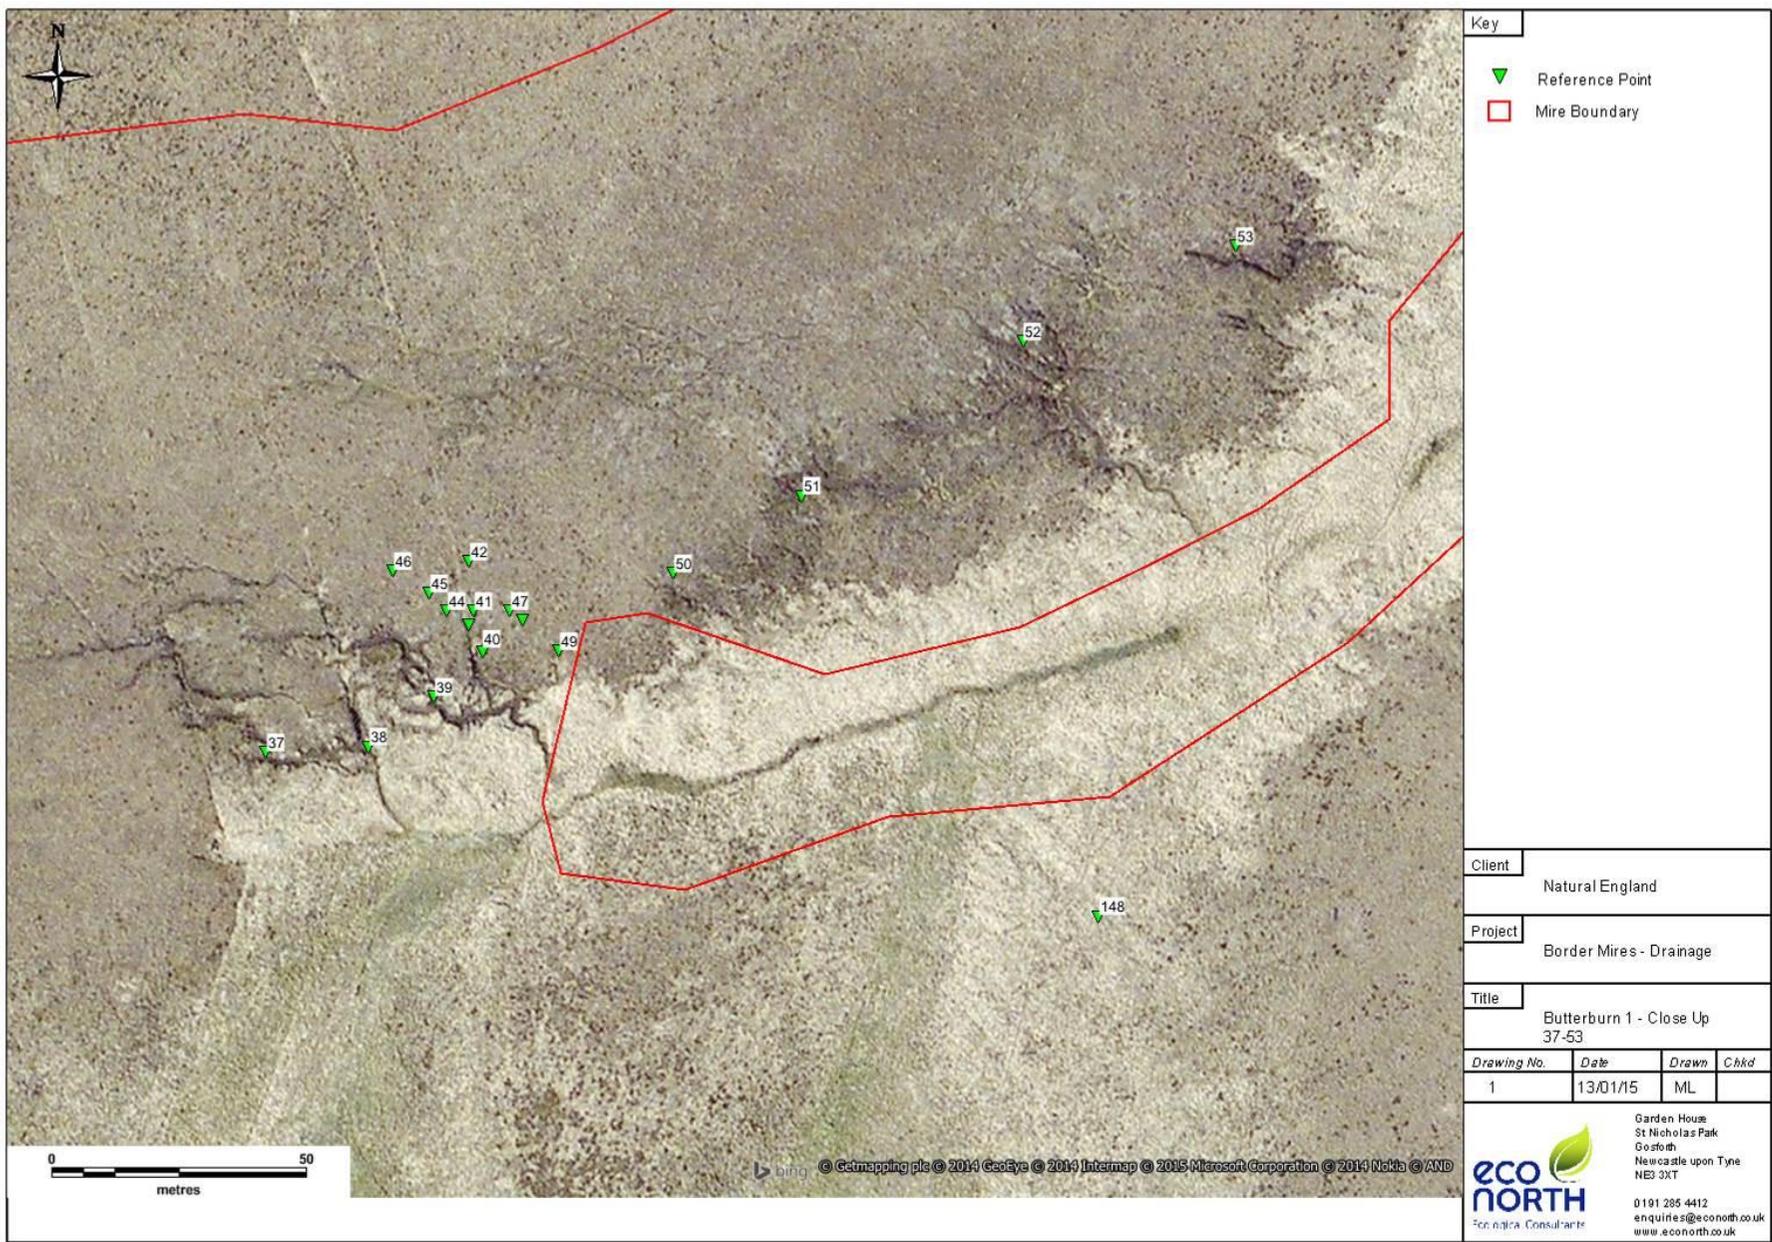
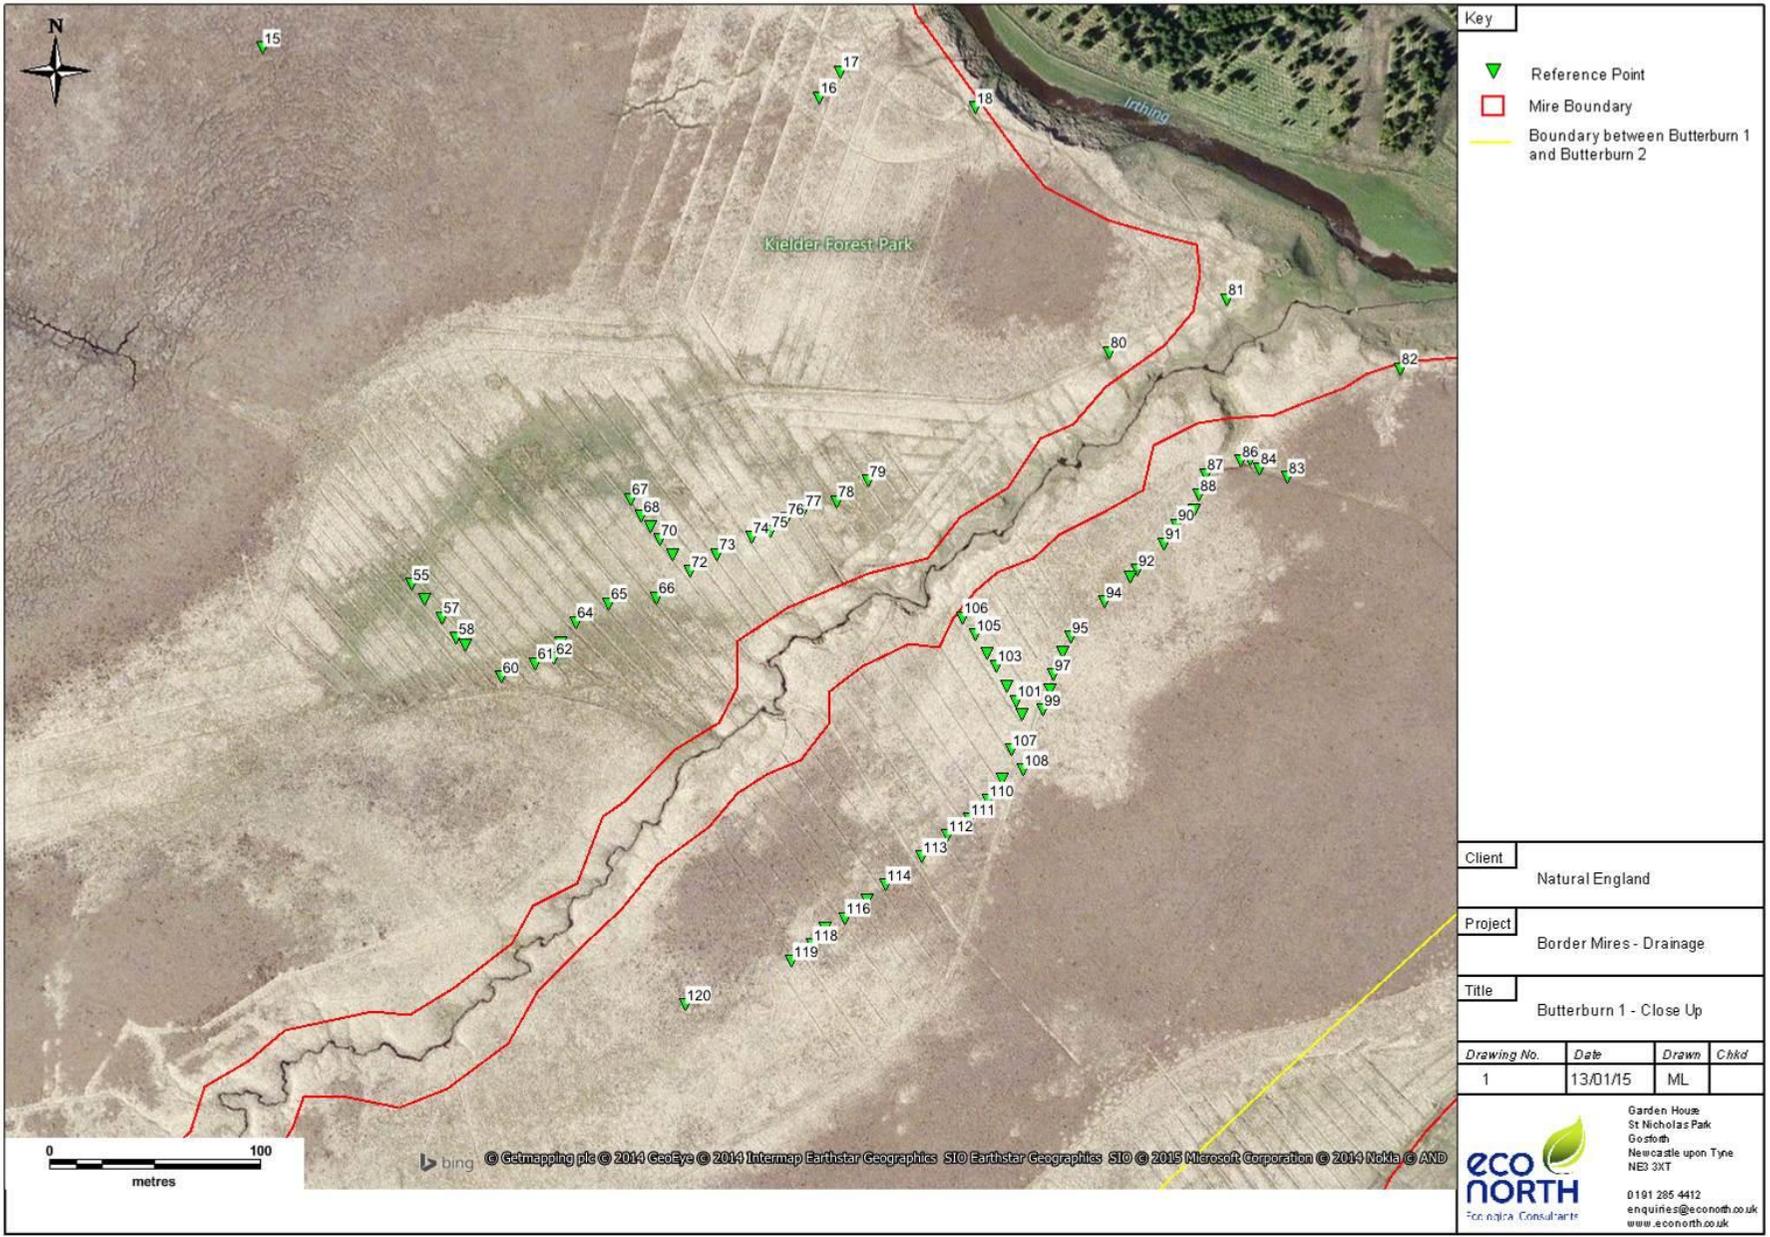
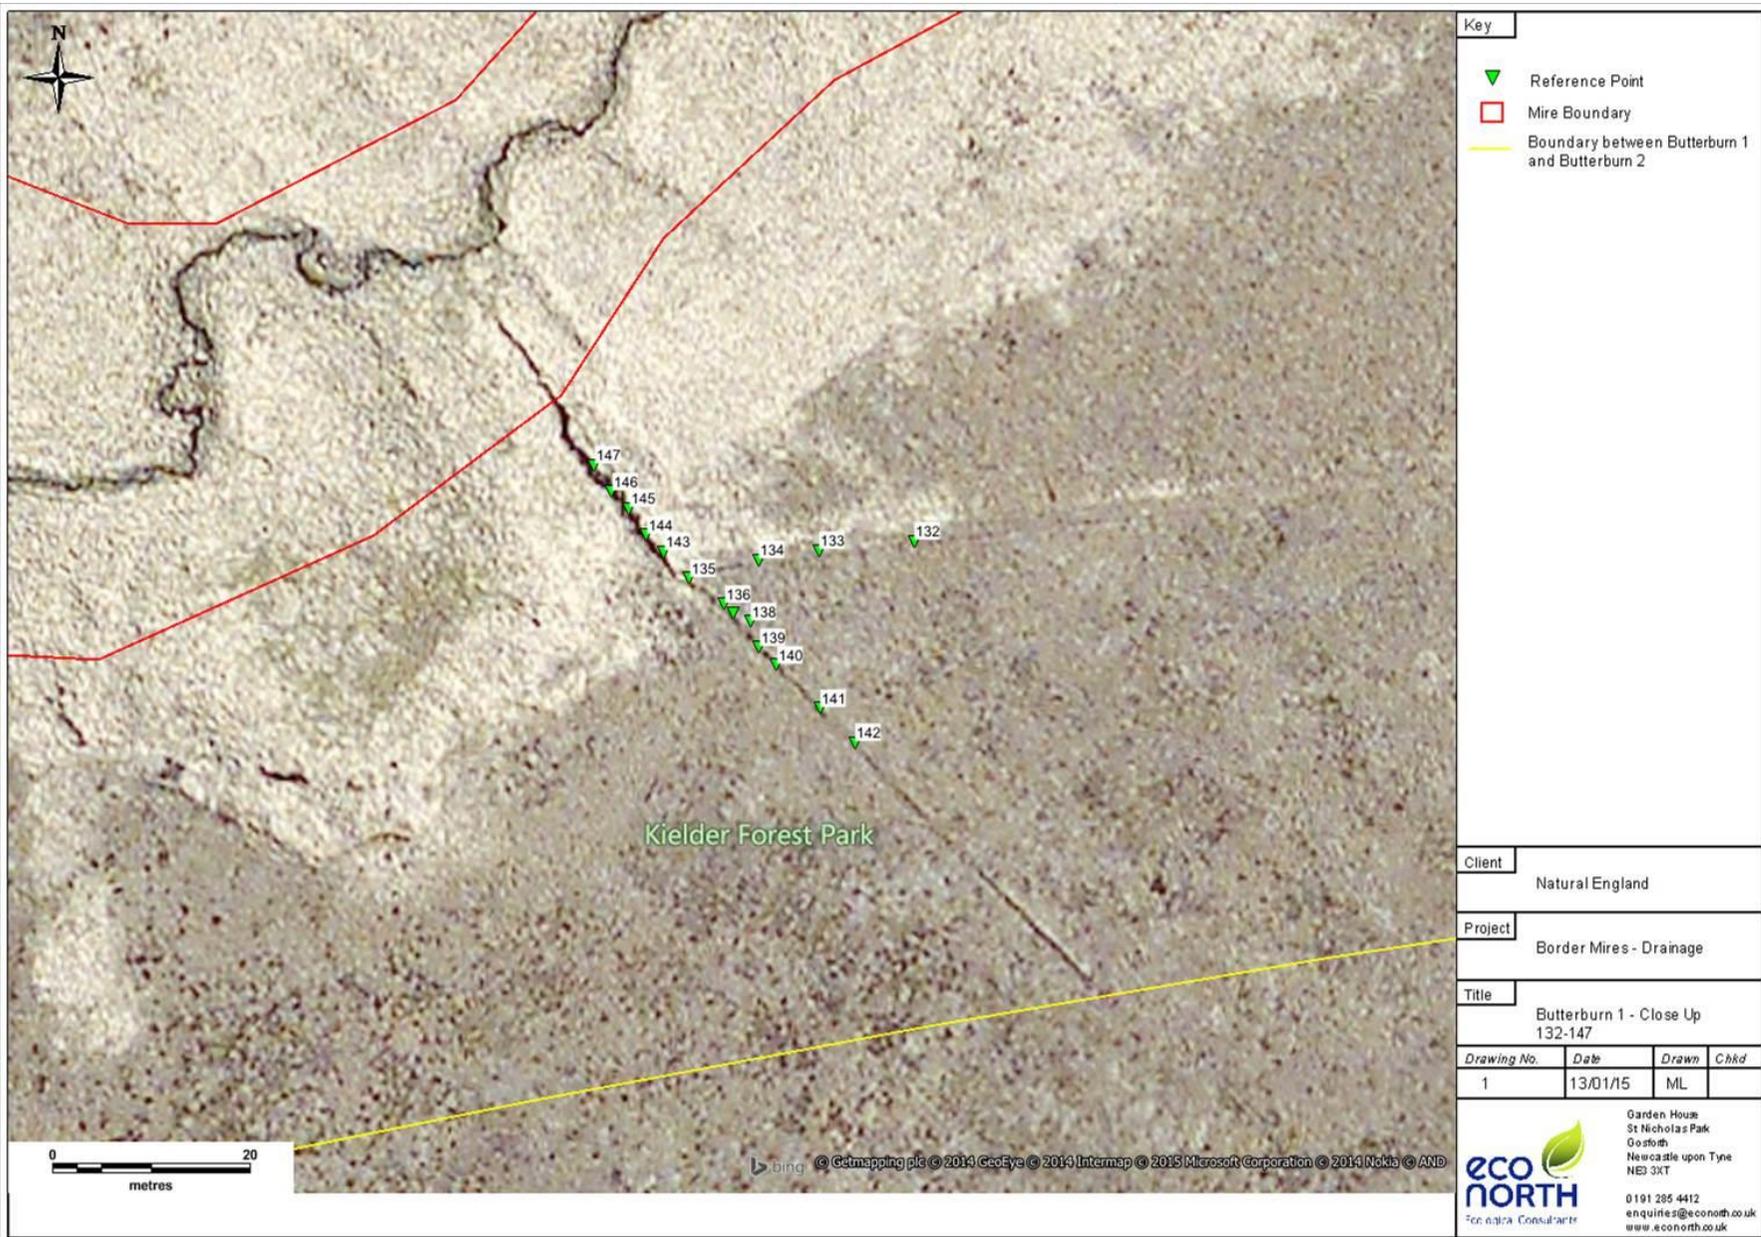
<u>Summary</u>
<p>Lots of standing water around ref point 1 and 2 (Butterburn 1).</p> <p>Perimeter drain is wet with no active flow; at ref point 4 is the only apparent active drain from the north. This drain is likely collecting water from the surrounding areas and feeding to this drain and to the river (Butterburn 1).</p> <p><u>Recommendation</u> - creating other drains along perimeter to block to stop all water draining to perimeter drain and then to river.</p> <p>To the west, adjacent to the river, is more marshy grassland than mire, with some natural flushes leading to the river but these are not extensive.</p>

Ref Point	Notes
1	Failing dams - natural channels dammed but some water flow through
2	Drain flowing e/w some standing water at surface also moss -functional
3	Perimeter drain, holding water at this point, wet flushes adjacent, hillocks of moss and rush
4	Decent flow from perimeter drain to river Irthing (flow from South) - active drain
5	Wet area next to river with some standing water adjacent areas are much drier however water likely collected in this wet area from surrounds and flows to river
6	Active drain running to the river from South - visible in the aerial. Drain is narrow and grass covered water flow is audible therefore is under grass
7	Drain only active to this point, gathers a lot of surrounding water here and flows directly to river - block potential here further south of ref point 7 a drain is not as obvious but there is a lot of standing water and sphagnum
8	Drain running N/S direction - little water within, approx. 50cm deep

9	Lost the drain from ref point 8, backed up with sphagnum maybe? No obvious drain on the landscape very hilly
10	Defunct drain at edge of mire habitat, to the north towards river is drier; drain is not flowing but no obvious water within
11	Drain holds some water
12	Active drain flowing north from South to river
13	Natural drain to river no apparent active flow, moss and rush covered - drain from South to north
14	Natural valley to drain at ref point 13. Comes S/E direction and joins ref point 13 drain
15	Nice mire surrounds standing water and sphagnum, also cotton grass dominates with some deer grass no apparent drains to river

28	Moves to better quality mire much wetter and no apparent drains surround - distance from river an effect on wetness?
29	Natural wet flush holding water well with rush and sphagnum
30	Start Point
31	End Point
32-33	Natural erosion channels, blocked by plastic and timber dams which are effective in some areas however, water is flowing around some and flowing through in an E/W direction
34-36	Straight channels, however is likely natural. Flow at base of hill but some areas are water logged with moss and rushes, possibly the beginning of the burn
37-39	Area of erosion, lot of flow towards start of burn - open water and flowing
40-54	Ditch blocked with vegetation which opens to eroded area with flowing water. Many areas where ground has been dry
55-59	Small ditches from top of hill that flows to a marshy rush flush. Ditches are small with water flowing, some plugs hold water
60	Wet flush, possibly natural with many rushes. Draining from hill from the north to the burn - wet flush is approx. 10-20m wide

61-66	Drains from top of hill, some with active flow
67-74	Some blockages on drain by grass, however, this is not significant
75	As with 67-74 but with more water present
76	As with 75 however with a lot more standing / pooling water suggesting more functional blockage
77	Some small flow to burn
78-82	Drain are blocked better here, holding more water, likely to be related to flatter gradient than further west along burn
83-87	Small natural drain, with water present that separates mire from grassland. Leads to an area of slipped land that drains to burn. Some areas in slipped land hold water well

Ref Point	Notes
88-99	Drain with water flow - to point 87 - audible flowing water in parts. Drains lined up in S/W to N/E direction
100-121	Drain extends directly north in straight line to burn, some water within the drain, appears dry in parts. No audible water flow however, could hold more water
122-131	Drain is dry in places however, is wetter as slopes towards the burn where it holds more water. Functional at this section
132-147	Drain forks, leading to burn (active) and mire (holds water)
148	Area has been tracked over by large vehicles - sleepers cover the tracks and quite churned up

9	Very heavy flow at ref point 9 and drain is very deep but not water filled - dam failing here
10	Another failed dam here water flow not as strong but still heavy flow
11	Narrow drain leading towards the river some water within light water flow. Drain is steep and could hold more water. Lined n/s direction
12	Drain with dam lines up n/s but very little water within. Steep drain with potential to hold water also side channels from west are dry. Side channels at ref point 12 lead to area other drain also very dry

<b>Ref Point</b>	<b>Notes</b>
<b>13</b>	Ref point 12 merges at ref point 13 with drain linked to river but little water within rush dominated and surrounding habitat appears drier
<b>14-16</b>	Drains within this area are many and all are quite dry and hold only shallow water with shallow moss filled. Could hold more water. drain with failing dams some water flow at ref point 14
<b>17-19</b>	Dominant drains, parallel to each other. Tussocky habitat with no water flow however, no pooling water. Drains here with a lot of potential to hold more water if blocked / dammed. Some natural damming with tussocks but not as wet as should be
<b>20</b>	Drain from N/E / S/W dirn that leads to ref point 6 - See notes above
<b>21</b>	Drain leads from tree line to Ref point 8. At this point drain is function, holding water
<b>22</b>	Deep drain from tree line to South West (ref point 22) ends at ref point 5 holds some water but drain not full

<b>23</b>	Fence line - distinct change in habitat, some spreading water / pooling to north of fence
<b>24</b>	Drains in this section are deep but relatively shallow, some hillocks/tussocks and no active flow but could hold more water
<b>25</b>	Area is very churned up and has some pooling water but only where vehicles have churned up ground. Not mire habitat
<b>26</b>	Drains leading to ref points 1 and 2 originate from this area
<b>27</b>	Start
<b>28</b>	End
<b>36-37</b>	Drains within this area are many and all are quite dry and hold only shallow water with shallow moss filled. Could hold more water
<b>38-39</b>	Drain leads from tree line to Ref point 8. At this point drain is functional, holding water
<b>40</b>	Deep drain from tree line to South West (ref point 22) ends at ref point 5 holds some water but drain not full

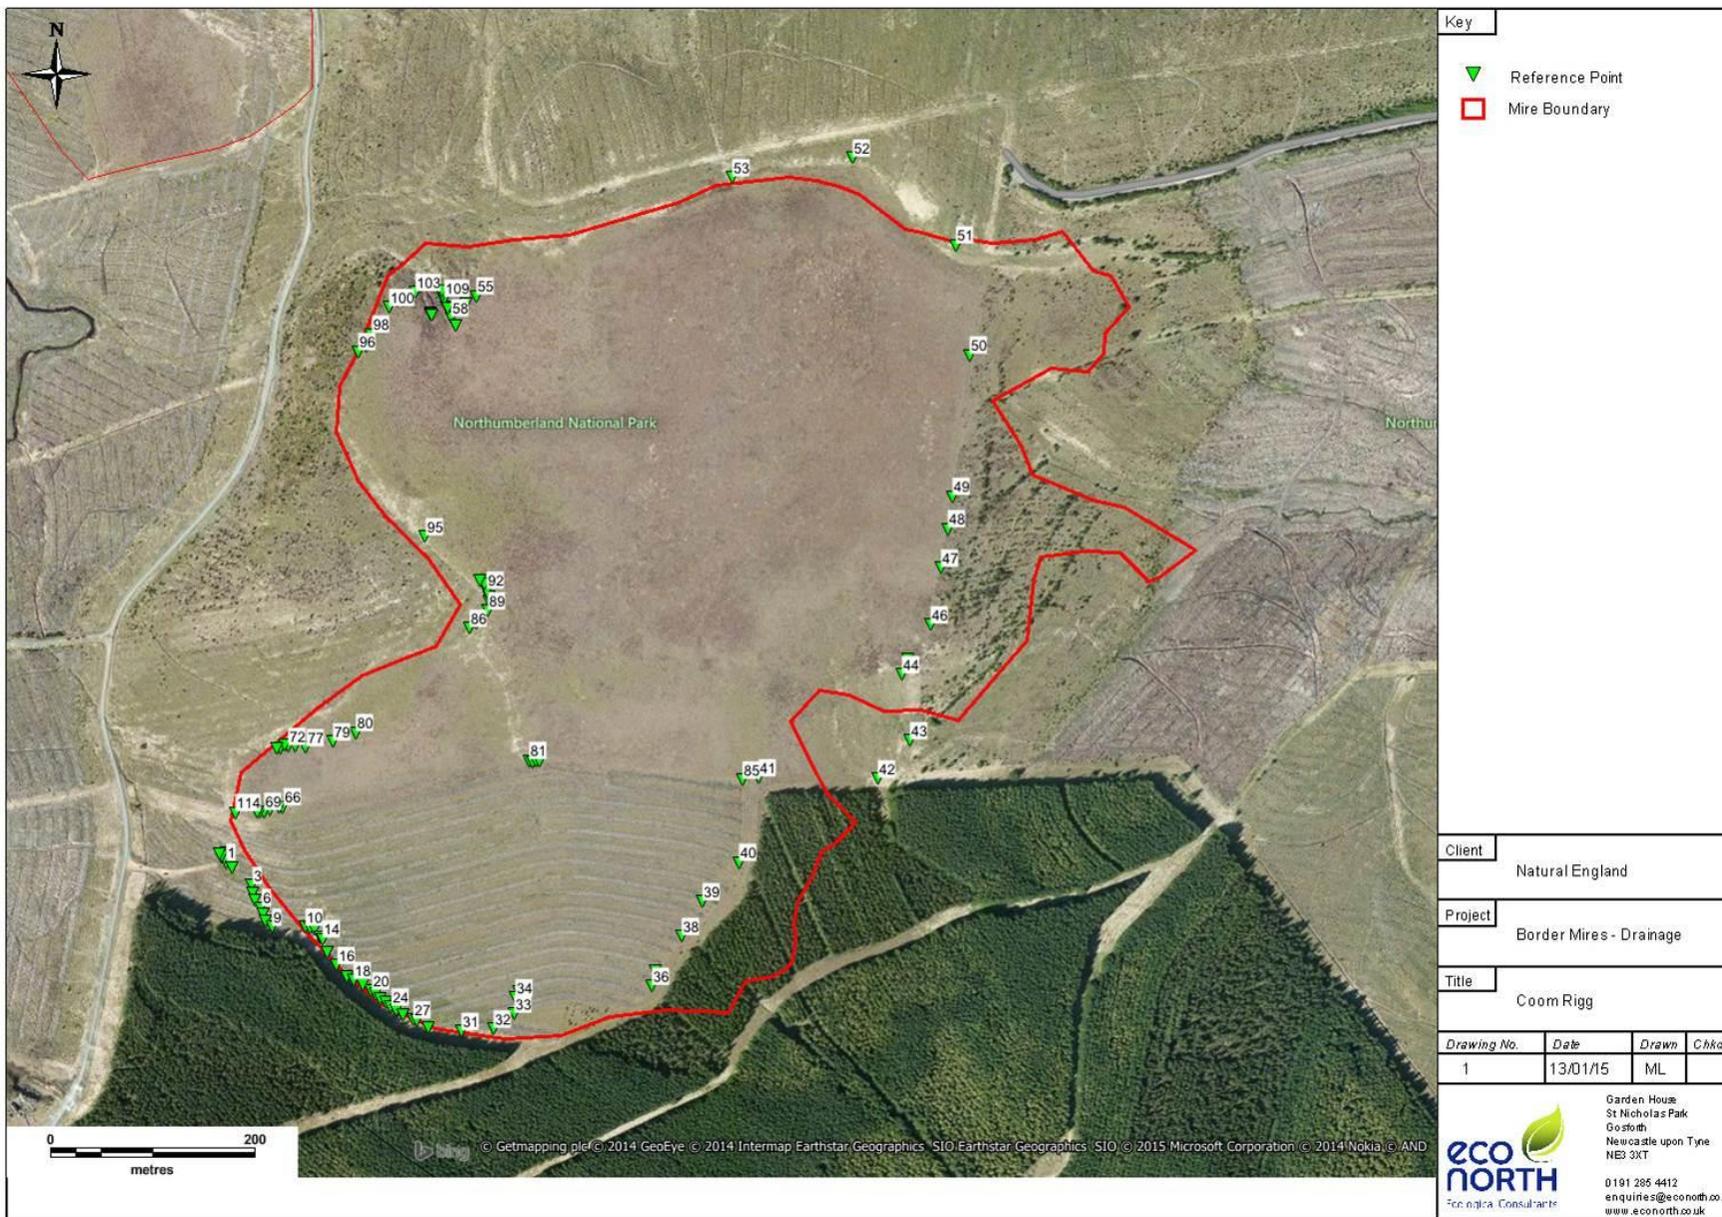
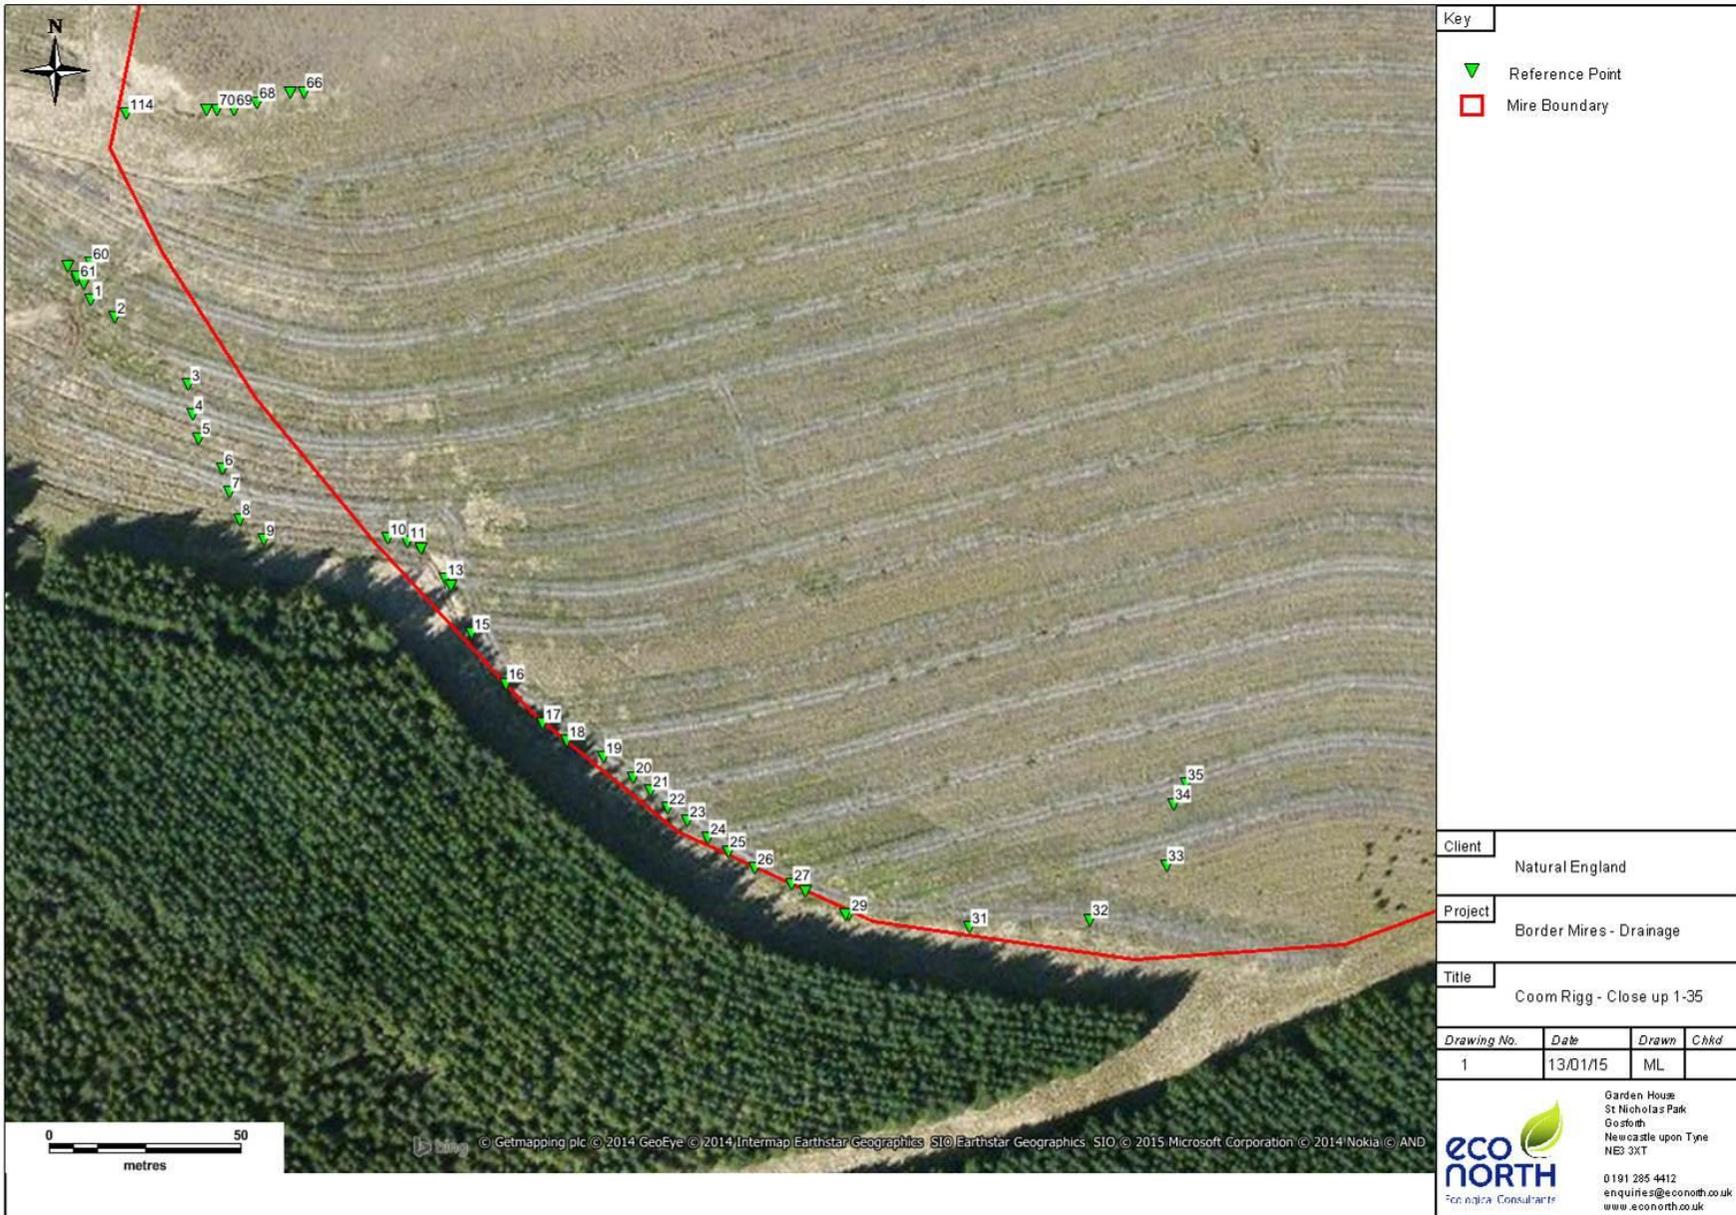
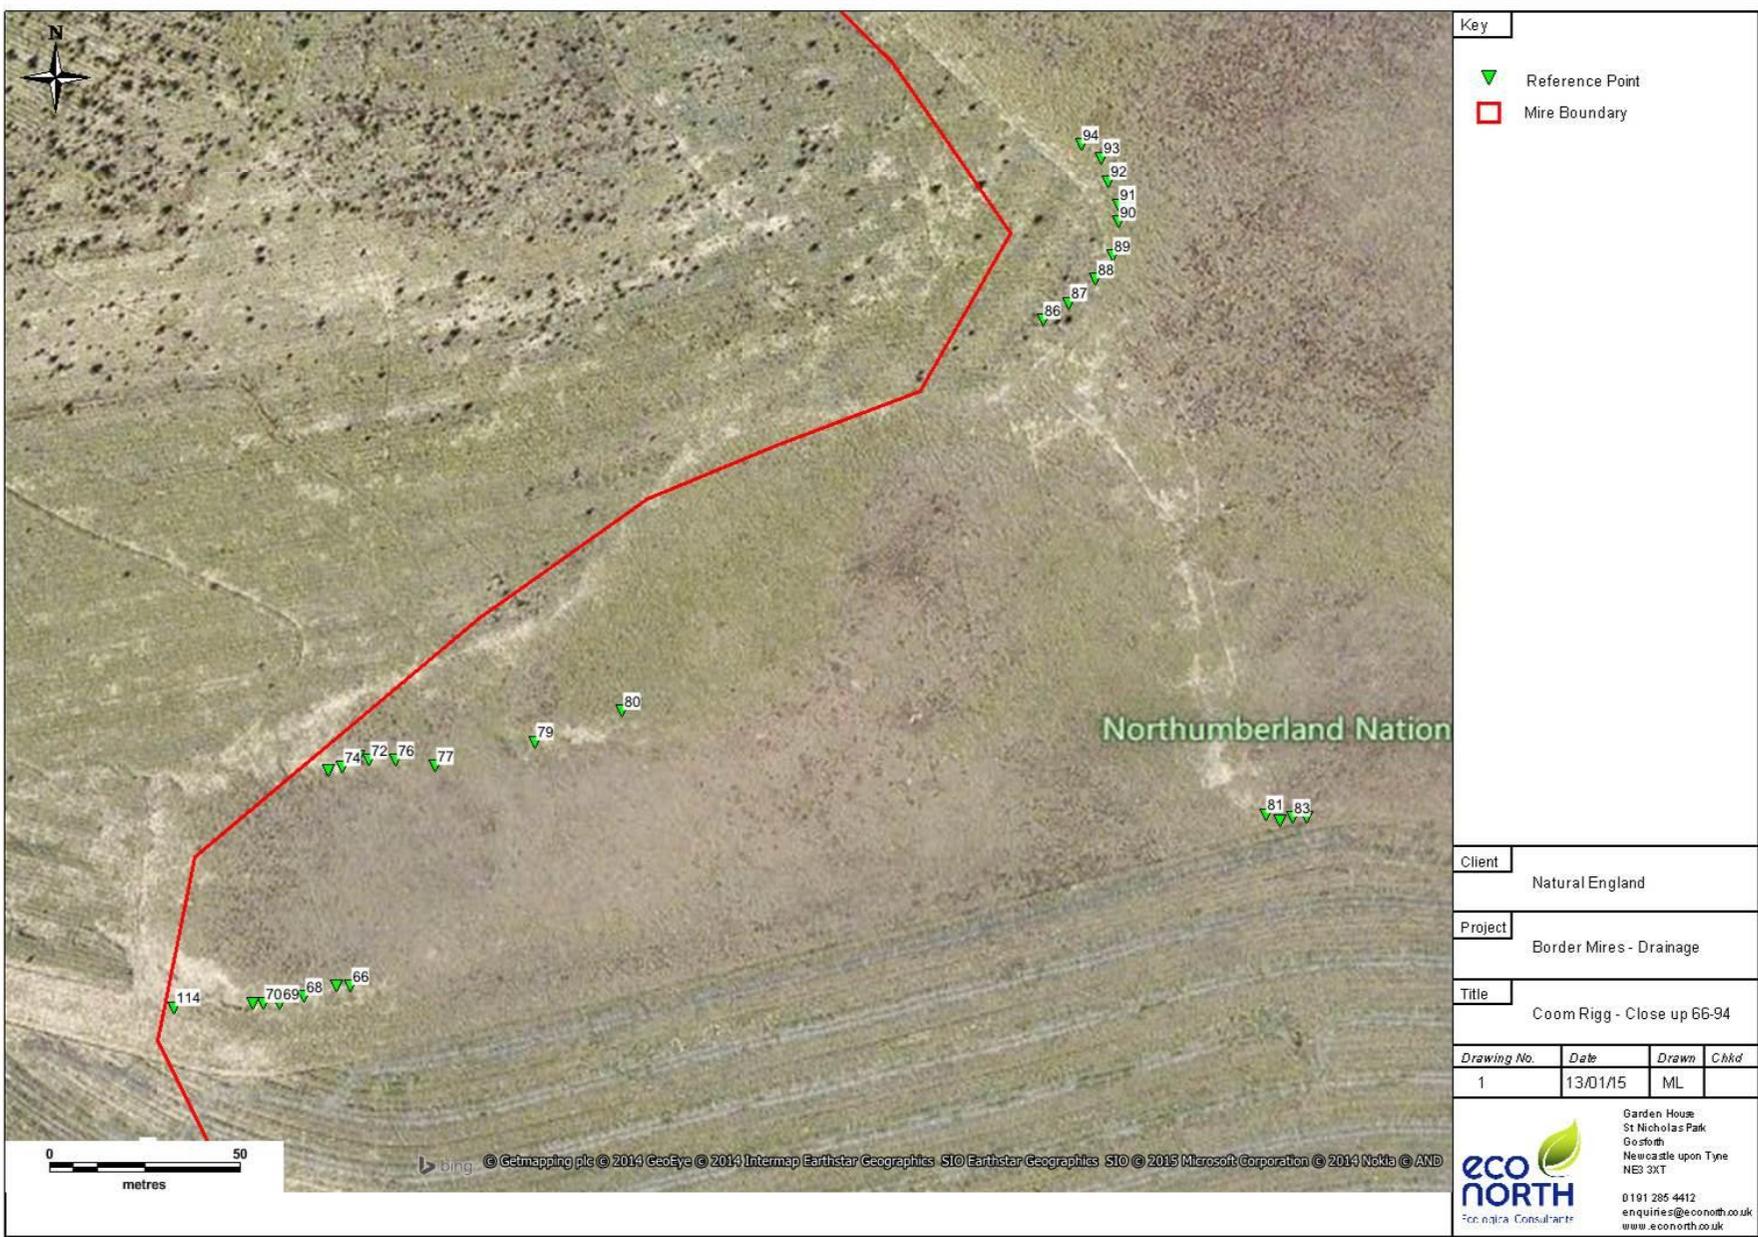
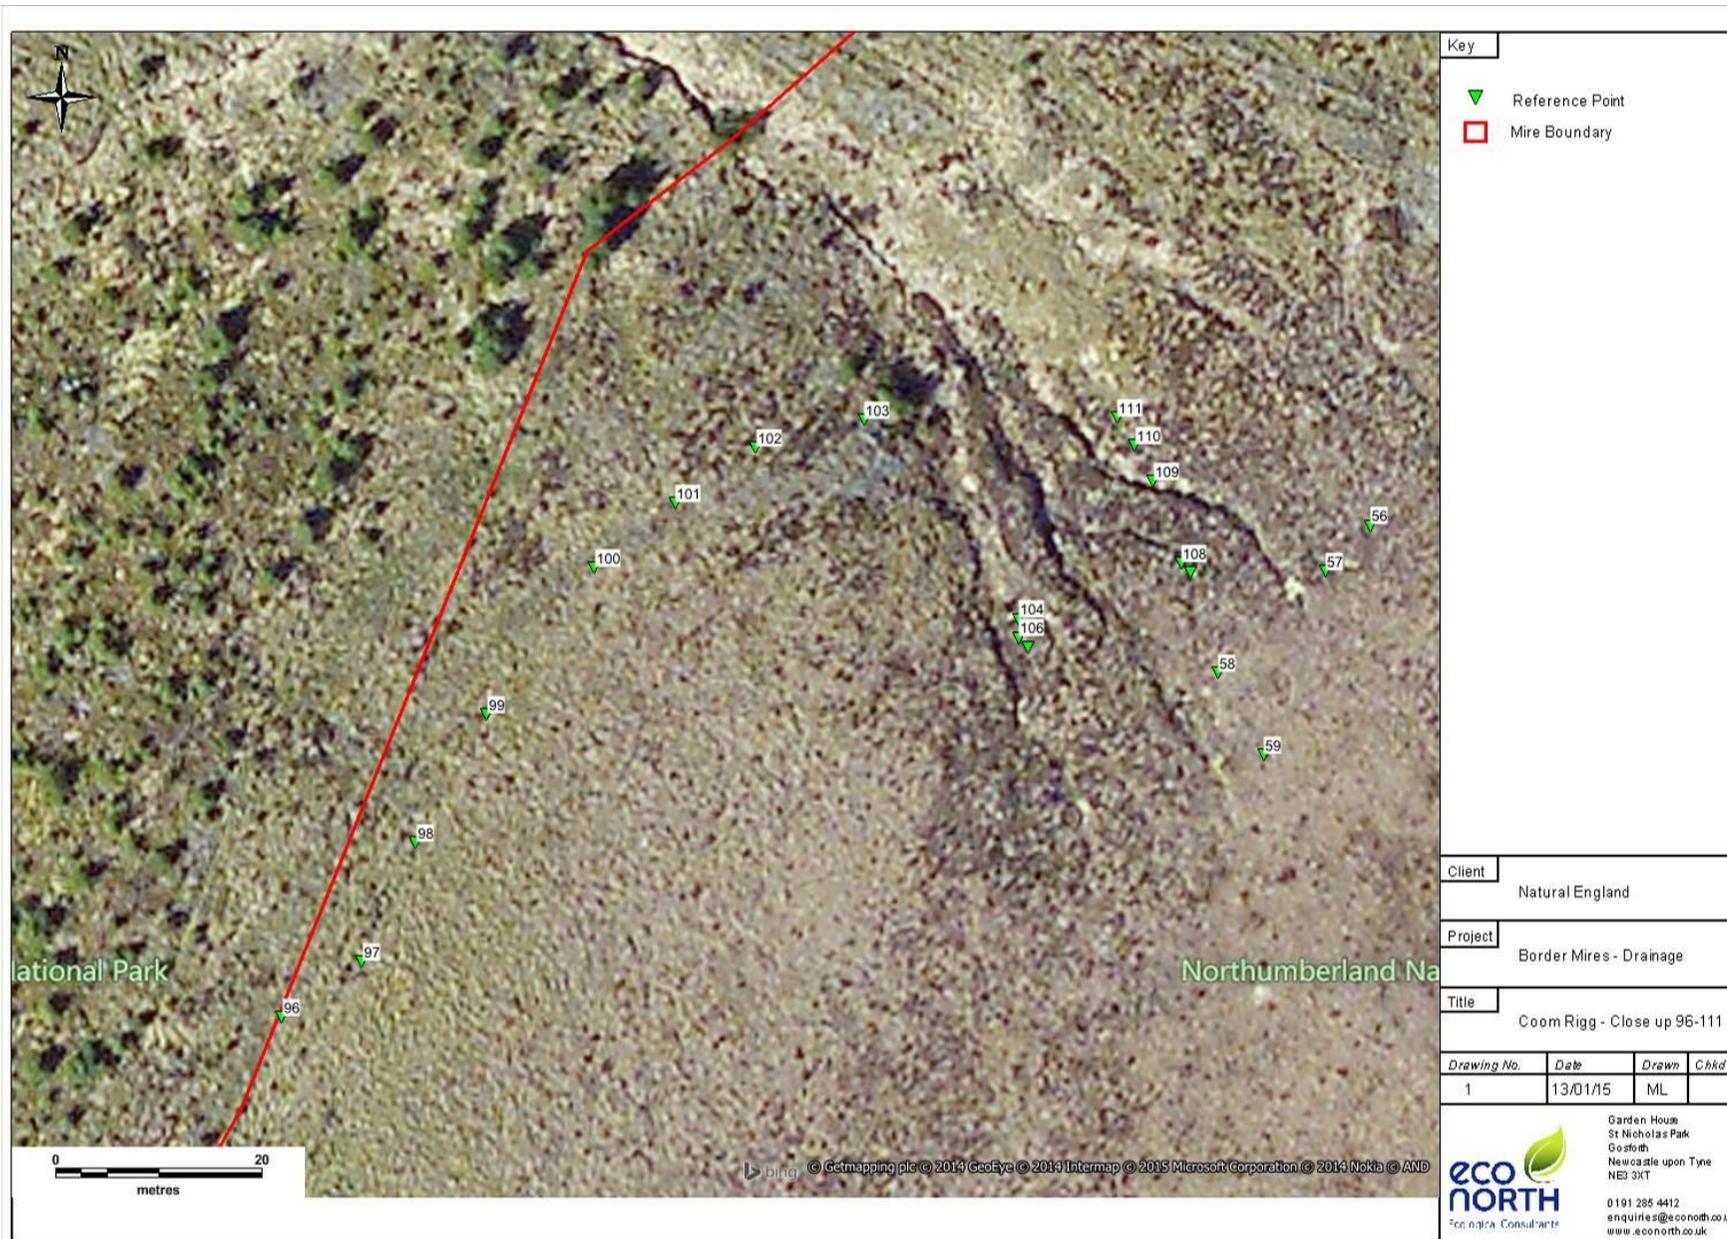
Client	Natural England		
Project	Border Mires - Drainage		
Title	Coom Rigg - Close up 66-94		
Drawing No.	Date	Drawn	Chkd
1	13/01/15	ML

<u>Summary</u>	
<p>Top central section of the mire is in good condition. Most of the active drains are to the south west and north west sections. Most of the water flows west.</p>	
<p>A flush is present on the eastern boundary that appears to hold water well. Water also holding well at the south eastern corner.</p>	
<p>Southern section is in relatively good condition despite it being comprised of track lines from forestry.</p>	
<p>North west section of the site will require dam repairs and extra dams put in place</p>

Ref Point	Notes
1-2	Drain in good condition, holding water well
3	Drain present - not active, holding water
4-6	Active drains
7	Drain in good condition, holding water
8	Main drain along tree line - active flow through for length to point 10 (100m approx.)
9	Drain in good condition, holding water along length (parallel to point 8 drain)
10-14	Drain present - not active until point 15
15-27	Active flow along this drain – perimeter drain
28-31	Drain is ok here but still slightly active
32	Flow increases again on this drain at this point
33	Drain (E/W direction) in good condition, no active flow
34	Drain has little flow here
35-41	Drains in good condition holding water well – perimeter drains on edge of old forestry (N/S and E/W directions)
42	Slightly active drain with flush surrounding
43	North/south drain active at this point
44	Flush leading to mire type habitat (north of this point)
45	Active drain leading to flush (point 44)

46	Perimeter drain appears to hold water well, not active
47	Drain in good condition
48	Failed dam present on same drain (as point 46) here, however, drain still holds water
49	Drain in good condition
50	Active side drain to perimeter drain
51	Perimeter flush active flow to here, could be dammed

<b>Ref Point</b>	<b>Notes</b>
<b>52</b>	Slightly active drain, potential to be dammed
<b>53</b>	Drain present (N/S) - not active
<b>54</b>	Slightly active drain (E/W direction) hidden under point 53 on map
<b>55</b>	Active flush with water entering from surrounding drains
<b>56</b>	Functional dam holding water on drains from north
<b>57</b>	Functional dam holding water on drains from north
<b>58</b>	Failed dam present here
<b>59</b>	Active drain to be dammed
<b>60-61</b>	Very active perimeter drain (south west corner of mire)
<b>62-65</b>	Active drains in this section (south west corner). Moss within drains, 0.2m deep, 0.3m wide, extends down to track to south west
<b>66-71</b>	Natural flow in small ditch - natural sink where fast flowing water runs both over land and under, predominantly underground flow towards track to west.
<b>72-80</b>	Natural flow same as drain ref point 66 - 71, with sphagnum build up. Blocked with moss in places where it holds the water well.

<b>81-84</b>	Effective intact plastic dam – plastic dam that is not damaged is holding water behind with moss in places, some water running past.
<b>85</b>	Very effective old plastic dam – almost entirely covered with moss, very effective
<b>86-103</b>	Small boundary drain – small, some flow but not much clogged with moss. Moss holding water in places
<b>104</b>	Large partially effective dam - water backed up but escapes
<b>105-107</b>	Large dam effective in holding water – moss growing behind, holding water
<b>108-109</b>	Large partially effective dam – water backed up but escapes
<b>110-113</b>	Large drainage system at north of mire – large 2m wide fissures draining water from mire. Water running off but blocked with vegetation in places. Number of large plastic dams in places.
<b>114</b>	Fast flowing ditch from forest drains – lots of running water
