Natural England Commissioned Report NECR141

# New Forest SSSI Ecohydrological Survey Overview

Annex C: Furzey Lodge Mire

First published 06 March 2014

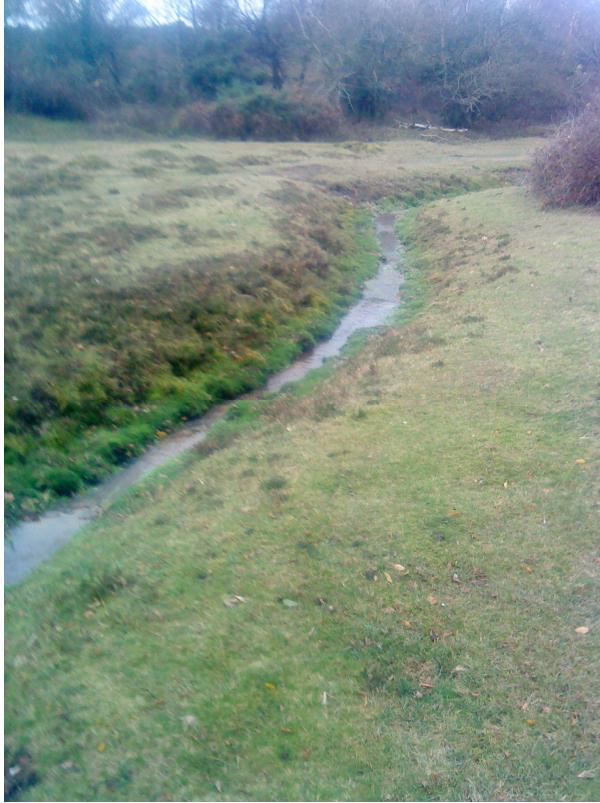
Figure 1-2: Drain at base of eastern valley looking northwards at NGR 436600, 102386

The eastern valley has been subject to artificial drainage with a small drain at its base (Figure 1-2). This has removed any wetlands from the valley except for a small undrained area in its upper reaches.

- Drained Valley - the drain should be infilled or blocked at regular intervals with earth bunds or bunds of other materials;
- Lawn - the lawn area appears to extend beyond the site unit boundary along Worts Gutter. Any restoration of this area should be developed to encompass plans for the whole Worts Gutter floodplain. The drain that enters from the main wetland areas should be infilled or blocked at regular intervals with earth bunds or bunds constructed from other materials;
- Scrub clearance - particularly of the pine that is encroaching into several areas. Control of Gorse - stands should not be allowed to encroach into mire and wetland areas, however, if they become wetter, this will no longer be a problem

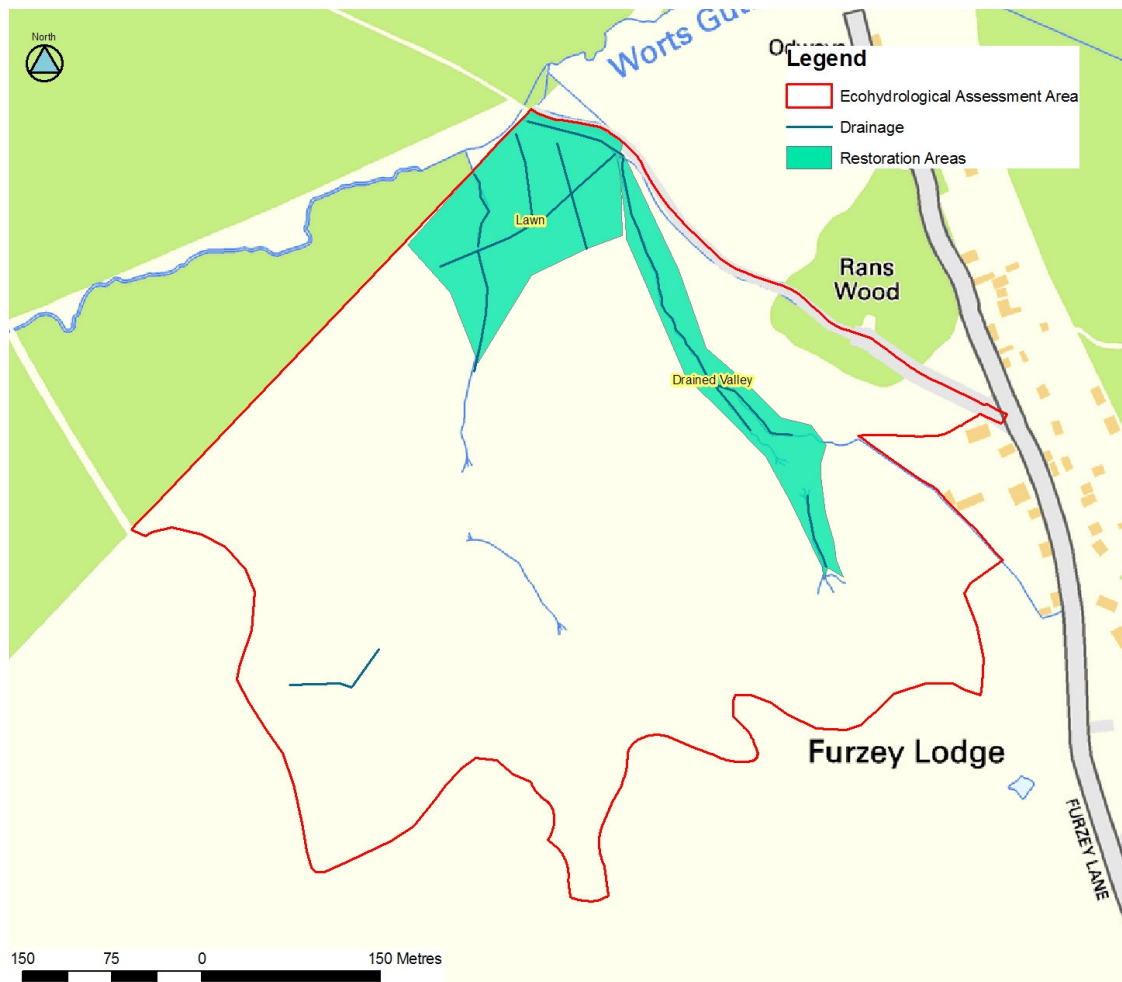
**Figure 1-4: Restoration Areas Map**

There are two areas of significant drain damage (see Figure 1-4):

- Drained Valley - the eastern valley where a valley bottom central drain has removed the wetland. Only mineral soils remain in this area.
- Lawn - lawn creation area in the northern part of the site.

The site is becoming increasingly unfavourable as Pine encroachment and scrub are beginning to dominate in some areas, especially in the north east of the site. The drain at the bottom of the main wetland is compromising the mire habitat (which runs directly alongside it)

and some areas are becoming drier, resulting in wet heath-grassland mosaic habitats forming instead, which are likely to become increasingly drier and scrubbed over without intervention.

Given that the two areas of drainage have almost completely removed the wetland habitats that existed in the past, robust restoration objectives should be developed for the site. For these areas to restore back to their former state will not just require drainage controls but also the build up of peaty soils over a long period of time. If the objectives developed for the site are the restoration of the wetlands, the following is recommended:
