# New Forest SSSI Ecohydrological Survey Overview

## Annex B: Lodge Heath Mire

First published 06 March 2014

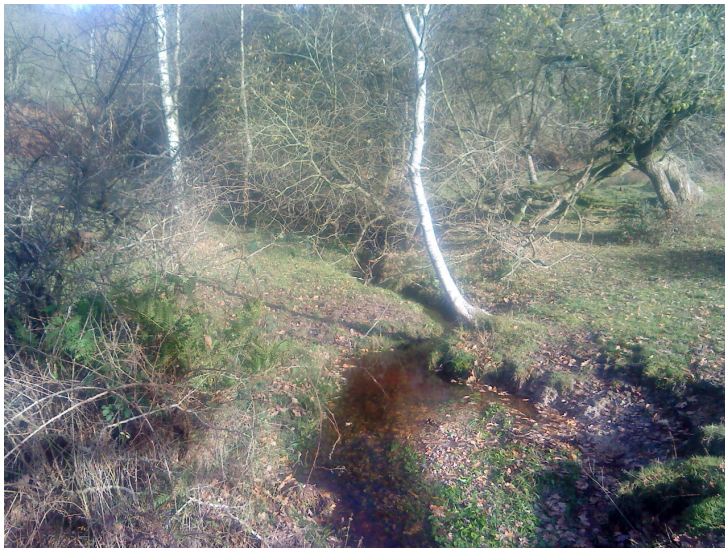
The unit consists of a narrow north-east to south-west trending a valley which is joined by a valley from the east 330m downstream of the road to Lodge Heath. The main valley contains a small stream along most of its length. This appears to have been straightened and deepened artificially along some reaches. There are a small number of valley basin wetlands (two significant ones) in the upper parts of the tributary valleys on both sides of the main stream. The extent of the northern valley basin wetland to the north of the main stream appears to have been reduced and damaged by past drainage works.

**Figure 1-2: Small Drain at Base of Main Valley (NGR 432750, 101832 looking north-east)**

build up of peaty soils over a long period of time. If the objectives developed for the unit are the restoration of the mire habitat then it is recommended that the drain at the base of the main valley be infilled or regularly blocked with earth bunds. If the aim is to ensure that the mire in the upper reaches of the main valley is maintained then the upper part of the drain in this arm of the stream could be blocked.

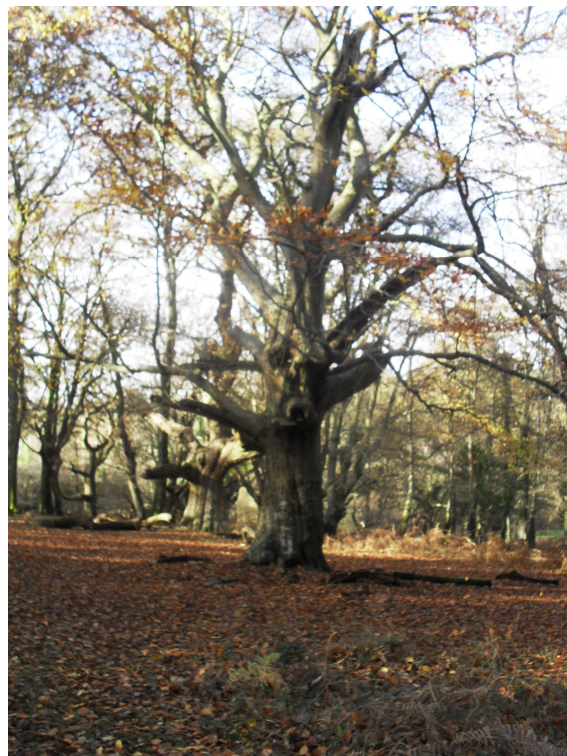
The western side of the unit contains broad-leaved woodland species including Beech *Fagus sylvatica*, Oak *Quercus robur* and Silver Birch *Betula pendula*. This woodland is analagous with W14 Beech woodland but has more Bracken that would be considered typical of the community type. This woodland, however, is notable for the large, ancient, senescent Beech trees present, some of which have been pollarded (Figure 1-3). These are a valuable habitat, especially for saproxilic species, in thier own right and care should be taken to ensure, as they stags-head, that they are not over-topped by taller growing, younger trees. However, there does not appear to be much risk of this at the moment as the current canopy surrounding the veterans is mature and there appears to be very little regeneration going on, limiting the age-class structure of this woodland (Figure 1-3).

**Figure 1-3 Ancient Beech *Fagus sylvatica* Trees now Stag-heading. The Trees to the Rear have been Pollarded. Note the Lack of Regeneration.**

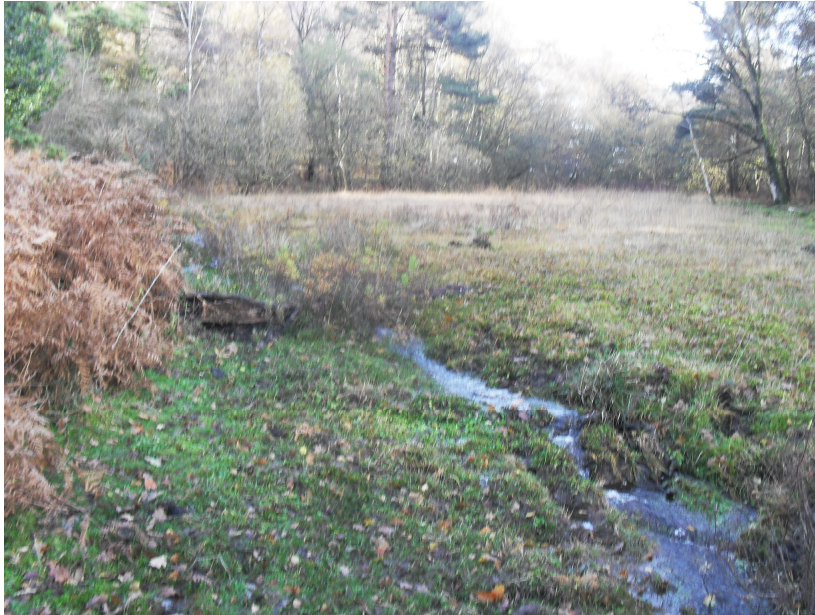
Wet grassland 'lawn' is also present within the main valley bottom, where a drain has been cut through it and this approximates to M23a typically although there are patches which grade into the *Molinia* M25a community and even the M21a valley bog plant community. This is instructive as it implies that the valley bottom here has been drying out and the more natural mire habitats that would have been present, mainly *Molinia* dominated but with some patches of *Sphagnum* dominated valley bog, are on the retreat (Figure 1-4). Grazing by large herbivores, which gain increasing access to these areas as they dry, will have exacerbated this process, leading to the loss of these habitats over time. The incised, straightened drain at the valley bottom is likely to be the cause of this long-term habitat change: change that is still continuing to the present day.

**Figure 1-4 Mire, with affinities to M21a, gradually turning to lawn under the twin influences of drainage and grazing pressure**

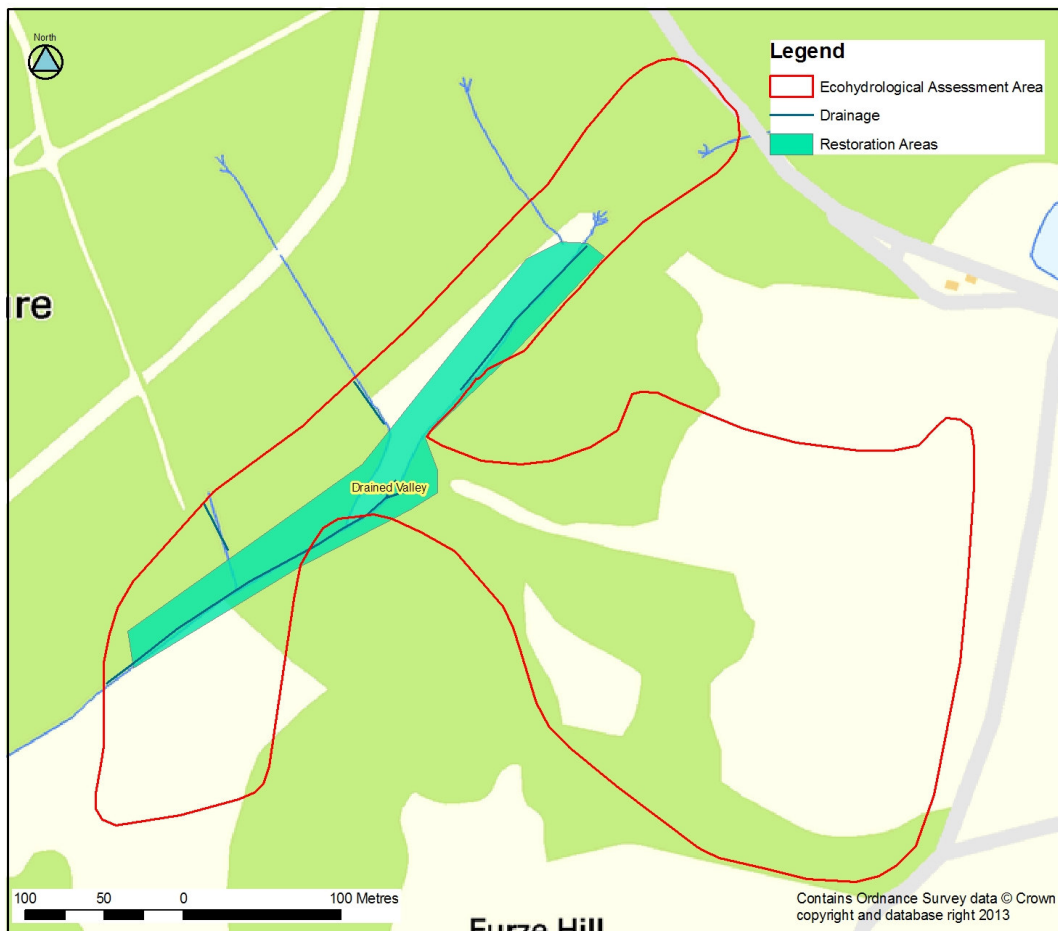
Figure 1-6: Restoration Areas Map

There is one area of significant damage (see Figure 1-6). This is in the main basin where a drain has limited the area of the valley basin mire. In this area the peat soils have degraded over time and the mire replaced with an area of marshy grassland.
