Spurn: Geomorphological Assessment

Humber Estuary SSSI (SAC, SPA, Ramsar)
Spurn Head Geological Conservation Review Site
Spurn National Nature Reserve
Spurn Heritage Coast

Geomorphological Assessment

**Report to Natural England
Dr Mark Lee and Professor John Pethick**

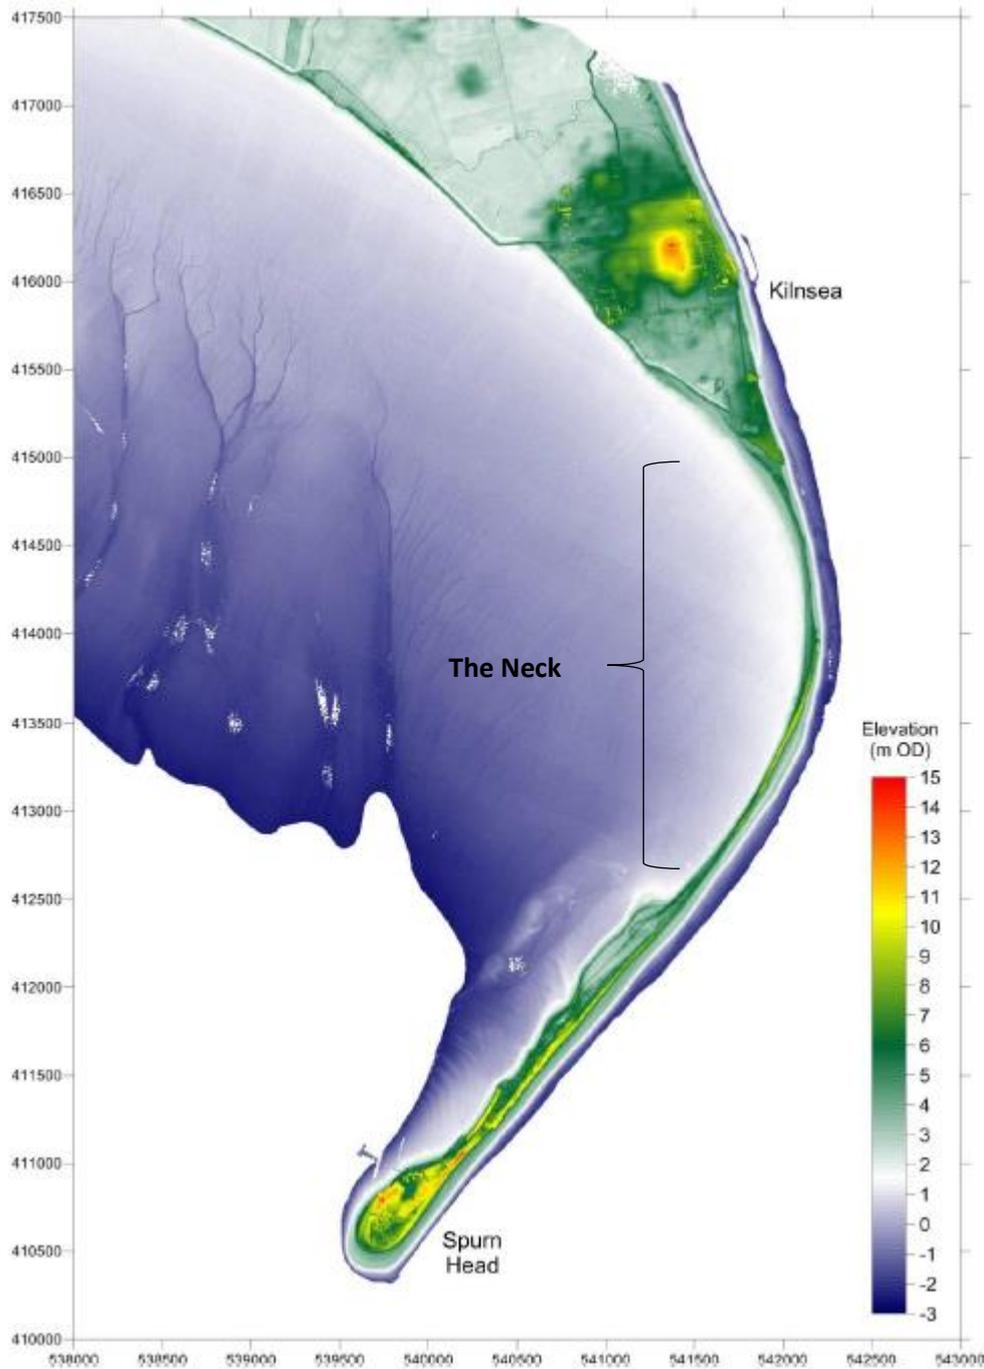
Figure 1 Spurn; elevations based on May 2000 LiDAR (from Pye and Blott, undated)

Spurn is a 5.5km long, curved, sand, gravel and cobble barrier capped with low dunes colonised by sea buckthorn and marram grass, at the mouth of the Humber¹. It comprises a broad, >350m wide, spatulate *Head* which is connected to the mainland at Kilnsea Warren by a narrow, <50m wide, *Neck* (the “narrows”). The crest height varies from around 3m OD at the Neck to over 10m on parts of the Head (Figure 1).

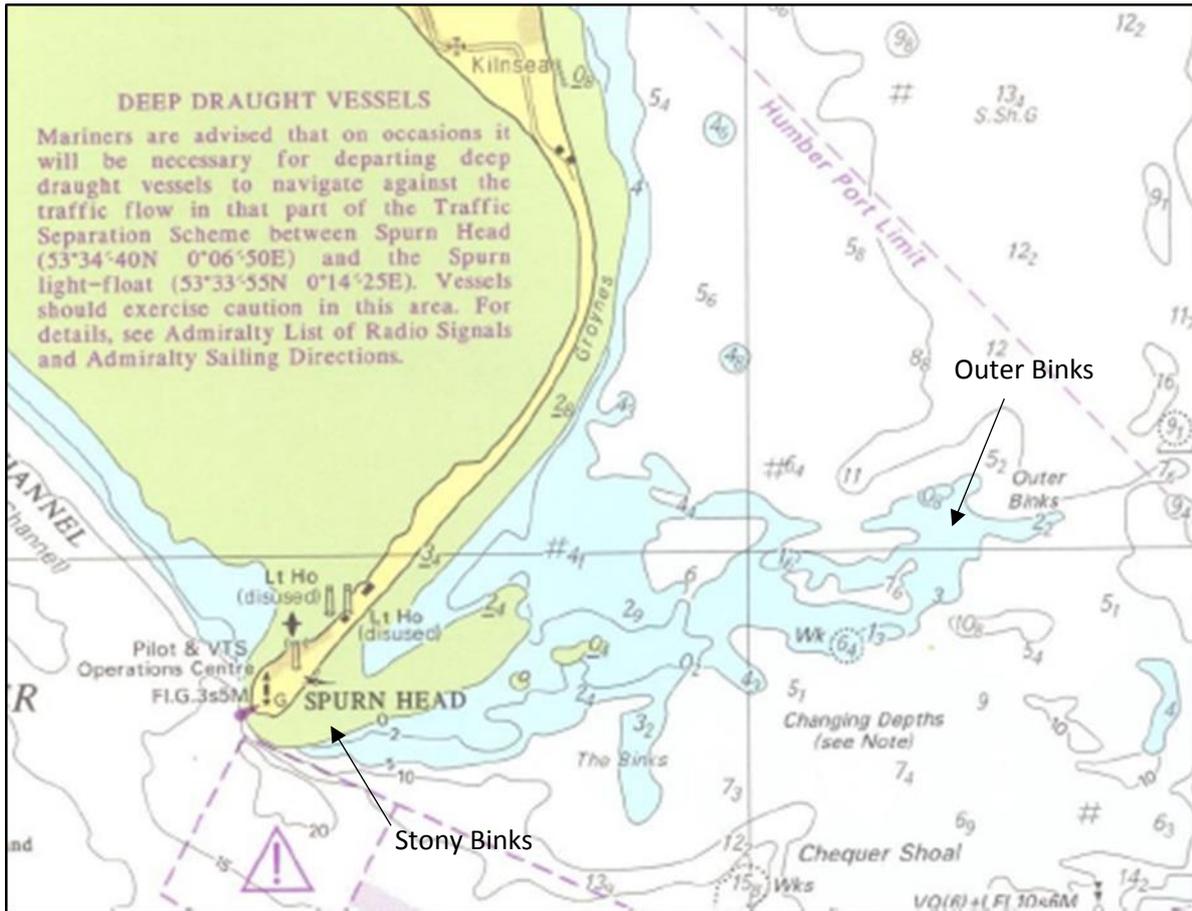
Figure 2 Hydrographic chart of the Spurn area (water depths in metres; chart datum is -3.9m OD; <http://www.ntsif.org/tides/datum>)

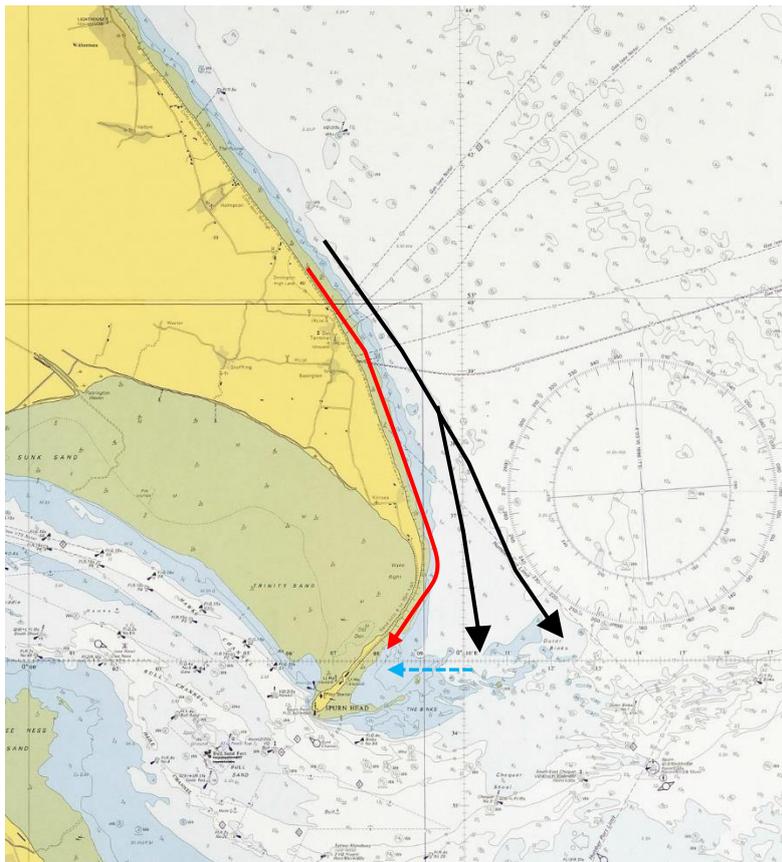
Figure 3 Coarse sediment transport pathways around Spurn: black lines indicate the transport pathway in 5-10m water depth; red line indicates the longshore transport on the beach; blue line is a conjectured onshore route.

Estimates of the transport into Spurn range from 60,000 m³/year (Ciavola, 1997) to only 3% of the Holderness sediment yield (Valentin 1954, p126) i.e. less than the potential transport rate. It is suspected that, as the seabed zone between 5m and 10m water depth widens from around 2km at Easington to around 5km at Spurn, a significant proportion of sediment transport is southwards across this broad seabed platform rather than alongshore towards Spurn. Halcrow/GeoSea (1990) suggest that up to 60% of the sand yield may move offshore around Easington. However, it is possible that there is an onshore sediment pathway across this seabed platform to Spurn (Figure 3).

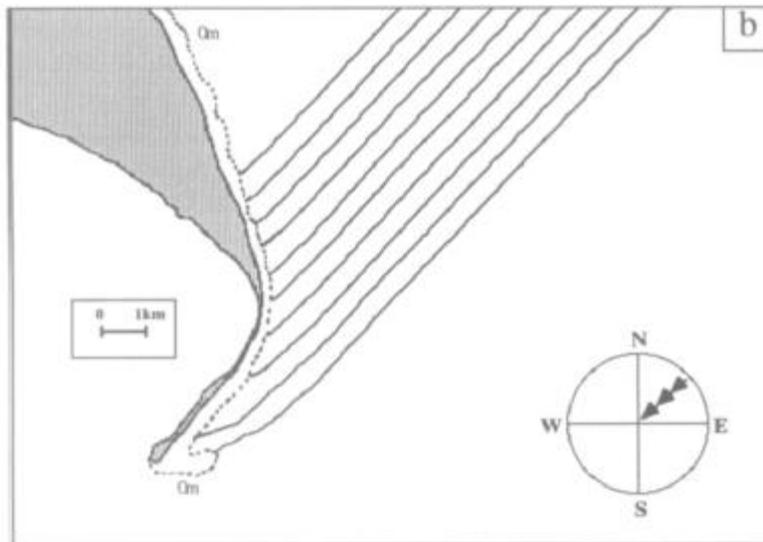
Figure 4 Wave refraction for NE waves (period 4.25s, height 0.85m). Note that there is little change in wave crest orientation for waves arriving at the Neck, but at the tip waves are refracted towards E (from Ciavola 1997)

- the Neck is a net exporter of sediment, hence the low crest, narrow width and vulnerability to breaching/overwashing and the recent retreat since the seawall failed. NE waves arriving at the Neck are not significantly affected by refraction (Figure 4).
- further south, the Head is progressively more sheltered by the Binks and nearshore shallow waters, making it a more stable setting. NE waves refract towards the tip due to the nearshore zone bathymetry, but energy is dissipated because of the shallow water. N'ly waves are refracted away from Spurn (IECS 1992; Ciavola 1997).

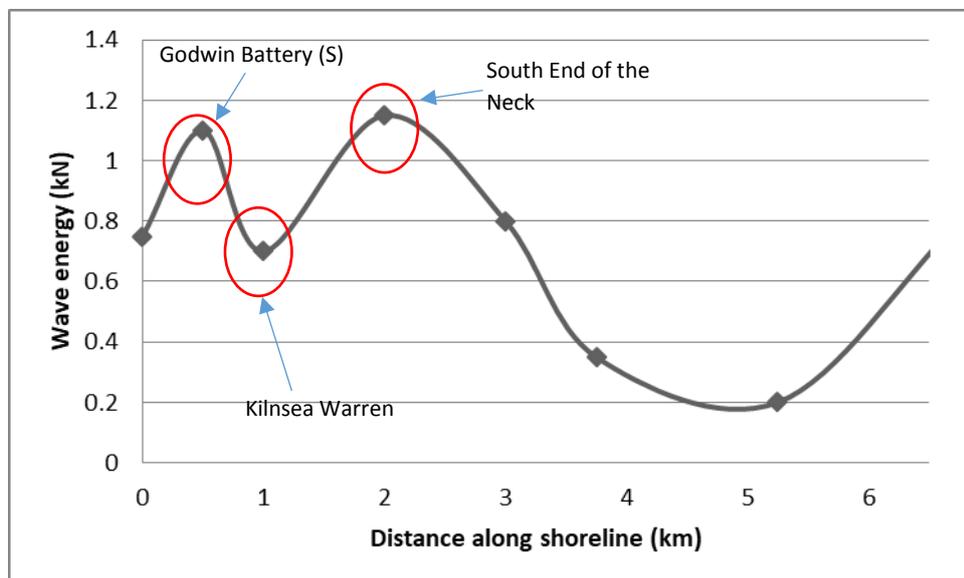
Figure 5 Longshore wave energy gradient along Spurn seaward shoreline (adapted from IECS, 1992). A positive longshore power gradient (i.e. increasing wave energy) indicates shoreline erosion, whereas a negative gradient (i.e. decreasing wave energy) indicates deposition.

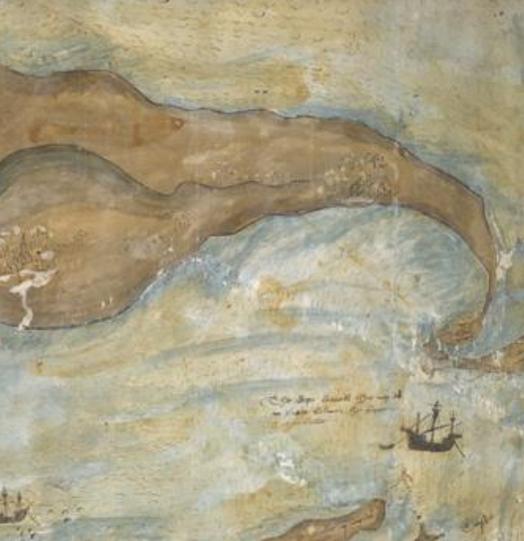
<p>c1540 Chart of the River Humber (British Museum, Cotton MS Aug. I.i.84) Spurn is shown comprising a bulbous head connected to the “mainland” by a narrow curved neck. The distal end of the feature lies to the north of a discontinuous, curved island or shoal (the Stony Binks). The Bull Sand is shown within the mouth of the Humber. The Holderness cliffs are shown not with a continuous, smooth plan-form, but a series of discrete segments with different orientations.</p>

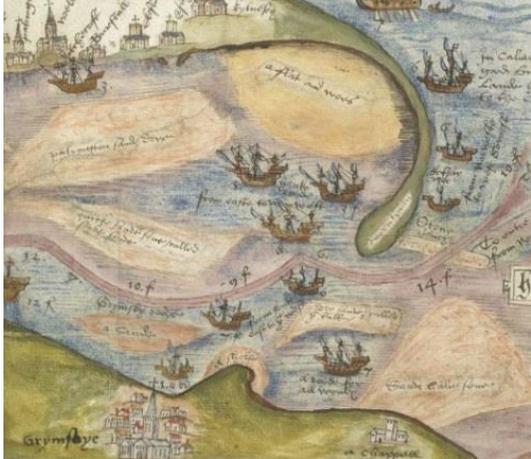
<p>c1560 Chart of the River Humber and Coast to Scarborough (British Museum, Royal MS 18 DIII (62)) The “Cecil map”. Spurn is shown comprising a bulbous head (labelled Ravenspurn) connected to the “mainland” by a narrow curved neck. The distal end of the feature lies adjacent to the Stony Binks. The Holderness cliffs are shown with a continuous, smooth plan-form.</p>

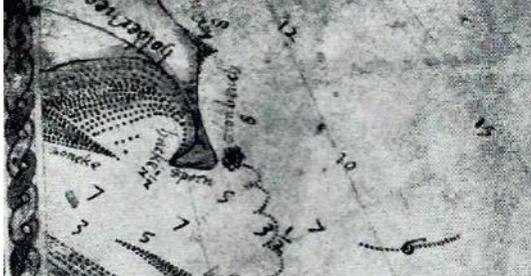
<p>c1584 Chart of the Thames Estuary and East Anglia Coast by Richard Polter (British Museum, Cotton MR Aug I.i.44) The bulbous Spurn head and the narrow neck are shown, along with the Stony Binks (adjacent to the head). A marked headland is shown on the cliffline, possibly around Kilnsea (?).</p>

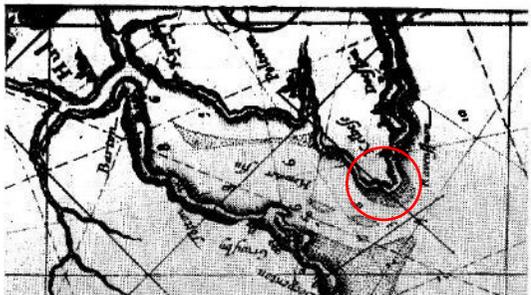
<p>1608 from Blaeu, “Het Licht der Zeevaert” (Dutch chart) A “clumsy and shapeless” representation of Spurn (de Boer, 1969)</p>

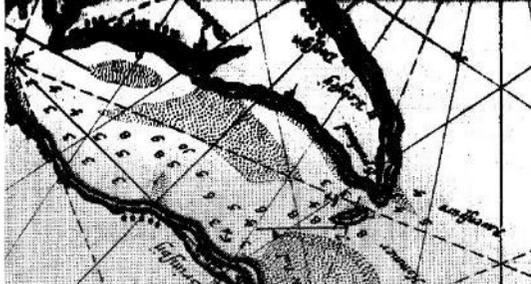
<p>1623 from Blaeu, "Zeespiegel" (Dutch chart)</p> <p>A gap is shown between the "mainland" and what appears to be either the bulbous head of Spurn (evidence for a breach?) or a shoal (the Den?)</p> <p>However, the "mainland" is labelled Spurnhead at its southern end.</p> <p>It is possible that the "island" is an exposed shoal in the mouth of the Humber (the Den?)</p>

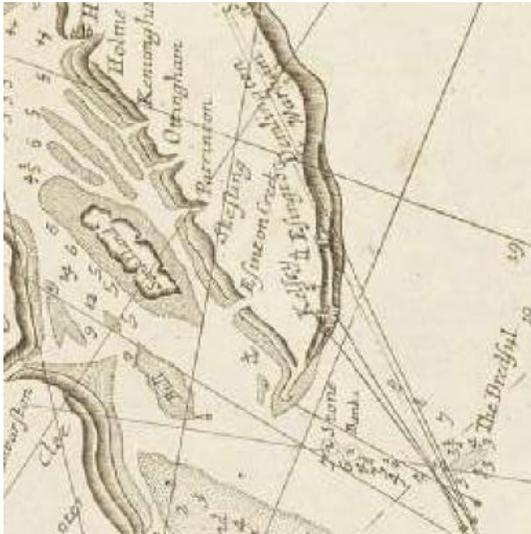
<p>This is a historical sea chart showing the east coast of England. It features the mouth of the Humber river, with labels for 'Holtme', 'Kentonpham', 'Ovingham', 'Pierpointon', 'The Den', 'The Dreadful', and 'The Binks'. The map uses a grid system and shows various geographical features and navigational points.</p>	<p>1682? Sea chart of the east coast of England, with the mouth of the Humber, Jan Luyken, Johannes van Keulen</p> <p>Spurn is shown as a promontory extending S from the mainland. The Stoney Binks and the Dreadful are shown as shoals extending E from the tip of Spurn. The Den is shown as an exposed island/shoal W of Spurn.</p>

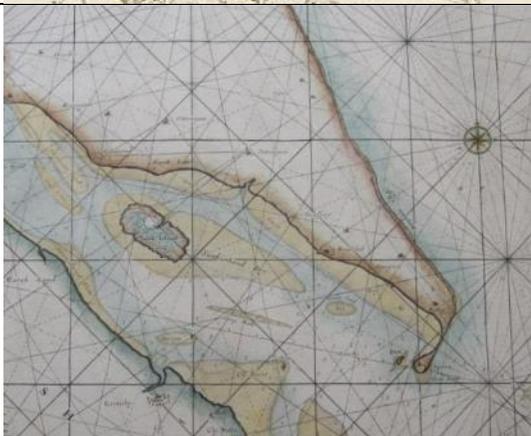
<p>This is a detailed chart of the River Humber. It shows the river's course and its connection to the sea at Spurn. Labels include 'The Den', 'The Binks', and 'Angell's Lights'. The chart uses a grid system and shows various geographical features and navigational points.</p>	<p>1684 Greenville Collins Chart of the River Humber</p> <p>Spurn is shown as a bulbous head connected to the "mainland" by a narrow, straight neck. The Den is shown as an exposed island/shoal W of Spurn. The Binks are shown as shoals S and SE of the tip of Spurn. The chart shows Angell's Lights at Spurn.</p>

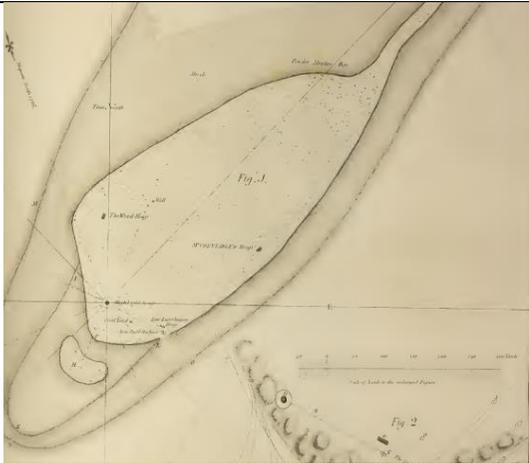
<p>1786 Smeaton's map from "Appendix to A Narrative of the Building of Edystone Lighthouse"</p> <p>Spurn is shown as a bulbous head connected to the "mainland" by a narrow neck. A small shoal or island is shown immediately south of the distal end. What appears to be a curved bank of shoals to the SE of the bulbous head is an inset map of changes to the tip between 1766 and 1786 (over 300 yards of shoreline advance).</p>

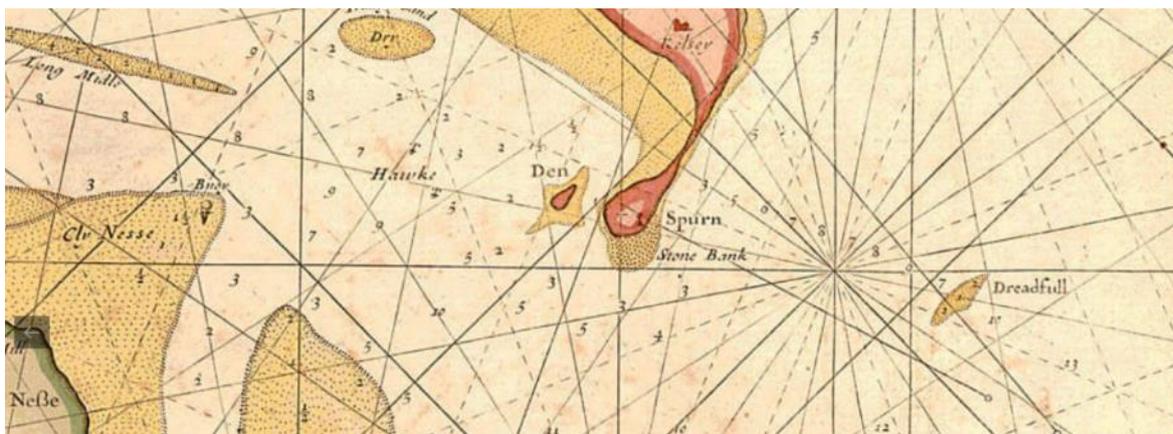
Figure 7 Section of Greenville Collin’s 1684 Chart of the River Humber (note that the Chart Datum is not stated, depths are in fathoms)

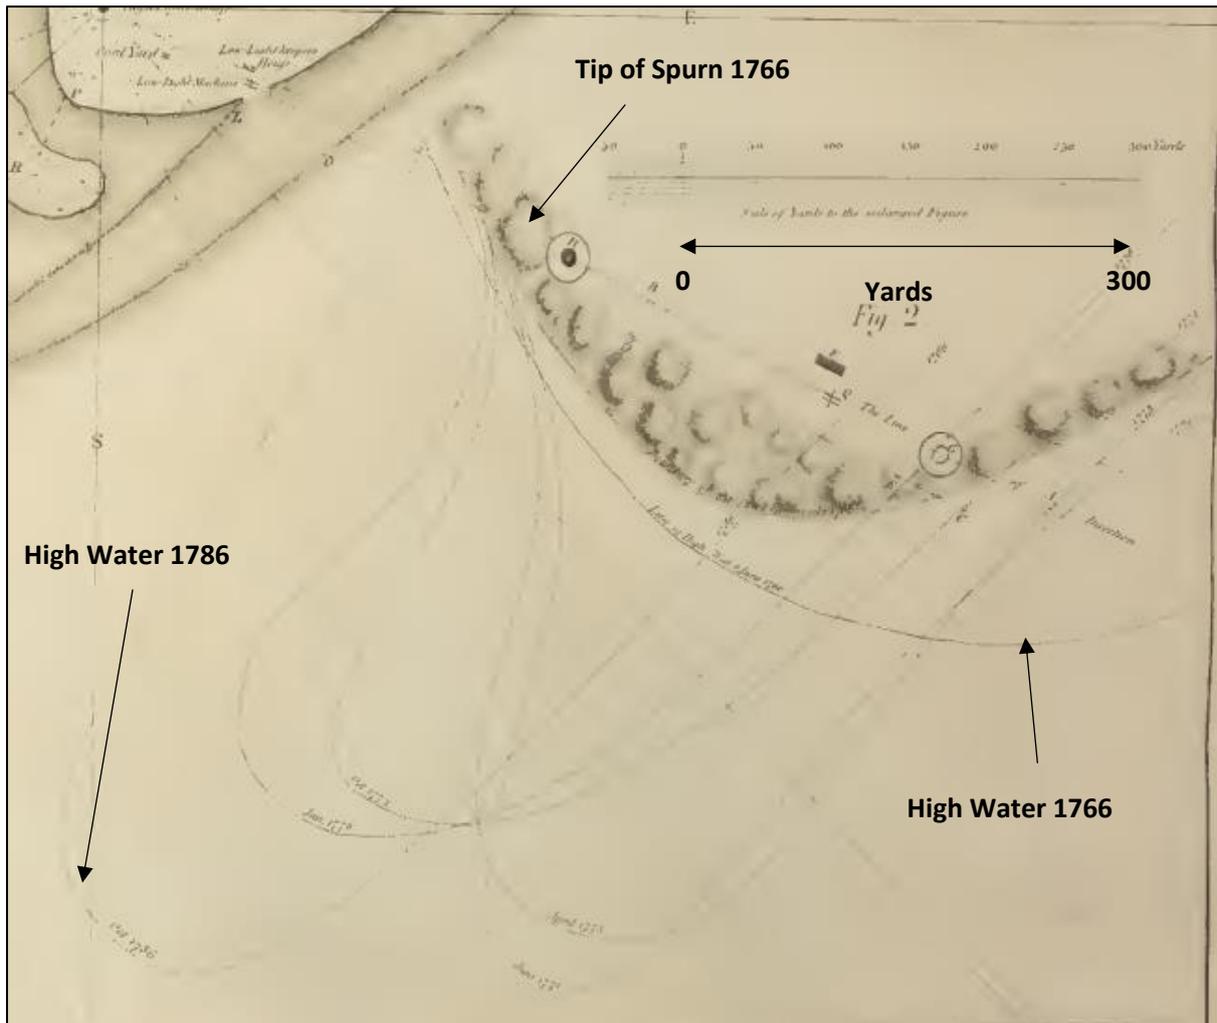
Figure 8 Changes in the tip of Spurn between 1766 and 1786 (from Smeaton 1791, with additional labels)

Angell’s lighthouses were replaced by Smeaton’s high and low lighthouses, built between 1771 and 1776. The site on which the high lighthouse was constructed was 80 yards (73m) further inland from a site chosen in 1766 (indicating the rate of shoreline erosion of Spurn at this time), and 1840 yards (1680m) to the south-west of Angell’s lighthouses (de Boer 1968 p54; Figure 8).

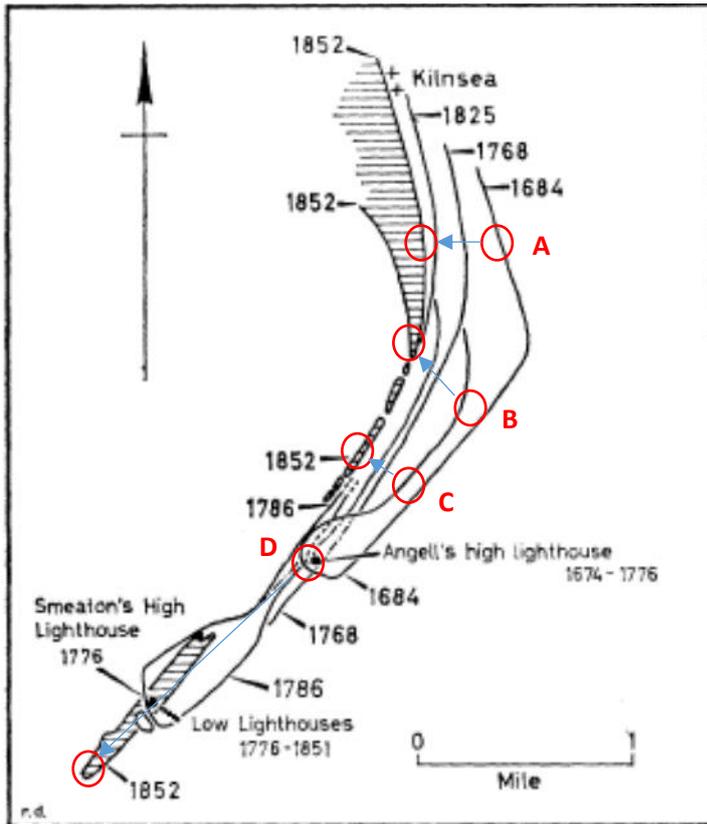
Figure 9 Spurn Point 1684-1852 (de Boer 1964). The outlines were based on Collin's chart of 1684, a Plan of Spurn from a 1768 survey (possibly for Smeaton), Smeaton's map of 1786 and the 1852 OS 6" to 1 mile map.

Over the same time period, there was significant erosion of the eastern shoreline, as indicated by the changes observed at the lighthouses (Figures 9 and 10):

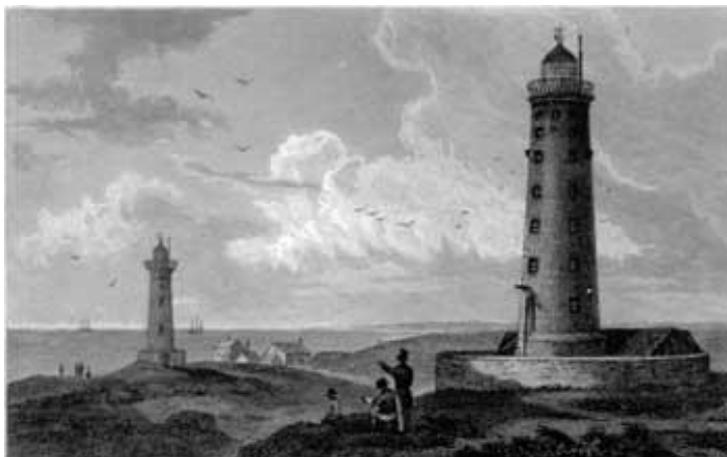
Figure 10 Smeaton's high lighthouse in 1829 (foreground) and one of the low lighthouses built in 1816

- in 1776 the original site for Smeaton's high lighthouse was swept away by a storm (Smeaton 1791, p188).
- by 1863 the shoreline had retreated to Smeaton's high lighthouse, a distance of 280 yards (256m; Shelford 1869, p481) in the 92 years since 1771 (2.8m/year, on average).

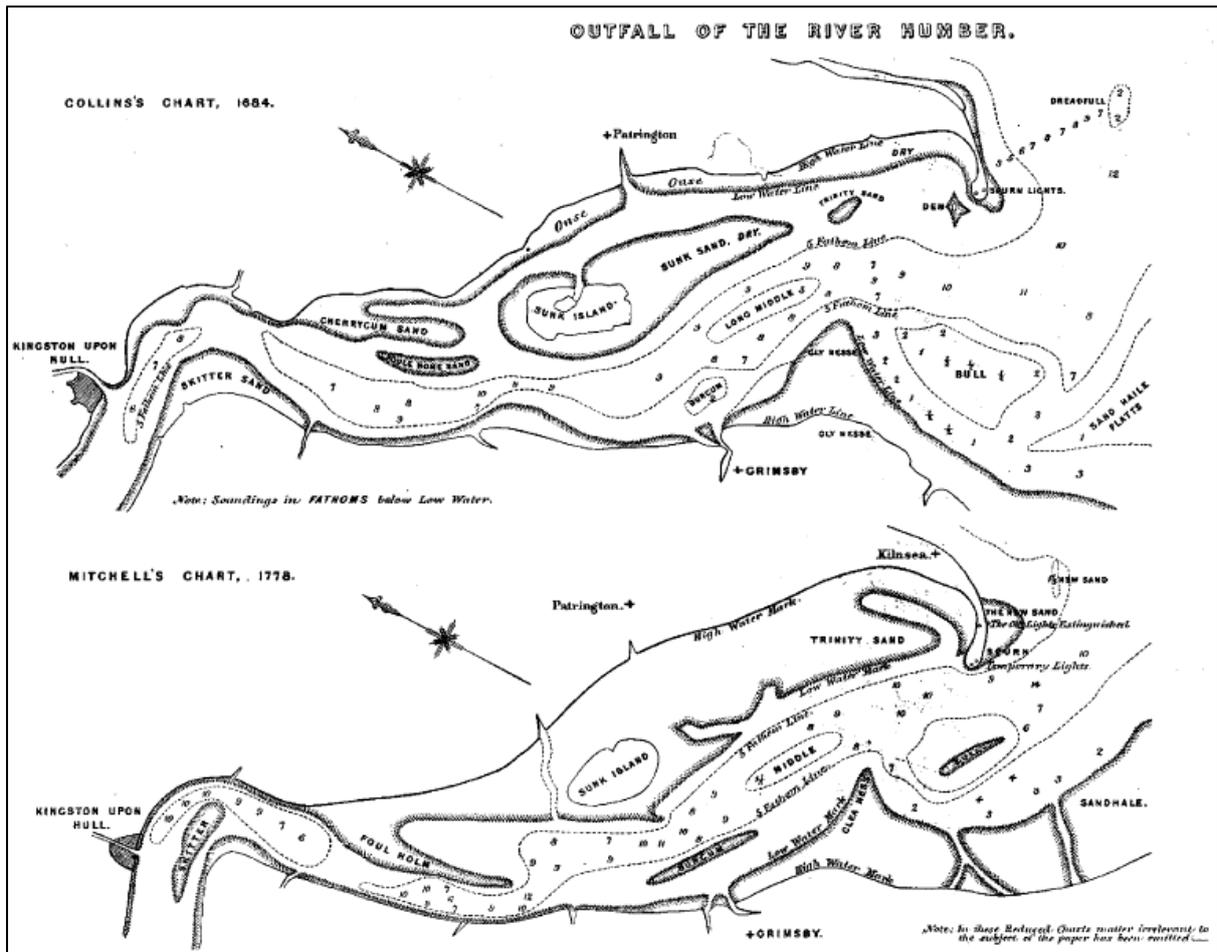
Figure 11 The impact of land reclamation at Sunk Island on the North Channel, between 1684 (top) and 1778 (bottom chart).

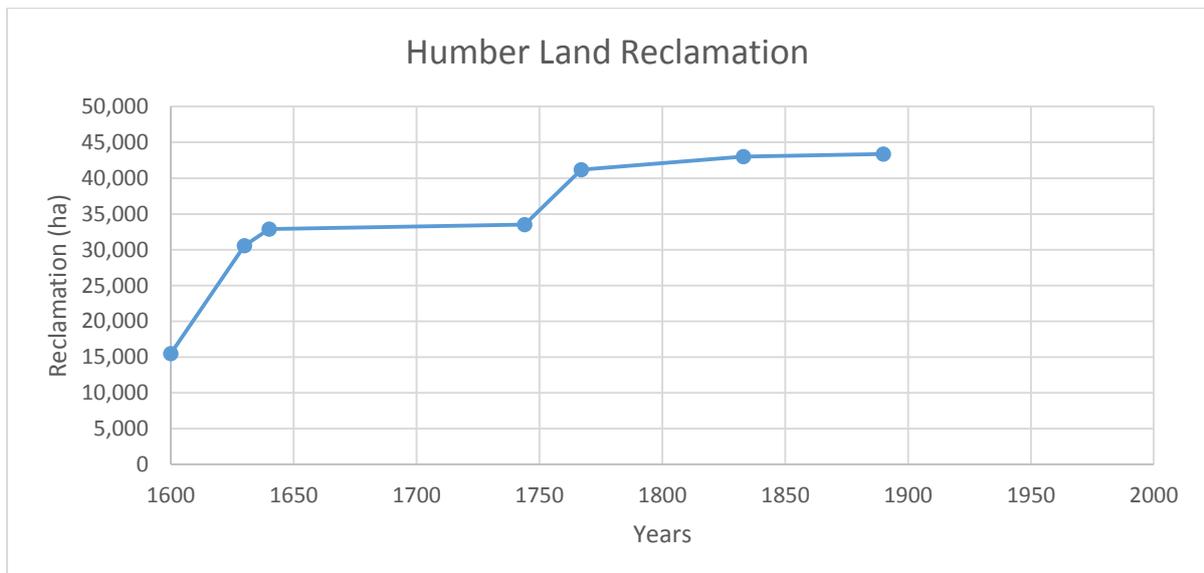
Figure 12 The post 1600 cumulative history of land reclamation in the Humber (the value at 1600 is for the Hull valley, believed to have been reclaimed earlier in the Millennium).

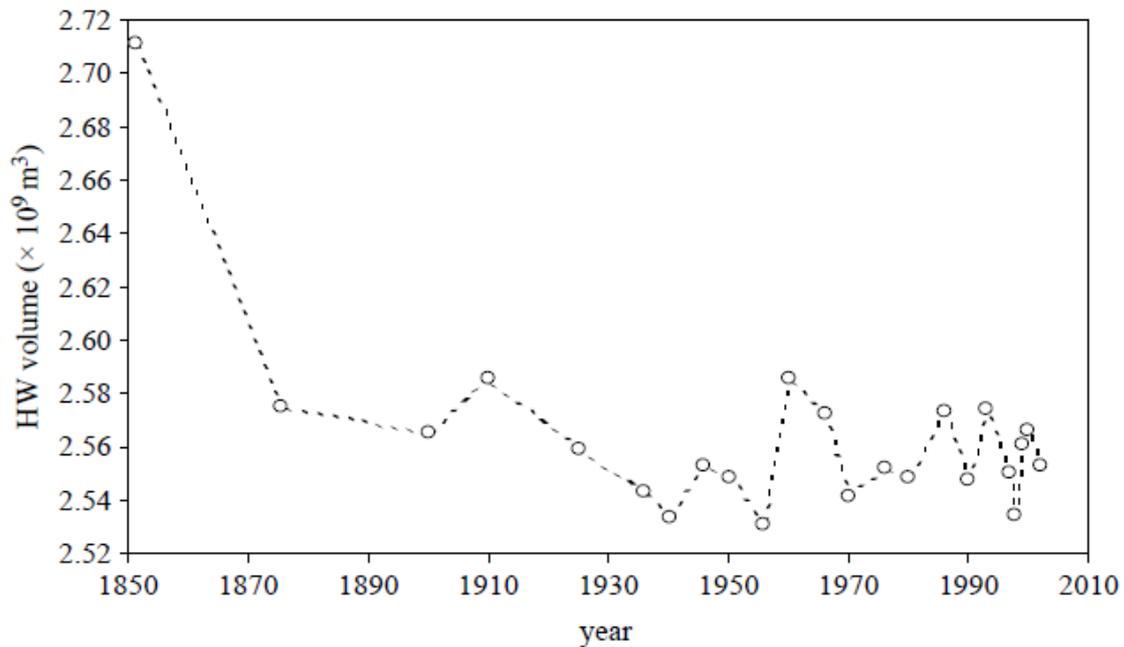
Figure 13 Historic changes in total estuary volume since 1850 (from Townend et al 2007)

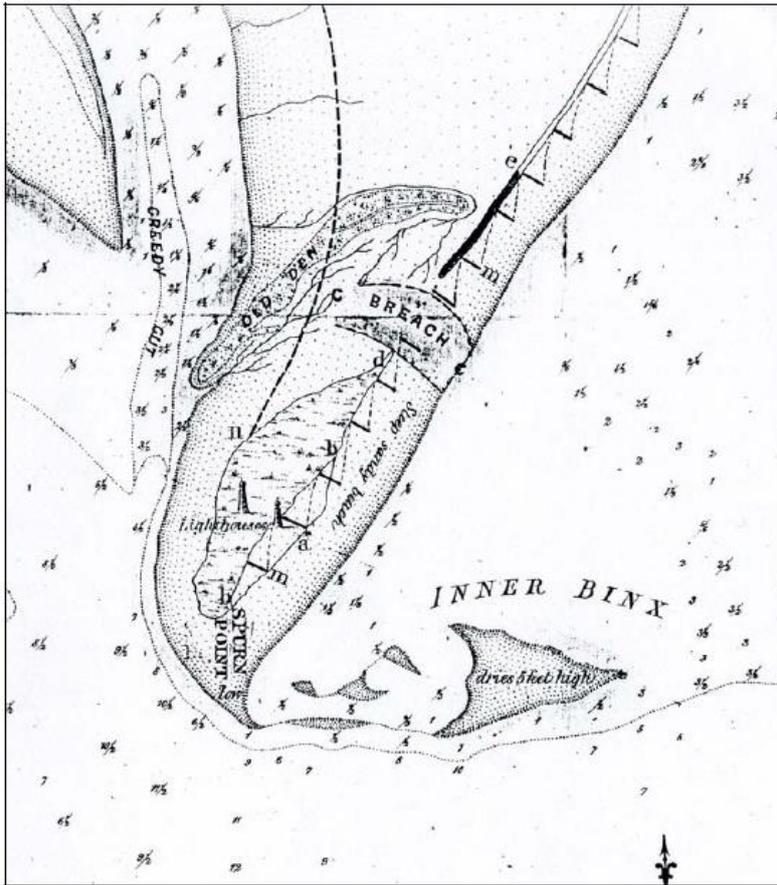
Figure 14 Map of Spurn Point in 1850 showing location of main breach; (Vetch, 1850)

On 28 December 1849, Spurn was breached during the course of a NNW gale which occurred at the time of an exceptionally high tide (Vetch 1850; Figure 14). The breach occurred close to the Old Den, around half and three-quarters of a mile north of Smeaton's high lighthouse, in the area worked for cobbles. Mathison (2008) has suggested that horse and cart traffic to remove the material would also have damaged the dunes.

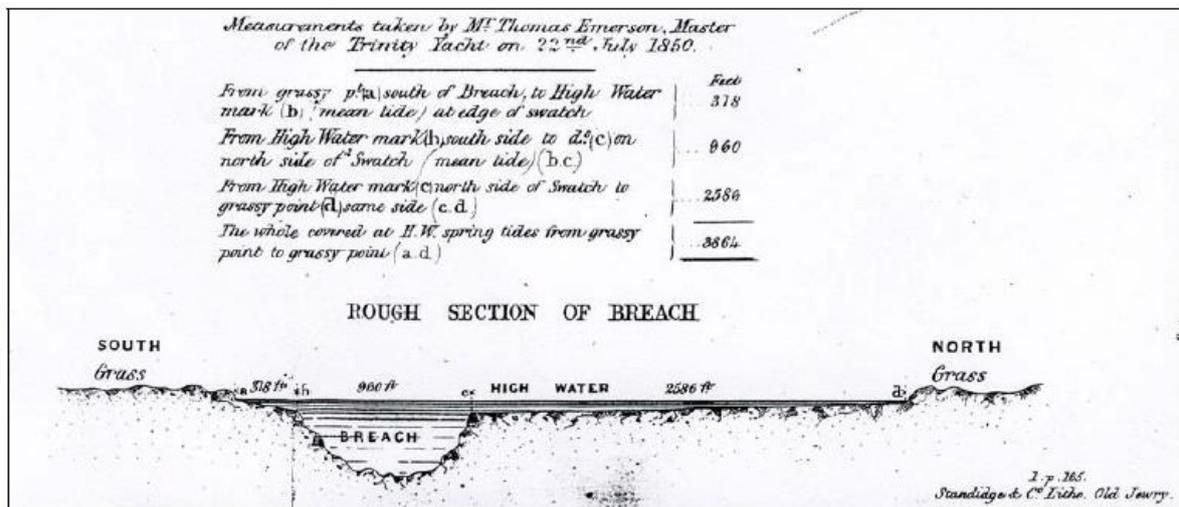
Figure 15 Section across 1849/50 breach (Vetch 1850)

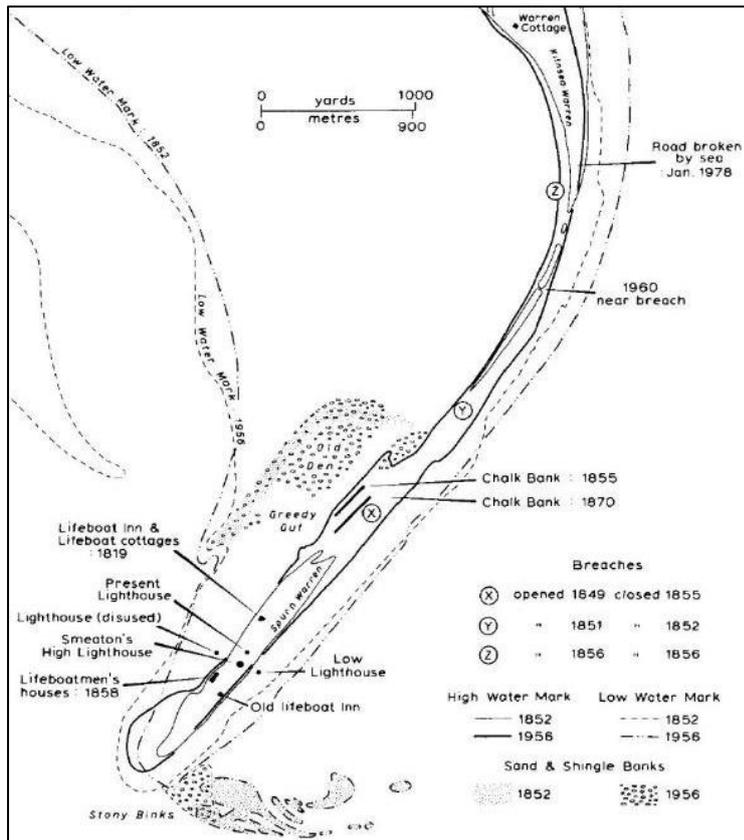
Figure 16 Location of the Chalk Banks and breach events (de Boer 1981)

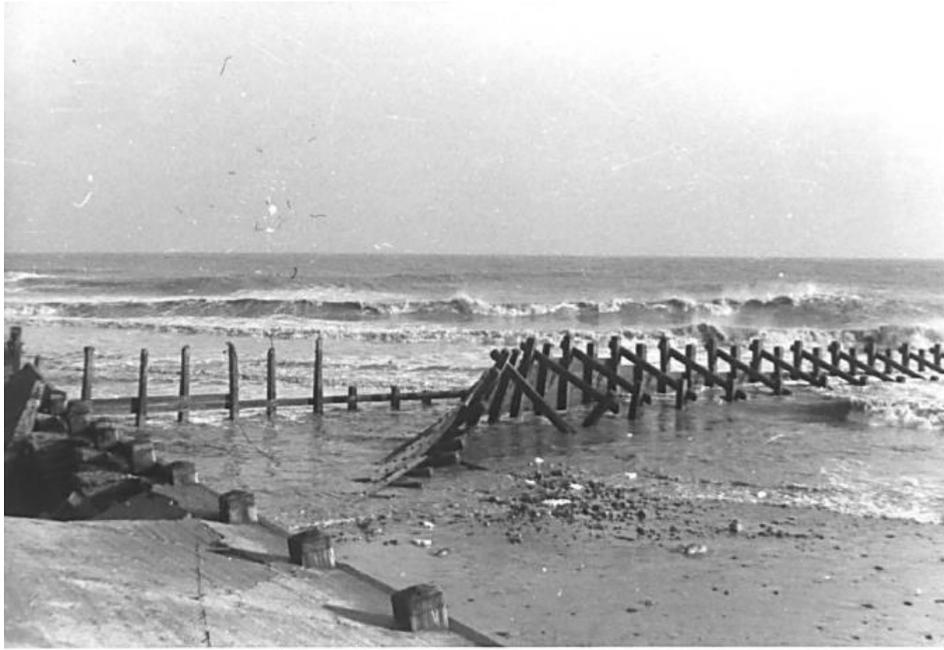
Figure 17 January 1960: Broken groyne and collapsed revetment along the Neck (from Phillips 1962)

"Along the whole length of the seaward side of Spurn Head groynes have been built In addition concrete revetments were built along the east side of High Bents (i.e. the Neck), near the lighthouse, and at Kilnsea. Except for a new section at the narrowest part of High Bents, built in 1958, most of the revetments were in poor condition in 1959." Phillips 1962

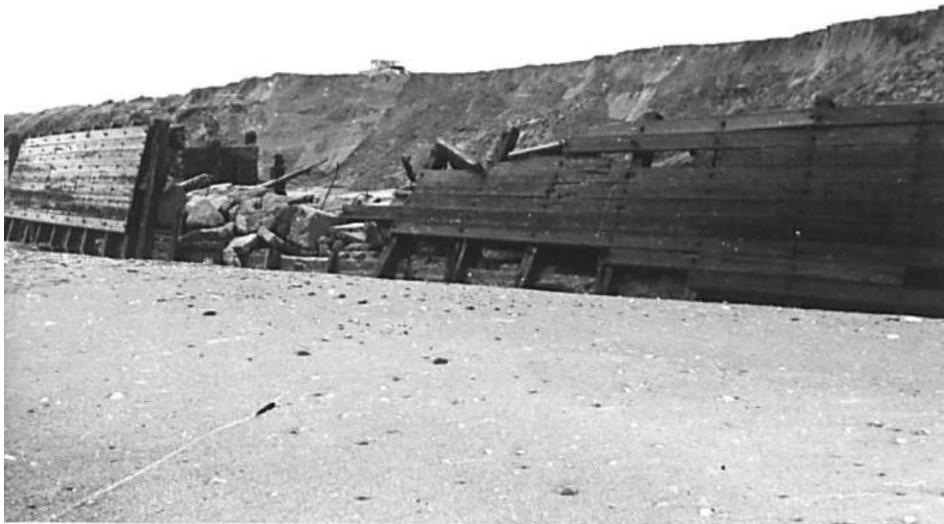
Figure 18 January 1960: Collapsed revetment along the Neck (from Phillips 1962)

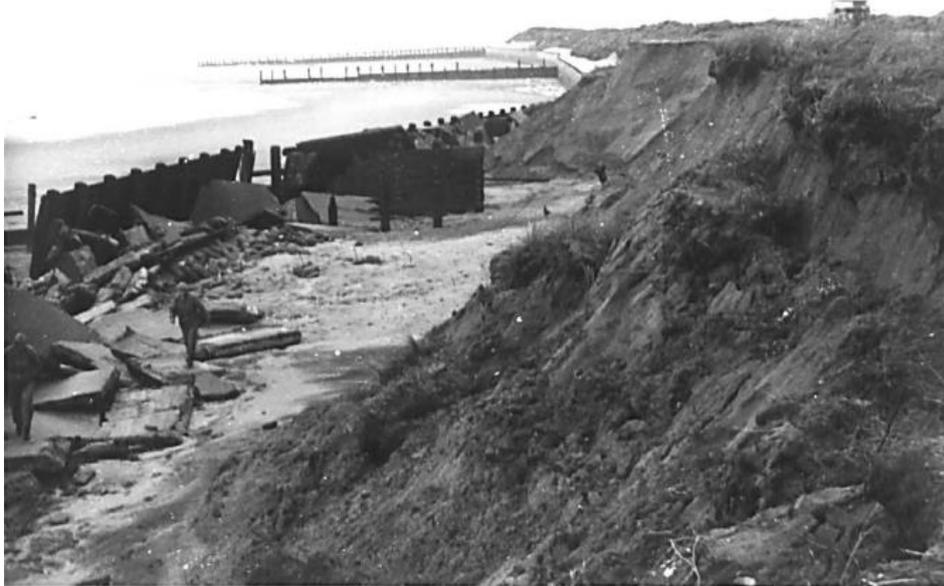
Figure 19 January 1960: Dune erosion behind collapsed revetment along the Neck (from Phillips 1962)

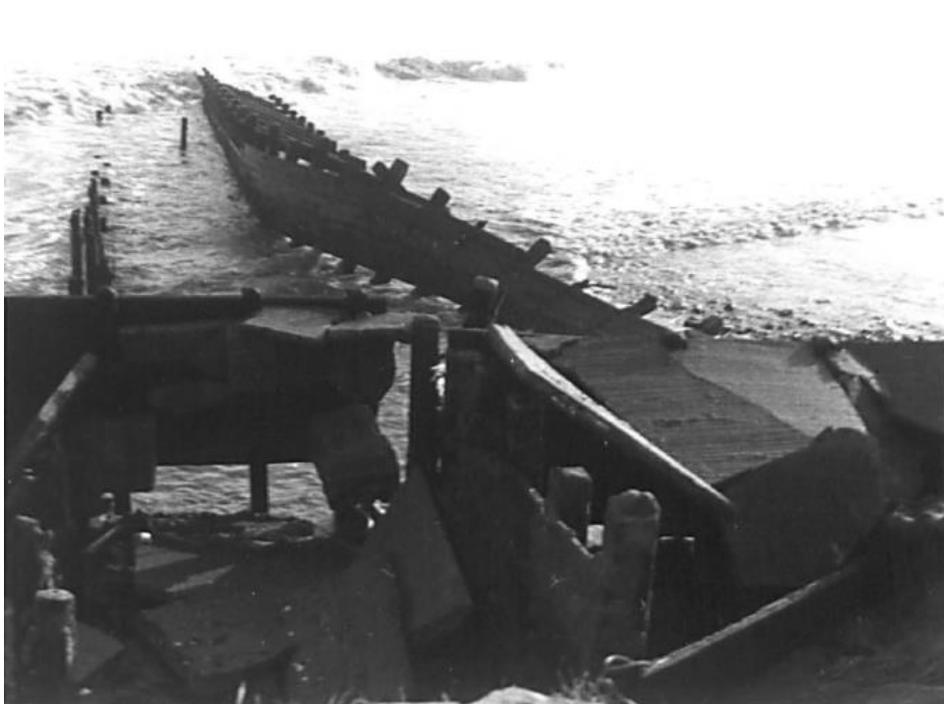
Figure 20 January 1960: collapsed revetment along the Neck – it appears to be fronted by a timber framework and topped with thin concrete slabs (from Phillips 1962)

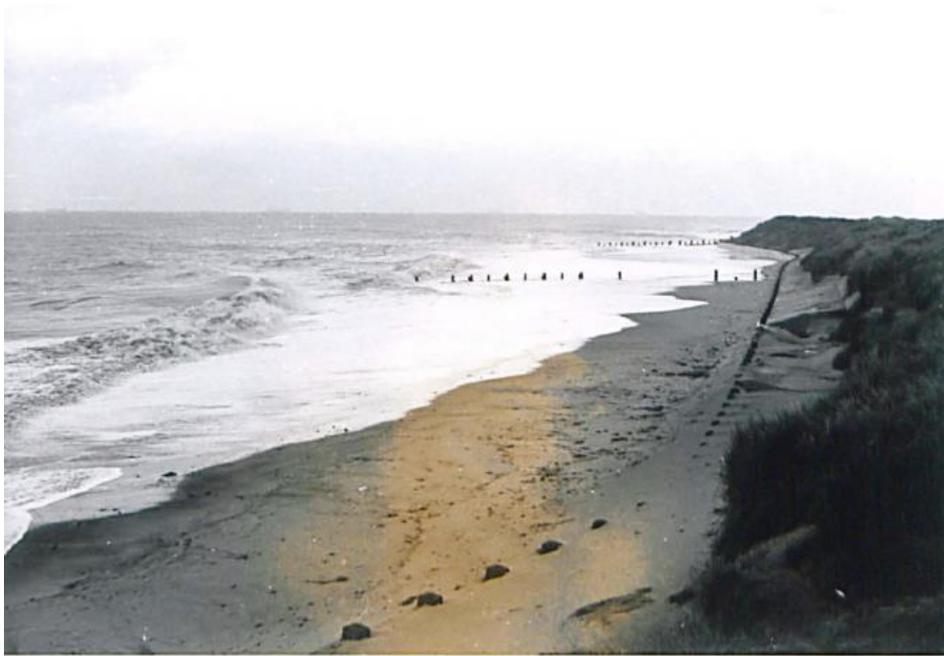
Figure 21 March 1961: Storm waves along the seaward shore of the Neck (from Phillips 1962)

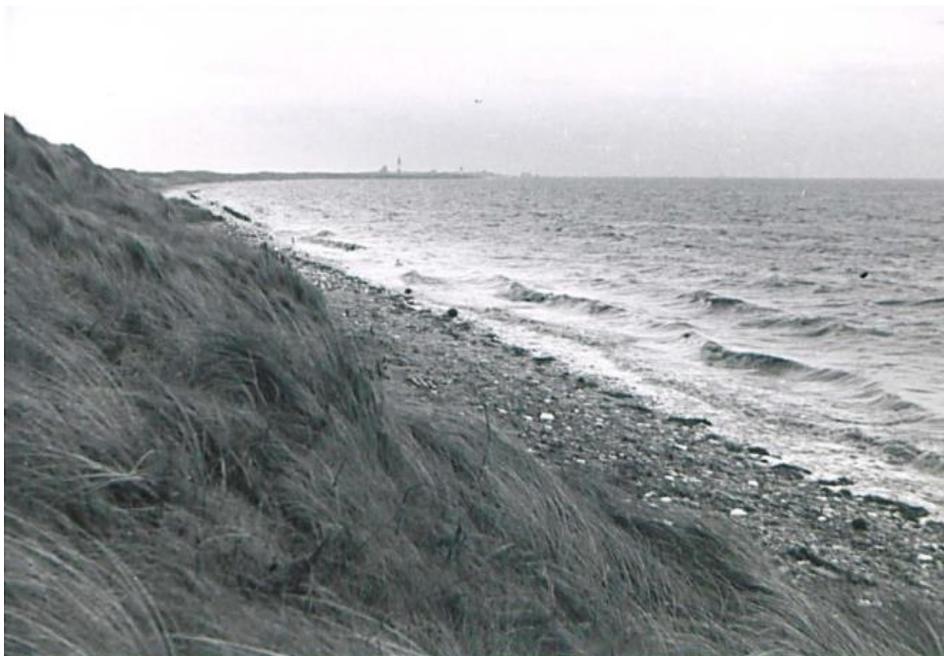
Figure 22 March 1961: Waves along the estuary shore of the Neck (from Phillips 1962)

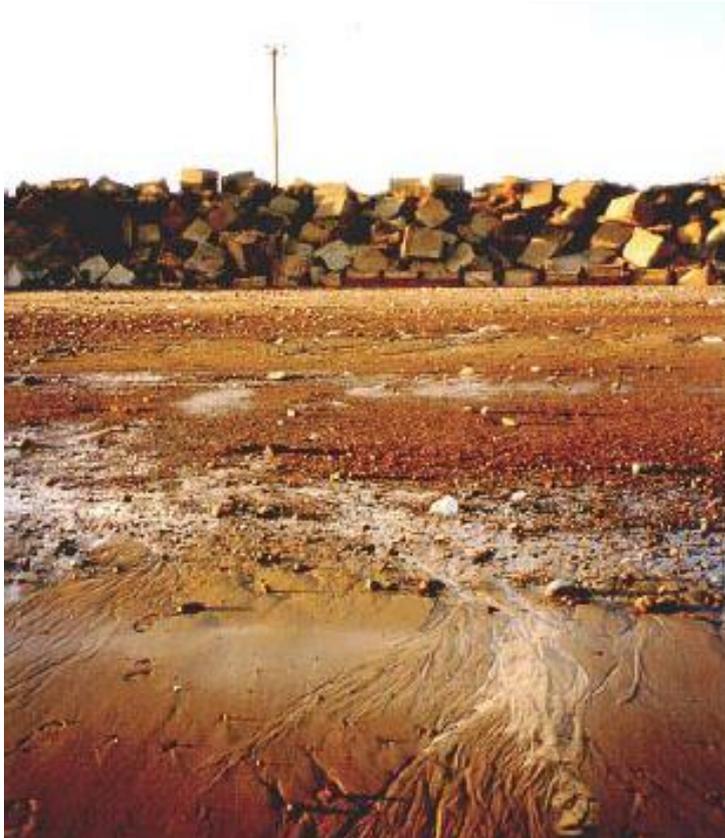
Figure 23 1997: Concrete block seawall/revetment along the southern part of the Neck (from Nicholas 2003)

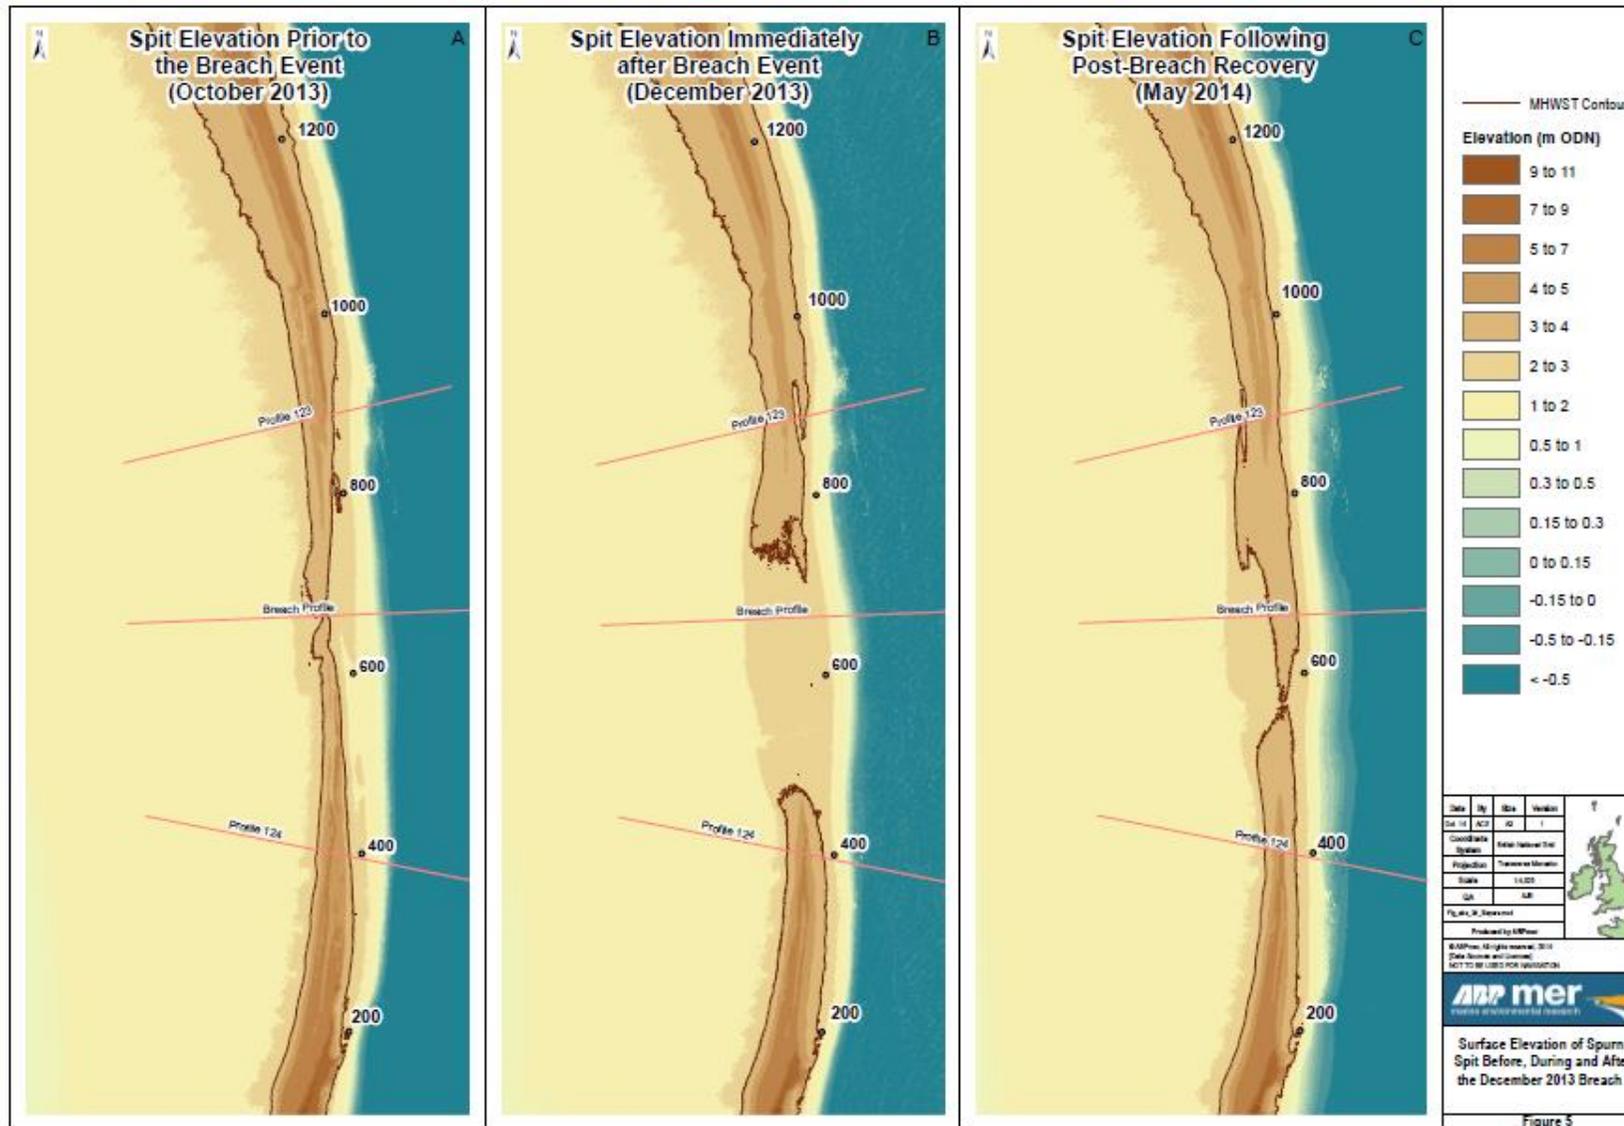
Figure 24 Surface elevation of Spurn prior to and after the 2013 temporary breach (from ABP mer 2014)
