Spurn: Geomorphological Assessment

Humber Estuary SSSI (SAC, SPA, Ramsar)
Spurn Head Geological Conservation Review Site
Spurn National Nature Reserve
Spurn Heritage Coast

Geomorphological Assessment

**Report to Natural England
Dr Mark Lee and Professor John Pethick**

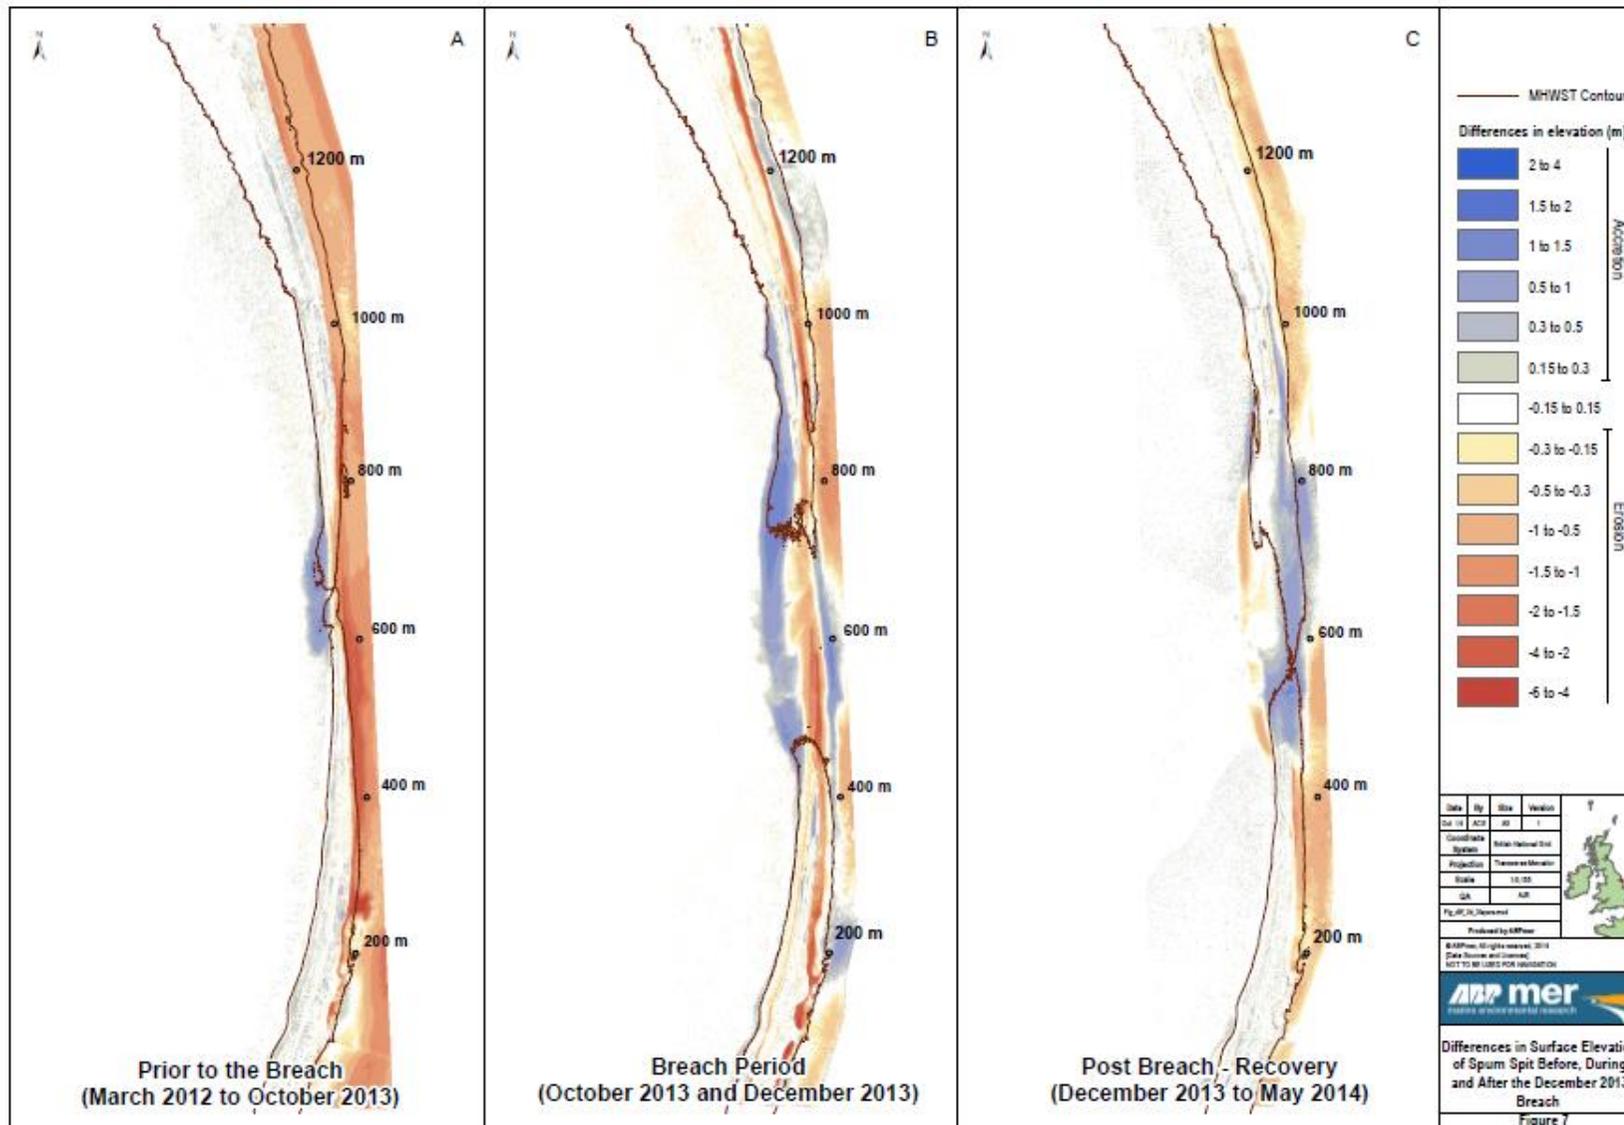
Figure 25 Differences in surface elevation before and after the 2014 temporary breach (from ABP mer 2014)

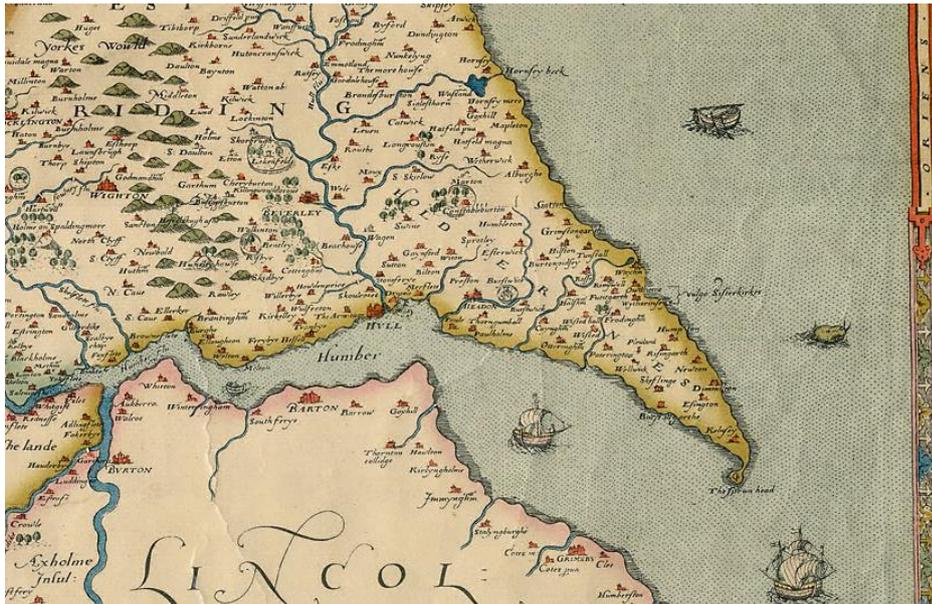
Figure 26 Part of Saxton's Map of Yorkshire 1577

However, as shown on Saxton’s map of Yorkshire, Spurn was present in 1577, before Camden made his description of Kilnsea (Figure 26); in this instance Camden’s promontory is probably the much larger triangle of land that forms Holderness: “*From Hull, a large promontory shoots out into the Sea, call'd by Ptolemy Ocellum, and by us at this day Holderness.*” (Camden 1586, p898).

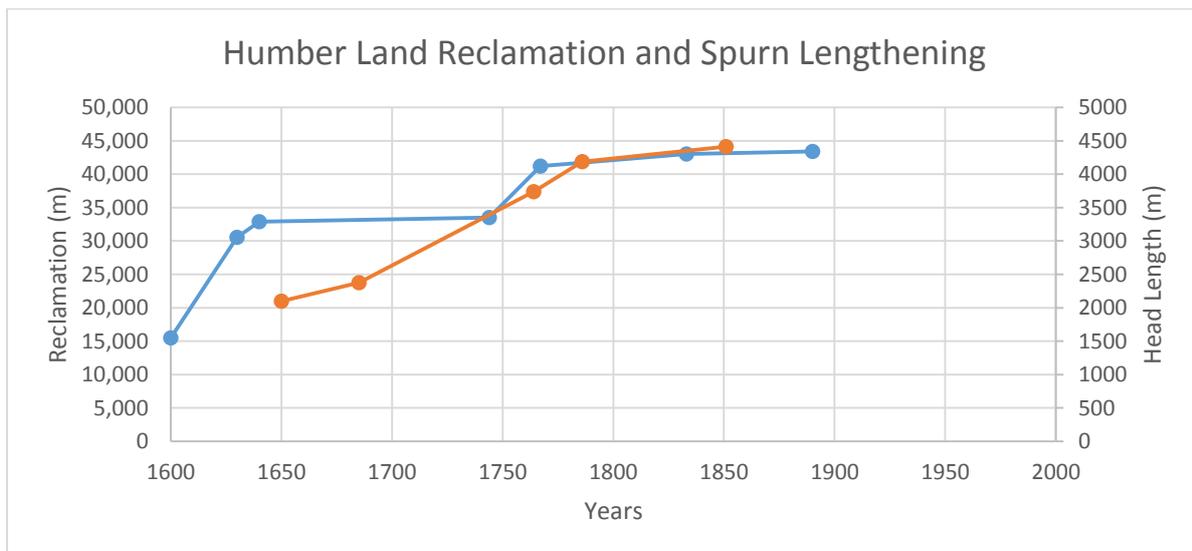
Figure 27 The relationship between the lengthening of the Head (orange line) and the pattern of land reclamation in the Humber (blue line)

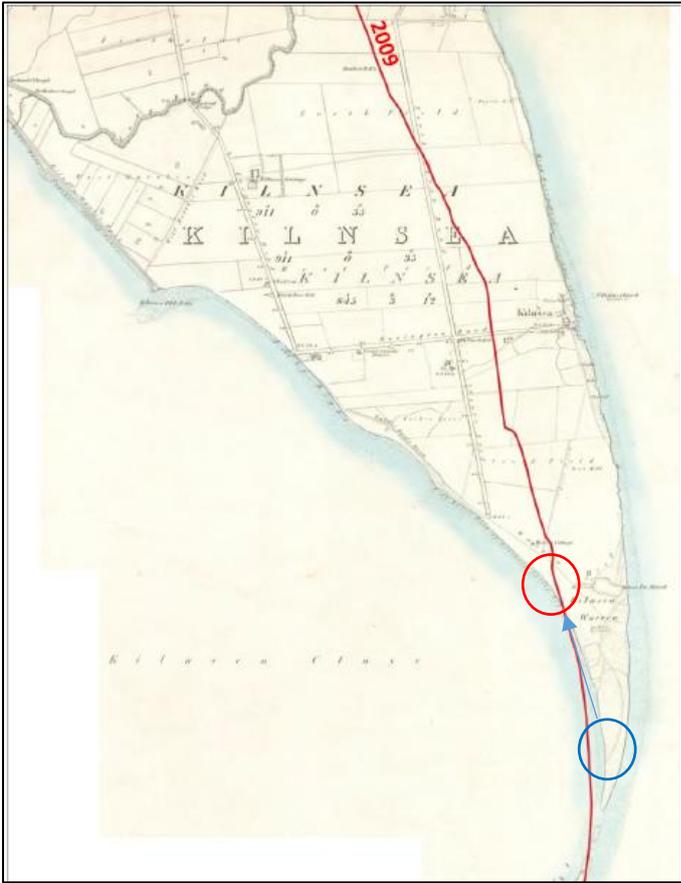
Figure 29 Northwards migration (approximate) of the junction between the end of the Kilnsea cliffs and the Neck of Spurn between 1855 (blue circle) and 2009 (red circle) (adapted from Pye and Blott, undated)

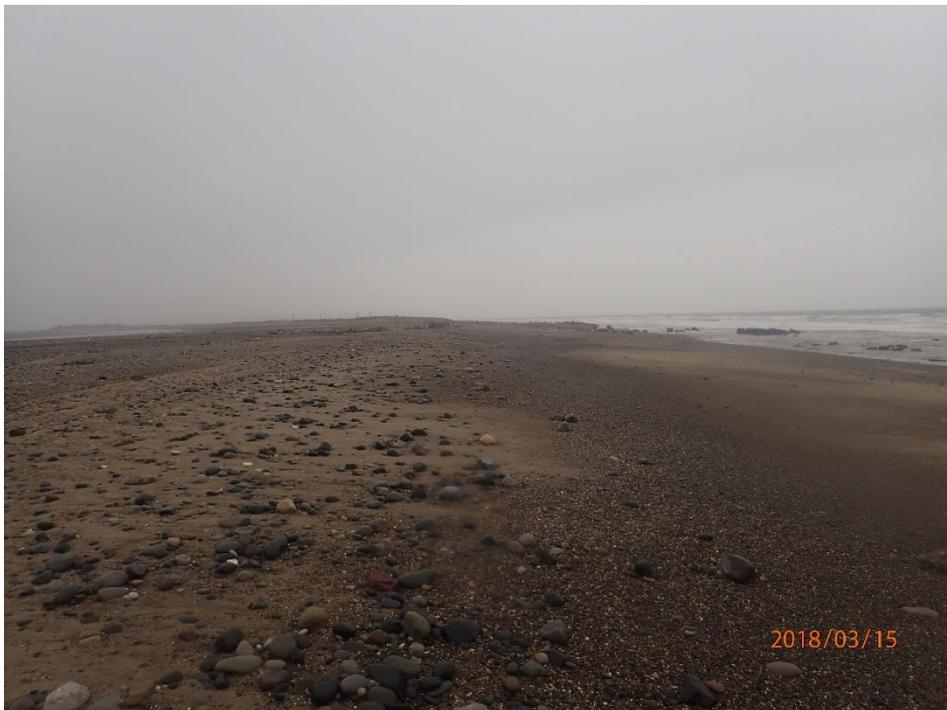
Figure 30 March 2018: the Neck, looking N

- considerable change has occurred along the Neck since the 1950s when Phillips (1962) wrote *“the dunes rise to over 30 feet O.D. with the highest point 31 feet O.D.”* In 2014 the highest point along the Neck was around 3m OD (ABP Mer 2014). The dunes have been lost and only a low sand and gravel barrier remains (Figure 30).

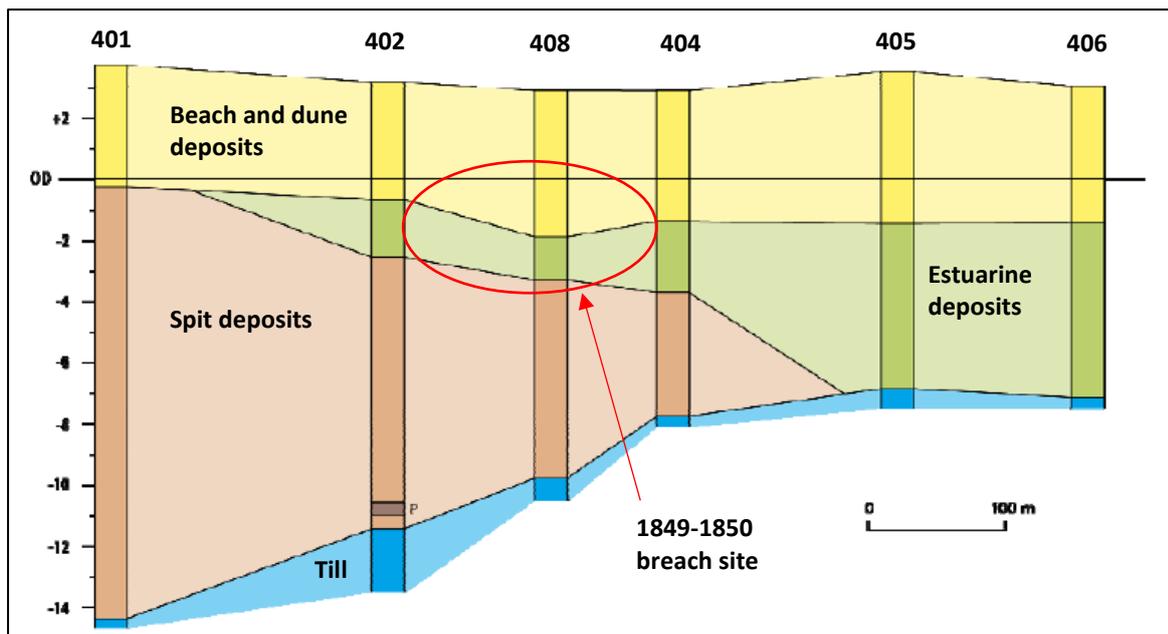
Figure 31 BGS borehole investigation at the 1849/1850 breach site (from Balson 2008).

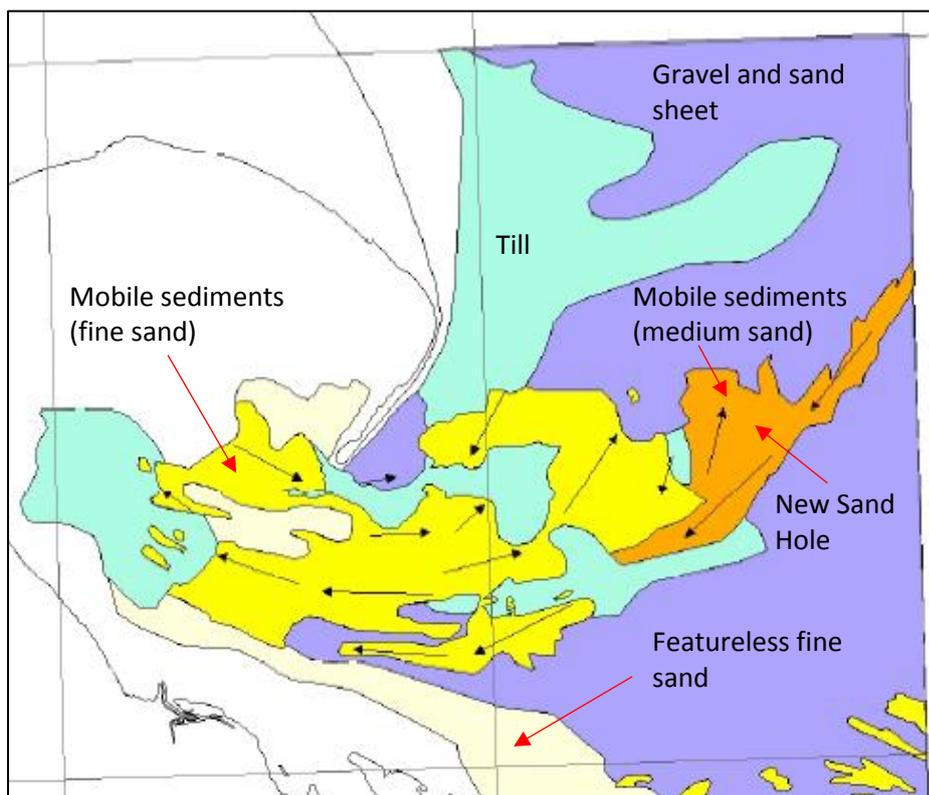
Figure 32 Seabed sediments map of the Humber mouth, black arrows indicate sediment transport directions (after Balson and Philpott 2004)

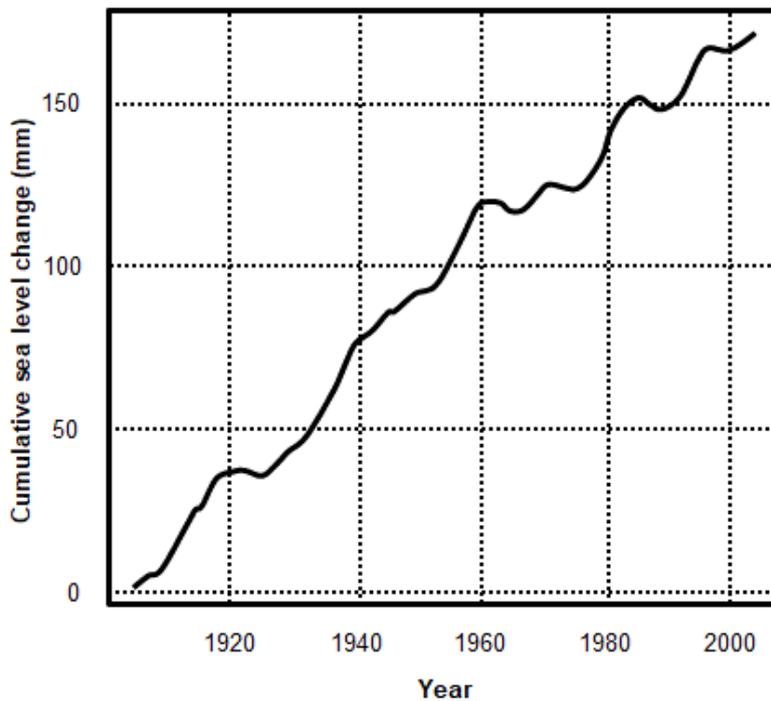
Figure 33 The mean global sea level record over the period 1904-2003 (from Holgate, 2007)

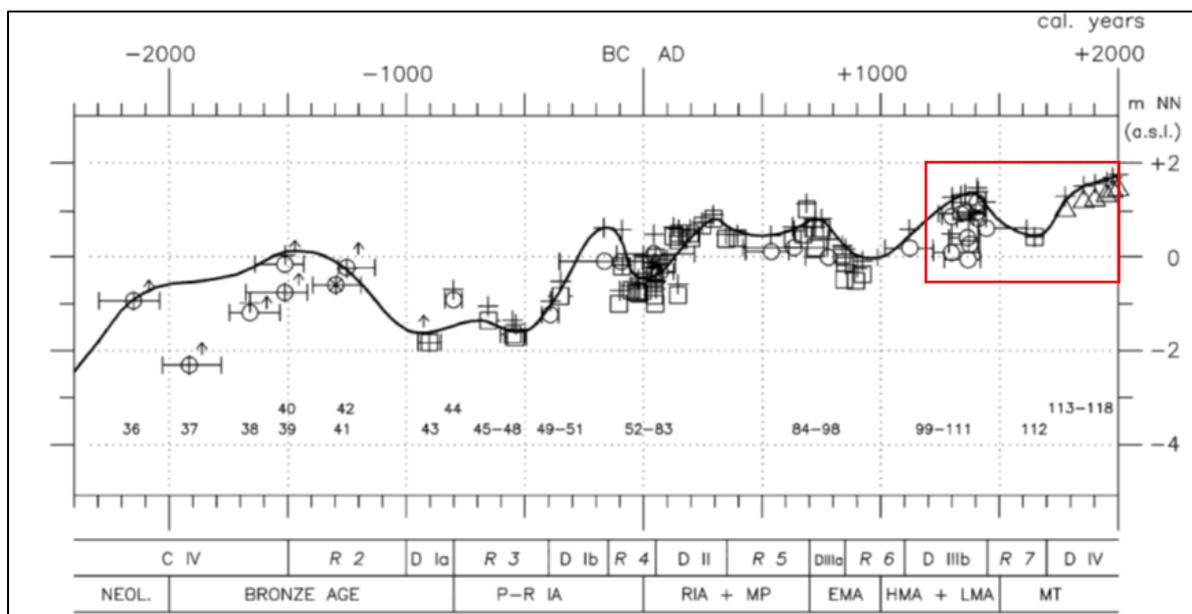
Figure 34 A Holocene sea-level curve for the southern North Sea (from Behre, 2007). The 14C dates the end of transgression D IIIb was at c. AD 1450, and was followed by Regression R7 The MHW decreased rapidly and reached a minimum at AD 1644. The final rise of the MHW, the Dunkirk IV transgression began around AD 1700.

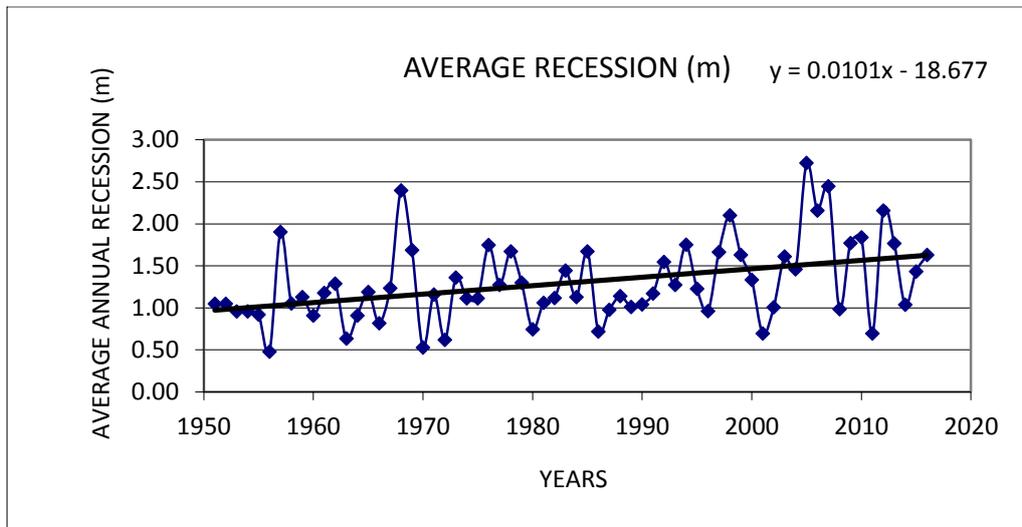
Figure 35 Holderness cliffs: overall annual recession rates 1951-2016

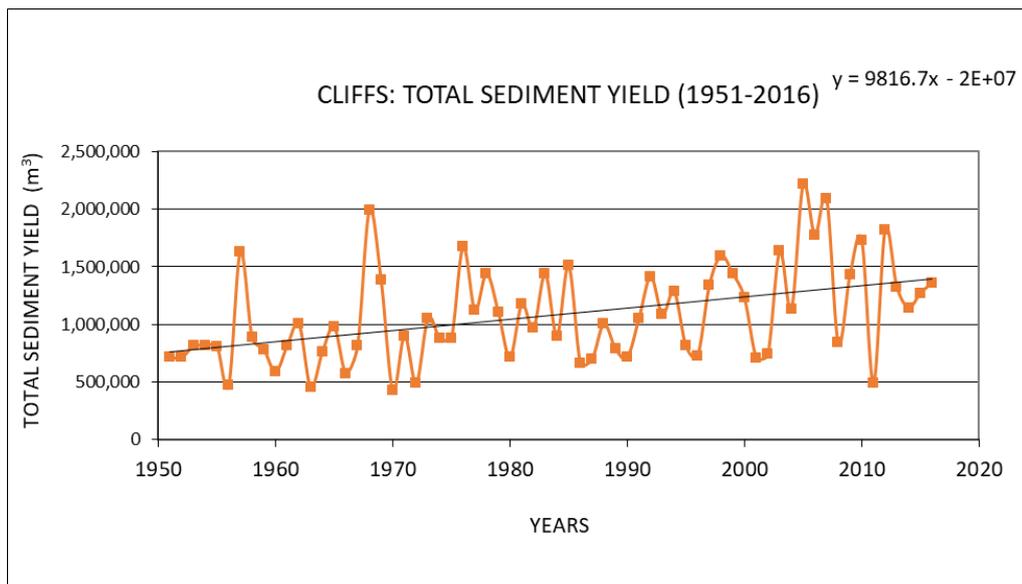
Figure 36 Holderness cliffs: total sediment yield 1951-2016

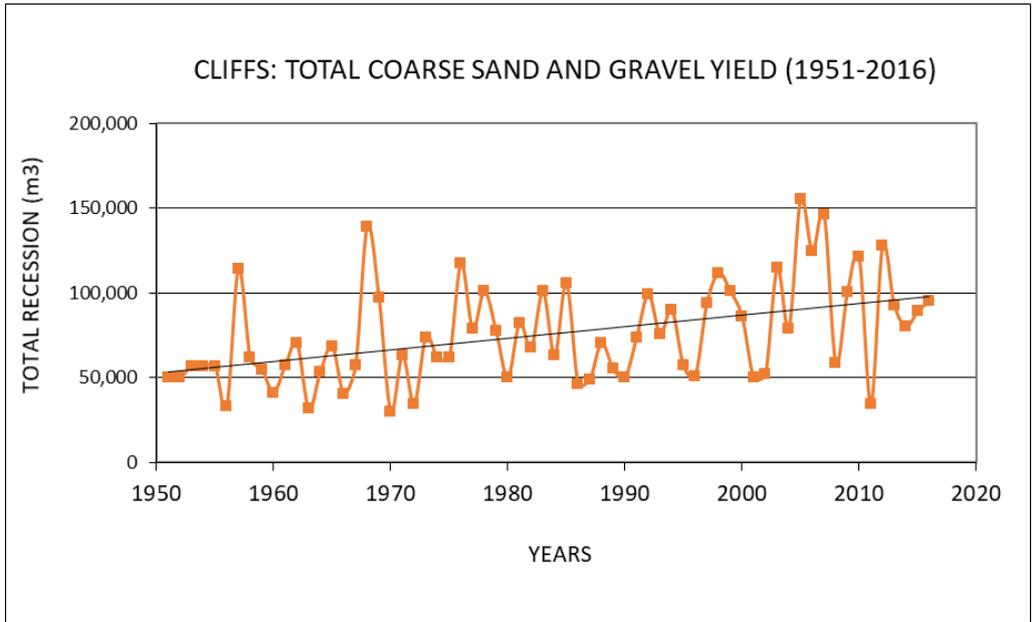
Figure 37 Holderness cliffs: total coarse sand and gravel yield 1951-2016

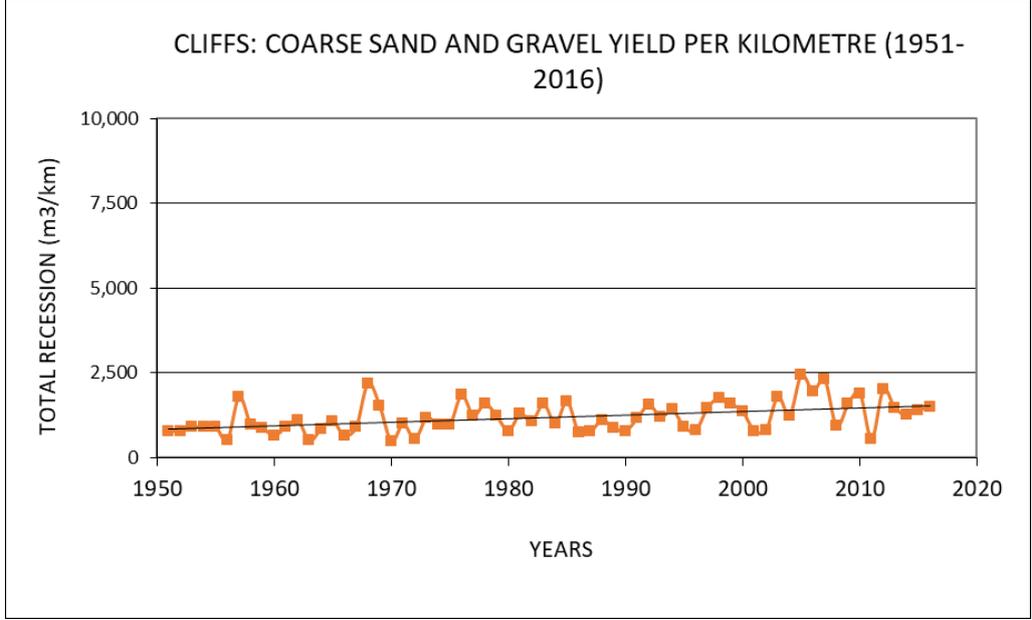
Figure 38 Holderness cliffs: total coarse sand and gravel yield per km, 1951-2016

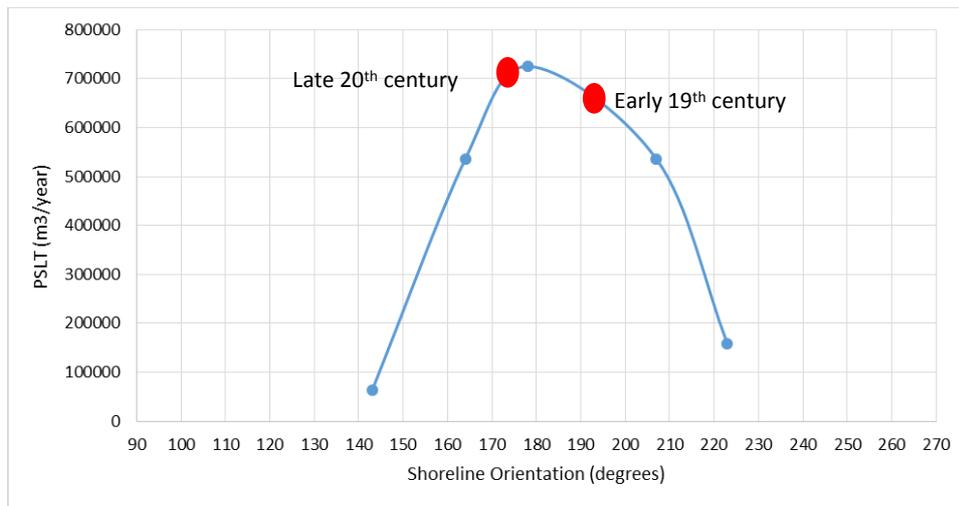
Figure 39 An indication of the effect of changing shoreline orientation on potential longshore sediment transport (PLST) along the Neck (note that the rates should be seen as relative rather than absolute values). Based on Dalrymple's sediment transport calculator, using 0.5m high NE waves.

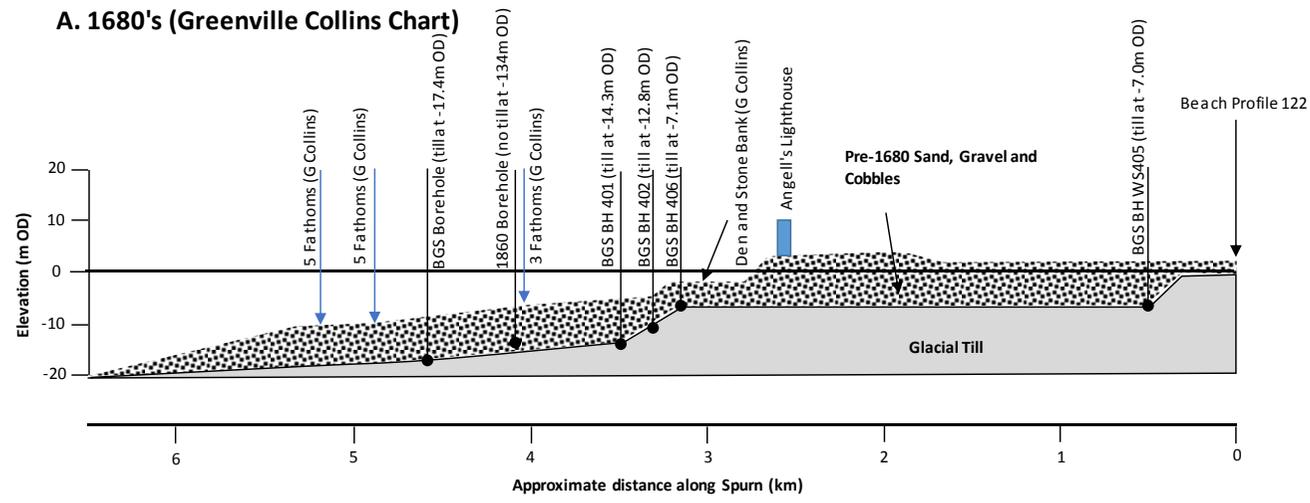
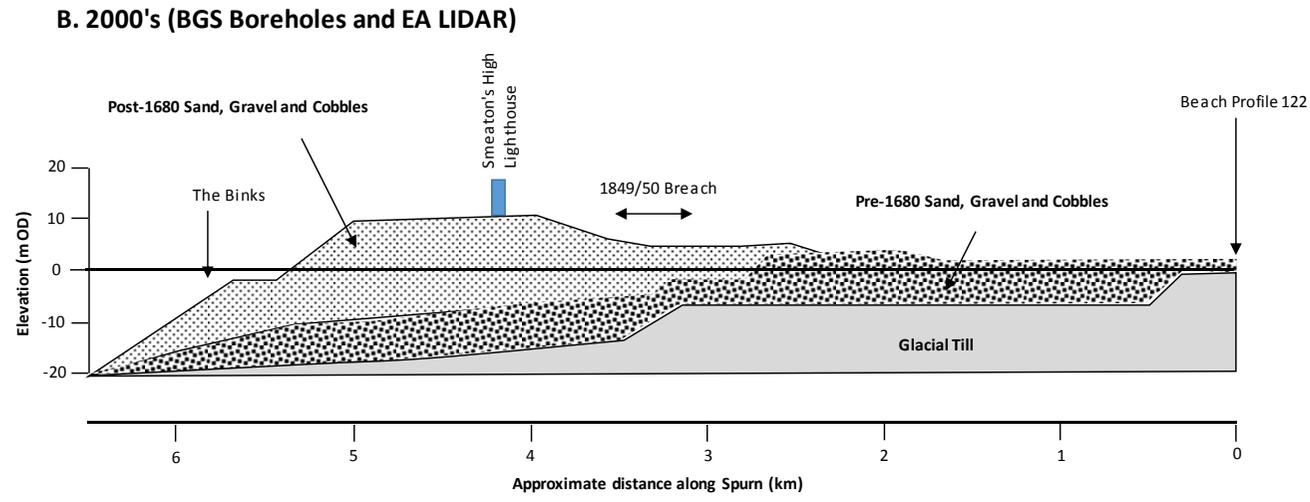
Figure 40 A schematic model showing how Spurn has changed since the late 17th Century (the section follows a line down the centre of the present day Spurn. Note the vertical exaggeration)

- the "foundations" for the present day Spurn were present (around 5-10m of sand and gravel/cobbles) prior to the phase of spit lengthening in the 17th to 20th centuries.

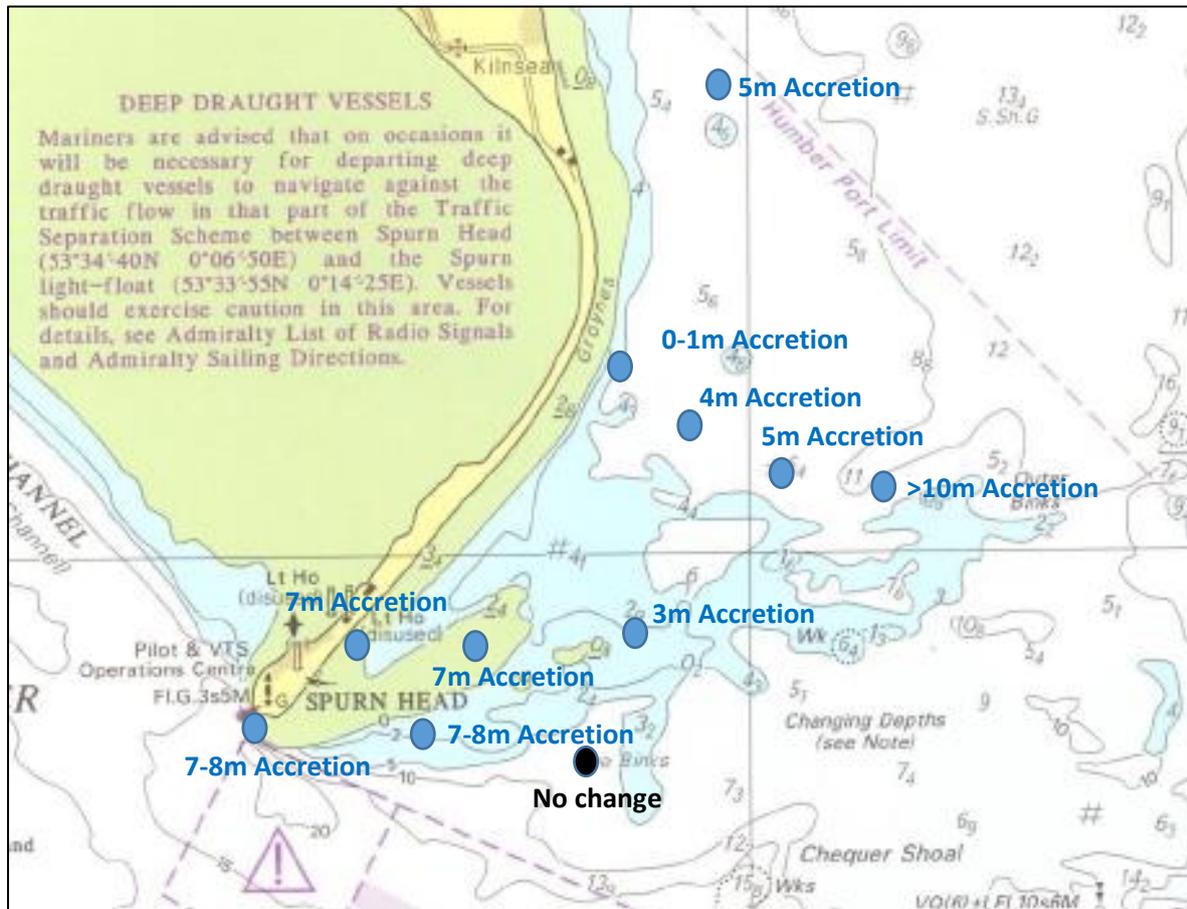
Figure 41 Comparison of the present day water depths with depths records by Greenville Collins on his chart of 1684. Blue dots are the approximate locations of Collin’s soundings; the labels indicate the amount of accretion since the 1680’s. (note that the Chart Datum is not stated and are assumed here to be to -2.7mOD, rather than the modern chart datum of -3.9m)

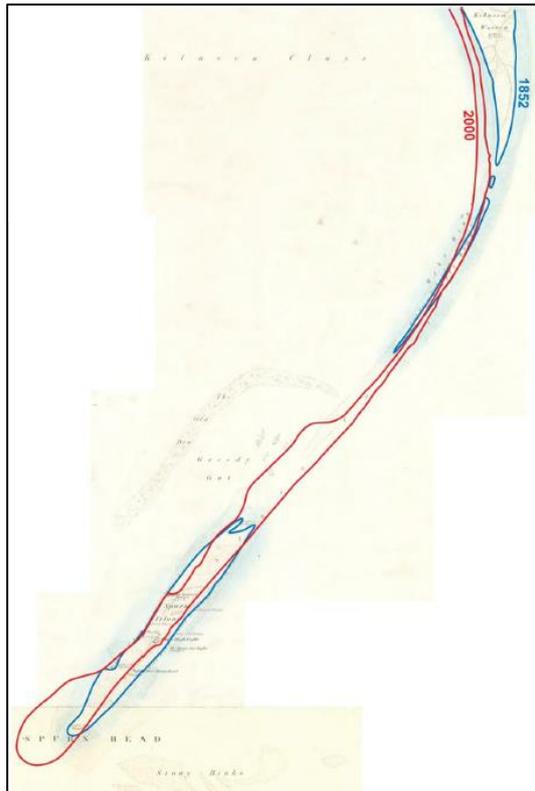
Figure 42 Comparison of the 1852 (blue line; this shows the spit following the 1849/50 breach) and 2000 (red line) shoreline positions along Spurn (from Pye and Blott, undated)

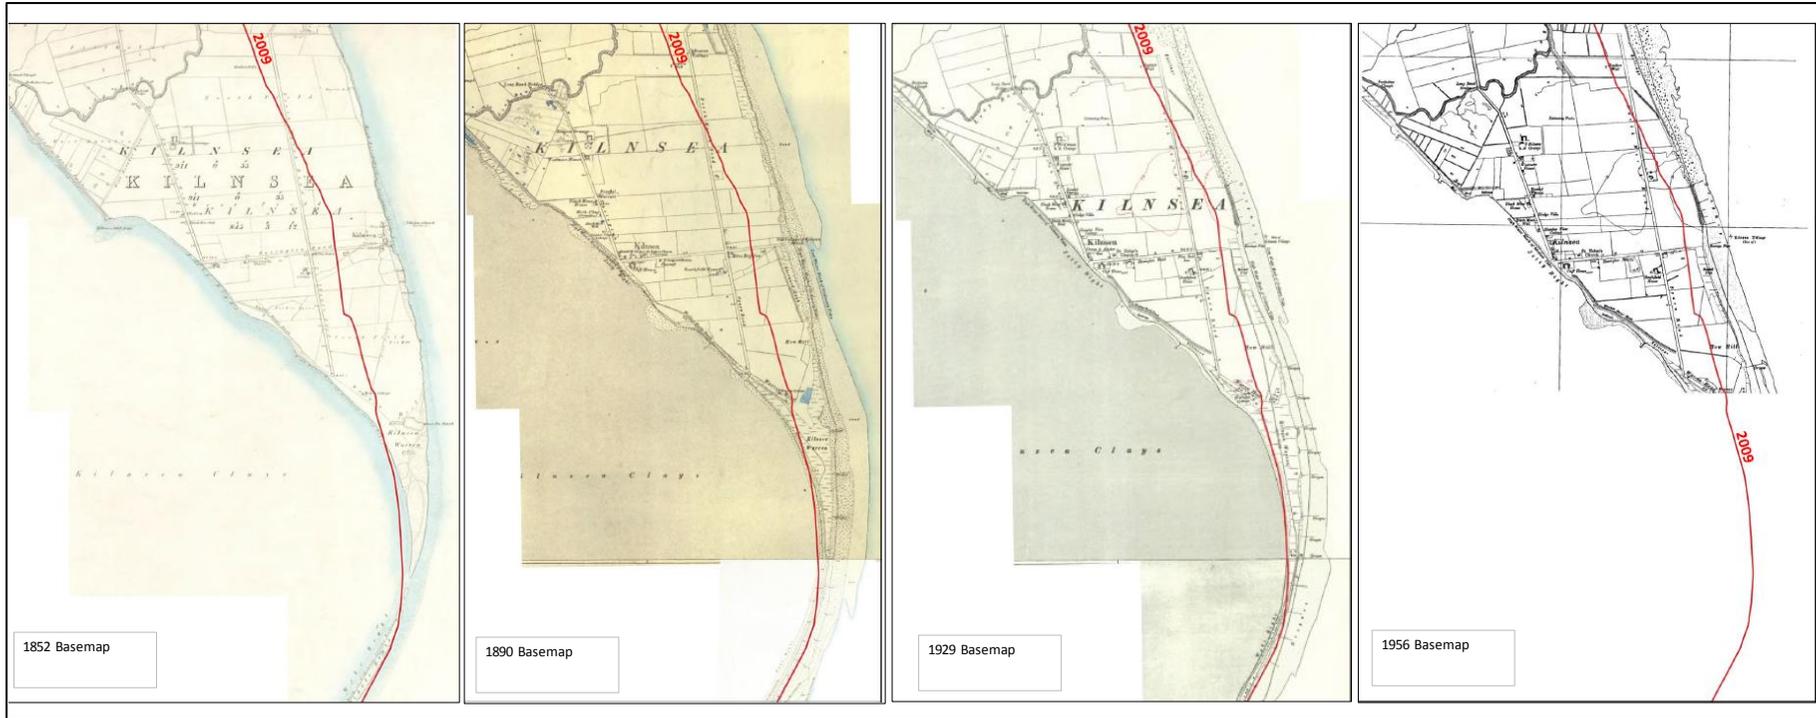
Figure 43 Comparison of the 2009 Kilnsea-Easington cliffline and Spurn Neck with the positions on earlier Ordnance Survey maps (from L-R: 1852, 1890, 1929, 1956). From Pye and Blott (undated)

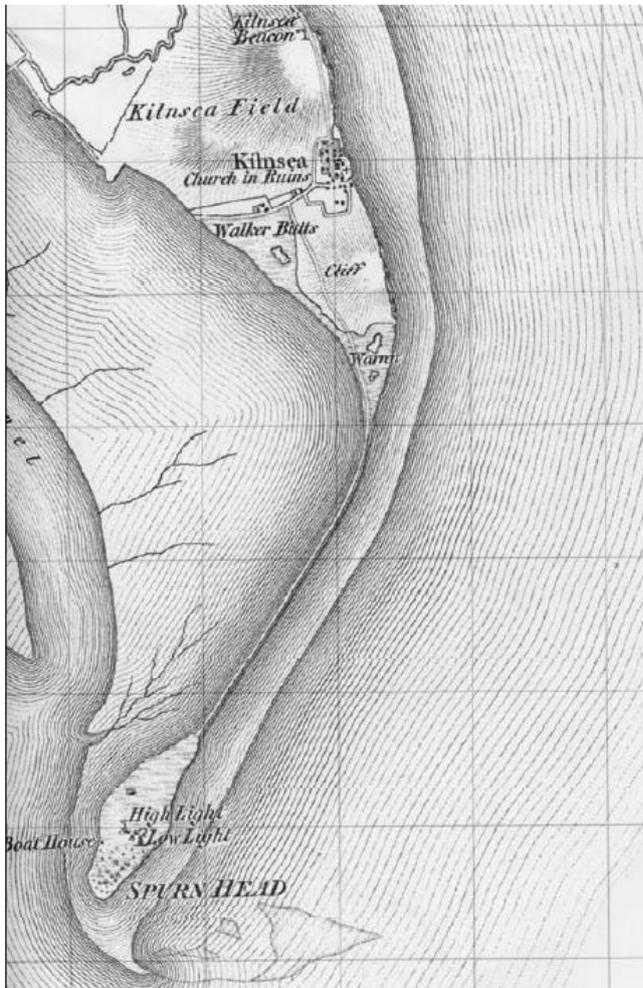
Figure 44 Spurn as shown on the 1824 Ordnance Survey map (1" to 1 mile); an analogy for the future Spurn after the defences have finally broken down?

could be quite dramatic, especially when the protection provided by the decaying defence works suddenly declines. The Neck will remain as a low sand and gravel barrier, without dunes. This seems to be the most likely scenario and would see a return to the type of landform shown on the 1824 First Edition Ordnance Survey map.

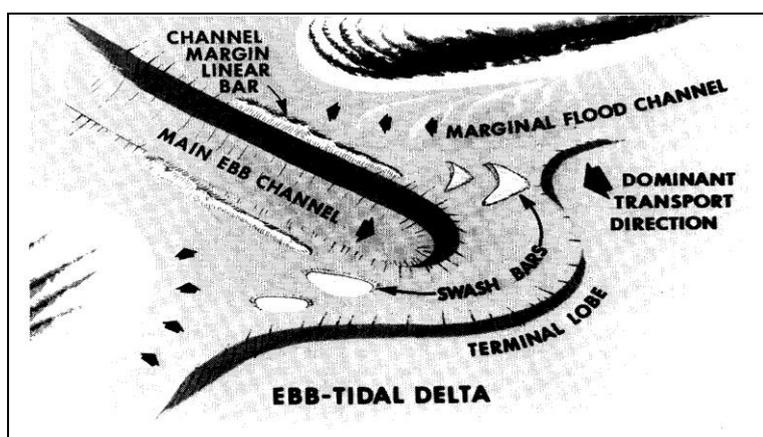
Figure 45 Schematic morphology of ebb-tidal deltas (from Hayes, 1980)

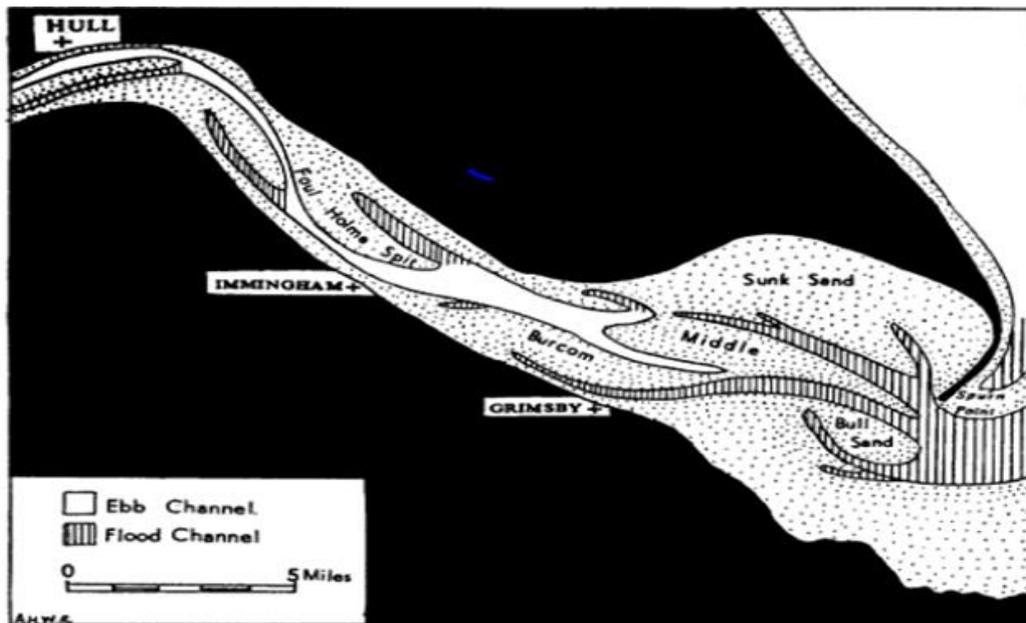
Figure 46 Ebb and flood channels in the outer Humber Estuary from Robinson (1960)

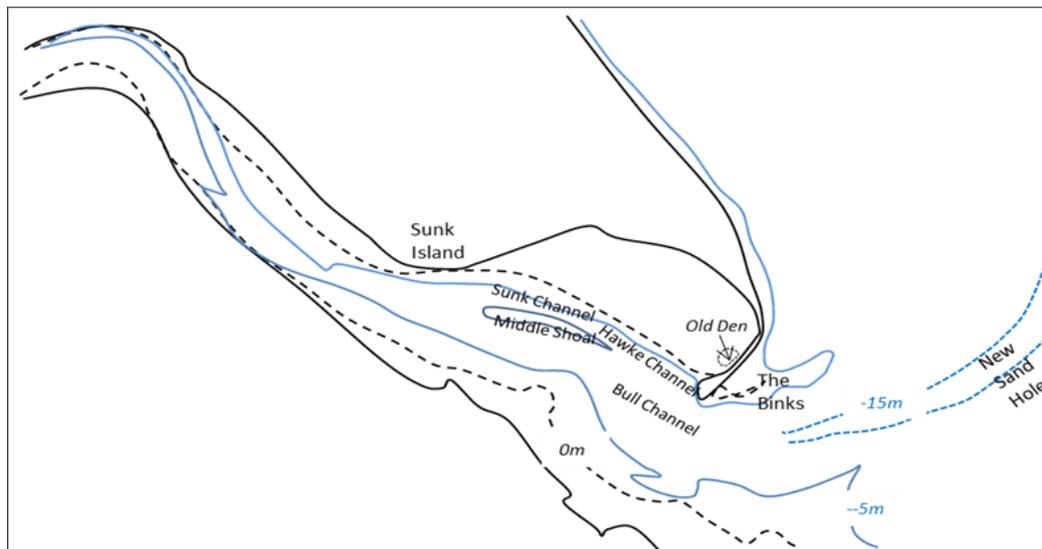
Figure 47 The Outer Humber and its approaches, showing features mentioned in the text. Isobaths depths refer to Admiralty Chart Datum at -3.9mOD

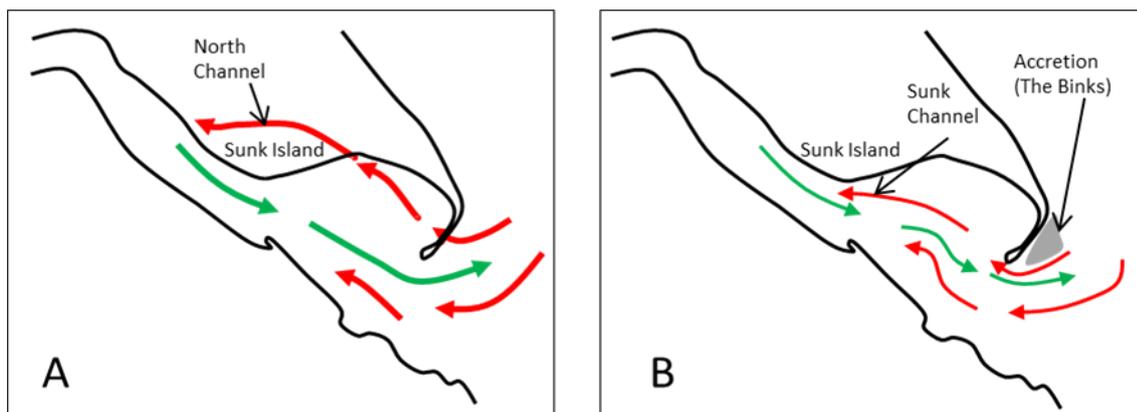
Figure 48 Flood and ebb channels in the outer Humber (A) Pre-reclamation - early flood enters at Old Den, thence through North Channel (B) Post-reclamation- early flood migrates south allowing accretion of the Binks and elongation of the spit

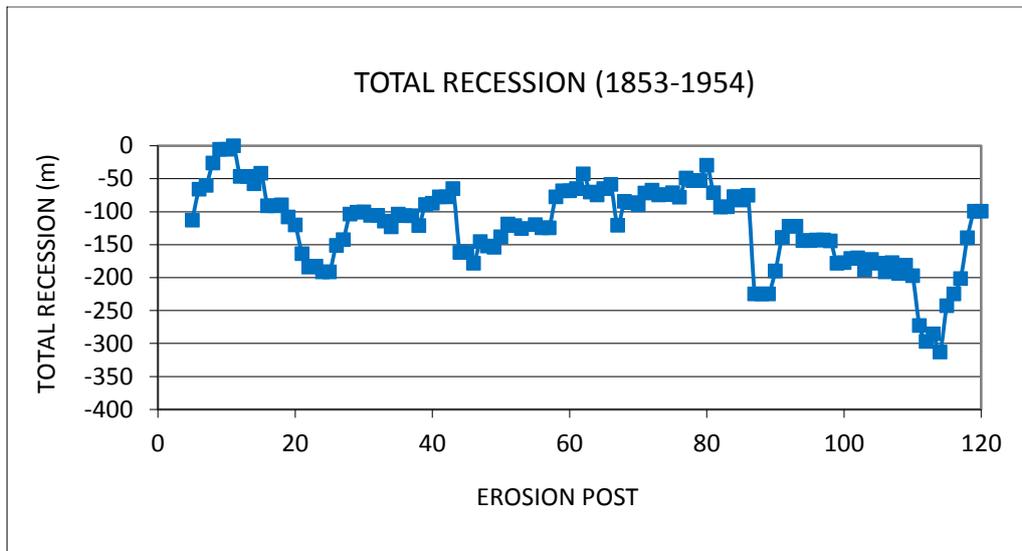
Figure 49 Holderness cliffs: total cliff recession at Erosion Post (EP) locations, 1853-1954 (data for the EPs are from the nearest beach profile site, generally within 100-200m)

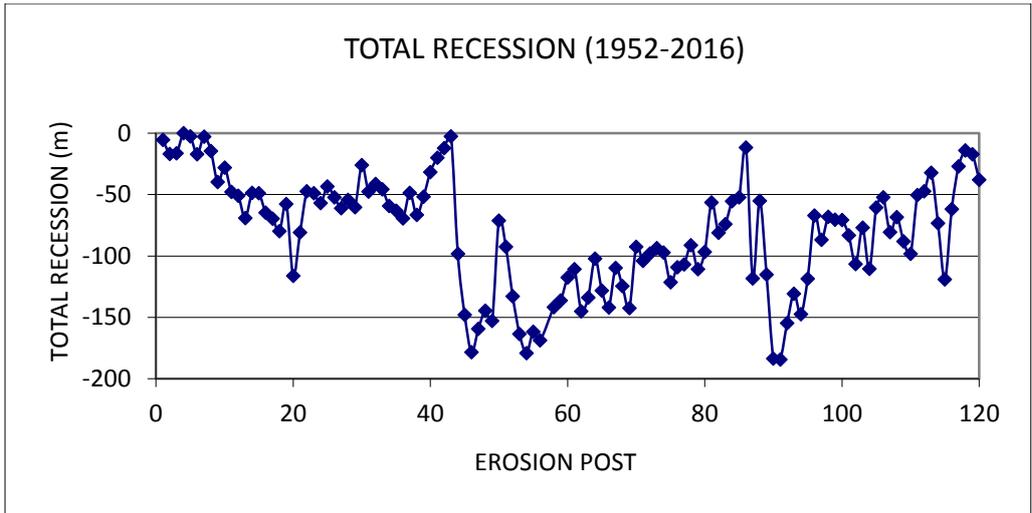
Figure 50 Holderness cliffs: total cliff recession at Erosion Post (EP) locations, 1952-2016 (data for the period 2010-2016 are from the nearest beach profile location)

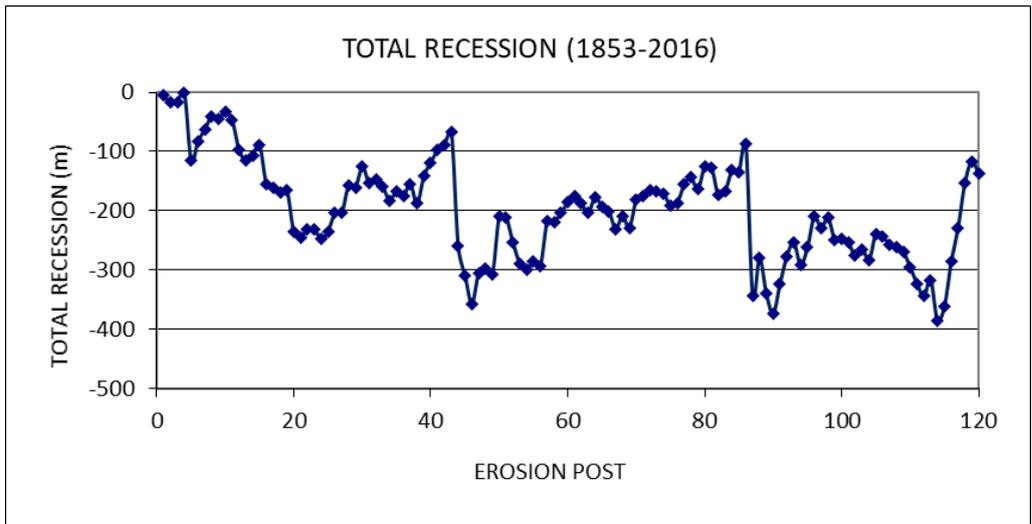
Figure 51 Holderness cliffs: total cliff recession at Erosion Post (EP) locations, 1853-2016 (combined data series)

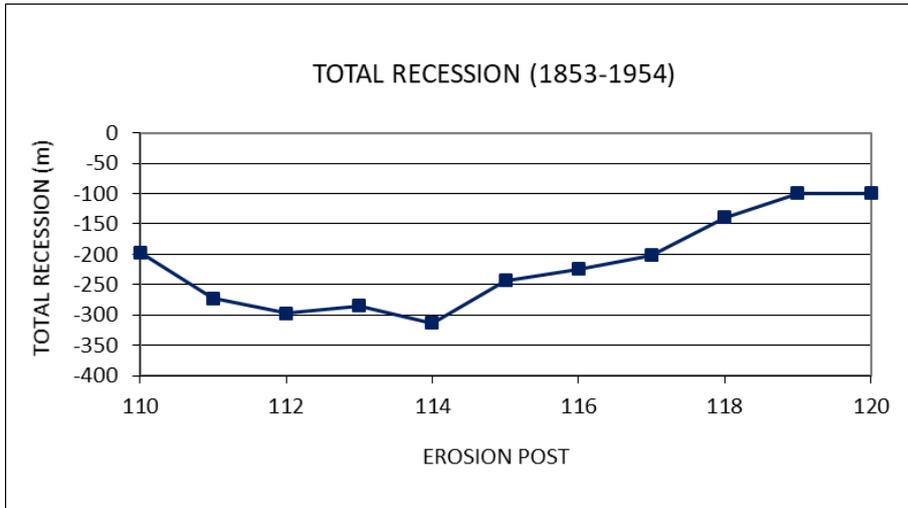
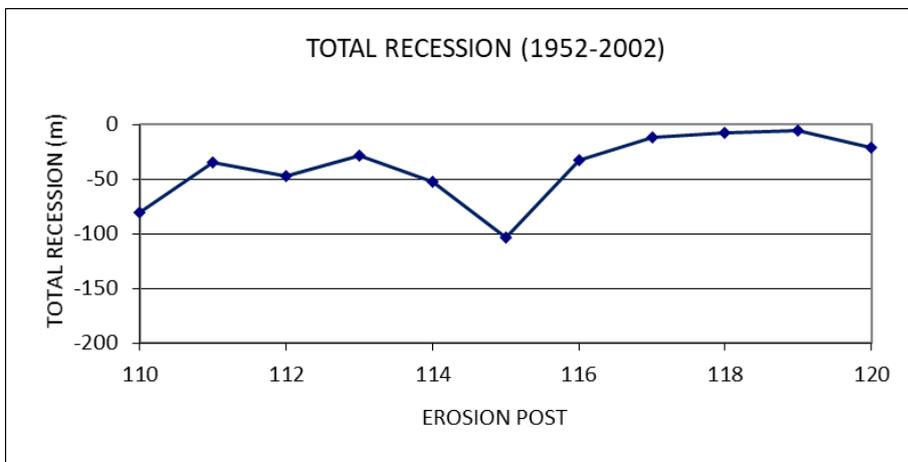
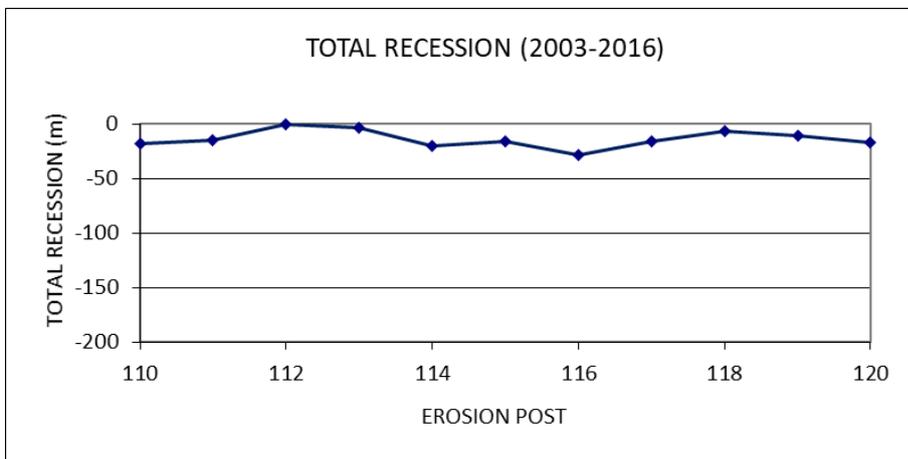
Figure 52 Holderness cliffs: recession south of Easington (top – 1853-1954; middle – 1952-2002; bottom – 2002-2016)
