Natural England Joint Publication JP013

River Dove Restoration Plan

‘Letting the Dove Flow’

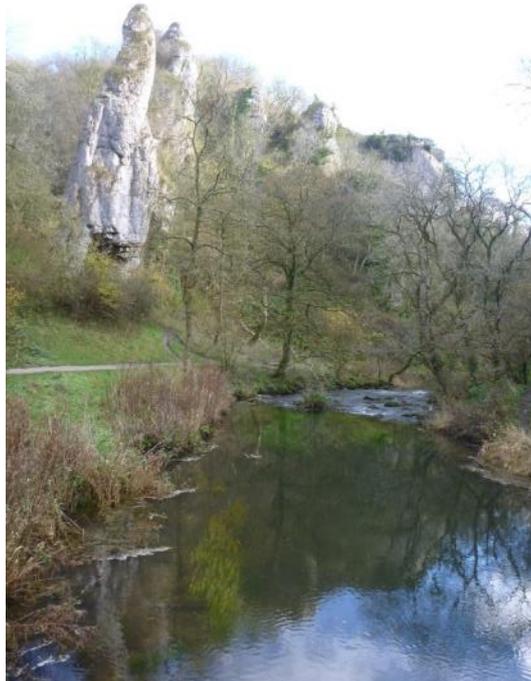
Figure 9 Changes at Pickering Tor - old picture and contemporary photograph. (Proctor's Hoopla circa 1925: Landscape Scene, Pickering Tors, Dovedale, Derbyshire, Barnes and Son Belper, courtesy of The Fairground Heritage Trust).

The comparison of old paintings with present day photo below highlights the effect of the bank reinforcements in eliminating natural variety in the banks, leaving them straight. In this condition they offer much less length (quantity) and variety of habitat for fish and other aquatic and bankside wildlife, such as native crayfish, which need the full range of naturally occurring river habitats, including naturally eroding cliffs and banks, mid channels bars, riffles and pools, bankside vegetation, softer banks for burrowing, and structures such as rocks or tree roots for shelter (Mott, N. 2015).

The image above shows natural 'rapids' in the 1920s. The contemporary image shows these have been formalised as a weir so the water behind is very smooth and slow flowing. (The river is flowing away from the viewer in these pictures of Pickering Tor).

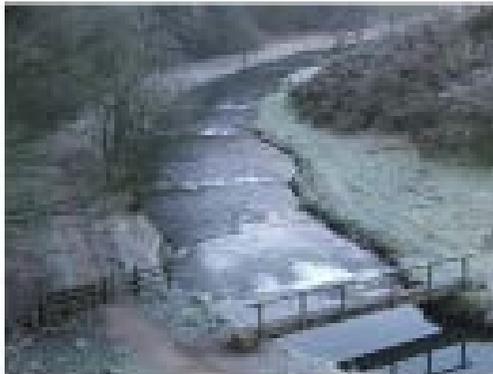
Flow is invigorated as it passes over the top of the weir, but this is short lived as almost immediately the next weir in the sequence slows flow rates and causes ponding of water flows. Weir sequence effectively traps coarse sediments such as cobbles and gravels reducing occurrence of deposition features such as point and side bars.

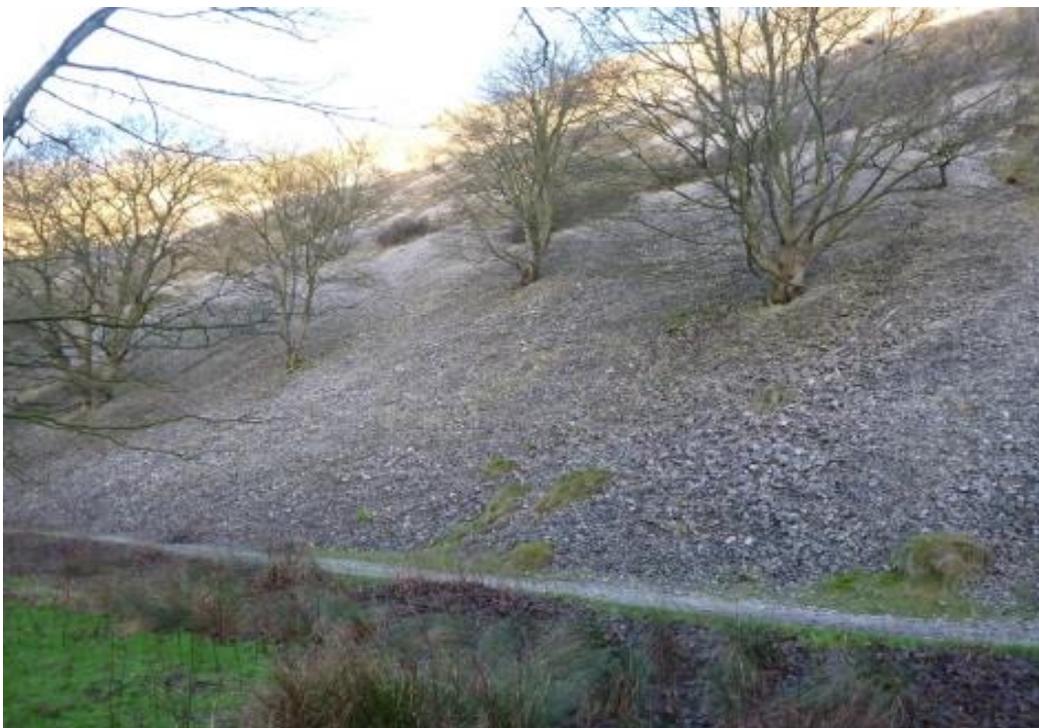
Scree slope in Wolfscote Dale. Scree is active (gathering around the trees) but is cut off from the valley floor by the path.

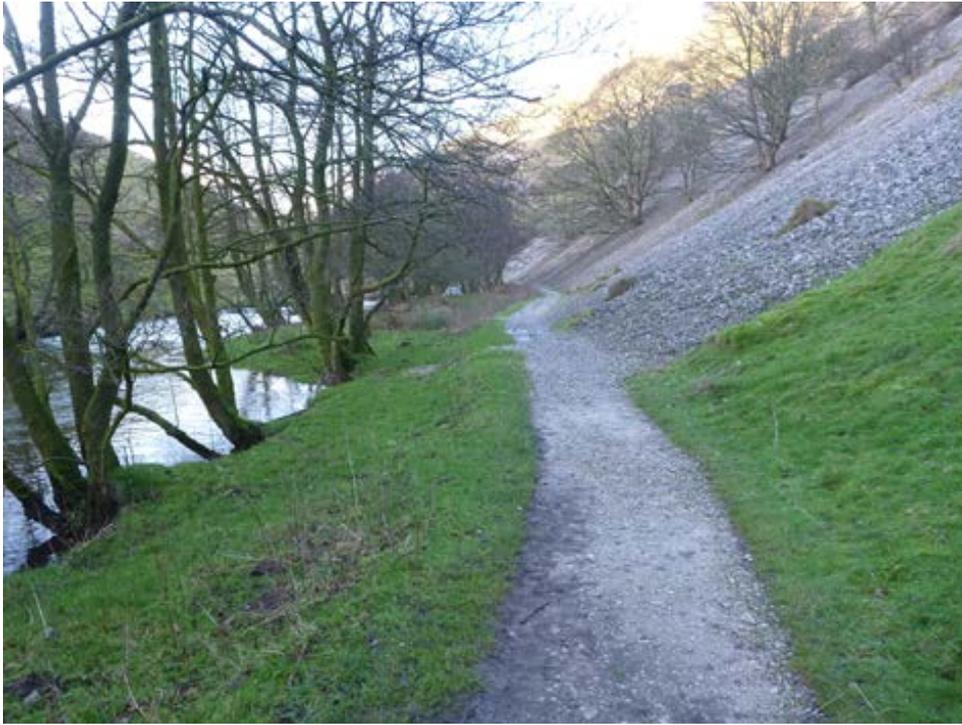
Here you can see how the stones are raising the footpath level, and again the material cannot reach the river.

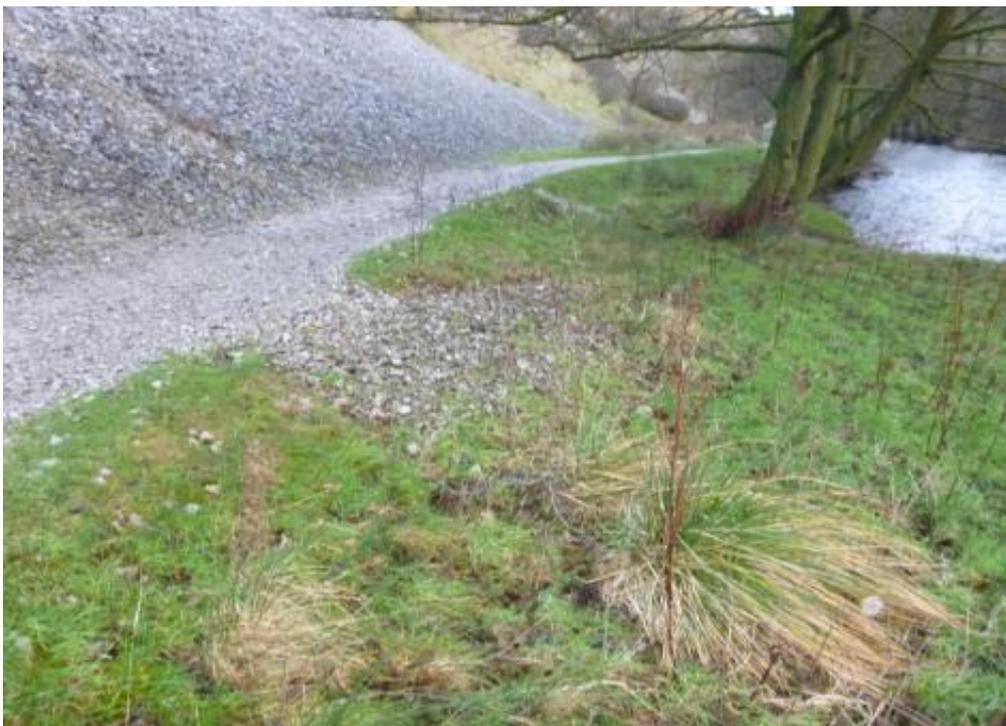
Where the stones have crossed the path they could be manually moved into the river without altering the 'angle of repose' of the stones on the other side of the path. The volume of material would be small however.

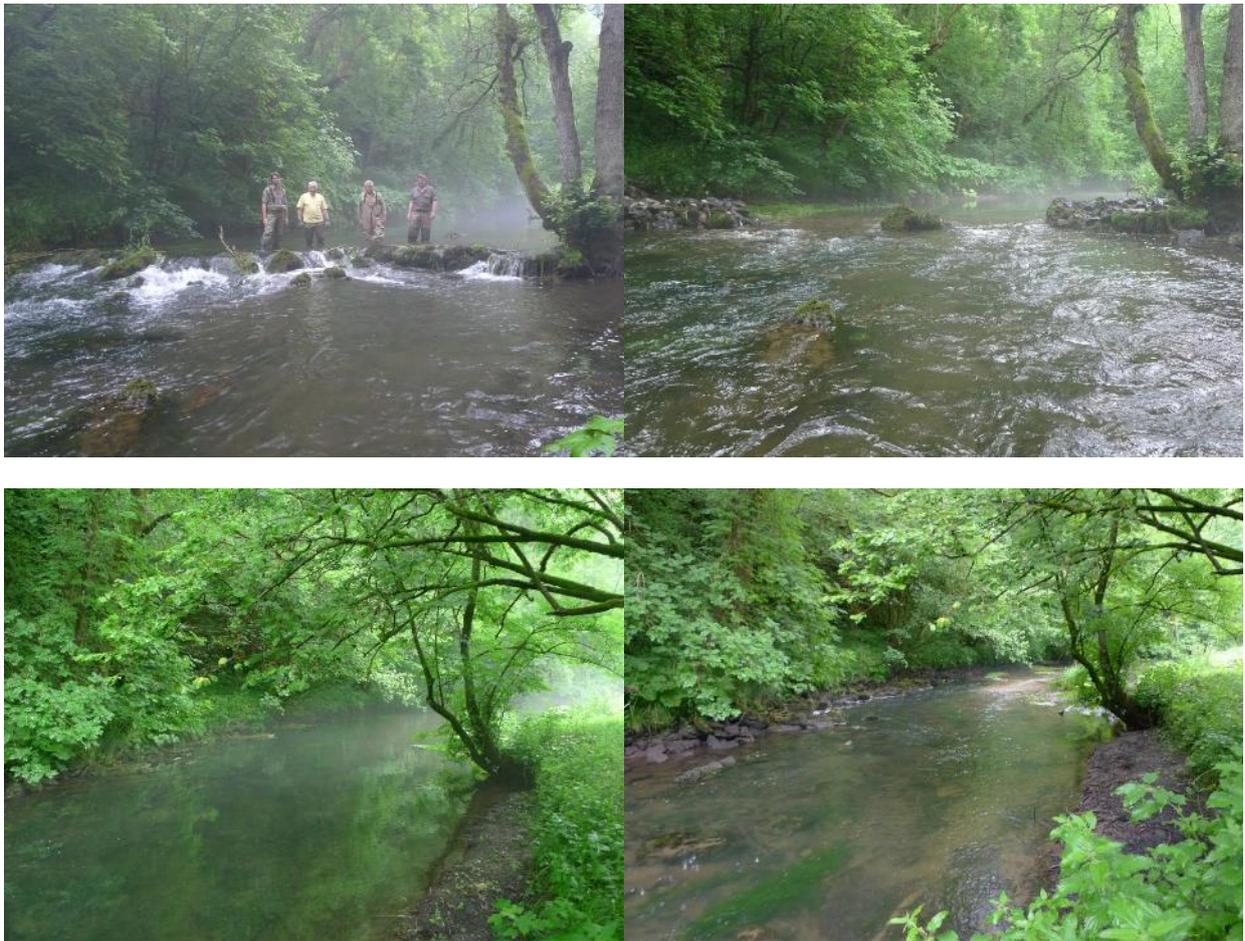
Figure 16 Weir removal photographs July 2010, Leek and District Fly Fishing Association.

Where weirs cannot be completely removed, they can be adapted by partially removing, lowering or breaching. Nevertheless, there may still be some weirs that will be retained for their importance to infrastructure, history, abstraction or other reasons.

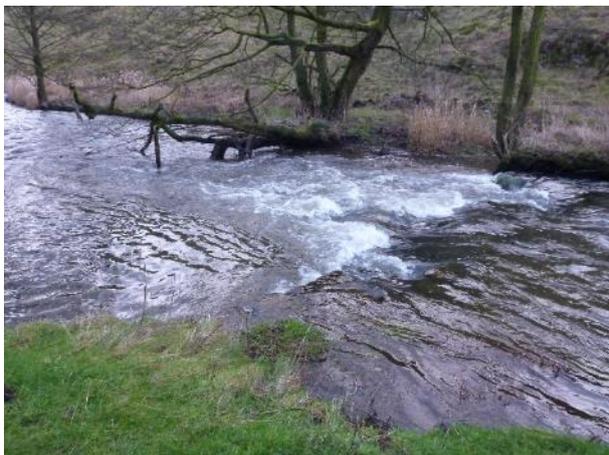
Weir beginning to break down.

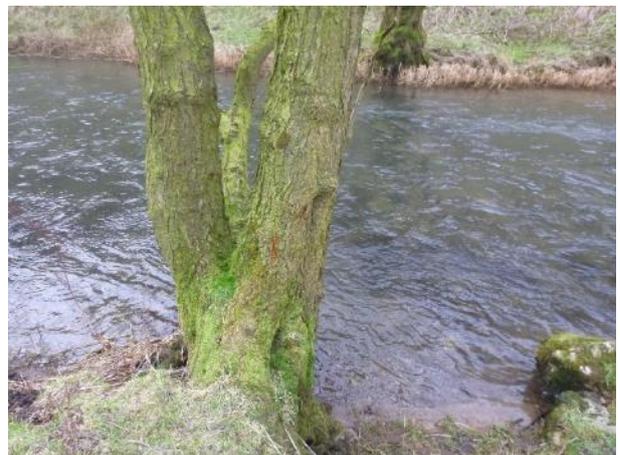
Signs of phytophthora.

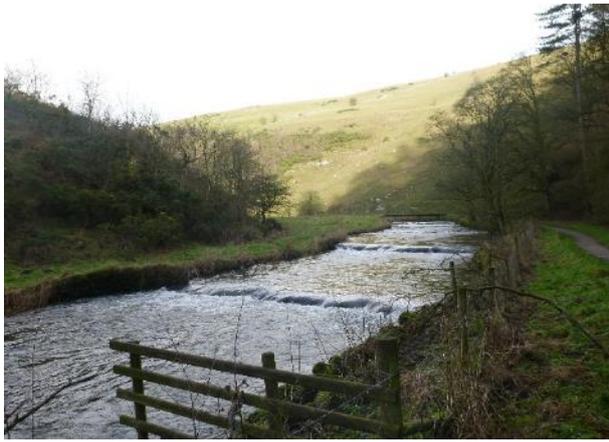
Closely spaced weirs with little natural flow diversity.

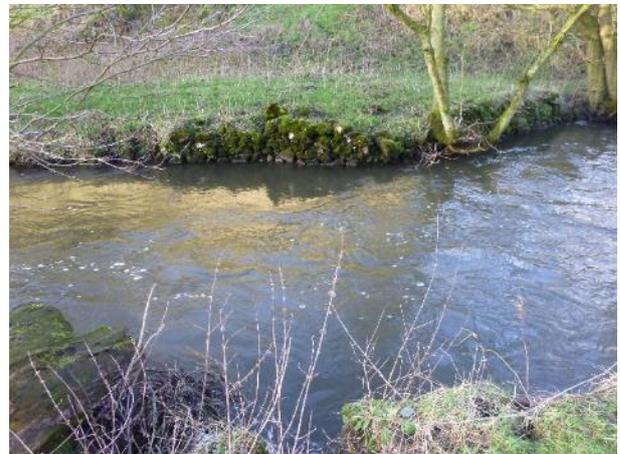
Example of stone bank protection typical of much of the river.

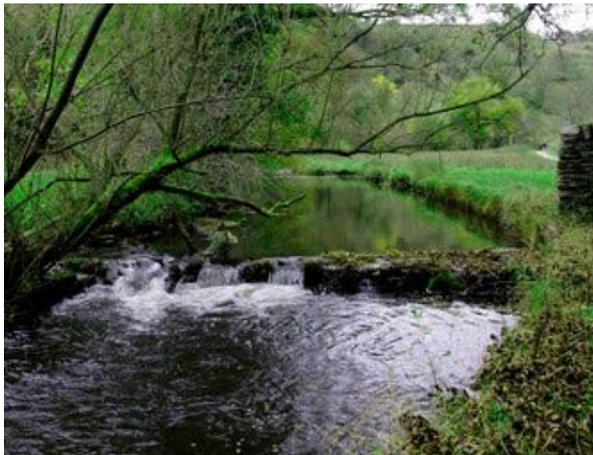
Weir impounds reach for a long way upstream.

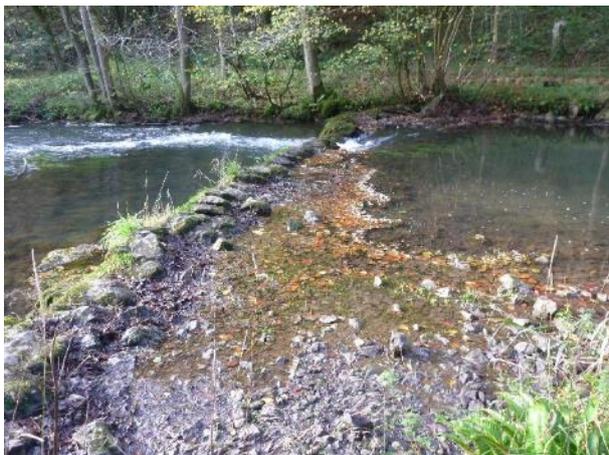
Weir has been breached naturally. Remove introduced stone.

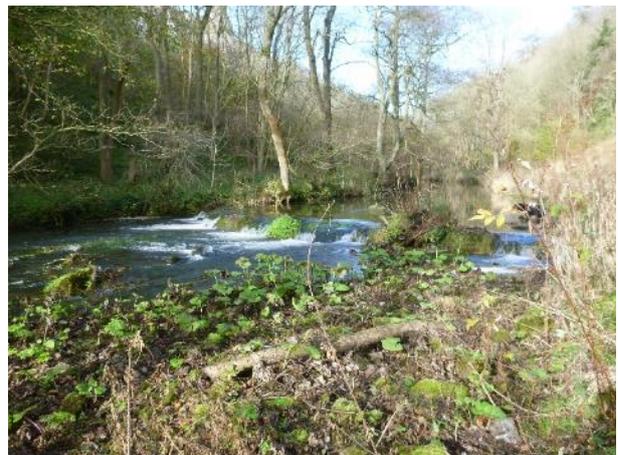
Weir built over natural boulders.

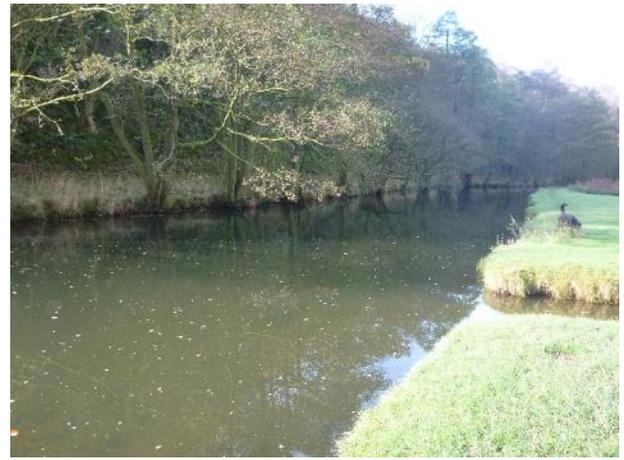
Long impoundment above this weir.
