# A clear solution for farmers

ENGLAND CATCHMENT SENSITIVE FARMING DELIVERY INITIATIVE

## Grange Farm, Tichbourne, Hampshire.

Case Study:

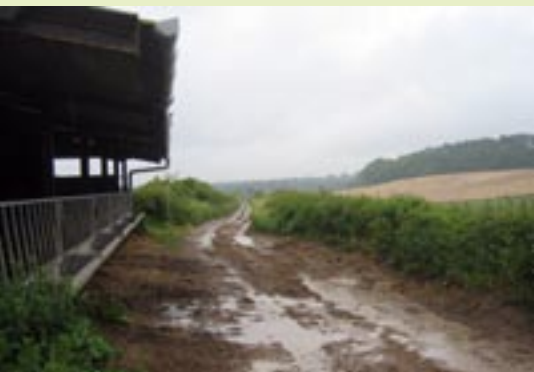
Figure 1. Cattle shed at the top of the track which contributed to the run off and contamination problems on the track – before improvements were made to the guttering

2. Kate and the farmer reduced run-off on the track by installing new guttering on the roof of the

cattle shed so that clean water could be diverted under the track. The entrance to the shed was moved to the side to reduce muck getting on the track. The farmer rotated the track (Fig 4) to reduce berms and ruts and cleaned out and re-profiled ditches to make blind ditches which stopped sediment running directly into the stream. (Fig. 7).

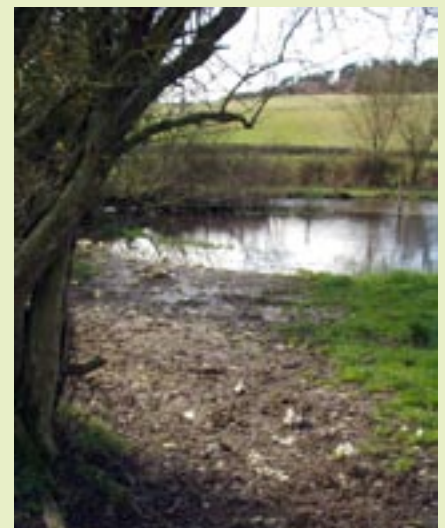
Figure 2. Cattle drinking bay prior to restoration

Grange Farm also has some of the steepest slopes in the catchment with silty soils prone to capping and run off to adjacent SSSI water meadows. Cattle from Grange Farm drinking from the stream, and freely accessing

it at crossing points were causing poaching, sediment loss and faecal deposition into the stream. Fencing large areas of riverbank was neither feasible nor desirable for landscape and biodiversity reasons.

1. Kate advised the farmer to fence two areas where the cattle drink and add two pumps to provide alternative drinking water to the stream. This provided the cattle with cleaner drinking water and reduced nutrient transfer into the stream.

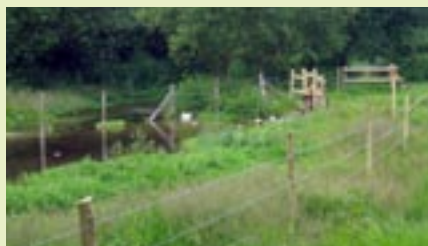
Figure 3. Drinking bay following fencing and pump installation

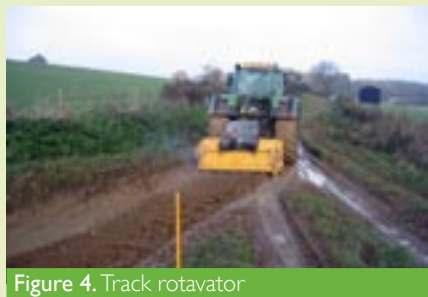
Figure 4. Track rotavator

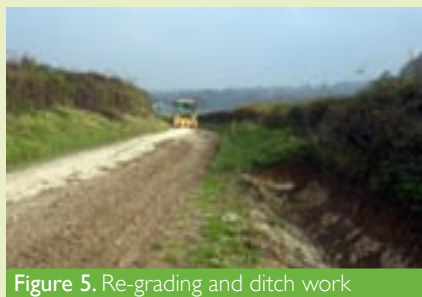
Figure 5. Re-grading and ditch work

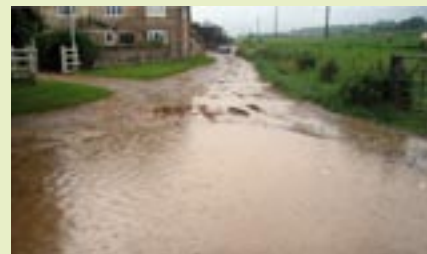
Manure, sediment and yard spillages were also washing into the stream off a farm track. Field run-off added to track pollution which then fed into a ditch and ended up in the river.

Figure 6. Runoff at bottom of track

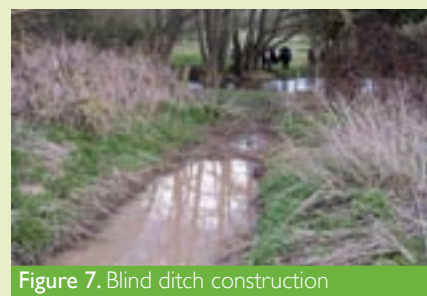
Figure 7. Blind ditch construction
